Wucho Fashion Ltd.

AFSAR UDDIN SHEIKH COMPLEX, HAZI LIAKAT, JAMGARA

3rd May 2018

Observations

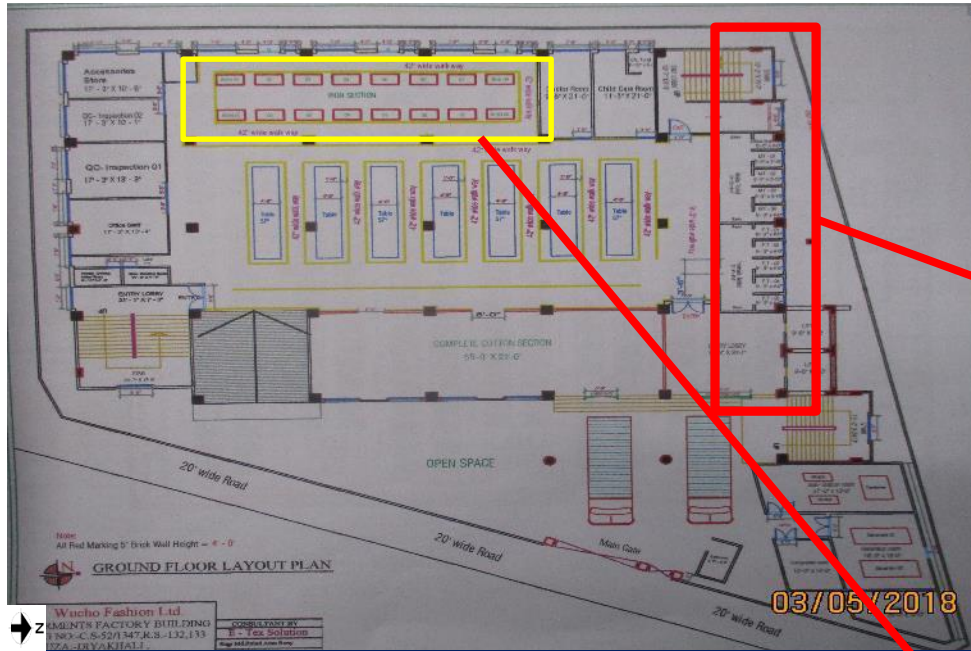
Typical floor layout plan

**Column stresses marginally exceeds the
normal design limit**

Cursory calculation indicates that columns appear to be stressed marginally above normal design limits considering floor built up loads and 3kPa live loads on typical floor.

Building engineer is required to review the column stresses and prepare allowable floor load plan.

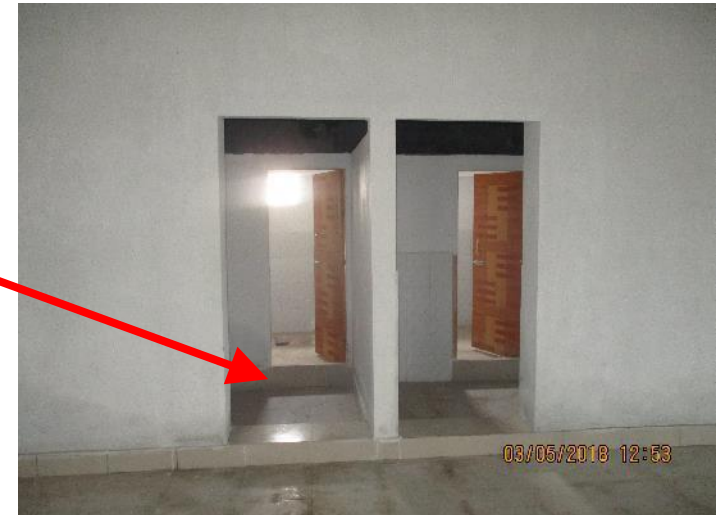
120~380 mm build up area in toilet zone.

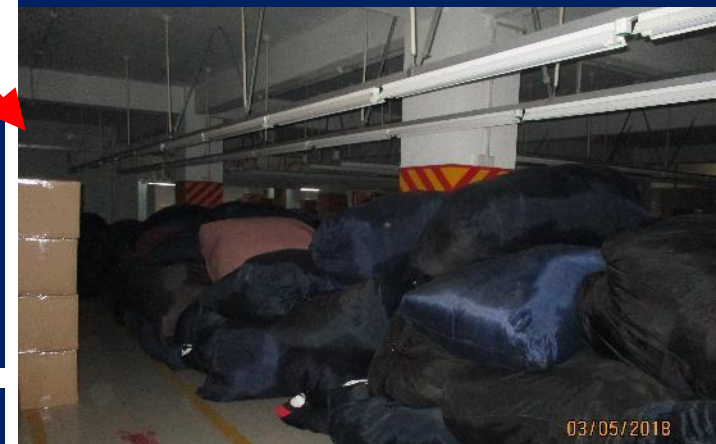
Uncontrolled loading exceeds 3 kPa

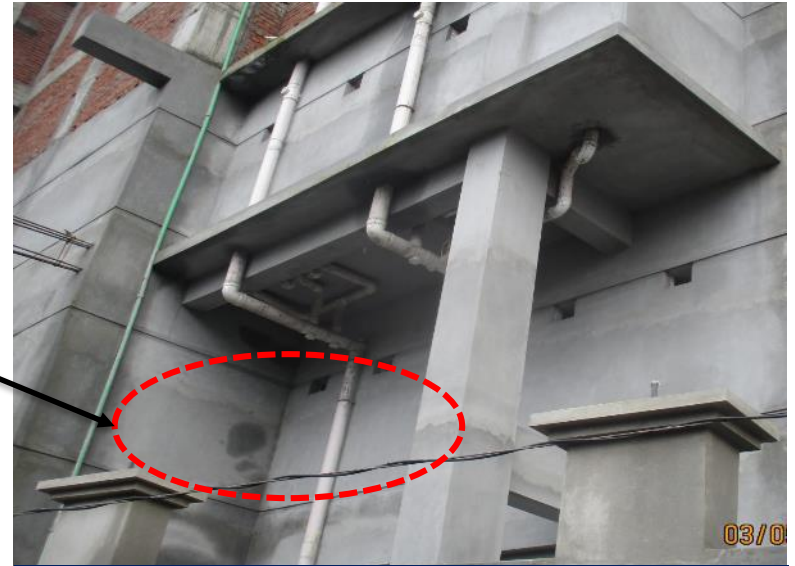
The marked beam was absent on 1st floor under south side toilet zone but the beam was shown in beam layout.

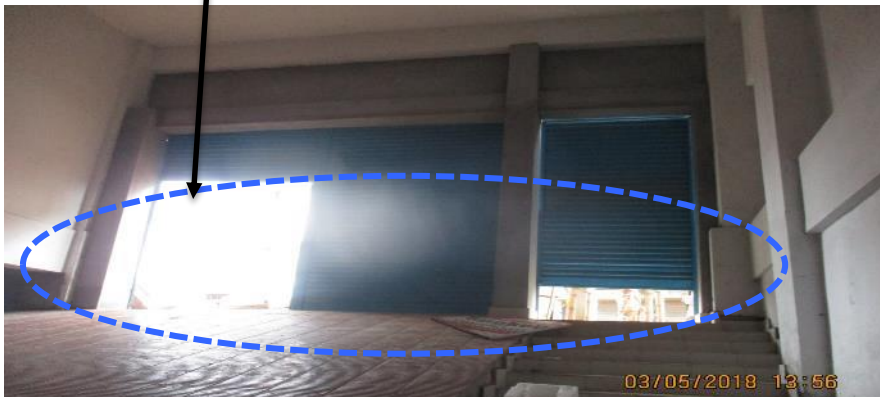
The marked beams were absent in basement floor on ramp area but the beam was shown in drawing.

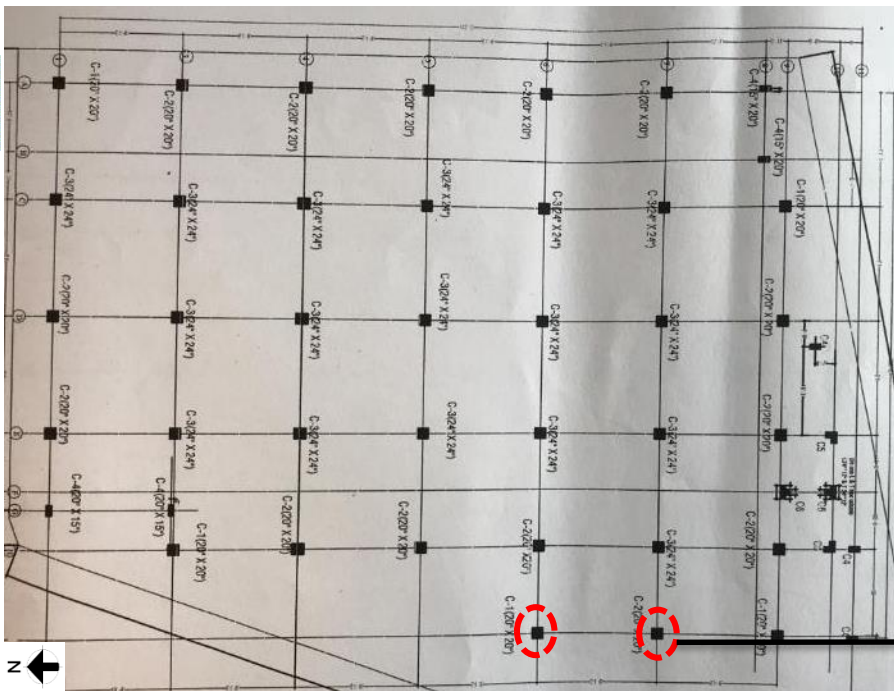
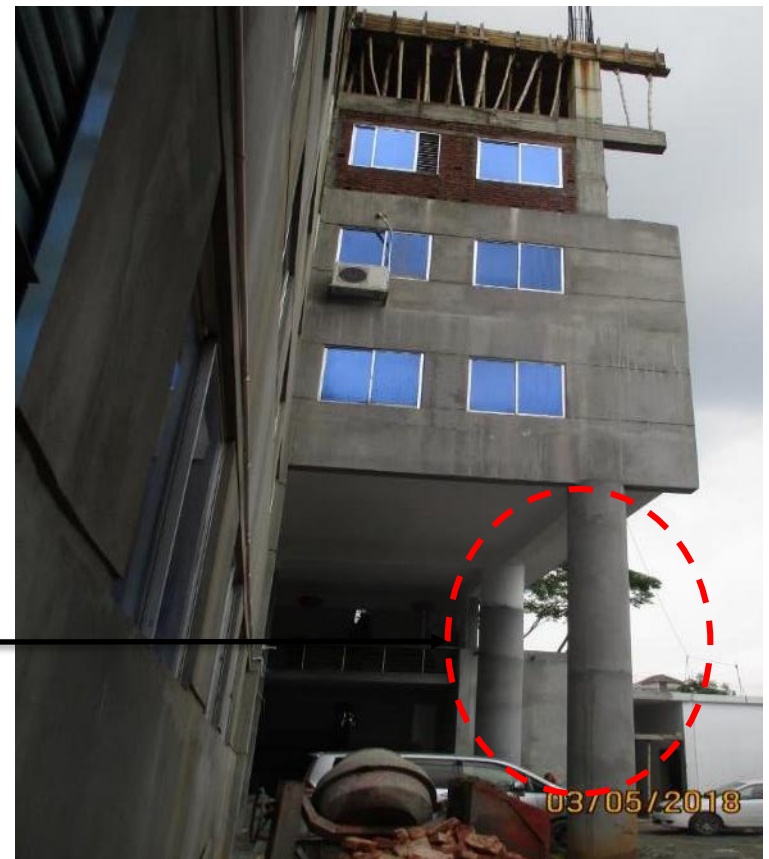
Column layout in provided drawing.

Circular columns were observed in marked position which continued up to 1st floor. But in column layout, C-1 and C-2 type rectangular columns were shown at the circular column's position. In addition, no detail of circular column was found in the column schedule.

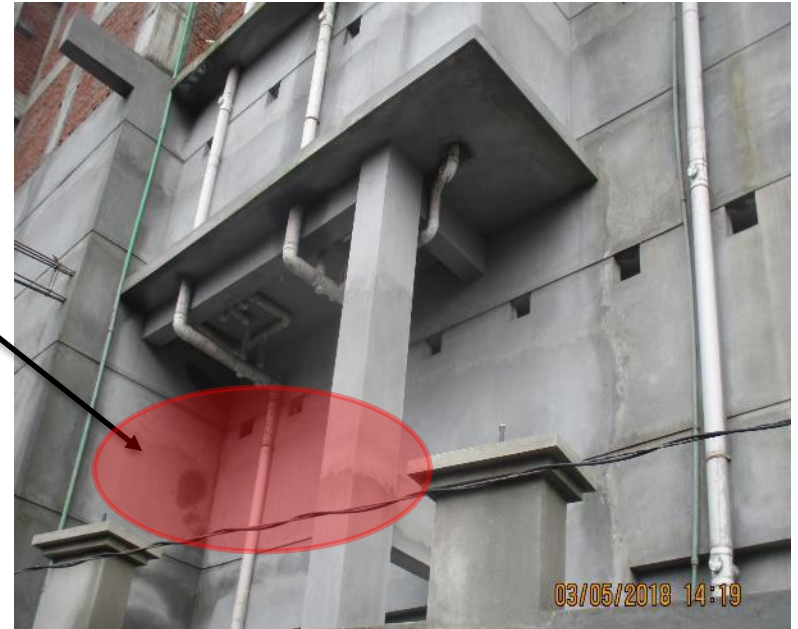
No slab was found under the toilet zone on 1st floor. Whereas, the slab was shown in slab detail drawing

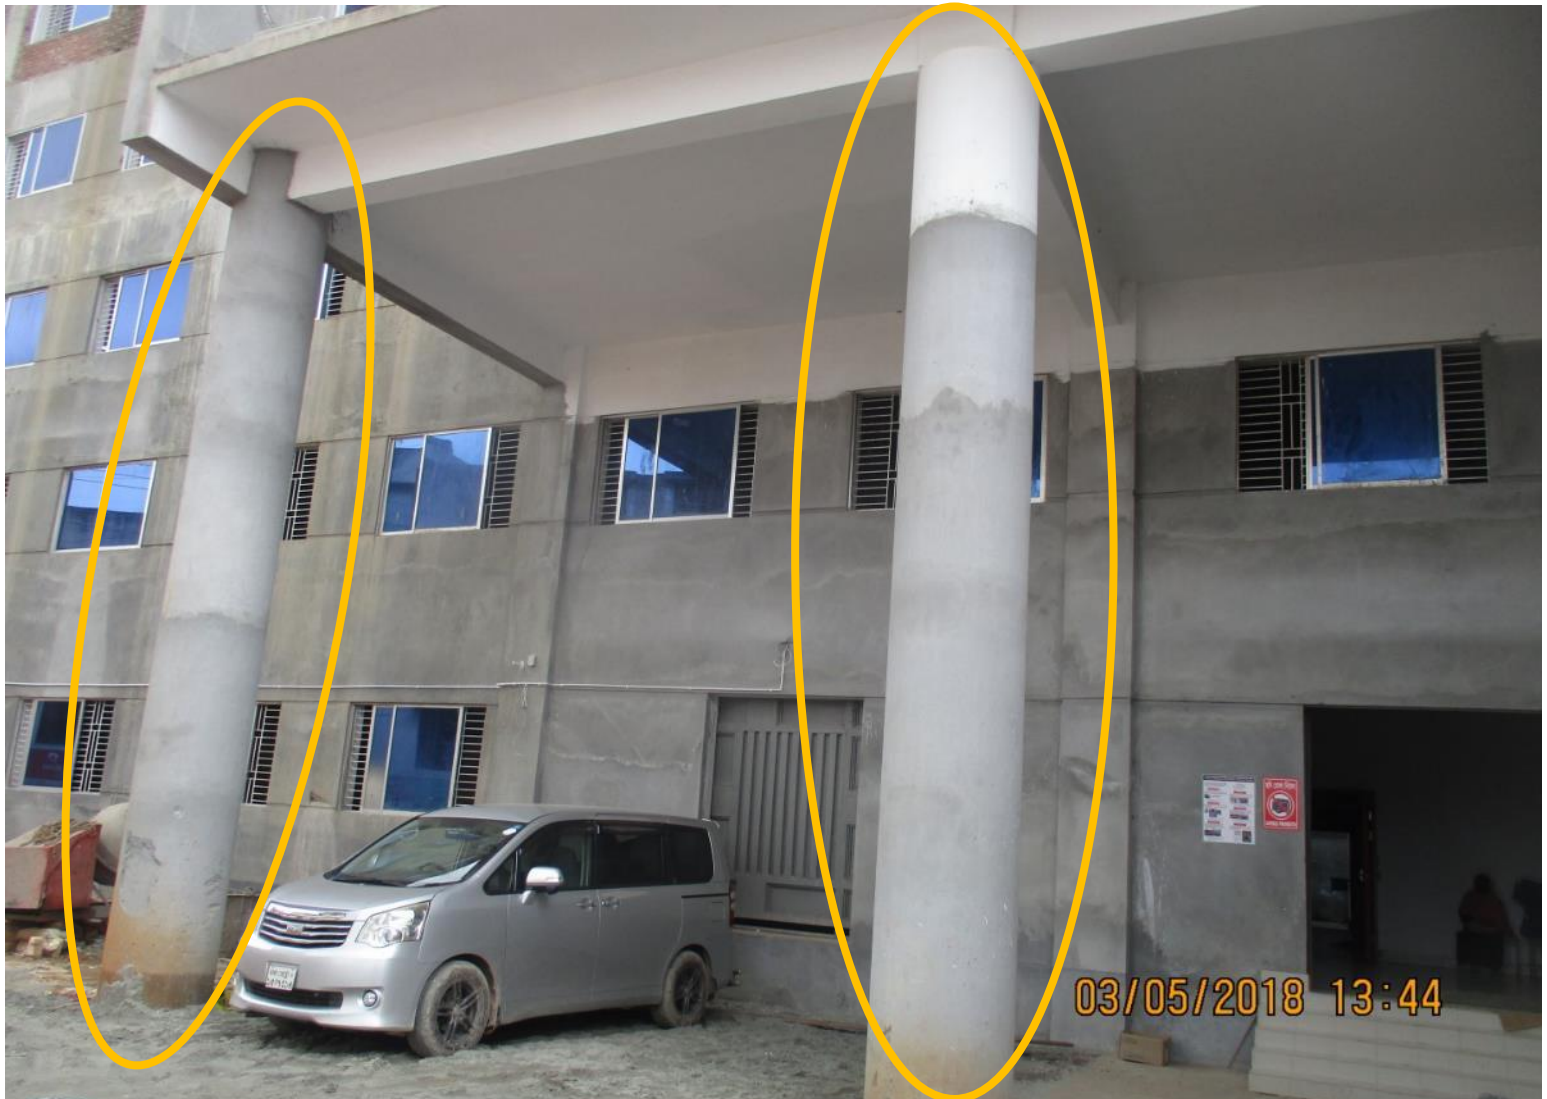
The highlighted columns is susceptible to vehicle impact. Building engineer is required to take necessary measures to protect the columns.

Item No.	Observation	Recommended Action Plan	Recommended Timeline
7	Columns susceptible to vehicle impact	Place protective barrier around susceptible columns.	6-weeks
8	Dampness observed on Basement wall	Building engineer is required to investigate the cause of the water ingress.	6-weeks
9	Dampness observed on Basement wall	Carry out remedial works as per recommendation of investigation report.	6-weeks
10	Railing missing on stair portion	Install railing properly to avoid falling hazard	6-weeks
11	Lack of as-built documentations	Factory engineer is required to survey and produce accurate as-built drawing as per actual condition.	6-weeks

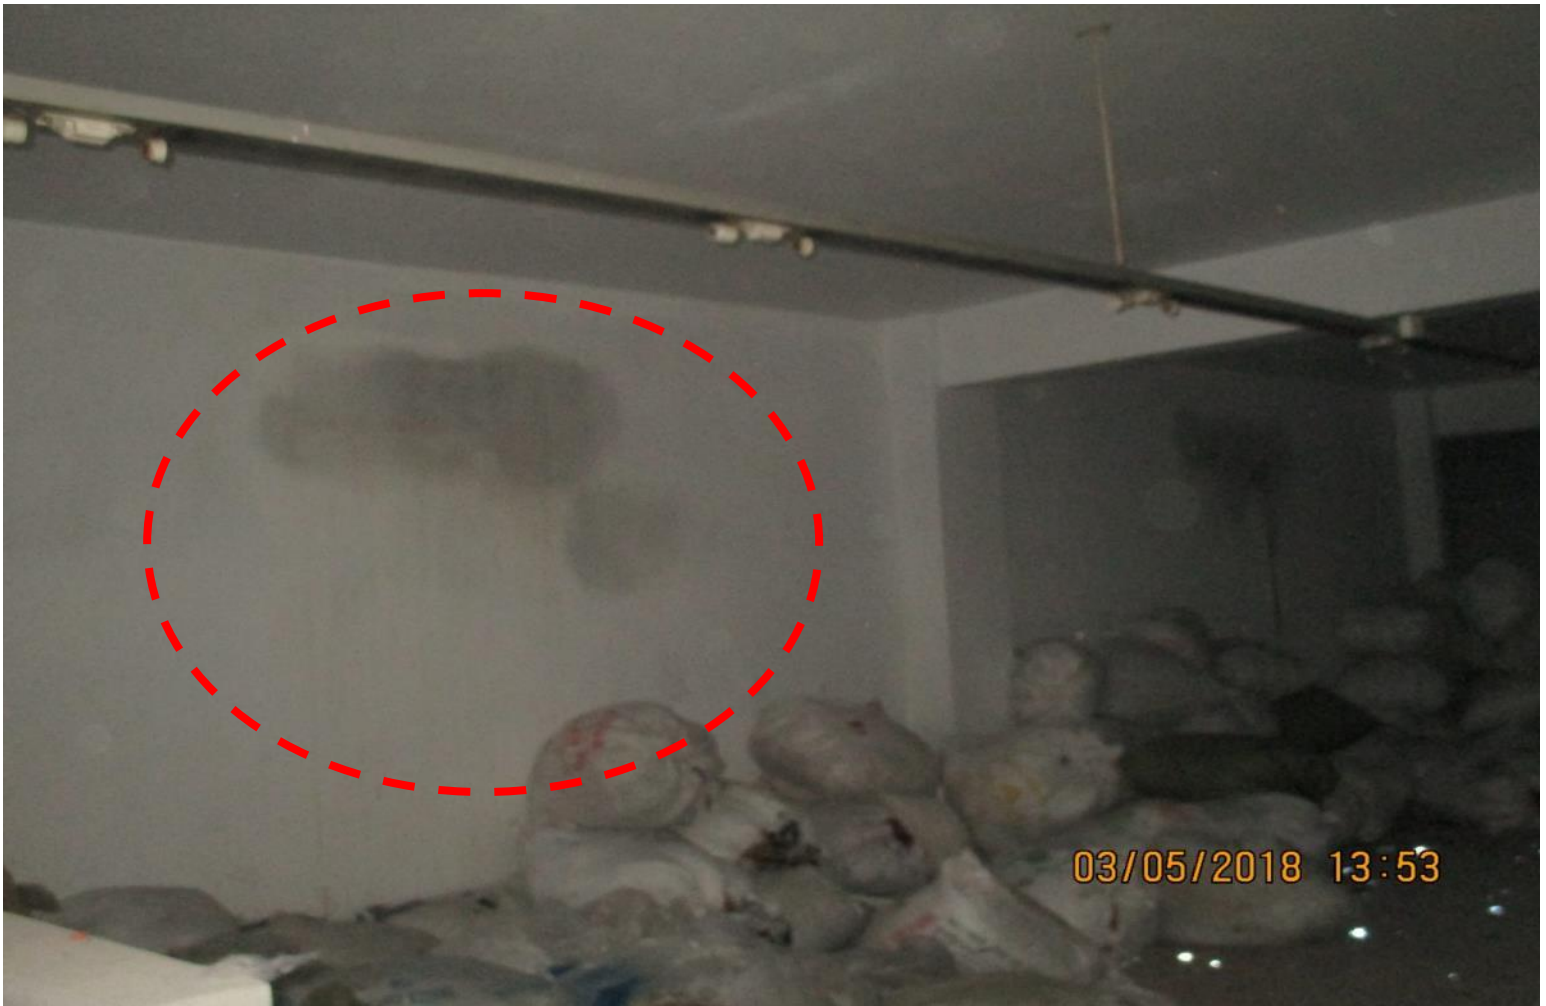
Dampness observed on Basement wall

Dampness observed on several places in the basement floor's wall. Building engineer is required to investigate the cause of the water ingress and the check whether the retaining walls have sufficient structural capacity.

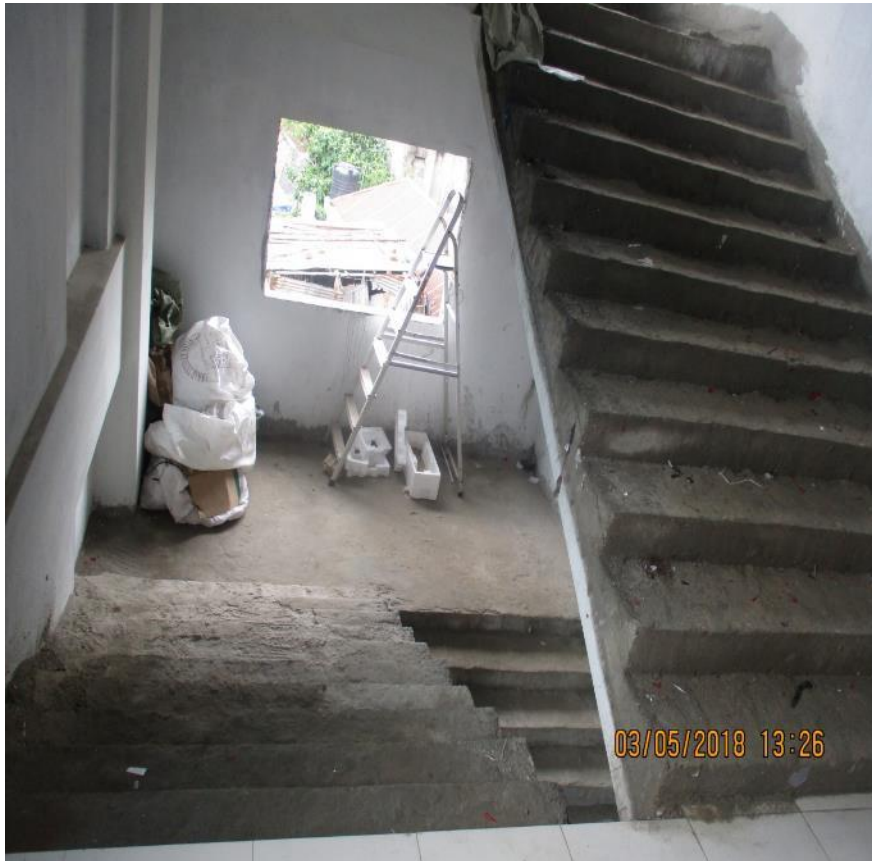
South-East stair case portion.

Railing was missing on both stair portion above 1st floor. Factory is required to install railing to avoid falling hazard.

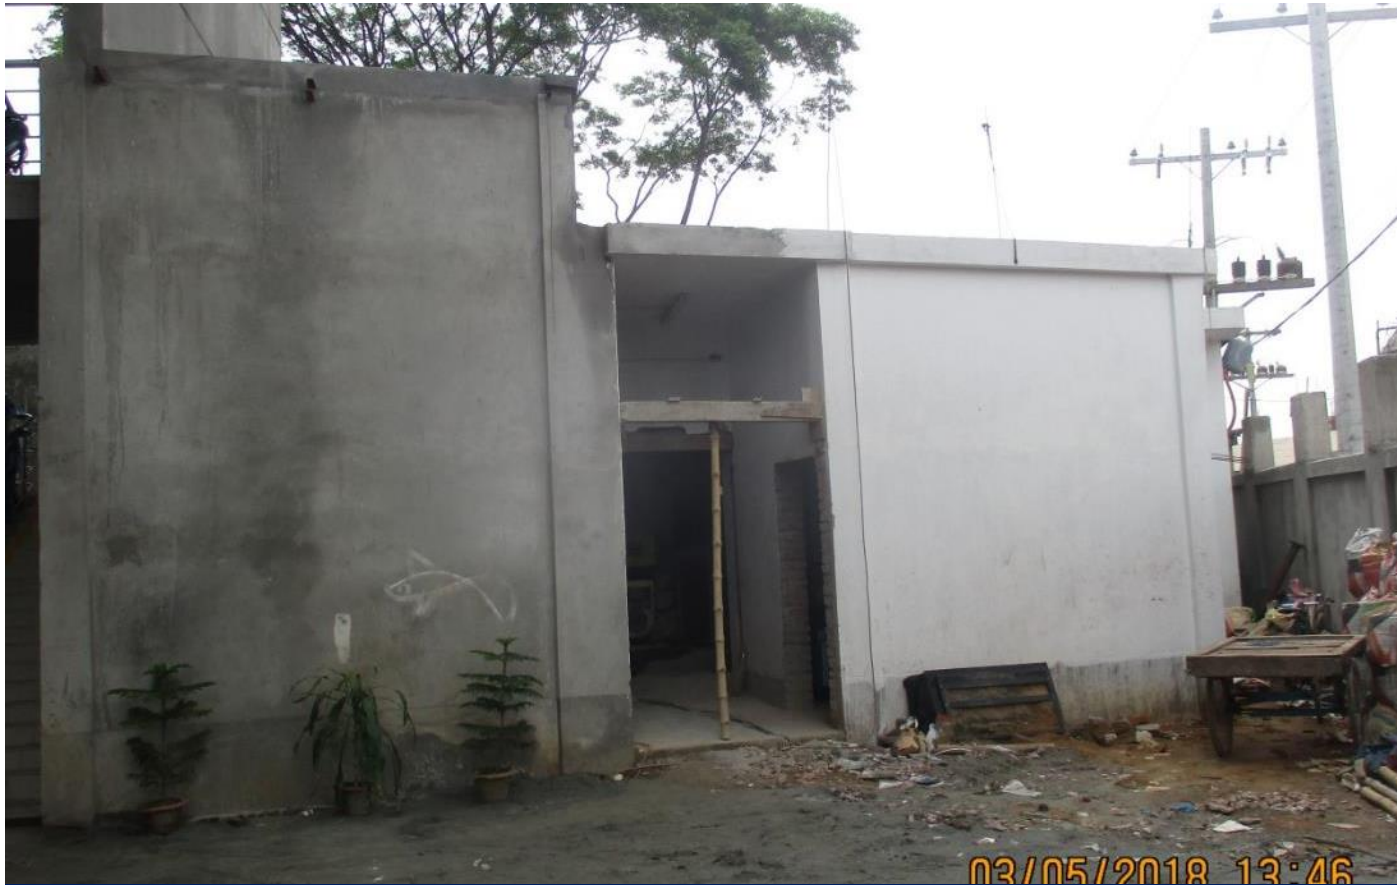
No drawings for utility building

No drawings were available for utility building. Factory Engineer is required to produce a full set of as built drawing reflecting on site condition for the building.
