# AB Apparels Ltd

225, Singair Road, Hemayetpur, Savar, Bangladesh.

9<sup>th</sup> November, 2016

# Observations

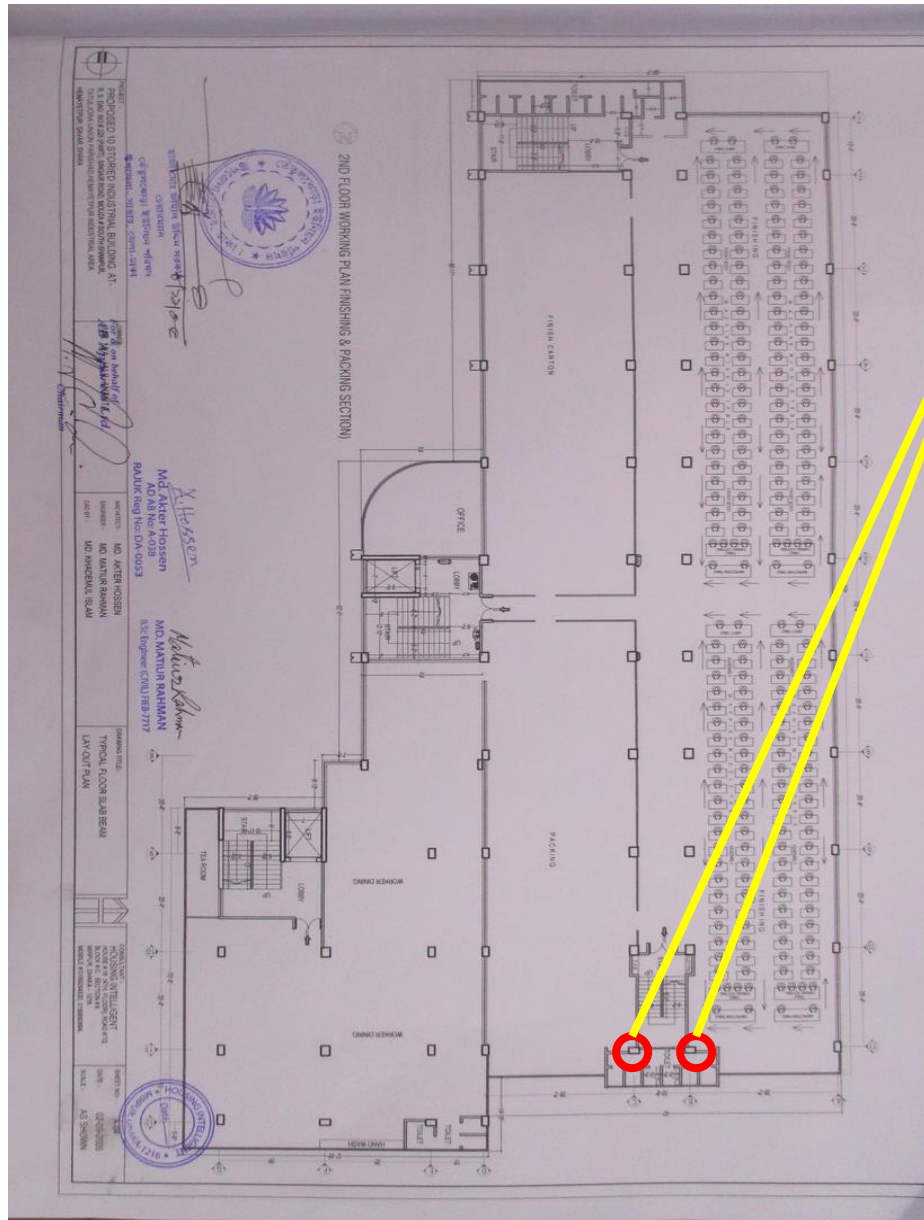
# High Stressed Columns in Building.

Based on the load  
rundown analysis with  
the agreed minimum  
design live load  
assignment, the column  
at the circled area has  
been found to possess  
very low factor of safety  
with respect to its load  
carrying capacity, giving  
a firm AMBER warning.

| Item No. | Observation | Recommended Action Plan | Recommended Timeline |
|---|---|---|---|
| 1 | High Stressed Columns in Building. | Verify in-situ concrete strength (using min. 4 nos. 100mm dia. Cores and/or assessment of available concrete strength data) and as constructed reinforcement for all columns from 1st phase of construction (Preferably from Ground Floor) . | <b>Immediate - Now</b> |
| 2 | High Stressed Columns in Building. | Factory Engineer to review design, loads and column stresses for all columns. Detail Engineering Assessment of as built structure to be commenced as per attached scope. | <b>6-weeks</b> |
| 3 | High Stressed Columns in Building. | Produce and actively manage a loading plan for all floors within the building giving consideration to floor capacity and column capacity. | <b>6-weeks</b> |
| 4 | High Stressed Columns in Building. | Continue to implement load plan. | <b>6-months</b> |
| 5 | High Stressed Columns in Building. | Implement strengthening measures where required by the DEA. | <b>6-months</b> |

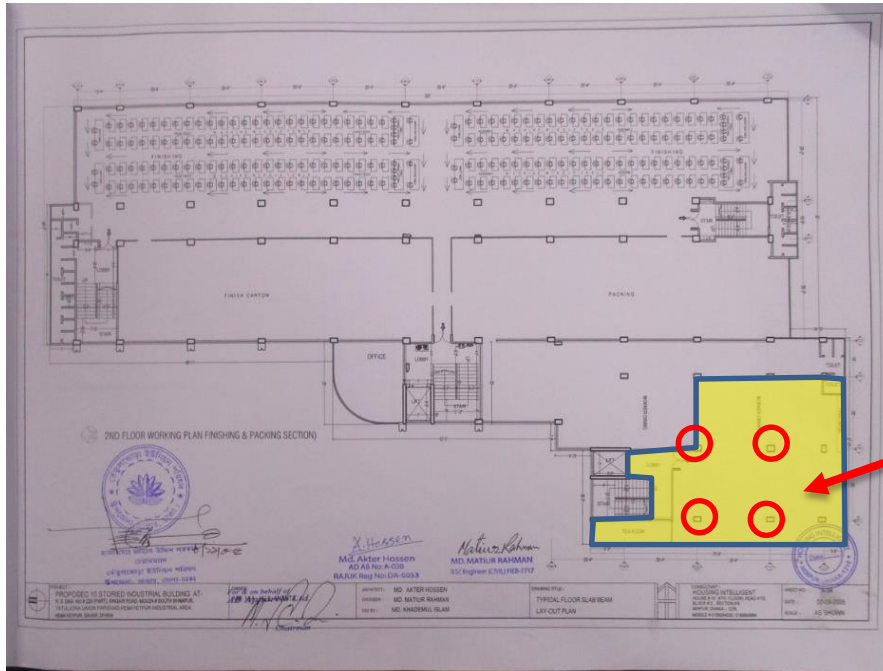
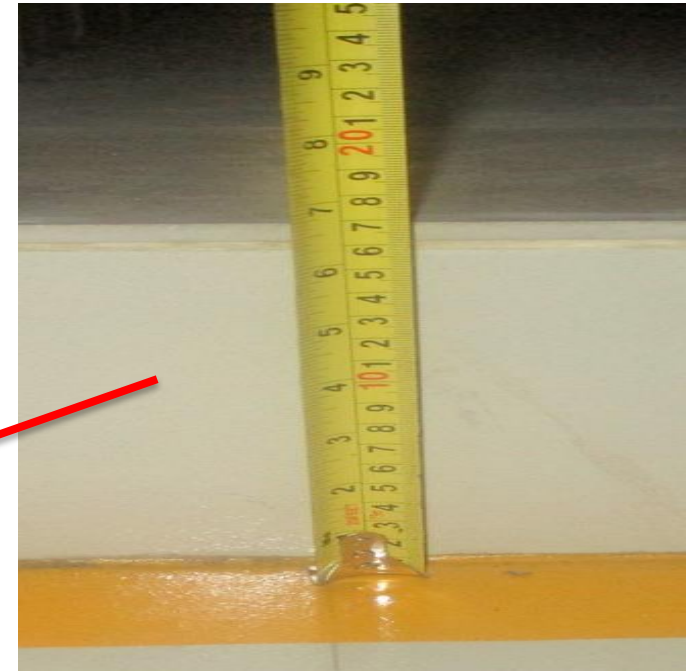
Build up found on the highlighted area of 2<sup>nd</sup> Floor. High Stack of finished goods have been observed.

Based on analysis by considering live loads according to load plan and build up loads, highlighted column stresses are found below normal design limit.

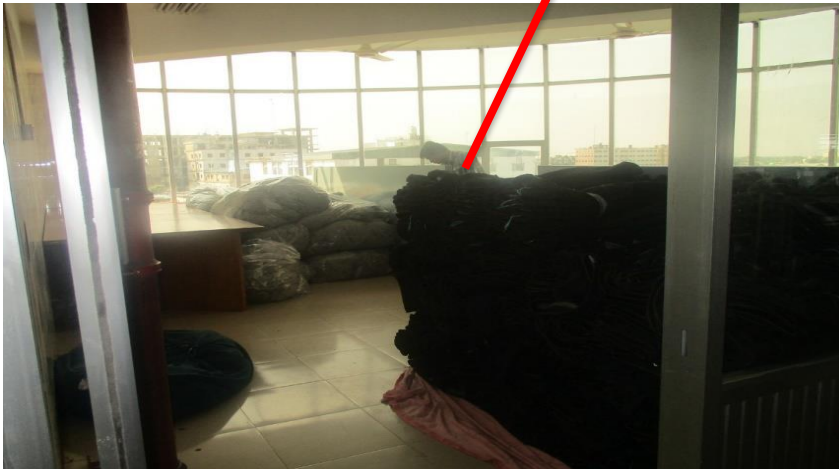
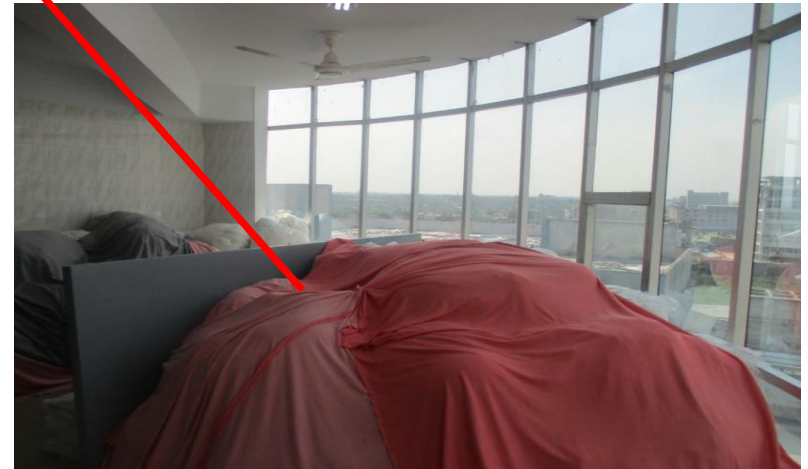
High Stack of Fabric Roll has been observed on 1<sup>st</sup> Floor.

| Item No. | Observation | Recommended Action Plan | Recommended Timeline |
|---|---|---|---|
| 6 | Localized area of high loading | Produce and actively manage a loading plan for all floor plates within the factory giving consideration to floor capacity and column capacity. | <b>6-weeks</b> |
| 7 | Localized area of high loading | Continue to implement load plan. | <b>6-months</b> |

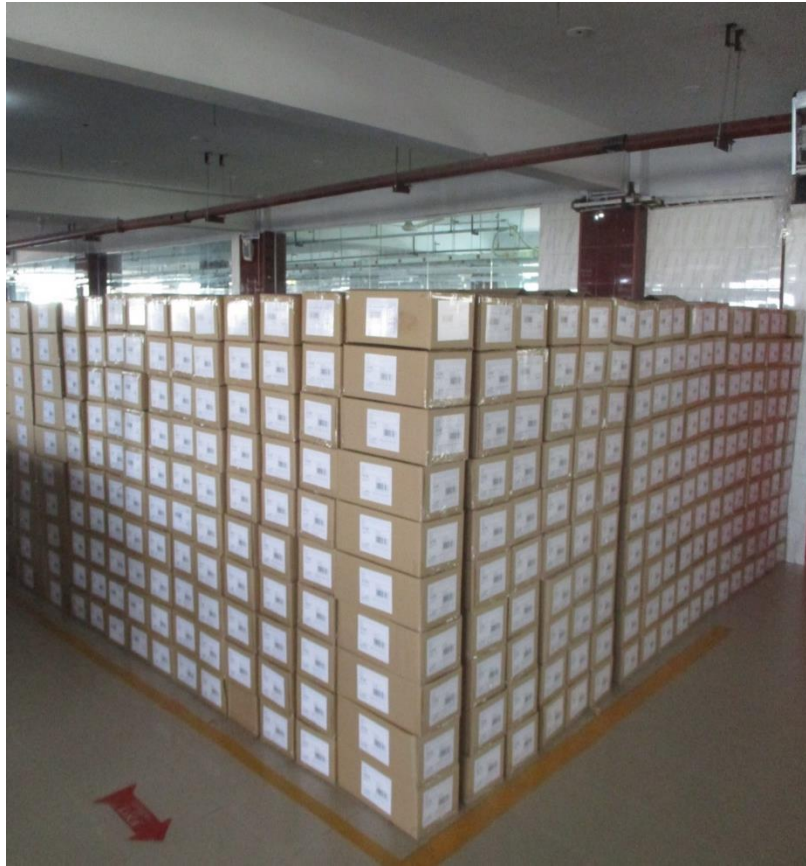
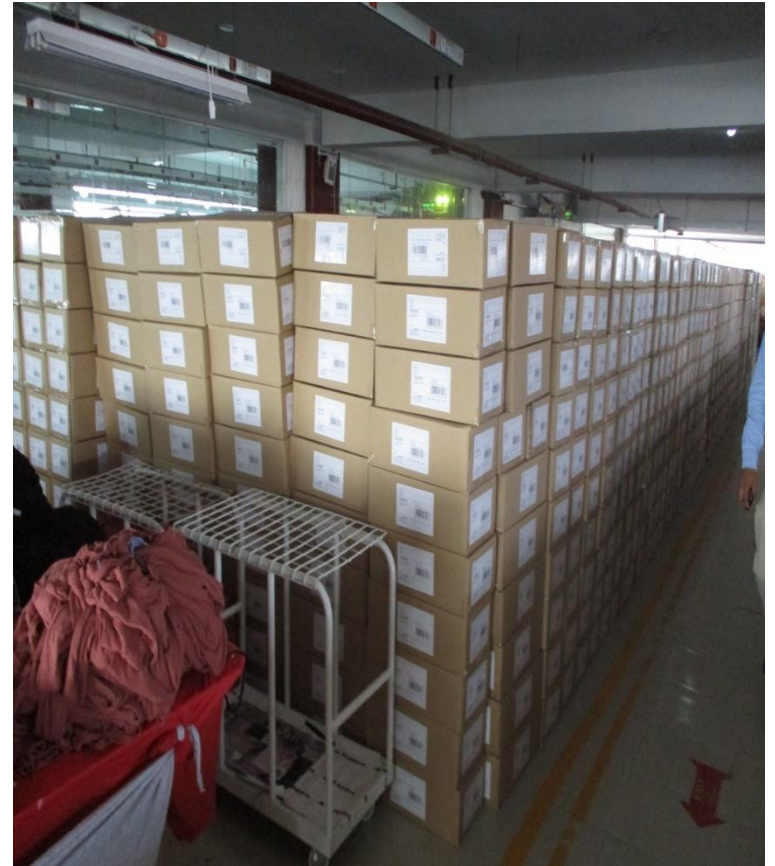
High Stack of finished goods observed on 6<sup>th</sup> Floor.

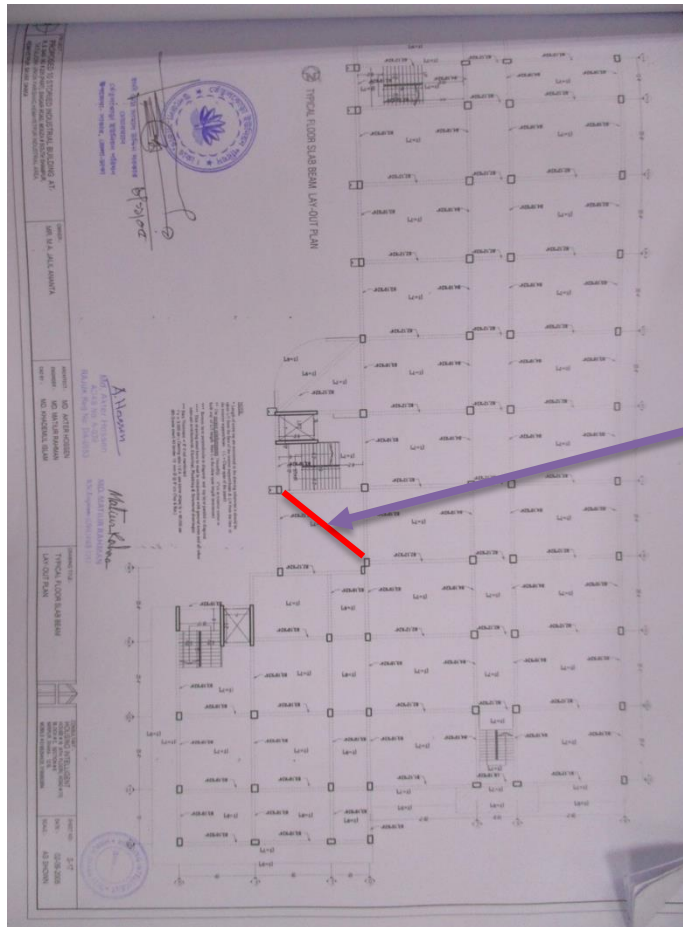
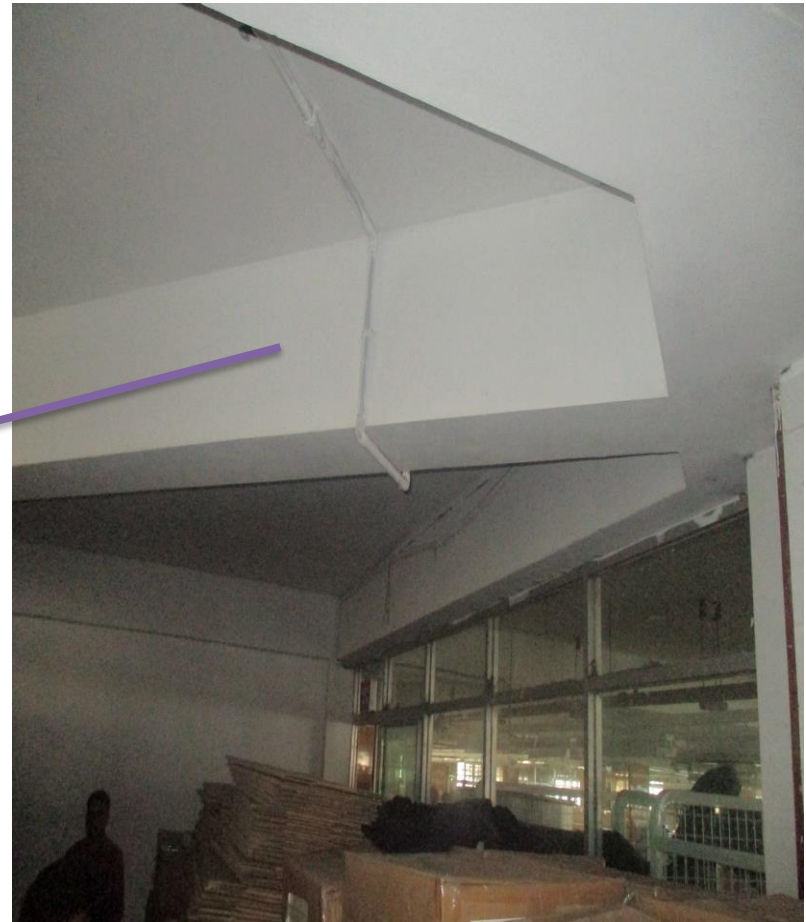
A inclined beam was found on 3<sup>rd</sup> Floor level which was not mentioned on beam layout

| Item No. | Observation | Recommended Action Plan | Recommended Timeline |
|---|---|---|---|
| 8 | Inconsistencies between permit drawings and as-built structures | As part of the DEA comprehensive As-Built drawings are to be produced. | 6-weeks |

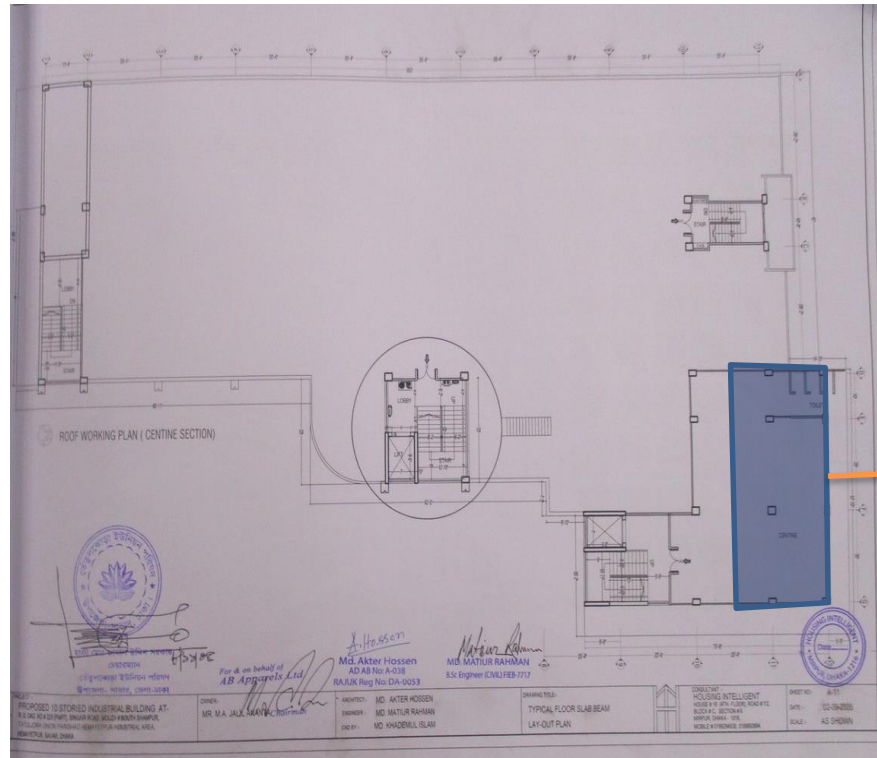
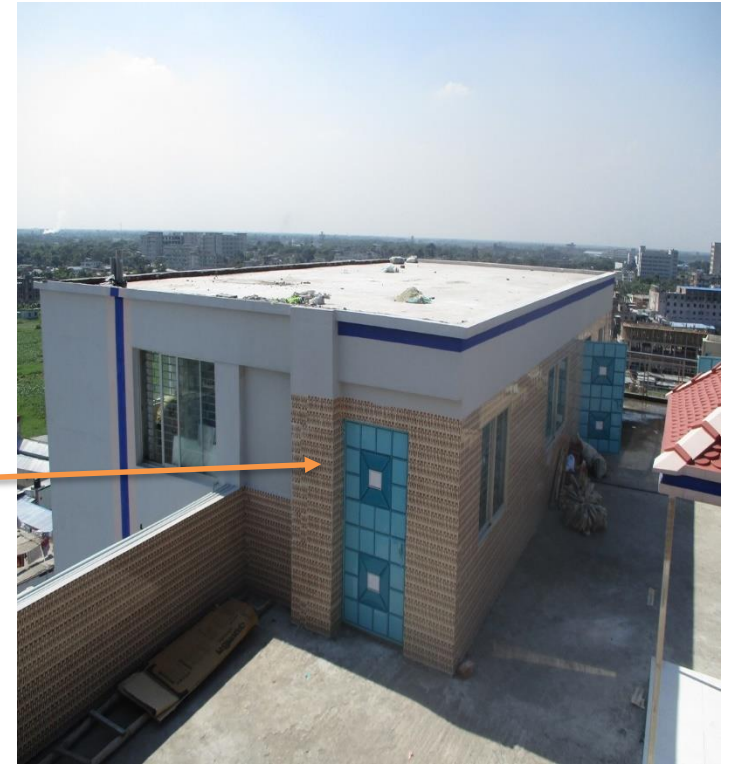
Mismatch found in As Built Drawing of Roof

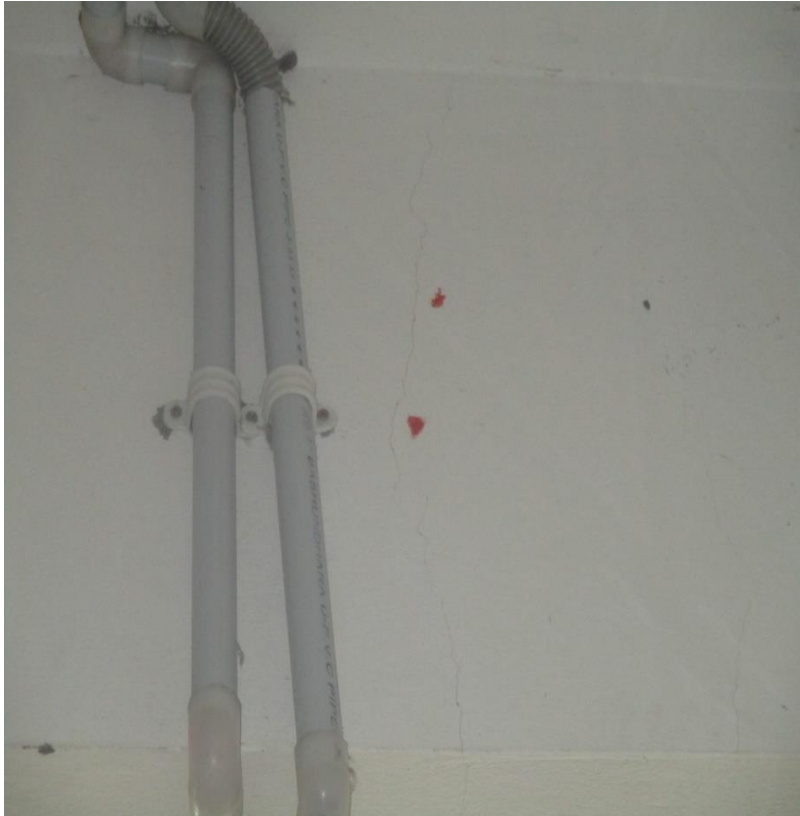
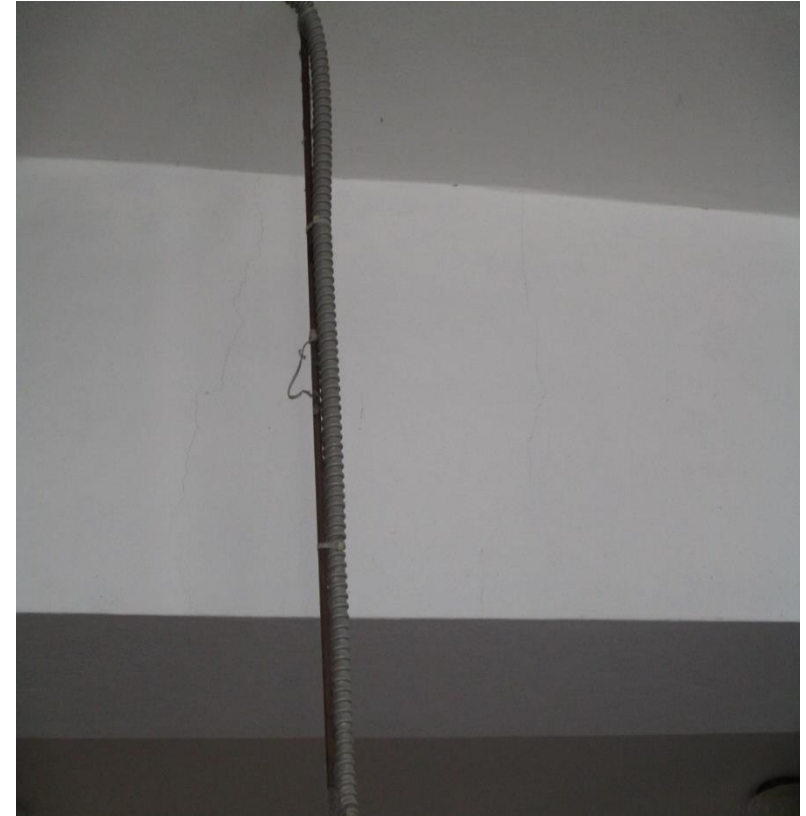
Hairline cracks found in beam and slab soffits in almost every floor. The cause of cracking must be checked and suggested if the slab is adequate to bear loading from upper floor.

| Item No. | Observation | Recommended Action Plan | Recommended Timeline |
|---|---|---|---|
| 9 | Hairline cracks on beam | Sections of plaster finish to beams and slab to be removed to investigate if cracks penetrate the building structure. | 6-weeks |
| 10 | Hairline cracks on beam | As part of the Detail Engineering Assessment (see Item 1), Building Engineer to carry out design check on beams and slab taking into account the effect of the cracks on the structure | 6-weeks |
| 11 | Hairline cracks on beam | Carry out any structural remedial works to cracks as required following assessment. | 6-months |

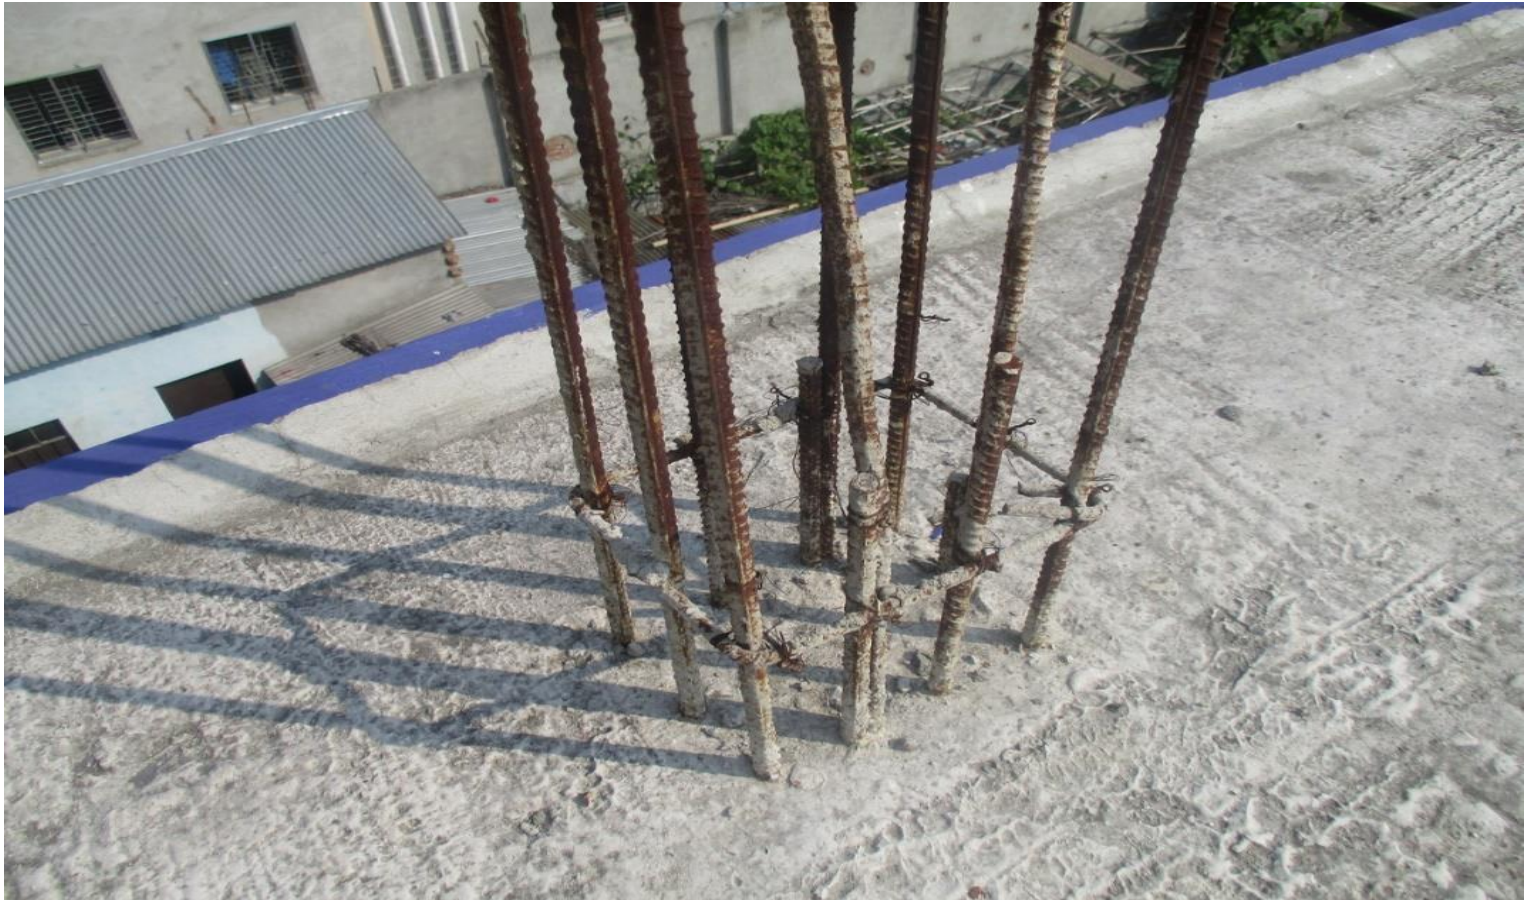
The rebar on roof of the Utility Building found to be exposed which might me corroded in future if not covered

| Item No. | Observation | Recommended Action Plan | Recommended Timeline |
|---|---|---|---|
| 12 | Exposed Bar on roof | provide proper rust proof material. | 6-weeks |

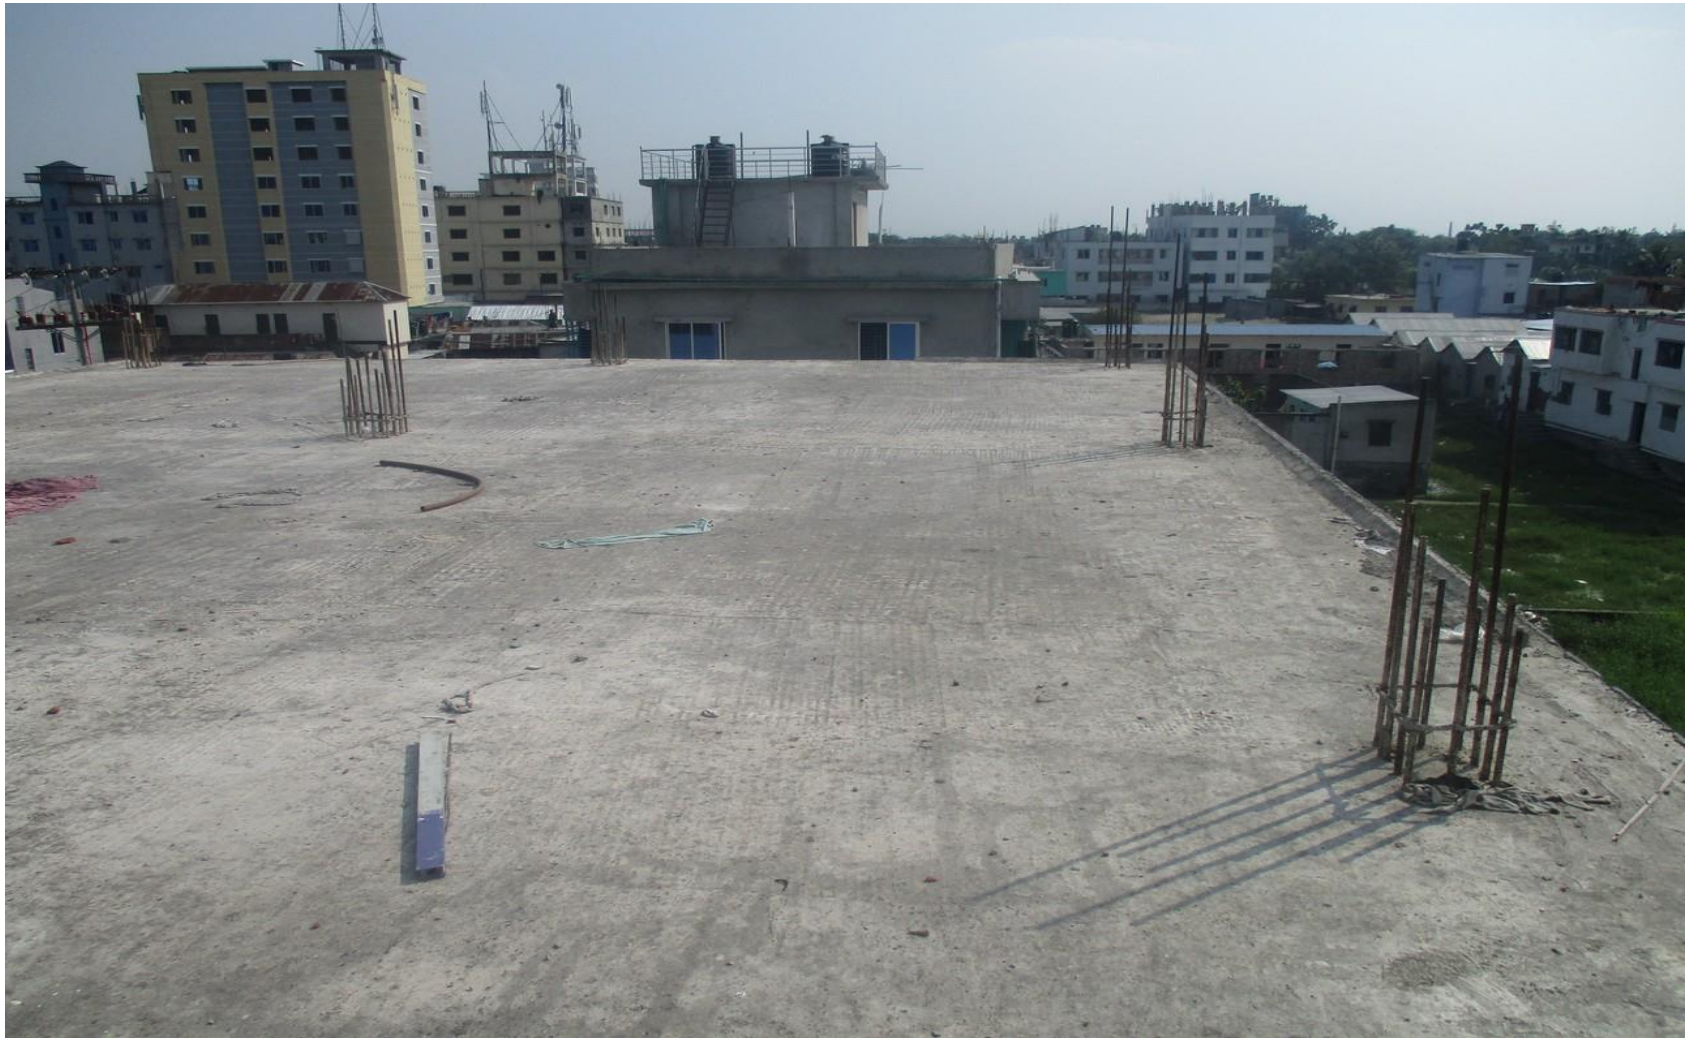
No Edge protection system ( handrail/ Parapet wall) has been provided on the roof of the Utility Building

| Item No. | Observation | Recommended Action Plan | Recommended Timeline |
|---|---|---|---|
| 13 | No Edge protection system | Provide proper edge protection on roof. | 6-weeks |
