**Manta Apparel Ltd (10302)**  
**Envoy Fashions Ltd (10109)**  
**Envoy Design Ltd (11277)**

Daikhali, Yearpur, Jamgara, Savar, Dhaka

07.April.2014

**ACCORD**  
on Fire and Building Safety in Bangladesh

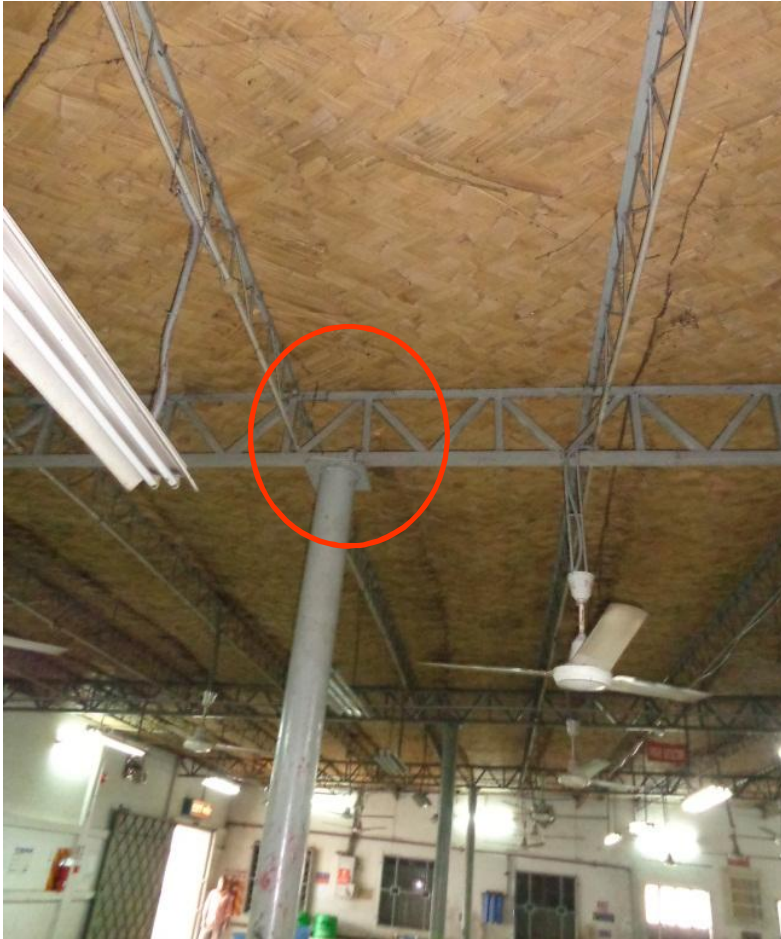
1<sup>st</sup> Priority 1  
Concern

Inadequate detailing  
of steel truss at  
column supports.  
Full engineering  
assessment of shed  
required

Inadequate detailing of steel shed truss column supports.

- Carry out an engineering assessment to determine the stability and capacity of roof.

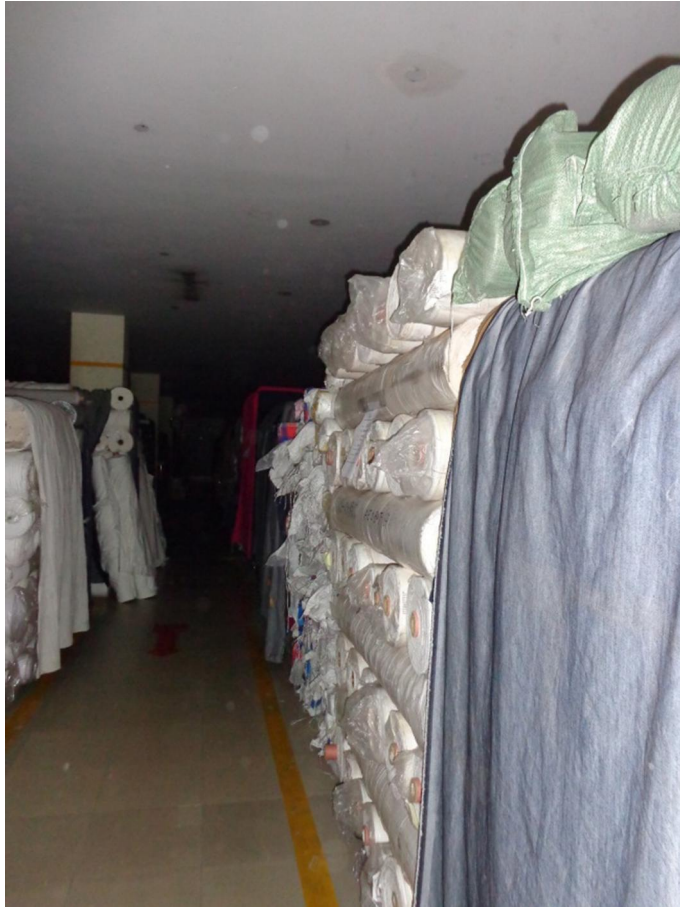
The ground floor is used to store stock up to approximately 2.5m height. Record drawings show this to be a 178mm thick slab spanning 6700mm between ground beams.

Rolls of yarn stored on suspended slab approximate height 2.5m. Load path is unclear due to lack of detailing of the foundations and ground beams.

Suspended ground floor is used for storage of yarn.

- Carry out an engineering assessment to determine the capacity of the slab and the current loading. Investigation of soil stiffness and load distribution should be done to better define load path.

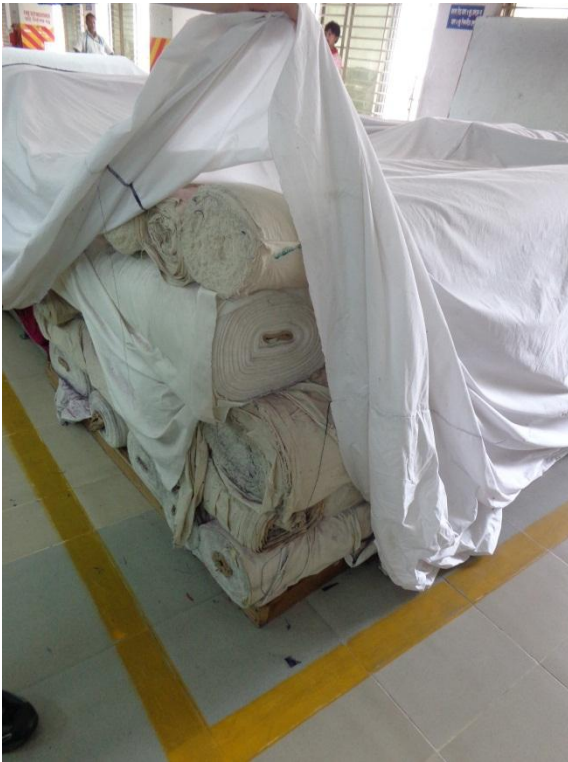
Storage of yarn rolls on the third floor slab. No loading plan visible.

A section of the third floor slab is used for storage of yarn.

- Produce and actively manage a loading plan for all floor plates within the factory giving consideration to floor capacity and column capacity.

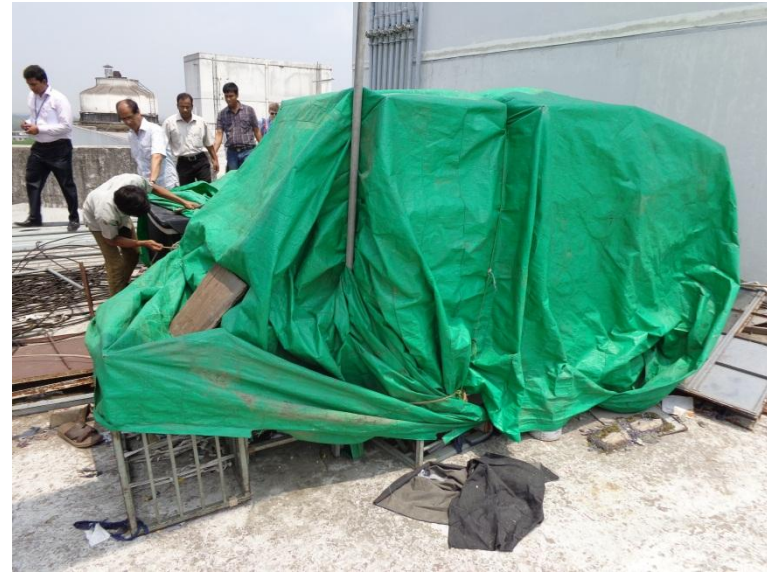
Storage of rubbish on the roof

Rubbish and storage on roof.

- Remove all rubbish and stored items on roof and do not use roof for storage.

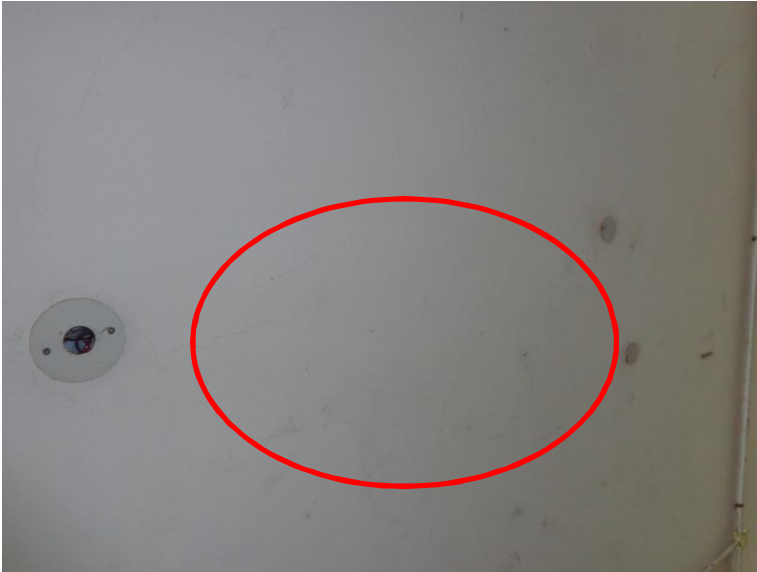
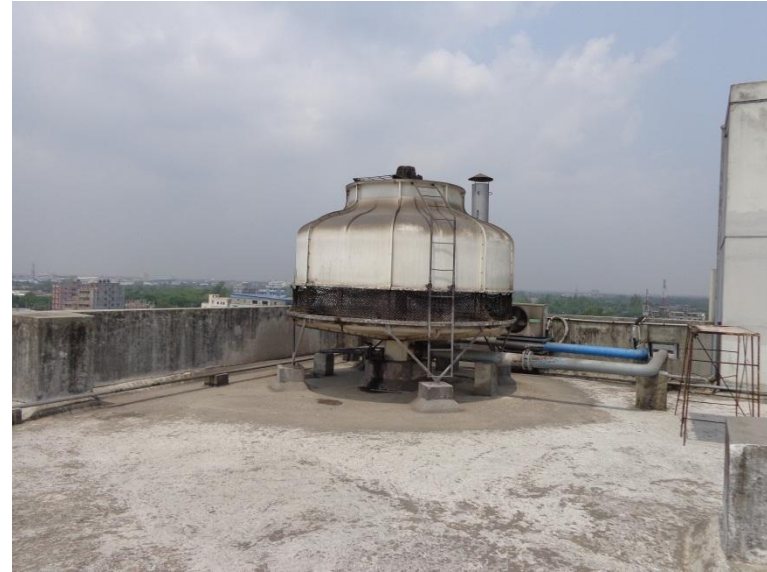
Apparent cracking to soffit of slab directly below water cooling plant. Weight could not be confirmed.

Cracked soffit of slab below water cooler on North West corner of roof.

- Carry out an engineering assessment to determine the capacity of the slab and the current loading.

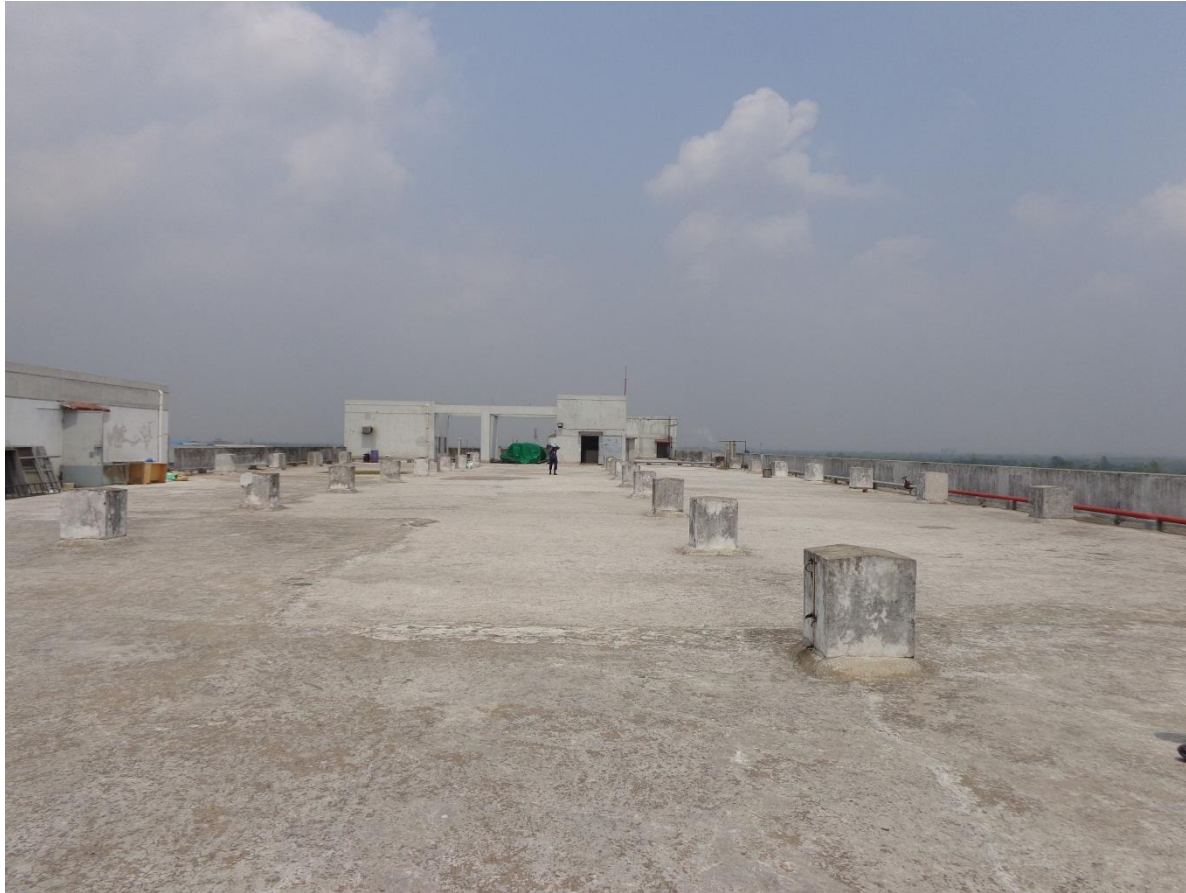
No waterproofing membrane was visible on the roof of the building. This means that any cracks in the surface finishes on the roof will allow water to seep into the concrete slab beneath the finishes, and cause long-term soaking of the slab.

Roof appears not to have any waterproofing system applied.

- Consider applying a new waterproofing membrane.

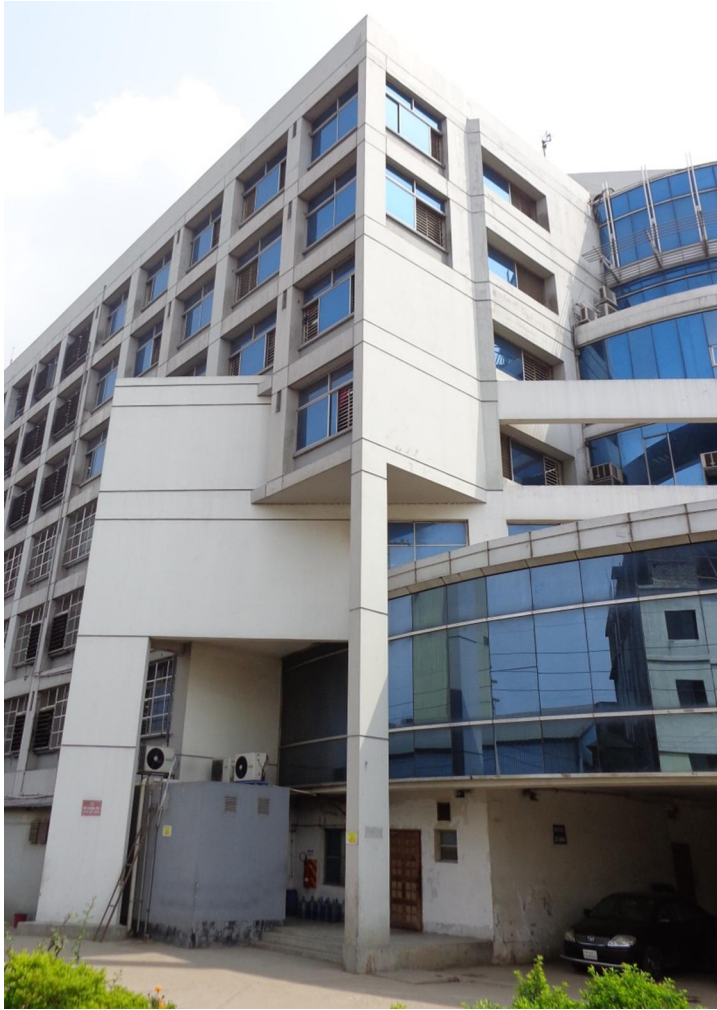
Column is unrestrained at 2 floors. Although not very loaded, this column may be unstable under second order effects (P-Delta).

Perimeter column appears to have a big slenderness ratio

- Engineer should verify slenderness ratio of column and verify possible instability with regards to second order effects (P-Delta).

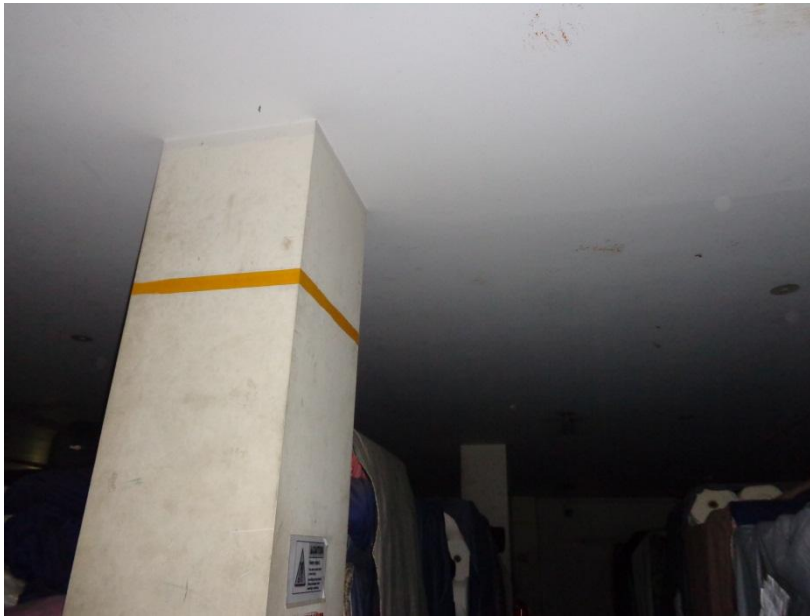
The building has four stairwells and two lift shafts, these walls are 250mm thick concrete.

Brick walls infills cannot be considered in the lateral load resisting system as they are not restrained.

Sway stability could also be expected from the 330mm slab working with the 610 sq

We require that these items be investigated in a Detail Engineering Assessment
