# Saturn Textiles Ltd.(Woven)

2/6, Darul Ahsan Road, Ausepara, Tongi, Gazipur, Bangladesh  
(+28.81063N, 90.357294E)

21 September 2013

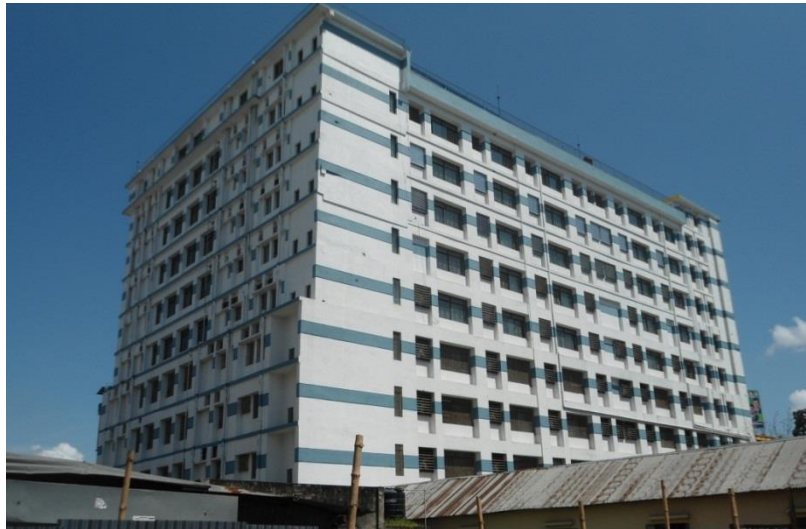
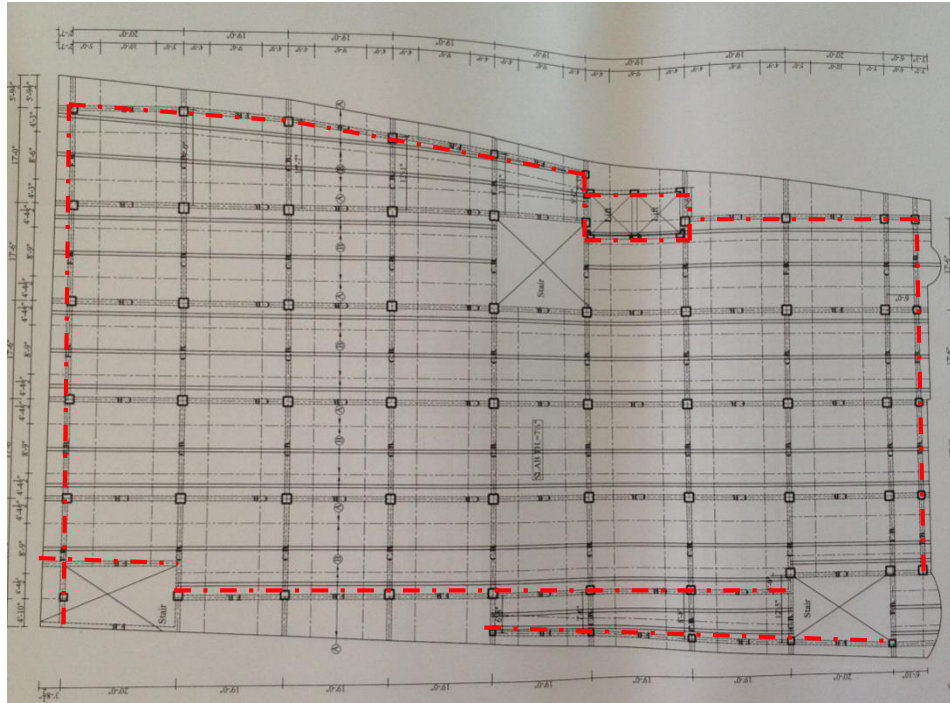
# Stability system lower 4th floor

R. C. Flat slabs and columns  
Moment frame stability system  
at edges.

Frames disappear lower 4<sup>th</sup>  
floor. Stability below 4<sup>th</sup> floor is  
apported by column-slab  
moment frame effect.

**ITEM 2:** Moment Frame stability system missed below 4th floor

Building Engineer must carry  
out a stability analysis of the  
full 10 storey building.

| Item No. | Observation | Recommended Action Plan | Recommended Timeline |
|---|---|---|---|
| 4 | Moment Frame stability system missed below 4th floor | The Engineer's drawings show an 10 storey building comprising reinforced concrete flat slab construction from 1st to 9th floor with downstand beams at edge and solid slabs with beams at G.F. and roof. Edge downstand beams has not been constructed between 1st to 4th floor. Building's Engineer must carry out a stability analysis of the full 10 storey building and propose additional stability system if necessary | 6-weeks |

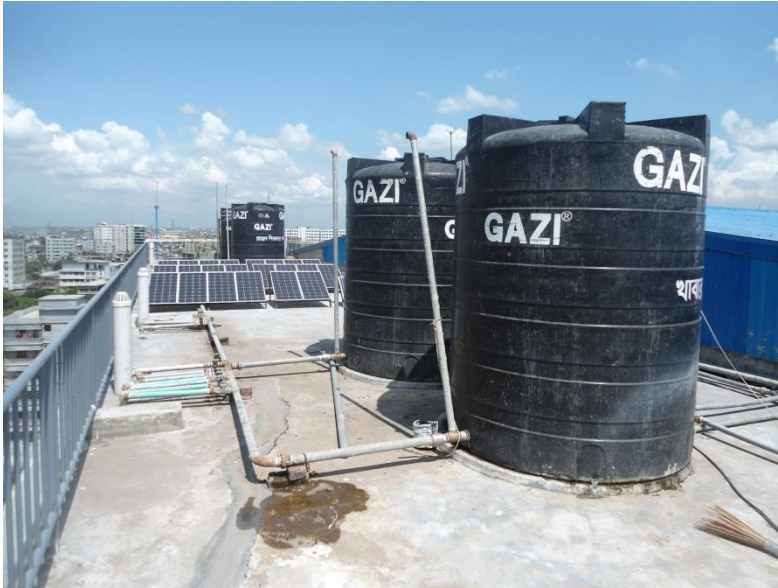
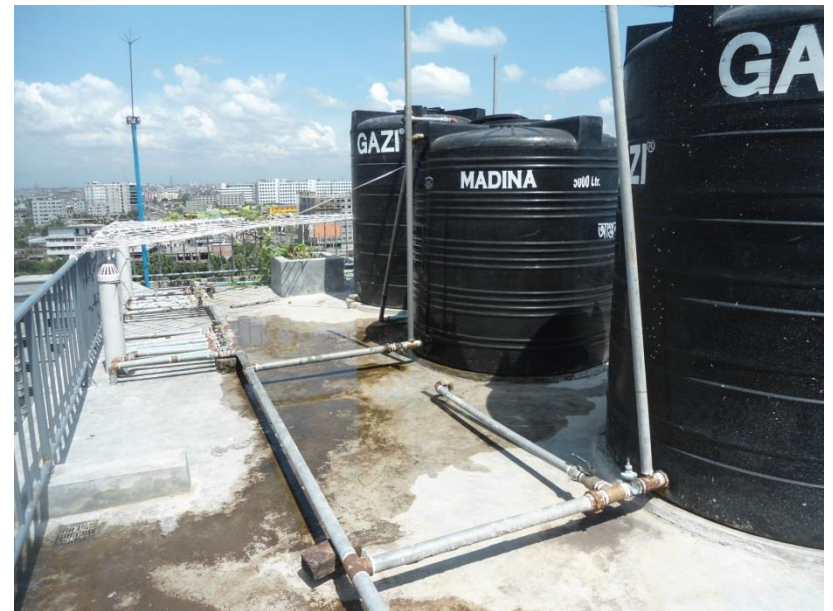
Five 5000 litres water tanks mounted on small concrete plinths

**ITEM 3:** Check on roof structure from localized high loading from water tanks required.

Building Engineer to check that beam and slab have been designed to accommodate loads.

| Item No. | Observation | Recommended Action Plan | Recommended Timeline |
|---|---|---|---|
| 5 | Check on roof structure from localized high loading from water tanks required. | Verify that beam/slab has sufficient capacity to support fully filled water tanks plus concrete plinth | 6-months |

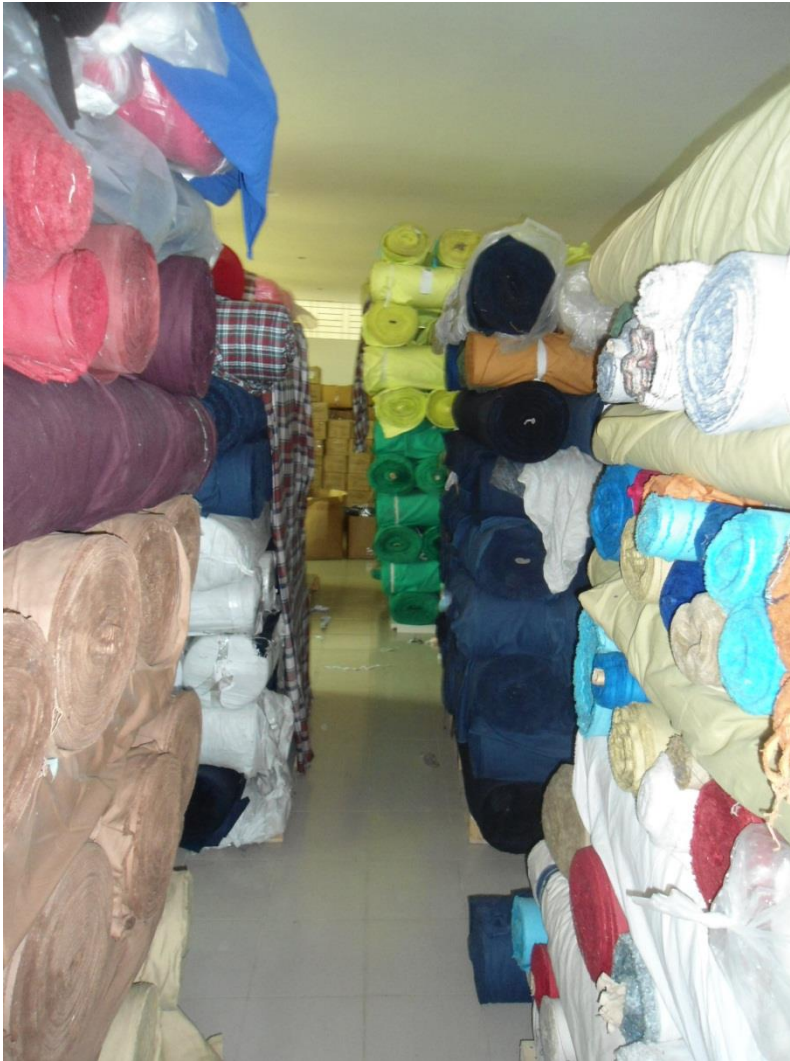
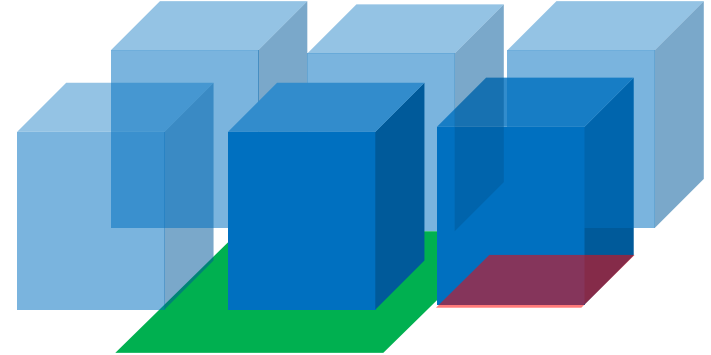
Material stacked to ceiling within bonded warehouse.  
Plan and height restrictions to be introduced to prevent future overloading.

**ITEM 5:** High density of loading in bonded warehouse and storage areas

Limit height to 1.80 (1.50x1.50 area) and keep 0.50-0.75 m cleared strip around.

| Item No. | Observation | Recommended Action Plan | Recommended Timeline |
|---|---|---|---|
| 7 | High density of loading in bonded warehouse and storage areas | Building Engineer to create controlled loading plans for all floors designating where storage can be placed and can not be placed. | 6-months |

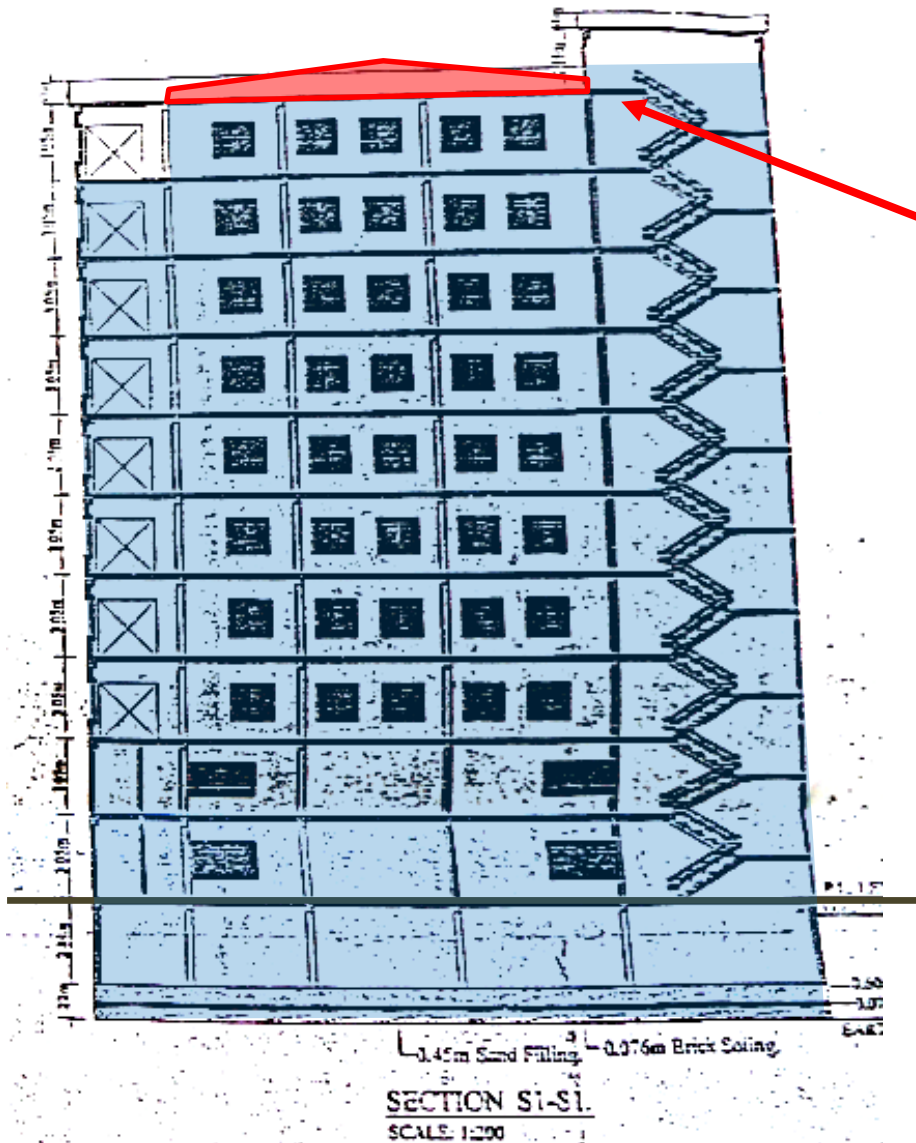
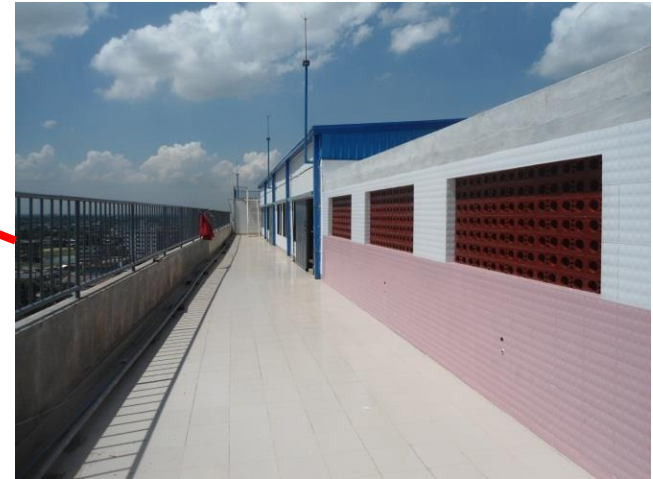
Lightweight roof structure doesn't agree with structural drawings for roof top.

**ITEM 4:** Structural drawings were not agree to the actual arrangement at top roof

| Item No. | Observation | Recommended Action Plan | Recommended Timeline |
|---|---|---|---|
| 6 | Structural drawings were not agree to the actual arrangement at top roof | The structural drawings showed inconsistencies compared to the current structure observed on site al roof top level. We suggest that the building engineer inspects and corrects these drawings soonest. | 6-months |
