# Mark Wear Ltd. (Pantalon Textiles Ltd.)

136/9, Dakhinkhan, Dhirasram, Sadar, Gazipur, Bangladesh.  
(+23.948282N, 90.413714E)

4<sup>th</sup> June 2014

# Building Observations

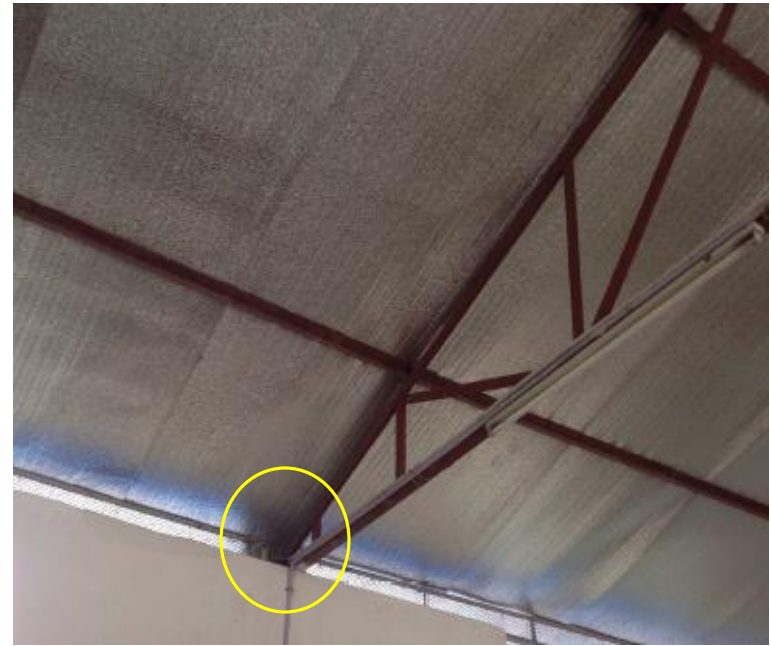
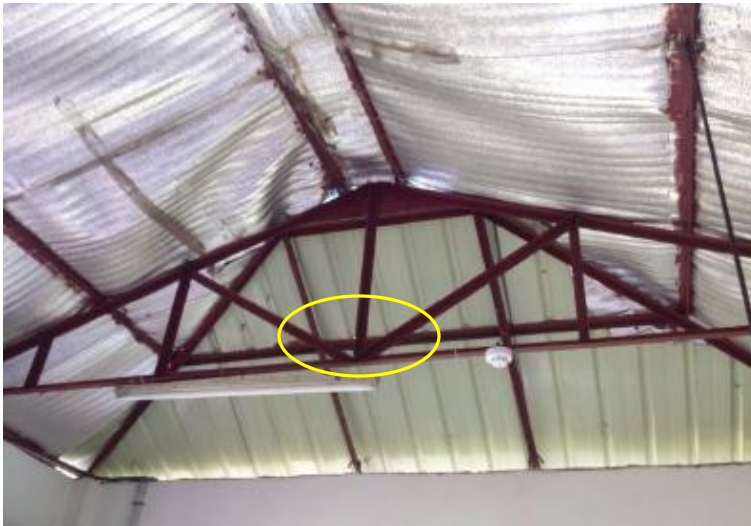
Generator building

Generally the single storey buildings have lightweight steel roofs which do not appear to be fully designed and verified by a Building Engineer due to lack of appropriate connection details between steelwork and concrete structure/ brick wall. Steelwork connections are all fully welded.

We recommend that a Building Engineer be engaged to review and verify that all of the steel roofs comply with code design load requirements – including wind loads.

| Item No. | Observation | Recommended Action Plan | Recommended Timeline |
|---|---|---|---|
| 1 | Adequacy of lightweight steel roofs to structures | Lightweight roof structures to be verified by the Building Engineer and upgraded as necessary to ensure adequacy for code vertical and wind loads. | 6-months |

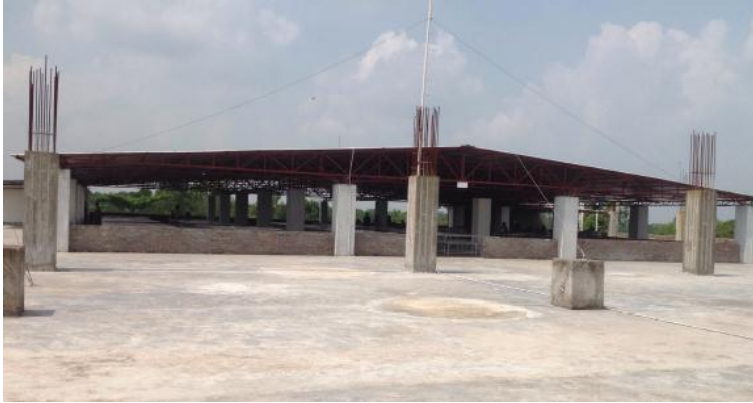
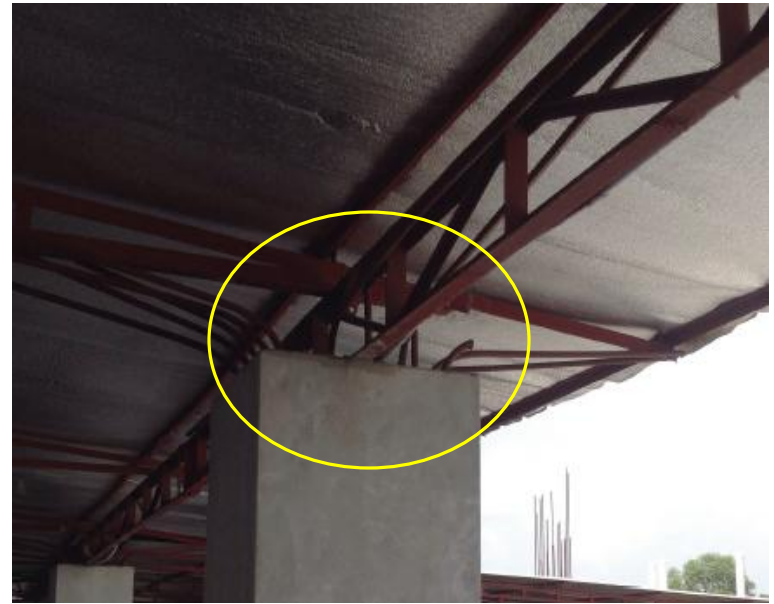
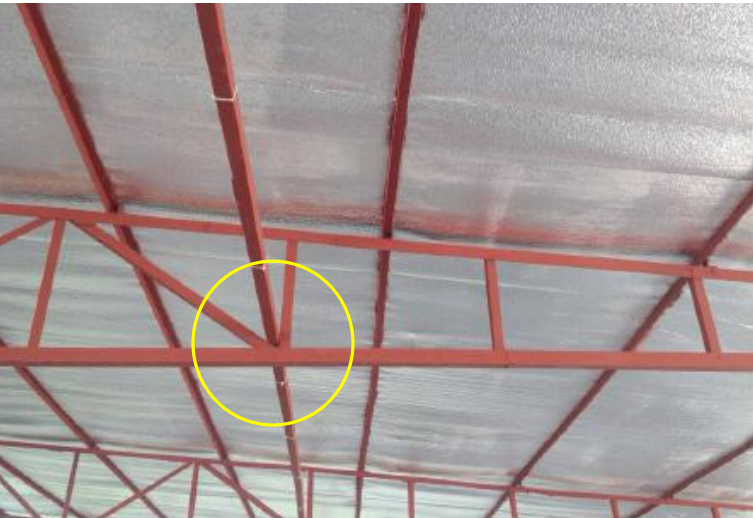
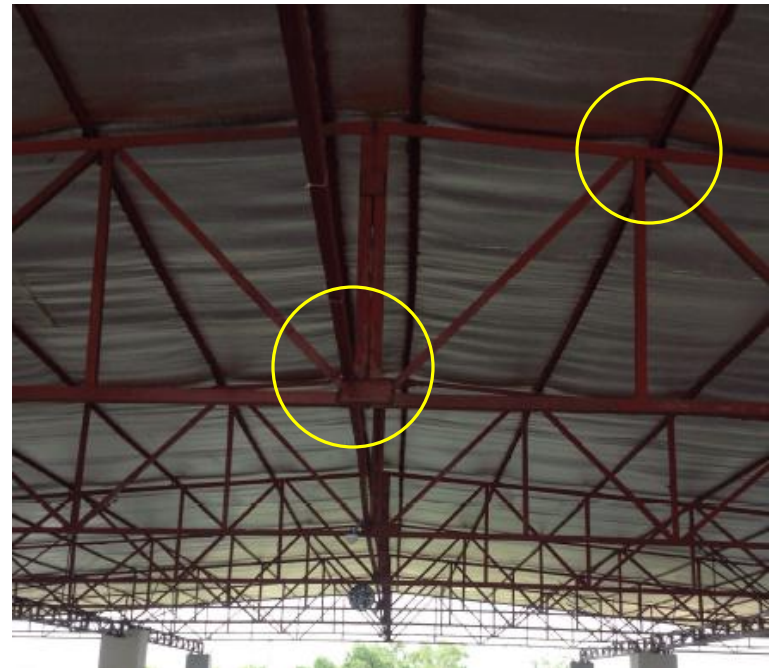
On the Main factory building - the roof to the canteen/ dining area is of lightweight steel construction and we recommend that a Building Engineer be engaged to review and verify that all of the steel roof structures comply with code design load requirements – including wind loads.

Main factory building; Apparently non-engineered steel structure and roof construction. Steel connection details and steel members are to be verified by the Building Engineer.

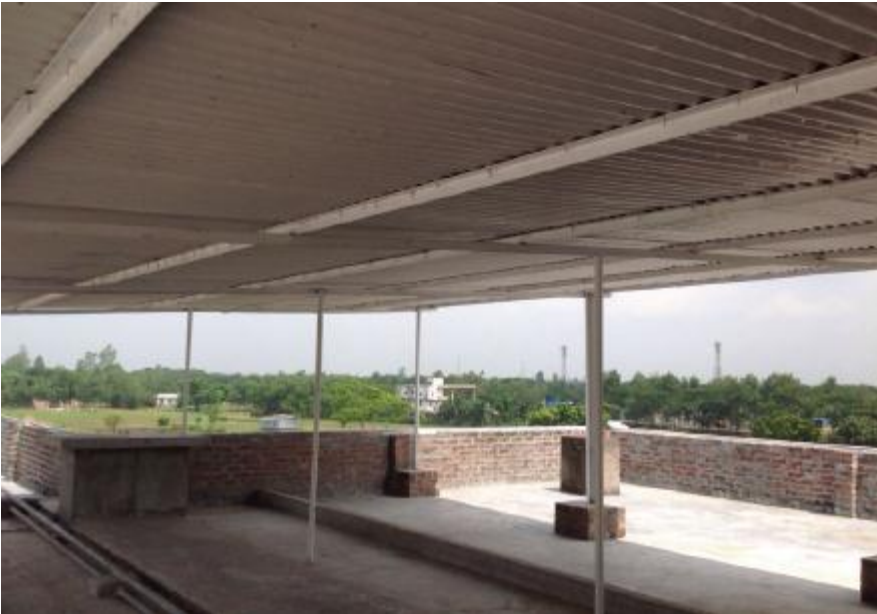
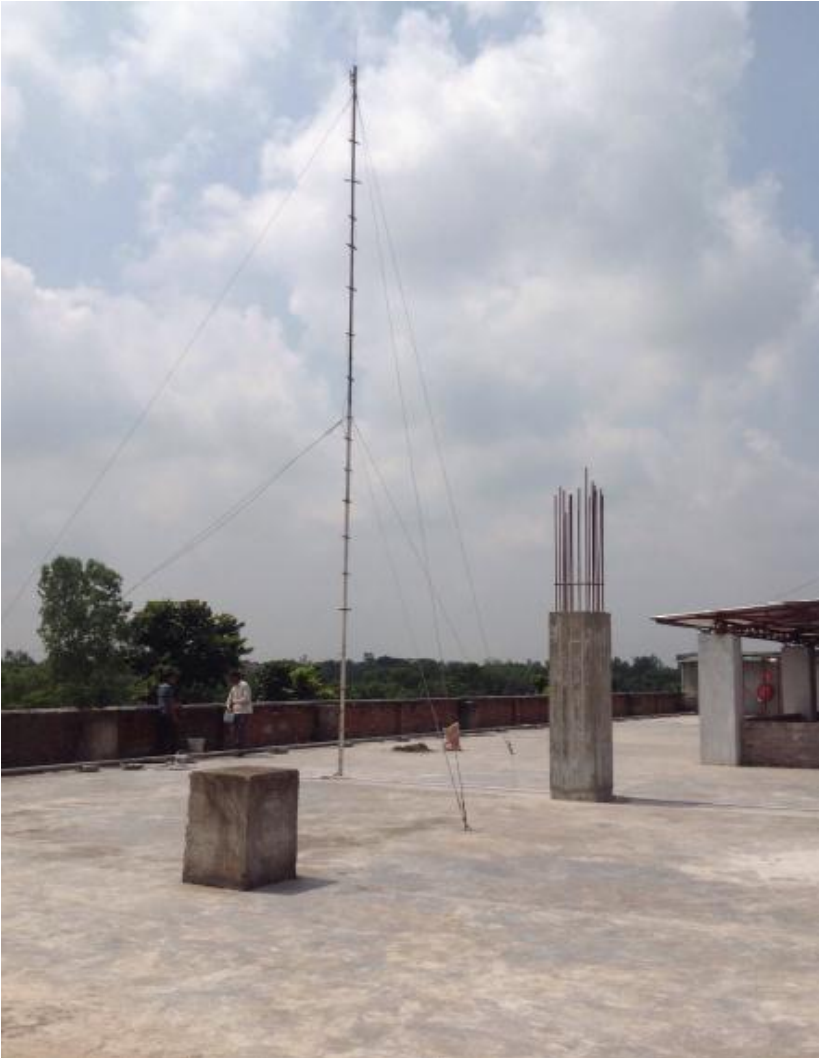
**Antenna at roof level**

**Antenna structure at roof level – design check  
recommended**

Lightweight antenna structure at roof level. We recommend that this antenna structure and fixings to the concrete roof be reviewed and verified by the Building Engineer.

| Item No. | Observation | Recommended Action Plan | Recommended Timeline |
|---|---|---|---|
| 2 | Antenna structure at roof level – design check recommended | Building Engineer to review and verify antenna structure including fixings at roof level. | 6-months |

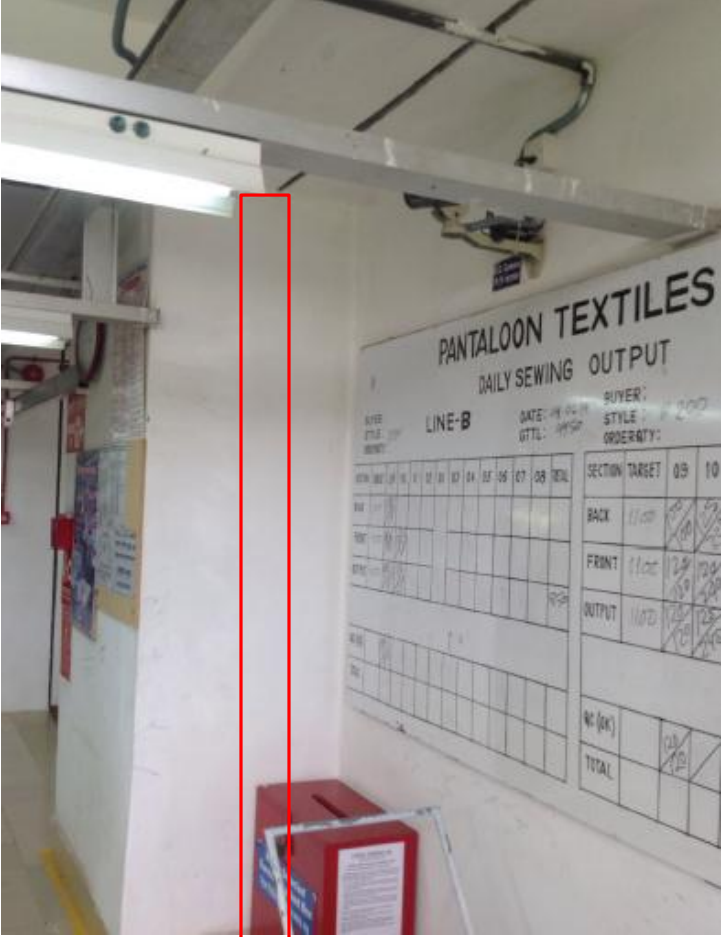
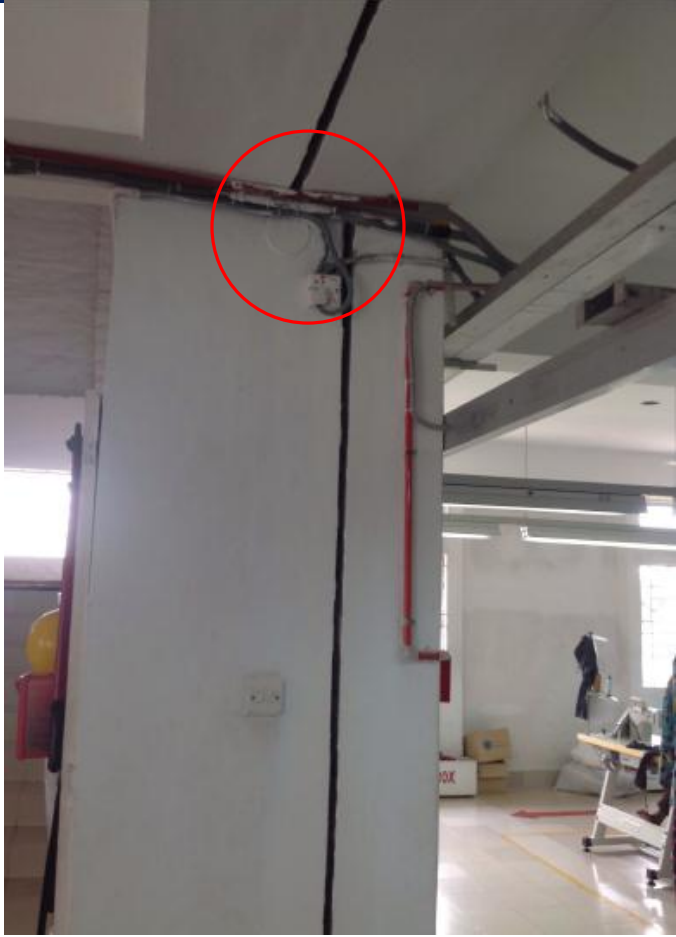
## Structural Movement Joint

# **Structural movement joint not reflected in building column**

The movement joint detail on Level 1 has not been reflected on one side of the column as indicated in red below. It is possible that this movement joint may have been in-filled with plaster after construction. The other side of the column incorporates the movement joint detail (note; it does not line up with the joint on the slab). The factory manager cannot confirm if the column was constructed this way.

We recommend that the movement joint at this location should be reviewed by the Building Engineer and the joint be exposed in the column plaster to ensure free movement of the building.

| Item No. | Observation | Recommended Action Plan | Recommended Timeline |
|---|---|---|---|
| 3 | Structural movement joint not reflected in building column | Expose joint / remove plaster covering the building movement joint to allow building movement to occur at the intended location. | 6-months |

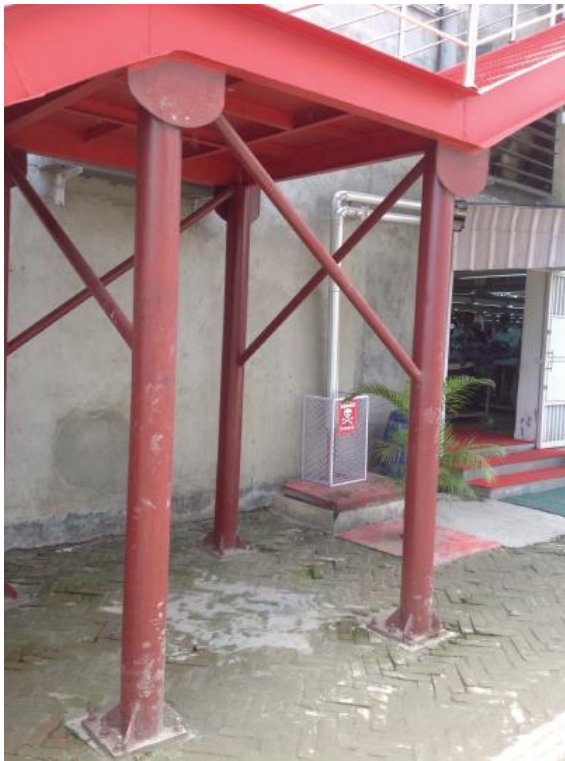
Steel stairs (west)

Steel stairs (emergency staircases for fire situation) located to the east and west elevation of the building. There are no steel drawings available for these stairs.

We note that all connection details appear to have been fully welded in-situ. Some of the welds which were available for inspection have rust marks. We also note that the paint protection for the steelwork has been touched up in the past, most probably because of premature failure.

| Item No. | Observation | Recommended Action Plan | Recommended Timeline |
|---|---|---|---|
| 4 | Connection details of steel stairs and deterioration of paint coating to welds | Engage a Building Engineer to review all weld details and conditions. | 6-months |
| 5 | Connection details of steel stairs and deterioration of paint coating to welds | Monitor condition of paint to steelwork and touch up as necessary to maintain steelwork protection. | 6-months |

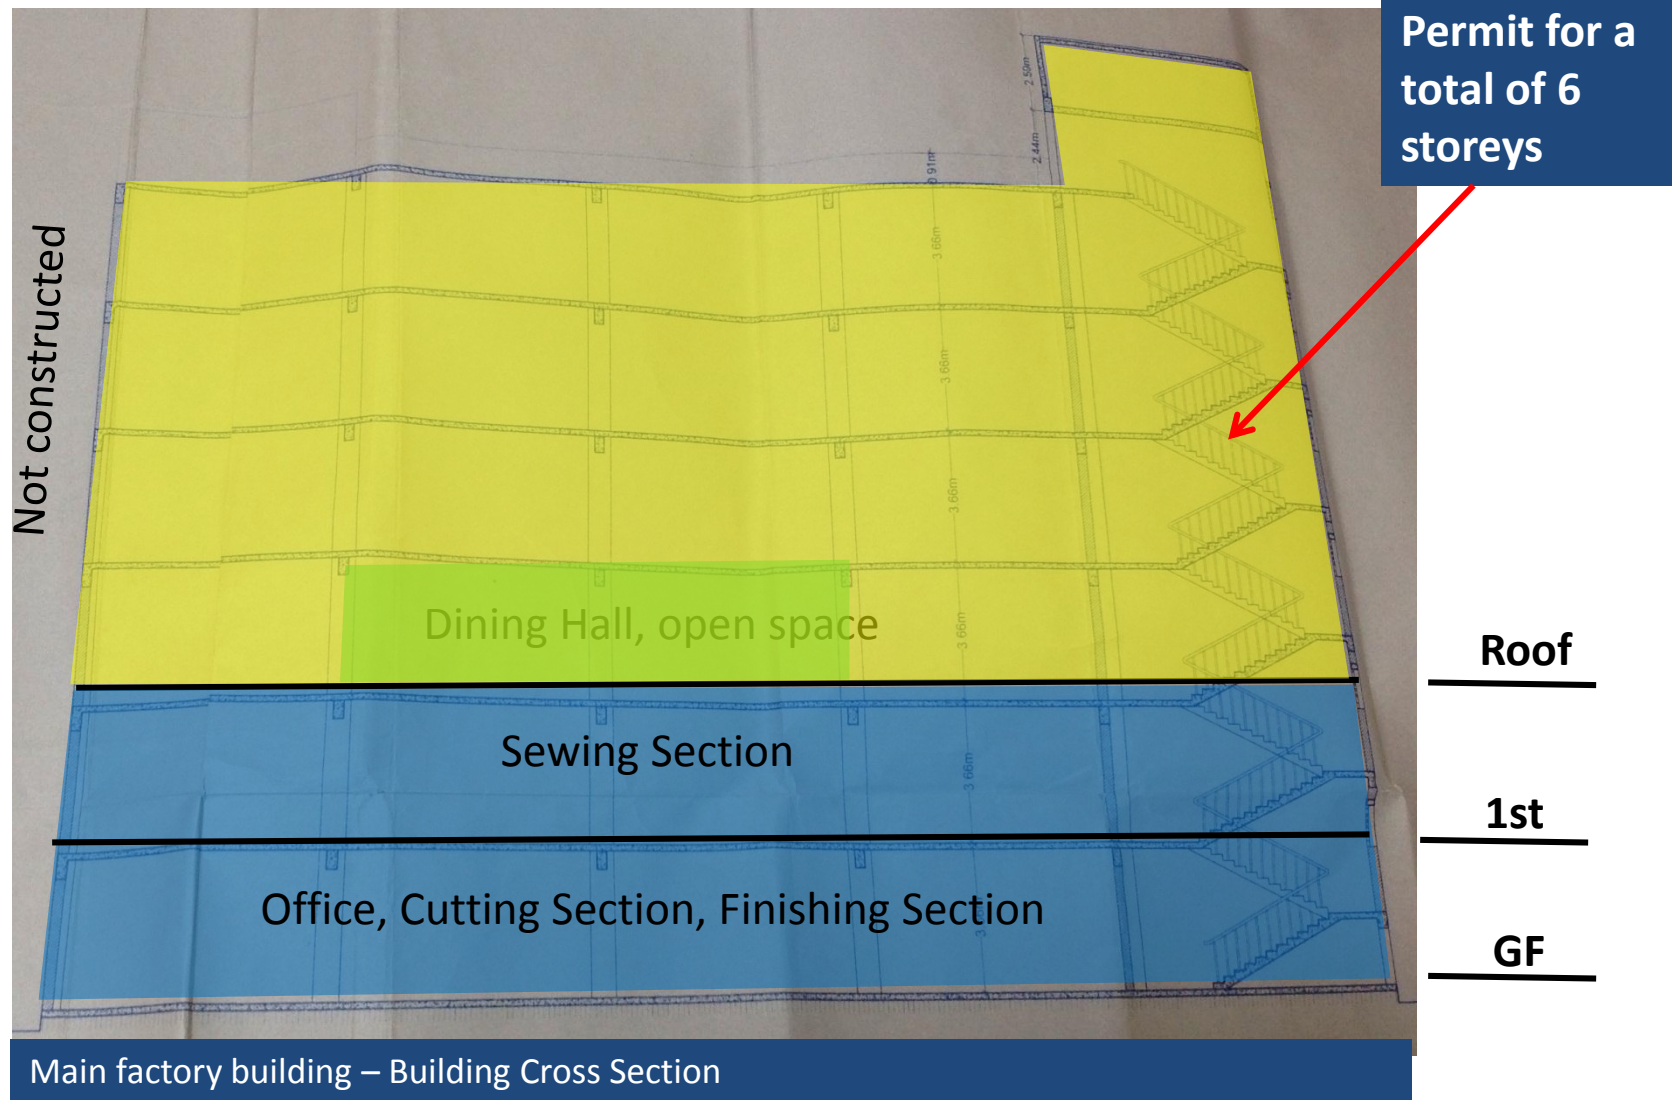
## Additional Building Storeys

**Any proposed additions to the existing building structure, including additional storeys, should be reviewed by the Building Engineer**

**Building Engineer to review structural design and concrete strength within existing columns prior to commencing construction of any further building extension.**

| Item No. | Observation | Recommended Action Plan | Recommended Timeline |
|---|---|---|---|
| 6 | Any proposed additions to the existing building structure should be reviewed by the Building Engineer | If any additions to the building structure are proposed, the Building Engineer shall provide calculations showing the structural adequacy of all columns taking into account any additions to the existing structure, the loading plans and as built structure, including insitu concrete strength testing. | 6-months |
