Vertex Innovative Apparels Ltd. (10524)

H.B. Intimates (11786)

Forkan Tower, 360/A, Bitak Bazar, Sagorika, Pahartoli Thana, Chittagong

15.MARCH.2014

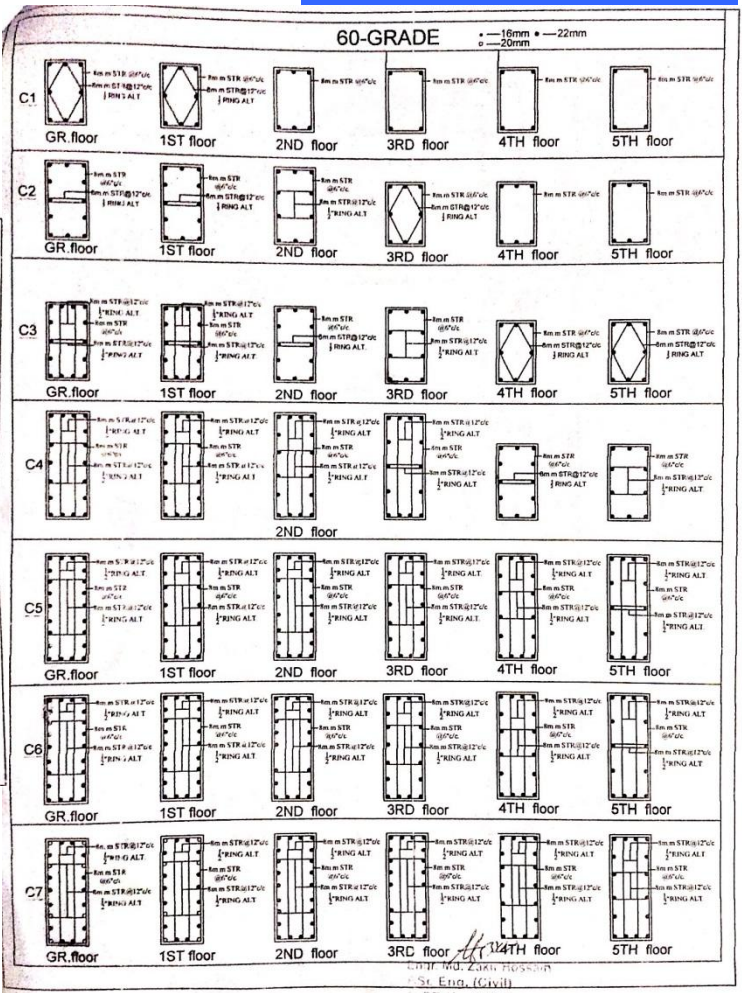
Low Column Safety Factors

Column load run-downs indicate lower than desirable column safety factors.

ITEM 1: (Priority 1) Column load run-downs indicate a low column safety factor for the completed building. It is notable that the building is currently under construction at the 5th floor slab level.

Column working stress will be higher than acceptable upon building completion and is still of concern at the current extent of construction.

- Do not continue construction past the 5th floor slab level. It is recommended that the 5th floor slab be used as the roof level.

- Factory engineer to review design, loads and column stresses.

- Produce and actively manage a loading plan for all floor plates giving consideration to slab and column capacity.

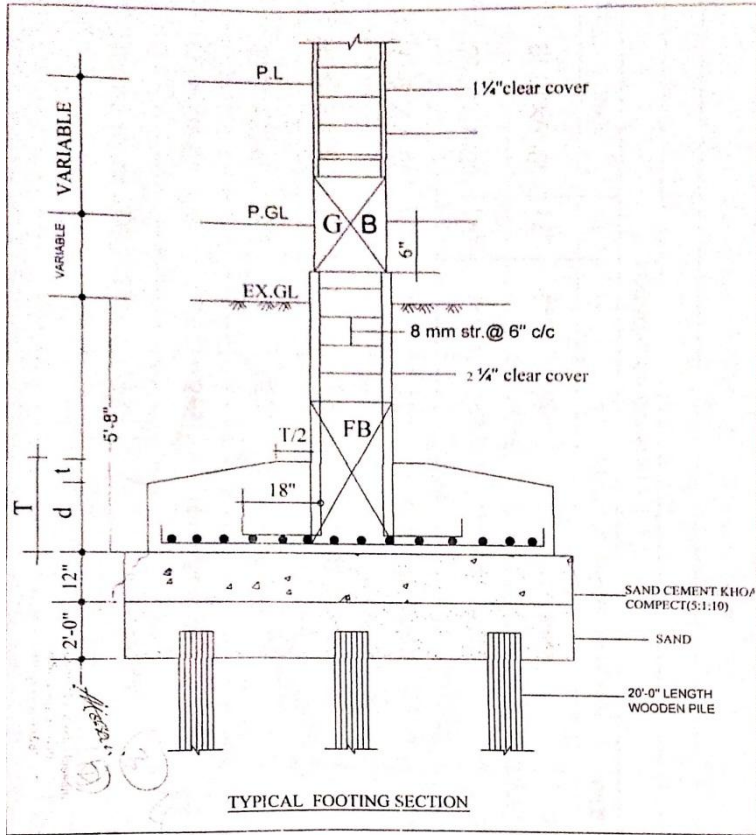
Soil Capacity/Footing Design

Foundations are built in a manner other than that recommended by the geotechnical report. General foundation capacity checks were performed. Based upon Geotechnical findings, the soil bearing capacity does not appear adequate to support the foundation shown on the structural drawings.

ITEM 2: (Priority 2) It was noted that the foundations shown on structural drawings do not match the recommendations made by the Geotechnical report. After examination of Geotechnical findings and various foundation checks based upon the foundations indicated by the structural drawings. It is doubtful that the soil bearing capacity is adequate to support the loads applied to the footings presented. Notably, bamboo piles were used beneath pad footings. However, they commence approximately 2 feet beneath the underside of footing and only extend to a depth of 28'-8" below grade where soil is of very poor capacity.

Foundation design is questionable given existing soil properties.

- A Detailed Engineering Assessment to be conducted in order to determine the adequacy of the as-built foundation for existing soil properties

- Carry out any remedial measures recommended by above mentioned detailed engineering assessment.

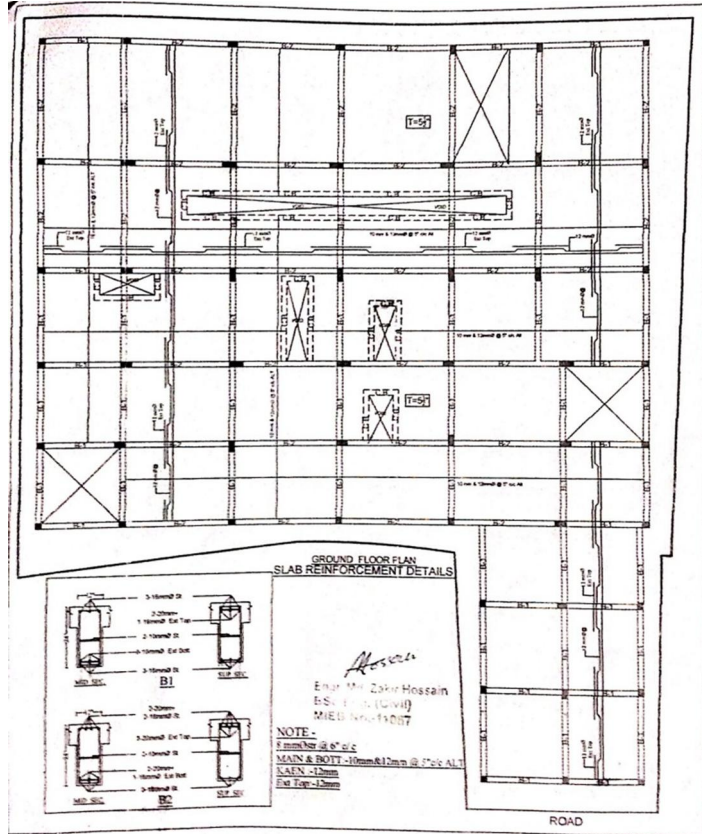
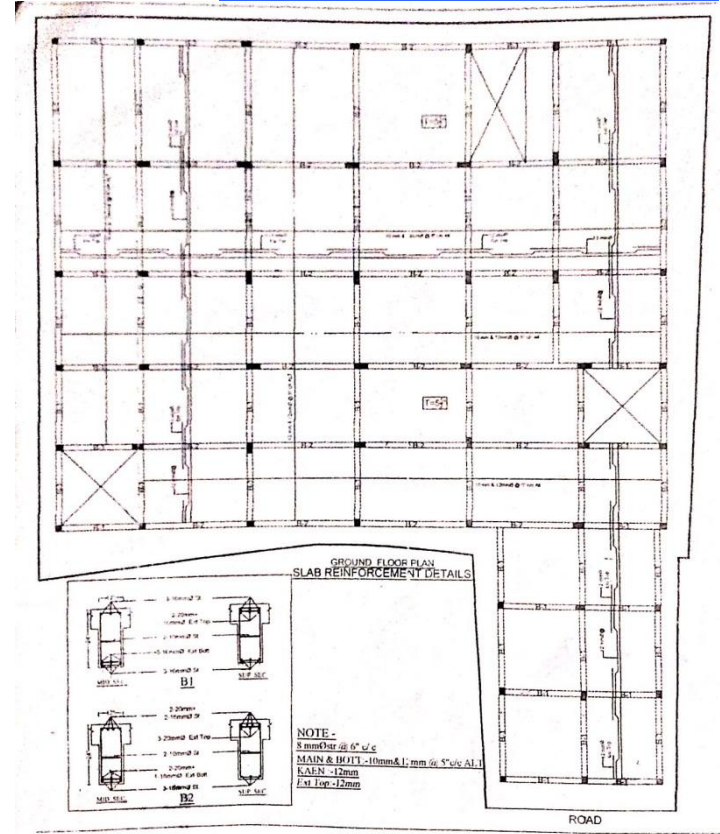
Incomplete Structural Drawings

Structural drawings are incomplete. Typical slab reinforcing and roof slab reinforcing plans are missing. Two differing ground floor slab plans are presented. Plans are generally of very poor quality.

ITEM 3: (Priority 2) Structural drawings were found to be inconsistent and of low quality. It is questionable how the full structure has been built while lacking clear concise structural drawings. As an example, there is no typical floor slab reinforcing plan provided. However, the structure is currently under construction at the 5th storey level.

Structural drawings are inconsistent and non-uniform. Critical building elements have been constructed without proper plans.

- A Detailed Engineering Assessment to be carried out in order to adequately formulate structural plans and assess the suitability of as-built structural elements

- Address findings and recommendations of the above mentioned detailed engineering assessment
