FIRE SAFETY INSPECTION REPORT

ARMOUR GARMENTS LTD

ACCORD ID: 10913

January 26, 2015

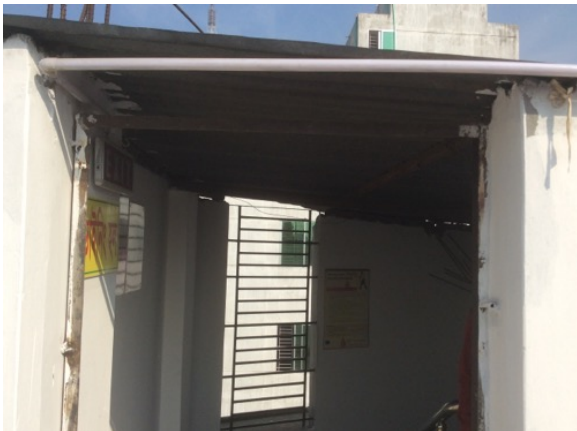
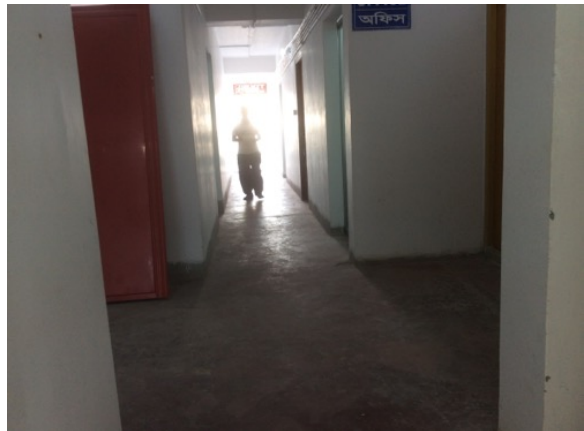
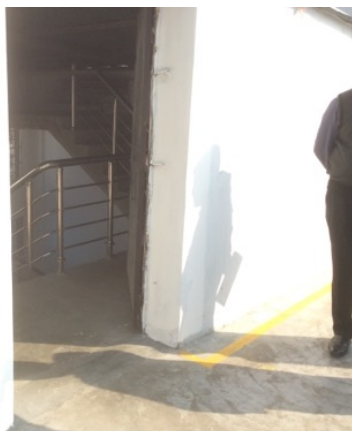
F-1	Fire Rated Construction	The exit stairs are not separated from work areas and other spaces on each floor by fire-rated construction.	Provide minimum 1.5-hr fire rated doors for buildings that are 4 or more stories. Seal all unprotected openings to separate the exit stairs from work areas and other building spaces on all floor levels. Ensure that the fire doors are self-closing and positive latching and that they are provided with fire exit (panic) hardware where serving production floors. If fire doors are required to be held open for functional reasons, provide automatic-closing devices tied to the fire alarm system. Every door in a stair enclosure serving more than 5 stories shall be provided with re-entry unless it meets ACCORD standard 6.8.3.1.	Within 3 months
-----	-------------------------	--	---	-----------------

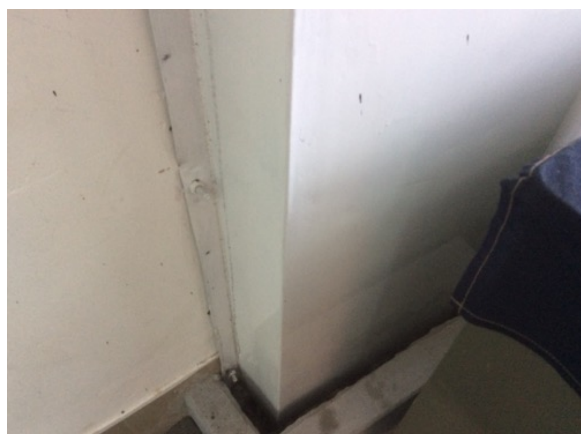
F-2	Fire Rated Construction	Unsealed electrical shafts are located in the fire-rated floor and ceiling assemblies.	Provide a minimum 2-hr fire-rated shaft to separate the utility risers from each floor level and seal all penetrations in floor and ceiling assemblies to maintain the fire separation.	Within 3 months
-----	-------------------------	--	---	-----------------

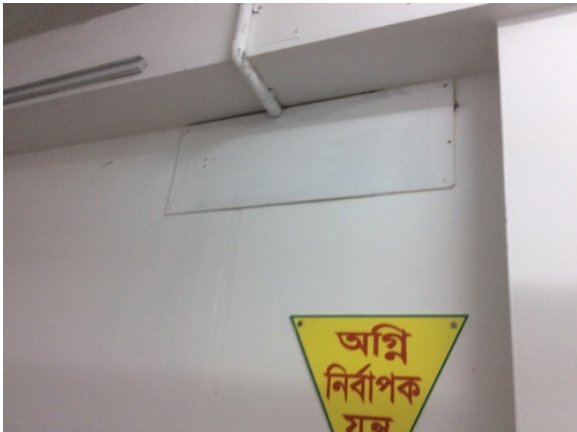
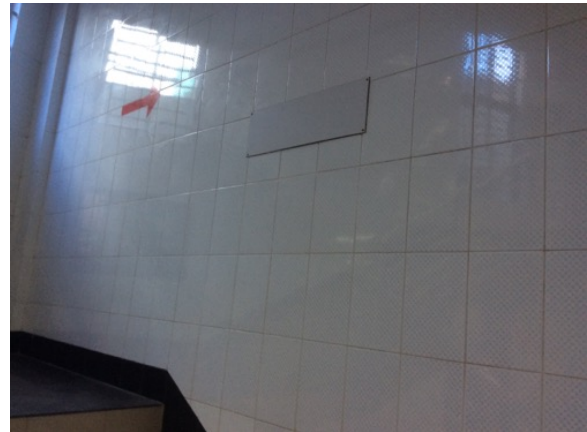
F-3	Fire Rated Construction	Unsealed penetrations and openings are located in exit stair enclosures.	Seal all penetrations and openings in exit stair enclosure walls to maintain the fire separation.	Within 3 months
-----	-------------------------	--	---	-----------------

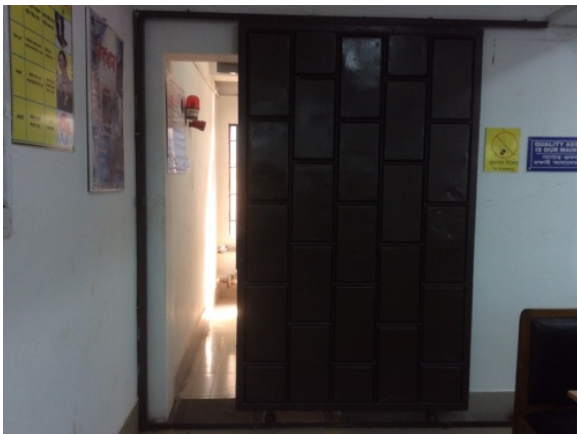
F-4	Fire Rated Construction	The boiler room is not separated by fire-rated construction due to opening and non-rated door on the first floor.	Separate the boiler room by a minimum 1-hr fire-rated construction. Seal and protect all openings to maintain the required fire separations.	Within 3 months
-----	-------------------------	---	--	-----------------

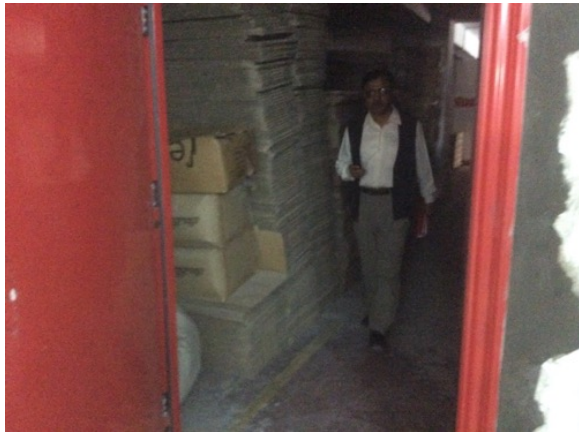
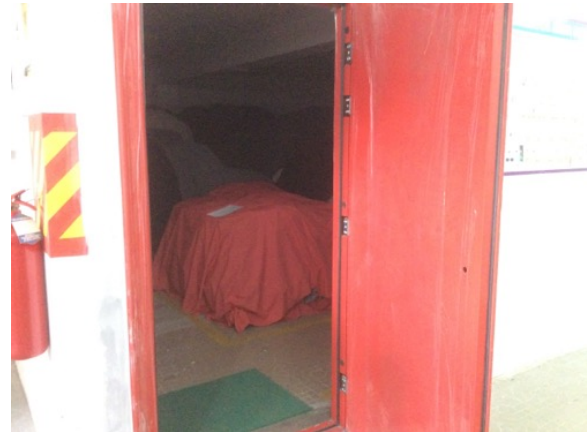
F-5	Fire Rated Construction	Rooms used for combustible storage are not separated by fire-rated construction on the ground and sixth floors.	Provide dedicated storage rooms separated by minimum 1-hr fire-rated construction.	Within 3 months
-----	-------------------------	---	--	-----------------

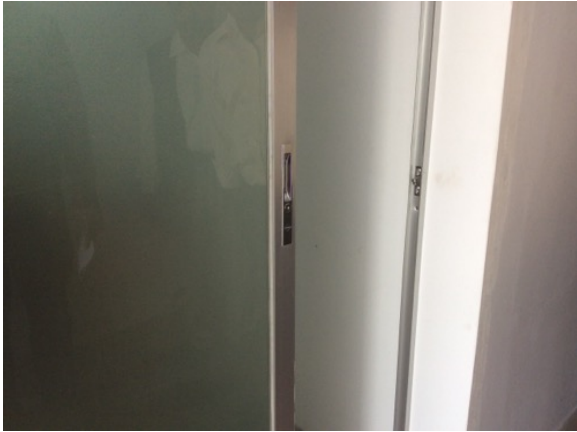
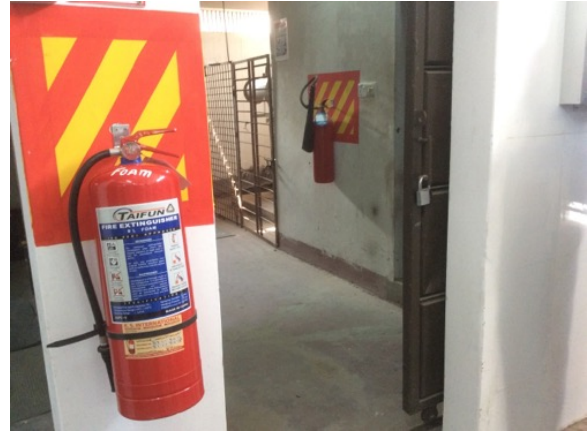
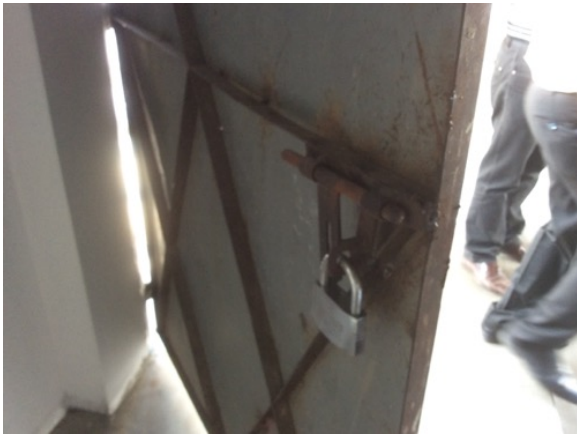
F-6	Egress	Building did not have occupant load signs at any floors.	Provide occupant load signs at required locations.	Immediately
F-7	Egress	Exit capacity (333) is not adequate for the occupant load (400) of the sixth floor.	Reduce occupant load immediately to not more than available exit capacity (333). Provide additional exits in the future to increase exit capacity.	Immediately
F-8	Egress	Egress doors with locking features are provided at exit stairs and along egress routes. All gates and doors were open and unlocked during the inspection.	Remove locking features from all egress doors. If locks are required for security reasons, utilize special door locking features complying with NFPA 101 and ACCORD standard 6.8.2.	Immediately

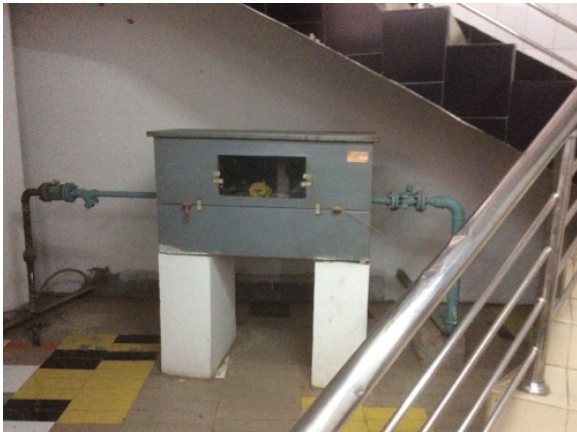
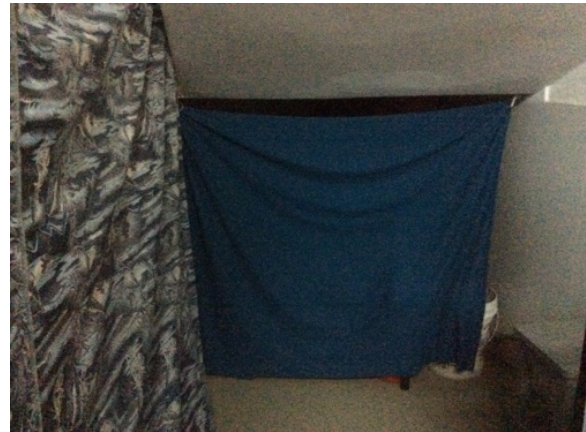
F-9	Egress	Storage was located in all the exit stairs on the ground floor.	Remove all storage from exit stairs and egress paths.	Immediately
-----	--------	---	---	-------------

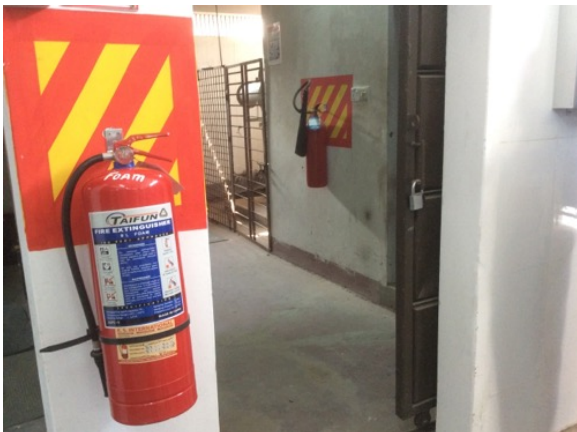
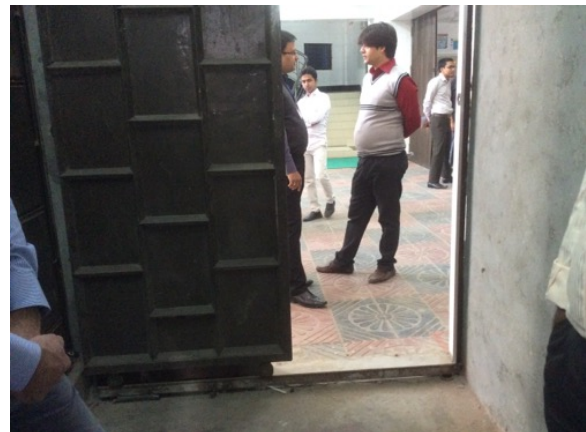
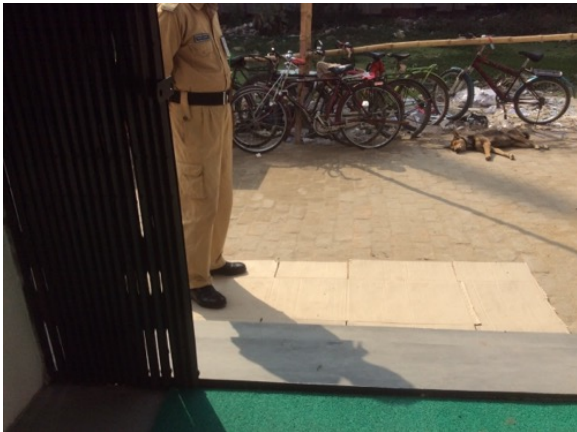
F-10 Egress

Collapsible gates and sliding doors are provided at building exits and along egress routes.

Replace all gates and sliding doors along the means of egress with side-hinged, swinging egress doors in accordance with ACCORD standard 6.8.1.

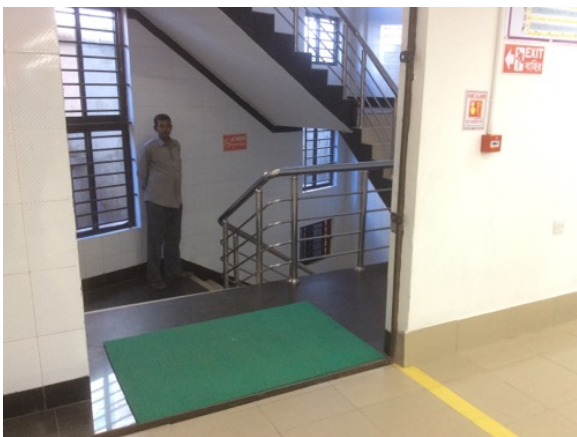
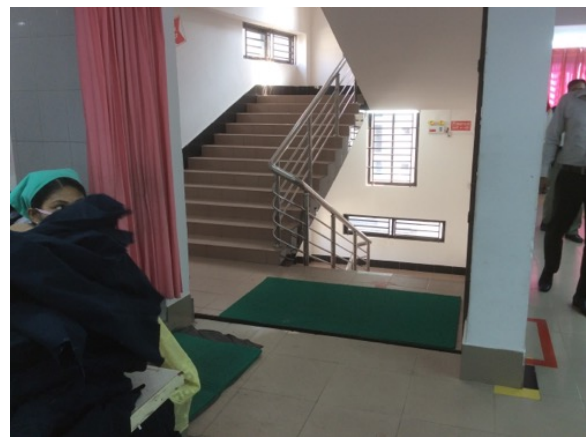
F-11 Egress

Handrails are not provided on both sides of all the exit stair.

Provide handrails on both sides of the exit stairs. New handrails shall have a minimum height of 865 mm (34 in.) and a maximum height of 965 mm (38 in.) as measured from the leading edge of the tread. Intermediate handrails shall be provided when the stair width exceeds 2.2 m (87 in.)

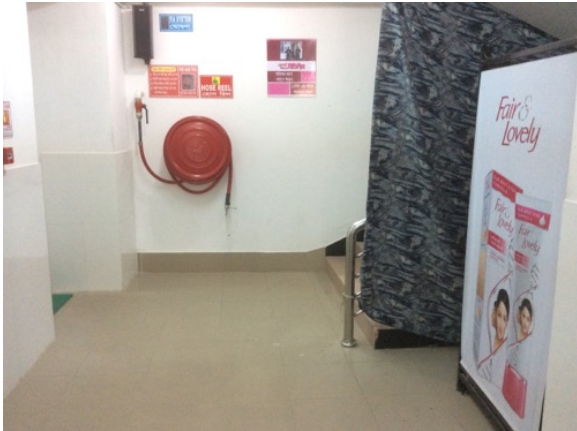
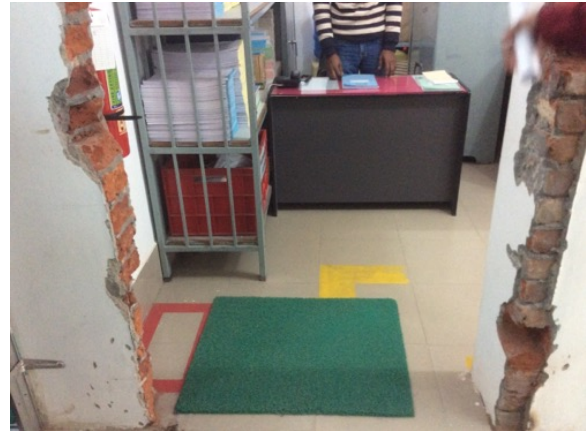
F-12	Egress	East exit stair discharges inside the building on the ground floor. The exit passageway is open to storage on the ground floor.	Provide 2-hr fire-rated exit passageway leading directly outside (vestibules to separate any storage areas).	Within 6 months
------	--------	---	--	-----------------

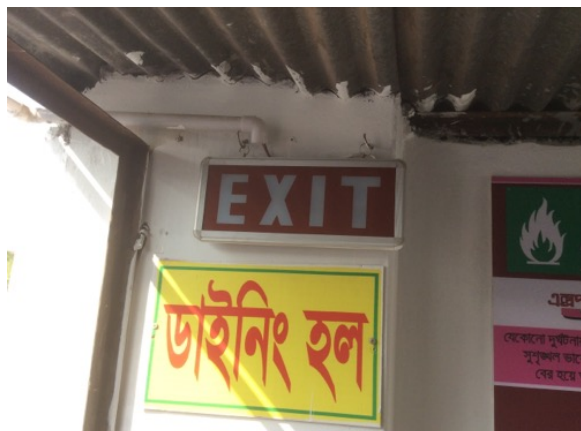
F-19	Egress Lighting	Exit signage not illuminated on the sixth floor at the east exit stair.	Regularly inspect all exit signage and replace or install lights as needed to illuminate signs. The source of illumination shall provide not less than 50 lux at the illuminated surface with a contrast of not less than 0.5. Approved self luminous signs which provide evenly illuminated letters having a minimum luminance of 0.2 cd/m ² may also be used.	Within 1 month

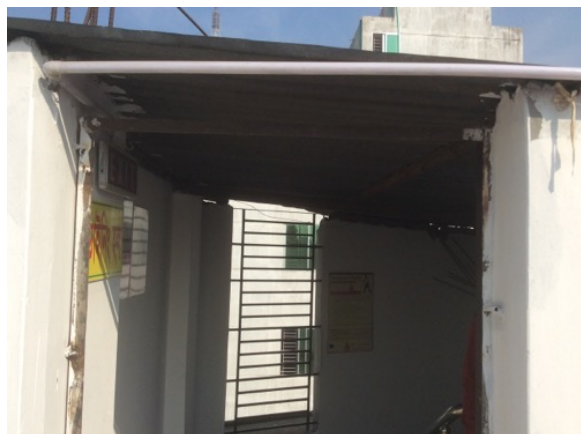
F-20	Egress Lighting	Exit signage was not provided in a readily visible location at the east exit stair entrance on the sixth floor.	Provide exit signs above all building exits to the exterior, all doors to the exit stairs and along all paths of travel where a change of direction is not obvious.	Within 1 month
------	-----------------	---	---	----------------
