# **FIRE SAFETY INSPECTION REPORT**

**LIDA TEXTILE & DYEING LIMITED**

**ACCORD ID: 12111**

January 30, 2015

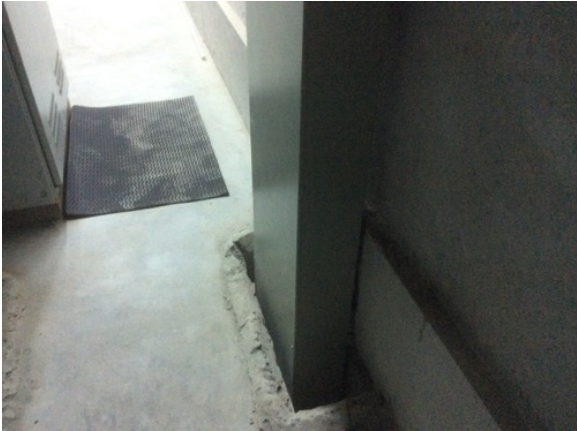
| No. | Category | Finding | Recommendation | Remediation Timeframe |
|---|---|---|---|---|
| F-1 | Fire Rated Construction | Unsealed electrical shafts are located in the fire-rated floor and ceiling assemblies. | Provide a minimum 2-hr fire-rated shaft to separate the utility risers from each floor level and seal all penetrations in floor and ceiling assemblies to maintain the fire separation. | Within 3 months |

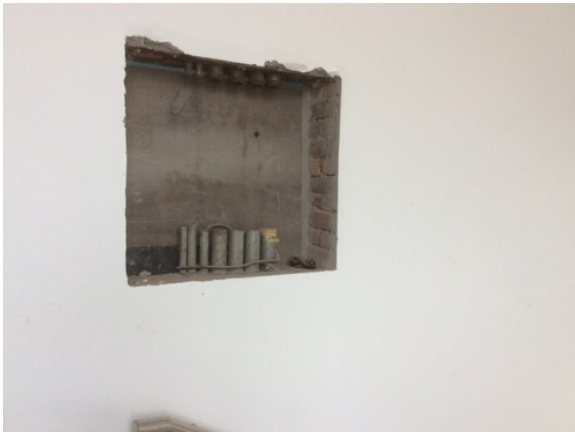
| No. | Category | Finding | Recommendation | Remediation Timeframe |
|---|---|---|---|---|
| F-2 | Fire Rated Construction | Unsealed penetrations and openings are located in exit stair enclosures. | Seal all penetrations and openings in exit stair enclosure walls to maintain the fire separation. | Within 3 months |

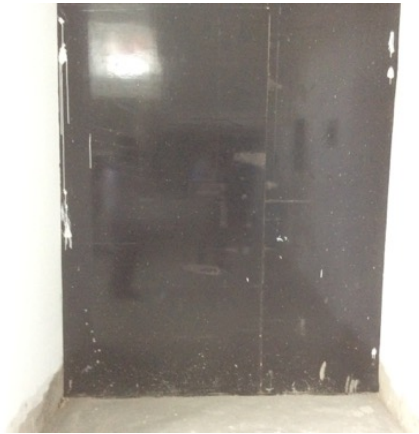
| F-3 | Fire Rated Construction | The west exit stairs are not separated from under construction space and electro-mechanical room on ground floor by fire-rated construction. | <p>Provide minimum 1.5-hr fire rated doors for buildings that are 4 or more stories. Seal all unprotected openings to separate the exit stairs from work areas and other building spaces on all floor levels. Ensure that the fire doors are self-closing and positive latching and that they are provided with fire exit (panic) hardware where serving production floors.</p> <p>If fire doors are required to be held open for functional reasons, provide automatic-closing devices tied to the fire alarm system.</p> | Within 3 months |

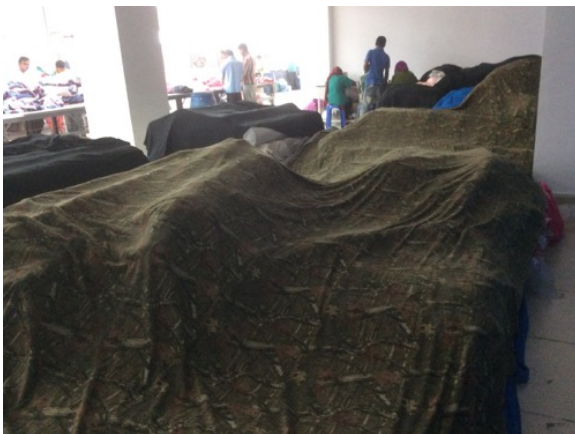
| F-4 | Fire Rated Construction | Areas used for combustible storage open to the factory are not separated by fire-rated construction on first and fifth floors. | <p>Provide defined storage areas and limit the storage arrangement as follows:</p> <ul style="list-style-type: none"> <li>- If sprinkler protected: maximum height of 3.66m (12ft.) and maximum area of 93m<sup>2</sup> (305ft<sup>2</sup>).</li> </ul> <p>Separate areas of unenclosed combustible storage by a minimum clear distance of 3m (10ft.).</p> | Within 3 months |

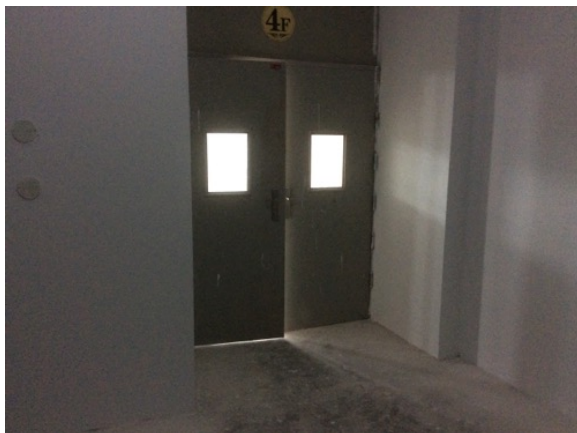
| F-6 | Egress | Building did not have stair designation signs and occupant load signs at required locations. | Provide stair designation signs and occupant load signs at required locations. | Immediately |

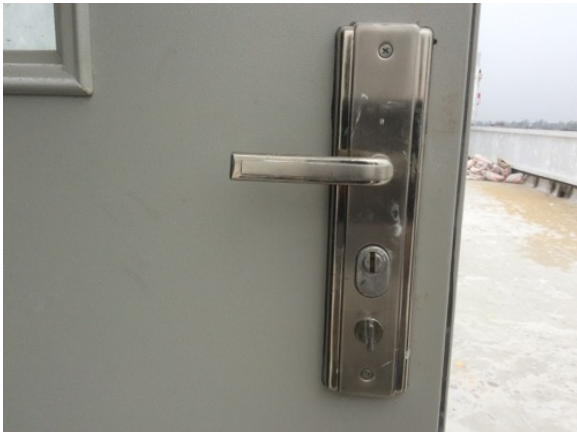
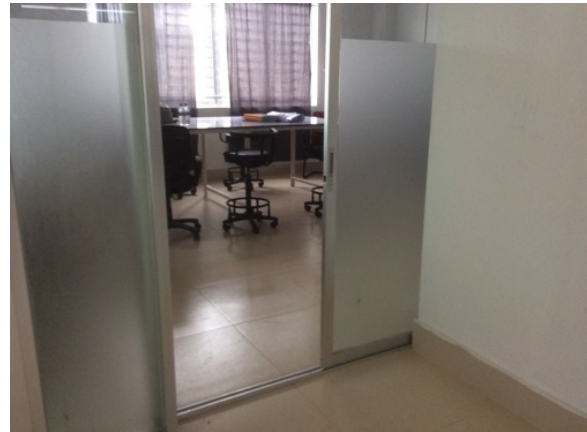
| F-7 | Egress | <p>Egress doors with locking features are provided at exit stairs and along egress routes.</p> <p>All doors were open and unlocked during the inspection.</p> | <p>Remove locking features from all egress doors.</p> <p>If locks are required for security reasons, utilize special door locking features complying with NFPA 101 and ACCORD standard 6.8.2.</p> | Immediately |

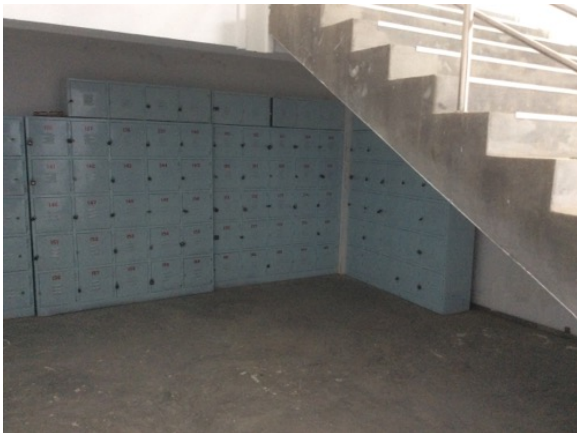
| F-8 | Egress | Storage was located in the west exit stairs on the ground floor. | Remove all storage from exit stairs and egress paths. | Immediately |

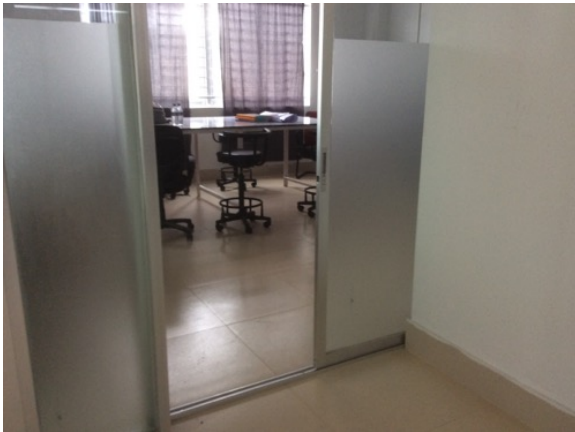
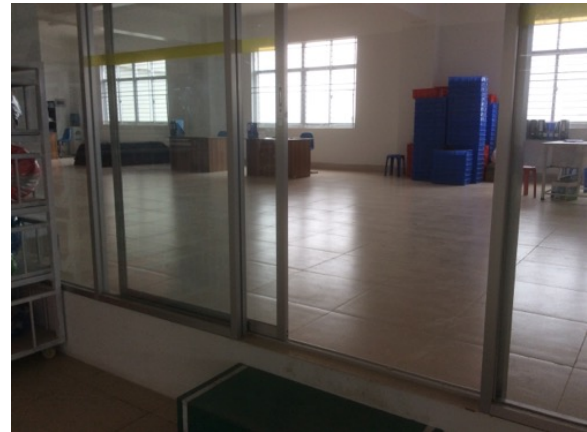
| F-9 | Egress | Sliding doors are provided along egress routes. | Replace all sliding doors along the means of egress with side-hinged, swinging egress doors in accordance with ACCORD standard 6.8.1. | Within 1 month |

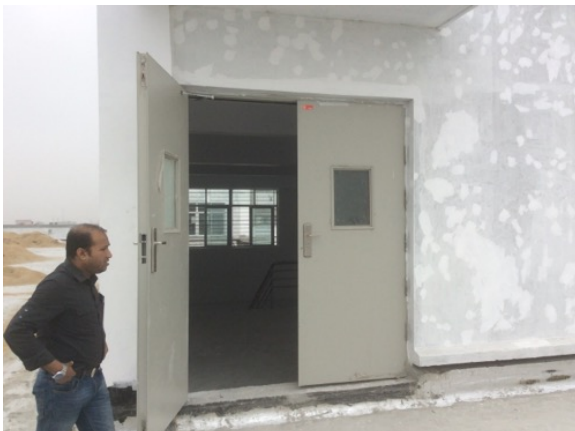
| F-10 | Egress | Exit stair door serving 50 or more occupants does not swing in the direction of egress travel on the roof top. | Modify the egress door to swing in the direction of egress travel. | Within 3 months |

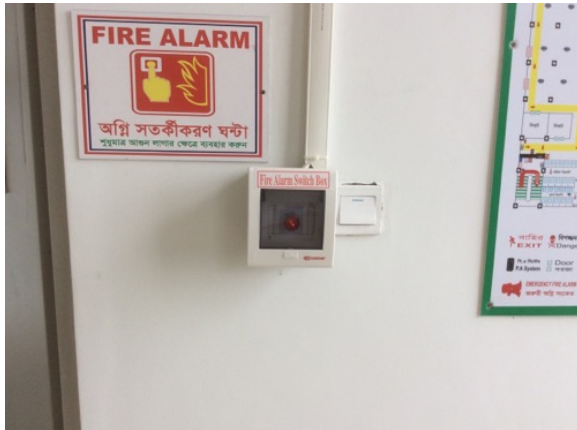
| F-11 | Fire Protection | The fire alarm system is antiquated, not a listed system and does not provide alarm and notification features consistent with acceptable standards. | Replace the fire alarm system with a new, listed addressable fire alarm system in accordance with NFPA 72. | Design within 4 months, install within 9 months |

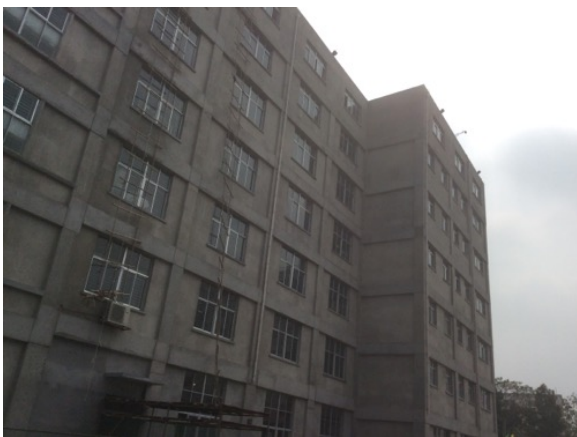
| F-12 | Fire Protection | The high-rise building has an occupied floor greater than 23m (75 ft.) and is not provided with automatic sprinkler protection. The large occupant loads, heavy fuel loading and anticipated extended egress times warrant sprinkler protection. | Provide automatic sprinkler protection throughout the building in accordance with NFPA 13. | Design within 6 months, install within 12 months |

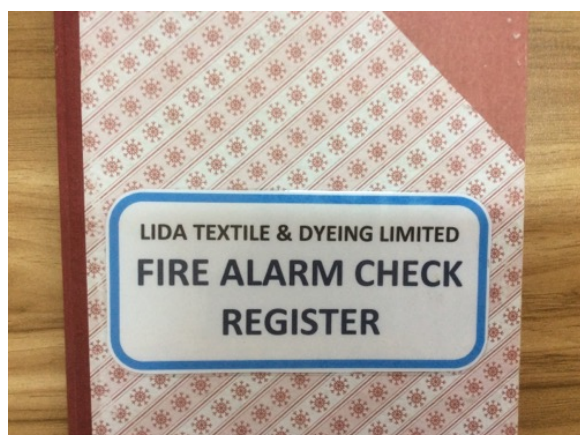
| F-15 | Fire Protection | Inspection, testing and maintenance for the fire alarm system is not in accordance with NFPA 72. | Inspect, test and maintain the fire alarm system and keep written records on-site, in accordance with NFPA 72. | Within 3 months |

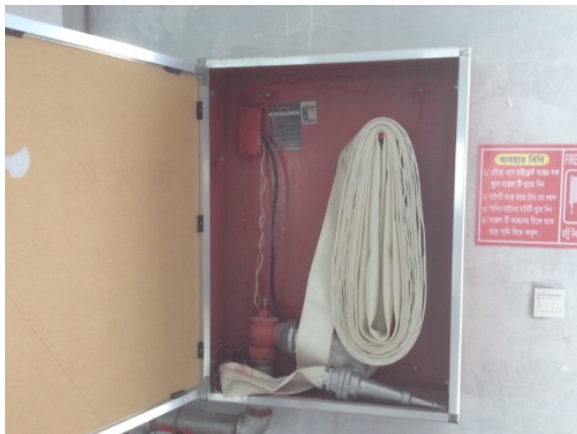
| F-18 | Fire Protection | The required standpipe system is not installed in accordance with the ACCORD standard. | <p>Install a new standpipe system in accordance with ACCORD standard 5.4 and NFPA 14.</p> <p>A class III system shall be installed in buildings with the highest occupiable floor 10 m (33 ft.) above grade or more.</p> <p>A class I system shall be permitted in buildings protected throughout by an approved automatic sprinkler system.</p> | Within 6 months |

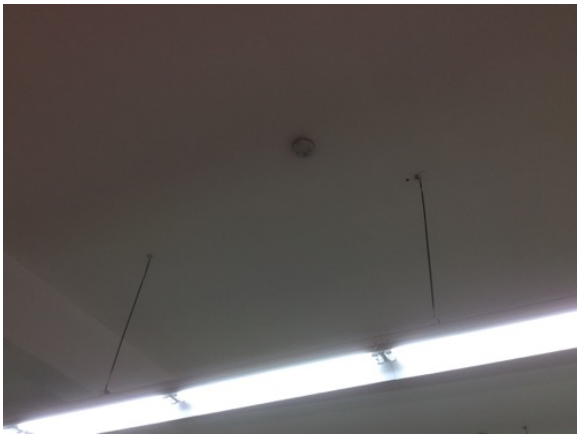
| F-19 | Fire Protection | The building is equipped with single-station smoke alarms. Smoke alarm activation sounds only a local alarm and does not provide automatic fire alarm notification of occupants. | Remove single-station smoke alarms. Provide automatic smoke detection throughout the building, tied into the fire alarm system, in accordance with NFPA 72. | Within 9 months |

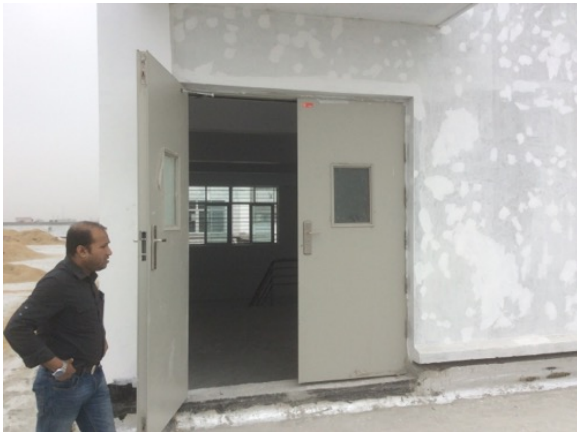
| F-20 | Egress Lighting | Exit signage was not provided in a readily visible location at all the exit stair entrances on the roof top. | Provide exit signs above all building exits to the exterior, all doors to the exit stairs and along all paths of travel where a change of direction is not obvious. | Within 1 month |

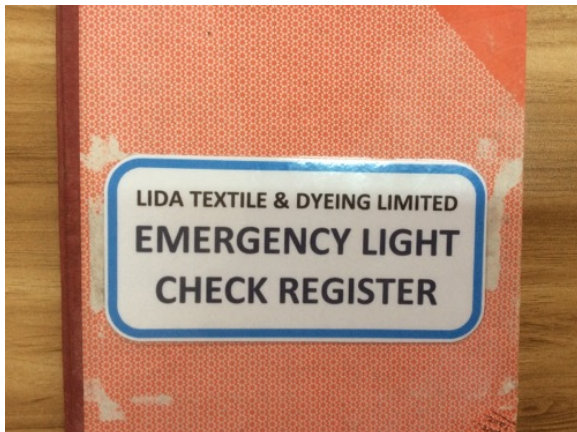
| F-21 | Egress Lighting | Inspection, testing and maintenance for the emergency lighting system was not in accordance with The ACCORD standard. | Inspect, test and maintain the emergency lighting system in the accordance with The ACCORD standard. Keep written records on-site. | Within 3 months |
