# **ELECTRICAL SAFETY INSPECTION REPORT**

## **RIO FASHION WEAR LTD. & RIO DESIGN LTD., DHAKA, BANGLADESH**

**Inspected on November 02, 2013**

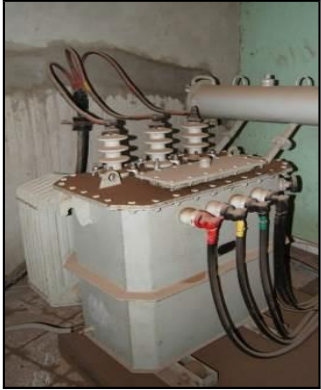
| <b>Finding #:</b> E- 1 | |

| <b>Finding:</b><br><p>Transformer compartment is too small for normal maintenance and not well ventilated.</p> | |
| <b>Remediation Timeframe:</b> 3 Months | <p>Power transformer inside substation room.</p> |

| <b>Recommendation:</b><br><p>Assess possibilities to expand the room or relocate. Otherwise, the transformer room must be guarded and notified to be completely shut down during any operation or maintenance.</p> | |

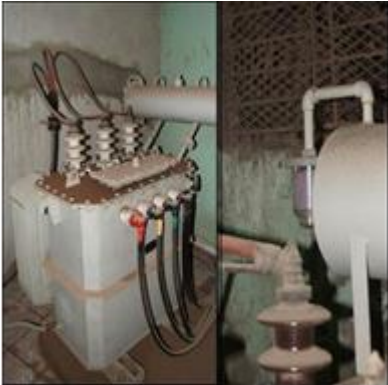
| <b>Finding #:</b> E- 2 | |

| <b>Finding:</b><br><p>Excessive dust deposit on the transformer and transformer room.</p> | |
| <b>Remediation Timeframe:</b> 3 Months | <p>Power Transformer room filled with dust (left) and wire mesh guarded window (right).</p> |

| <b>Recommendation:</b><br><p>Clean the transformer and transformer room regularly. Install ventilating shutter on the wire mesh window.</p> | |

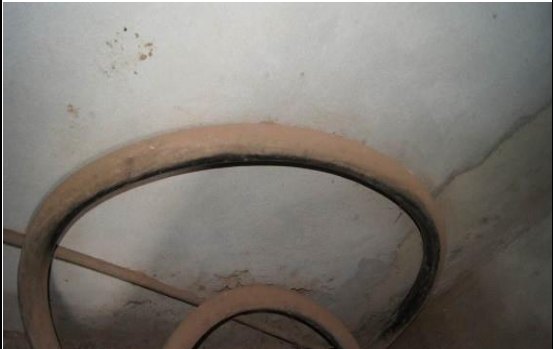
| <b>Finding #:</b> E- 3 | <p>Excess power cables coiled and leaning on wall inside transformer room.</p> |

| <b>Finding:</b><br><p>Excess HT cable not supported and not protected.</p> | |

| <b>Recommendation:</b><br><p>Excess cable must be supported and protected in cable trenches or in trays. HT service cables may be buried underground outside the substation building before entering.</p> | |

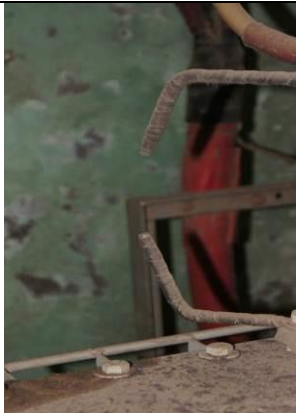
| <b>Finding #:</b> E- 4 | <p>A pair of Arcing horns.</p> |

| <b>Finding:</b><br><p>Arcing horns are tapped with insulation tapes.</p> | |

| <b>Recommendation:</b><br><p>The tapes must be removed during one of the shutdowns or maintenance and gaps between the horns must be adjusted as per voltage ratings.</p> | |

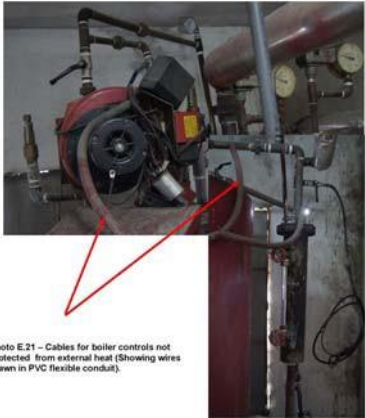
| <b>Finding #:</b> E- 5 | <p>Photo E.21 – Cables for boiler controls not protected from external heat (Showing wires drawn in PVC flexible conduit).</p> <p>Wirings in flexible PVC conduits in boiler room.</p> |
| <b>Finding:</b><br><p>Wiring in boiler room are not spaced/protected from heating components</p> | |

| <b>Recommendation:</b><br><p>The cables may be enclosed or run in heat resistant enclosures. Damages due to heat may also be prevented by installing cable trays and avoiding direct contact with the hot objects. Termination of cables and wires must also be redone to avoid ingress of moisture</p> | |

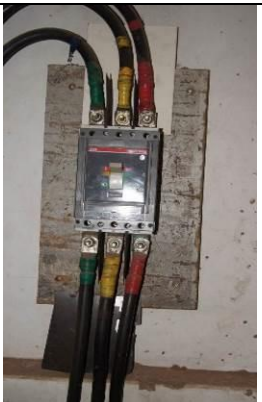
| <b>Finding #:</b> E- 6 | |

| <b>Finding:</b><br><br>Transformer output (LV side) is connected through MCCB (In=400A) and is not enclosed (directly mounted on the wall). | |
| <b>Remediation Timeframe:</b> Within 1 Month | MCCB installed on the wall (Transformer room) without enclosure. |

| <b>Recommendation:</b><br><br>The MCCB may be installed in standard enclosures and must be protected. Cables terminating at the MCCB must be firmly fixed with cable glands. Install phase barrier between MCCB terminals. | |

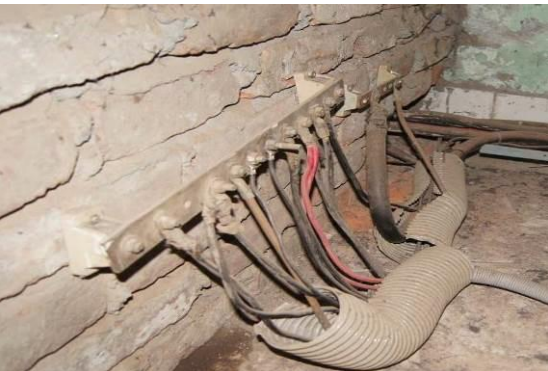
| <b>Finding #:</b> E- 7 | |

| <b>Finding:</b><br><br>The ground connections and the Earth Bus are not proper. The earth conductors terminating to & from Earth Bus are of various type and sizes. | |
| <b>Remediation Timeframe:</b> 3 Months | Main earth strip (bus) in substation. Earth conductors of different sizes terminating at the strip. |

| <b>Recommendation:</b><br><br>All earth conductor terminating to and from earth bus must be checked and sized as required. All connections must be reinstalled cable lugs and nuts & bolts (Brass/steel) | |

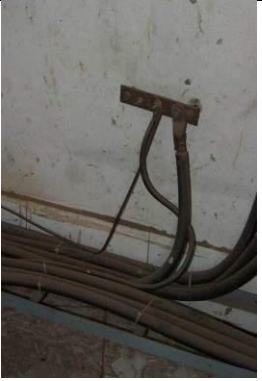
| <b>Finding #:</b> E- 8 | |

| <b>Finding:</b><br><br>Earth Lead (from earth electrode) installed is not sized adequately. | |
| <b>Remediation Timeframe:</b> Within 1 Month | Main earth bus terminating the main earth conductor from the electrode. |

| <b>Recommendation:</b><br><br>Earth lead must be replaced by higher cross-sectional area. | |

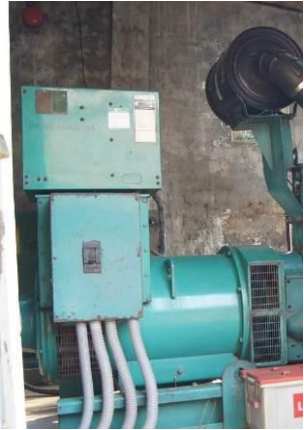
| <b>Finding #:</b> E- 10 | |

| <b>Finding:</b><br>Cables terminating at generator terminal box are not supported and not firmly fixed. | |
| <b>Remediation Timeframe:</b> Within 1 Month | Cables in flexible PVC conduits terminating at MCCB termination box. |

| <b>Recommendation:</b><br>Cables terminating at generator terminal box must be supported and protected. Existing cables in flexible PVC conduit must be additionally supported. Cables may be supported in risers and securely fixed to the terminal box installing cable glands. | |

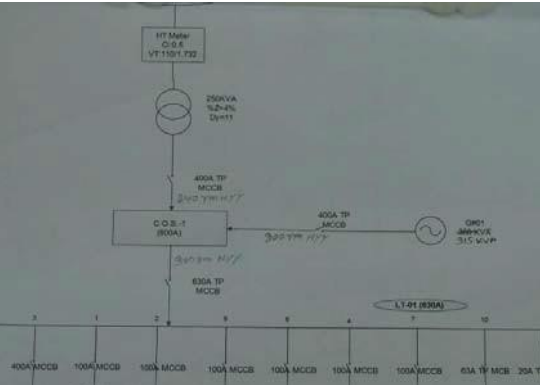
| <b>Finding:</b><br><br>The Switchgears (like MCCB, Changeover Switches, Feeder protection breakers) are not selected/engineered properly. The up-stream breakers are lower current rated than the downstream breakers. | |

| <b>Recommendation:</b><br><br>Proper selection of switchgear and protective devices after detail engineering must be done. Protection coordination of Main breaker with the downstream breakers must be checked and coordinated. Might require replacement/resizing of some switchgear. | Factory Electrical system SLD showing cable sizes |

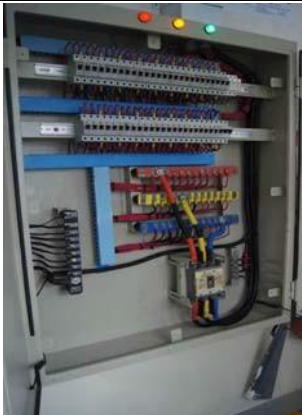
| <b>Finding:</b><br><br>Sub-Distribution boards are not of proper standards. Wiring, termination and Bus bars arrangements are not as per standards. | |
| <b>Remediation Timeframe:</b> 6 Months | Arrangement inside SDB board. |

| <b>Recommendation:</b><br><br>Bare bus bars inside the SDBs are placed at the lower part inside the SDB which poses danger of electric shock to the operator(s) during operation and maintenance. Exposed bus bars may be protected with insulating and electrically graded covers. | |

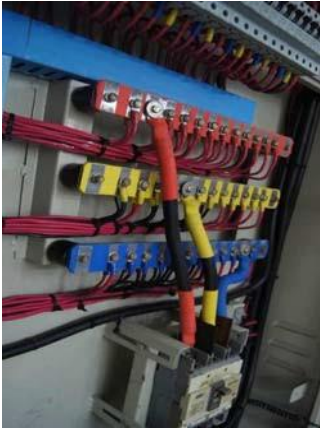
| <b>Finding #:</b> E- 15 | |

| <b>Finding:</b><br><p>Spacing between the phases inside panels are dangerously close. Slight increase in temperature above operating temperature may result in direct short circuit.</p> | |
| <b>Remediation Timeframe:</b> Within 1 Month | <p>Cable links between main MCCB and bus bars crossing other phases without safety clearances.</p> |

| <b>Recommendation:</b><br><p>Cables connecting the MCCB and the respective bus bar must be changed and dressed from the side to provide safe spacing between any two phases.</p> | |

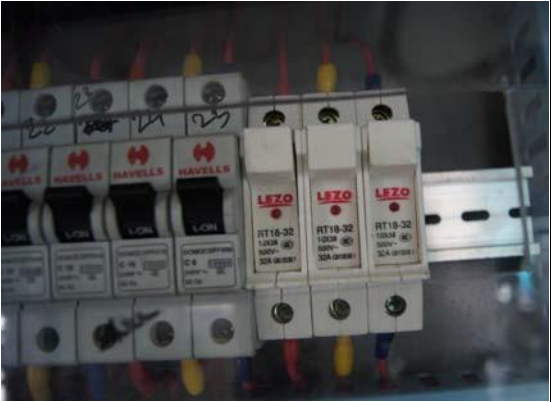
| <b>Finding:</b><br><p>Sub-distribution board inside factory are overcrowded with MCBs. No spare feeders and provisions for spare.</p> | |
| <b>Remediation Timeframe:</b> 3 Months | <p>One end of the DIN rail on which the MCBs are mounted inside the SDB.</p> |

| <b>Recommendation:</b><br><p>Additional SDBs may be installed to provide space for safe working environment or the existing panels can be replaced with larger panels. The bus bars provided in the panels can be removed by providing loop of sufficient current carrying capacity on incoming end of the MCBs.</p> | |

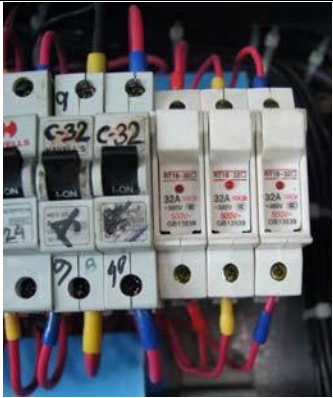
| <b>Finding #:</b> E- 17 | |

| <b>Finding:</b><br><p>Breaker identifications are written in ink on the specific MCB with Numbers over its ratings.</p> | |
| <b>Remediation Timeframe:</b> Within 1 Month | <p>MCBs inside panel marked with marker over the MCB ratings.</p> |

| <b>Recommendation:</b><br><p>MCB schedule may be prepared and displayed on the panel door. Alternatively, it can be marked on the inner separation board and provide the details on the SLD.</p> | |

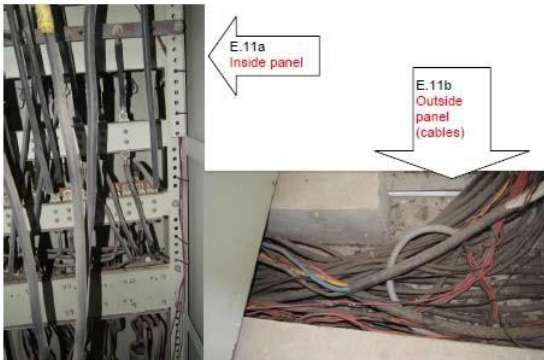
| <b>Finding:</b><br><br>Panels are not installed with required safety features. | |

Cables entering panel (in open trench) and inside the same panel.

| <b>Recommendation:</b><br>a) Panels must be fixed with gland/base plates and must be protected from entry of dust, mice, insects and other small animals.<br>b) Cable terminating at the panels must be firmly attached with proper glands.<br>c) Cable inside the panel must be terminated with proper lugs/terminals | |

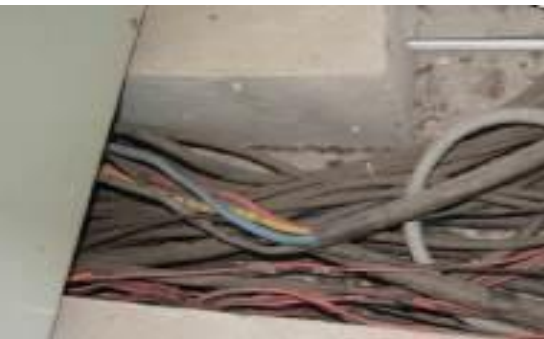
| <b>Finding #:</b> E- 19 | |

| <b>Finding:</b><br><br>Scheduled maintenance not performed on regular basis. | |

Cable covers and sheath removed before entering the panel and wires exposed (not protected).

| <b>Recommendation:</b><br><br>Maintenance schedule must be redesigned to ensure no or little dust collection on/in the panel. Summary of Maintenance records must be displayed in the LT panel and detail maintenance record registers must be maintained. | |

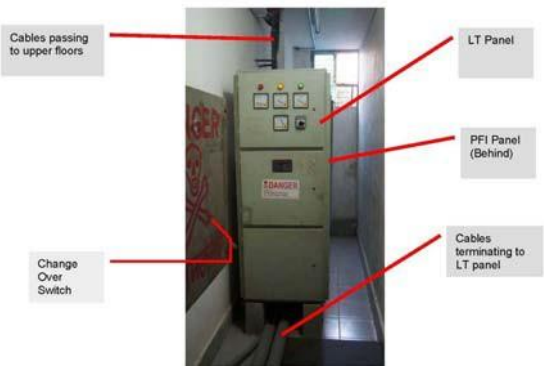
| <b>Finding #:</b> E- 20 | |

| <b>Finding:</b><br><br>Electrical panel room congested and do not have adequate working space around panels. | |

One of the main panels in the factory installed in a narrow room with many other panels.

| <b>Recommendation:</b><br><br>Some of the panels may be relocated to provide safe operating space around the panels. Relocating all panels may be an option as the space is used for Electrical Service Shaft | |

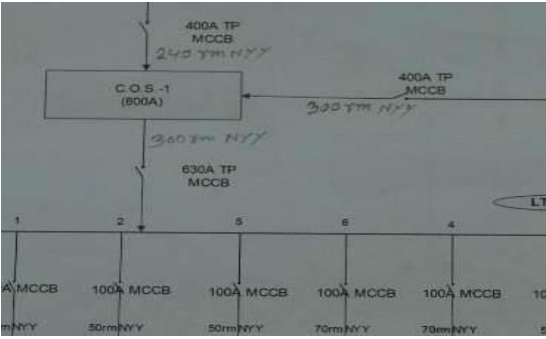
| <b>Finding:</b><br>Cables sizes in the electrical systems are not selected in coordination to the load connected to it. | |
| <b>Remediation Timeframe:</b> 6 Months | <p>7Cables entering floors in electrical room along with wiring in flexible PVC conduit.</p> |

| <b>Recommendation:</b><br>Cable sizes must be calculated and designed to match with the plant capacities (Main transformer, Generators and voltage drop). | |

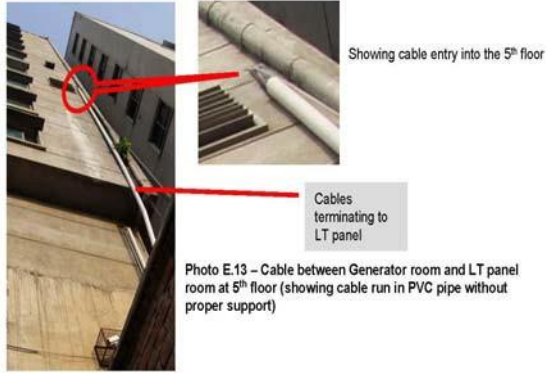
| <b>Finding:</b><br>Power Cable delivering power to the LT panels at 5 <sup>th</sup> and 7 <sup>th</sup> Floors are not supported and directly passes through wall opening. | |
| <b>Remediation Timeframe:</b> Within 1 Month | Main cables installed outside building and in large PVC pipes but not supported/fixed at regular intervals. |

| <b>Recommendation:</b><br>The cables from Generator Room to 5 <sup>th</sup> and 7 <sup>th</sup> floors must be properly clipped/mounted on cable tray/ cable ladders from Generator output panel to Changeover panel. The cable ends must be firmly fixed to the gland/base plate of respective panels. Entry into the floors must be protected by installing conduits and cable must not be stressed. | <p>Photo E-13 – Cable between Generator room and LT panel room at 5<sup>th</sup> floor (showing cable run in PVC pipe without proper support)</p> |

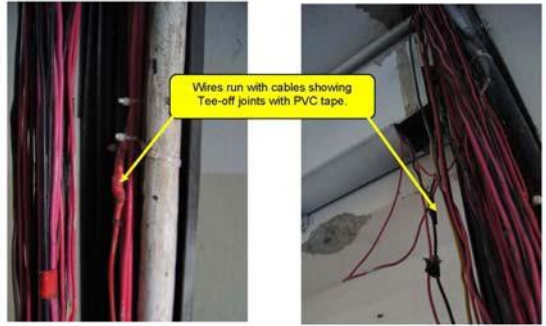
| <b>Finding:</b><br>Wire joints and spliced in between terminals. Wires in trays or ducts are not protected. | |
| <b>Remediation Timeframe:</b> 3 Months (refer E-24) | Bunch of wires between floors without supports and protections. Some of the wires in it are joined. |

| <b>Recommendation:</b><br>Wiring between floors must be replaced with proper size cables. Joints between terminals must be avoided and where not avoidable, must be joined installing standard cable/wire jointing kits. | |

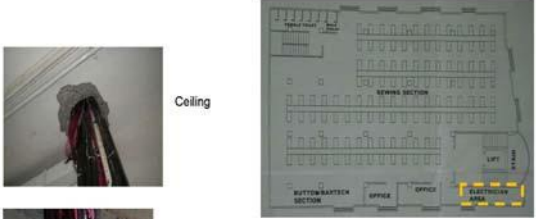
| <b>Finding:</b><br><br>Wires and cables passing through ceiling/floor between different levels are not supported and not protected. | |
| <b>Remediation Timeframe:</b> Within 1 Months | Wires and cables bunched and passing through floors and ceiling (Diagram show recommended electrical shaft) |

| <b>Recommendation:</b><br><br>Cables and wires passing through ceiling / floors must be protected in rigid pipes and remaining gaps around it must be sealed with fire rated materials. Wires in trays/duct must be additionally protected in conduits. Recommended to install all cables and wires through electrical shaft in ducts. | <p>Photo E.15a - Showing cable entry from a floor and ceiling</p> |

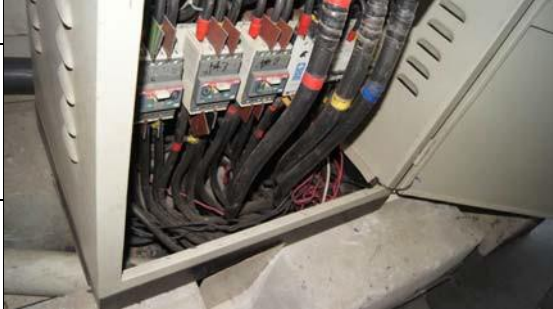
| <b>Finding:</b><br><br>Cables terminating at LT panels and PFI panels are not firmly fixed and safely supported inside the panel. | |

| <b>Recommendation:</b><br><br>Cables terminating at panels must be firmly fixed with cable glands through gland plates. Panel base plates must be installed. Cables inside panel must cross over switchgear or devices and must be securely fixed through safe routes inside panel. | <p>Cables terminating at panels entering from base without base plates.</p> |

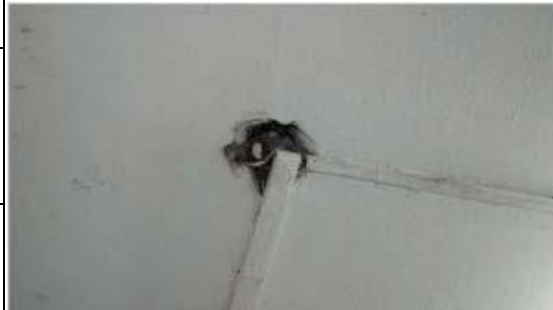
| <b>Finding:</b><br><br>Unutilized light & ceiling fan points are left open. Wiring extended from concealed wiring points. | |

| <b>Recommendation:</b><br><br>All unused concealed points must be safely protected and covered. Wiring extended from existing concealed wiring points must be connected through terminals or ceiling rose and extensions must not exceed the permissible load. | <p>Wirings in PVC casing capping wiring extended from concealed wiring point in ceiling.</p> |

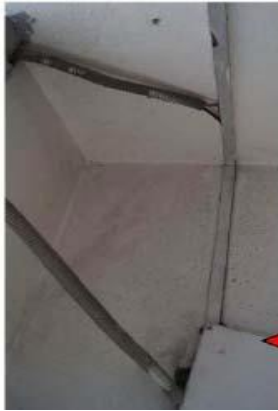
| <b>Finding #:</b> E- 27 | |

| <b>Finding:</b><br>Wiring inside factory supported in PVC conduits and casing capping are exposed at junctions or at damaged wiring supports. | |
| <b>Remediation Timeframe:</b> 3 Months | A typical wiring systems with no standard system followed. |

| <b>Recommendation:</b><br>Wiring supports must be industrial grade and must provide protection and support throughout its length. Wiring supports must be installed with junctions, bents and sockets to prevent exposing wiring in it. | |

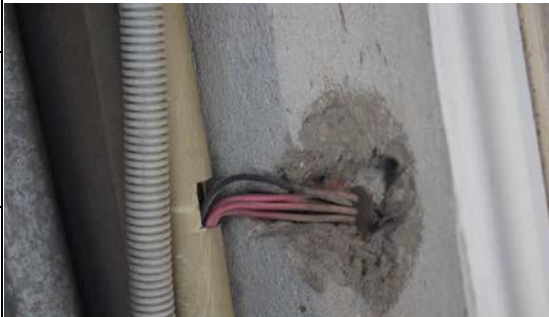
| <b>Finding #:</b> E- 28 | |

| <b>Finding:</b><br>Wires passing through permanent walls, (Ceiling and floors). | |
| <b>Remediation Timeframe:</b> 3 Months | Wirings extended from concealed conduit wiring to PVC conduit joined without junctions. |

| <b>Recommendation:</b><br>Wiring passing through walls (ceiling/floors) must be protected in rigid pipes. Damaged conduits may be replaced or repaired and all wiring supports must be installed with its necessary accessories. | |

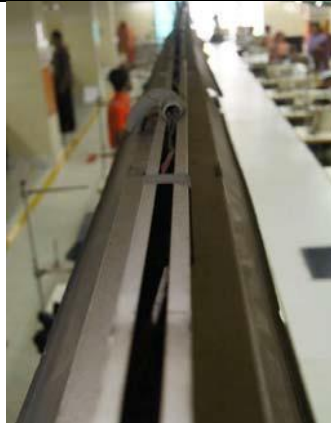
| <b>Finding #:</b> E- 29 | |

| <b>Finding:</b><br>Wirings supported in overhead GI Sheet wiring ducts are not protected. | |
| <b>Remediation Timeframe:</b> 3 Months | Overhead wiring duct supporting wiring over work tables in one of the production floors. |

| <b>Recommendation:</b><br>Wirings supported in ducts above work tables must be covered to prevent ingress of lint. Wires joined inside ducts must be replaced and existing joints must be connected at the terminals. Power and lighting circuits must separate. | |

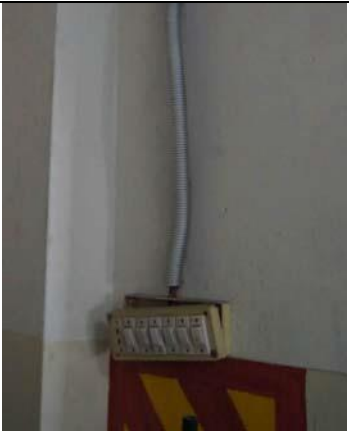
| <b>Finding #:</b> E- 30 | |

| <b>Finding:</b><br><br>Broken switches and wiring installation are seen in many places. It may add to difficulties during hazards. | |
| <b>Remediation Timeframe:</b> Within 1 Month | Switchboard (gang) damaged and loosely installed. |

| <b>Recommendation:</b><br><br>Broken switchboards, wiring and conduits must be rectified. Cables/wires run through PVC flexible conduits must be replaced with conduit (rigid PVC or Steel). | |
