# Lida Textile & Dyeing Ltd.

Holding No. 100/2, Block-B, East Chandura, Ward-8, Shafipur, Kaliakair, Gazipur.

4<sup>th</sup> February 2015

## Structural Inspection Report

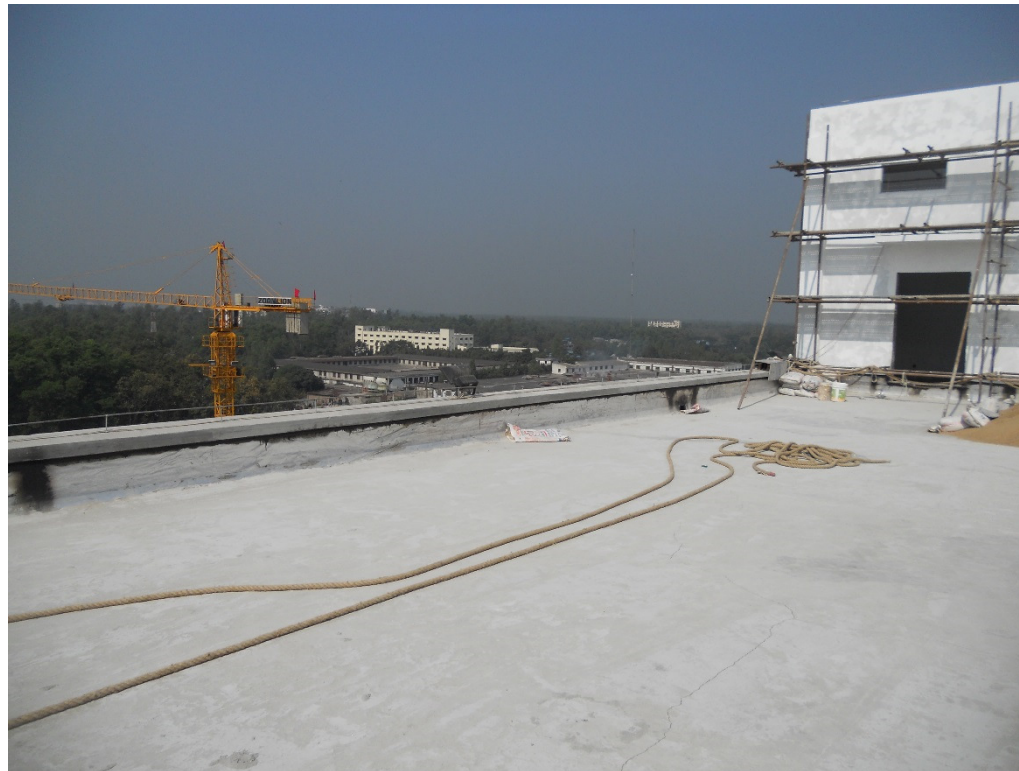
## **Lack of edge protection**

**We also have concerns regarding the lack of guarding/edge protection at the highest roof levels (roof to offices). **Appropriate edge protection should be provided immediately.****

**No edge protection was provided on the roof  
over office areas**

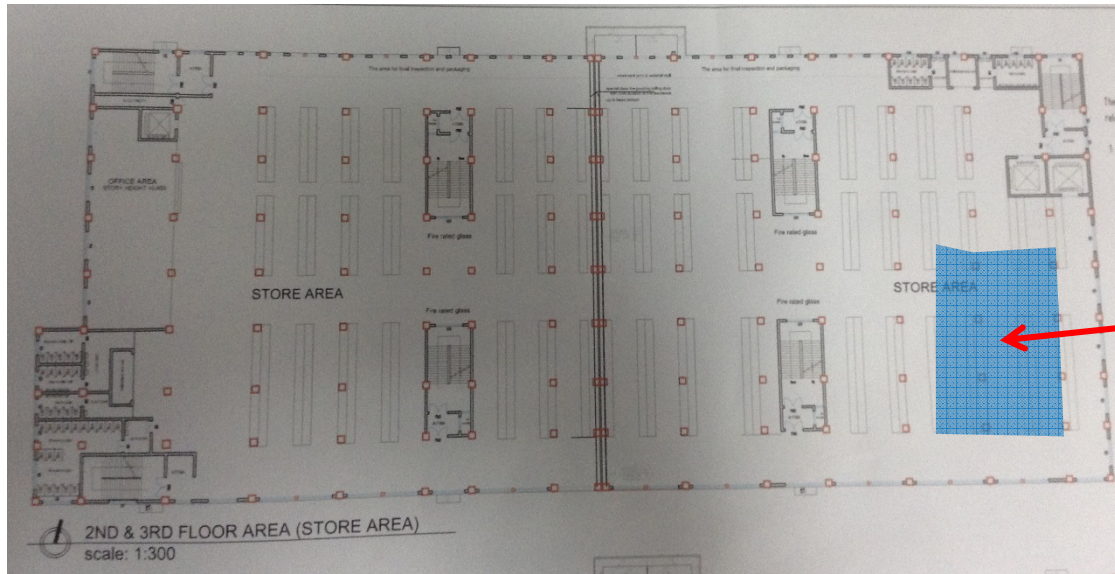
Observed loading varied up to 3.6kPa on 2<sup>nd</sup> and 3<sup>rd</sup> floors

- Building Engineer to prepare Loading Plans for each floor of the building based on column capacity and beam/slab capacity.
- Comply with the loading on each floor as specified in the loading plans

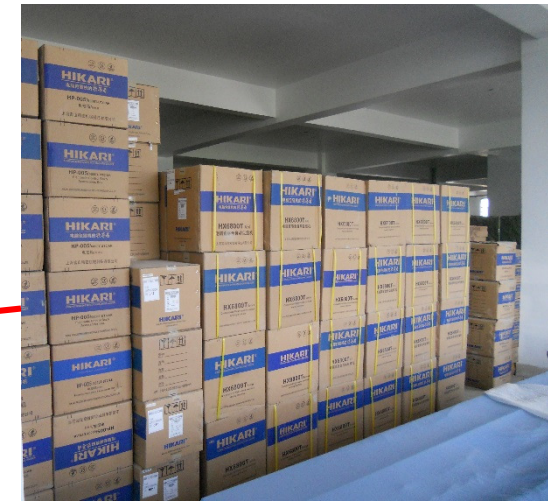
Area of localised 5.5kPa loading at 2<sup>nd</sup> floor

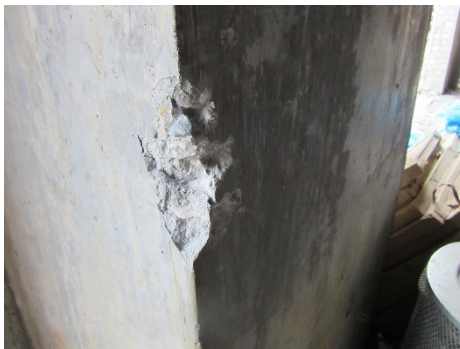
**Stone aggregates**

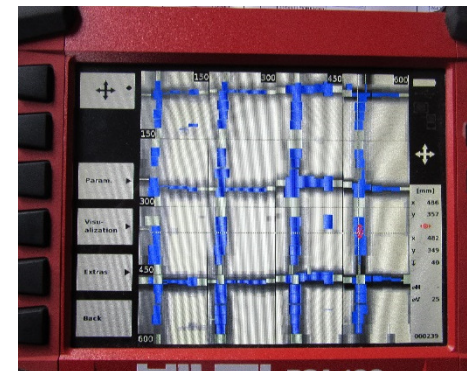
**Site measurements and observations correspond to drawings.**

**Detailed scan result**
