Habitus Fashion Limited

Gajariapara, Bhawal Mirzapur, Gazipur-1703

08 February 2015

Structural Inspection Report

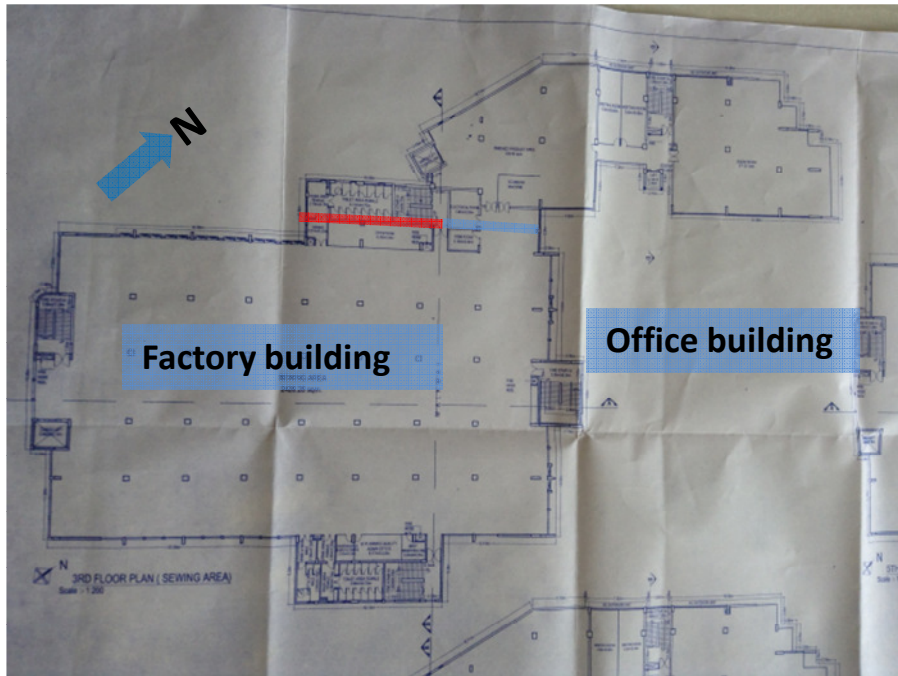
Partial constructed expansion joint between Office building and Factory building

Expansion joint is constructed

No expansion joint in this area

- The Engineer is carry out a review of the partial expansion joint. Carry out any remedial works as required.

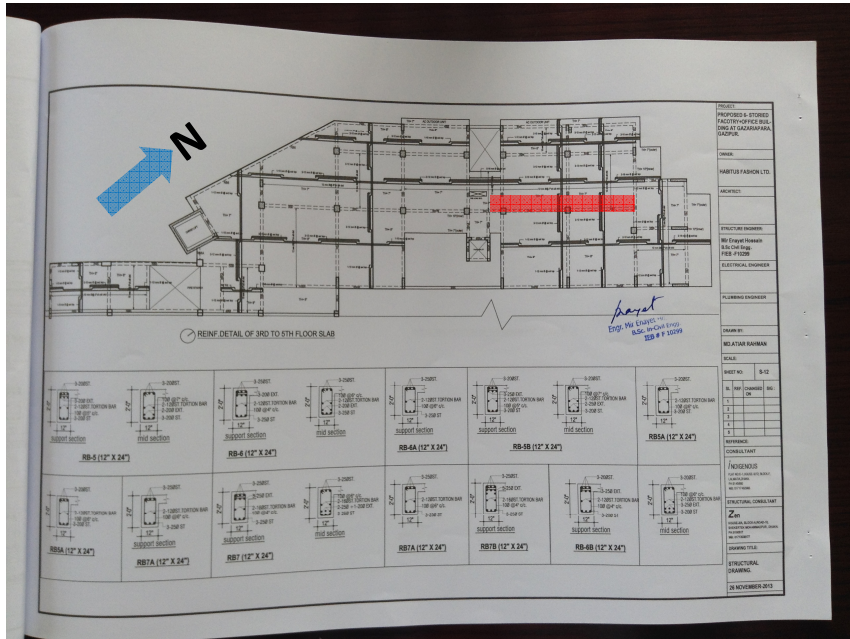
Slab Reinforcement Drawing

**Minor variation between structural drawing and
As-built. (beam omitted on underside of roof)**

There is a beam shown on the structural drawing

- Engineer to review the difference between the as constructed roof slab and the engineering drawings.
- Carry out any remedial work if required

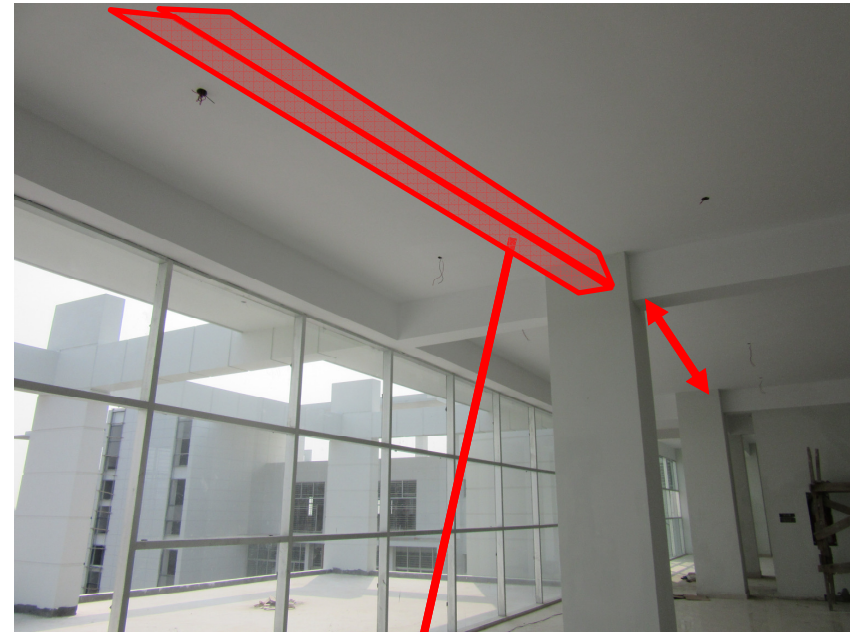
No beam was found during the inspection on underside of roof slab

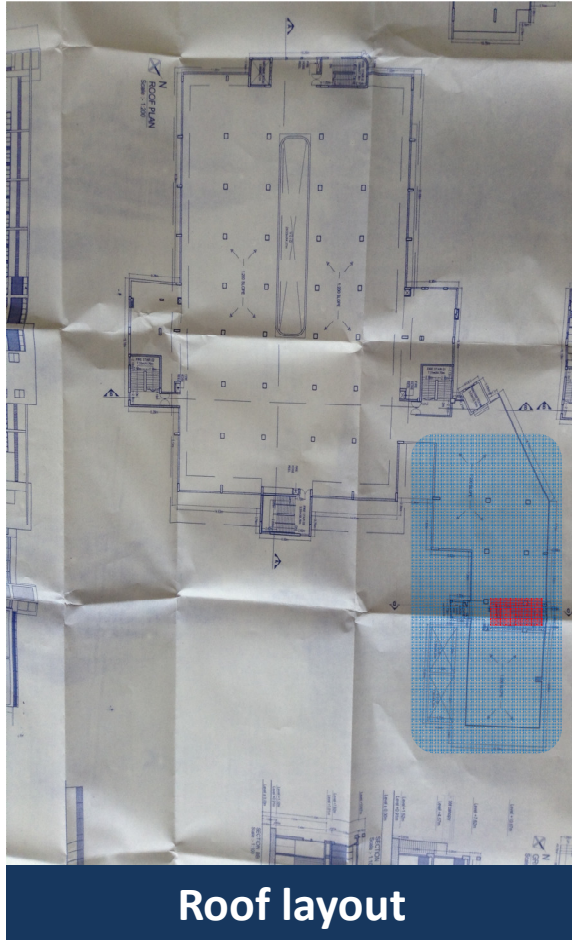
Roof layout

Water tanks on stair cores unusual construction

Position of water tanks

- The Building engineer to review the design of the water tank.
- Carry out any remedial works as required.

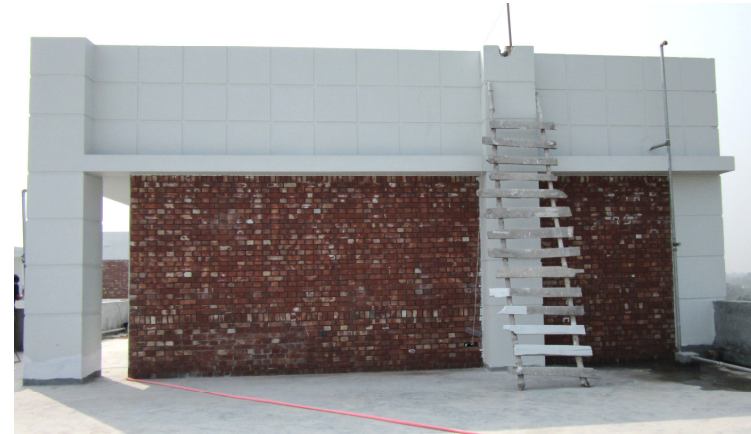
Water tank was observed on the stair cores of Office building

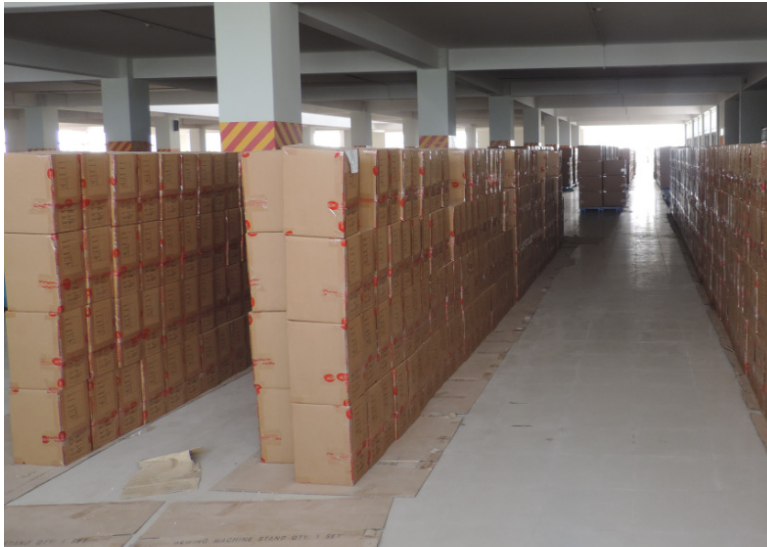
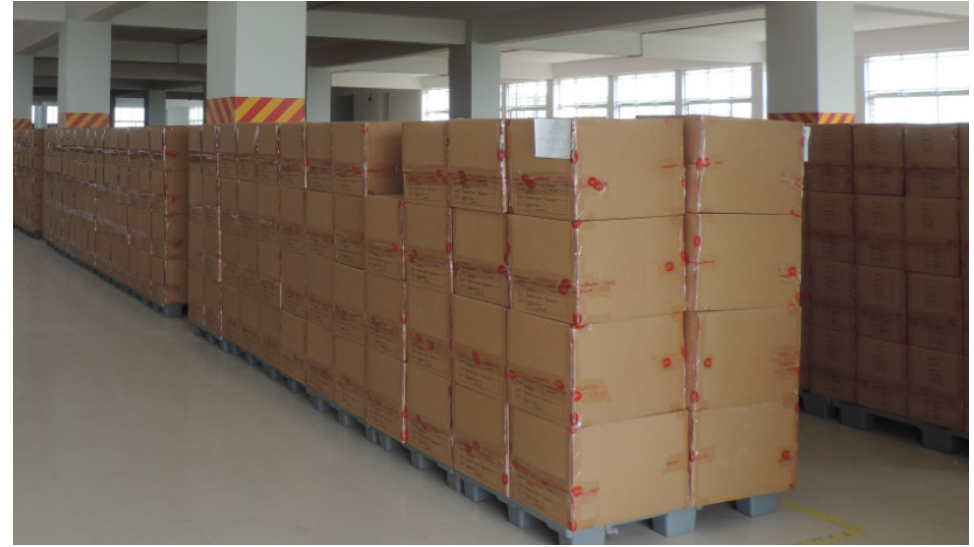
No Loading Plan

Storage on 3rd and 4th floors on Factory building

- Engineer should develop a loading plan for each floor that is compatible with the structural design.
- Impediment loading plan
