# Purbachal Apparel Ltd.

South Panjora, Ward#05, Nagori, Gazipur  
(23.888930N, 90.502231E)  
10<sup>th</sup> June 2018

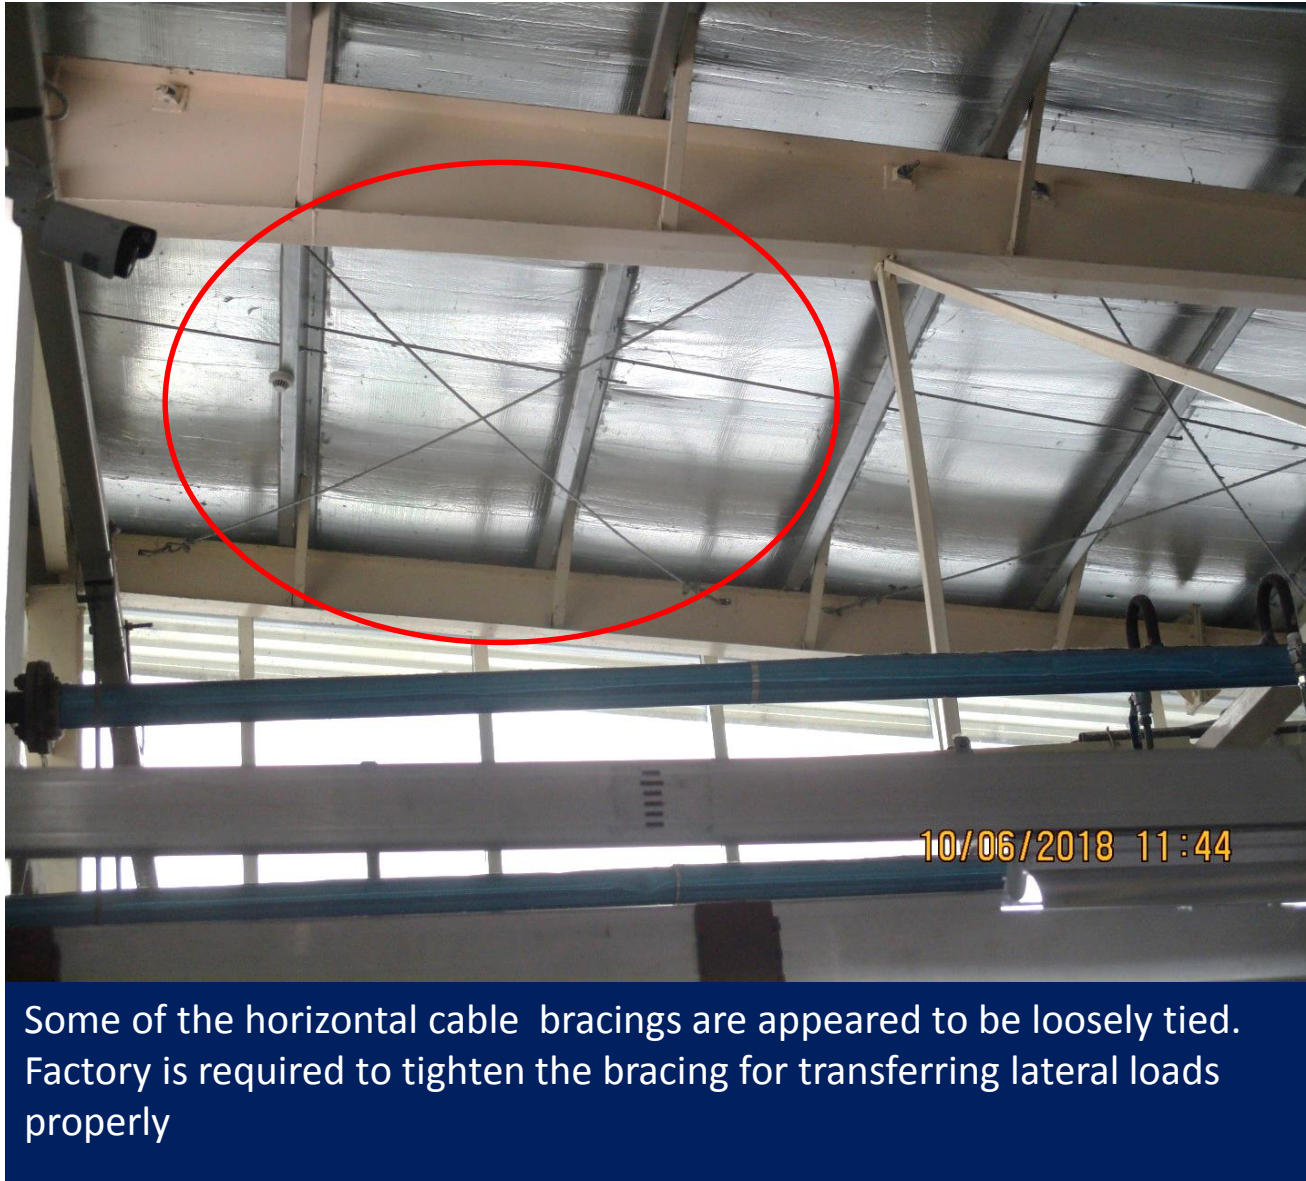
# Loose cable bracing

Some of the horizontal cable bracing are appeared to be loosely tied. Factory is required to tighten the bracing for transferring lateral loads properly

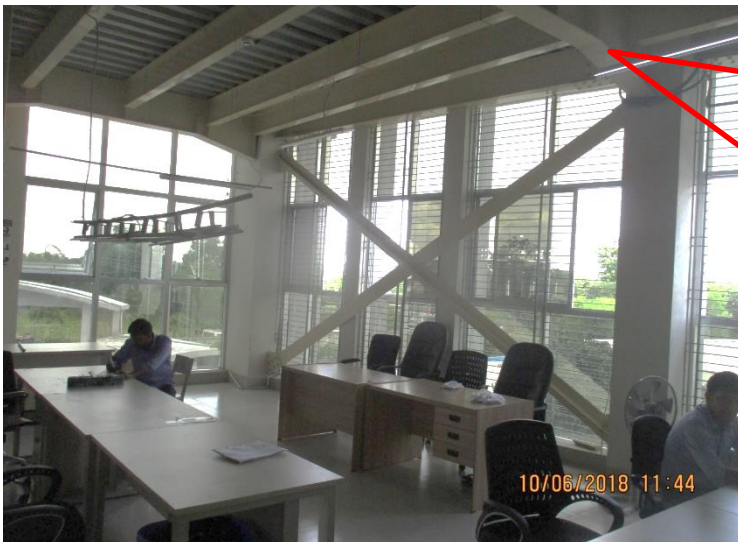
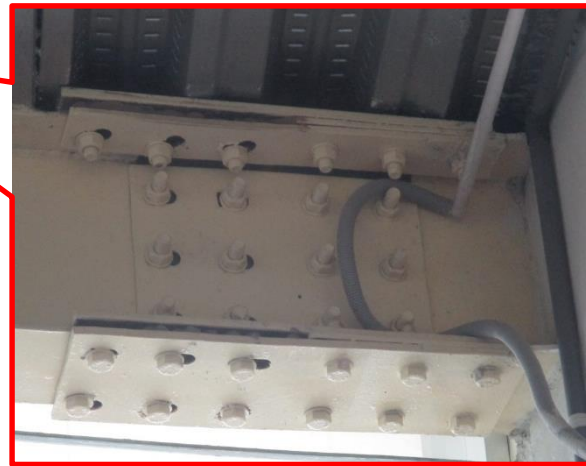
# Improper bolted connection between rafter and columns

Beam & column joints at ground floor and rafter & column joint at 1<sup>st</sup> floor joints are appears to be improper as there is large bolt hole than the bolt diameter. The faulty connection is to be repaired as per suggestion of factory engineer.

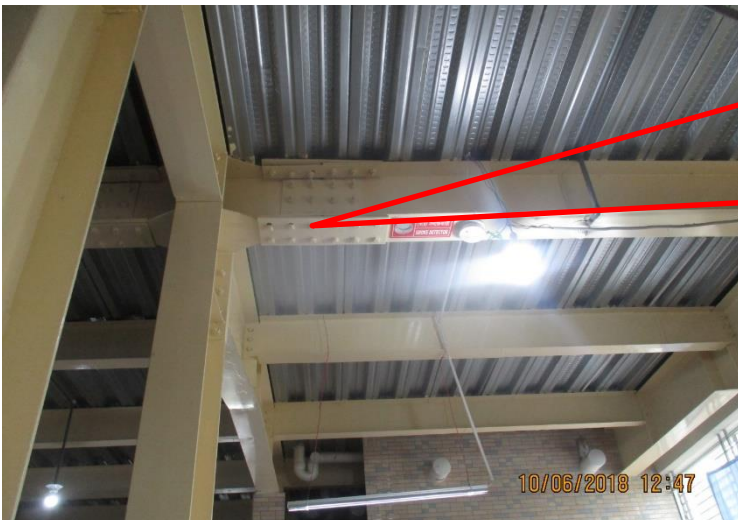
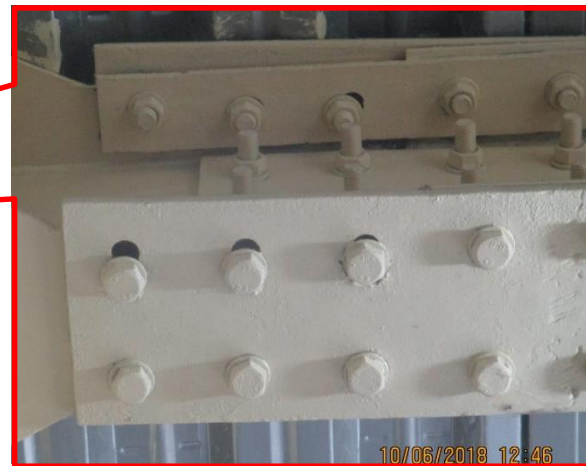
Improper connection was observed in ground floor at column and beam joint

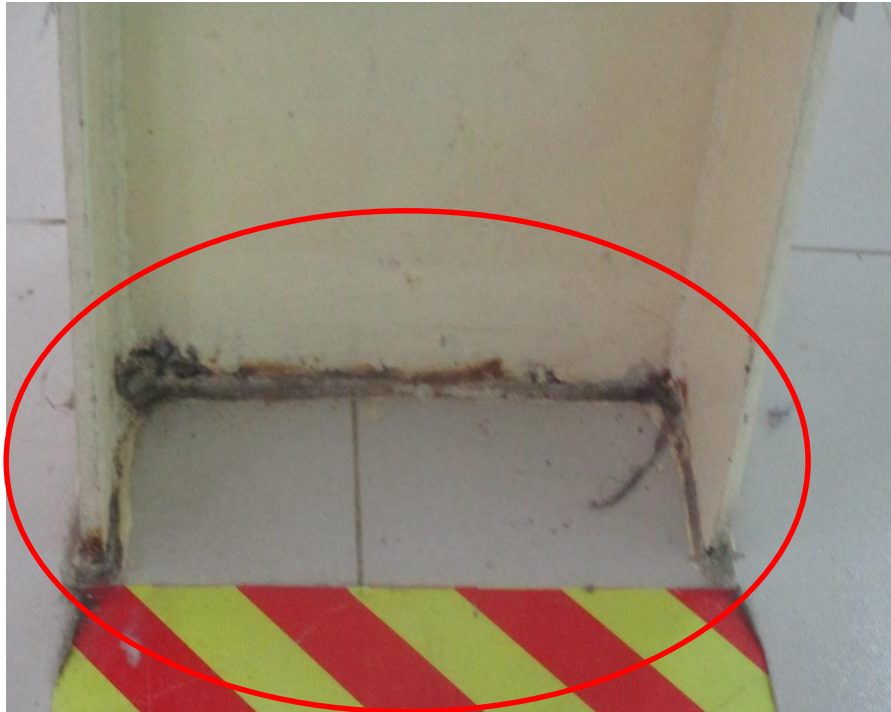
Corrosion was observed at joint of deck slab and steel column of 1<sup>st</sup> floor in production areas.

Corrosion was observed on steel columns on different locations of 1st and ground floor areas. Factory is required to identify the corroded locations and take proper remedial measures.

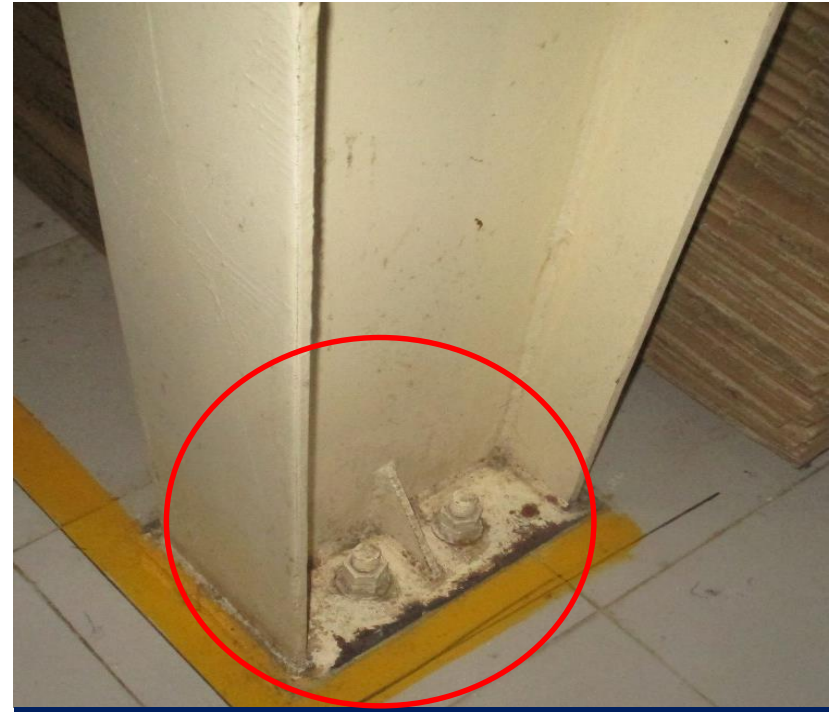
Corrosion was observed at joint of pedestal column and steel column.

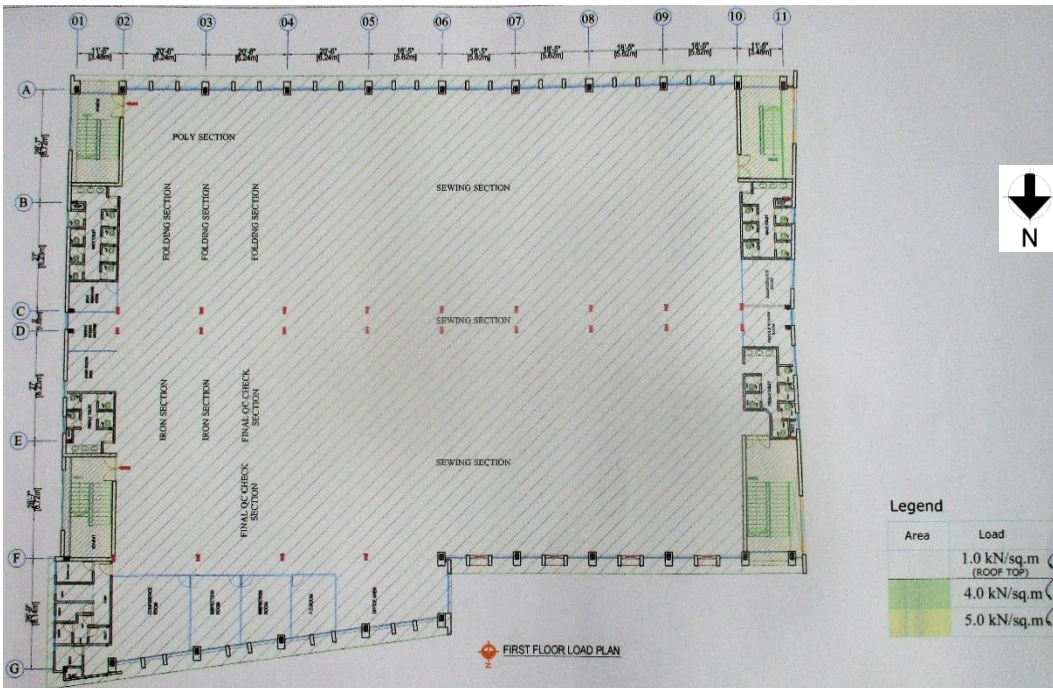
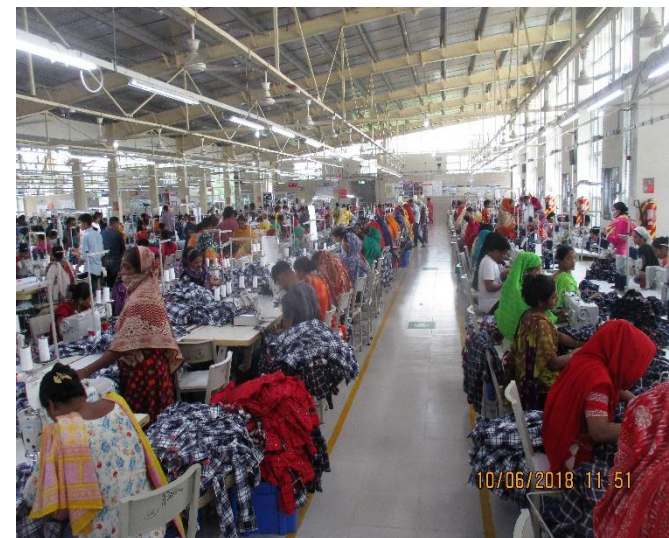
Sewing area

Factory engineer prepared a load plan for 1<sup>st</sup> floor considering 4.0 kPa as allowable load but no analysis or calculation was available for ensuring that the columns and beam have adequate capacity to carry the proposed floor loads. Factory is required to verified the load plan if factory management intends to maintain the load plan.

Load was measured below 2Kpa on every floor and FOS calculation for internal column was found satisfactory considering 3kPa allowable floor live loading.

Factory is required to maintain the floor live load 3 kPa until further verification of the load plan.

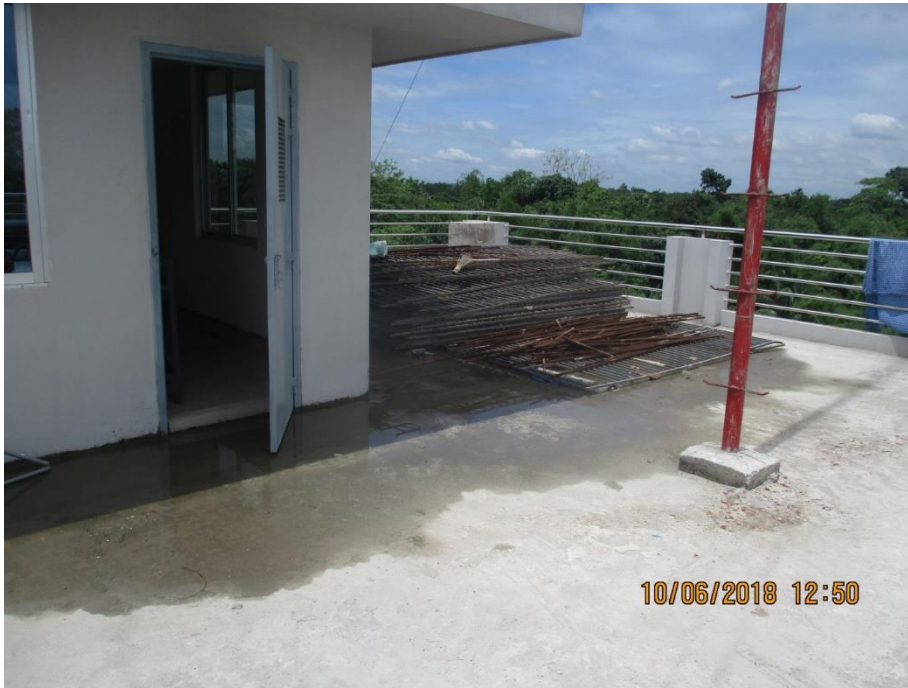
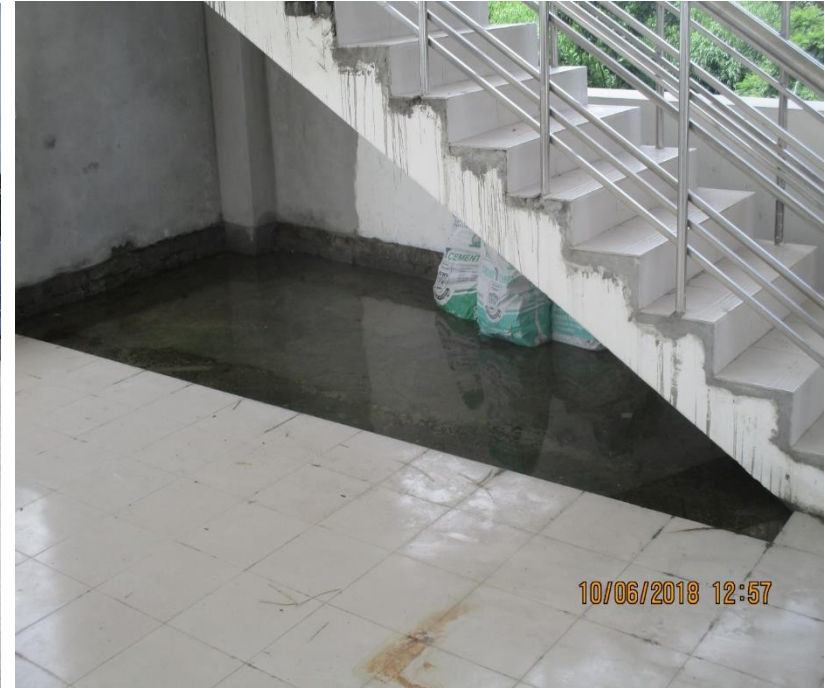
# Water clogging on roof top and 1st floor

During inspection, water clogging was observed on roof top and 1st floor. Factory is required to improve the water drainage system for preventing water clogging.

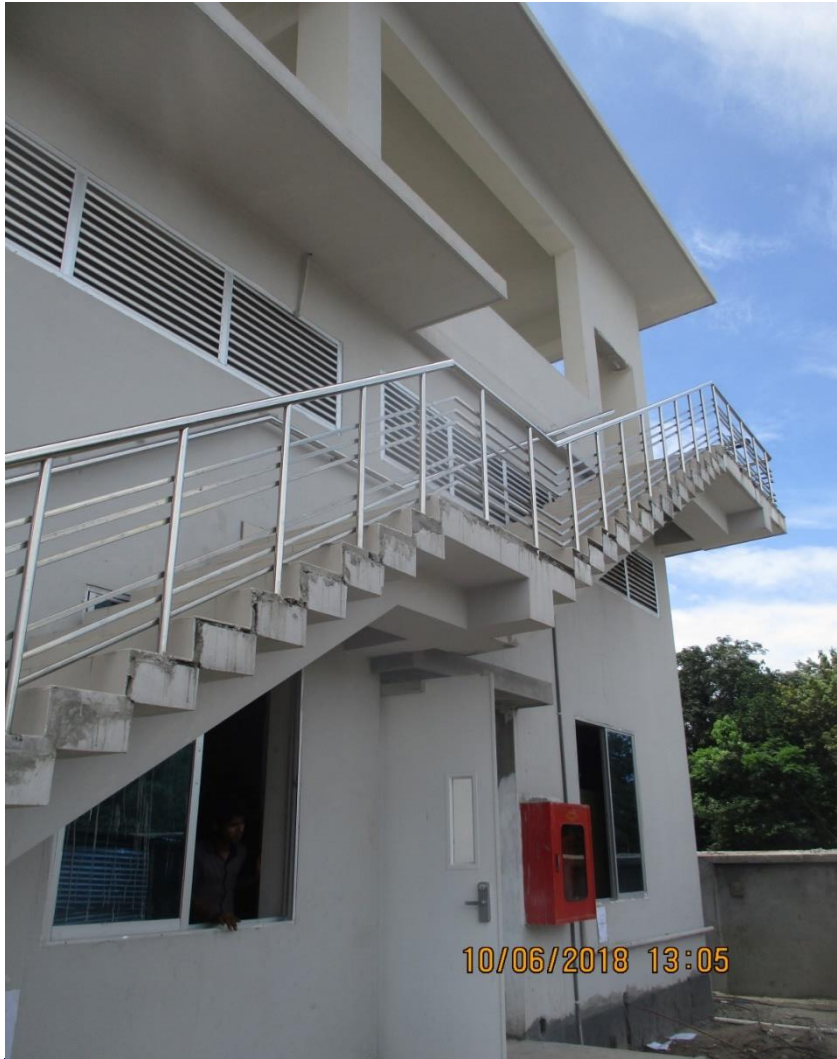
Concerns on cantilever beam supporting external stair case. A capacity check of the cantilever beam need to be carried out.

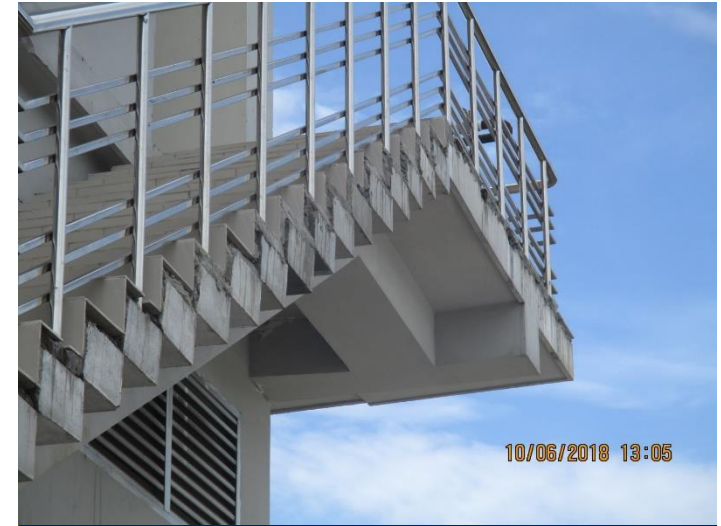
The external stair is supported by cantilever beam

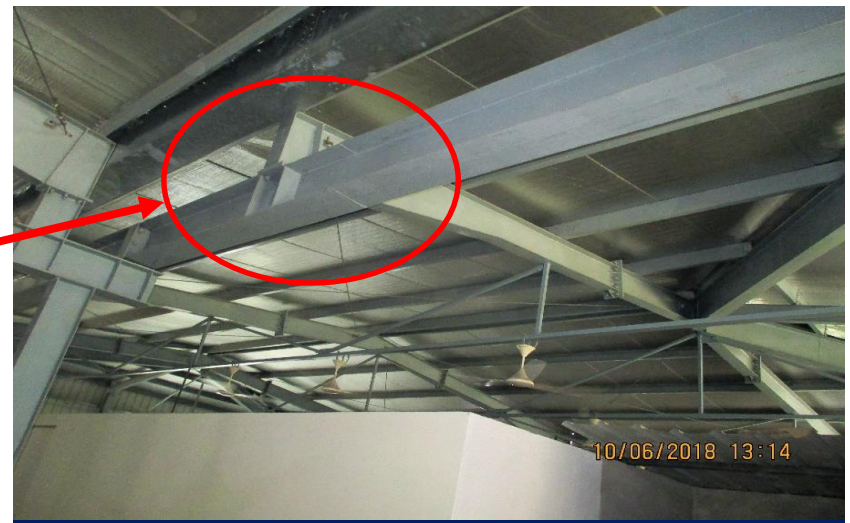
Jack beam supporting rafters

From the layout plan and visual inspection it was observed that the lateral stability of the structure partly depends on the jack beam as some of the rafter are resting on it. Apparently no obvious lateral load resisting system on north-south direction due to insufficient of lateral load transfer media. Factory engineer is require to verify the lateral stability of the structure against the horizontal and vertical loads.

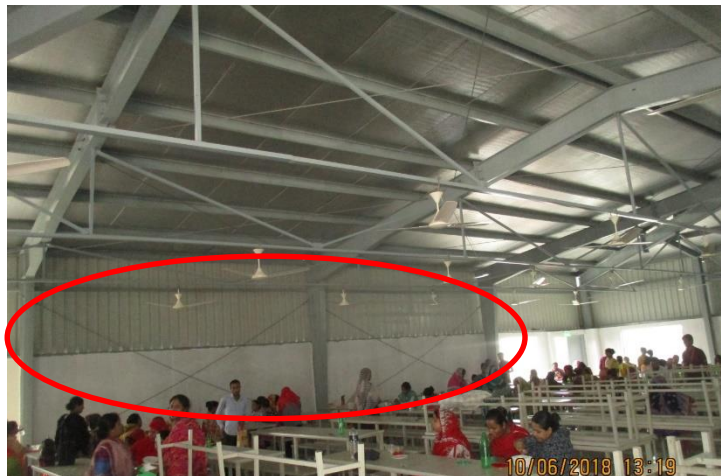
Loosely tied vertical cable bracing at east side

Some of the horizontal and vertical cable bracings are appeared to be loosely tied. Factory is required to tighten the bracing for transferring lateral loads properly

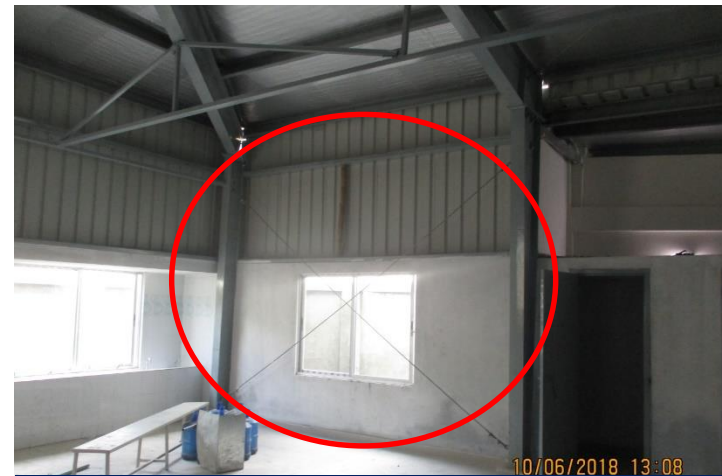
Loosely tied vertical cable bracing at west side

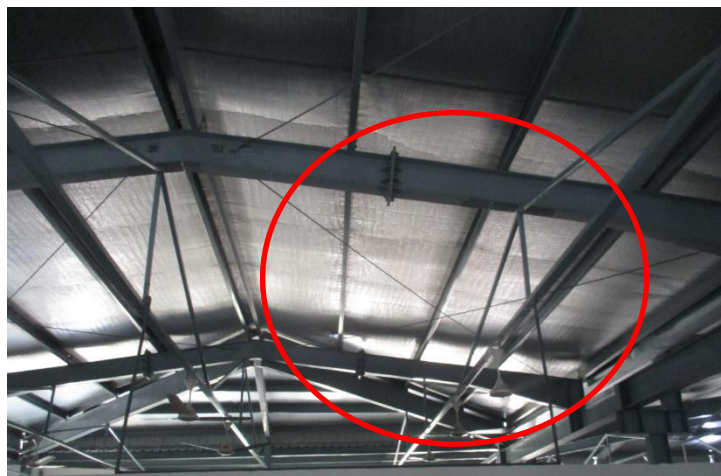
Loosely tied roof cable bracing

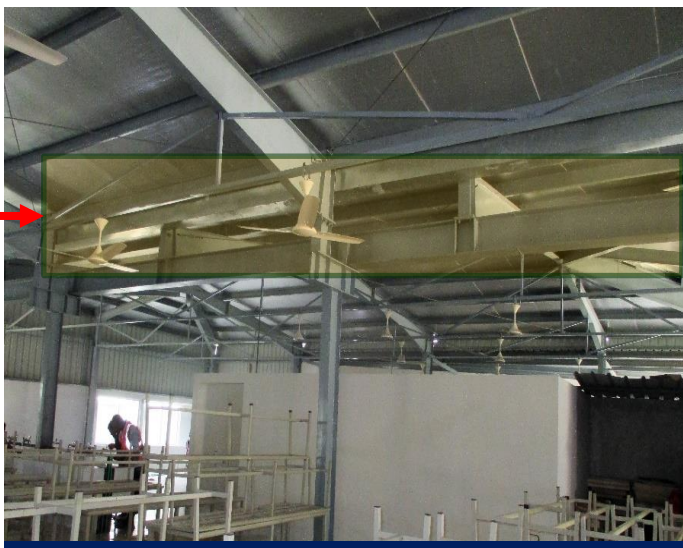
No column bracing was found on site in grid 5B-5C, 5C-5D, 7A'-7B' & 7B'-7C'

The location of column to column vertical bracing didn't match with provided bracing layout drawings. Factory is require to install the bracings as per bracing layout drawings.

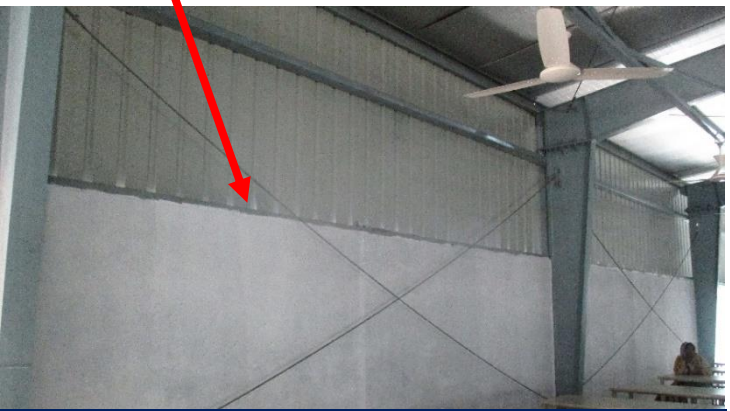
Only cable bracing was found in grid 1B-1C & 1C-1D but no compression strut was observed.

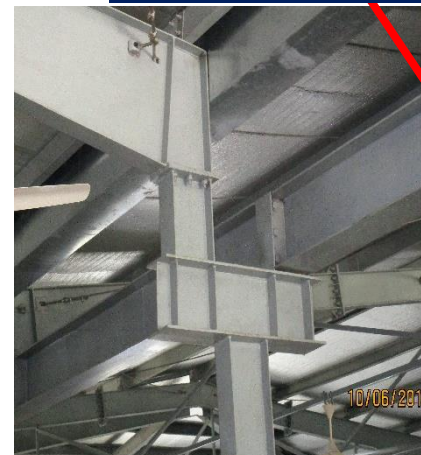
The size of Jack beam at grid B-5 was found F200mm (10mm) X W300mm(5mm) which was supposed to be F240mm (10mm) X W350mm(5mm) as per provided as-built structural drawing.

Jack beam BR-300 at grid B-5

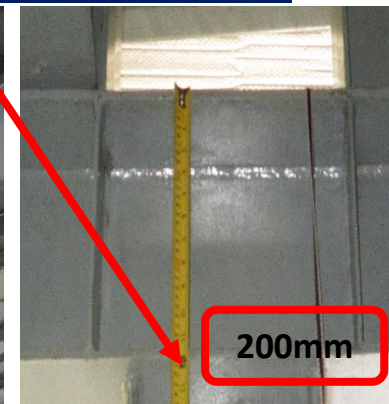
Depth of Jack beam measured on site
