# Kaizer Knitwears Ltd.

Nayapara, Kashimpur, Gazipur.

21<sup>st</sup> May, 2018

# Observations

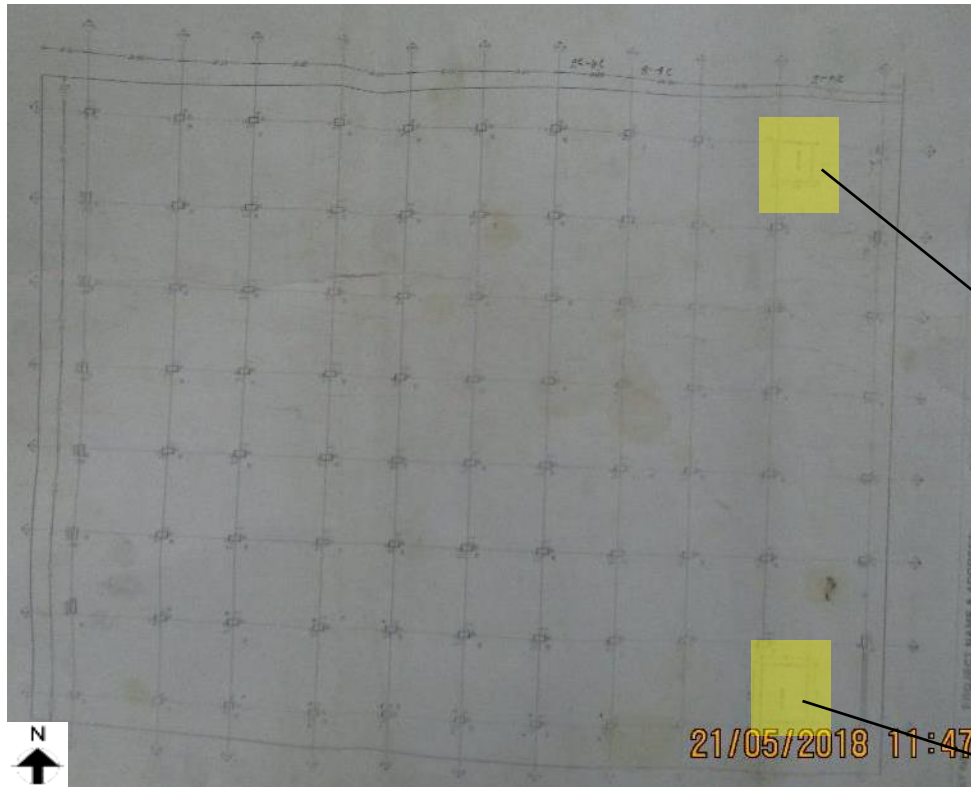
Column and Shear wall layout plan

**Lateral stability system to be verified**

As per drawing, there are two shear walls provided for the structural system which was not constructed on site. Actual design may have considered the shear walls to resist lateral loads. Building engineer is required to check the structural system considering the moment resisting frame actions.

| Item No. | Observation | Recommended Action Plan | Recommended Timeline |
|---|---|---|---|
| 1 | Lateral stability system to be verified | Building engineer is required to check the lateral stability of the building considering moment resisting frame action. A Engineering Assessment of Factory Building to be carried out. | 6-weeks |
| 2 | Lateral stability system to be verified | Implement the recommendation of Engineering Assessment. | 6-months |

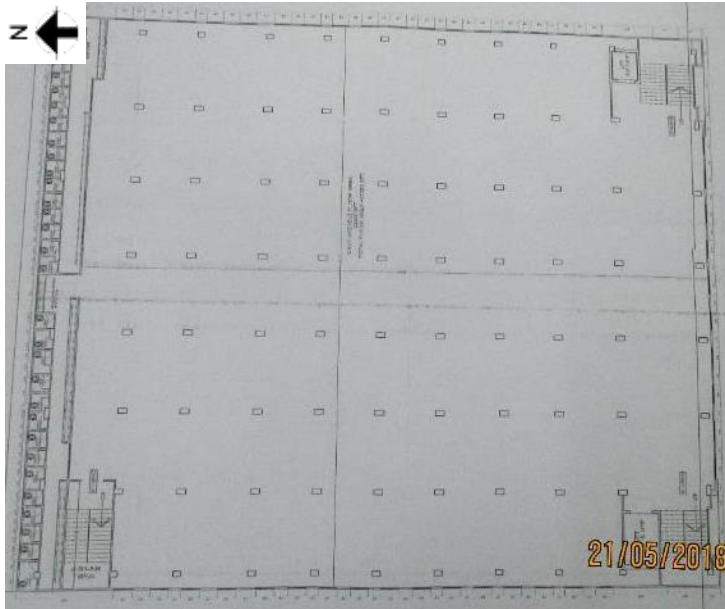
Floor layout plan not matched with site condition.

6 bays constructed instead of 7 in East-West direction. Also stair position not matched.

No credible as built drawings were available on site for review. Building engineer is required to survey the structure and prepare accurate as built drawings.

| Item No. | Observation | Recommended Action Plan | Recommended Timeline |
|---|---|---|---|
| 3 | As built drawings not indicative to the site condition | Building engineer is required to survey the structure and produce as constructed drawings. | 6-weeks |

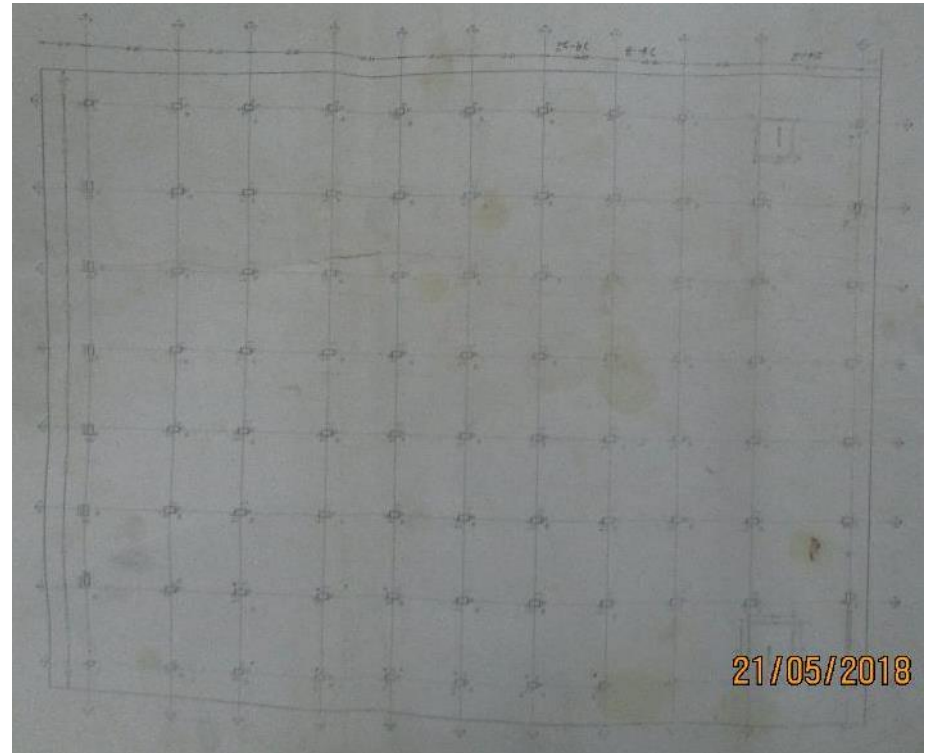
Column Schedule not matched with site condition.

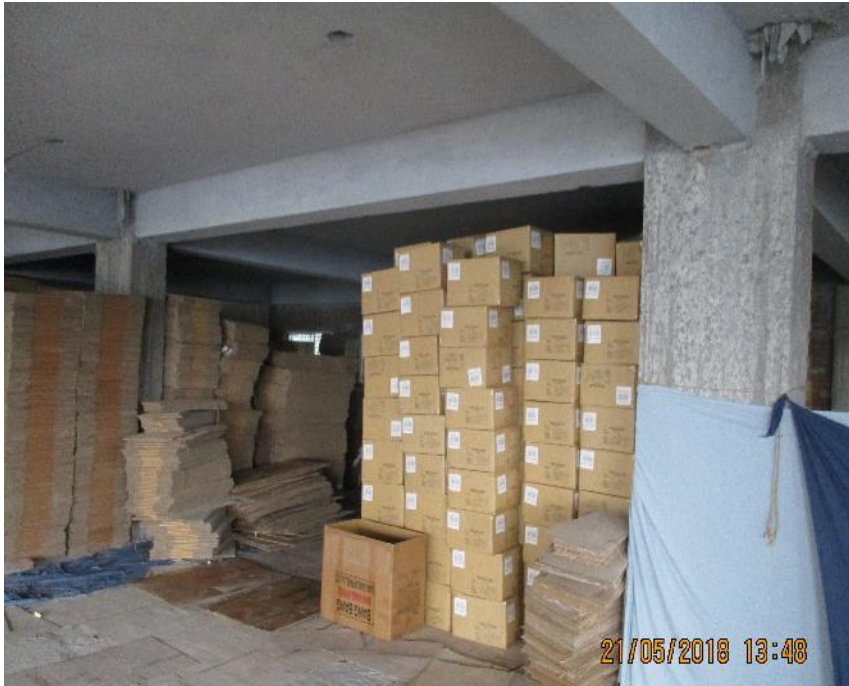
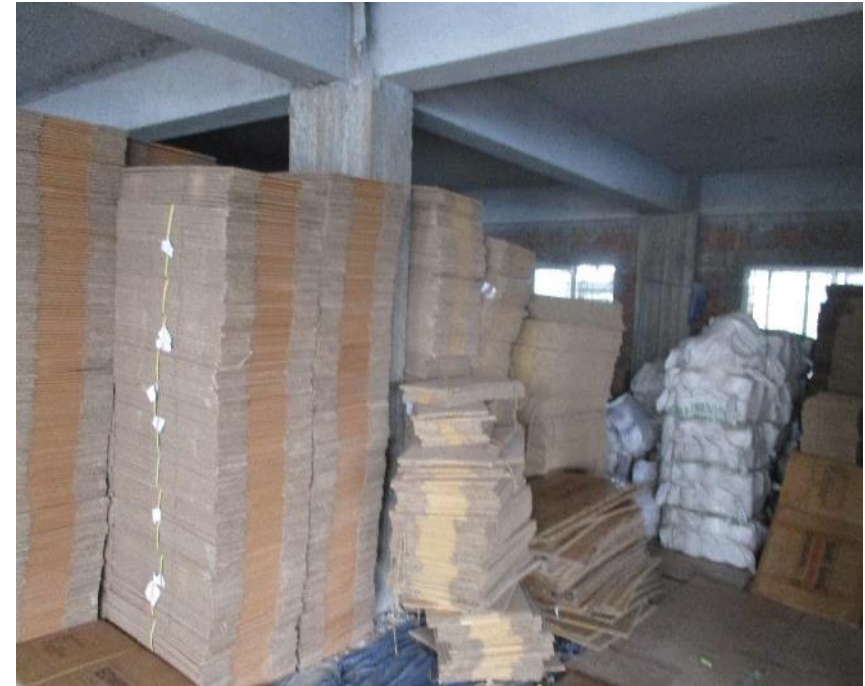
Uncontrolled loading.

No load management programs were visible. Factory is required to implement load management program as per its floor loading capacity and follow the load plans for all floors of the buildings and make sure that the workers understand the loading requirements.

| Item No. | Observation | Recommended Action Plan | Recommended Timeline |
|---|---|---|---|
| 4 | Implement floor load management program | Maintain loading below 3 kPa. | 6-weeks |
| 5 | Implement floor load management program | Produce and actively manage a loading plan for all floor plates within the factory giving consideration to floor capacity and column capacity. | 6-weeks |
| 6 | Implement floor load management program | Continue to implement load plan. | 6-months |

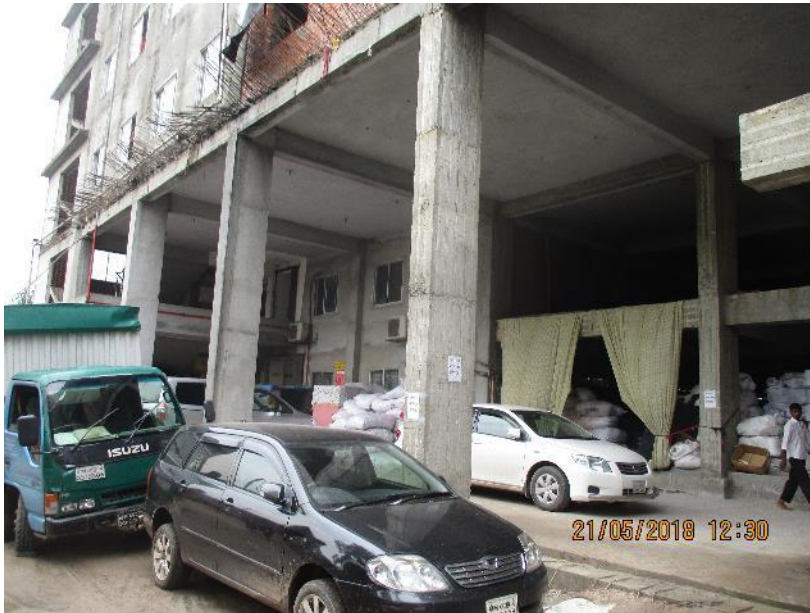
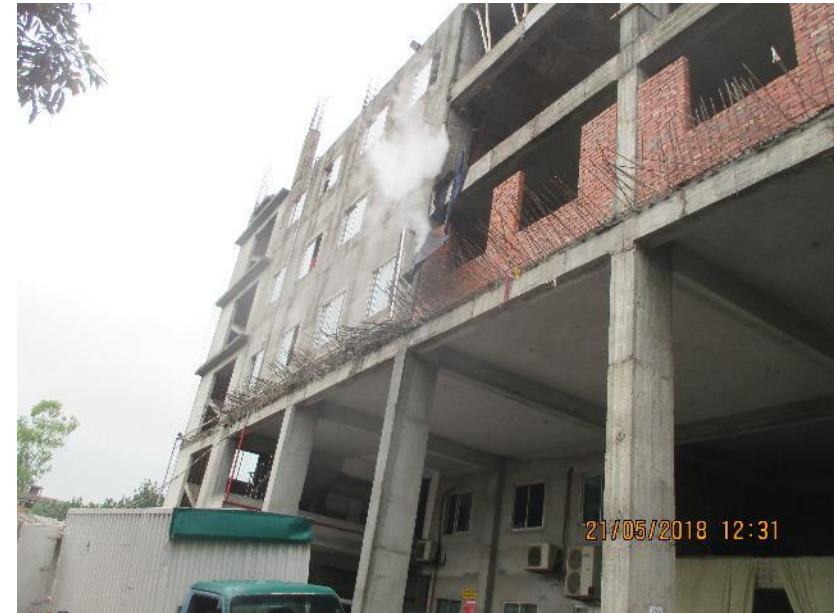
Columns were suspected to vehicle impact. Safety barrier is required to protect the vehicle impact.

| Item No. | Observation | Recommended Action Plan | Recommended Timeline |
|---|---|---|---|
| 7 | Columns susceptible to vehicle impact | Safety barrier is required to protect the vehicle impact. | 6-weeks |

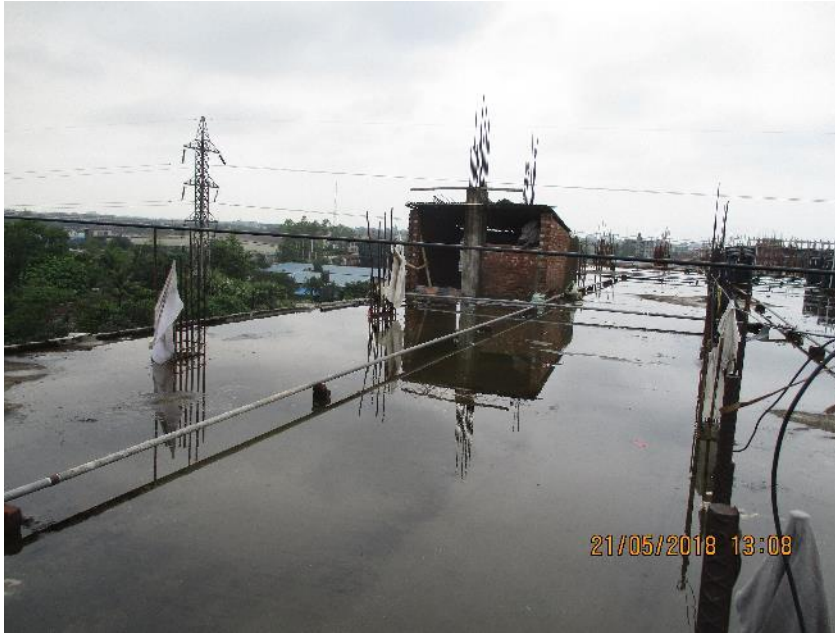
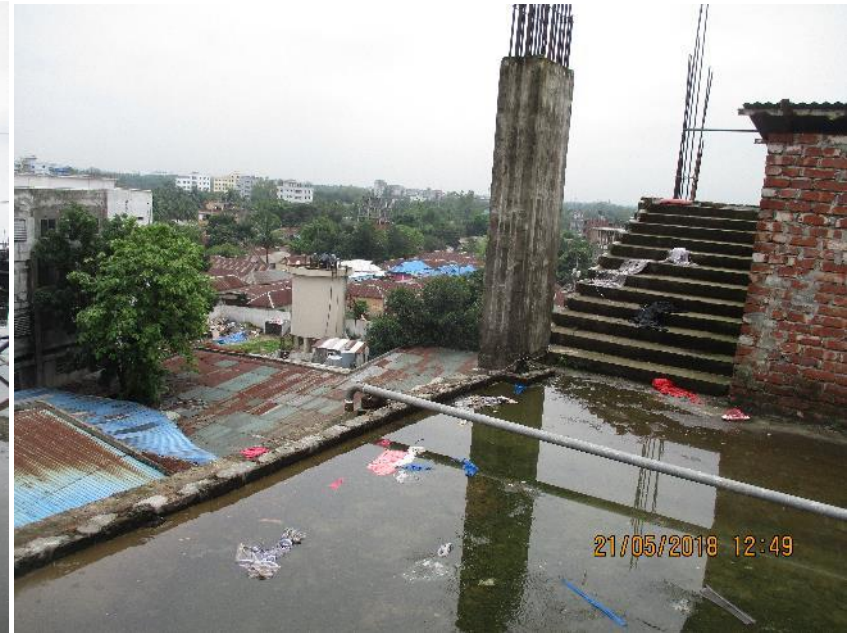
No edge protection was provided on roof.

| Item No. | Observation | Recommended Action Plan | Recommended Timeline |
|---|---|---|---|
| 8 | Falling hazard at roof | Provide edge protection to prevent falling hazard. | 6-weeks |

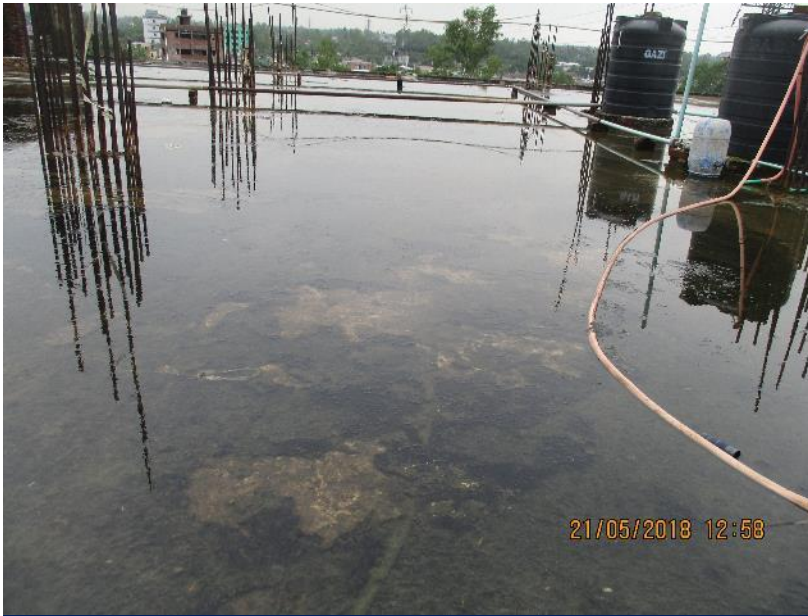
Water ponding observed on roof. Very poor drainage system and uncoated slab observed. Building engineer is required to improve the drainage system and apply water proofing membrane on roof.

| Item No. | Observation | Recommended Action Plan | Recommended Timeline |
|---|---|---|---|
| 10 | Water ponding and rebar corrosion on roof | Waterproofing on the roof slab is to be applied. Moreover the roof slab drainage system should be investigated and improved. | 6-weeks |

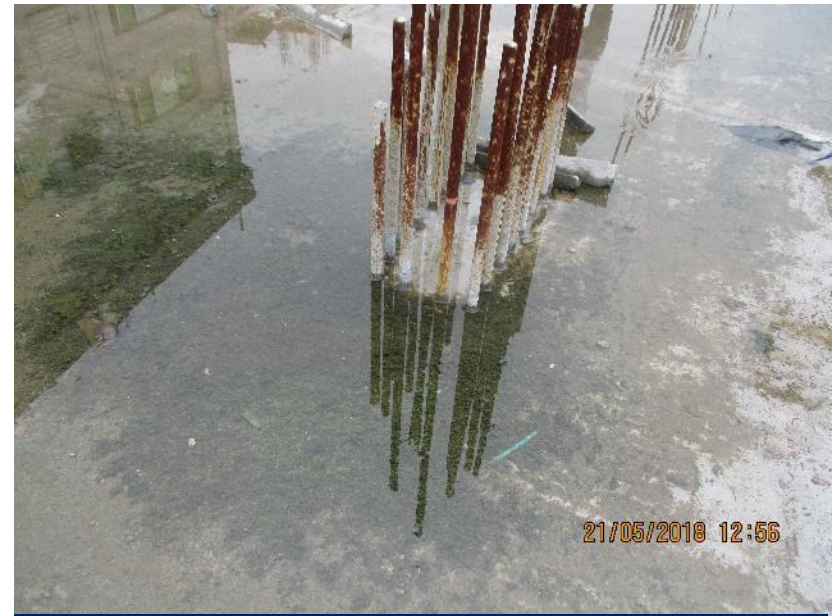
The exposed rebar's are prone to be corroded. Rust proof coating is required to applied by building engineer.

| Item No. | Observation | Recommended Action Plan | Recommended Timeline |
|---|---|---|---|
| 9 | Water ponding and rebar corrosion on roof | For both durability and serviceability, rust proof paint or any appropriate method is recommended. | 6-weeks |

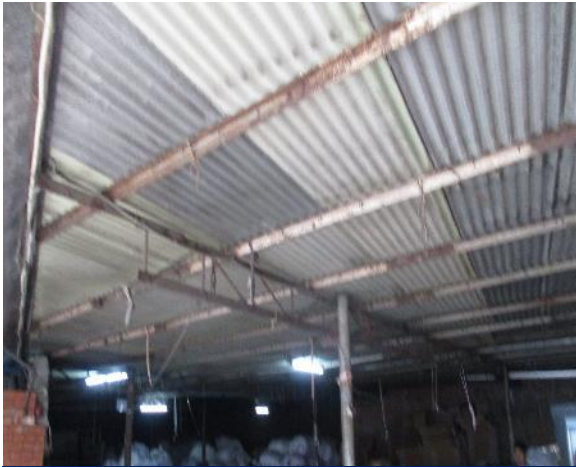
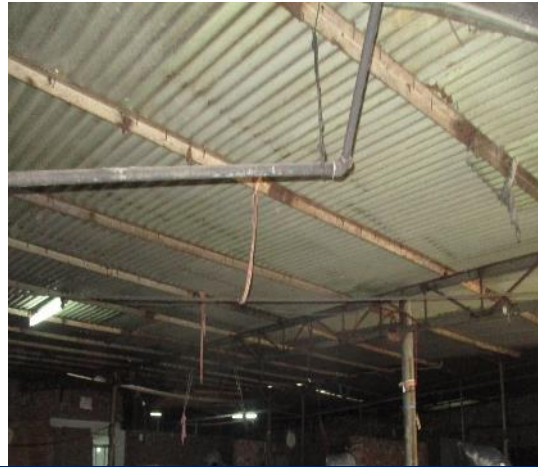
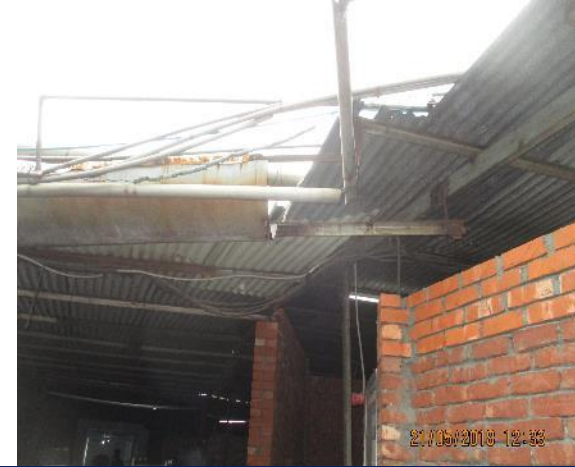
Non engineered shed.

The non engineered shed must be replaced by following reasons:

1. Hazards occupancy like boiler, compressor, generator.
2. Inadequate and distorted steel members.
3. No clear/define load path.
4. Poor connections.
5. Corroded steel.

| Item No. | Observation | Recommended Action Plan | Recommended Timeline |
|---|---|---|---|
| 11 | Non engineered shed to be replaced | Demolish the non engineered shed. | 6-weeks |
| 12 | Non engineered shed to be replaced | Replace the non engineered shed by an engineered structure. | 6-months |

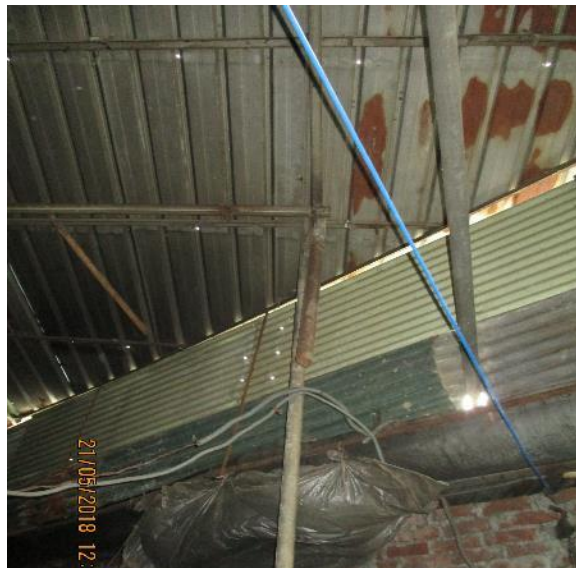
Poor connection.
