# **FIRE SAFETY INSPECTION REPORT**

**MASCO COTTONS LTD.**

**ACCORD ID: 10230**

January 30, 2015

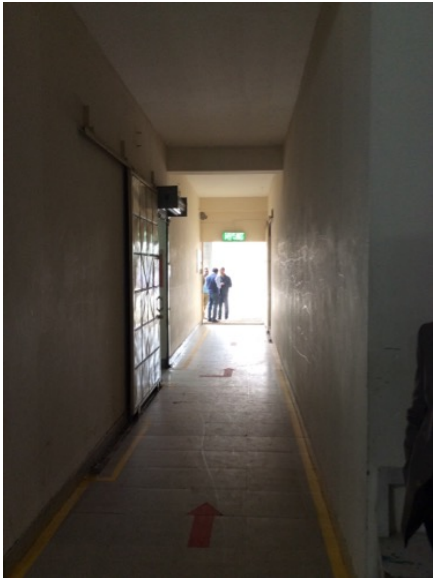
| No. | Category | Finding | Recommendation | Remediation Timeframe |
|---|---|---|---|---|
| F-1 | Fire Rated Construction | The exit access corridor from the ground floor dining room was not provided with 1 hr. fire resistance rating or approved NFPA 13 sprinkler system. | Provide exit access corridors with 1 hr. fire resistance rating or approved NFPA 13 sprinkler system. | Within 3 months |

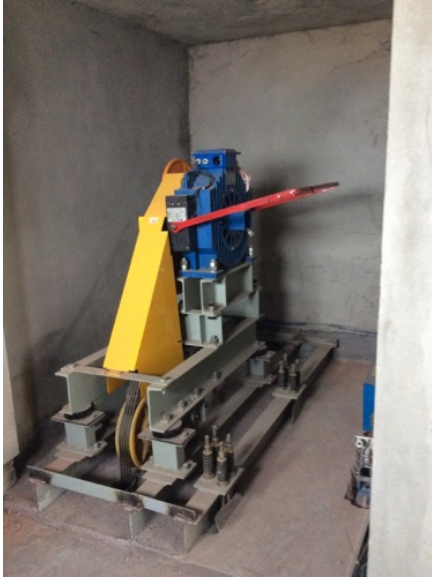
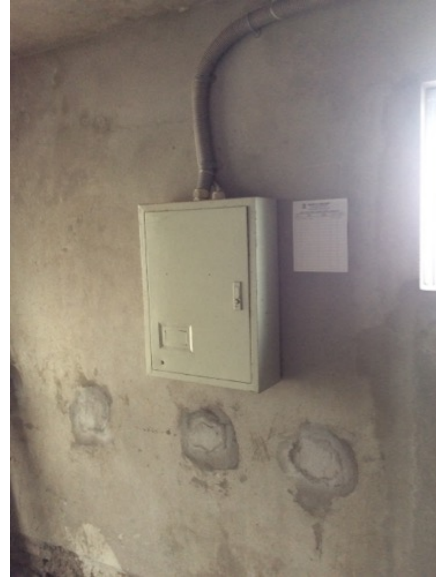
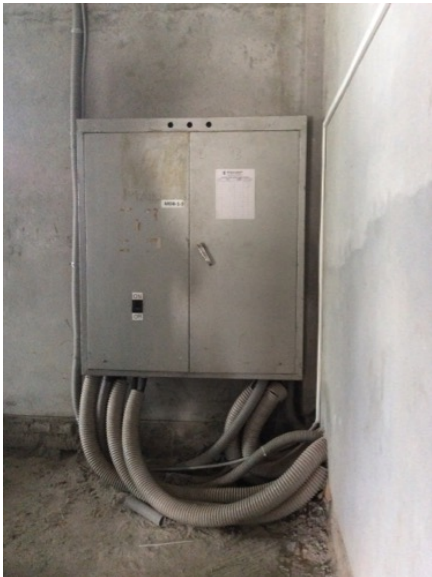
| No. | Category | Finding | Recommendation | Remediation Timeframe |
|---|---|---|---|---|
| F-2 | Fire Rated Construction | The northwest elevator machine room, located at the top of the northwest exit stair, is not separated by fire-rated construction due to openings and a non-rated door. | Separate the elevator machine room by a minimum 1-hr fire-rated construction. Seal and/or protected all openings to maintain the required fire separations. | Within 3 months |

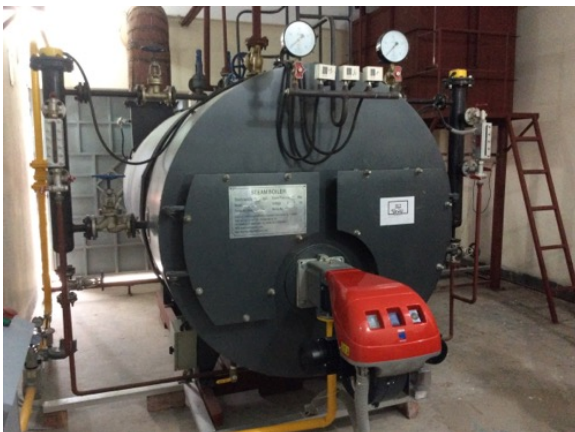
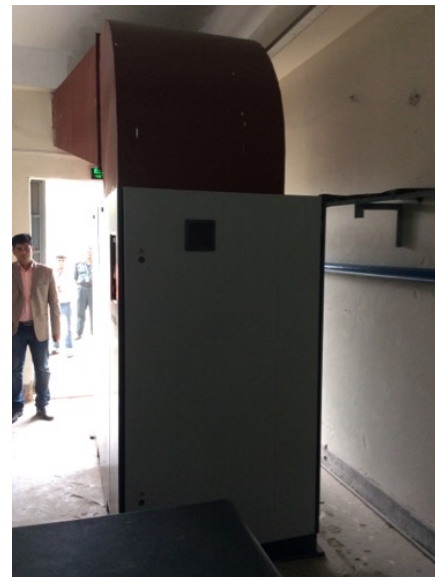
| F-3 | Fire Rated Construction | The boiler and air compressor rooms on the ground floor, were not separated by fire-rated construction due to openings and non-rated doors. | Separate the boiler and air compressor rooms by a minimum 1-hr fire-rated construction for non-high rise, and 2-hr fire rated construction for high rise. Seal and/or protect all openings to maintain the required fire separations. When located to the exterior of a building, 3m (10 ft.) separation is required. Provide proper ventilation and consult a qualified engineer. | Within 3 months |

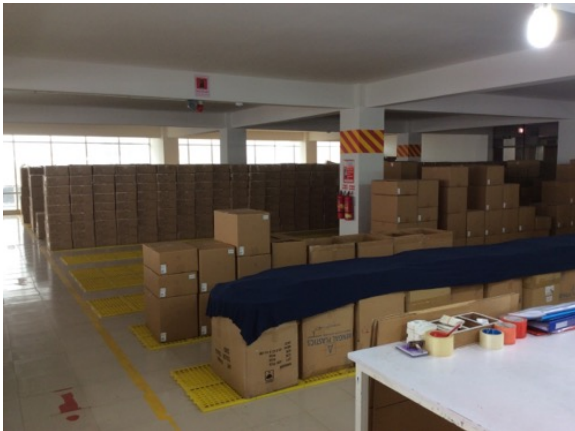
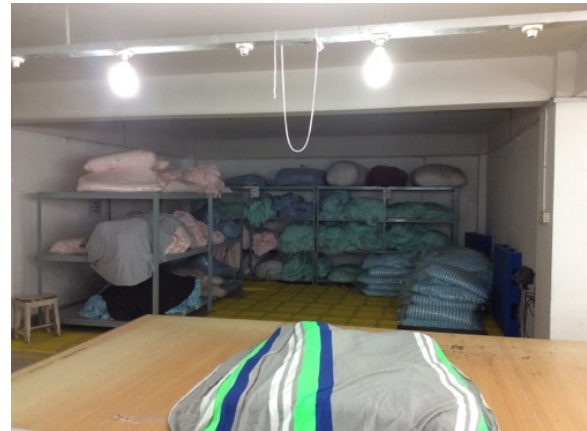
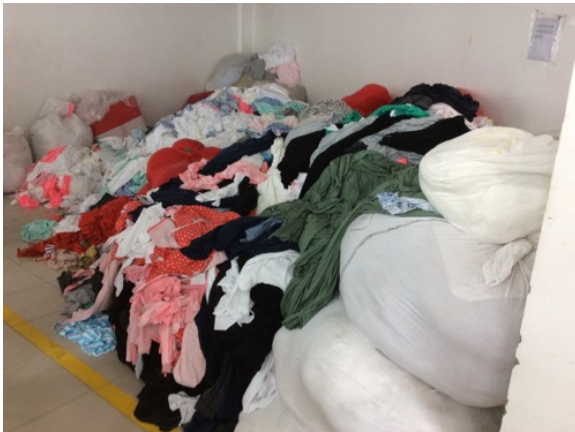
| F-4 | Fire Rated Construction | Areas used for combustible storage, open to the factory are not separated by fire-rated construction. Specifically, the packing rooms on the fifth, fourth, third and second floors, there were also other random locations throughout the building that had storage open to the factory floor. | Provide defined storage areas and limit the storage arrangement as follows:<br>- Maximum height of 2.45m (8ft.) and maximum area of 23m <sup>2</sup> (250 ft <sup>2</sup> )<br>- If sprinkler protected: maximum height of 3.66m (12ft.) and maximum area of 93m <sup>2</sup> (305ft <sup>2</sup> )<br><br>Separate areas of unenclosed combustible storage by a minimum clear distance of 3m (10ft.). | Within 3 months |

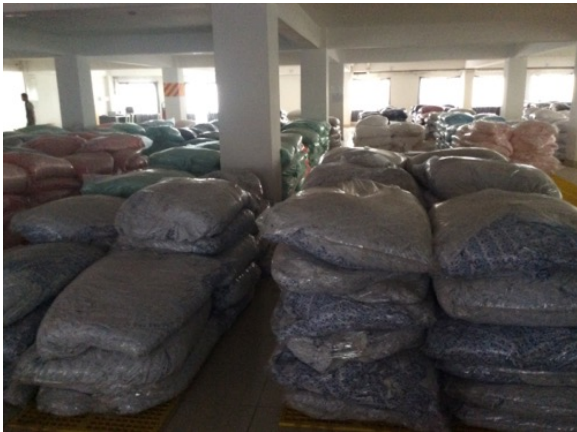
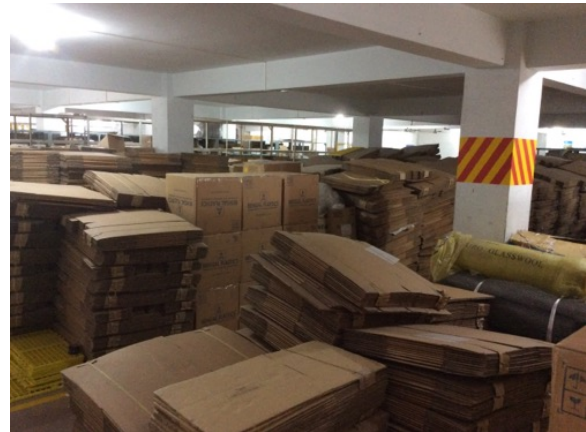
| F-5 | Fire Rated Construction | <p>Rooms used for combustible storage are not separated by fire-rated construction.</p> <p>Specifically, the fabric store on the sixth floor, the cut panel room and accessory store on the first floor and the godown and wastage godown on the ground floor. The sixth floor fabric store discharged to the northwest exit stair and first floor cut panel room discharged to the northeast exit stair.</p> | <p>Provide dedicated storage rooms separated by minimum 1-hr fire-rated construction.</p> <p>Provide a vestibule where a storage room discharges to an exit stair. Install a 1-hr fire rated door on the storage room side and a 1.5-hr fire rated door on the exit stair side.</p> | Within 3 months |

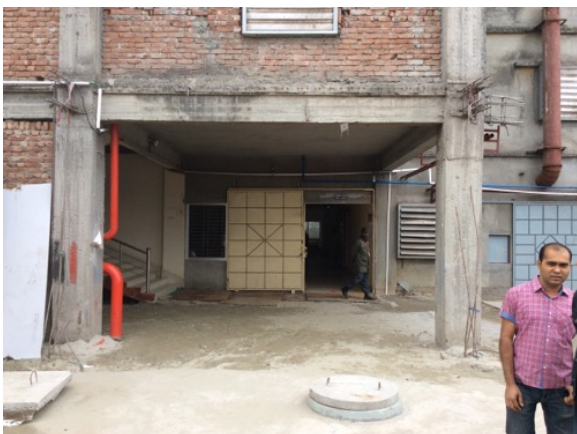
| F-6 | Fire Rated Construction | The northeast exit stair enclosure was not separated from work areas and other spaces on the ground floor by fire-rated construction. | The exit stair enclosure shall be provided with a minimum 1-hr fire resistance rating for buildings with 3 or fewer stories and a minimum of 2-hr fire resistance rating for buildings 4 or more stories. | Within 3 months |

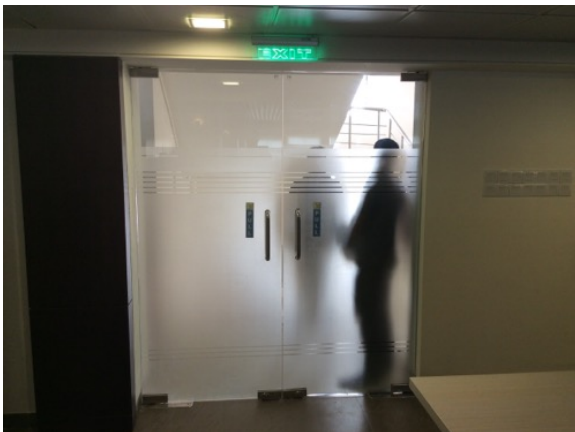
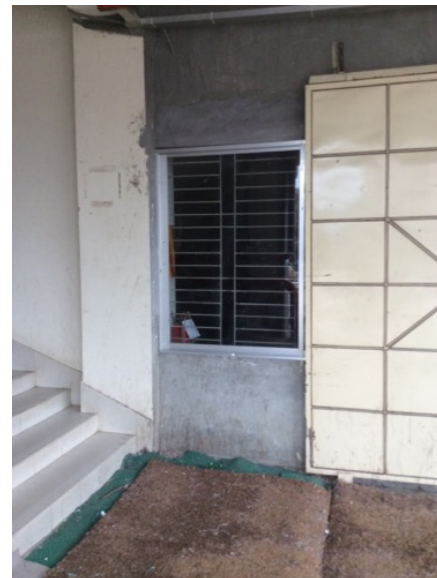
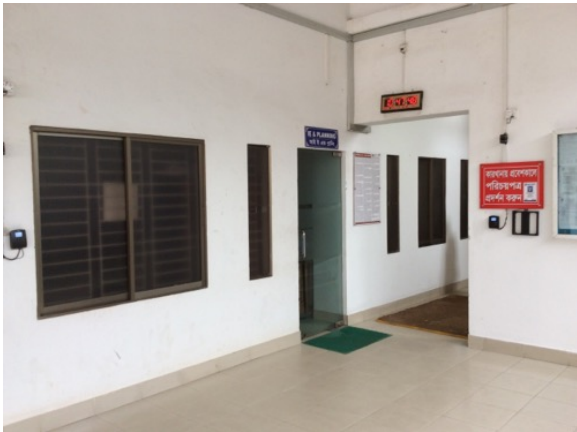
| F-7 | Fire Rated Construction | The exit stairs are not separated from work areas and other spaces on each floor by fire-rated construction. | Provide minimum 1-hr rated doors for buildings with 3 or fewer stories and 1.5-hr fire rated doors for buildings that are 4 or more stories. Seal all unprotected openings to separate the exit stairs from work areas and other building spaces on all floor levels. Ensure that the fire doors are self-closing and positive latching and that they are provided with fire exit (panic) hardware where serving production floors. | Within 3 months |

If fire doors are required to be held open for functional reasons, provide automatic-closing devices tied to the fire alarm system.

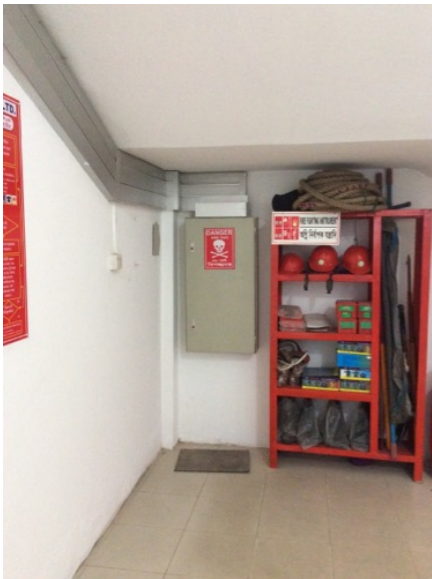
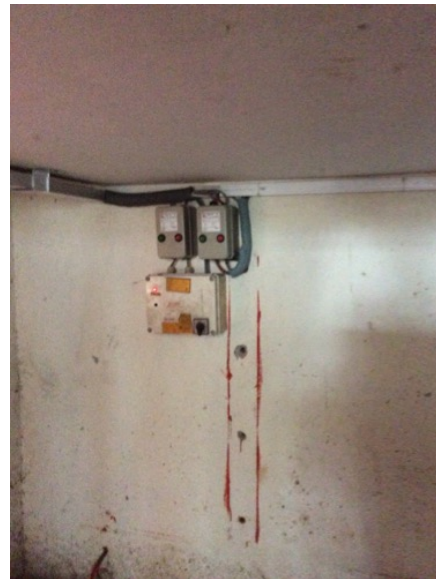
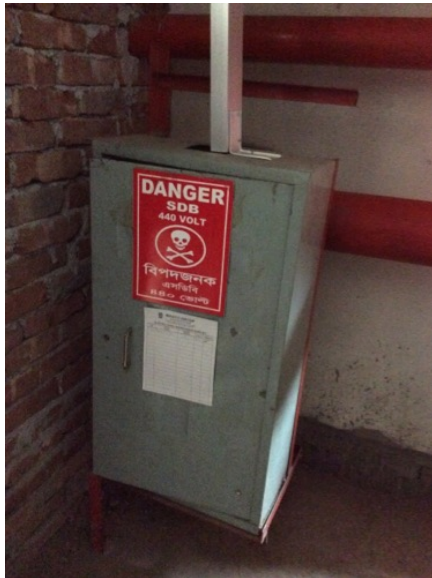
| F-8 | Fire Rated Construction | Electrical panels were located in the south and northeast exit stair enclosures on the ground floor. | Remove and re-locate all electrical panels from exit stair enclosure | Within 3 months |

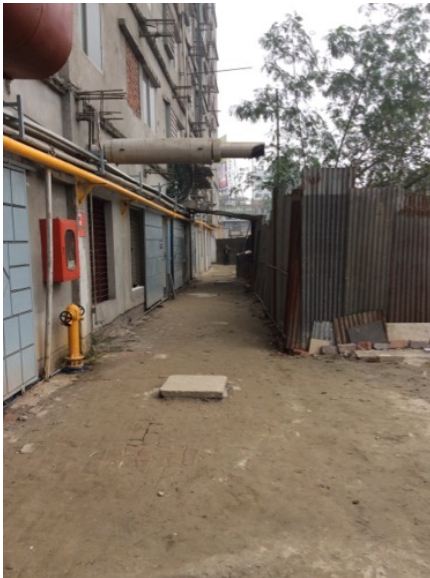
| F-9 | Fire Rated Construction | The exit discharge path serving the northeast exit stair is less than 10 ft. wide and is not separated from the building interior. The ground floor boiler room, air compressor room, generator room, sub station, medical room and maintenance room all have unprotected openings to the discharge path. | Seal all penetrations and openings to the interior of the building along the discharge path, up to a height of 10 ft., to provide a minimum 1-hr fire separation.<br><br>Alternatively, provide a second remote discharge path to the public way. | Within 6 months |

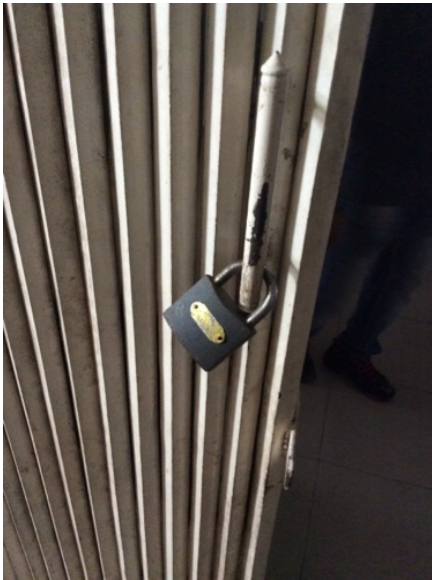
| F-11 | Egress | Egress doors and gates with locking features are provided at building exits, exit stairs and at exit discharge. All gates and doors were open and unlocked during the inspection. | <p>Remove locking features from all egress doors and gates.</p> <p>If locks are required for security reasons, utilize special door locking features complying with NFPA 101 and ACCORD standard 6.8.2.</p> | Immediately |

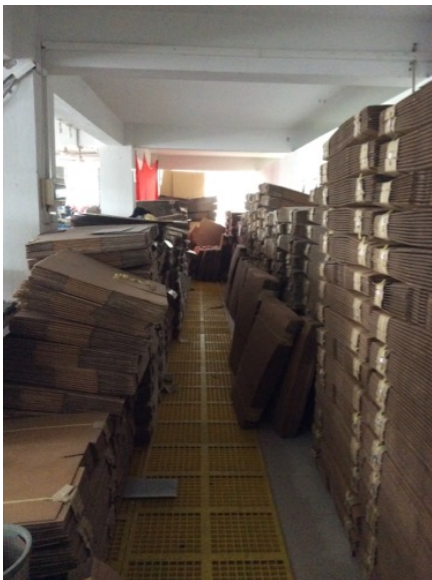
| F-12 | Egress | Storage was located in a required egress path from the first floor sample section. | Keep egress paths and stairs clear of storage. | Immediately |

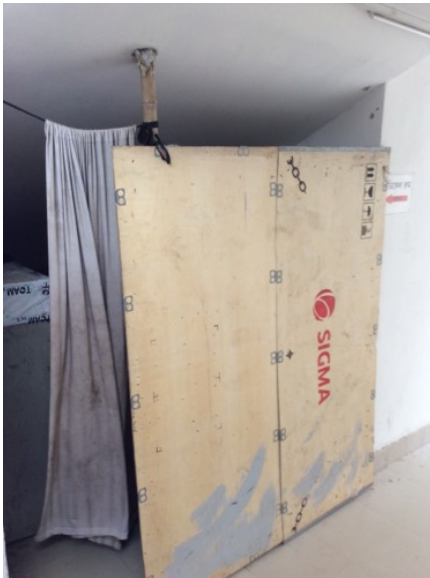
| F-13 | Egress | Storage was located underneath the northwest exit stair on the ground floor. | Remove all storage from exit stairs and egress paths. | Immediately |

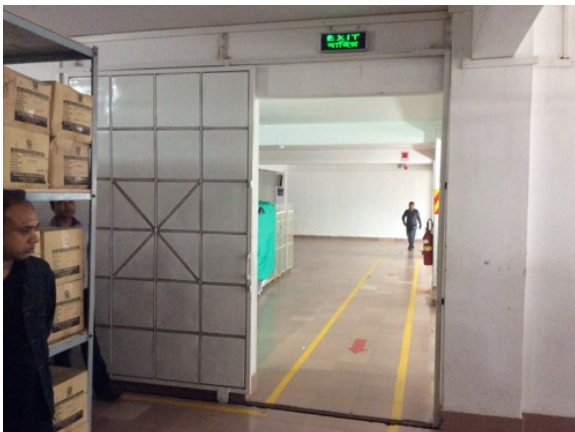
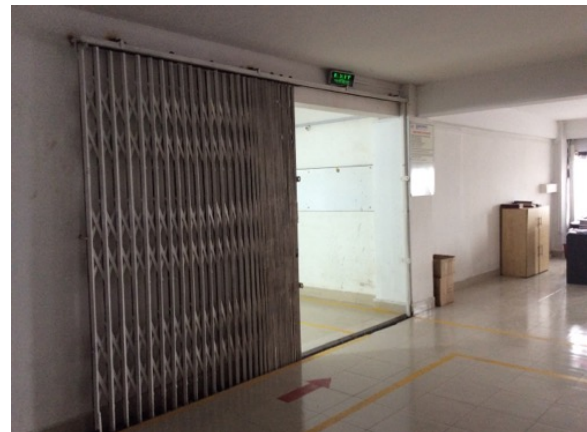
| F-14 | Egress | Collapsible gates and sliding doors are provided at building exits, exit stairs, along egress routes and at exit discharge. | Replace all gates and sliding doors along the means of egress with side-hinged, swinging egress doors in accordance with ACCORD standard 6.8.1. | Within 1 month |

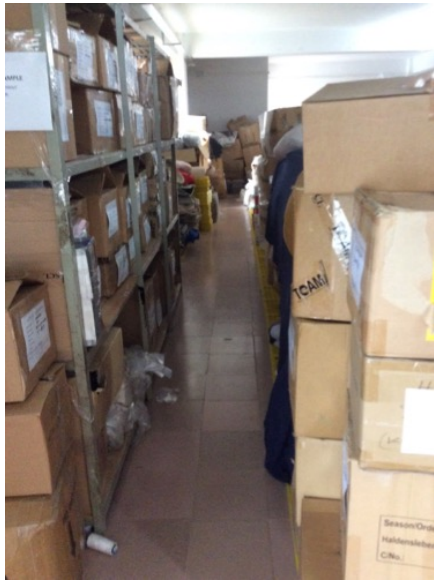
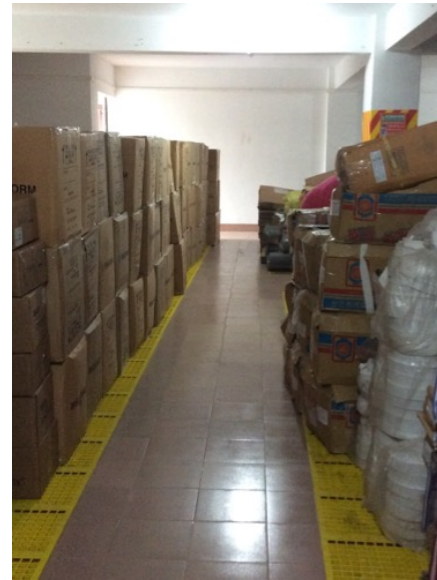
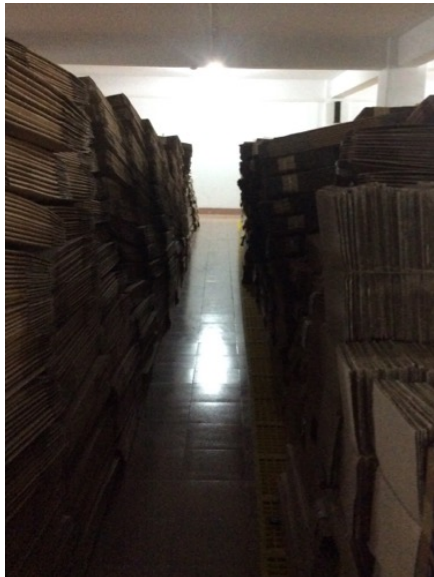
| F-15 | Egress | The width of several egress aisles in the first floor accessory store, were less than 36-in. | Provide minimum aisle widths of 36-in. | Within 3 months |

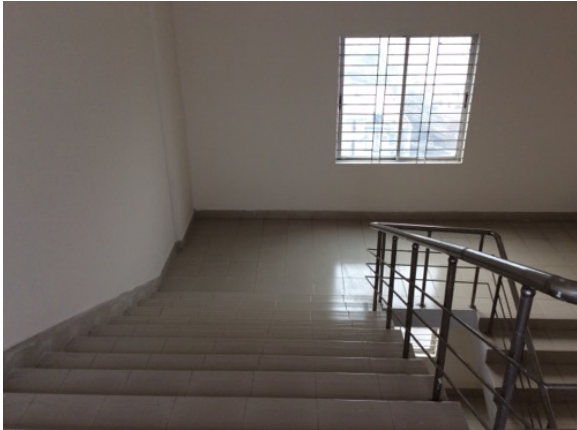
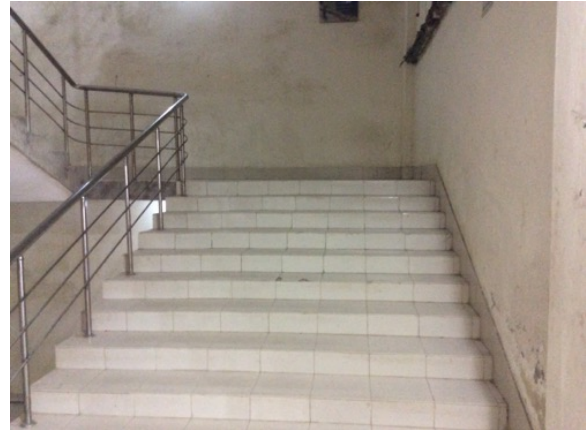
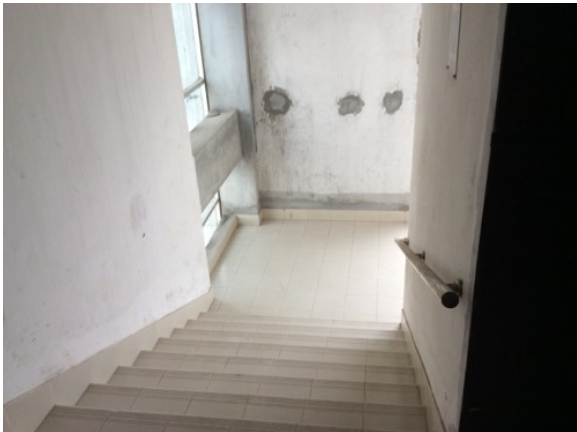
| F-16 | Egress | Handrails were not provided on both sides of all exit stairs. | Provide handrails on both sides of the exit stairs. New handrails shall have a minimum height of 865 mm (34 in.) and a maximum height of 965 mm (38 in.) as measured from the leading edge of the tread. Intermediate handrails shall be provided when the stair width exceeds 2.2 m (87 in.) | Within 3 months |

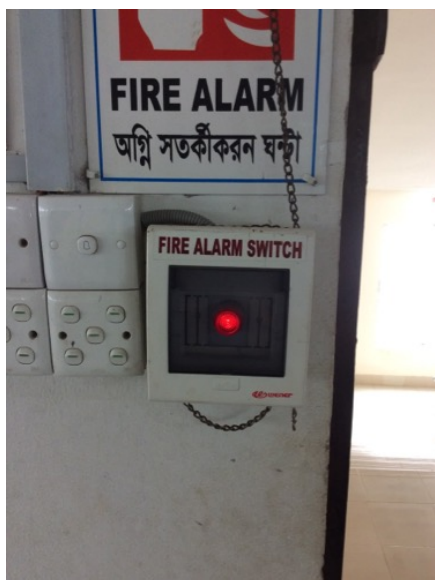
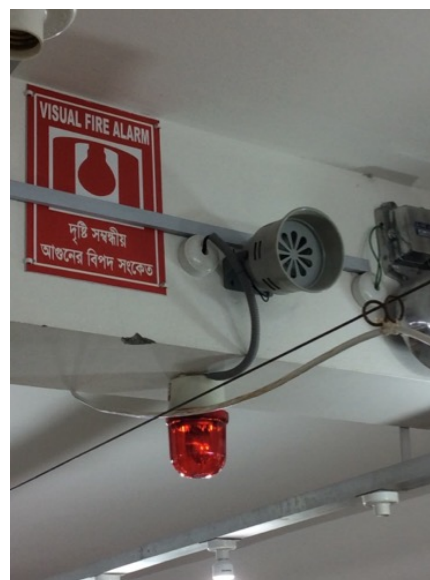
| F-17 | Fire Protection | <p>The fire alarm system is antiquated, not a listed system and does not provide alarm and notification features consistent with acceptable standards.</p> <p>Also, no fire alarm system was provided on the seventh floor.</p> | <p>Replace the fire alarm system with a new, listed addressable fire alarm system in accordance with NFPA 72.</p> | <p>Design within 4 months, install within 9 months</p> |

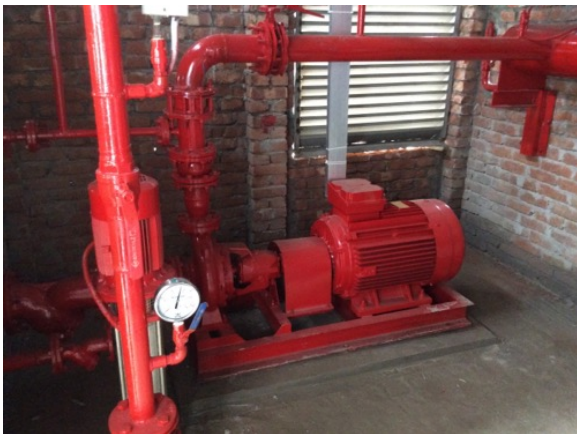
| F-23 | Fire Protection | Fire pump did not meet ACCORD standard 5.5. | Ensure that the fire pump meets ACCORD standard 5.5. If not, provide a new fire pump. | Within 6 months |

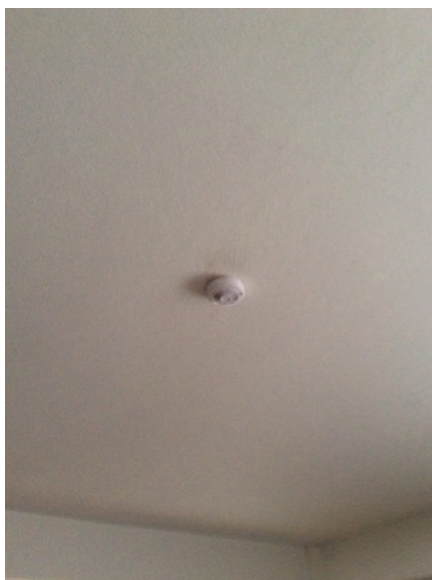
| F-25 | Fire Protection | The building is equipped with single-station smoke alarms. Smoke alarm activation sounds only a local alarm and does not provide automatic fire alarm notification of occupants. | Remove single-station smoke alarms. Provide automatic smoke detection throughout the building, tied into the fire alarm system, in accordance with NFPA 72. | Within 9 months |

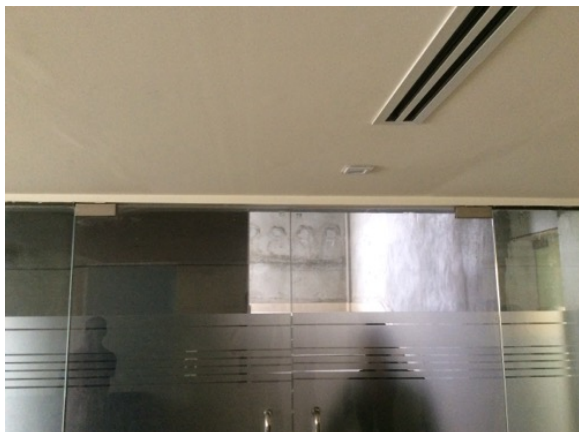
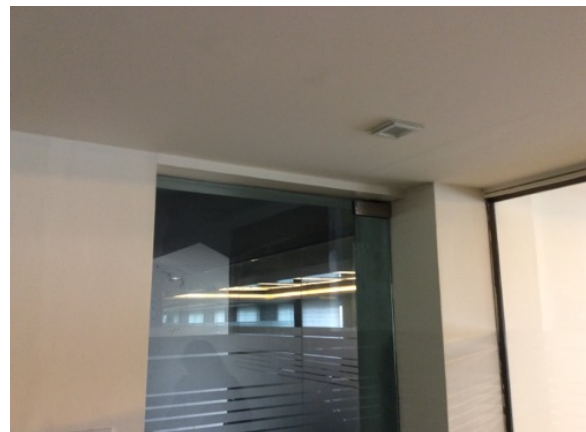
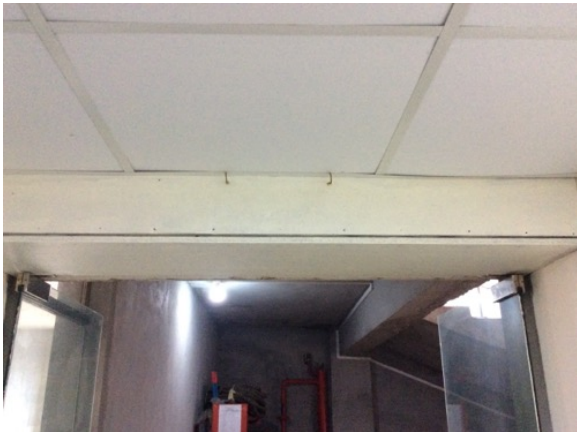
| F-26 | Egress Lighting | Exit signage was not provided in several locations throughout the building. Specifically, from the seventh floor training room, to the seventh floor northwest exit stair (and along route), to the seventh floor northeast exit stair (and along route), to the first floor northeast exit stair and from the ground floor child care room. | Provide exit signs above all building exits to the exterior, all doors to the exit stairs and along all paths of travel where a change of direction is not obvious. | Within 1 month |
