Besta Apparels (New)

666/1, Gasa, Boad Bazar, Ward#36, National University-1704, Gazipur
(23.941965N, 90.369348E)
06th June 2018

Observation

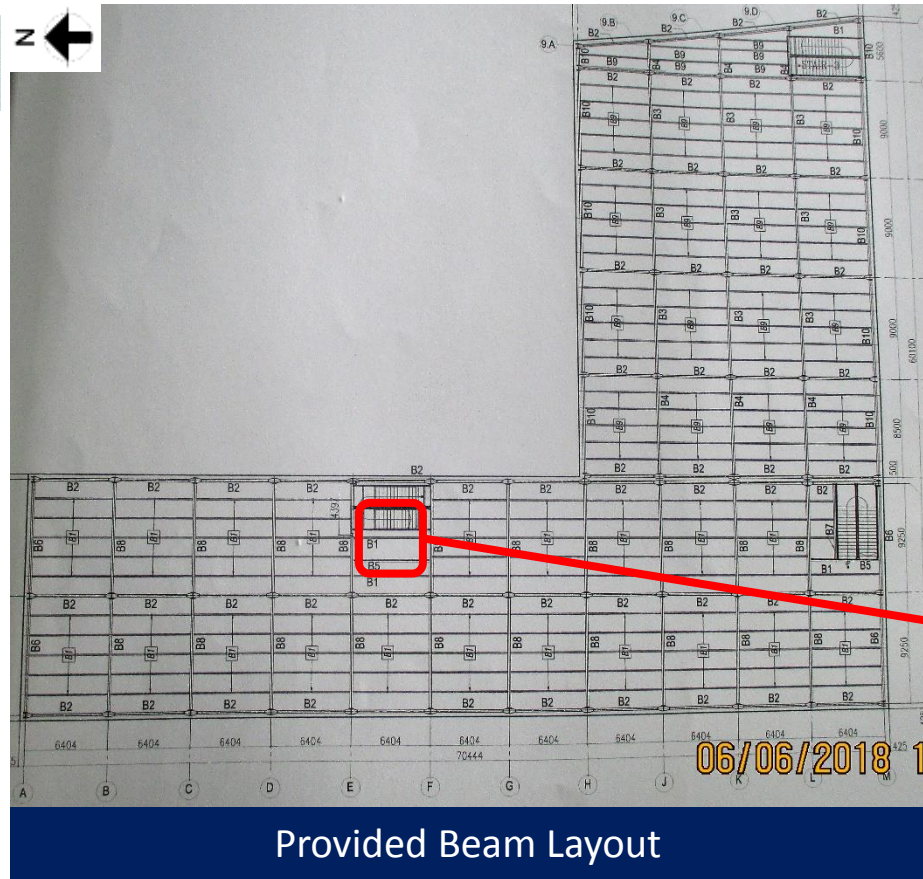
Provided Beam Layout

Beam layout provided in as-built structural drawing does not match with on site placement of beam on stair case. Three beams were found on site between grid shown on the provided beam layout which were not in drawing.

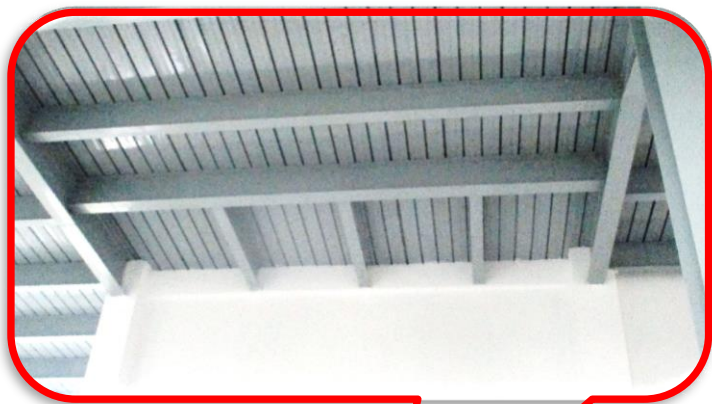
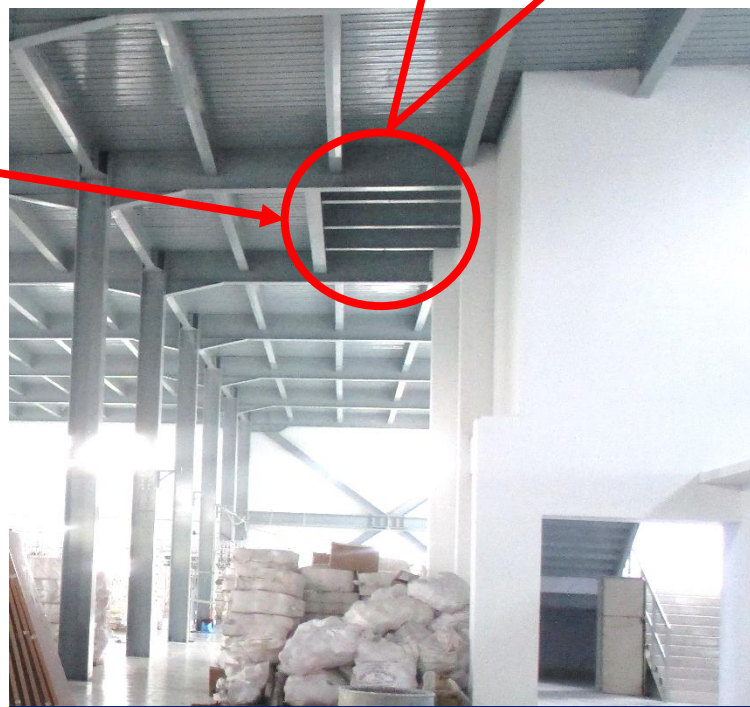
Three beams found on site

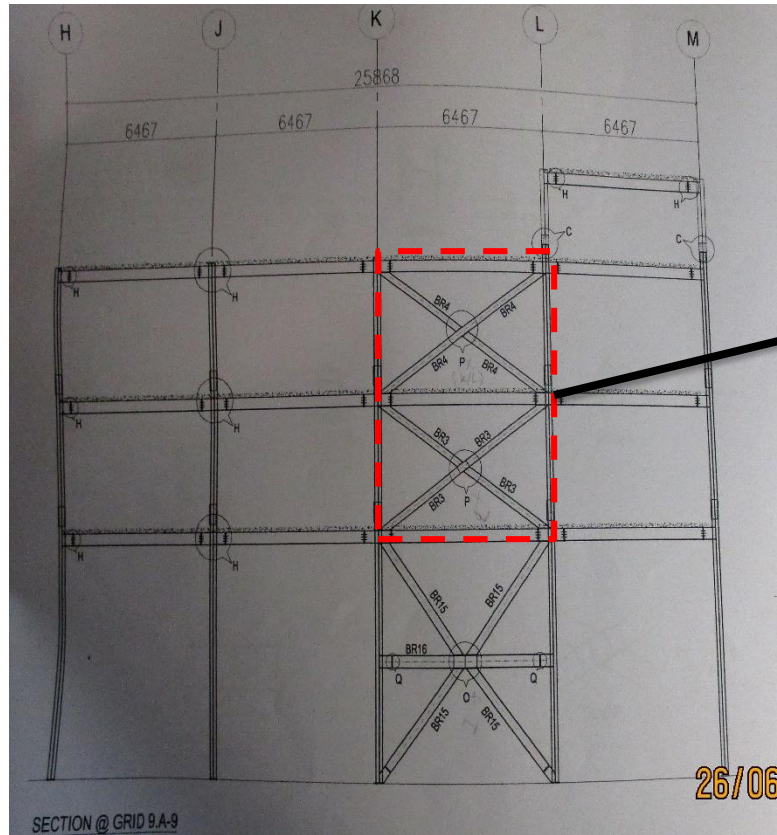
Provided Bracing Layout at grid 9A-9

As per provided as-built drawings connection of bracing between grid K&L on 1st & 2nd floors was supposed to be represented by detail "P". But on site the connection found represents detail "K".

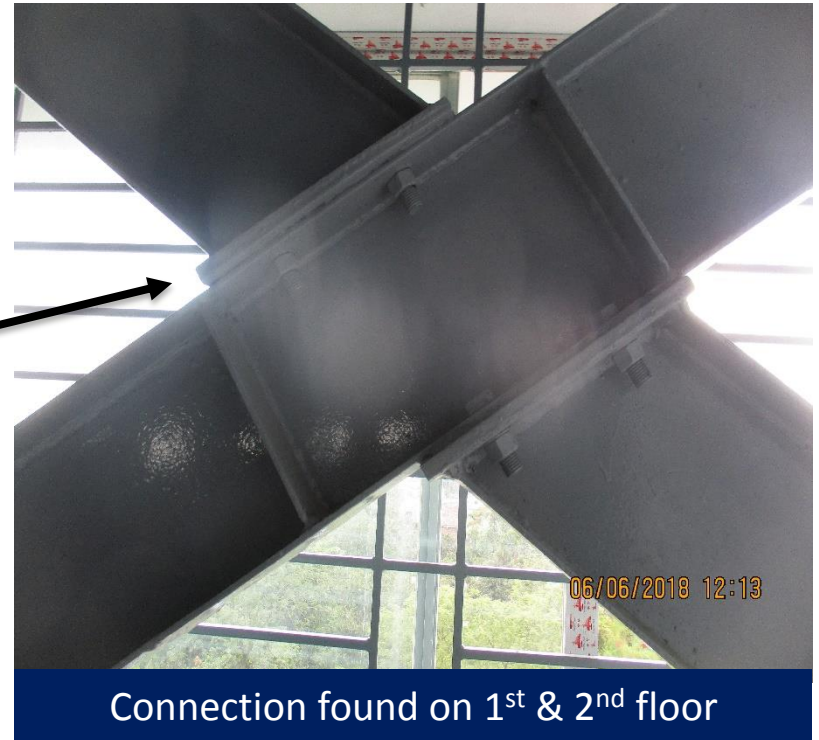
Connection found on 1st & 2nd floor

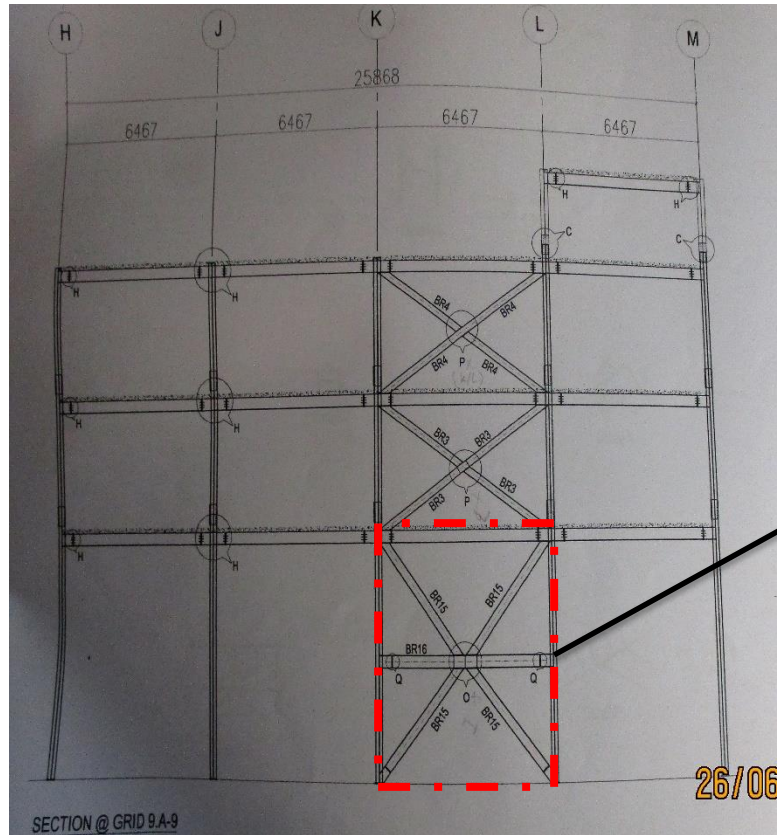
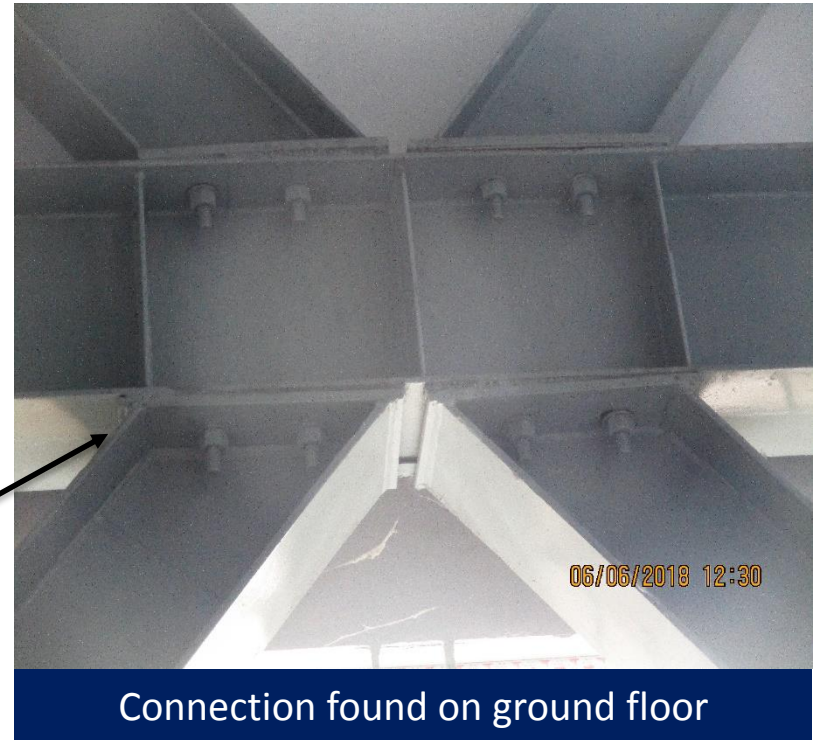
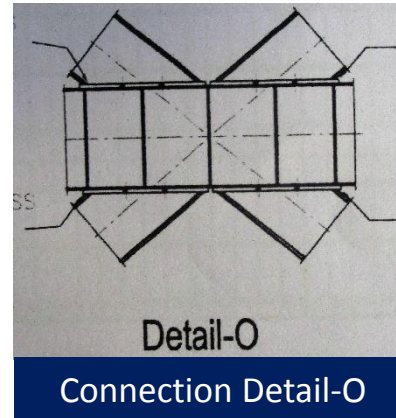
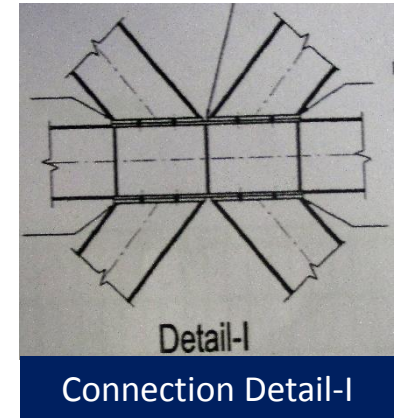
Provided Bracing Layout at grid 9A-9

As per provided as-built drawings connection of bracing between grid K&L on ground floor was supposed to be represented by detail "O". But on site the connection found represents detail "I".

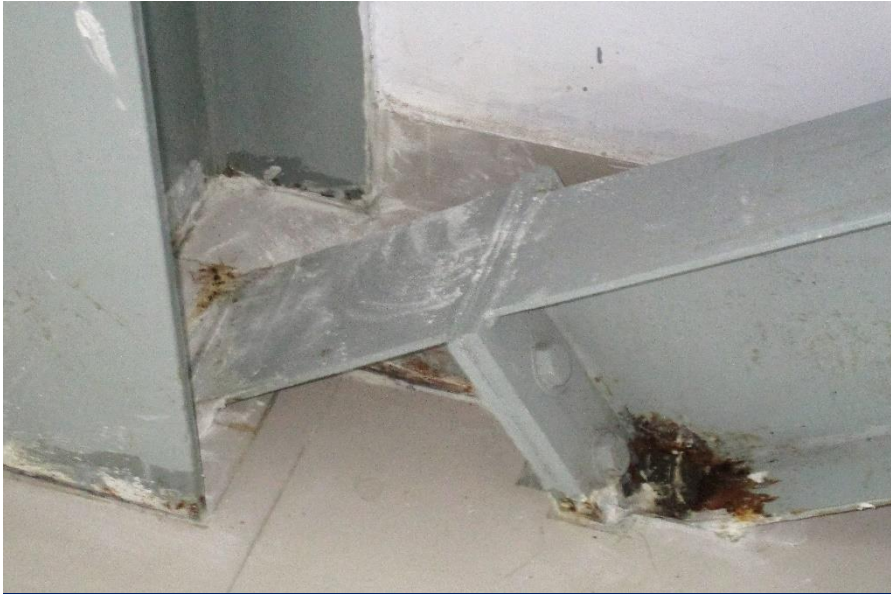
Corrosion observed at the joint of column and bracing.

Corrosion was observed on steel columns on roof top and at the joint of column and bracing. Factory is required to identify the corroded locations and take proper remedial measures.

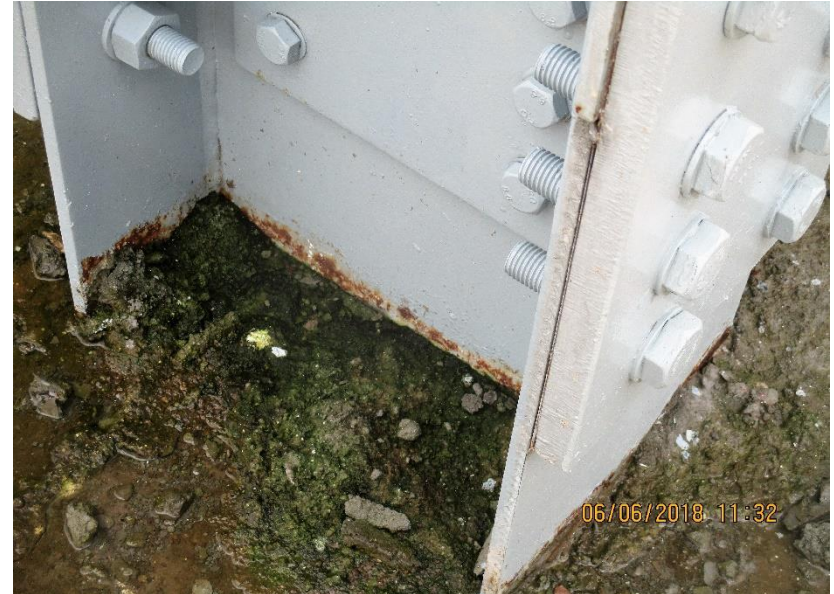
Corrosion was observed on steel column at roof top.

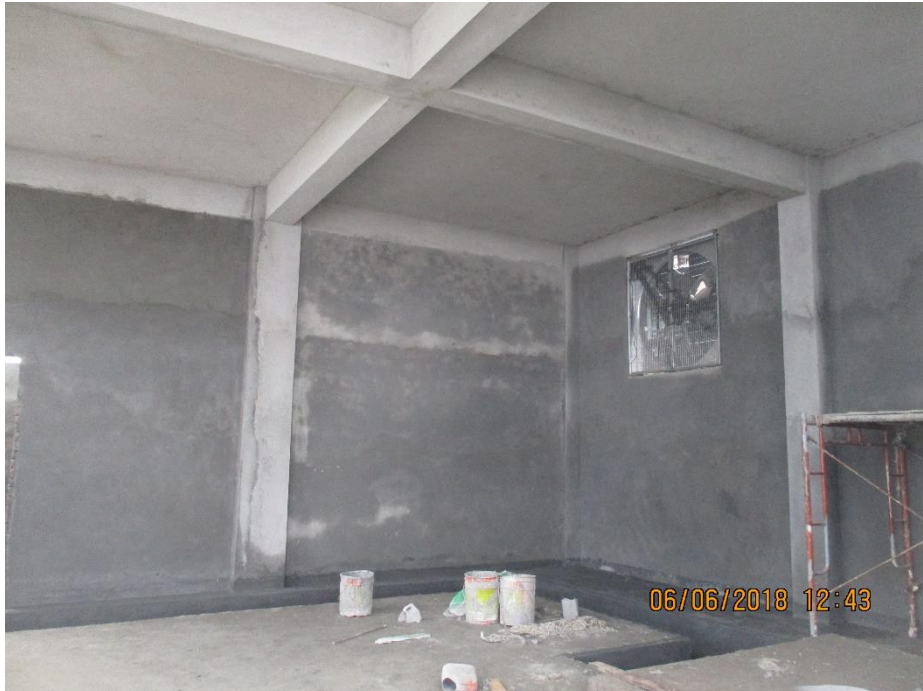
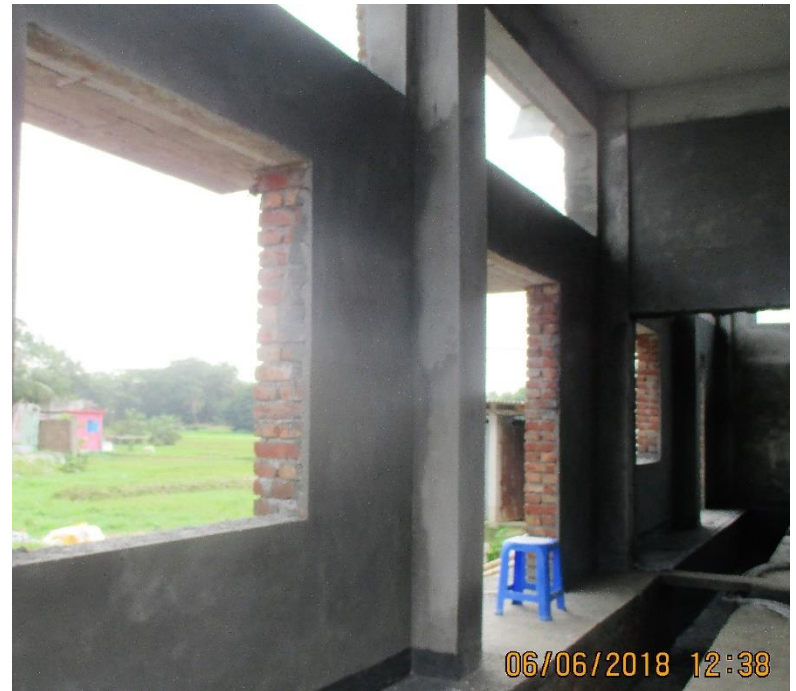
Factory could not provide any as-built drawings for the utility building. Factory Engineer is required to produce a full set of as-built drawings reflecting actual condition.
