Versatile Textiles Limited (New Buildings)

89/2 Chaydana, Degerchala Road, National University

4th June 2018

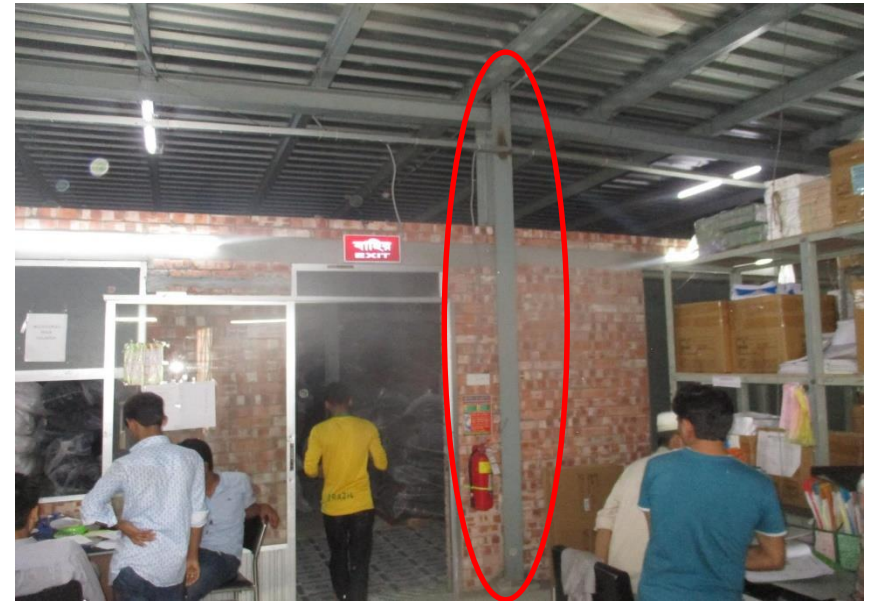
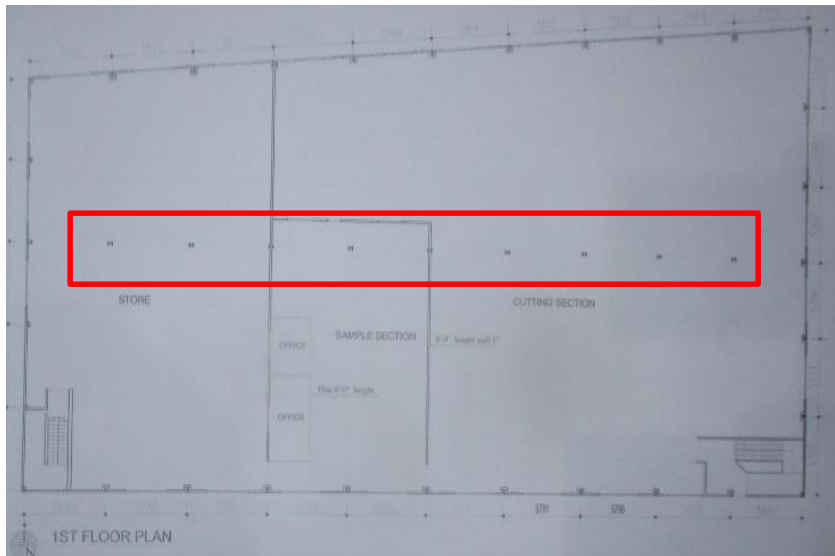
Floor plan

High stress column

Cursory calculation shows that the stresses of central columns exceed the normal design limit at ground level. Detail Engineering Assessment (DEA) to be commenced immediately based on in-situ steel strength.

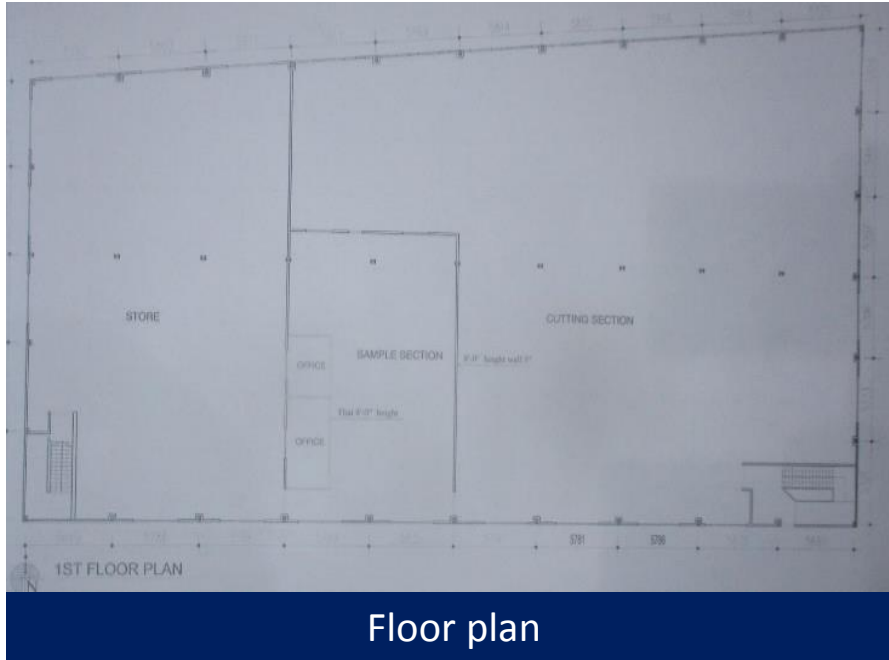
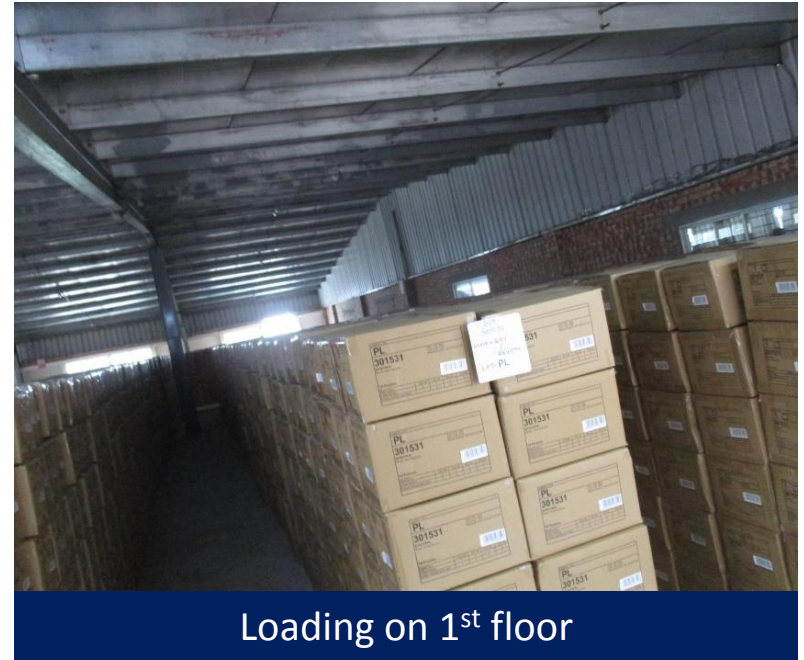
Loading on 1st floor

Floor loading observed around 3KPa on 1st floor. No load plan found on site. Building engineer is required to produce a safe floor load plan and maintain accordingly.

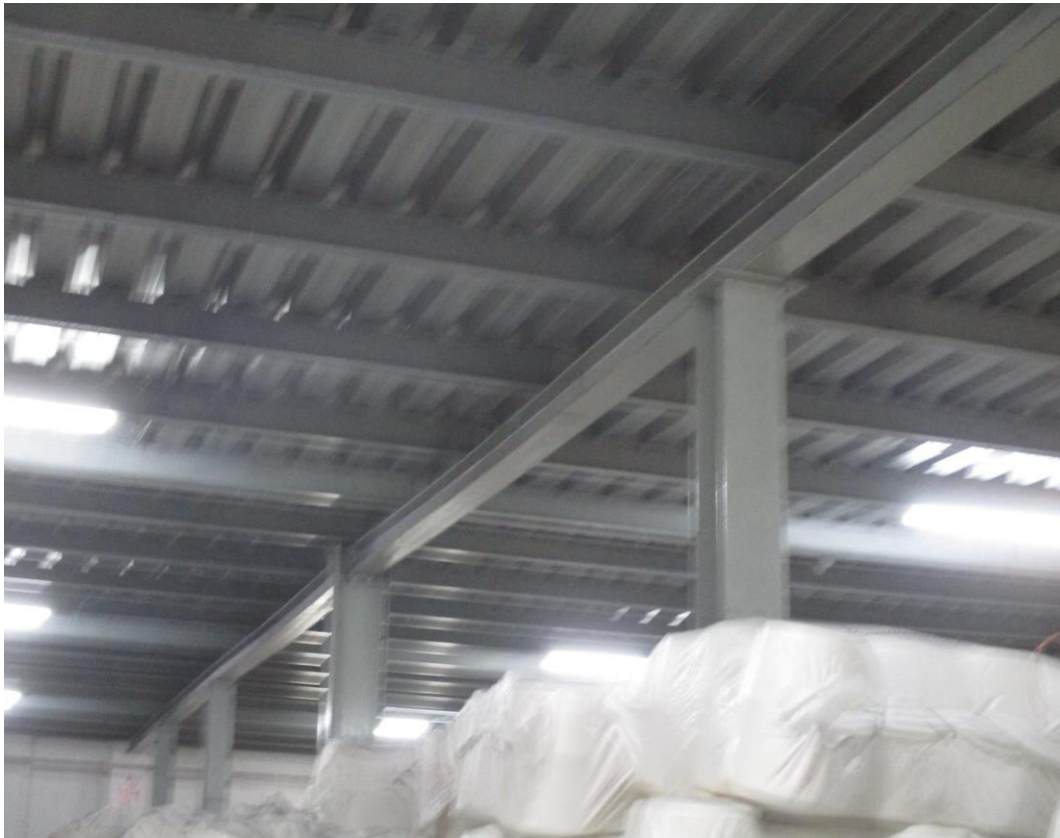
Deflection of main beams

Deflection of beams were observed in several locations. Also, the cable bracings were sagged. Factory engineer to check the adequacy of the beams for gravity loading and prepare a safe loading plan for the floor based on beam, column and foundation capacities. Also, check the bracing adequacy for lateral loadings.

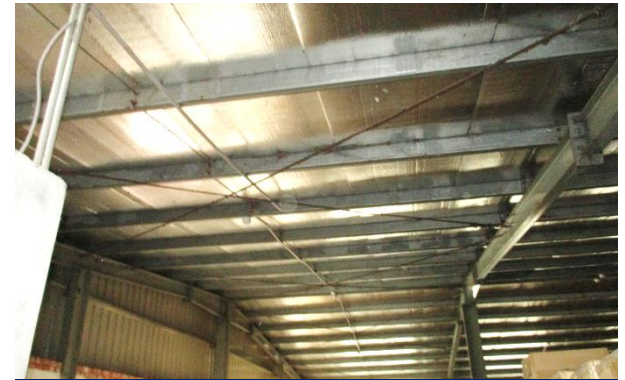
Sagging of cable bracings

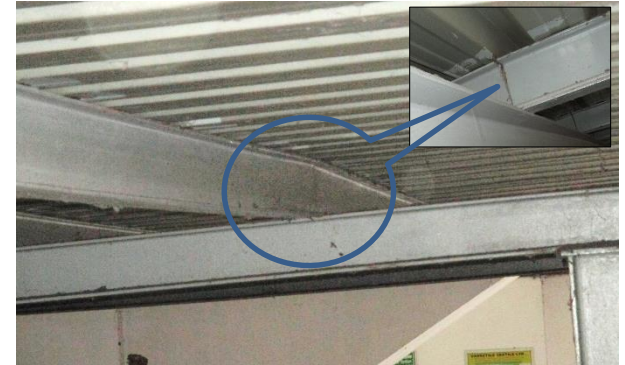
Deflection of sub-beam

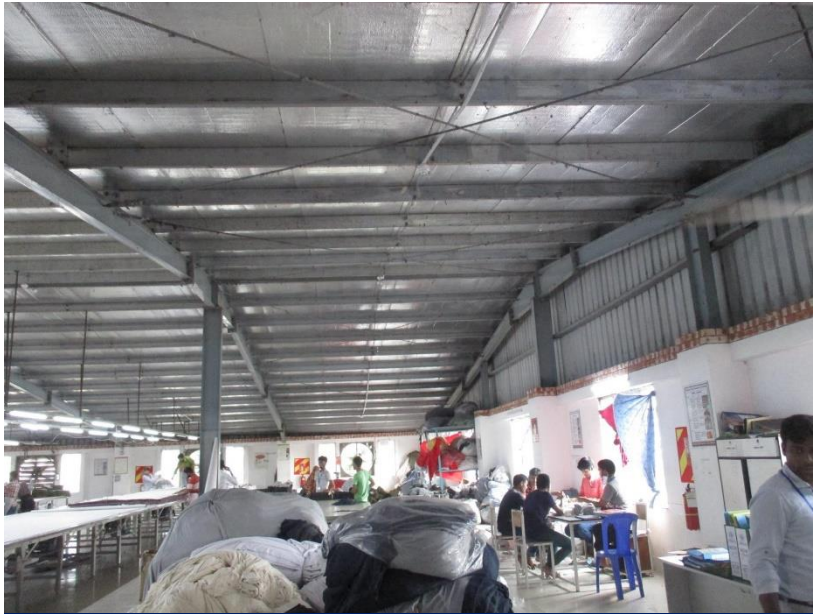
Portal frame at 1st floor

The ground floor beam-column connections were flexible and lateral load resisting system was absent. Compression strut and vertical bracing was not observed for the steel portal frame structure on roof. Also, the horizontal cable bracings were loose and there was no alternative lateral load resisting system. Factory engineer to check the stability of the structure against code defined lateral and gravity forces as part of Detail Engineering Assessment (DEA).

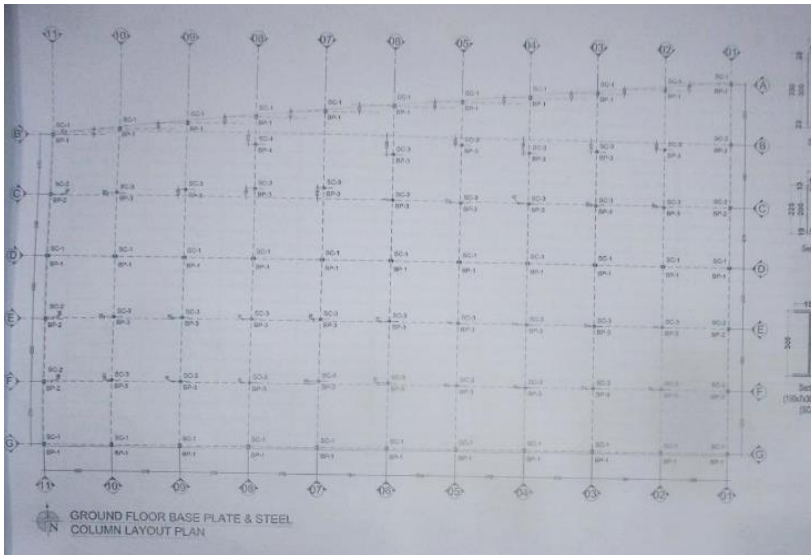
Steel column layout

As per drawings, the steel columns are shown in every grid location. But the foundation layout shown only for the periphery and central columns. Also, there is no detail for RC floor slab and stairs.

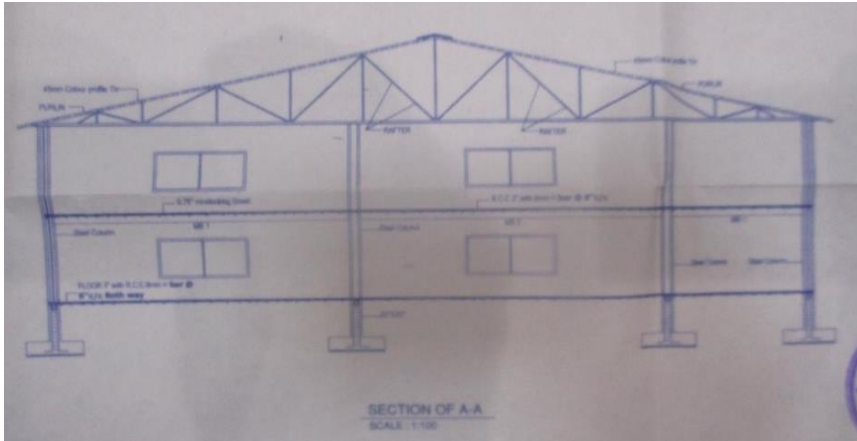
Frame section in approved drawing

Truss roof system was approved but portal frame system was constructed without any design consideration.

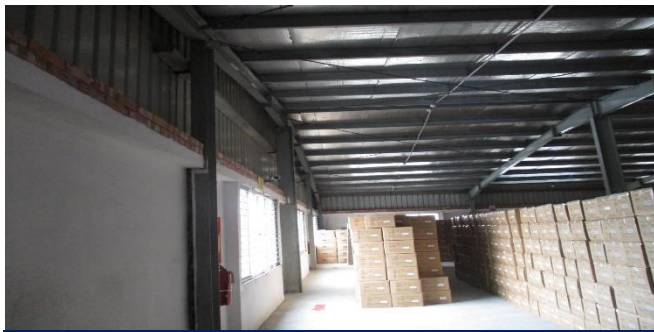
Steel column flange thickness observed 6mm instead of 7mm.

Discrepancies observed in the sectional dimension of SC-2 columns and rafter at ridge. Building engineer is required to update the as-built drawing and design documents.

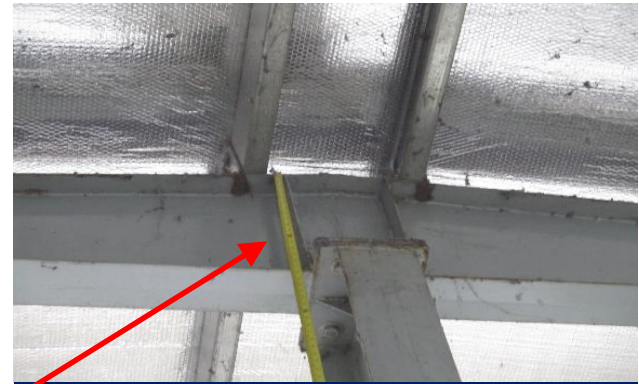
Depth 450mm instead of 500mm

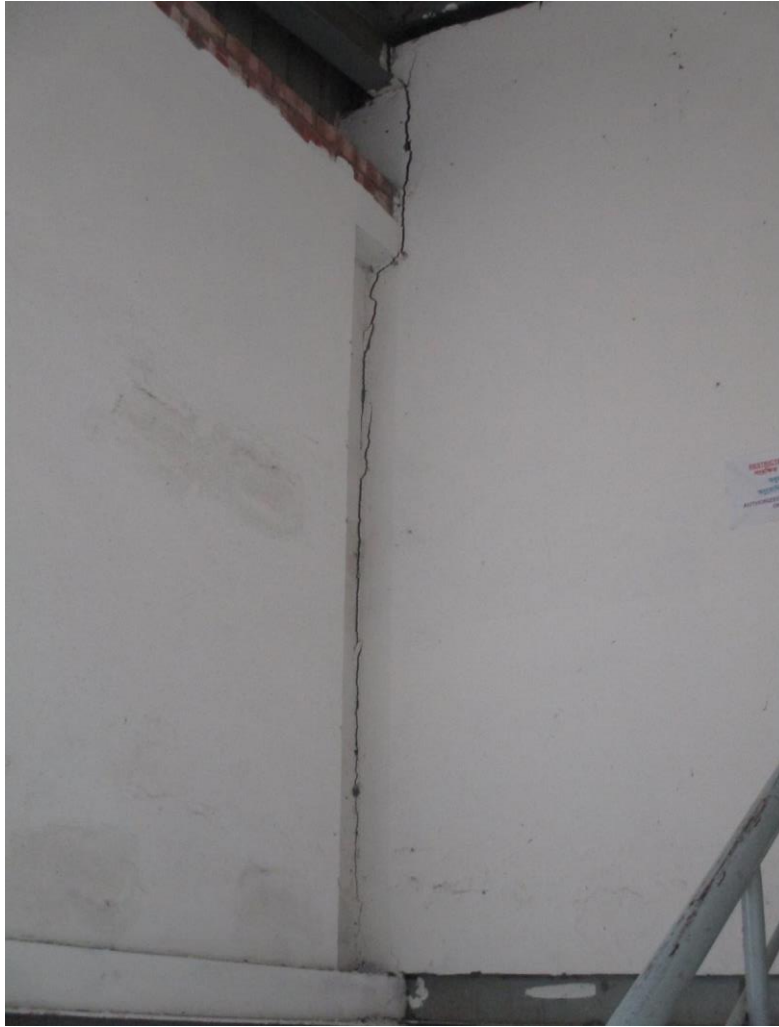
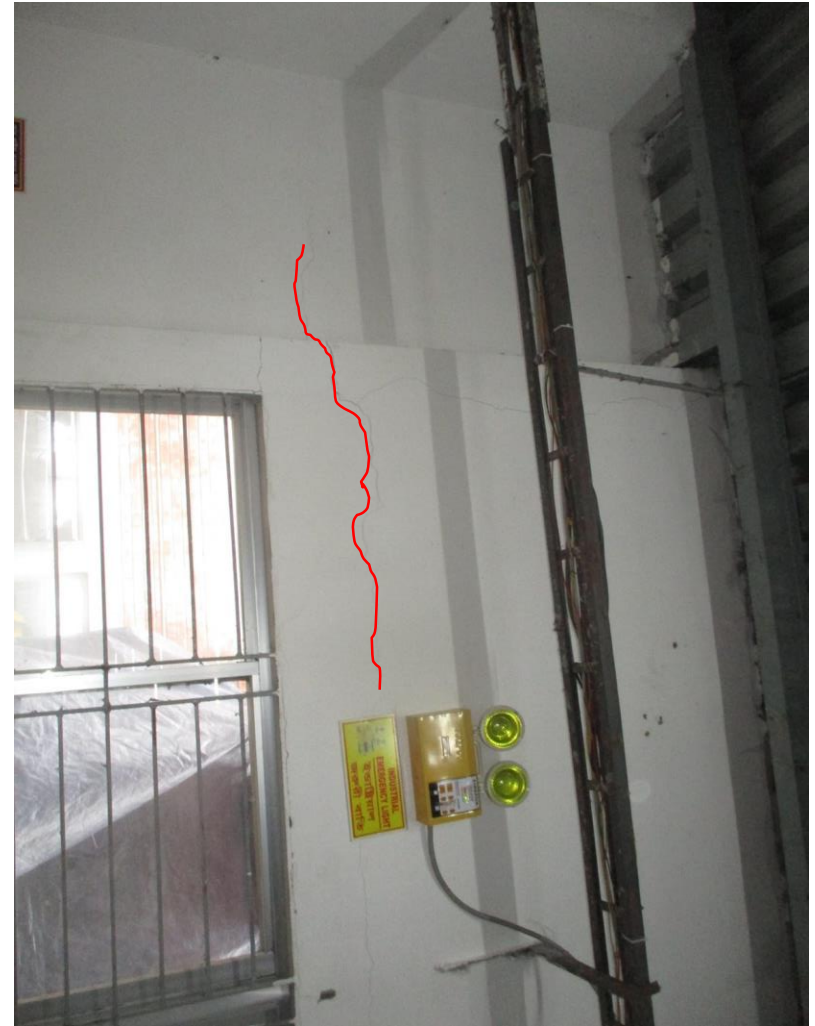
Crack on brick walls

Vertical cracks were observed on joints of the brick walls. Building engineer to investigate the cracks and prepare an investigation report with proper remedial measures.

Item No.	Observation	Recommended Action Plan	Recommended Timeline
12	Crack on brick walls	Building engineer to investigate the cracks and prepare an investigation report with proper remedial measures.	6-weeks
13	Crack on brick walls	Carryout any remedial works as per crack investigation report.	6-months
14	Hairline crack on floor beam	Building engineer to investigate the cracks and prepare an investigation report with proper remedial measures.	6-weeks
15	Hairline crack on floor beam	Carryout any remedial works as per crack investigation report	6-months
16	Mismatch in as-built drawings	Building Engineer to survey the structure and prepare as-built drawings to the as-constructed status.	6-weeks
17	Apparently non-engineered structure	Building Engineer to check the connections and rafter adequacy against gravity and lateral forces.	6-weeks
18	Apparently non-engineered structure	Implement any structural alterations recommended through the Engineering Assessment.	6-months

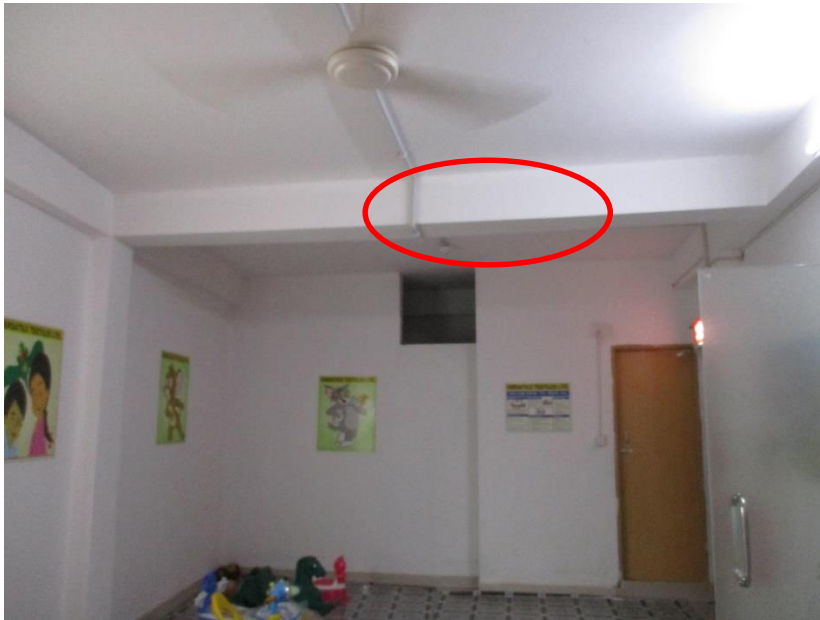
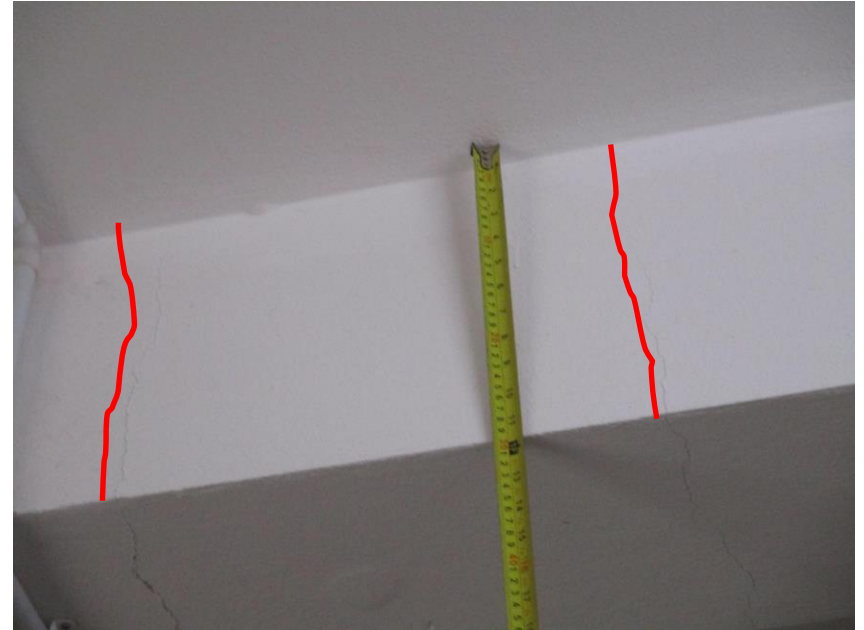
Hairline crack on floor beam

Vertical cracks were observed on midspan of the floor beam. Building engineer to investigate the cracks and prepare an investigation report with proper remedial measures.

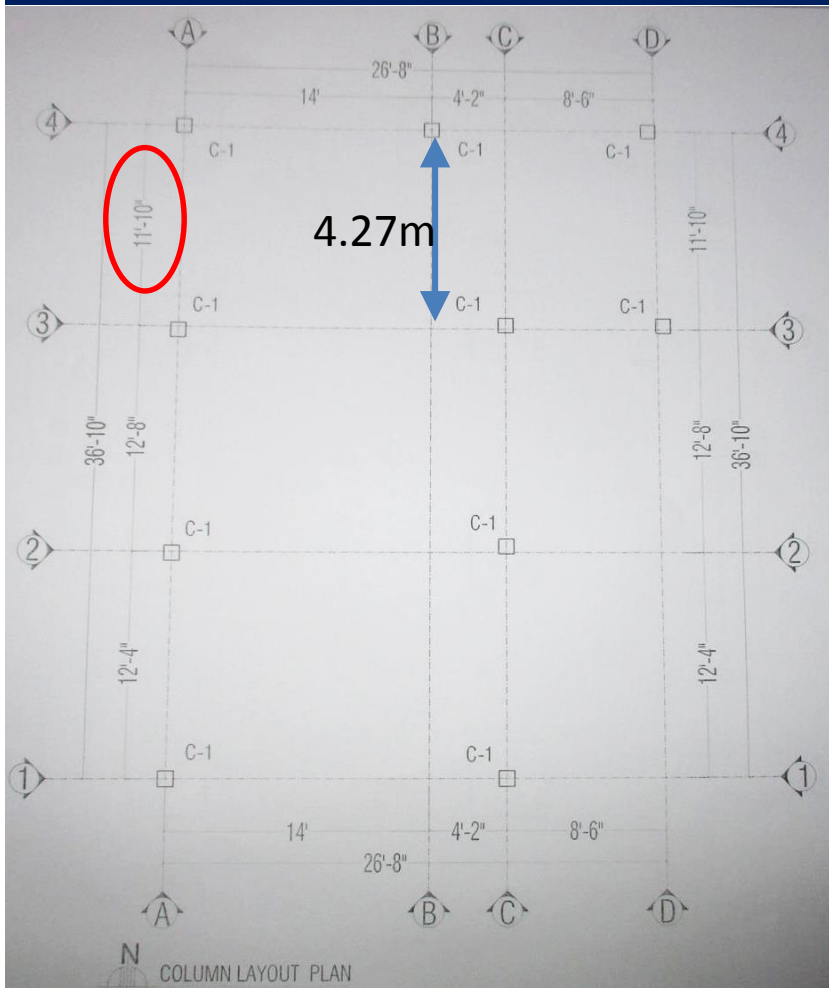
Column layout

The distance between grid 3&4 was measured 4.27m where drawing shows 3.36m. The drawings to be updated.

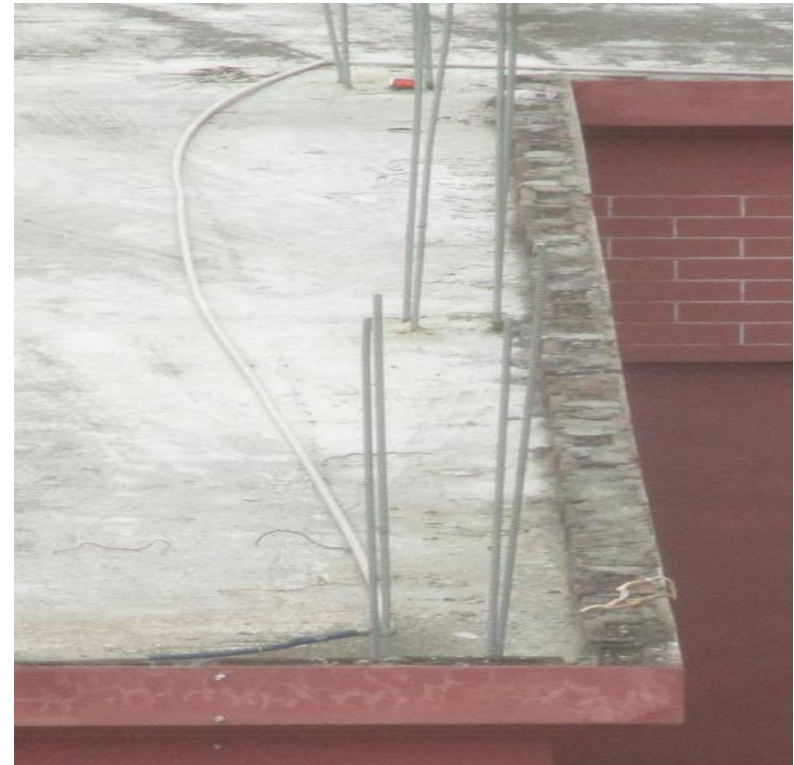
6-rebars shown in drawing where 4-rebars was observed on roof.

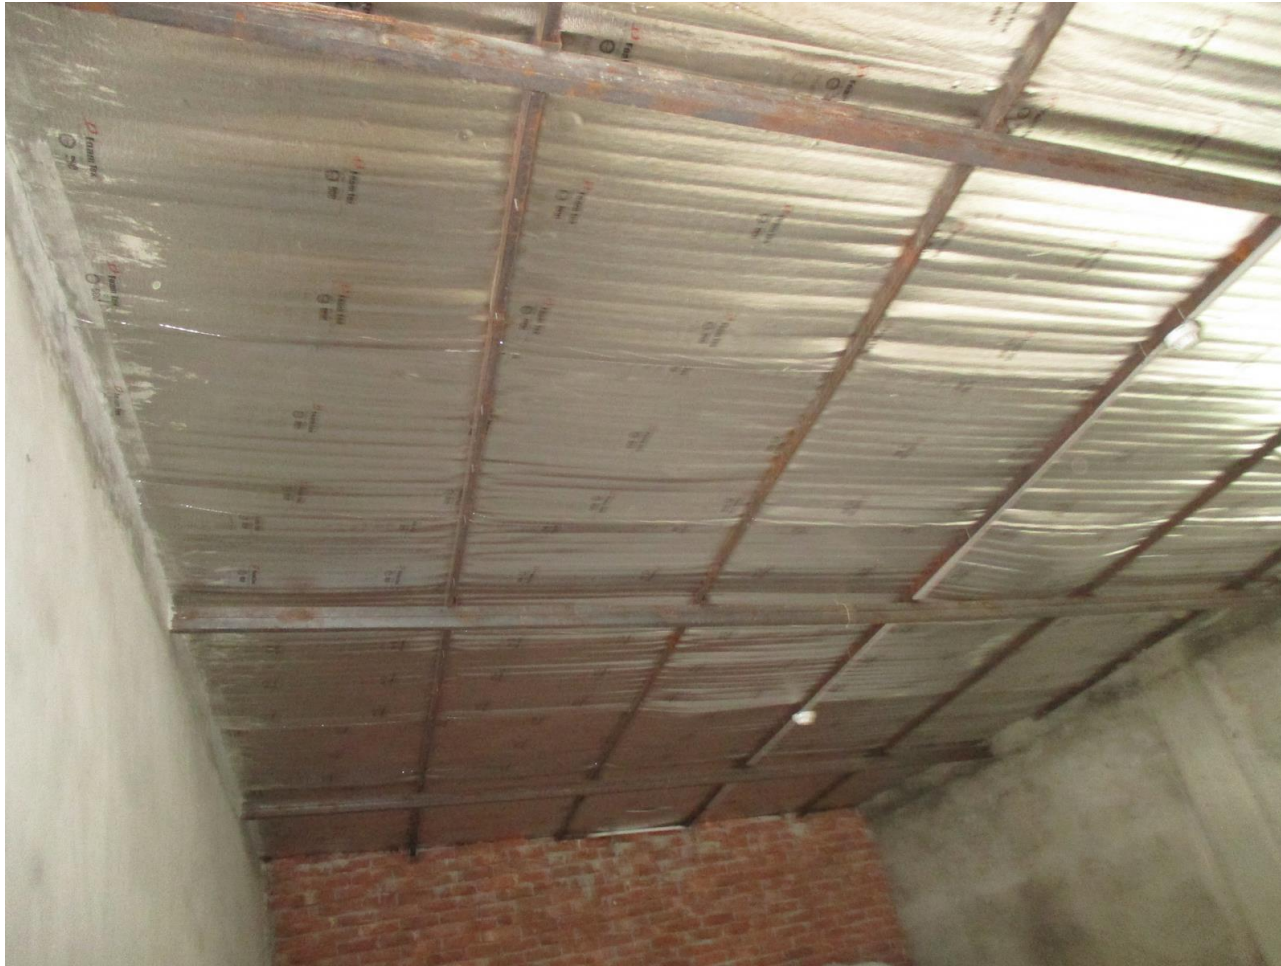
Apparently non-engineered structure. Factory engineer to check the connections and rafter adequacy against gravity and lateral forces.
