Trouser World (Pvt.) Ltd.(New Building)

378/1, Kunia, National University, Joydebpur, Gazipur
(23.926324N, 90.387200E)
7th June 2018

Observations

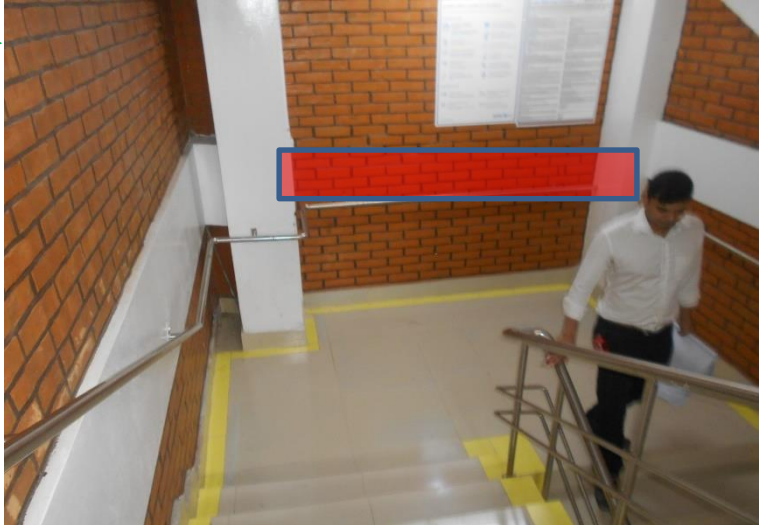
During inspection, stair beam was found missing in the south side and east side stair.

Shaded area indicates beam is missing at eastern side stair.

Stair beam was not found as per beam layout plan. Stair beam was found missing in the in the south side and east side stair. One beam was found missing for each stair. Update of as-built drawing is required. Stair stability is required to be assessed.

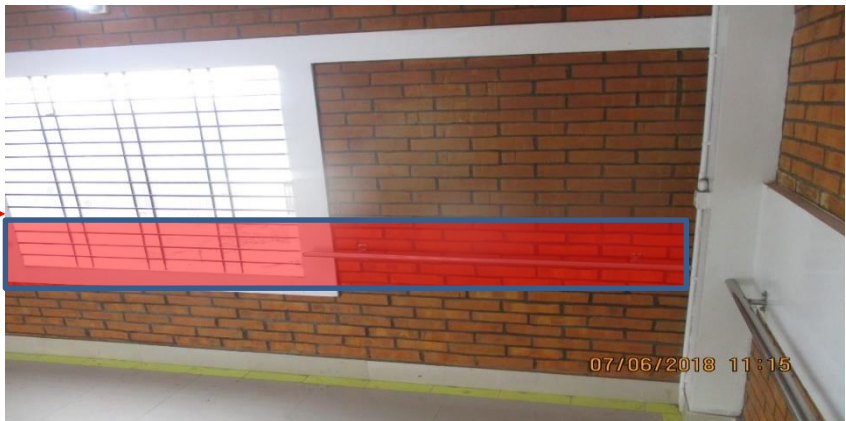
Shaded area indicates missing beam at southern side stair.

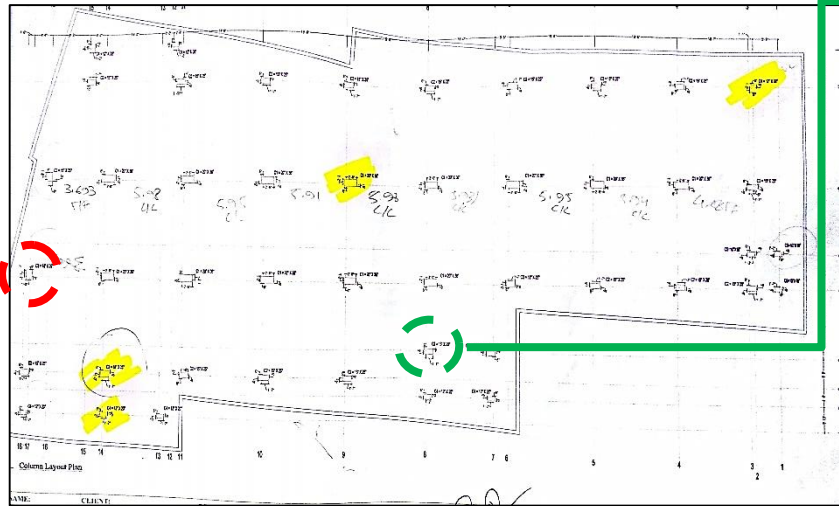
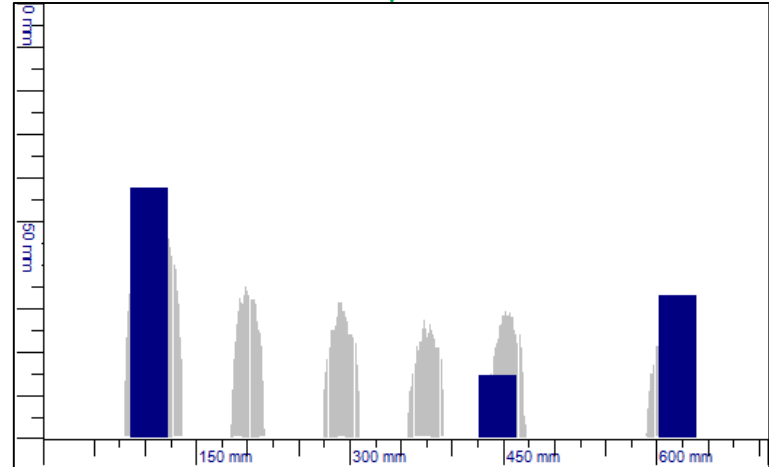
Location of Column type C-3 and Column type C-2 column layout plan.

The number of rebar did not match with as-built drawing for C-2 type column type from 1st to top floor.

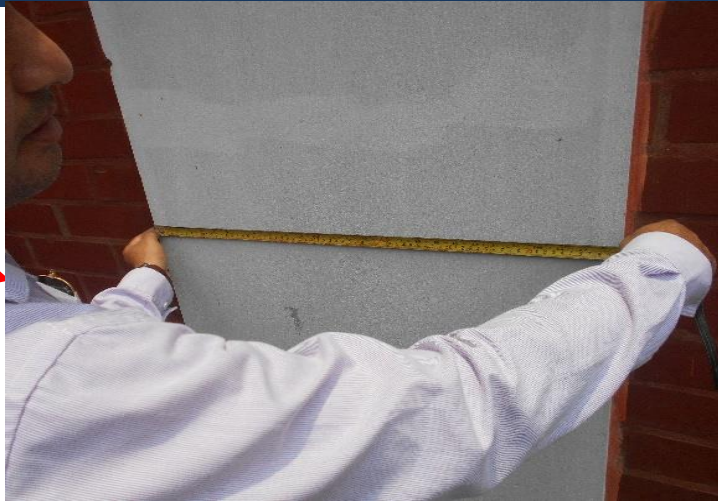
Dimension of column type C-3 in grid E-17 was not found as per drawing. Rebar of column type C-2 in grid D-8 was found less than mentioned in the drawing.

C-3 type column dimension was found less than mentioned in the column schedule.

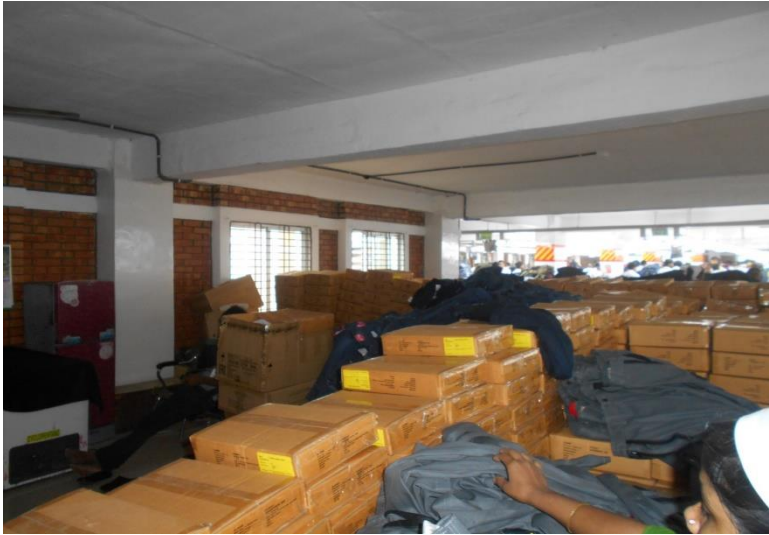
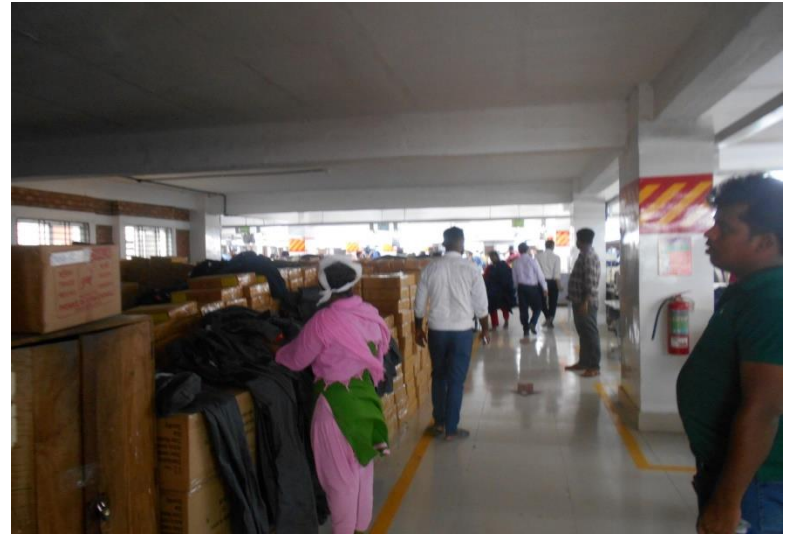
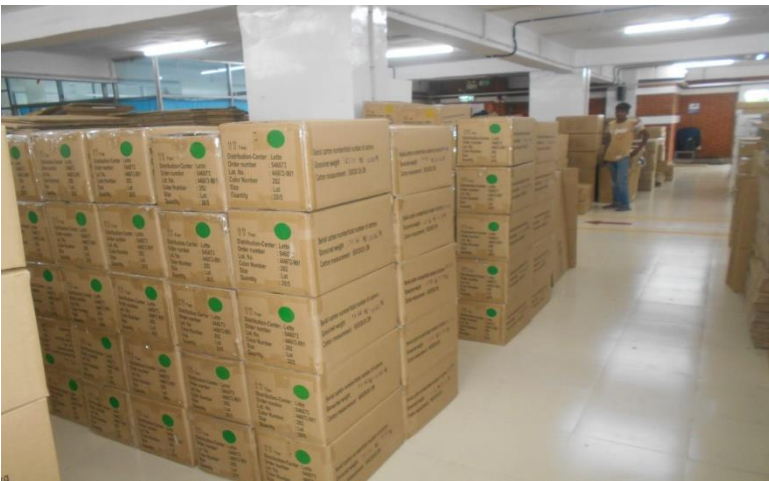
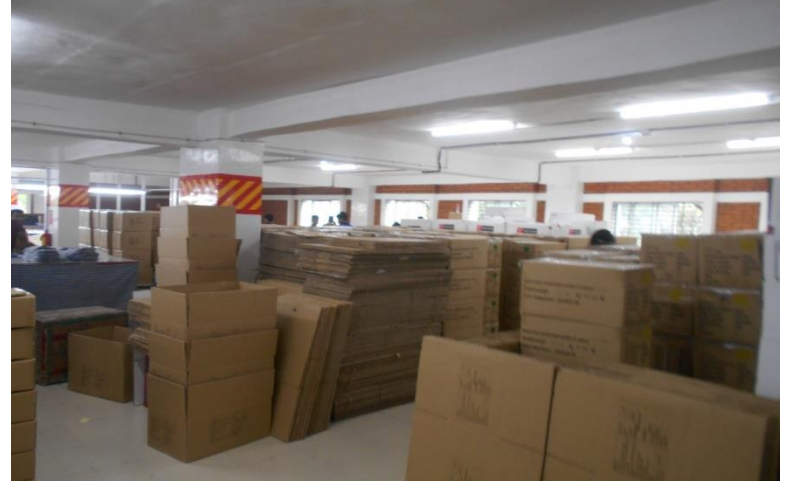
No load plan was found posted on any floor. Factory is required to produce load plan as per it's floor capacity. Load marking is required to be posted as per floor capacity in the temporary and permanent storage areas.

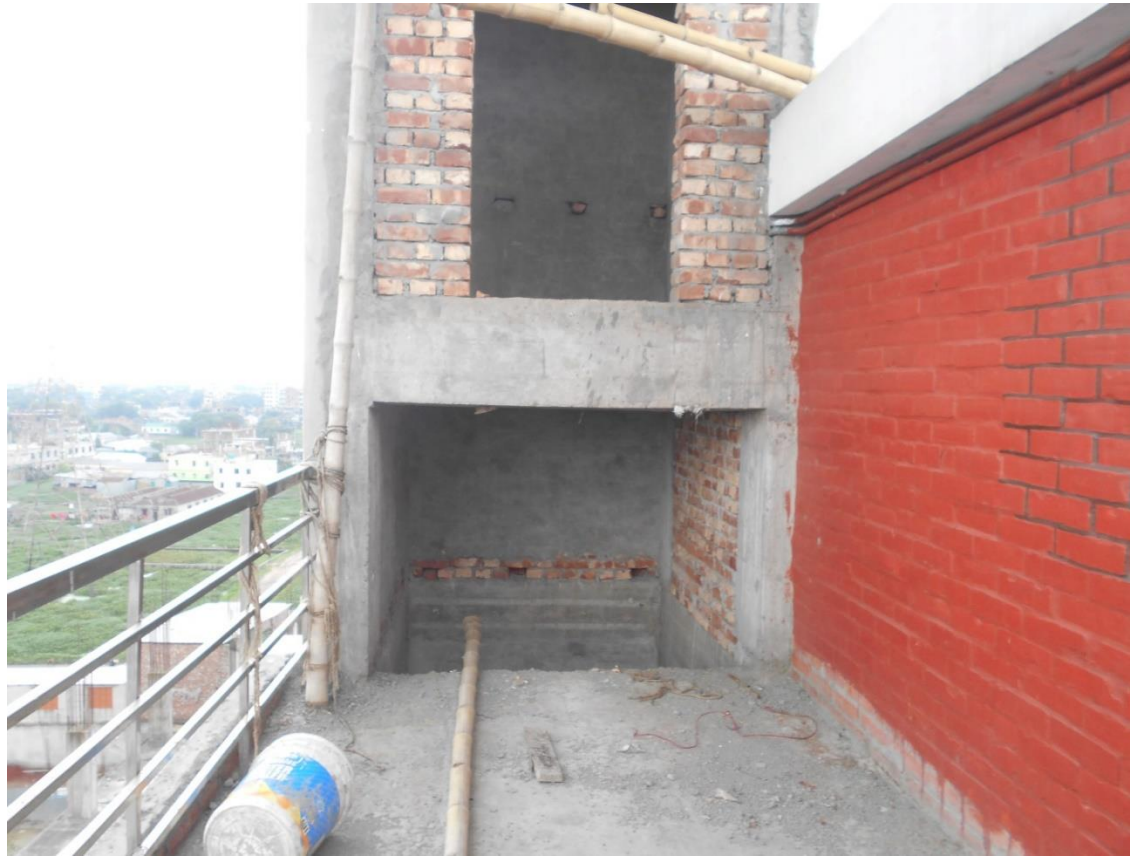
No safety guard or wall was observed at the opening of lift core at roof top. This area is prone to falling hazard.

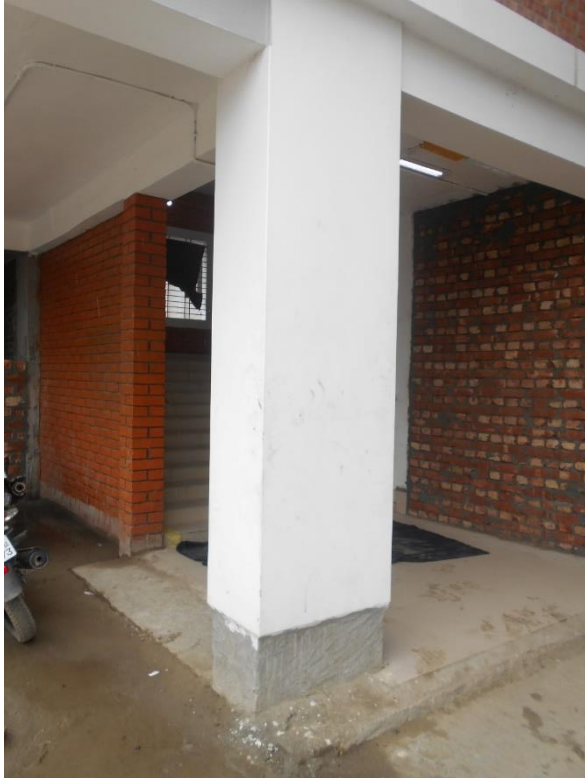
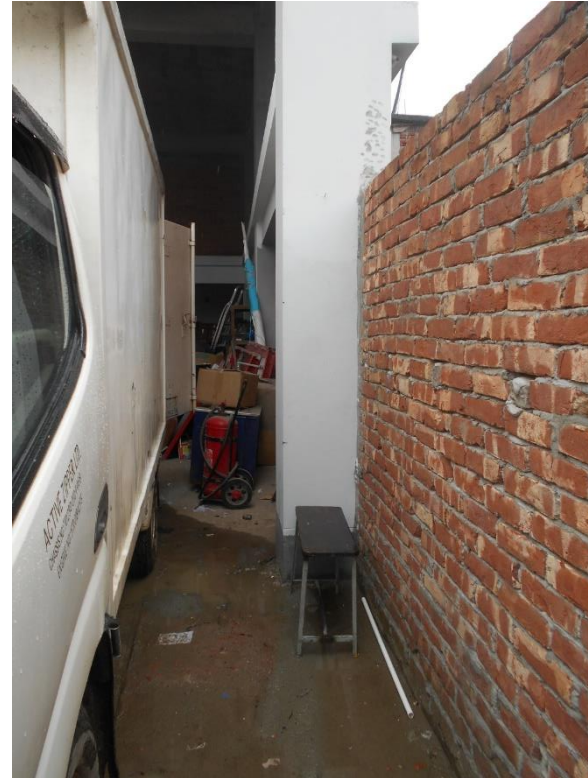
Columns of Ground floor are prone to vehicular impact. Factory is required to protect the columns from vehicular impact.

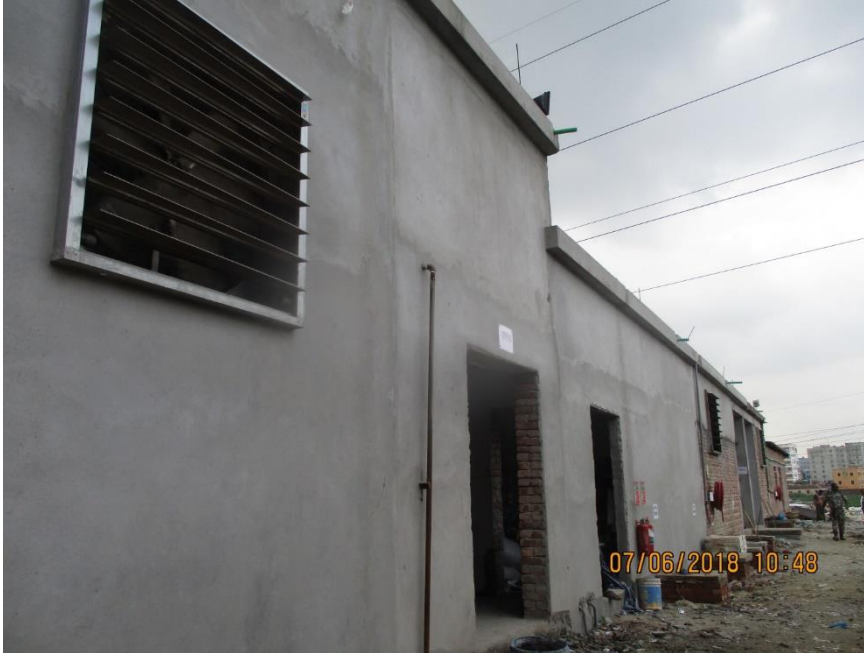
Utility building

No as-built documents was found for the Dining shed and Utility Building. Factory is required to produce as-built documents for these occupancies.

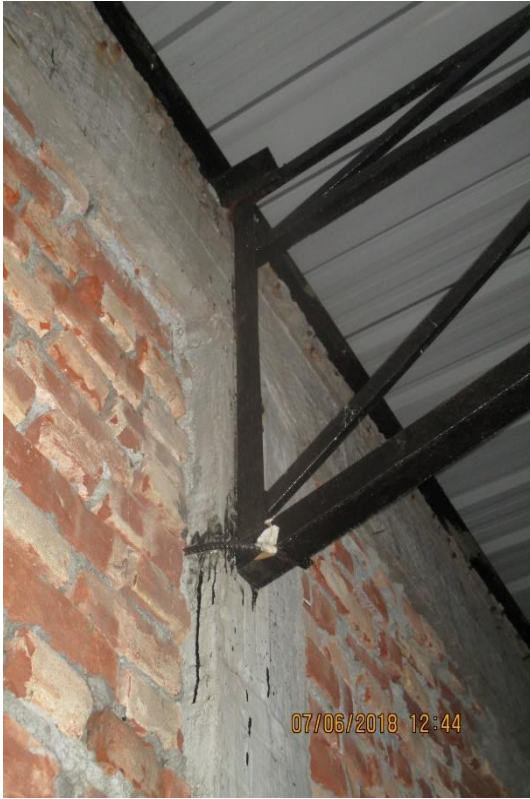
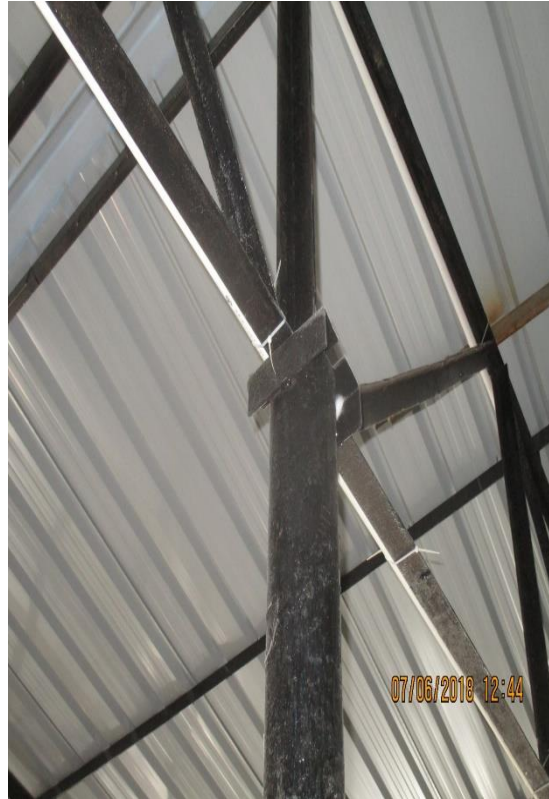
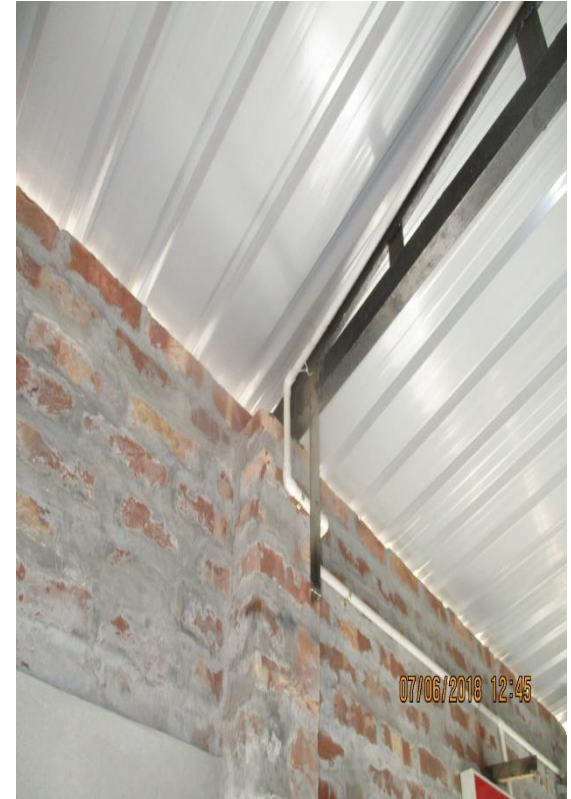
Truss is supported in the brick wall. Connection of truss and RCC column seems poor and inadequate. Truss and steel column connection appeared to be inadequate. Adequacy check for the connection system is required.

9	Poor structural connection and lack of lateral stability of Dining shed	Check the adequacy of the members and connections against uplift and lateral forces	6-weeks
10	Poor structural connection and lack of lateral stability of Dining shed	Implement remedial works suggested by the building engineer.	6-months
