# Atashi Fashion Ltd. (New)

Plot No.- 83/2, Joypura, Dhamrai  
(23.913781, 90.176976)

10<sup>th</sup> June 2018

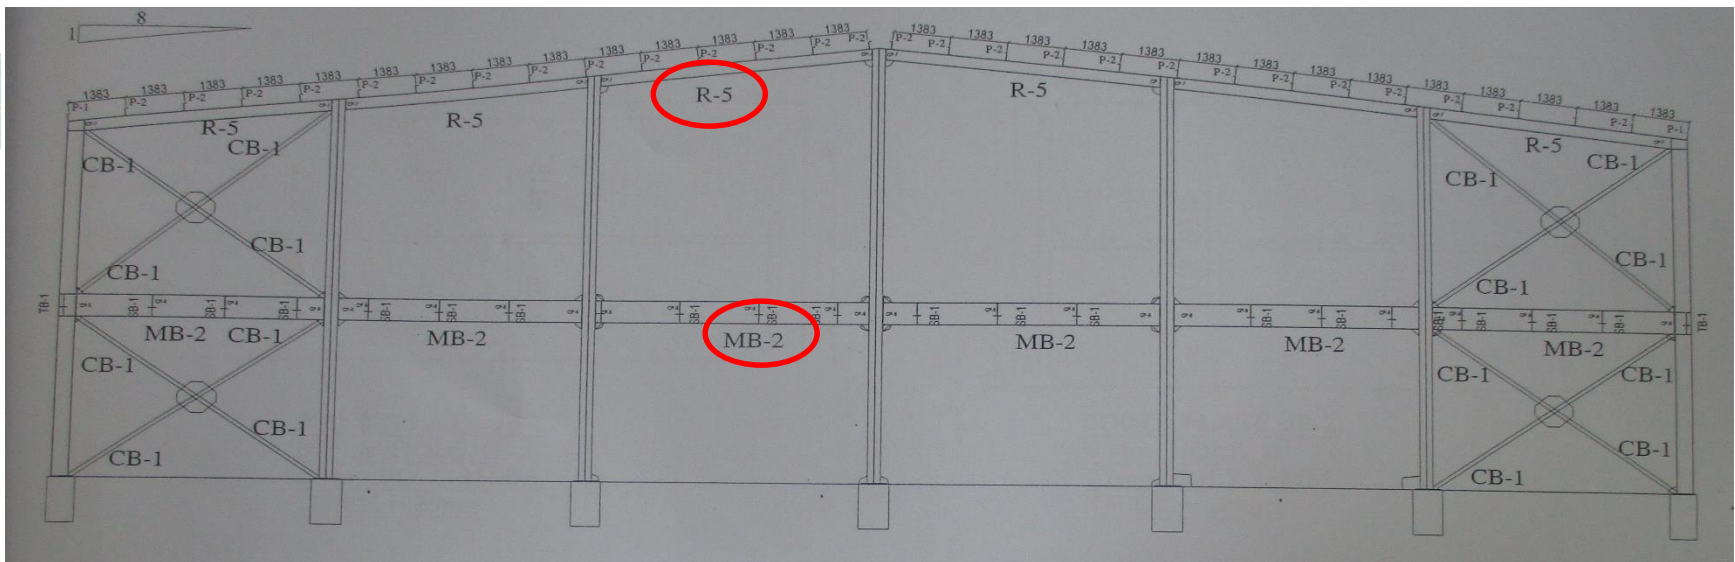
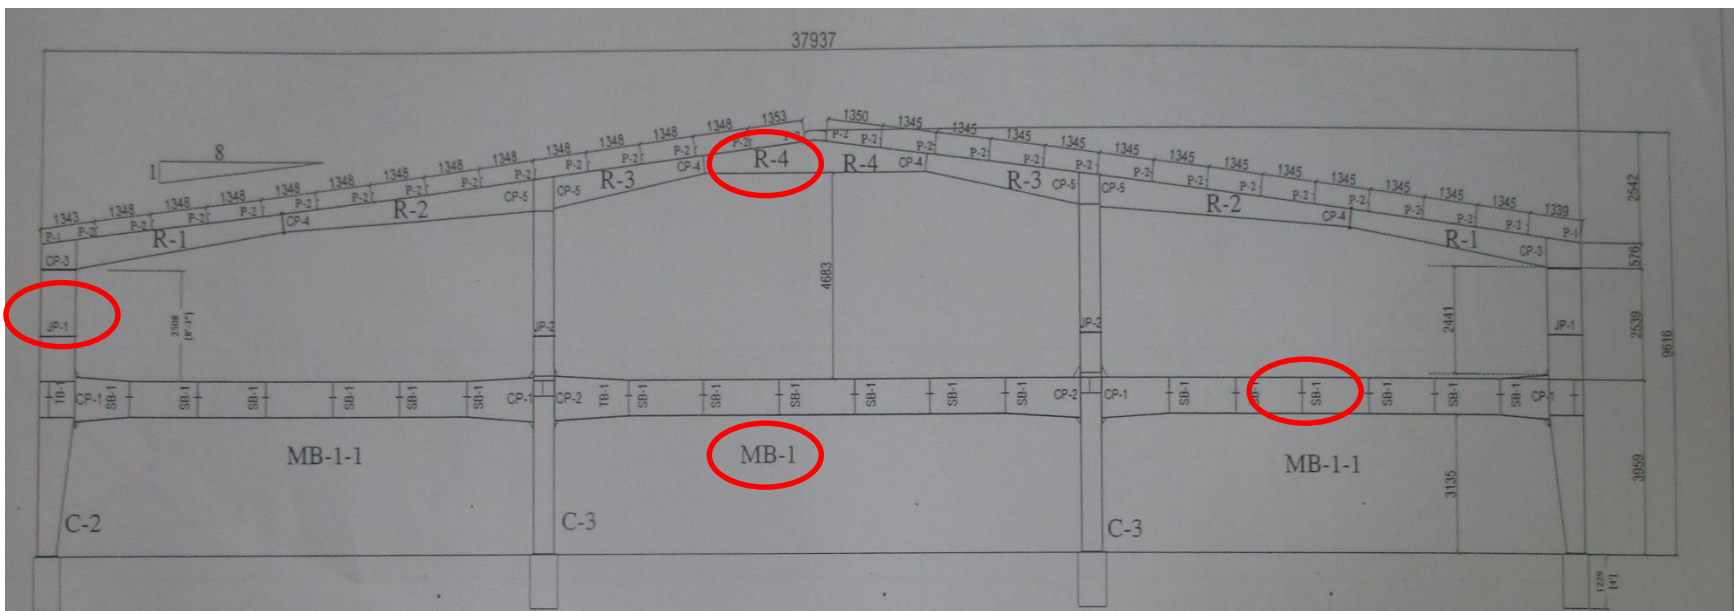
**Section size not mentioned in drawing**

Sectional size of column, beam and rafters were not shown in drawings.

| Item No. | Observation | Recommended Action Plan | Recommended Timeline |
|---|---|---|---|
| 1 | Section size not mentioned in drawing (Main Factory Building) | Engage a Building Engineer to survey the structure and prepare a full set of “as-built” drawings reflecting the actual condition. | 6-weeks |

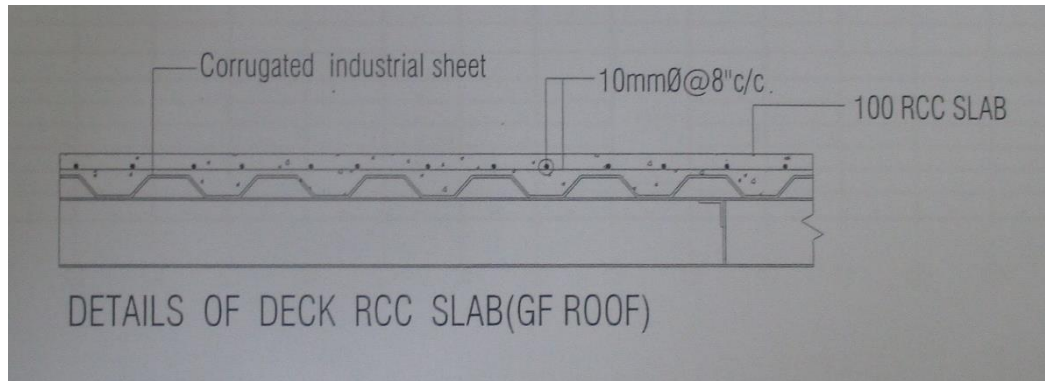
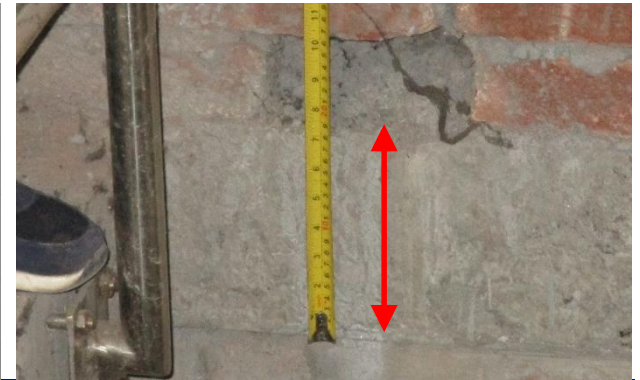
100 mm RCC slab shown in drawing but 175mm thick slab observed on site.

There are some discrepancies in provided drawings of Main building. Factory is required to update the as-built drawings for the structure.

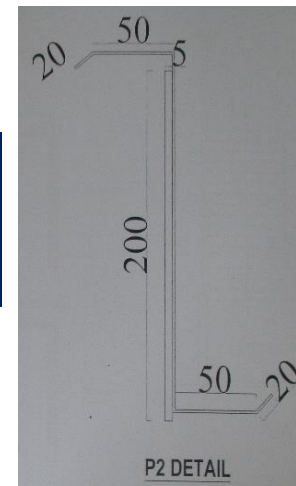
Thickness of purlin was shown 5mm where 3 mm observed on site. Also, flange was observed 75 mm instead of 50mm.

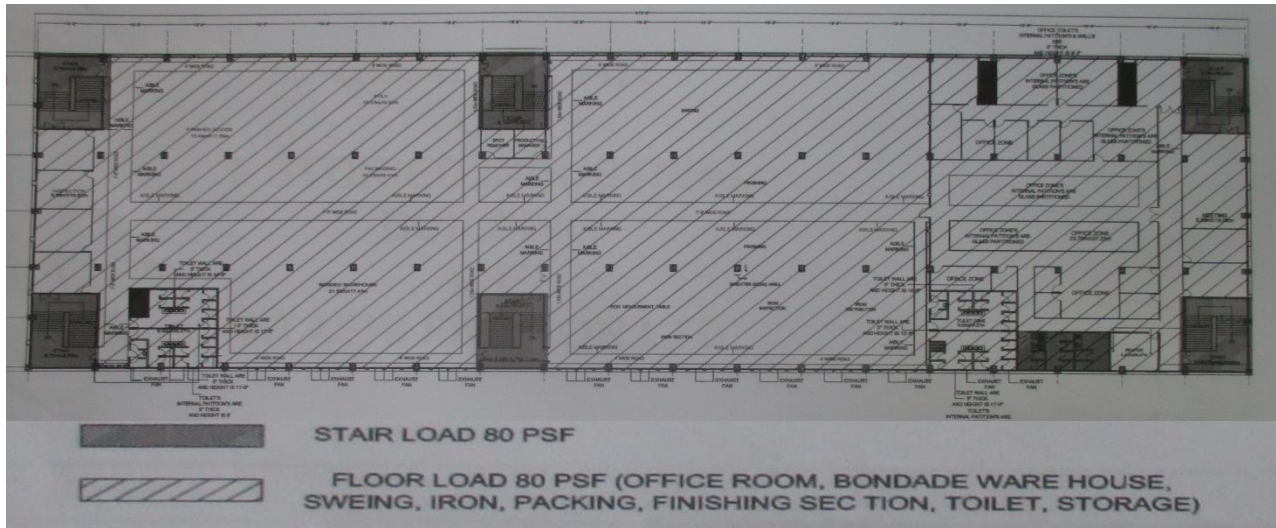
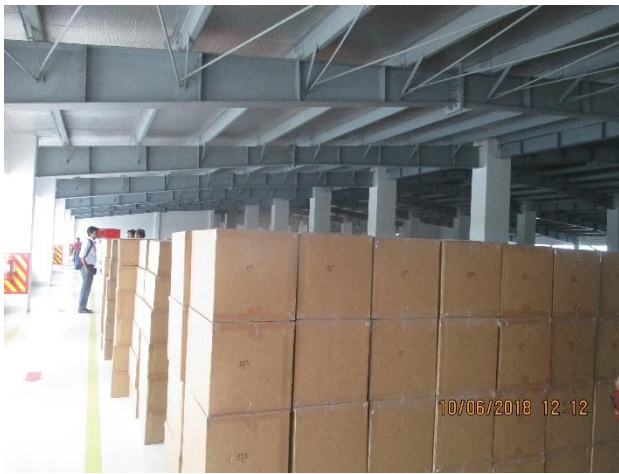
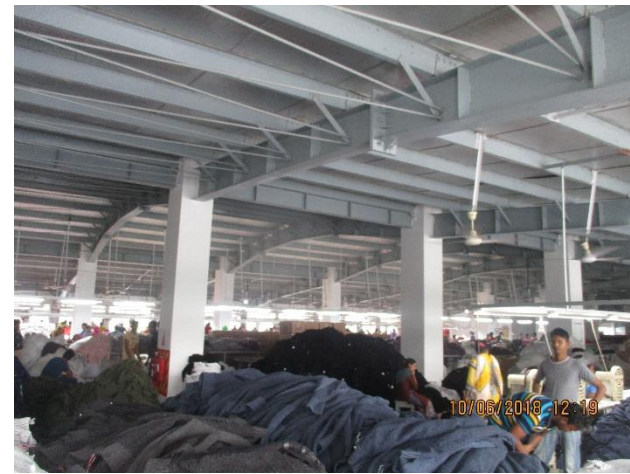
# Implement the floor load management program

No visible load plan observed to maintain the design live load.

| Item No. | Observation | Recommended Action Plan | Recommended Timeline |
|---|---|---|---|
| 2 | Implement the floor load management program (Main Factory Building) | Maintain live loading within 4 kPa on 1st floor. | 6-weeks |
| 3 | Implement the floor load management program (Main Factory Building) | Post the floor load plan and provide proper signage. | 6-weeks |

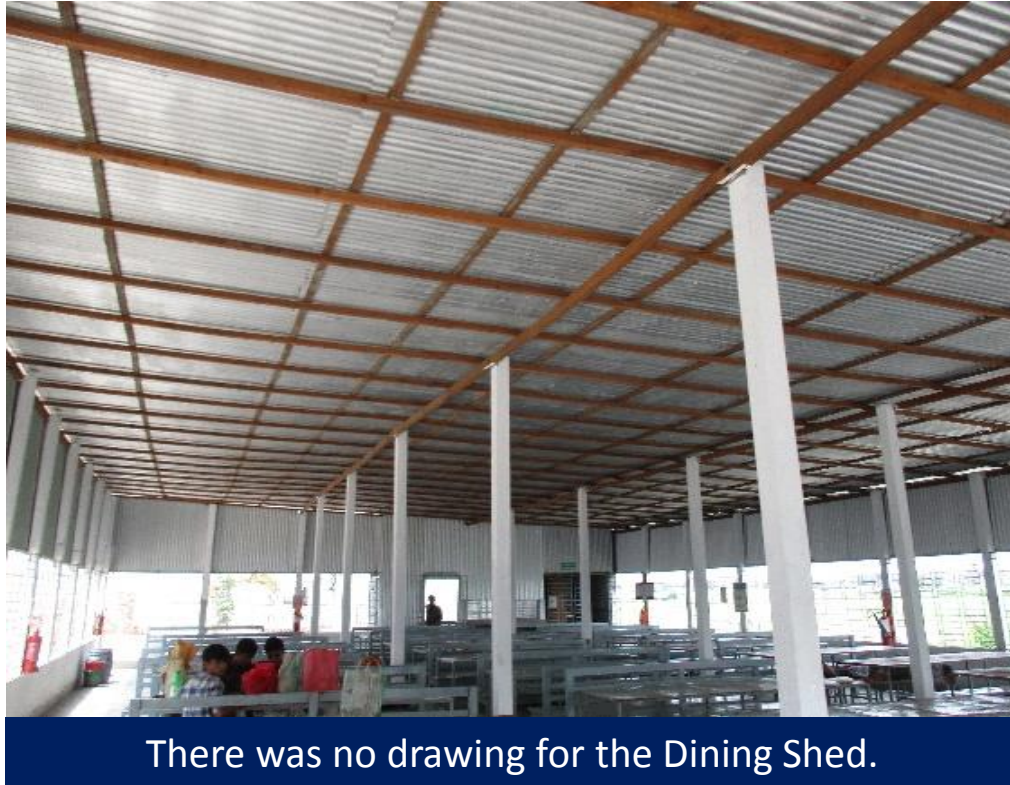
# Lack of as-built drawings

There was no drawing for the Dining Shed.

The as-built drawing of the Dining shed was not available. Factory is required to prepare the as-built drawings for the structure.

| Item No. | Observation | Recommended Action Plan | Recommended Timeline |
|---|---|---|---|
| 4 | Lack of as-built drawings | Engage a Building Engineer to survey the structure and prepare a full set of “as-built” drawings reflecting the actual condition. | 6-weeks |
