**Moonlux Knit Garments Ltd. #10694**  
**West Knit Wear Ltd. #9892**  
**West Fashion Ltd #11020**  
**Moonlux Composite Knit Garments Ltd. #11699**

7504-7505 Waxbill Plaza, Sumilpara, Siddirgonj, Narayanganj

16.April.2014

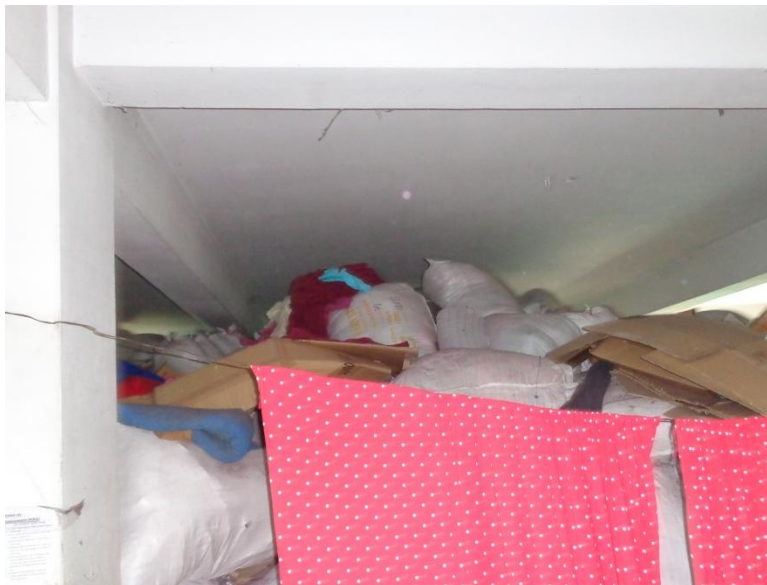
## 1<sup>st</sup> Priority 2 Concern

During our visit, we have found that the floors used for excessive storage. For example, on the 3<sup>rd</sup> floor of the front building, we found a cantilevered section loaded at 6 kPa. The factory and floor manager were advised to lower the height of the storage by half in that area.

We also noticed that some construction material stored at the roof. Loading of the roof has to be limited to a minimum.

This concern is applicable for both buildings

- Limit storage height

- Produce and actively manage a loading plan for all floor plates within the factory giving consideration to floor and column capacities.
- Verify in situ concrete stresses either by 100mm dia. Cores.

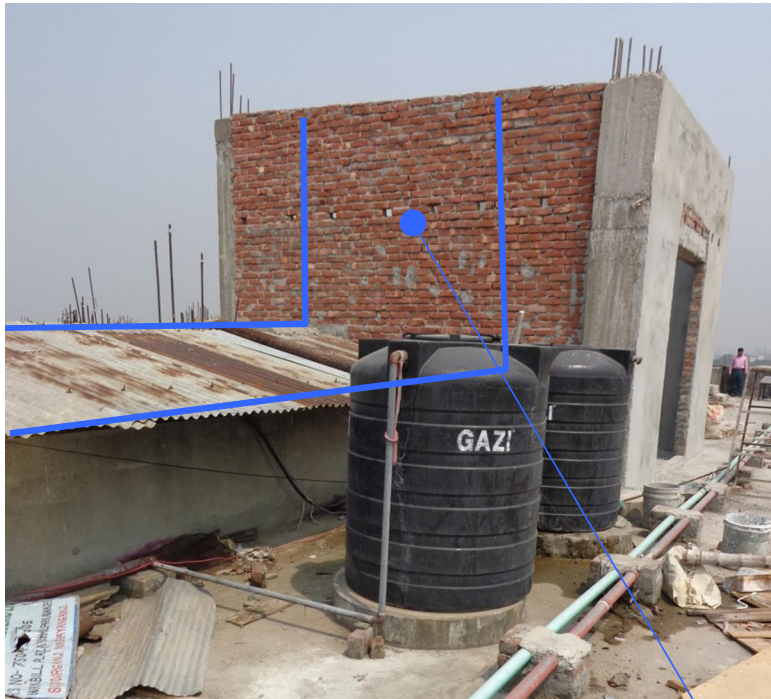
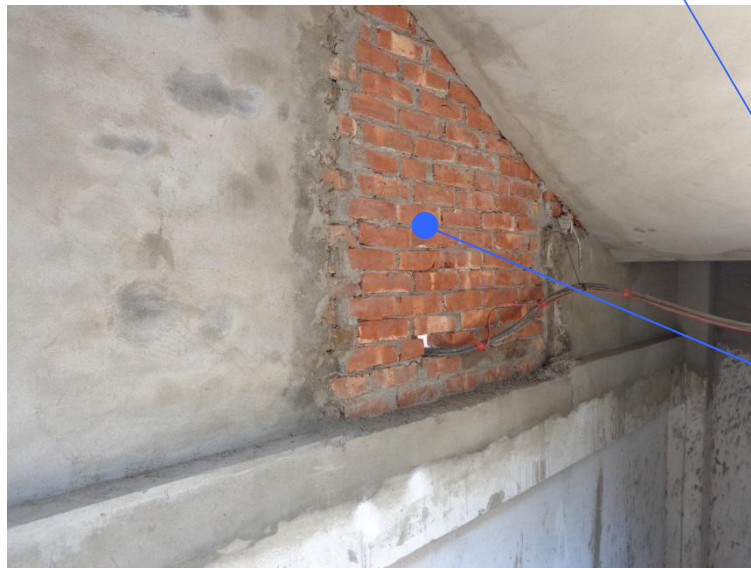
Building gap

During our visit, we have found that the main staircase, also used as an emergency egress, was connected to both buildings.

As the 2 buildings have different geometries, number of floors and floor heights, they will both act differently under seismic loading. There is reasonable doubt that the staircase will act as a restraint and attract lateral loads for which it is not designed.

If this staircase was to fail during an earthquake, the building would lose a main means for escape.

- A Detailed Engineering Assessment should be carried out with regard to the current lateral system.

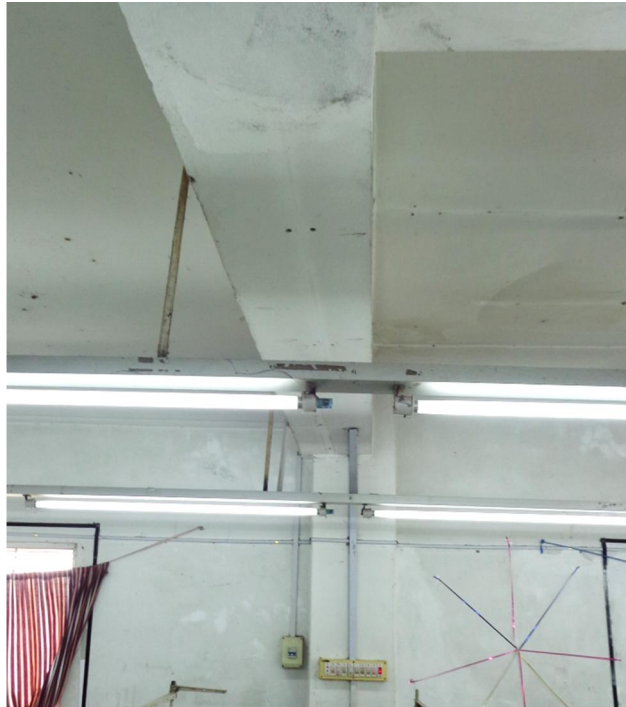
At last floor of back building below communication tower

During our survey, we have found multiple beams with a certain eccentricity with regard to the column. This can create an unwanted moment in the column.

We require that these columns be checked for compression vs moment interaction in a Detailed Engineering Assessment.

- A Detailed Engineering Assessment of columns with eccentric loading is to be commenced, see attached scope.

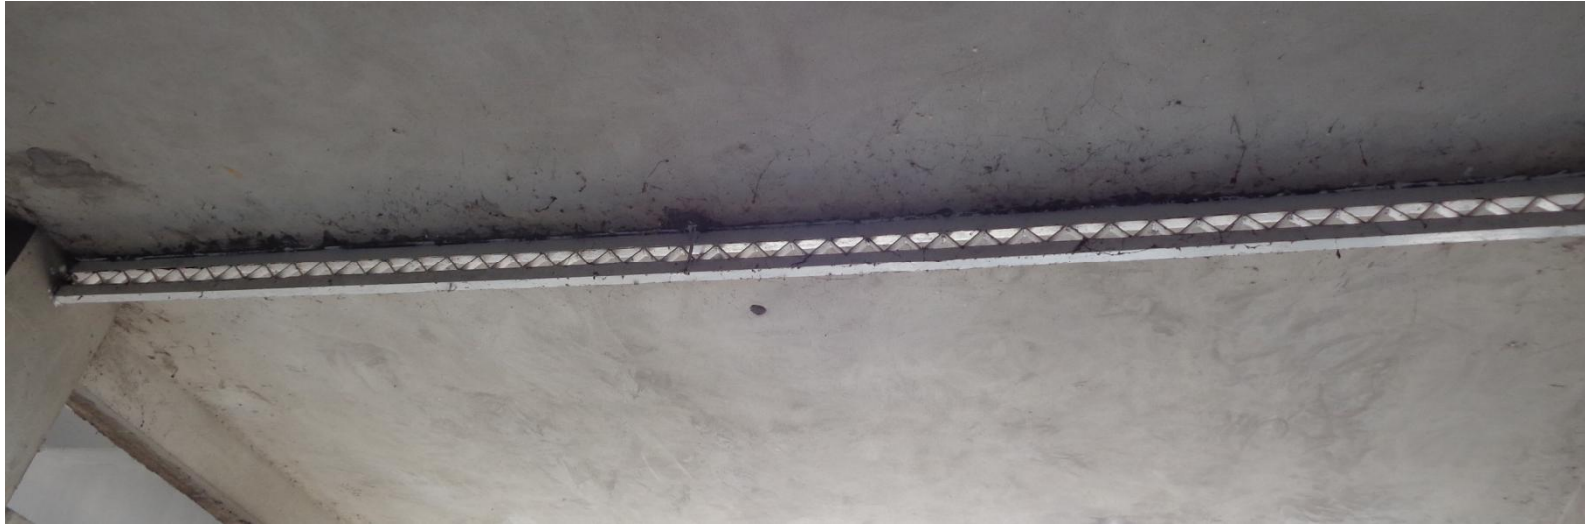
Below first floor slab of front building - entrance

During our survey, we have found structural elements that seem unorthodox. We require a full detailed engineering assessment of the steel reinforcing elements.

- A Detailed Engineering Assessment of the reinforcing is to be commenced, see attached scope.

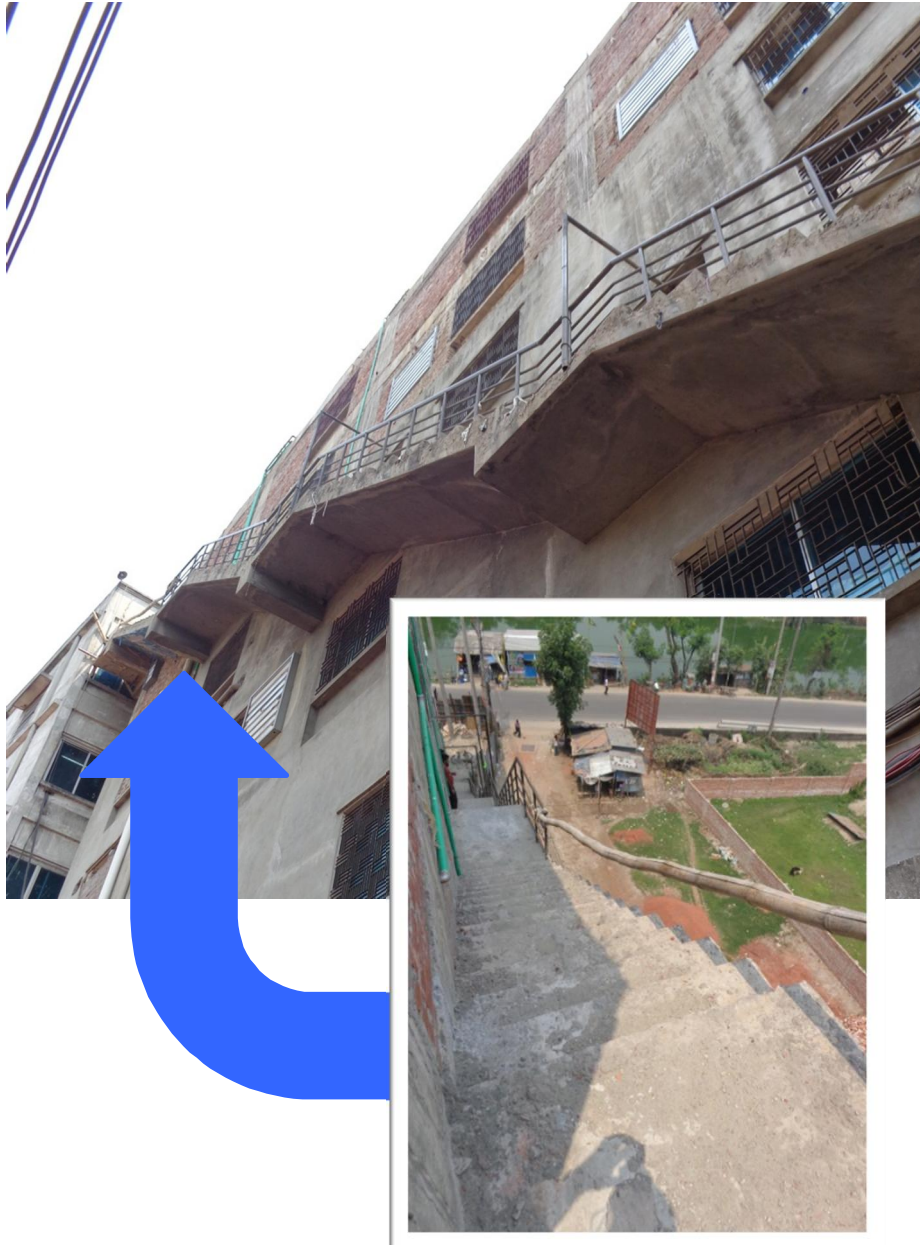
At the front building, there is a cantilevered building with an inadequate bamboo railing poorly fastened. This is to be replaced immediately by standard steel railing

- Replace bamboo railing by adequate standard railing system.

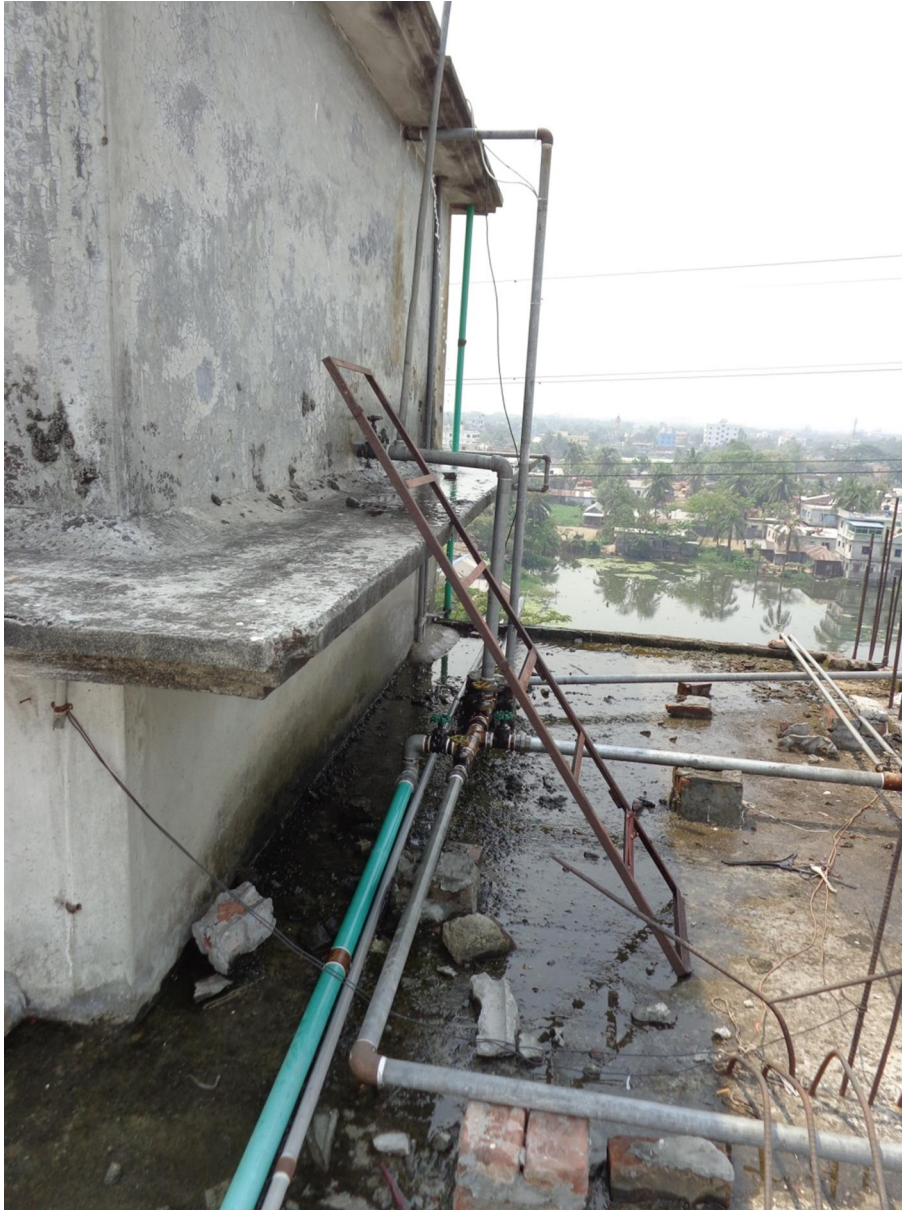
On the roof of the back building, the water tank is leaking from a poorly sealed connexion with piping. The rate of leaking is enough to create a small accumulation of water. Refer to waterproofing concern.

- Repair leak to prevent any further water ingress.

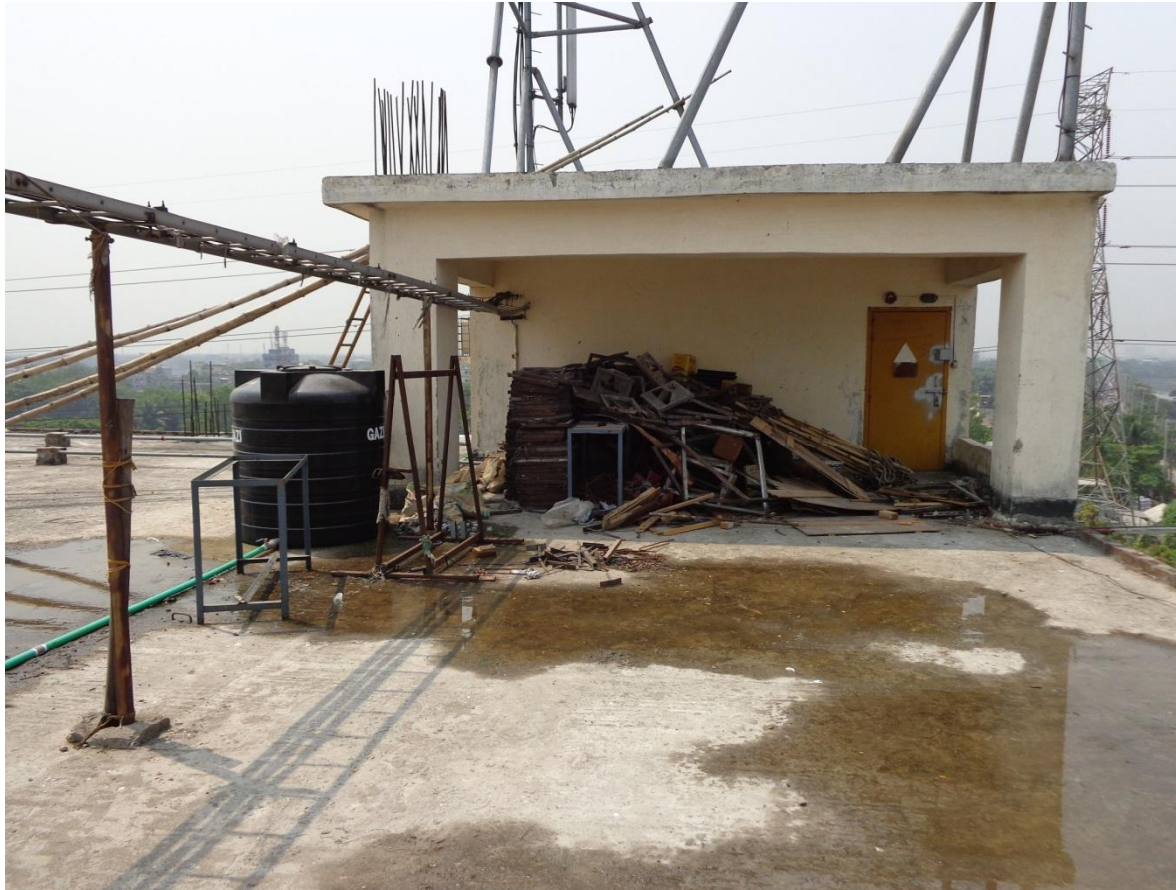
During our survey, we noticed a cement based waterproofing finish. In certain areas, it has been damaged by construction material storage. Consequently, any cracks or damage in the surface finishes on the roof will allow water to seep into the concrete slab beneath the finishes, and cause long-term soaking of the slab. Same goes for water tanks at roof.

- Repair waterproofing where damaged and waterproof areas where no protection is provided.

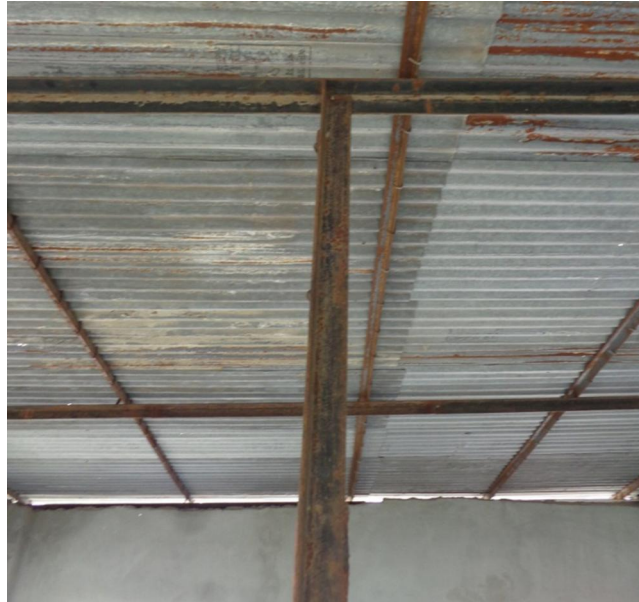
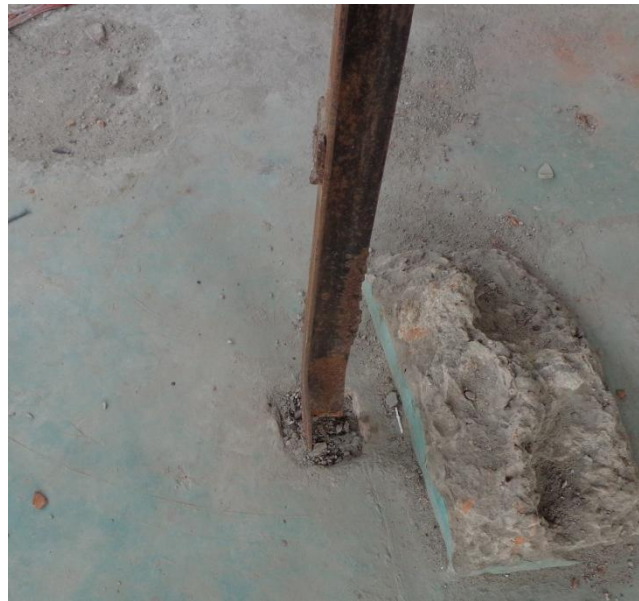
There are some small section of steel roofing on for sheds on both roofs. 1 close to the communication tower, 1 over the joint and 1 over the elevator shaft.

We surveyed a steel angle column, roughly 3m high, with a damaged bottom. This space should stay unoccupied.

- A Detailed Engineering Assessment of the columns with the eccentric loading is to be commenced, see attached scope.
