FNF Trend Fashion Ltd.

H -2282/1 NOBI ULLAH MIR MANSION, HAZI LIAKAT ALI MIR ROAD, JAMGORA, ASULIA, DHAKA.
(23.934778N, 90.289052E)
27th December 2017

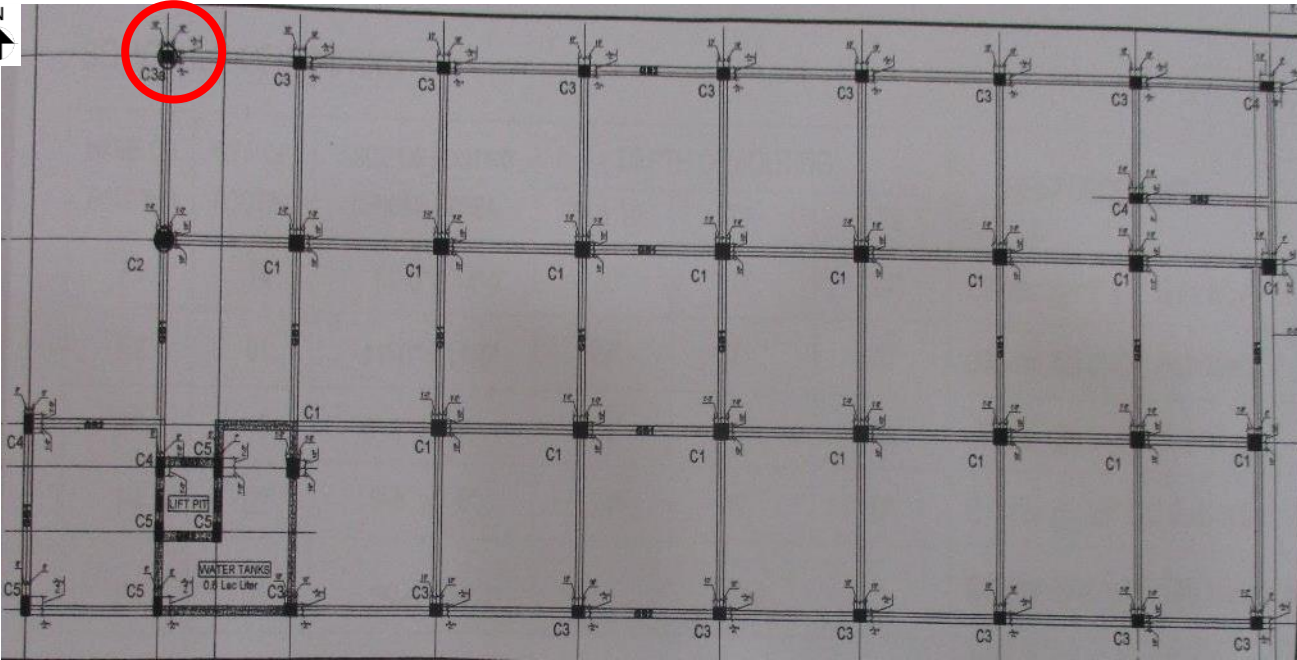
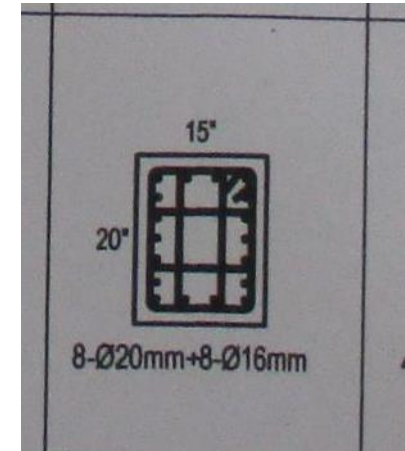
Provided Column Layout

16 nos. rebar were shown in column schedule for C-3a type column in 1st floor

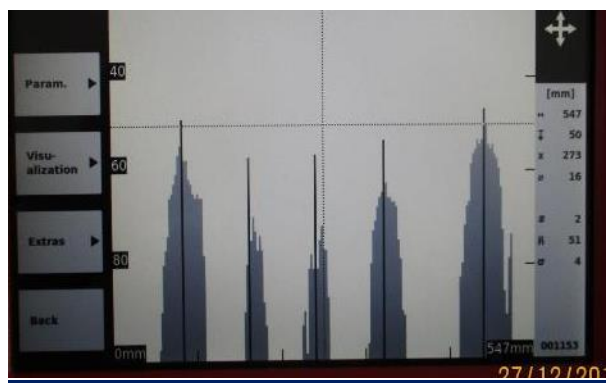
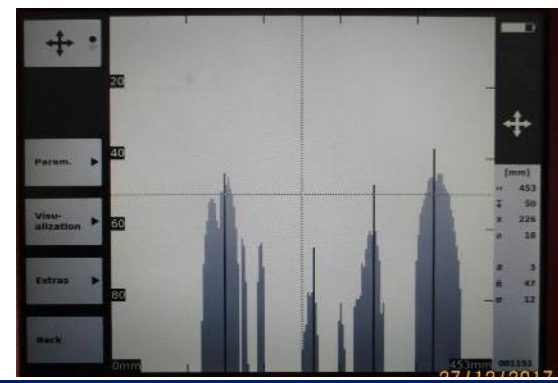
Ferro Scanning Image of marked column

14nos. (5x4) rebar was observed by ferro scanning of C-3a type column on 1st floor. But as per column schedule of the provided drawing, there are 16 nos. rebar

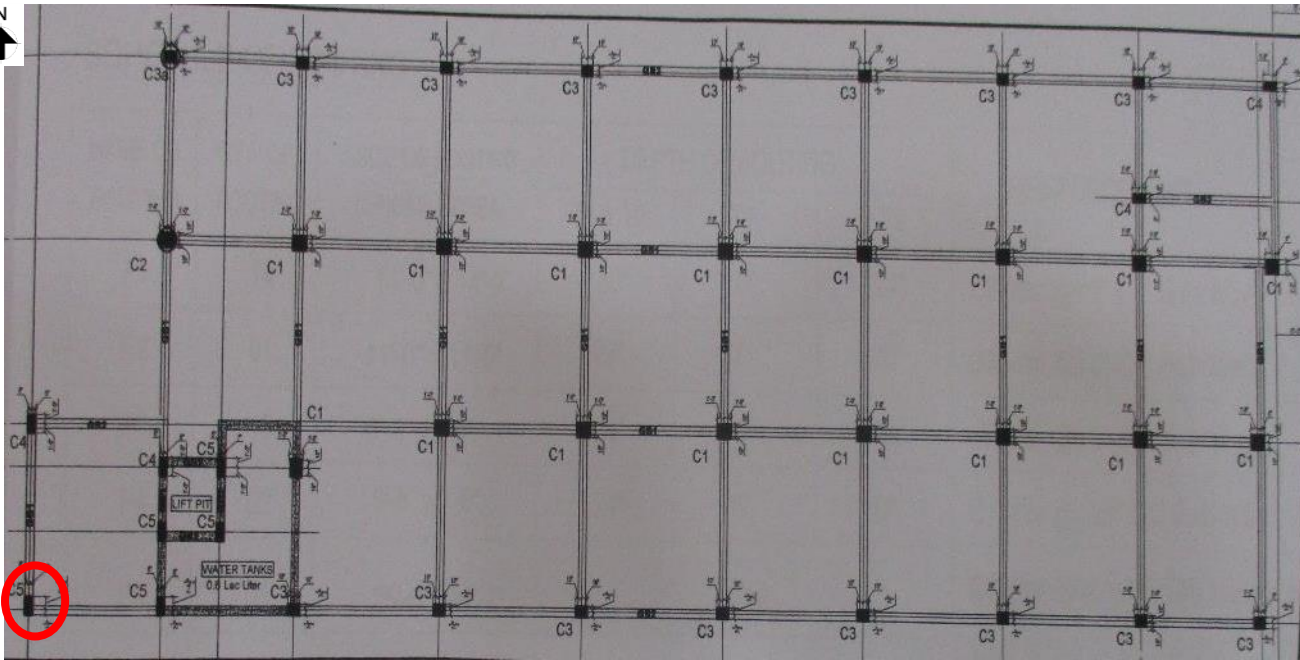
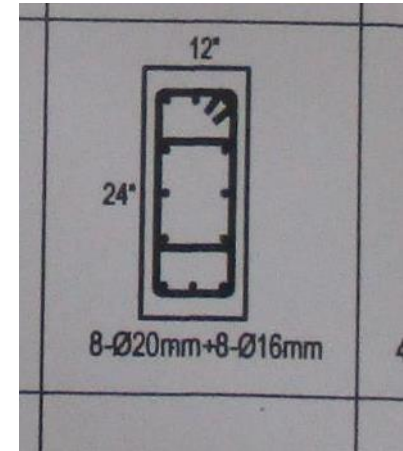
Provided Column Layout

16 nos. rebar were shown in column schedule for C-5 type column in 1st floor

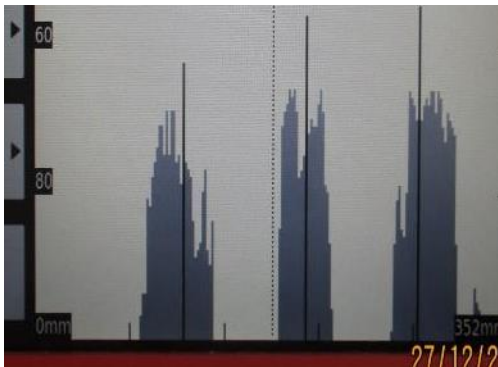
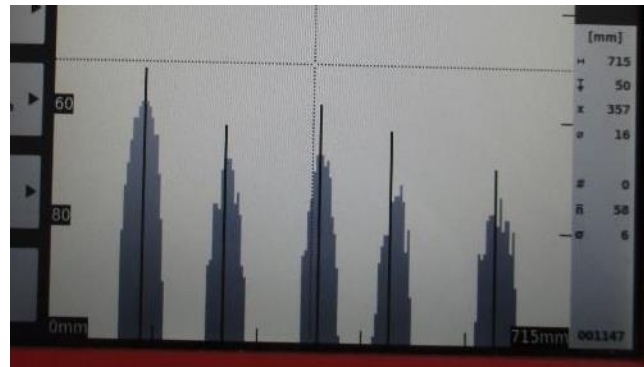
Ferro Scanning Image of marked column

12nos. (5x3) rebar was found by ferro scanning in C-5 type column in 1st floor. But in column schedule, 16 nos. rebar was mention in column schedule in provided drawing.

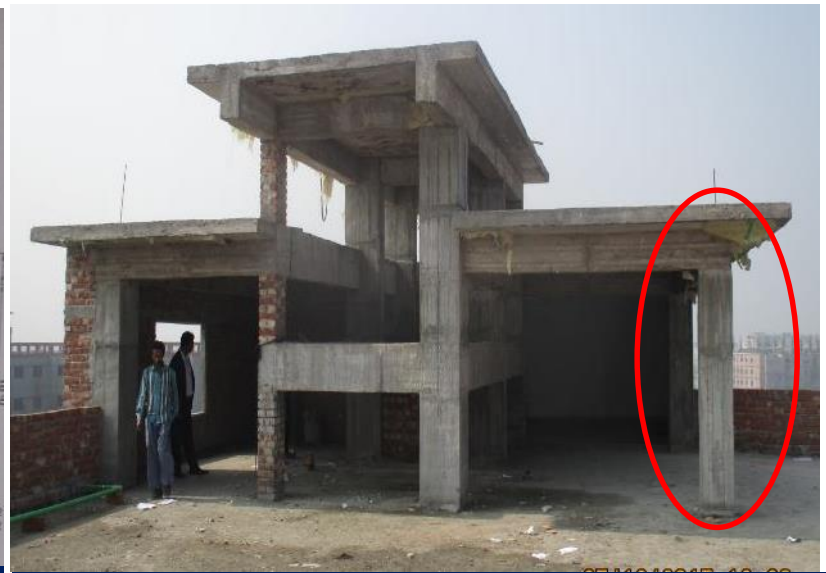
The beam- column layout was different than the provided drawing. The highlighted portion of the stair roof slab was not constructed. Also, the red marked column is not shown in the drawing. The column was constructed from the slab.

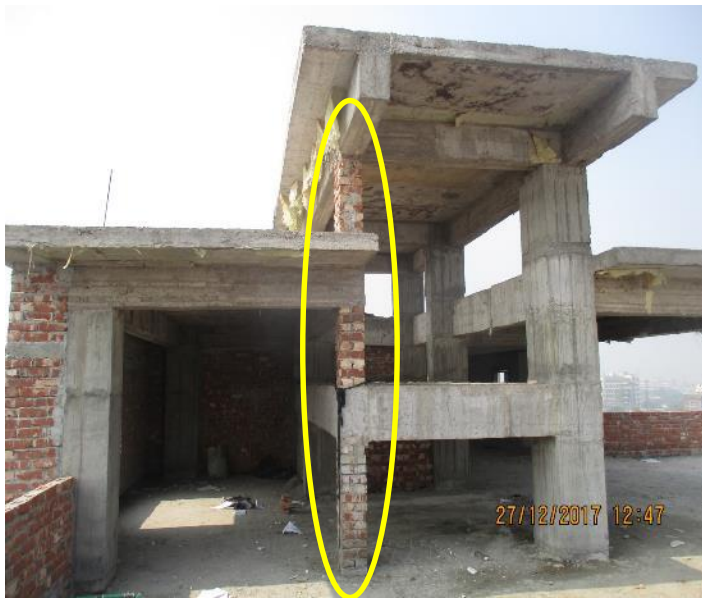
The marked brick column was not shown in the drawing. The brick column carry the load from the roof slab. Factory engineer is required to assess the capacity of the brick column.

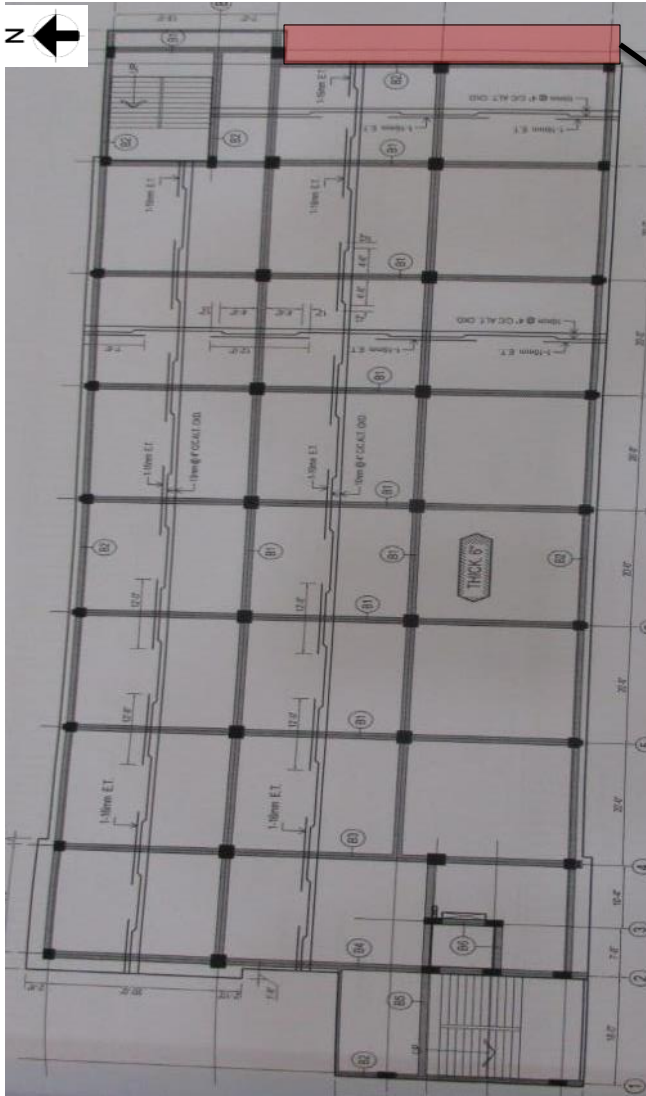
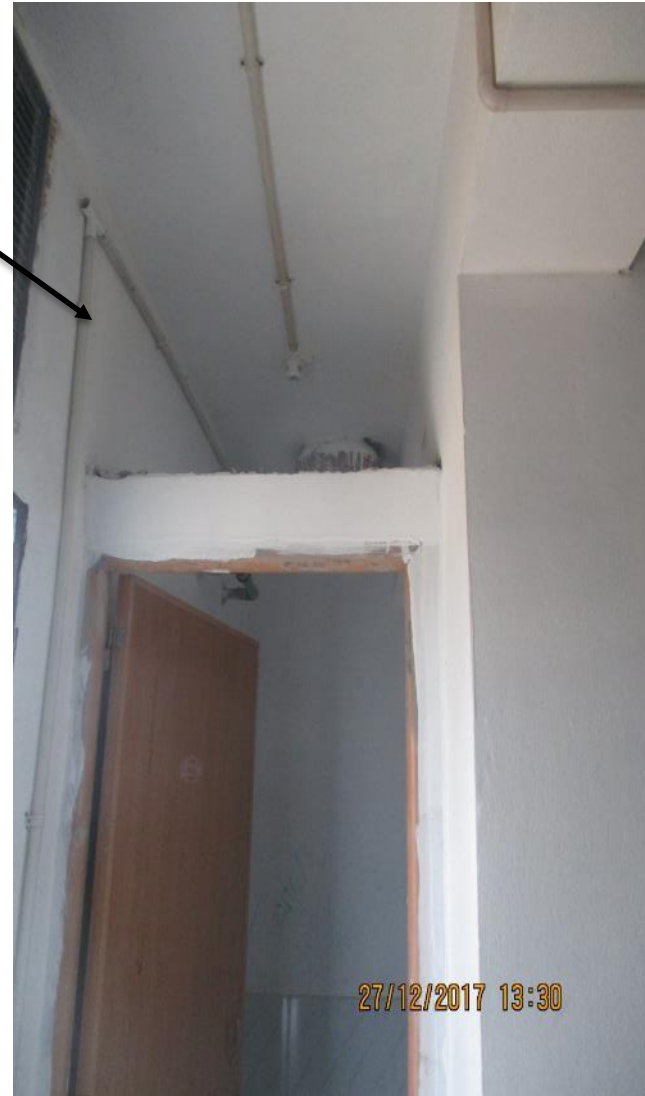
475 mm wide cantilever was found on every floor on east side toilet zone.

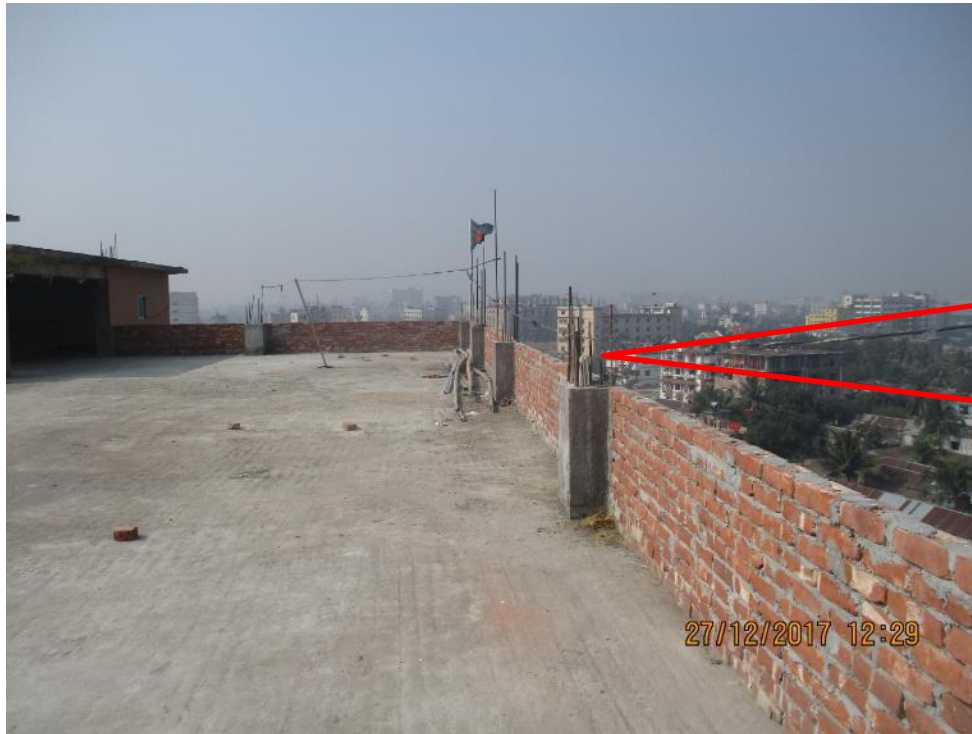
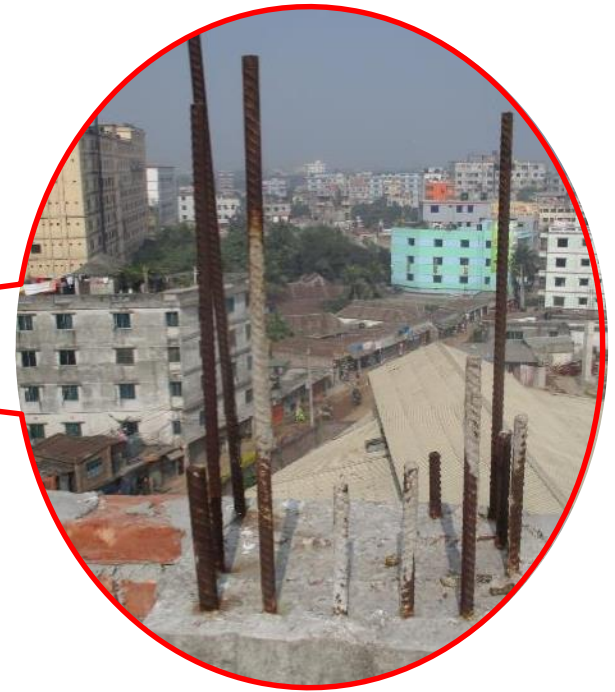
Corrosion of roof top exposed reinforcement

Corrosion was observed on almost all exposed reinforcement of column on roof top. Factory is required to take proper measures to protect rebars from corrosion.

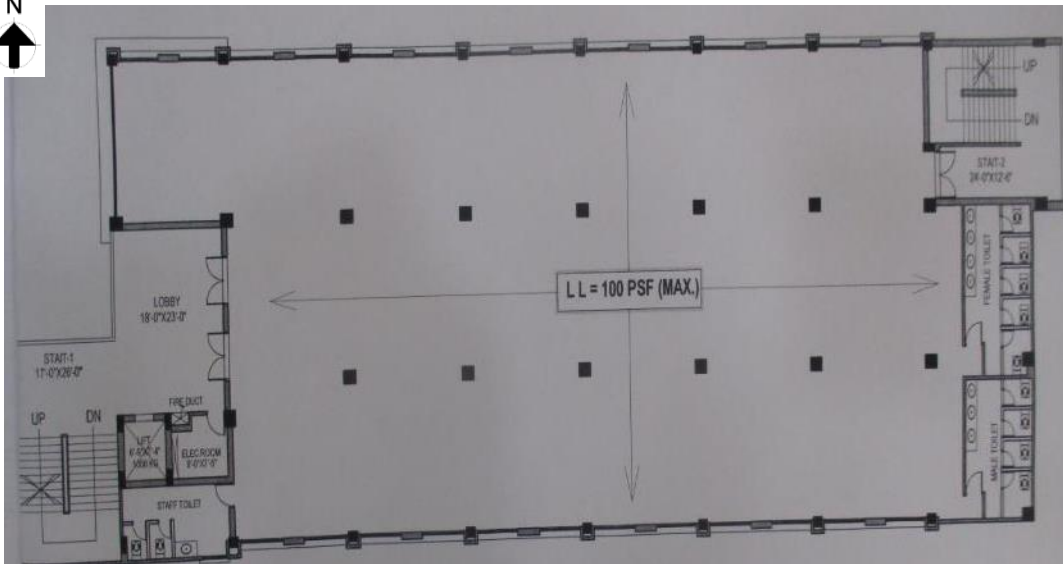
Prepared load plan required to be verified

Factory engineer prepared a load plan for 1st to 6th floor considering 4.8 kPa as allowable load. Factory is required to review the load plan as a part of engineering assessment if factory management intends to maintain the load plan.

Factory is required to maintain the floor live load 3 kPa until further verification by design engineer.

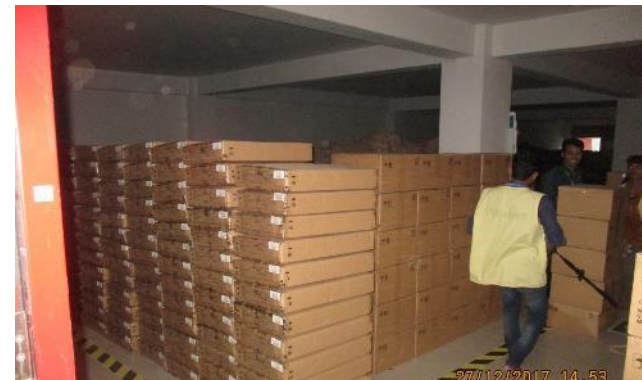
1st floor finishing goods storage area.

Load was measured below 2Kpa on every floor and FOS calculation for internal column was found satisfactory considering 3kPa allowable floor live loading.

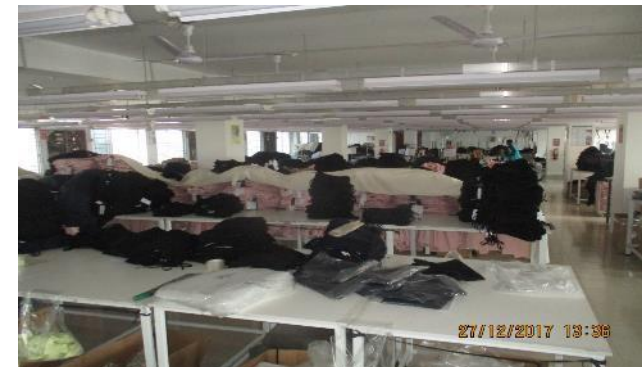
Cutting area

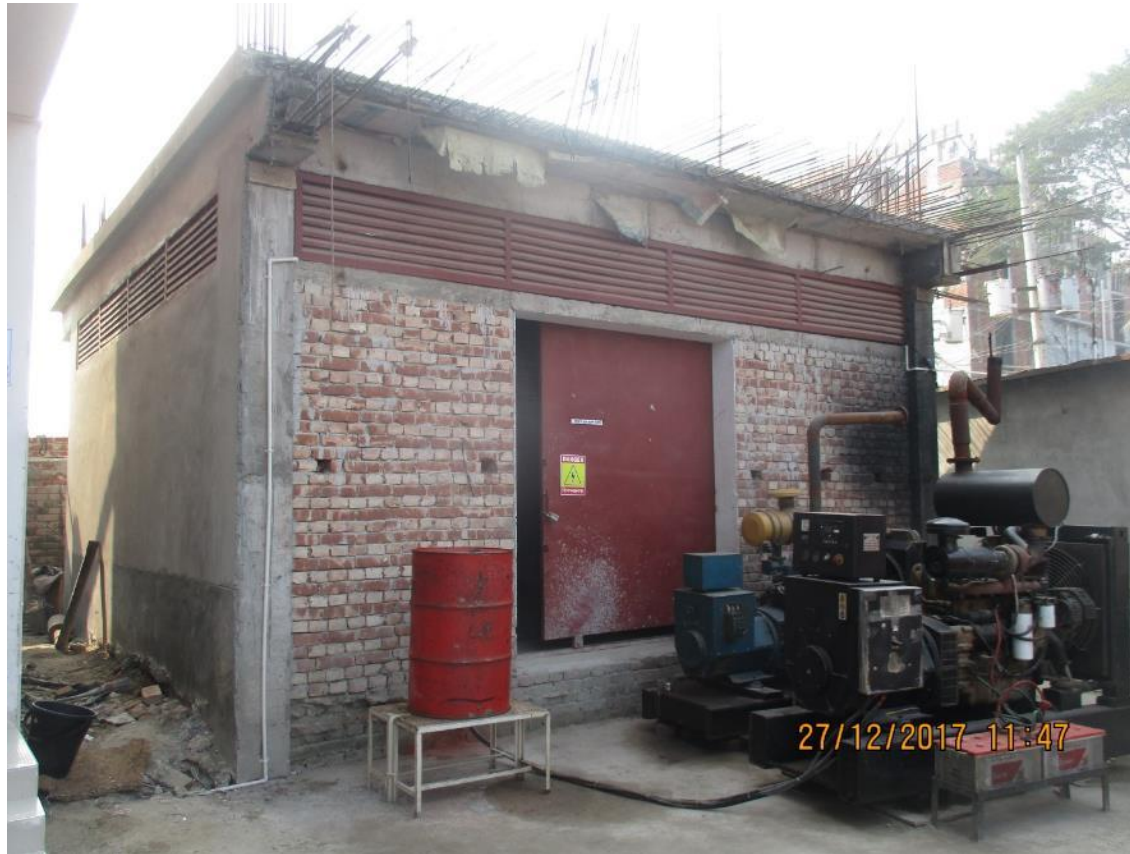
Lack of as-built documentation

Factory could not provide any drawing for the building. Factory Engineer is required to produce a full set of as built drawing reflecting on site condition for the building.

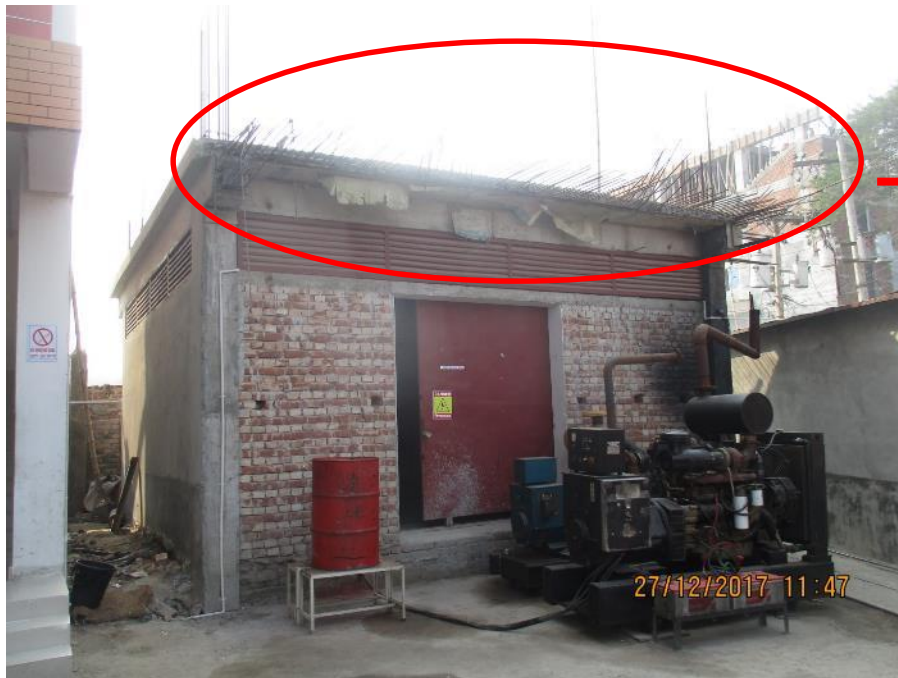
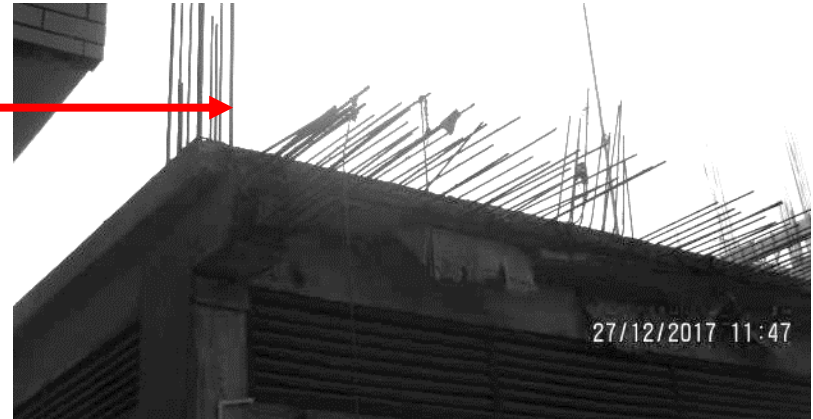
Corrosion on roof top exposed reinforcement

Corrosion was observed on almost all exposed reinforcement of column and slab. Factory is required to take proper remedial measures to protect rebars from corrosion.

13	(Sub-station Building) Corrosion on roof top exposed reinforcement	Factory engineer is required to take proper remedial measures to protect rebar from corrosion.	6-weeks
