# Space Sweater Ltd. (Jogitala)

Shi-145/1, Jogitola, Joydebpur, Gazipur  
(23.973670N, 90.405423E)  
2<sup>nd</sup> July 2018

# Observations

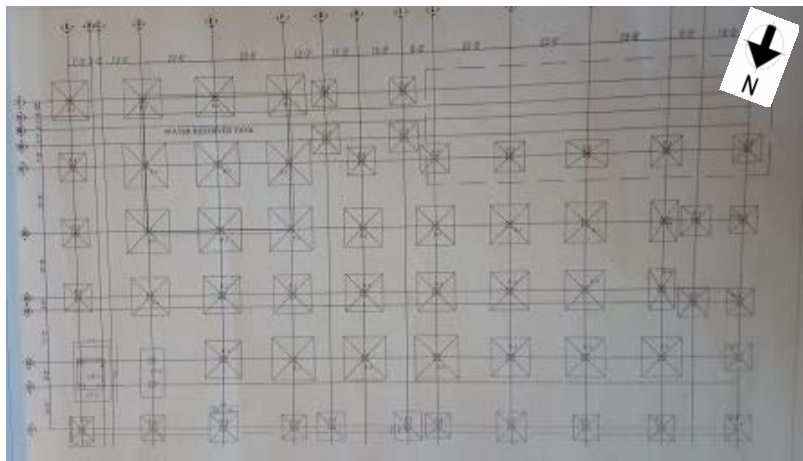
Foundation layout plan

**Foundation to be stressed above normal  
design limit**

Cursory calculation indicates that foundation appears to be stressed above normal design limits. Factor of safety (FoS) is less than the minimum requirement of BNBC. Factory engineer is required to review the adequacy of foundations considering actual depth and bearing capacity of footing and comply with BNBC.

| Item No. | Observation | Recommended Action Plan | Recommended Timeline |
|---|---|---|---|
| 1 | (Production Building)<br>Foundation to be stressed above normal design limit | Maintain 3kPa live load on typical floor and 2kPa on toilet zone. | 6-weeks |
| 2 | (Production Building)<br>Foundation to be stressed above normal design limit | Factory Engineer to review design, loads and footings stresses and a Detail Engineering Assessment to be completed. | 6-weeks |
| 3 | (Production Building)<br>Foundation to be stressed above normal design limit | Produce and actively manage a loading plan for all floor plates within the factory, giving consideration to floor, column and foundation capacity. | 6-weeks |
| 4 | (Production Building)<br>Foundation to be stressed above normal design limit | Complete implementation of remedial works deemed necessary by the review design. | 6-months |
| 5 | (Production Building)<br>Foundation to be stressed above normal design limit | Continue to implement loading plan. | 6-months |

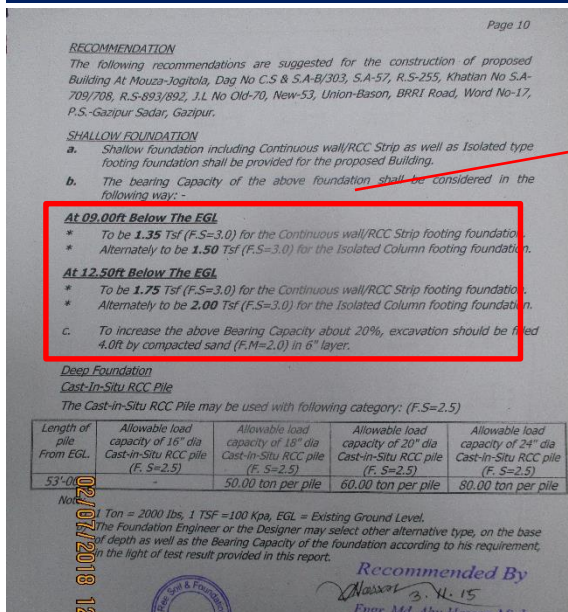
Recommendation of geotechnical investigation report

Recommended soil bearing capacity 1.5 Tsf for 9 ft. (2.74 m) depth, Considering FoS = 3

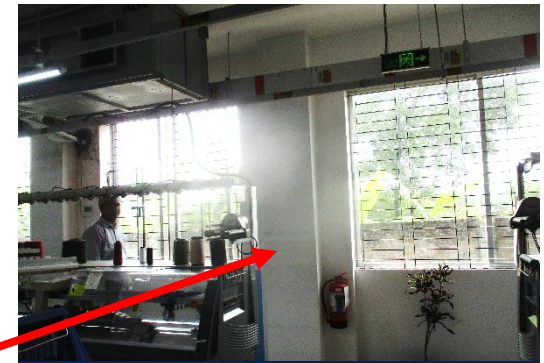
C-1 type column

Number of rebar for C-1 column does not match with column schedule. 12 nos. of rebar were found by ferro scan whereas 16 nos. of rebars are shown in column schedule.

| Item No. | Observation | Recommended Action Plan | Recommended Timeline |
|---|---|---|---|
| 6 | (Production Building)<br>Discrepancies between provided drawings and on site condition | Building Engineer to confirm the number of rebar in columns and prepare accurate as-built survey information for the building. | 6-weeks |

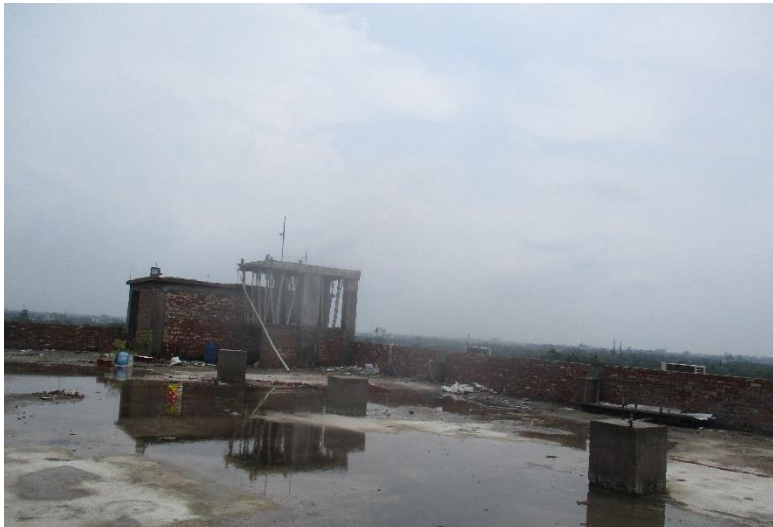
Stagnant water on roof

Water ponding was found at roof of the production building. Factory is required to improve water drainage system to avoid water clogging.

| Item No. | Observation | Recommended Action Plan | Recommended Timeline |
|---|---|---|---|
| 7 | (Production Building)<br>Water ponding on roof | Factory is required to provide water proofing layer and improve water drainage system to avoid water clogging. | 6-weeks |

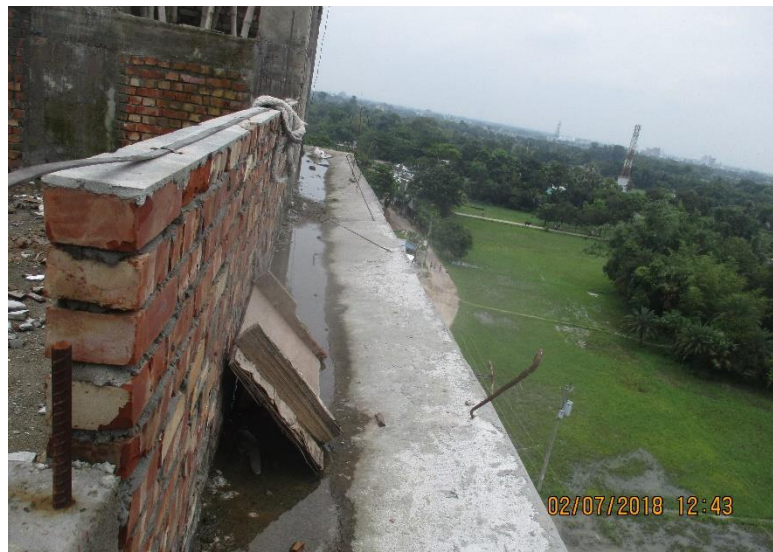
Improper Drainage

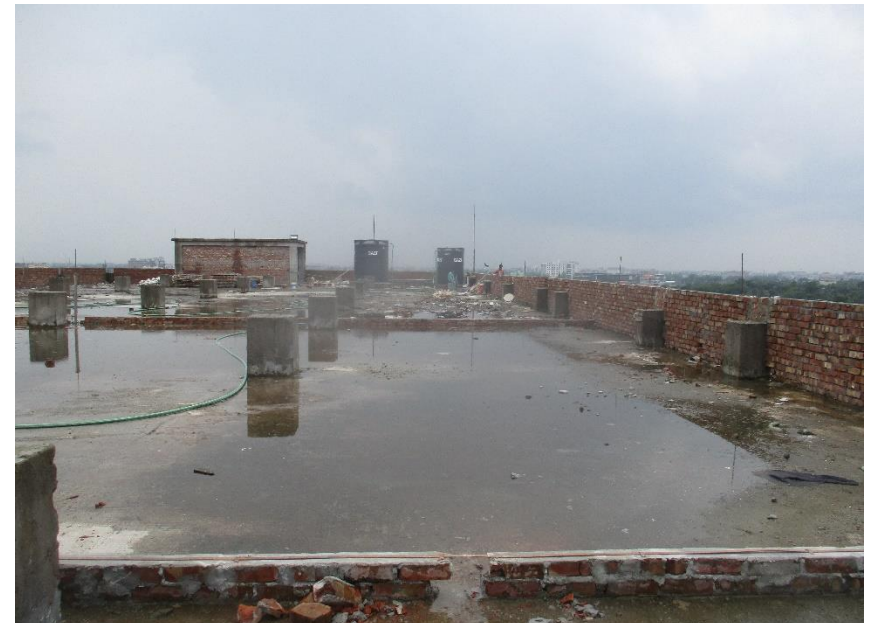
Stagnant water on roof

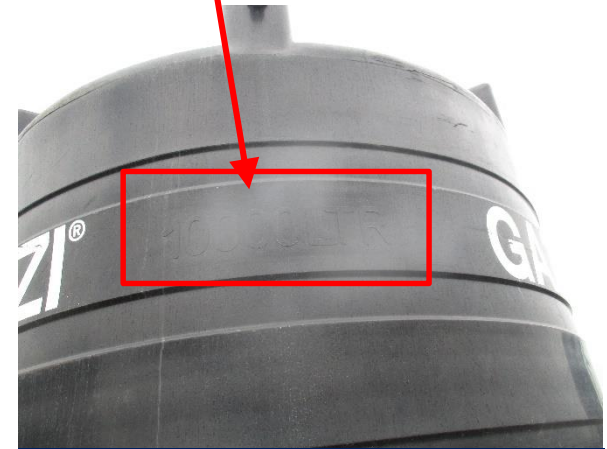
Having 10,000 liters capacity

Over head plastic water tank having 10,000 & 5000 liters capacity was found at west side of roof

| Item No. | Observation | Recommended Action Plan | Recommended Timeline |
|---|---|---|---|
| 8 | (Production Building)<br>Heavy water tank on roof | Verify that supporting structures have adequate capacity to support heavy loading such as (10,000 liters) plastic water tank. | 6-weeks |
| 9 | (Production Building)<br>Heavy water tank on roof | Remedial works to be carried out if required. | 6-months |

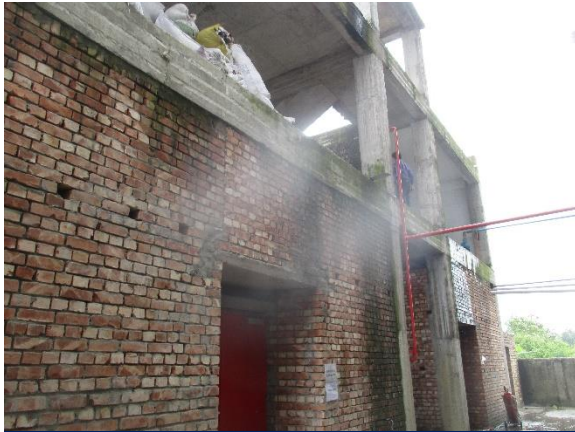
Utility Building

Structural drawings are not prepared for ancillary structures.

| Item No. | Observation | Recommended Action Plan | Recommended Timeline |
|---|---|---|---|
| 10 | (All ancillary buildings)<br>No structural drawings for ancillary buildings | Prepare an “as constructed” drawings which reflect the actual site dimensions with complete structural information. | 6-weeks |

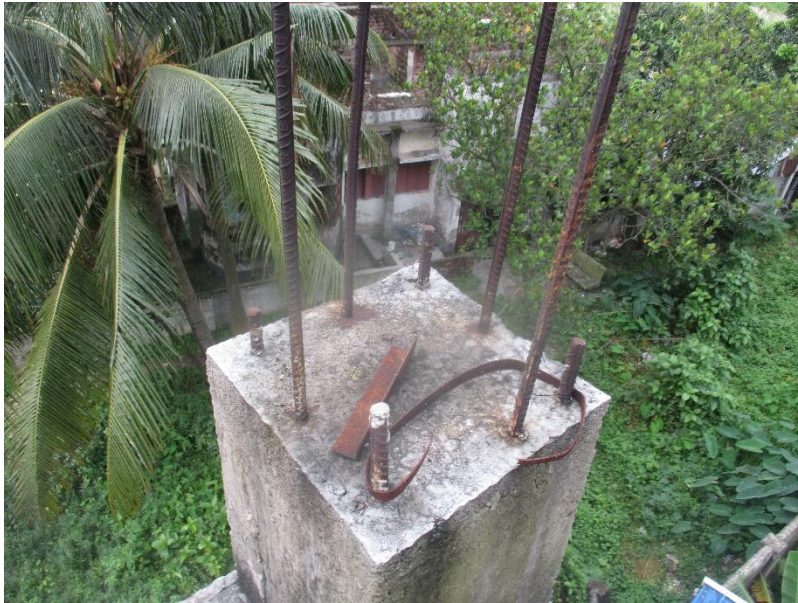
All exposed reinforcement must have adequate protection from the elements. Currently the exposed reinforcement is prone to corrosion. Also, falling hazards due to unprotected edge of under construction utility building.

Expose rebar

| Item No. | Observation | Recommended Action Plan | Recommended Timeline |
|---|---|---|---|
| 11 | (Utility Building)<br>Expose rebar and falling hazard risk at roof | All exposed reinforcement is to be protected from corrosion which may cause degradation of the concrete. | 6-weeks |

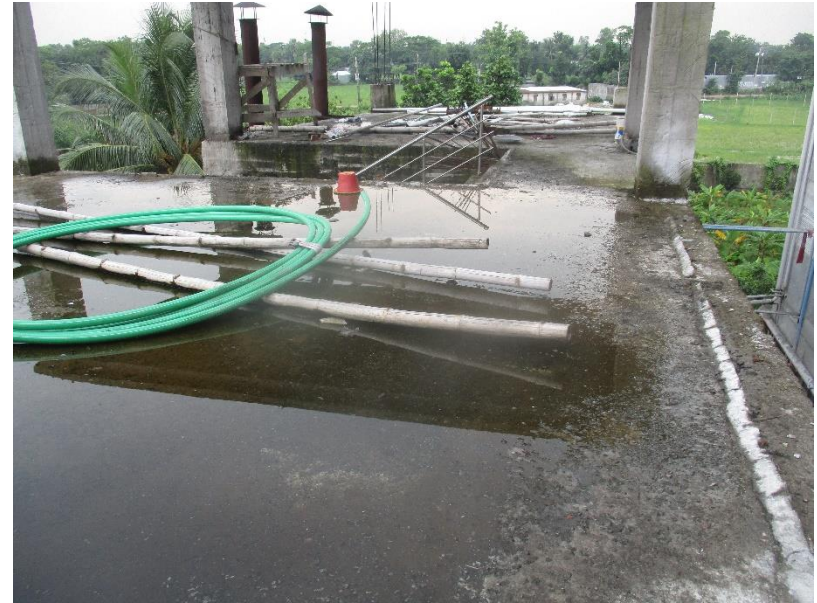
Unprotected edge

| Item No. | Observation | Recommended Action Plan | Recommended Timeline |
|---|---|---|---|
| 12 | (Utility Building)<br>Expose rebar and falling hazard risk at roof | Provide periphery railing/parapet wall to avoid possible falling hazard. | 6-weeks |

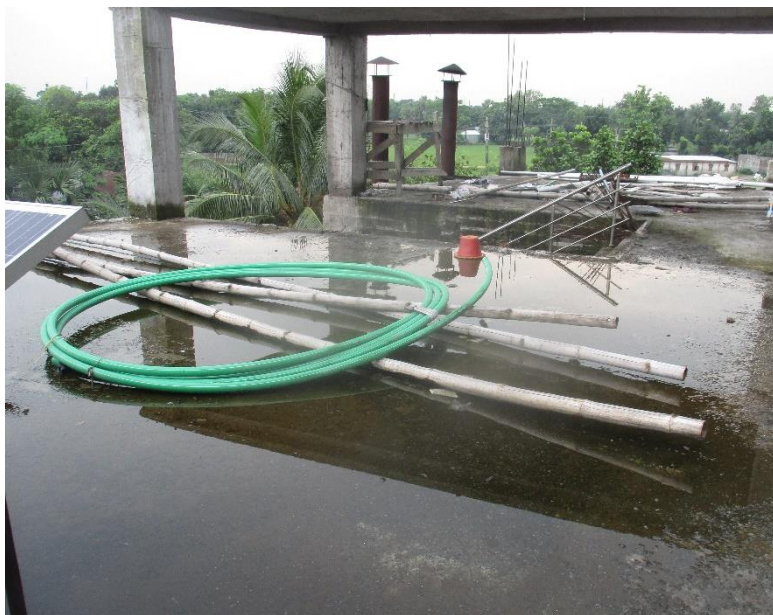
Water ponding was found at roof of the Utility building. Stagnant of water was seen during inspection. Factory is required to improve water drainage system to avoid water clogging.

Stagnant water on roof

| Item No. | Observation | Recommended Action Plan | Recommended Timeline |
|---|---|---|---|
| 13 | (Utility Building)<br>Lack of water proofing | Factory is required to provide water proofing layer and improve water drainage system to avoid water clogging. | 6-weeks |

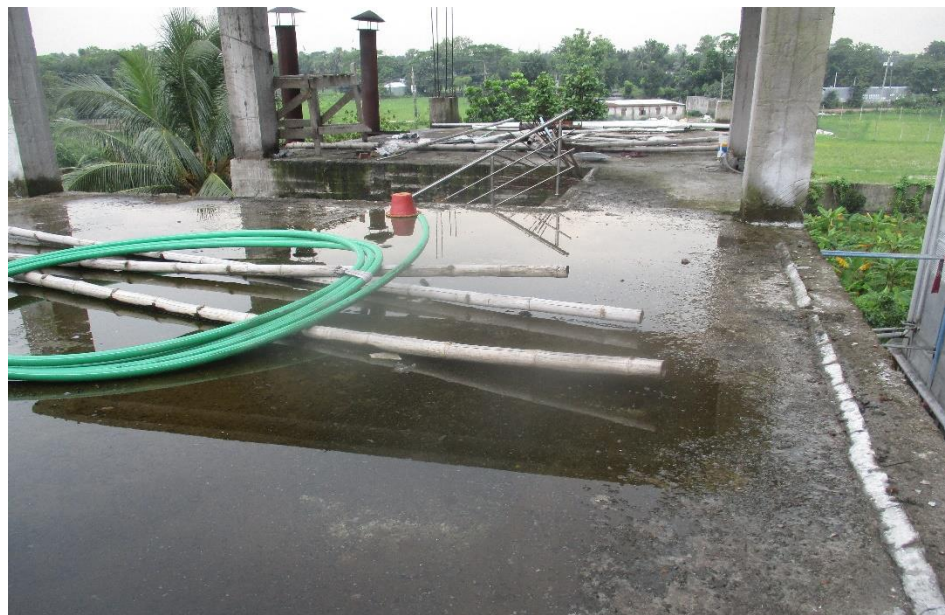
Stagnant water due to improper drainage system
