# Liberty Knitwear Ltd. Unit-2 (Extension)

G-88/1, Chandra, Pallibyddut, Kaliakoir, Gazipur.

27<sup>th</sup> May & 3<sup>rd</sup> June 2018

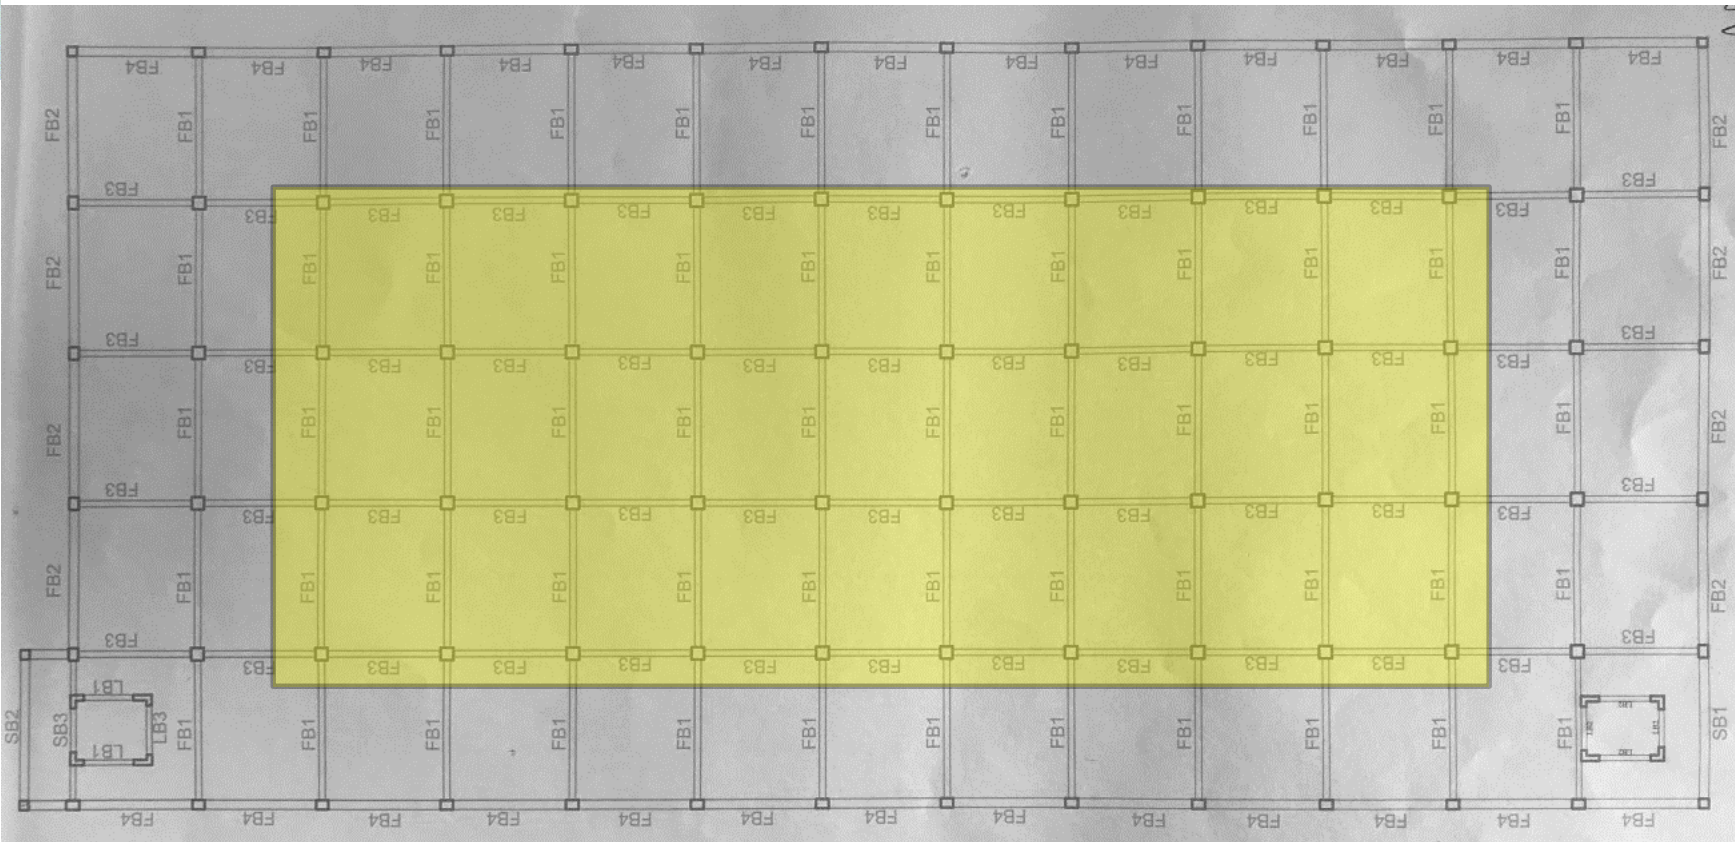
**Columns appeared to be stressed in excess  
of normal design limits**

Cursory calculation indicates that highlighted columns appear to be stressed above normal design limits due to large grid dimension and less reinforcement found from ferro scanning compared with that of column schedule. Factory engineer needs to check column stress and factory should take necessary action according to report.

| Item No. | Observation | Recommended Action Plan | Recommended Timeline |
|---|---|---|---|
| 1 | (Printing tower building)<br>Columns appeared to be stressed in excess of normal design limits | Factory Engineer to review design, loads and columns stresses in all columns. | 6-weeks |
| 2 | (Printing tower building)<br>Columns appeared to be stressed in excess of normal design limits | Verify in-situ concrete stresses by taking 100mm diameter cores from a minimum of 4 columns. Verify grade of steel reinforcement used. | 6-weeks |
| 3 | (Printing tower building)<br>Columns appeared to be stressed in excess of normal design limits | Produce and actively manage a loading plan for all floor plates within the factory giving consideration to floor capacity and column capacity. | 6-weeks |
| 4 | (Printing tower building)<br>Columns appeared to be stressed in excess of normal design limits | Make structural alterations as advised by Engineer. | 6-months |

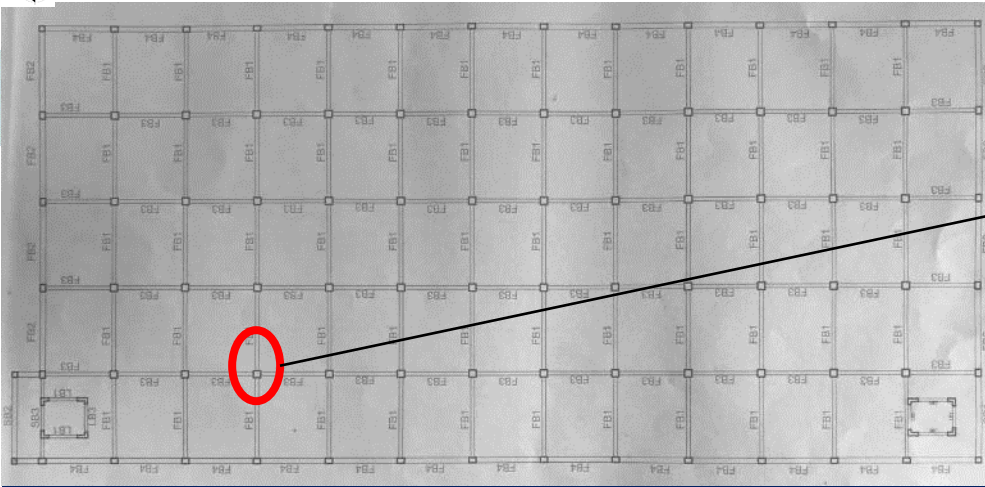
Typical internal grid dimension 7.3m x 6.1m

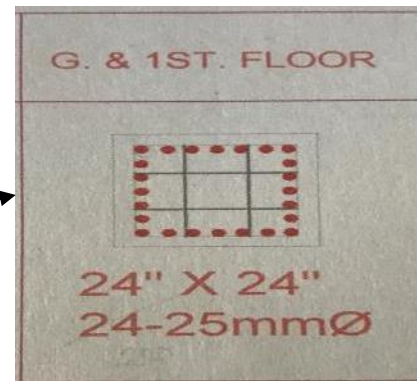
Column schedule of C-1 column for ground & 1<sup>st</sup> floor

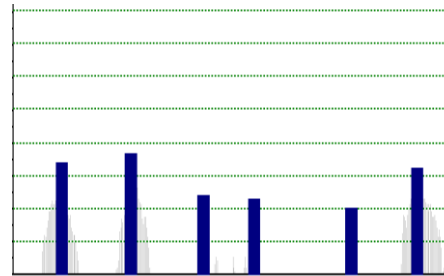
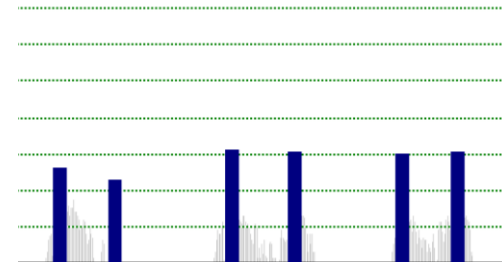
20nos. Rebars (6x6) were found in C-1 column

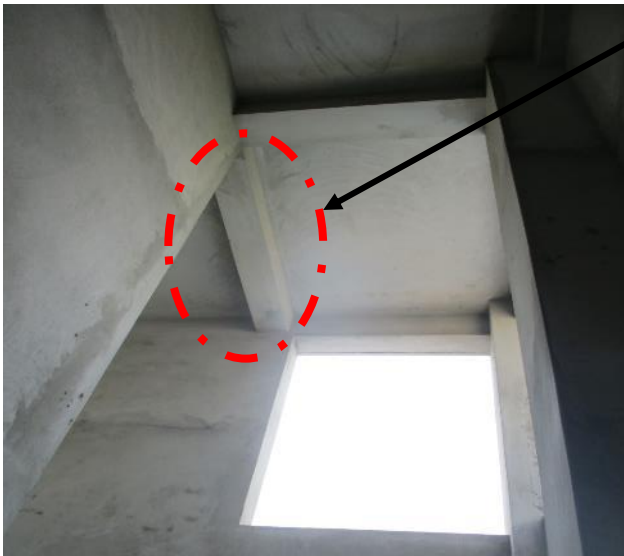
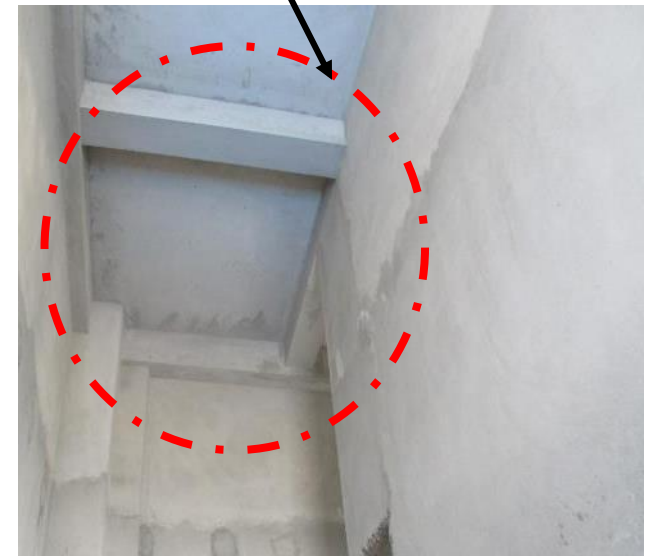
Some extra beams were found in the stair case in every floor which were not in as-build drawing.

| Item No. | Observation | Recommended Action Plan | Recommended Timeline |
|---|---|---|---|
| 6 | (Printing tower building)<br>Discrepancies between drawings and on-site observation | Factory engineer is required to survey the structural elements properly and produce correct as built drawings. | 6-weeks |

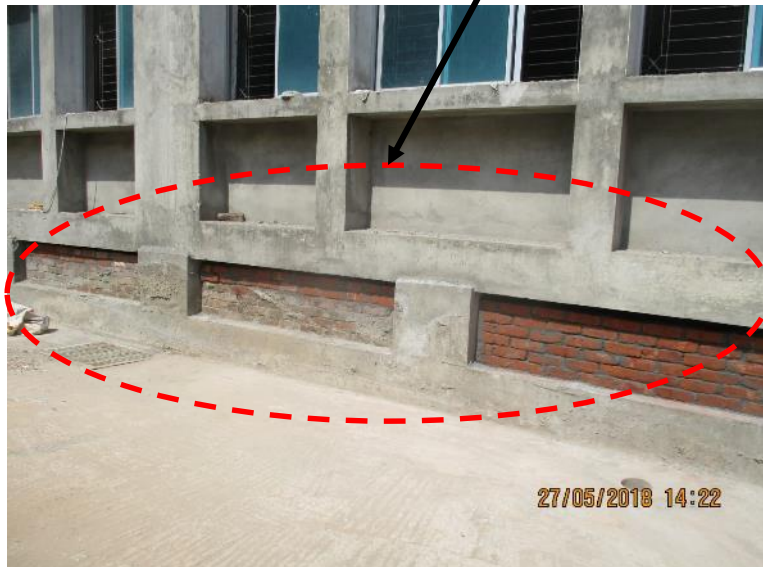
Inverted beam was found on west side

Inverted beams were observed on all side of the building at ground floor level. But in the as-built drawing's beam schedule, the beams were not shown as inverted beams. Factory is required to update the as-build drawing.

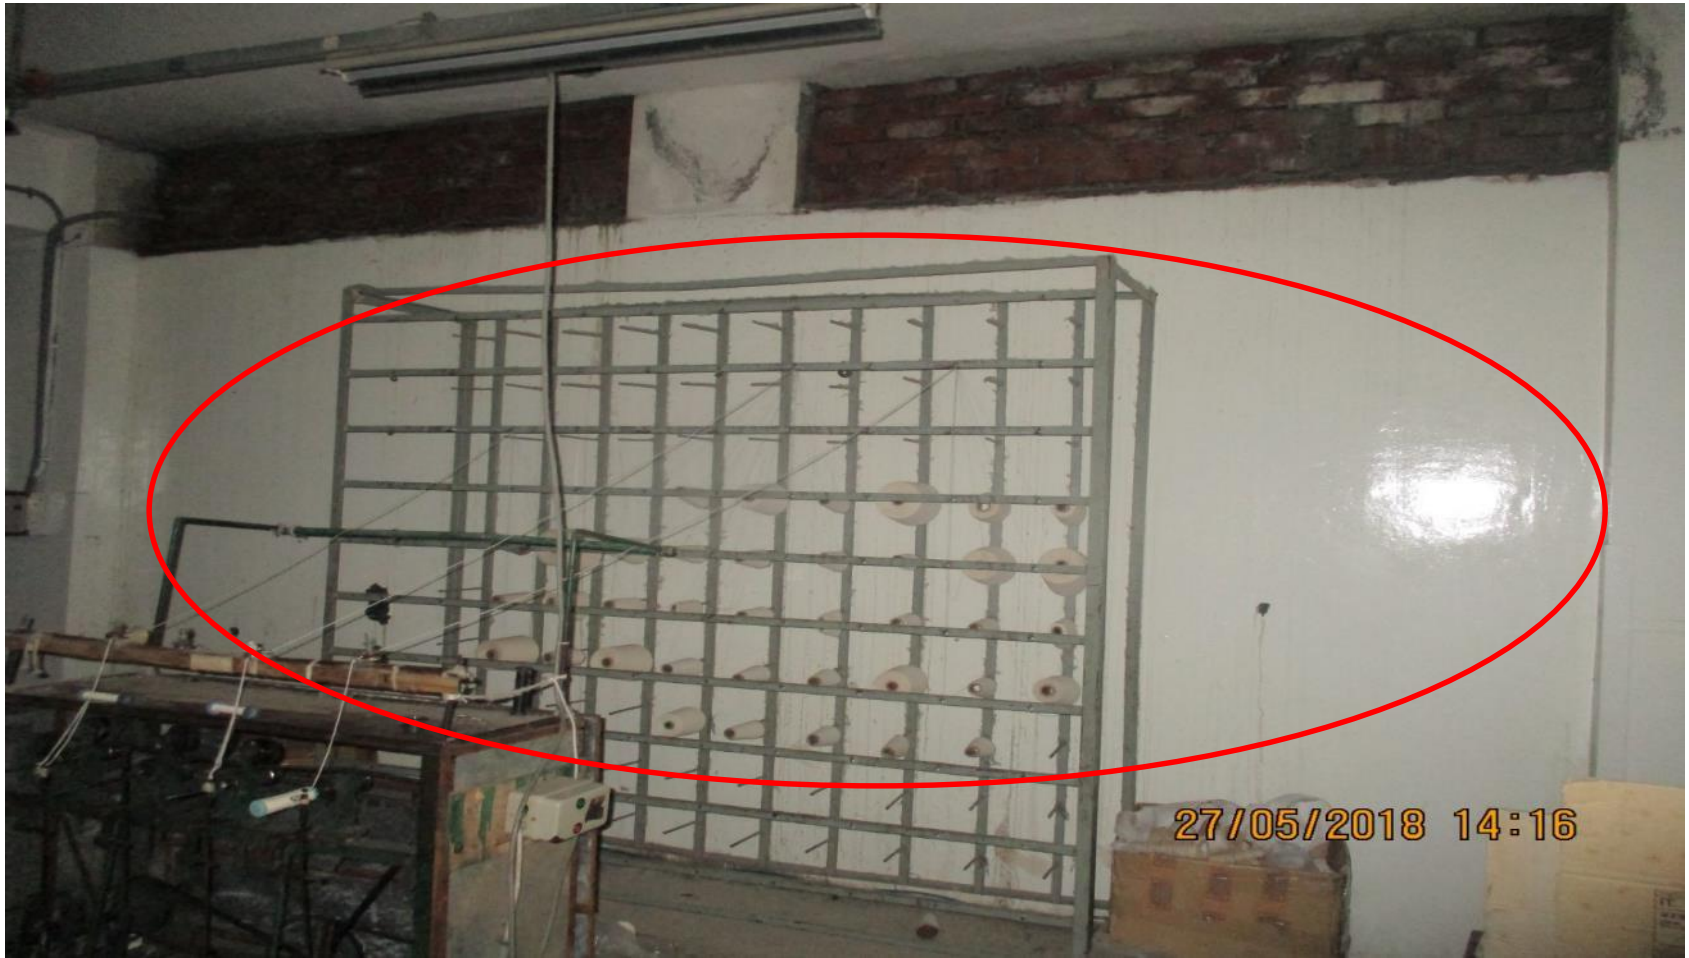
Dampness observed on several places in the basement wall. Factory Engineer is required to investigate the extent of dampness and suggest necessary remedial action.

| Item No. | Observation | Recommended Action Plan | Recommended Timeline |
|---|---|---|---|
| 7 | (Printing tower building)<br>Dampness observed on Basement Floor | Factory Engineer is required to investigate the extent of dampness and suggest proper remedial measures accordingly. | 6-weeks |
| 8 | (Printing tower building)<br>Dampness observed on Basement Floor | Carry out remedial works as per recommendation of investigation report. | 6-months |

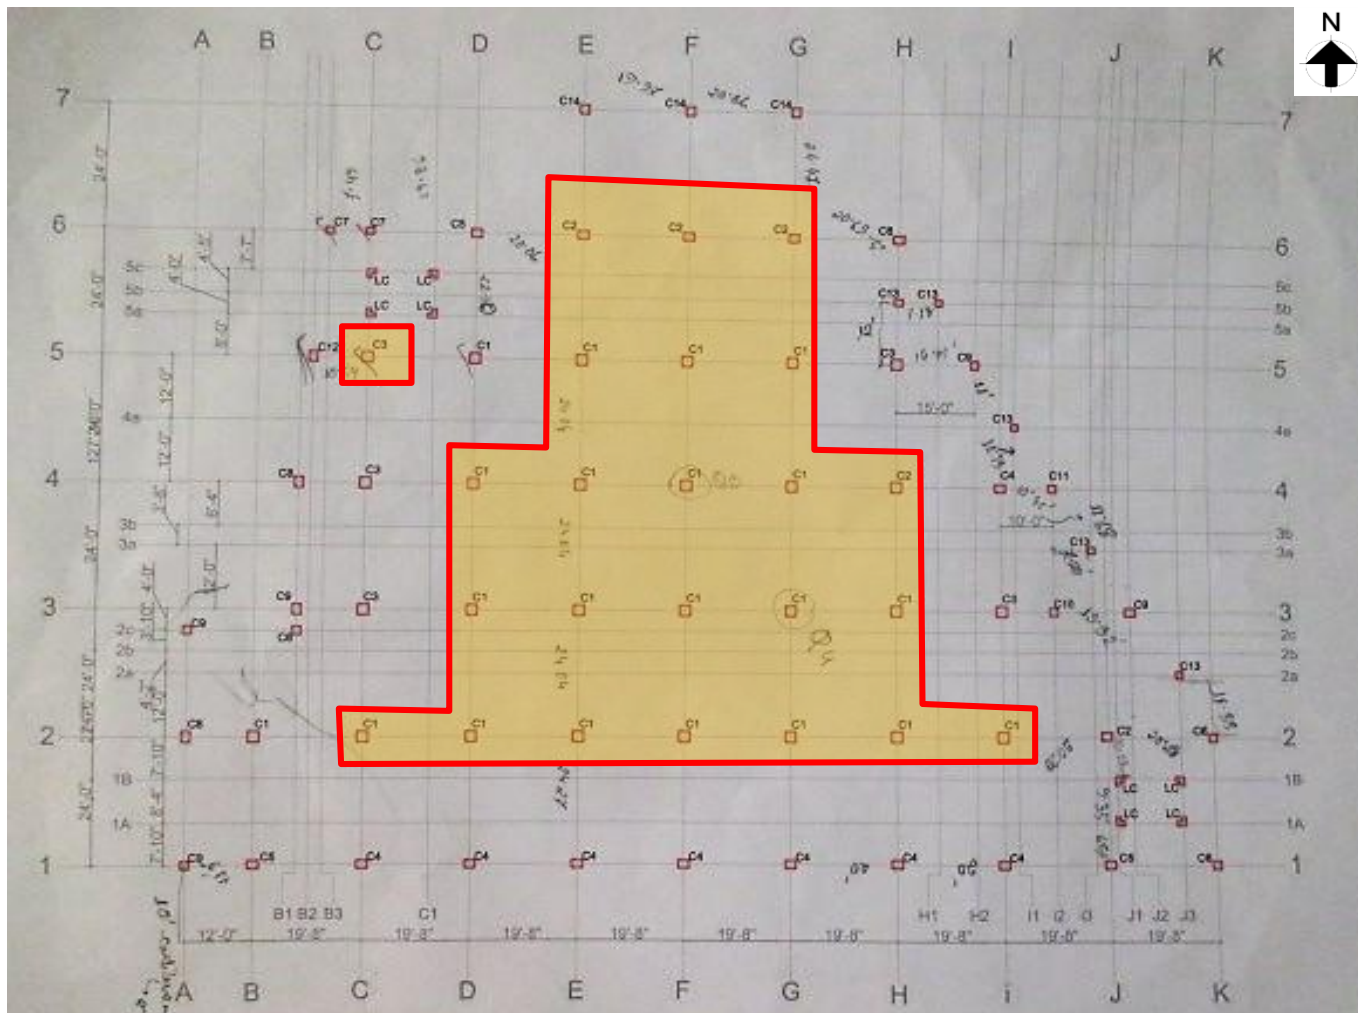
Cursory calculation indicates that highlighted columns appear to be stressed above normal design limits. Factory engineer needs to check column stress and a Detail Engineering Assessment (DEA) must be carried out and factory should take necessary action according to report.

| Item No. | Observation | Recommended Action Plan | Recommended Timeline |
|---|---|---|---|
| 9 | (New Admin Building)<br>Columns & foundations appear to be stressed in excess of normal design limits | Factory Engineer to review design, loads and stresses in all columns and foundations. | 6-weeks |
| 12 | (New Admin Building)<br>Columns & foundations appear to be stressed in excess of normal design limits | Detail Engineering Assessment to be completed. | 6-weeks |

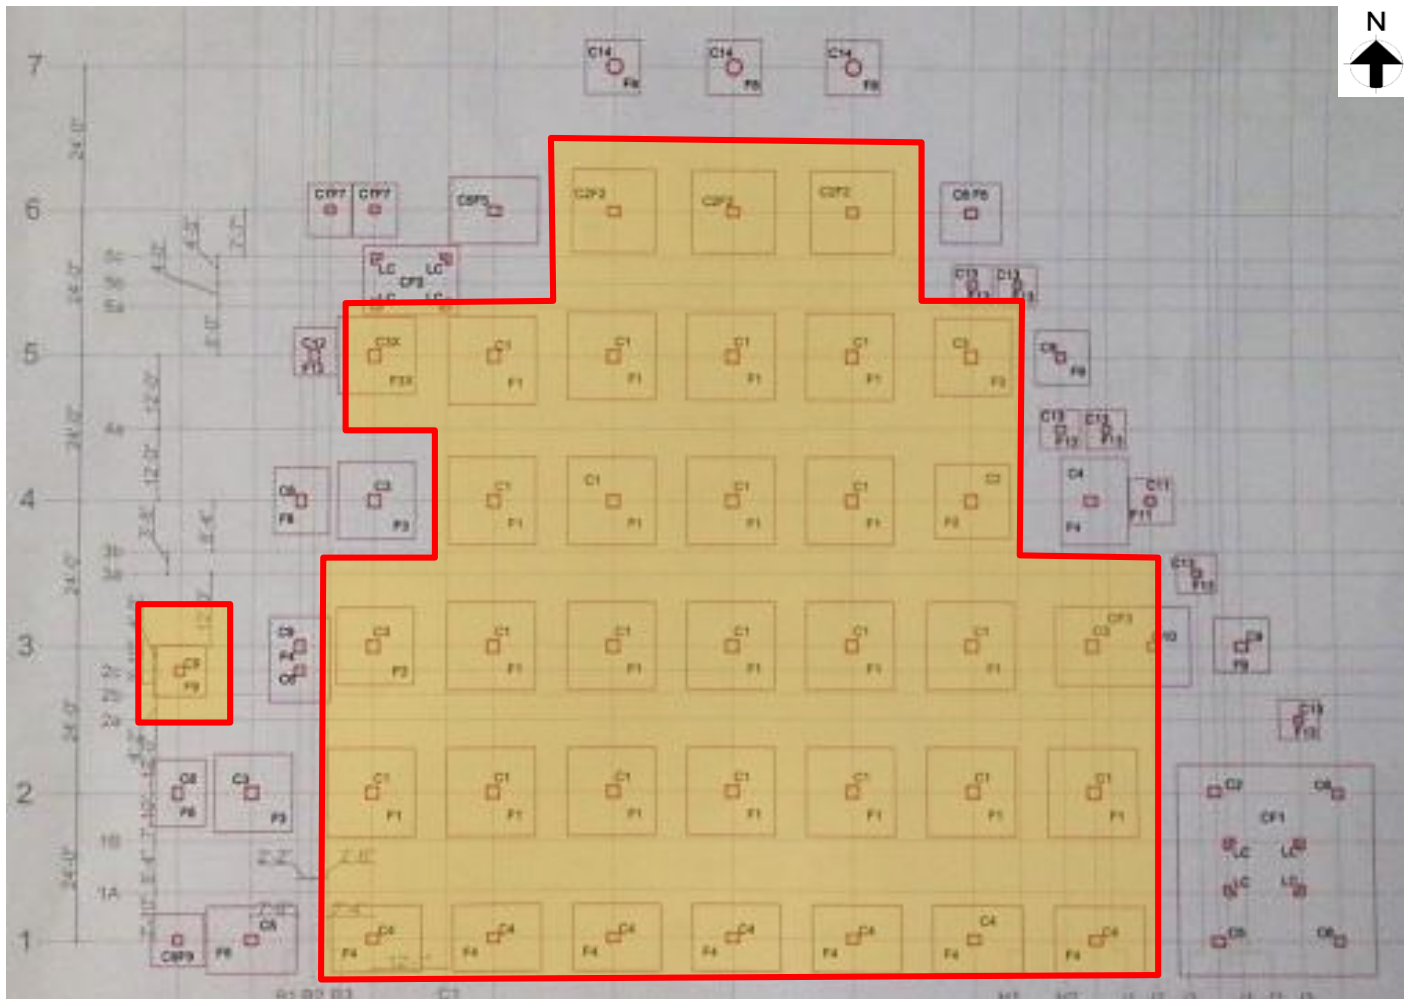
Cursory calculation indicates that highlighted foundations appear to be stressed above normal design limits. Factory engineer needs to check foundation stress and a Detail Engineering Assessment (DEA) must be carried out and factory should take necessary action according to report.

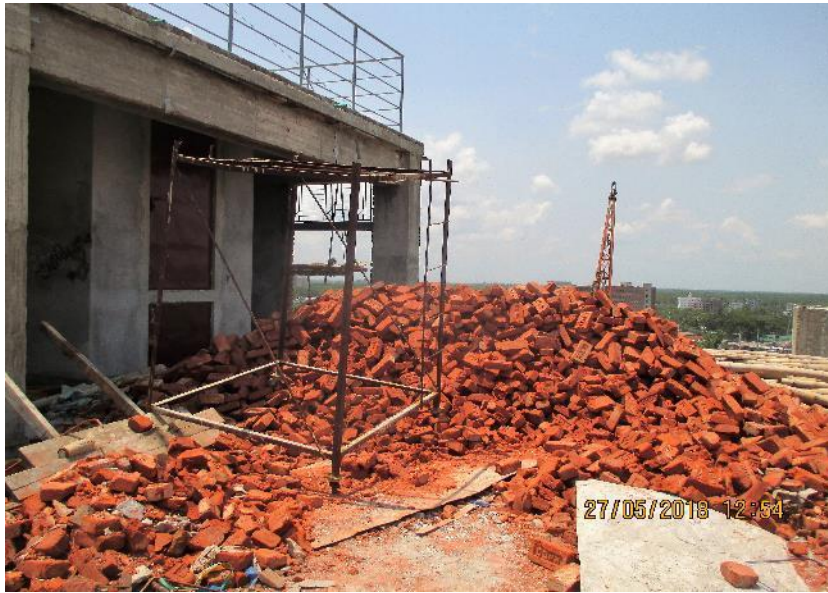
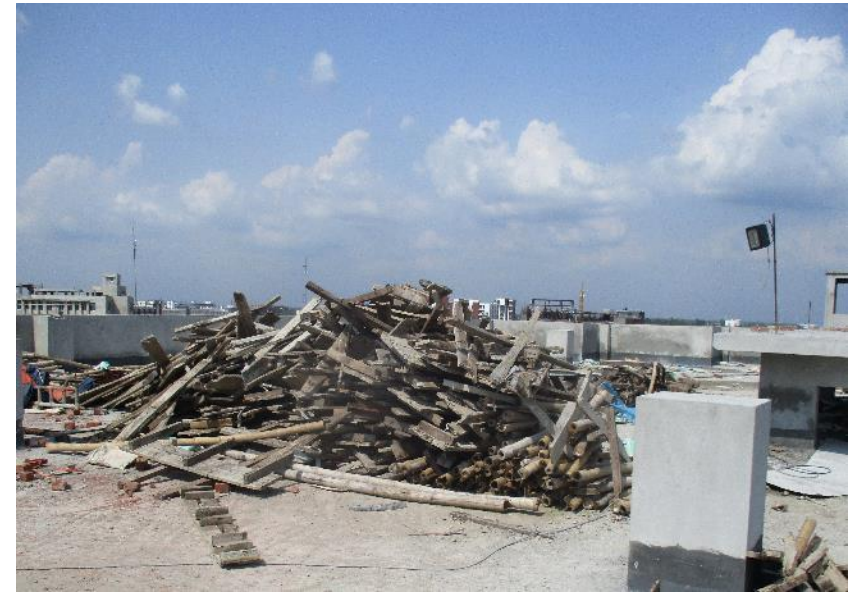
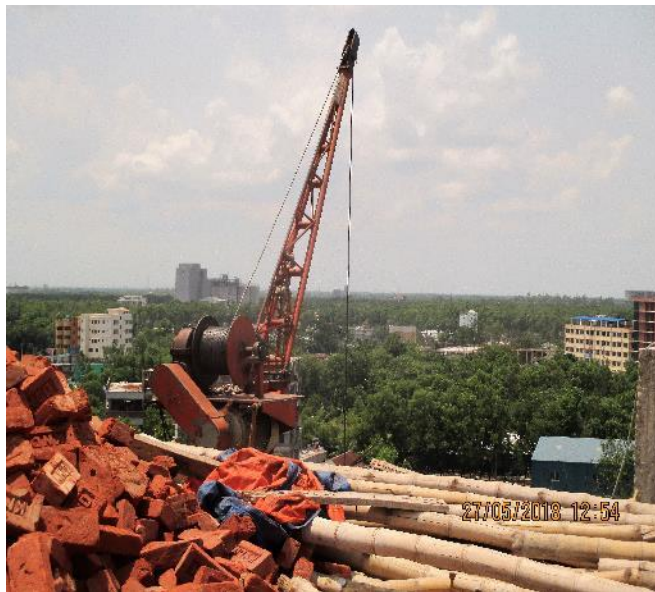
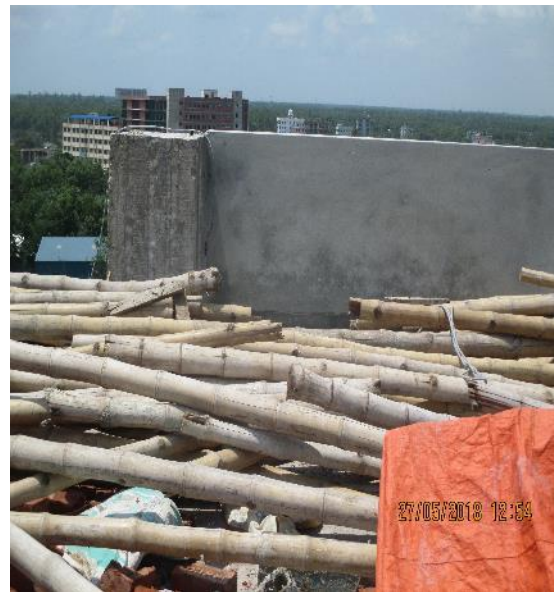
Construction debris and material piled up on current roof, which may exceed the design floor loading capacity. Building engineer is required to ensure that loading does not exceed the floor capacity.

| Item No. | Observation | Recommended Action Plan | Recommended Timeline |
|---|---|---|---|
| 15 | (New Admin Building)<br>Construction debris and materials piled up on roof, exceeding design loading for current roof. | Implement better control to prevent overloading of floors due to construction materials and derbies. | 6-weeks |

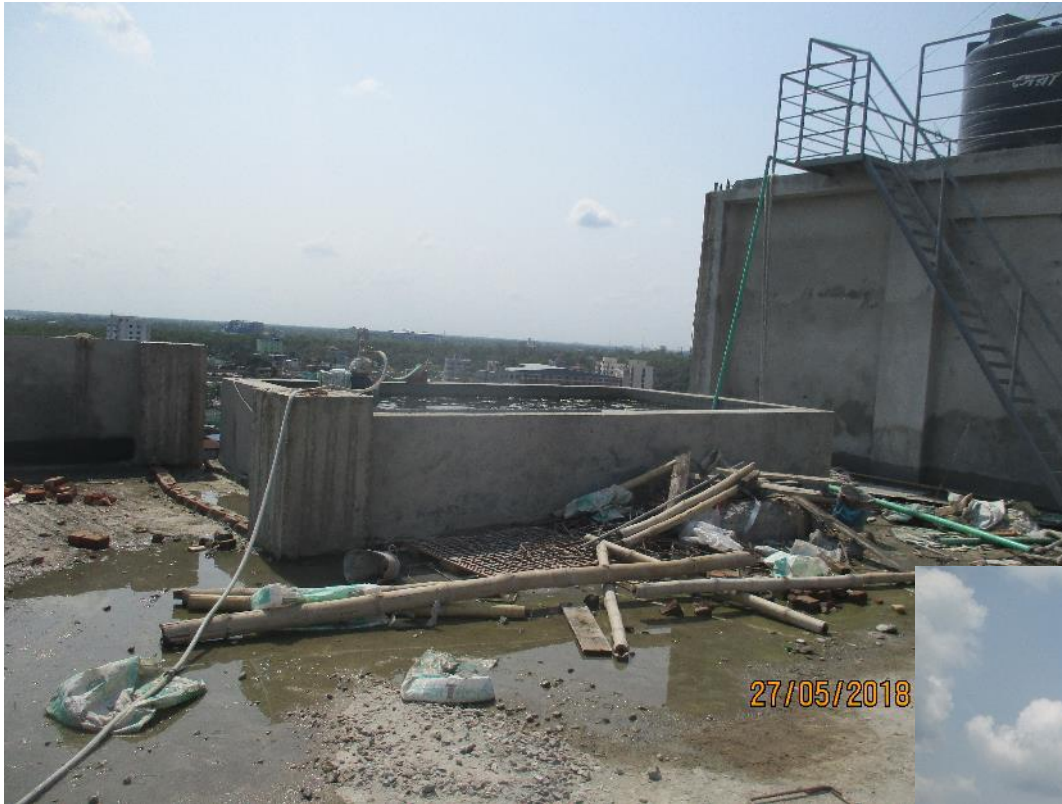
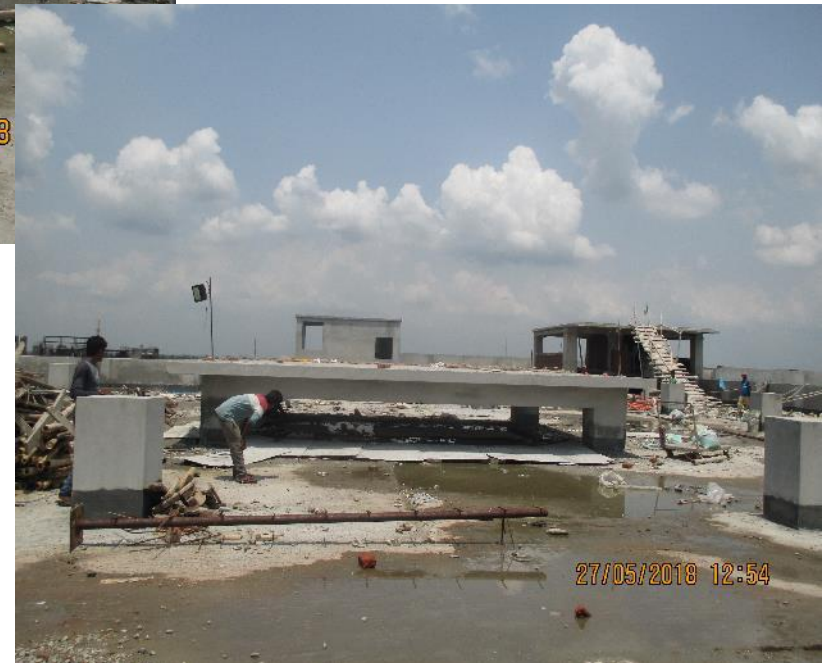
Water clogging was observed on roof top which indicates poor drainage system. Factory engineer is required to provide water proofing material with appropriate sloping and improve drainage system.

| Item No. | Observation | Recommended Action Plan | Recommended Timeline |
|---|---|---|---|
| 16 | (New Admin Building)<br>Water clogging and lack of drainage system on roof | Water proofing material with required sloping is to be applied on roof slab and drainage system to be improved. | 6-weeks |

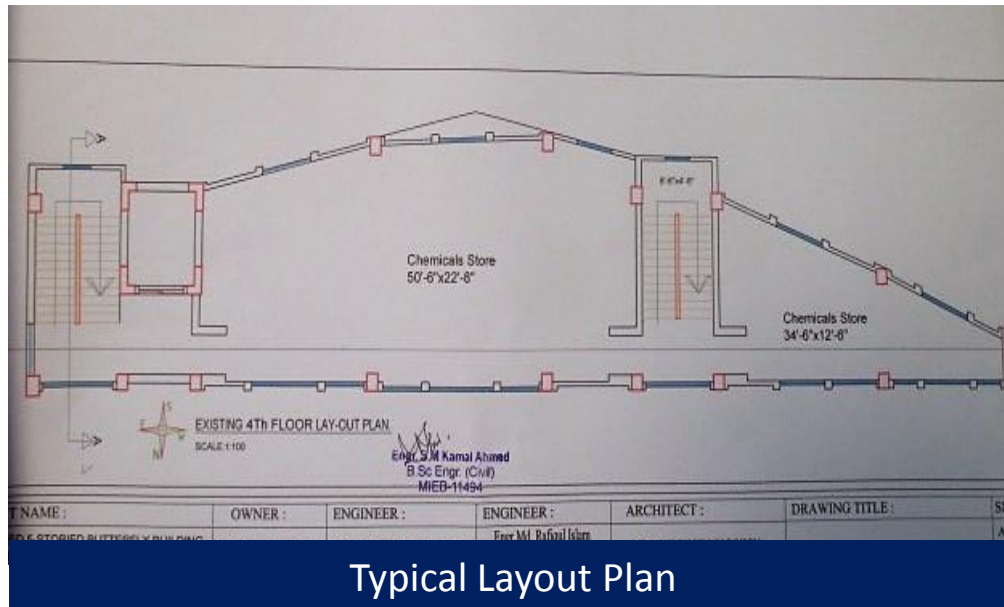
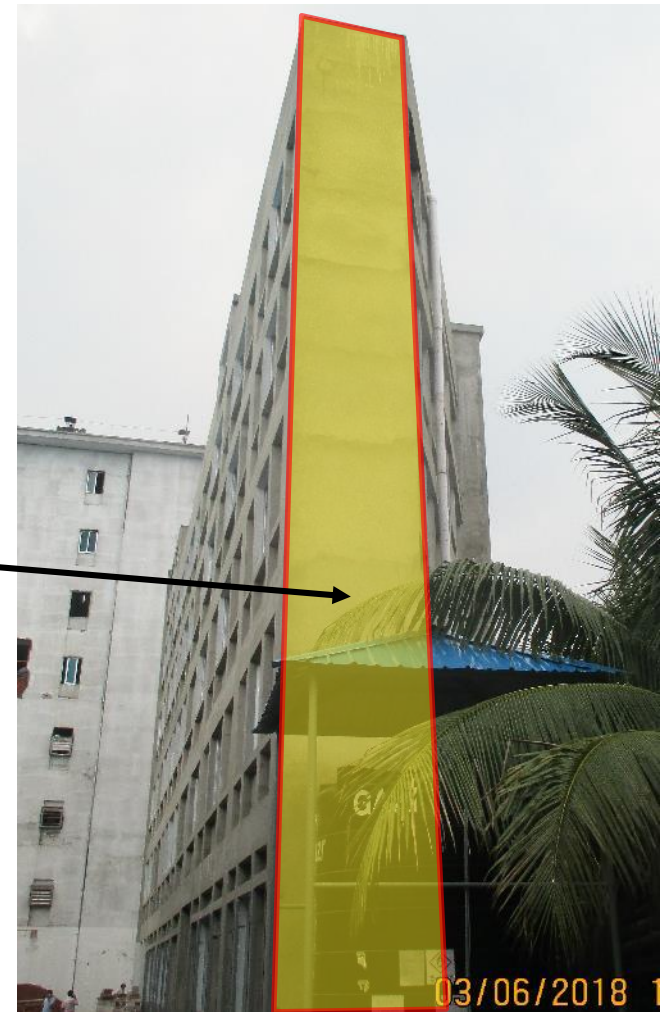
Factory engineer to check lateral stability of the building against lateral load combination for poor aspect ratio. The structural arrangement in tall slender building may result in net tension in structural element.

| Item No. | Observation | Recommended Action Plan | Recommended Timeline |
|---|---|---|---|
| 17 | (Butterfly Building)<br>Apparent lack of lateral stability | Factory engineer to check the stability of the structure under vertical and horizontal loads. | 6-weeks |
| 18 | (Butterfly Building)<br>Apparent lack of lateral stability | Carry out remedial works resulting from engineering assessment if necessary. | 6-months |

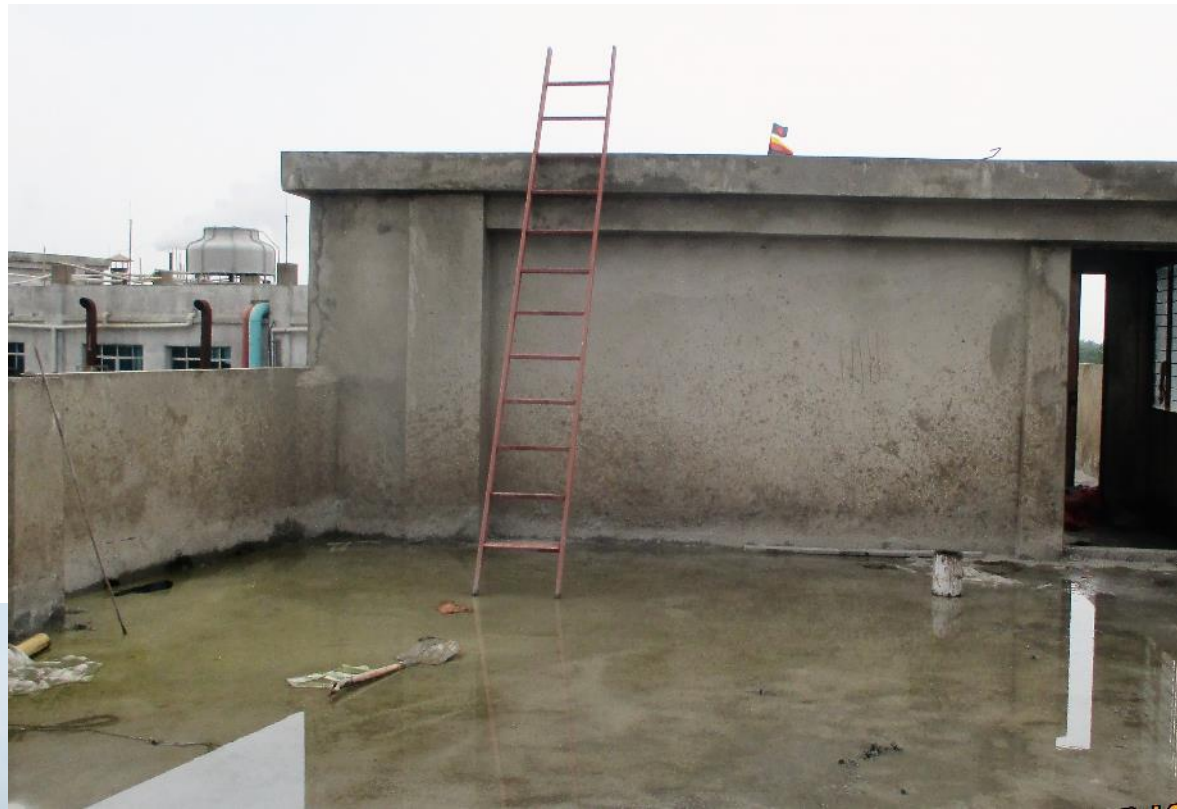
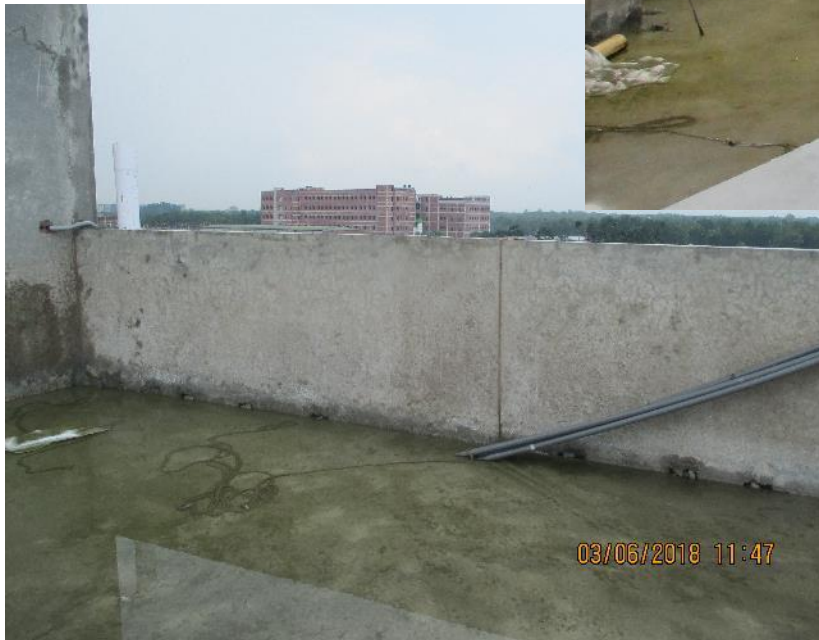
Water clogging was observed on roof top which indicates poor drainage system. Building engineer is required to provide water proofing material on the roof top with appropriate sloping and improve drainage system to prevent water ponding.

| Item No. | Observation | Recommended Action Plan | Recommended Timeline |
|---|---|---|---|
| 19 | (Butterfly Building)<br>Water clogging and lack of drainage system on roof | Water proofing with required slope is to be applied on roof slab and drainage system to be improved. | 6-weeks |

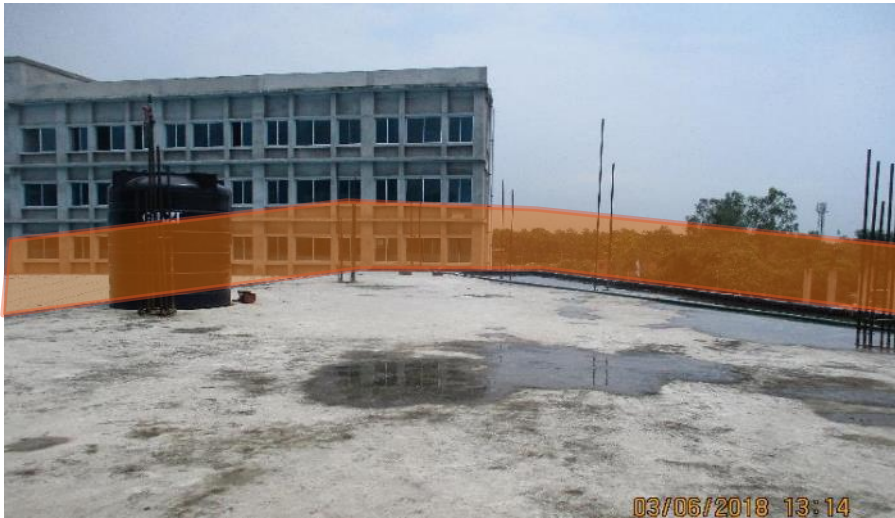
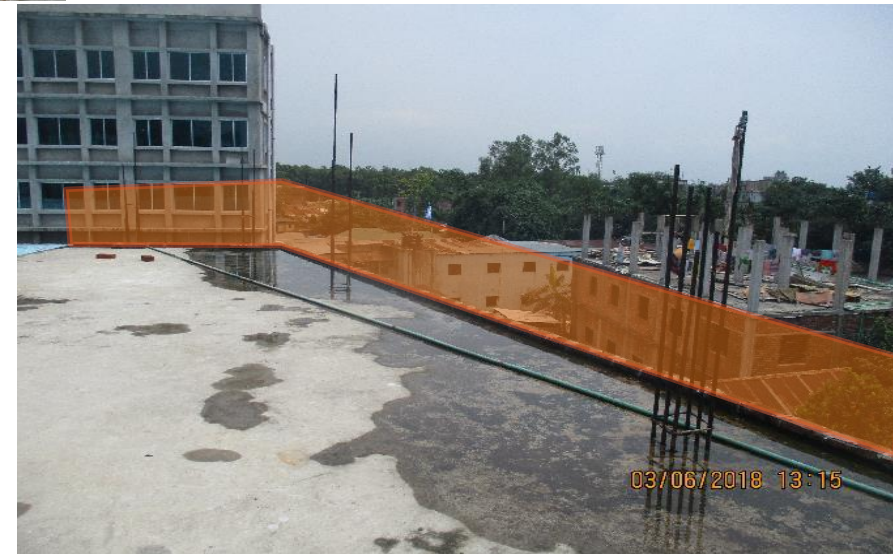
No edge protection was observed against falling hazard. Necessary protection to be provided to prevent falling hazard from roof top.

| Item No. | Observation | Recommended Action Plan | Recommended Timeline |
|---|---|---|---|
| 20 | (Watch Tower Building)<br>Falling hazard on roof top | Secure the appointed areas of hazards and provide an appropriate fall protection. | 6-weeks |

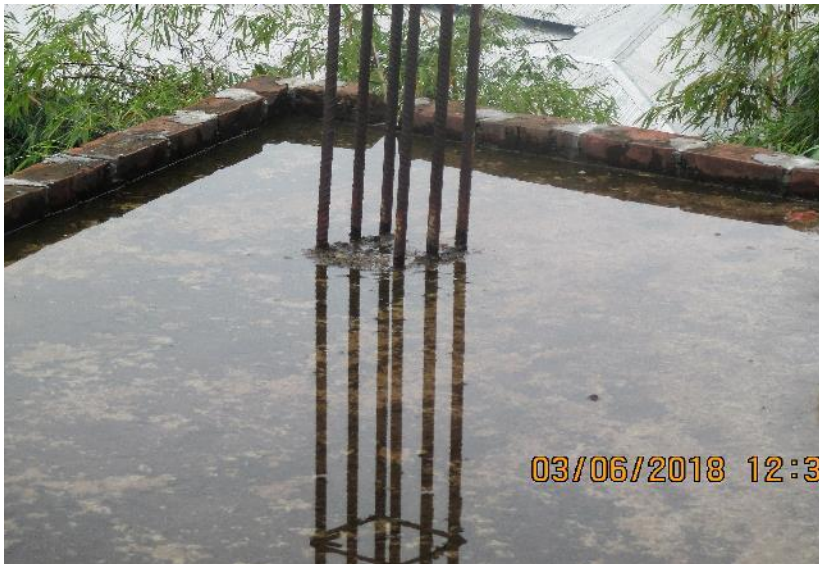
Water clogging on roof top

Water clogging was observed on the roof top which indicates absence of drainage system. Moreover, corrosion was observed on exposed rebar on roof top. Drainage system to be improved. Also, exposed rebars are to be protected from corrosion.

| Item No. | Observation | Recommended Action Plan | Recommended Timeline |
|---|---|---|---|
| 22 | (Watch Tower Building)<br>Corrosion observed on exposed rebar and lack of drainage system on roof | Factory engineer required to improve the water drainage system and provide water proofing layer for preventing the water clogging and dampness of roof slab. | 6-weeks |

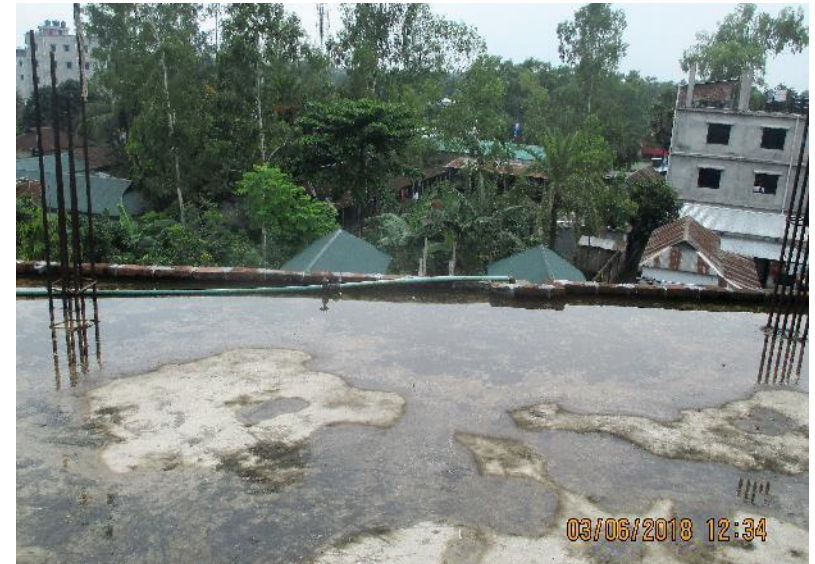
No obvious drainage system was observed

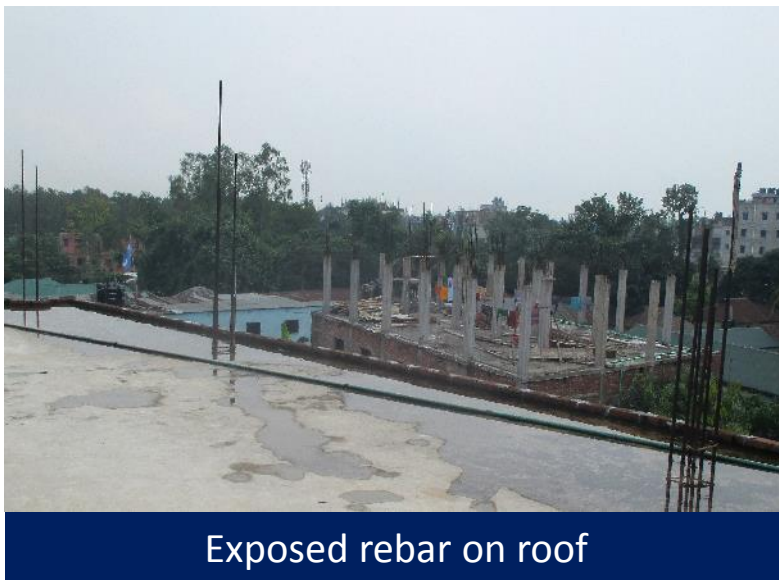
Exposed rebar on roof

| Item No. | Observation | Recommended Action Plan | Recommended Timeline |
|---|---|---|---|
| 21 | (Watch Tower Building)<br>Corrosion observed on exposed rebar and lack of drainage system on roof | Factory engineer to suggest and implement proper remedial measures to protect steel from corrosion. | 6-weeks |

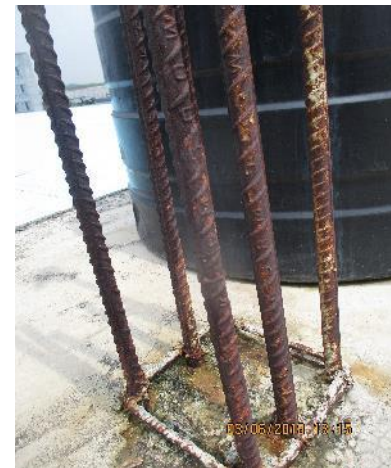
Corrosion observed on exposed rebar

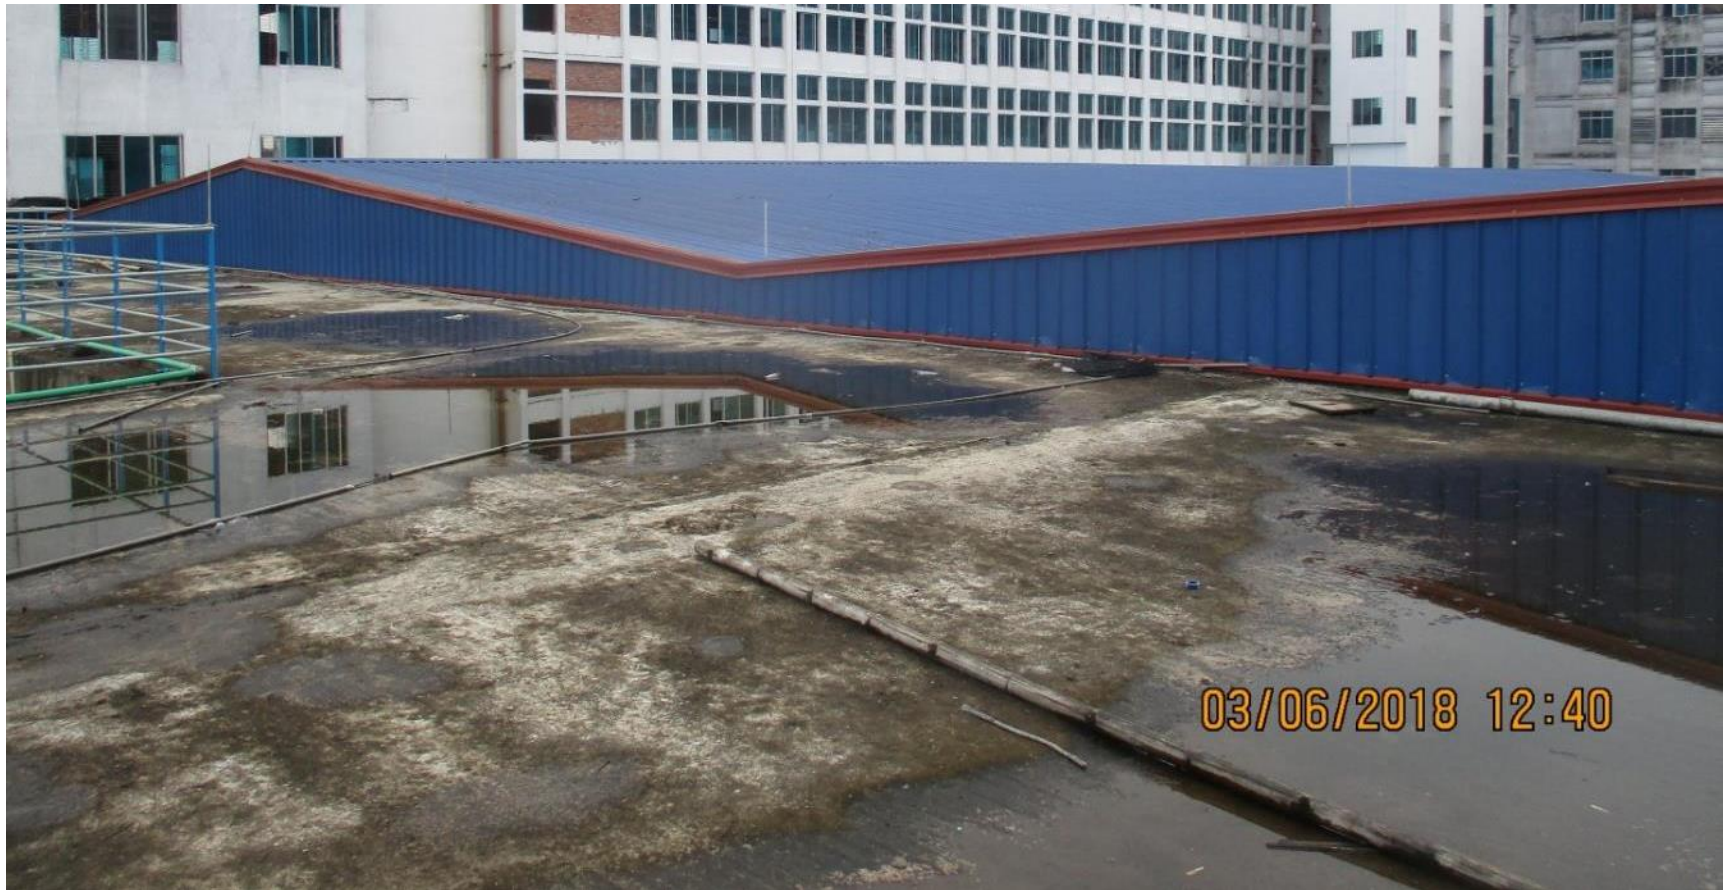
During inspection, water clogging was observed on roof top at several areas. Factory is required to improve the water drainage system and provide water proofing with necessary slope for preventing the water clogging as well as dampness in concrete roof slab.

| Item No. | Observation | Recommended Action Plan | Recommended Timeline |
|---|---|---|---|
| 23 | (Knitting building)<br>Water clogging on roof top | Factory engineer is required to improve the water drainage system and provide water proofing layer with proper sloping to prevent the water clogging and dampness of roof slab. | 6-weeks |
