Muazuddin Textile Limited (New Unit)

235/236 East Chandura, Shafipur, P.S. Kaliakore, Gazipur
(24.034397N,90.271276E)
21st May 2018

Observations: Production Building (New Unit)

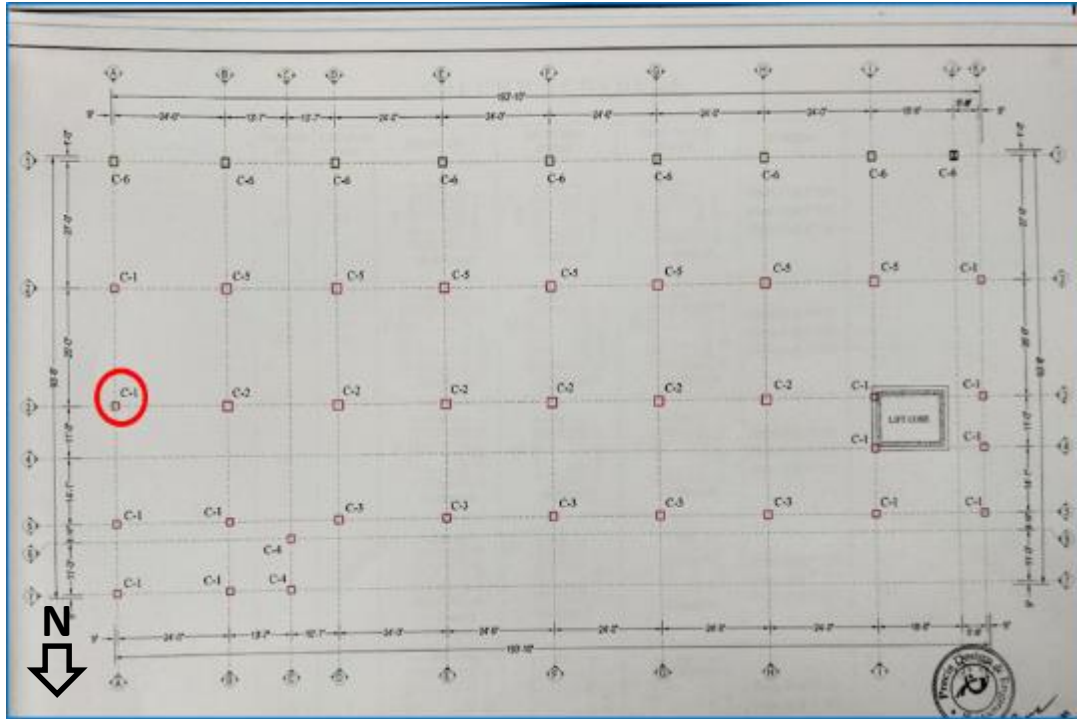
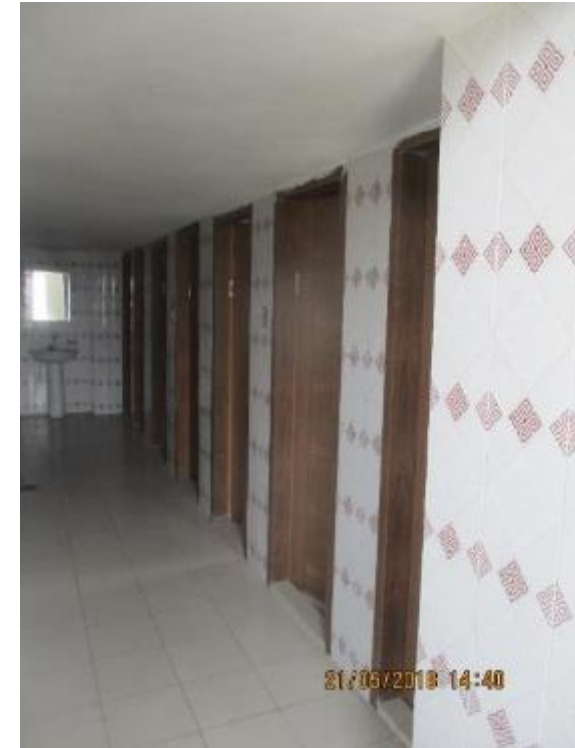
Column Layout

**Columns appeared to be stressed above
normal design limit**

Cursory calculation indicates that highlighted column appear to be stressed above normal design limit due to brick wall & build-up of toilet area. Factory engineer need to check column stress and should take necessary action according to report.

Item No.	Observation	Recommended Action Plan	Recommended Timeline
1	Production building (New Unit) Columns appeared to be stressed above normal design limit	Maintain live load below 3kPa on every floor.	Immediate - Now
2	Production building (New Unit) Columns appeared to be stressed above normal design limit	Factory Engineer to review design, loads and columns stresses in all columns.	6-weeks
3	Production building (New Unit) Columns appeared to be stressed above normal design limit	Verify in-situ concrete stresses by taking 100mm diameter cores from a minimum of 4 columns. Verify grade of steel reinforcement used.	6-weeks
4	Production building (New Unit) Columns appeared to be stressed above normal design limit	Produce and actively manage a loading plan for all floor plates within the factory giving consideration to floor capacity and column capacity.	6-weeks
5	Production building (New Unit) Columns appeared to be stressed above normal design limit	Implement required remediations as per assessment report.	6-months

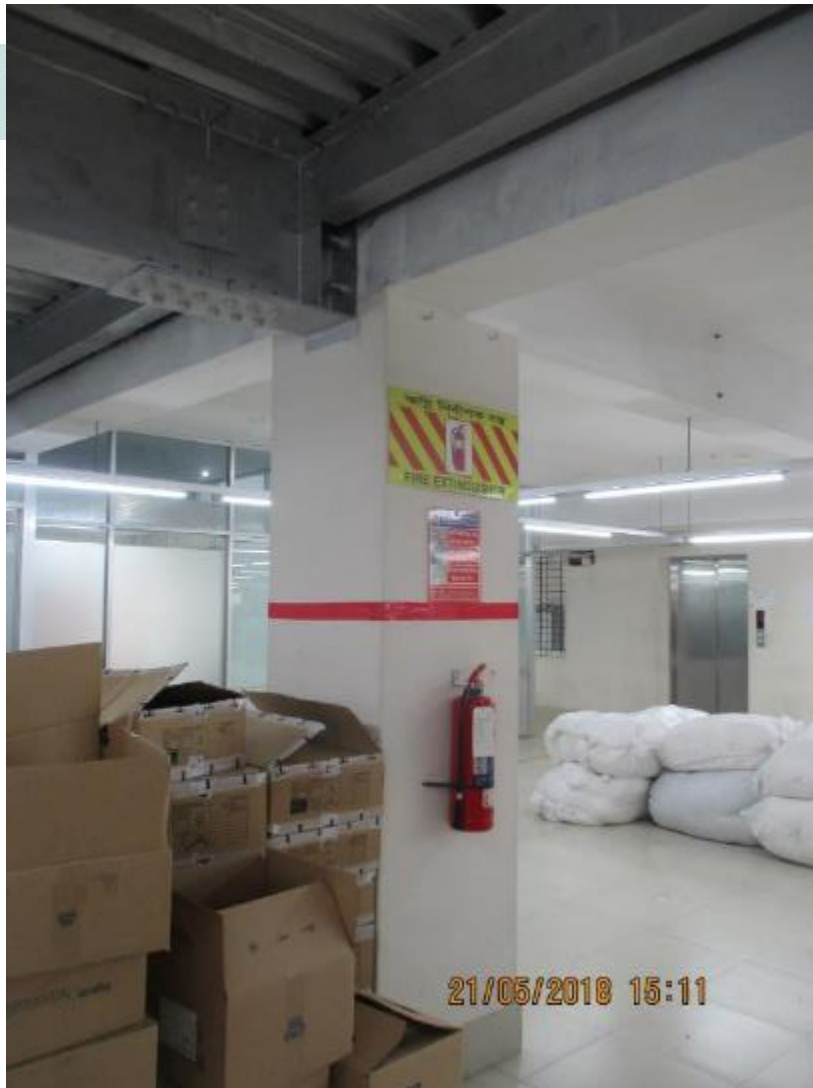
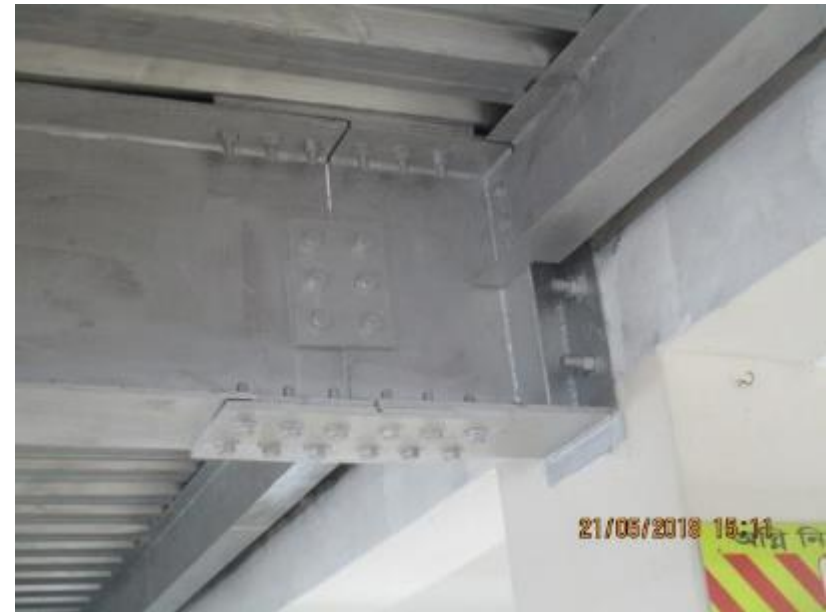
Bolted connection between RC column and steel beam

Connection between steel and reinforced part is required to be evaluated

Steel part is found connected by bolt with RC part. The factory is required to engage an engineer to evaluate the connection between two part.

Item No.	Observation	Recommended Action Plan	Recommended Timeline
7	Production building (New Unit) Connection between steel part and reinforced concrete part is required to be evaluated	Factory engineer is required to evaluate the connection between steel part and reinforced concrete part.	6-weeks
8	Production building (New Unit) Connection between steel part and reinforced concrete part is required to be evaluated	Carry out remedial works resulting if necessary.	6-months
9	Production building (New Unit) Discrepancies between drawings and on-site observation	Factory engineer to survey the whole building and produce as-built documentation reflecting the as constructed condition.	6-weeks
10	Production building (New Unit) Missing information in provided drawing	Incorporate the missing information in revised the as-built drawings.	6-weeks

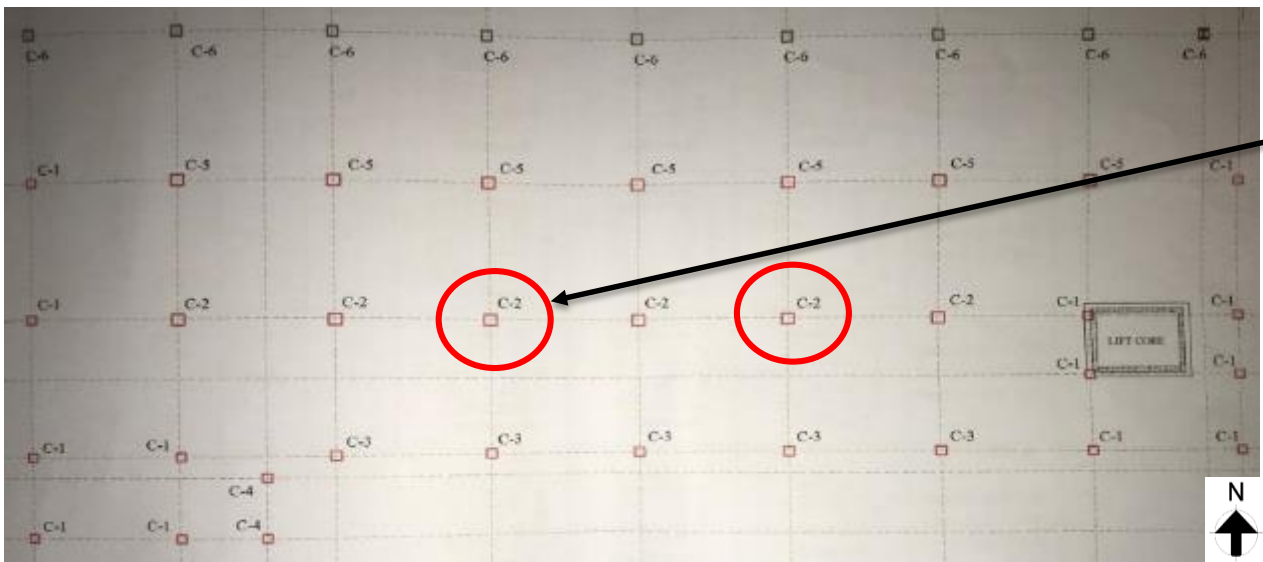
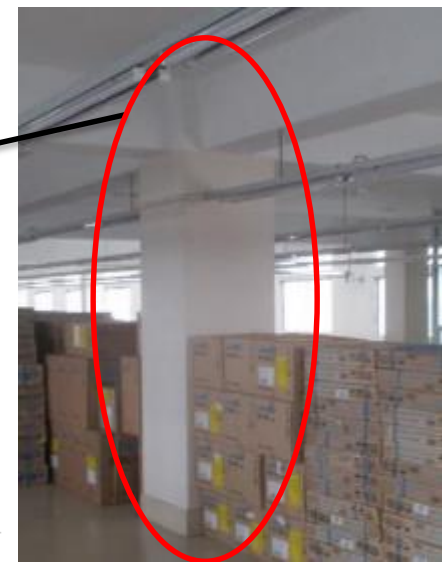
Column Layout Plan

Discrepancies between drawings and on-site observation

22 number of rebars were shown on the drawing in C-2 type column but during inspection 18 number of rebars were found by ferro scanning in 1st floor.

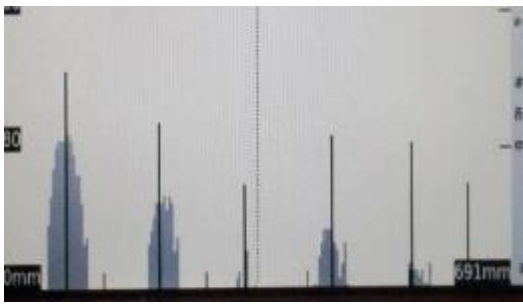
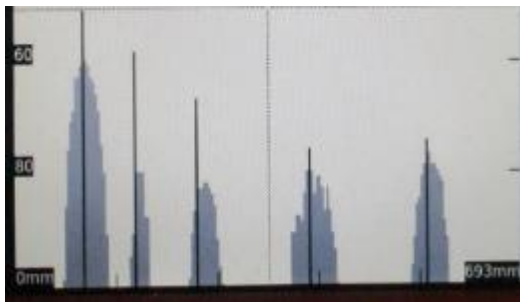
18 number of rebars were found by ferro scanning in C-2 type column

22 number of rebars were shown in column schedule for C-2 type column in 1st to top floor

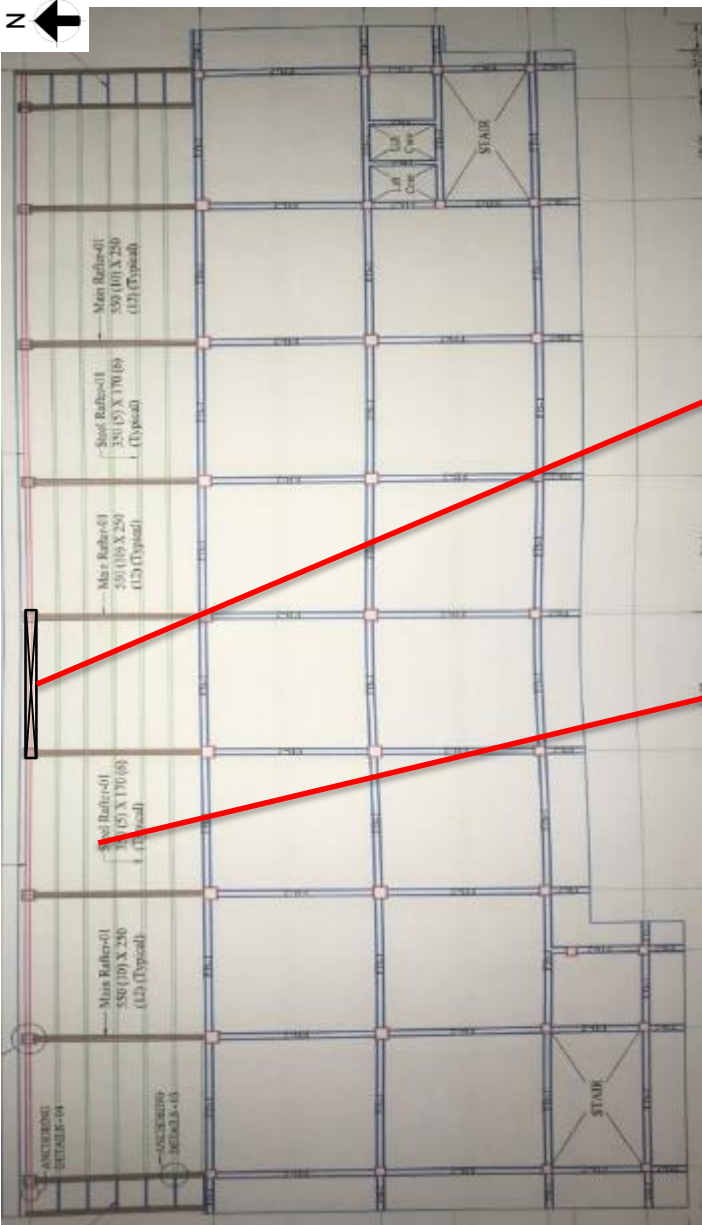
Beam layout in typical floor

Vertical 'I'-section bracing was observed on marked location in ground to 4th floor. But no bracing layout or detail was found in drawing. Also, deck slab was observed on the steel part but no detail drawing of the deck slab was observed in provided drawing.

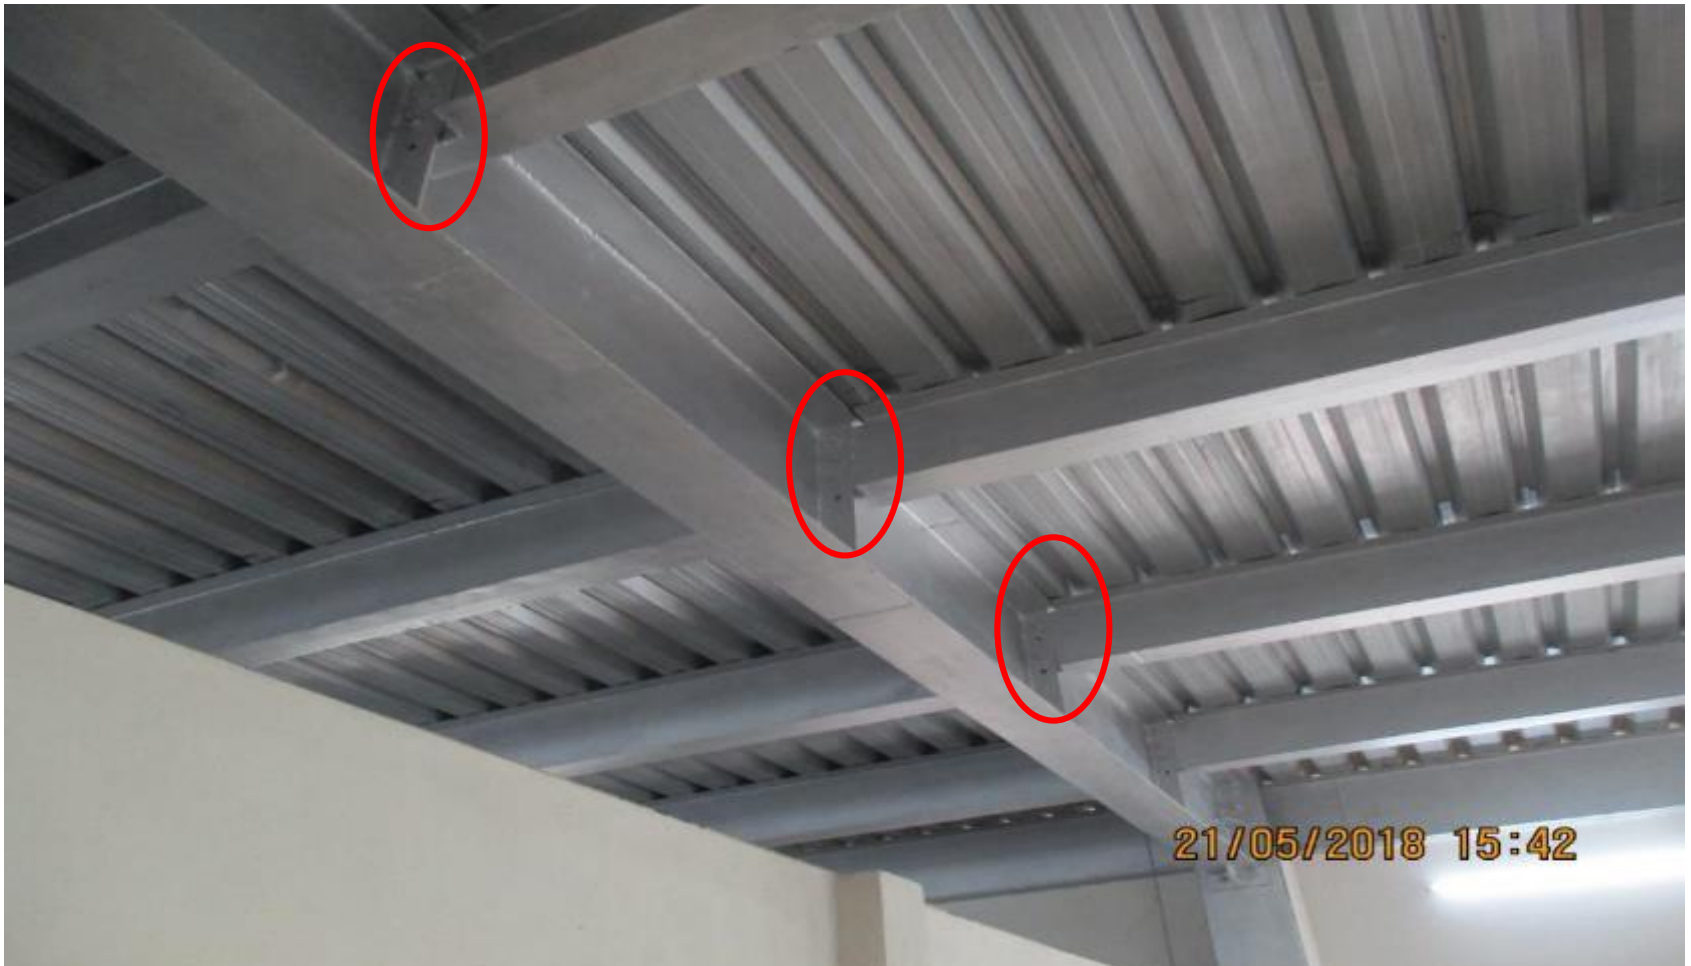
Missing Bolts

Bolts were missing on sub-beam to main beam connection in several location on different floors. Factory is required to install the bolts according to the as-built drawing.

Item No.	Observation	Recommended Action Plan	Recommended Timeline
11	Production building (New Unit) Missing Bolts	Factory engineer is required to install the bolts according to the as-built drawing.	6-weeks
12	Production building (New Unit) Water clogging on roof top	Factory engineer is required to improve the water drainage system to prevent the water clogging.	6-weeks
13	Utility building (New Unit) Discrepancies observed between As- Built drawing and on-site condition	Factory engineer to survey the whole building and produce as-built documentation reflecting the as constructed condition.	6-weeks
14	Utility building (New Unit) Non-engineered steel stair at the east side of the utility building	Factory engineer is required to check the connection details between slab & stair and check the stability of the steel stair.	6-weeks
15	Utility building (New Unit) Non-engineered steel stair at the east side of the utility building	Implement required remediations as per Factory Engineer.	6-months

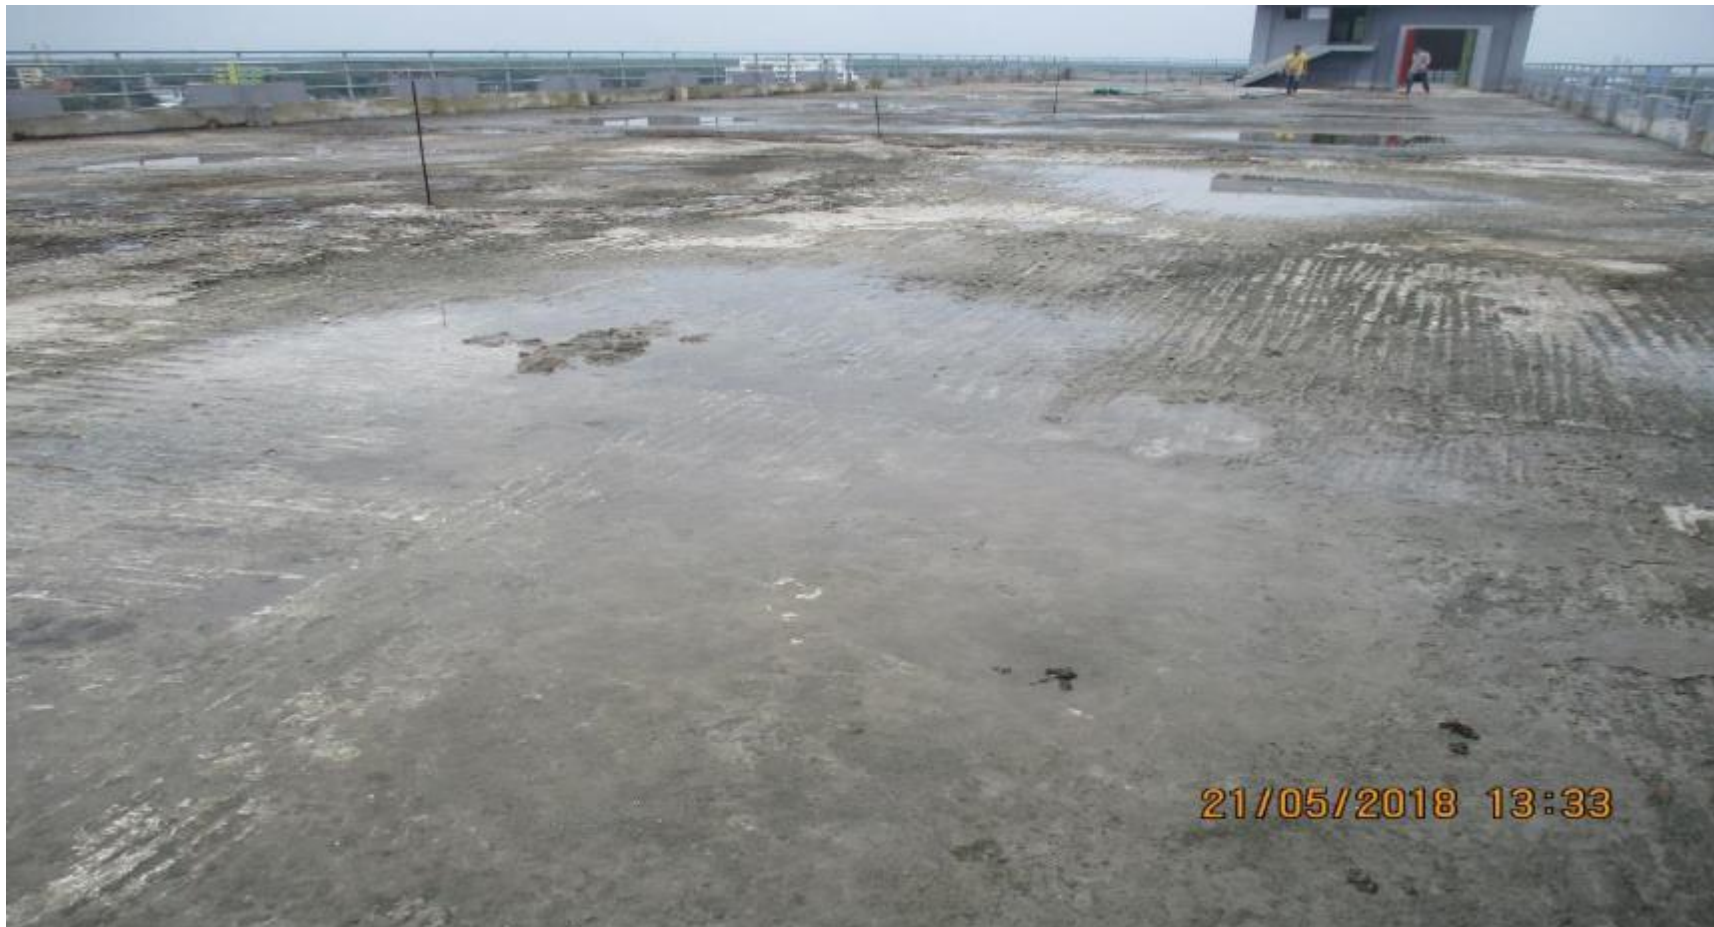
Water clogging on roof top

During inspection, water clogging was observed on roof top. Factory is required to improve the water drainage system to prevent the water clogging.

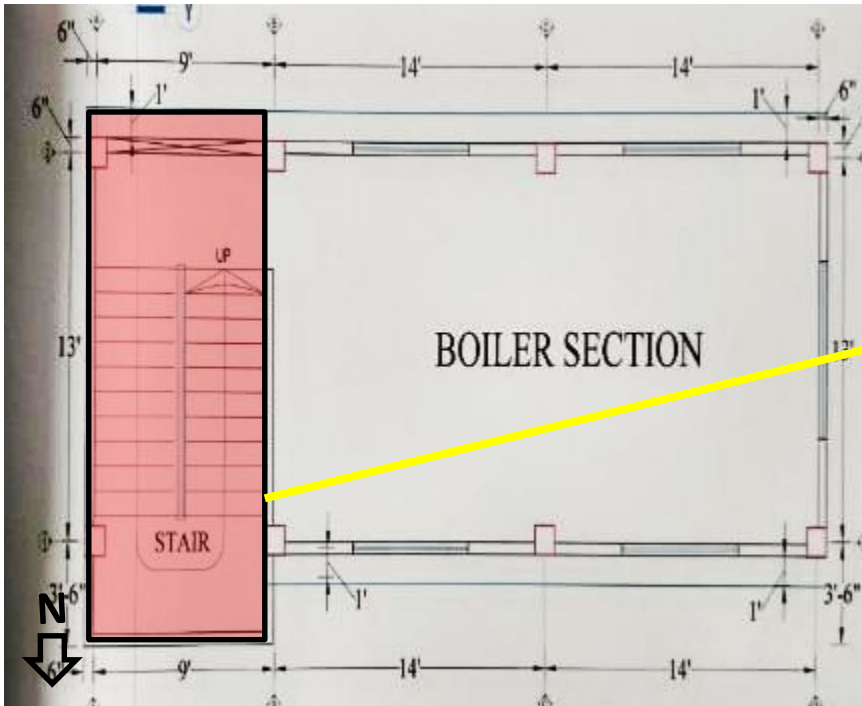
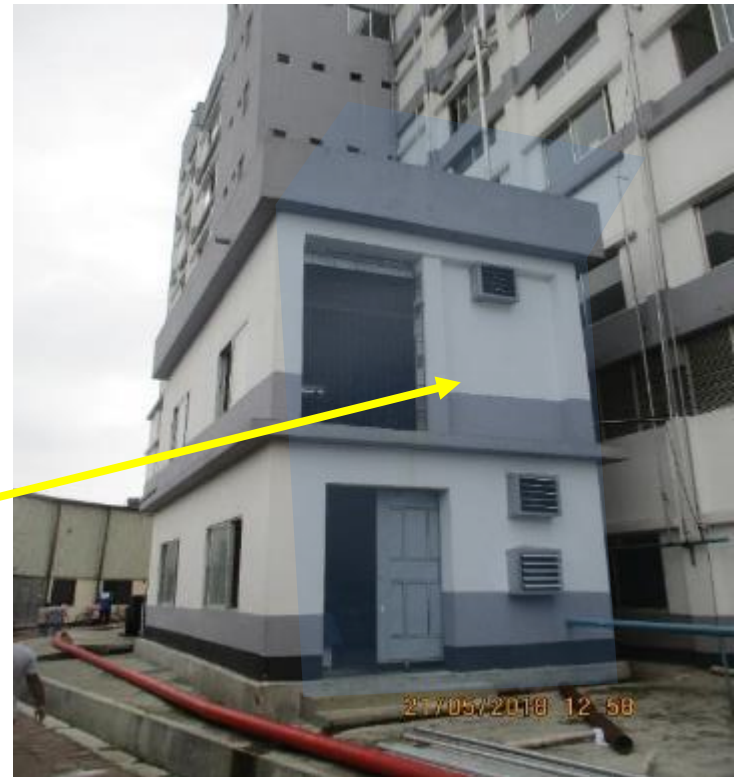
Typical Layout Plan

Discrepancies observed between As- Built drawing and on-site condition

Stair portion was not found on-site. Factory is required to update drawing as per on-site condition.

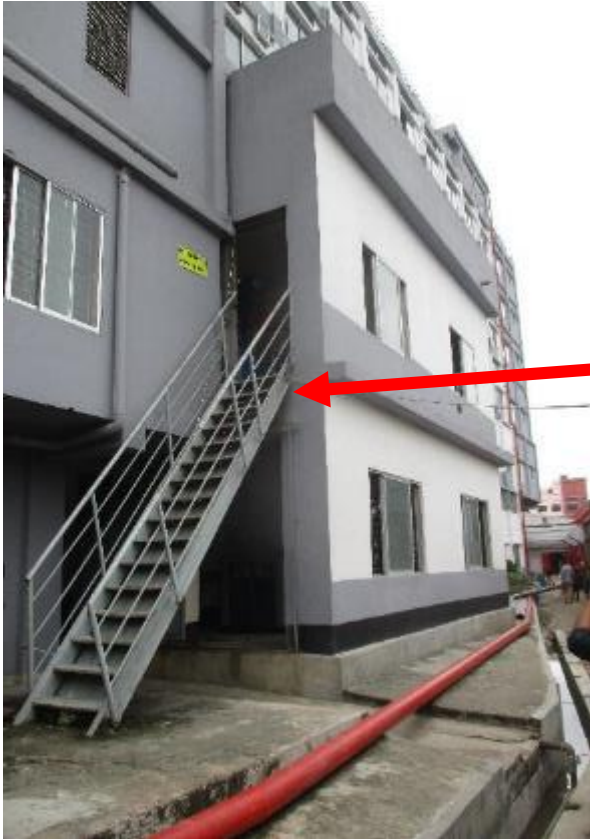
Non-engineered steel stair at the east side of the utility building

Non-engineered steel stair at the east side of Utility building.

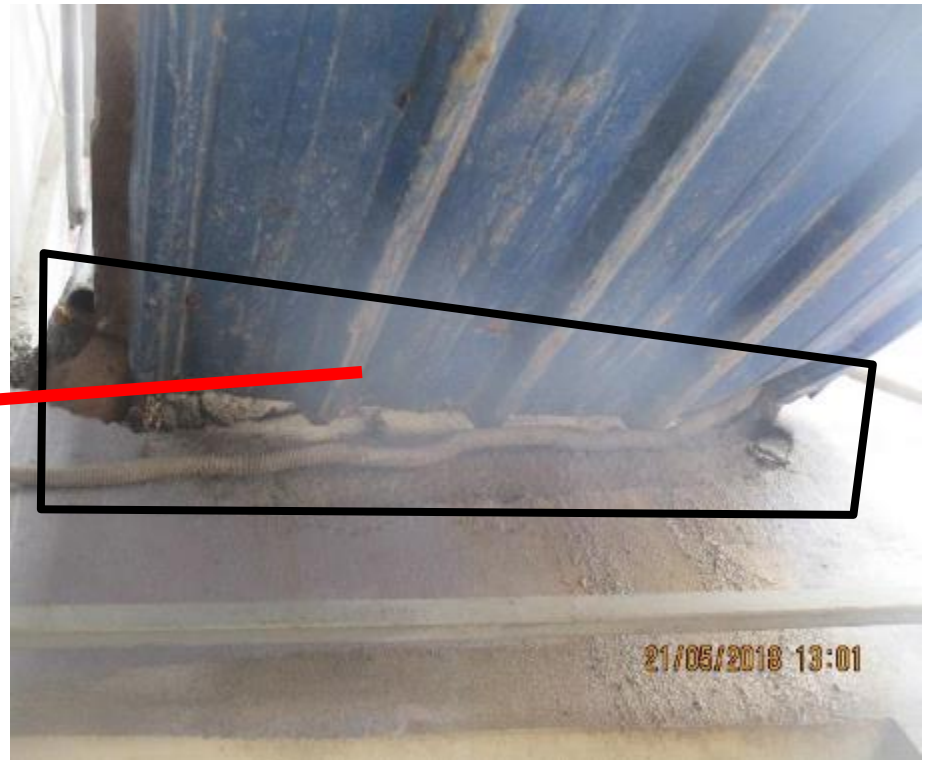
Steel stair poorly connected with slab. Factory engineer is required to check the stability of the steel stair.
