# Rio Fashion Wear Ltd

Industrial Plot No.3, Milk Vita Road, Section 7, Mirpur, Dhaka  
(23.81596N, 90.3625E)

2 November 2013

# Site Observations

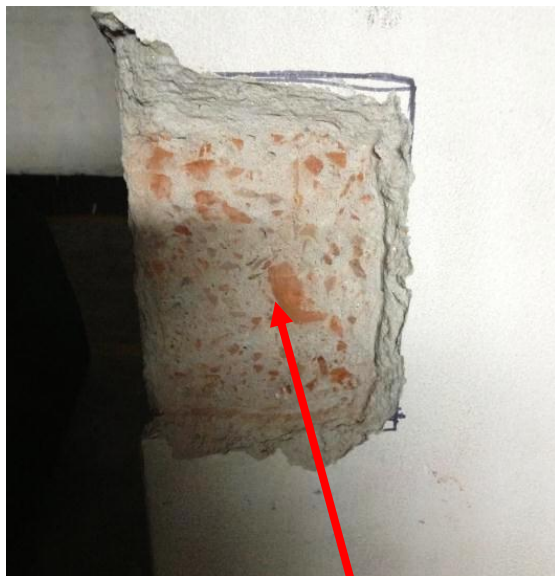
**Design drawings indicate stone aggregate concrete was to be used. 8<sup>th</sup> floor column opened for Schmidt Hammer test clearly showing concrete contains brick aggregate**

| Item No. | Observation | Recommended Action Plan | Recommended Timeline |
|---|---|---|---|
| 1 | Check Column stresses and verify aggregate type in columns at basement and ground floor level | Remove plaster from a minimum of 4 columns at basement and a minimum of 4 columns at ground floor and a minimum of 4 columns at first floor to verify aggregate type. Remove plaster from sufficient columns at upper floors to determine when the aggregate type changes from stone to brick. | <b>Immediate - Now</b> |

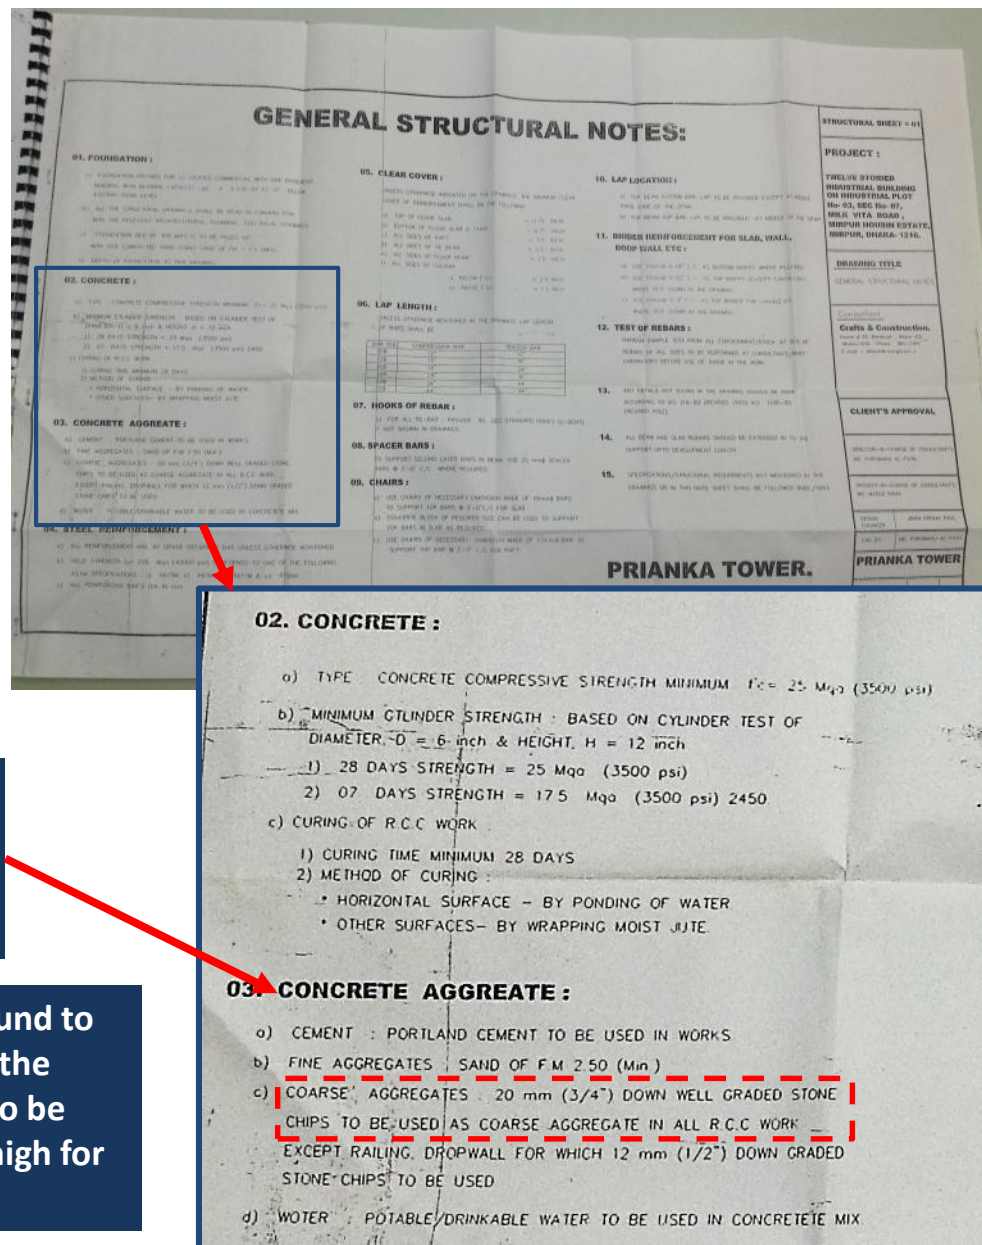
## Column aggregate type

**3 columns opened up at basement level were found to be stone aggregate. It is unknown at what level the columns change to brick aggregate. This needs to be confirmed as the column working stress is very high for brick aggregate concrete.**

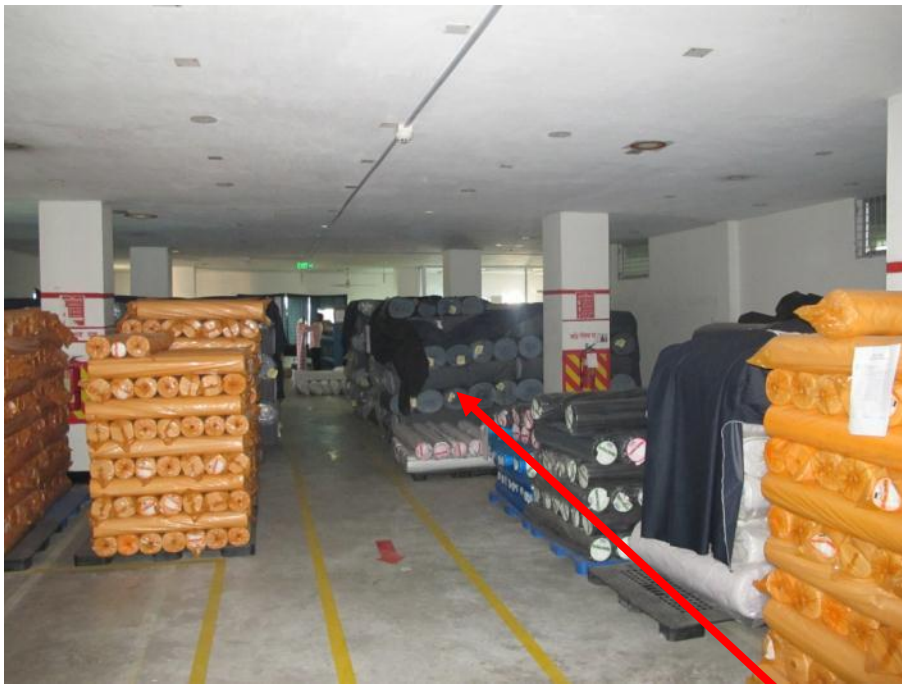
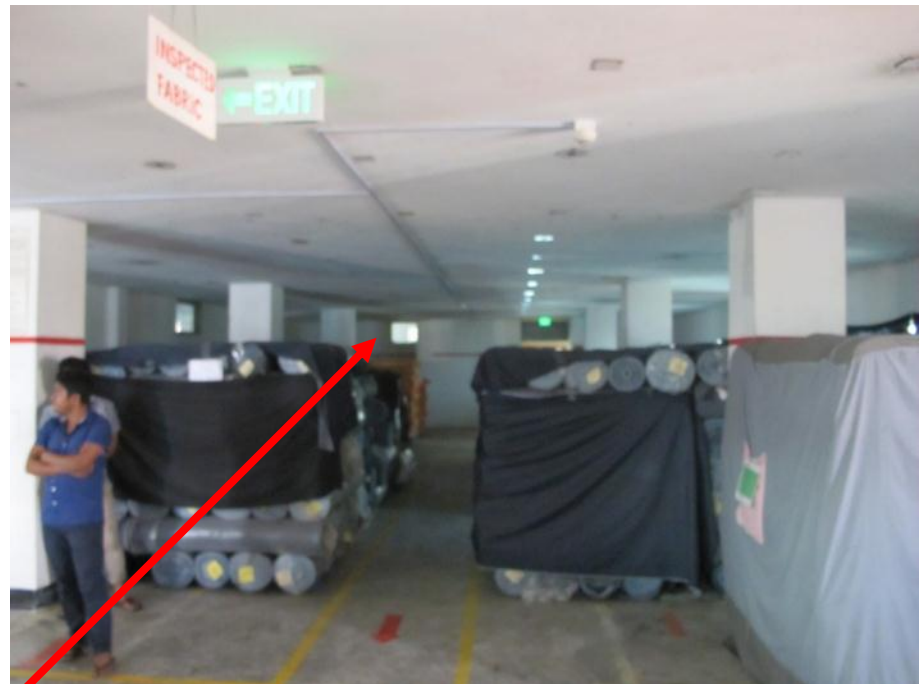
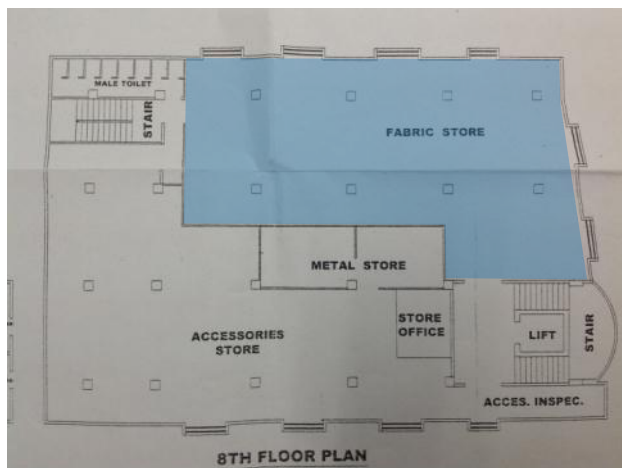
**Rolls of denim stacked 2m high over areas of 1.5m x 3m**

**Loading in this area needs to be reduced See below**

| Item No. | Observation | Recommended Action Plan | Recommended Timeline |
|---|---|---|---|
| 9 | Heavy loading in fabric store on 8th floor has resulted in overloading of the slab and cracking to the soffit of the 7th floor | Reduce loading on 8th floor. Assuming 1.5m x 1.5m area limit height of rolls of fabric to 1.5m height . Ensure 1m clear pathway around 4 sides of every 1.5m x 1.5m pallet. Remove all loading in bay directly over crack. | Immediate - Now |

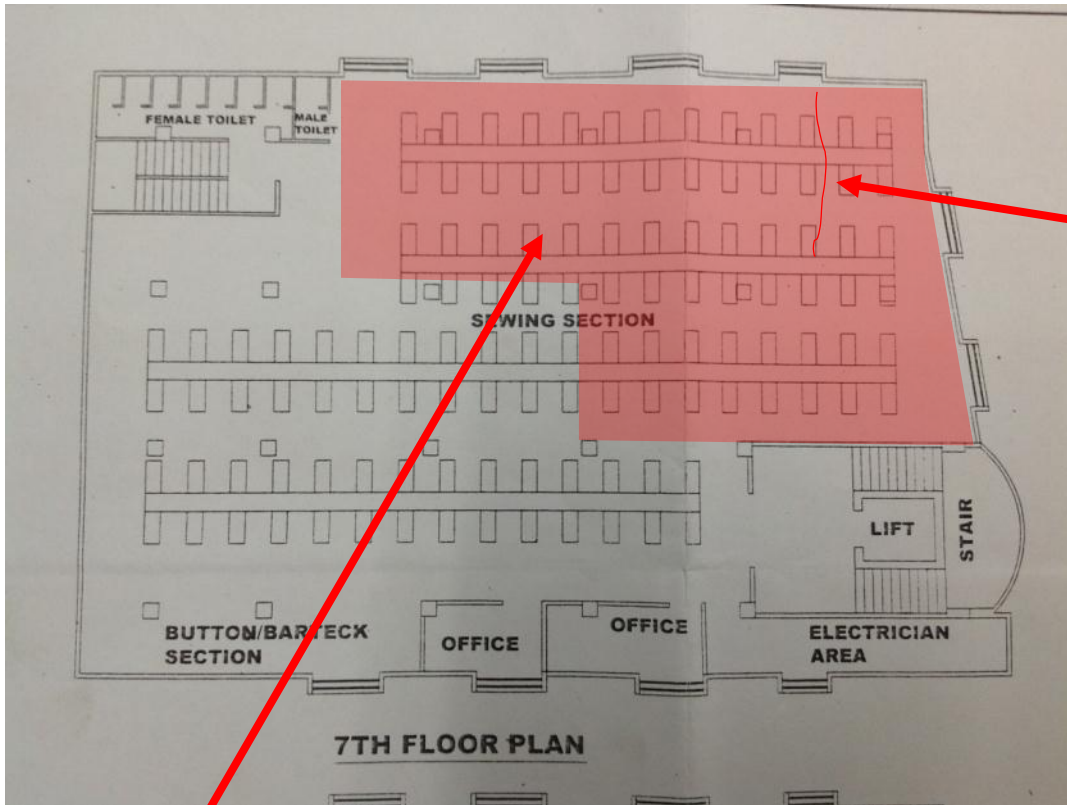
**Multiple hairline cracks in underside of 8<sup>th</sup> floor slab**

| Item No. | Observation | Recommended Action Plan | Recommended Timeline |
|---|---|---|---|
| 10 | Heavy loading in fabric store on 8th floor has resulted in overloading of the slab and cracking to the soffit of the 7th floor | Qualified Engineer to assess slab, confirming reinforcement diameter, condition and cover depth). Check for voids in slab under storage area using Non-Destructive Testing apparatus. | 6-weeks |
| 11 | Heavy loading in fabric store on 8th floor has resulted in overloading of the slab and cracking to the soffit of the 7th floor | If voiding is not extensive in situ repair may be feasible with imposed loads on 8th floor limited to a quantified design capacity. If voiding is extensive slab will need to be propped and strengthening options developed. | 6-weeks |

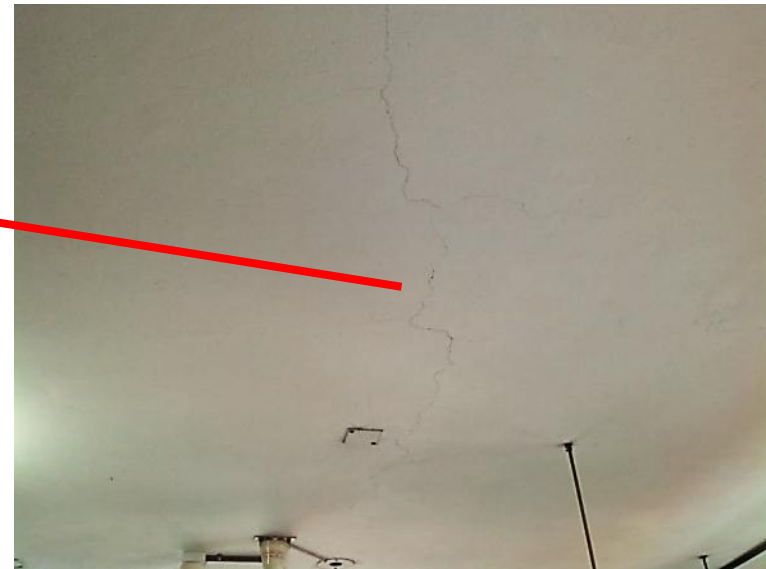
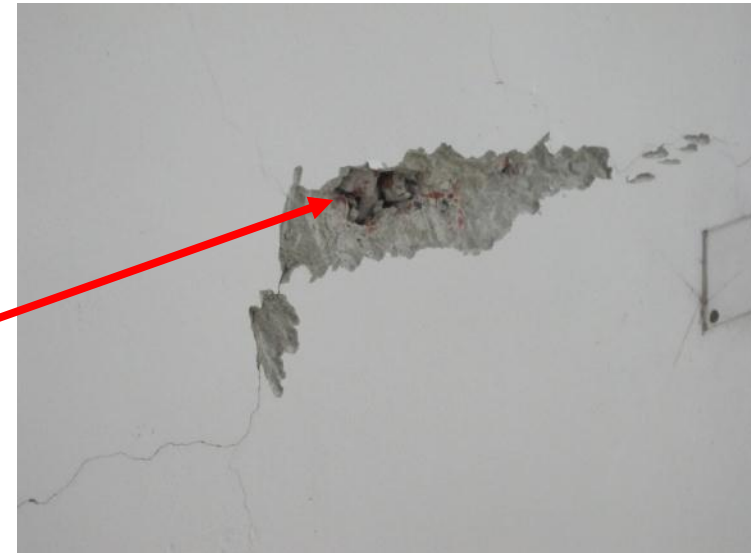
**Crack opened up with hammer revealed voids in concrete**

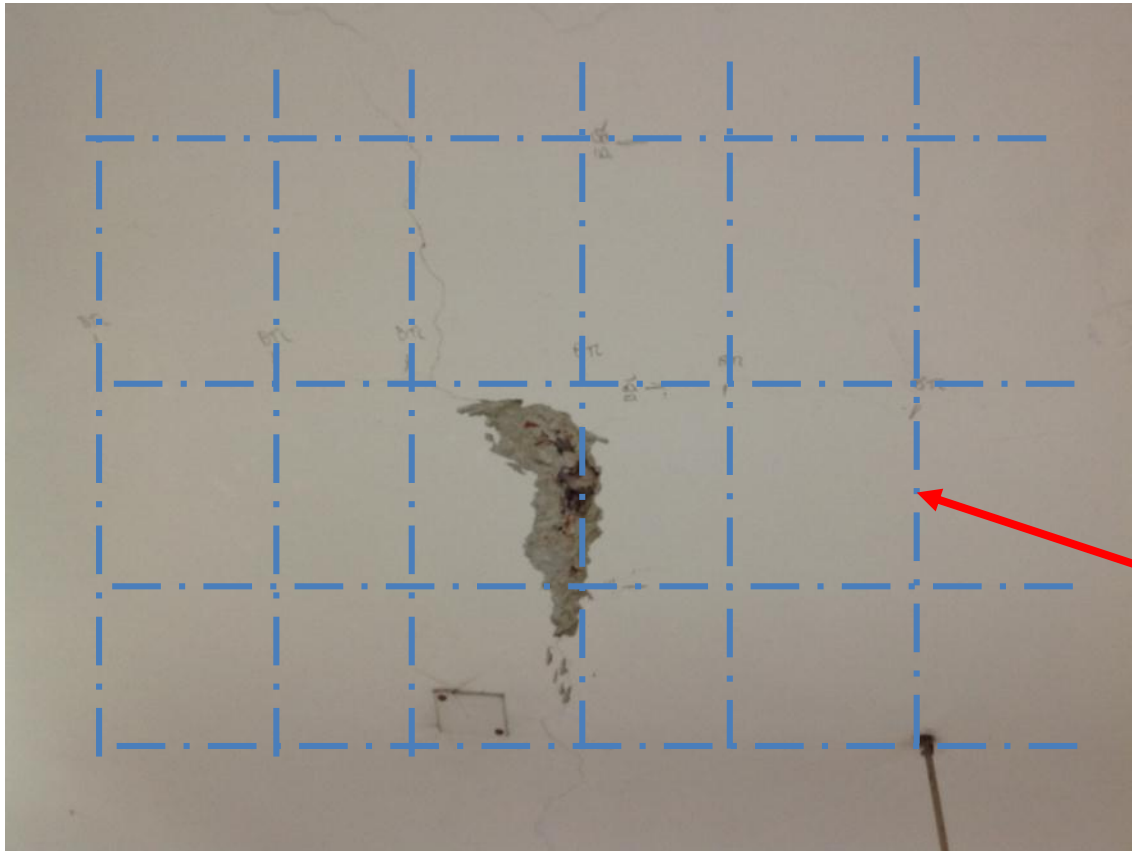
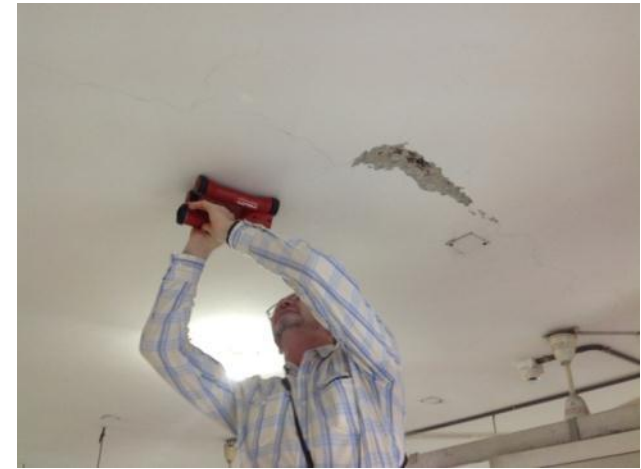
**Ferroskan of slab soffit indicates reinforcement at depth approx 60mm at 150mm to 200mm centres in both directions. Bar could not be located in formed opening**

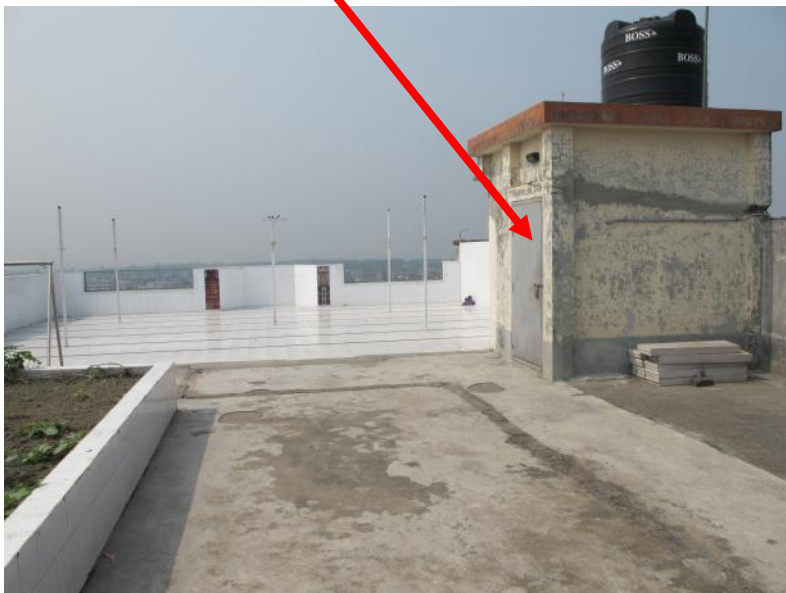
Store room and water tank

Structure not on permit drawings and walls do not align with columns or beams below

| Item No. | Observation | Recommended Action Plan | Recommended Timeline |
|---|---|---|---|
| 13 | Loading on roof slab (medical room, water tank and planter) | Remove water tank / storage room and planter<br>Or<br>Factory Engineer to review design, loads and slab/beam stresses in roof slab and provide evidence that roof slab has adequate capacity for loads. | 6-weeks |

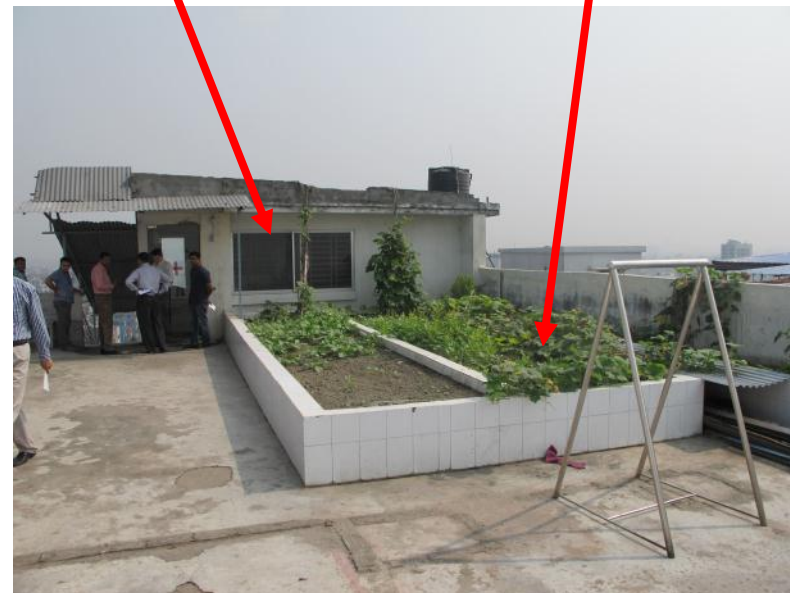
Medical room and roof top planter

Structure not on permit drawings

High loads due to weight of soil. It is unlikely the slab will have been designed for this load

High loading on roof slab

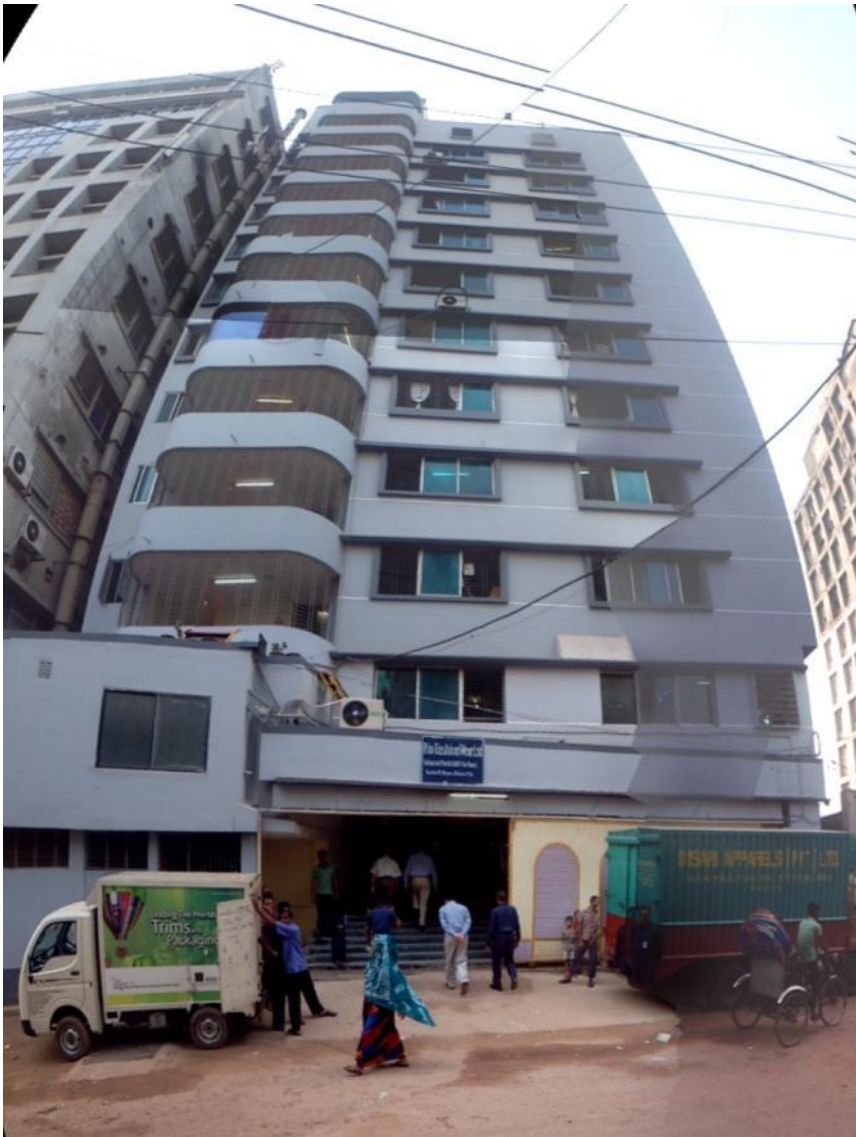
**Stability system**

Stability system is by  
column-slab moment frame

Building Engineer must carry  
out a stability analysis of the  
full 13 storey building.

| Item No. | Observation | Recommended Action Plan | Recommended Timeline |
|---|---|---|---|
| 15 | Stability system for building | Detail Engineering Assessment of Factory to be commenced and in particular Stability and foundation aspects to be investigated in detail, see attached Scope (Item 1) | Immediate - Now |

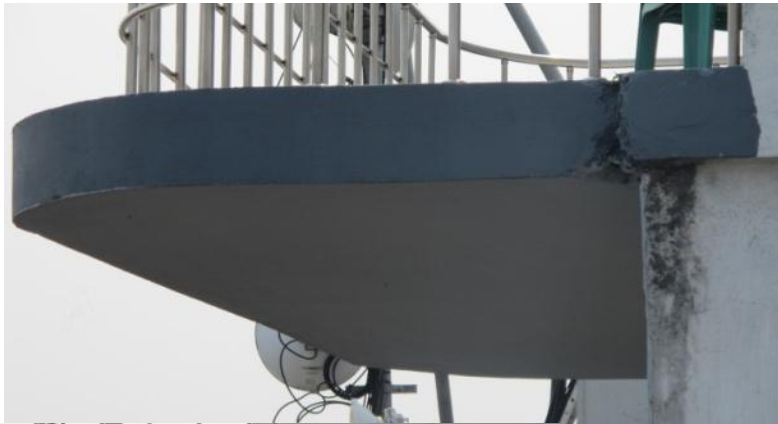
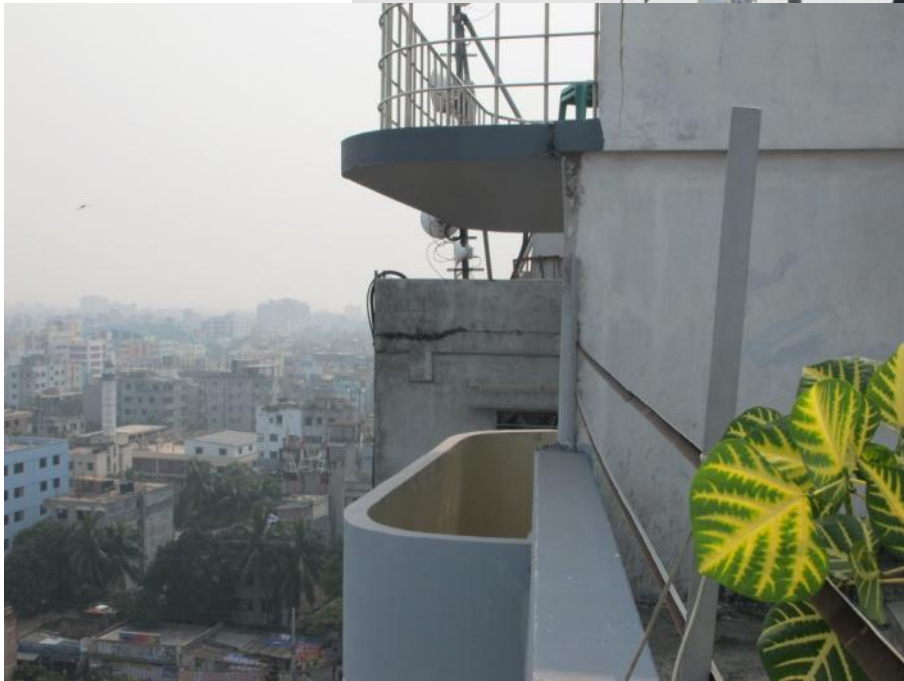
**Poor compaction of concrete on  
cantilevered balcony roof slab**

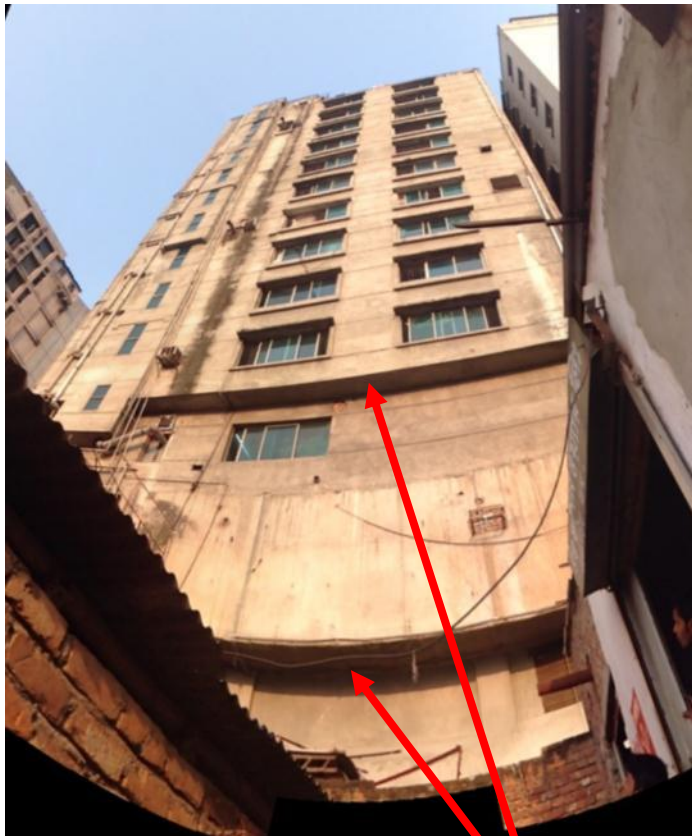
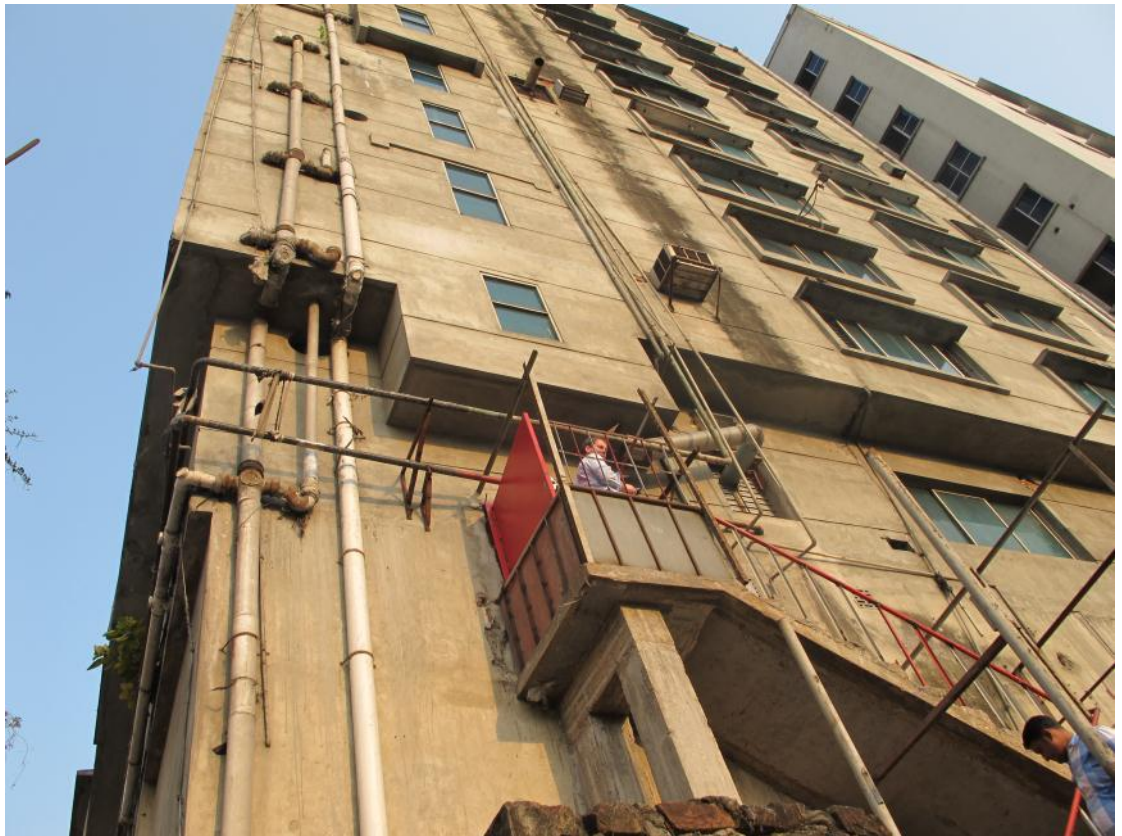
Steps in rear facade

Steps in façade at 2nd and  
ground not shown on drawings

| Item No. | Observation | Recommended Action Plan | Recommended Timeline |
|---|---|---|---|
| 17 | Discrepancies between drawings and as built structure over steps in slab edge (steps in façade at 2nd and ground not shown on drawings). | Survey and drawing work required under Detail Engineering Assessment (Item1) | <b>Immediate - Now</b> |
| 18 | Discrepancies between drawings and as built structure over steps in slab edge (steps in façade at 2nd and ground not shown on drawings). | Factory Engineer to review design of slab edge cantilevers taking in to account steps in rear facade. Update structural and permit drawings to reflect as built geometry. | <b>6-weeks</b> |

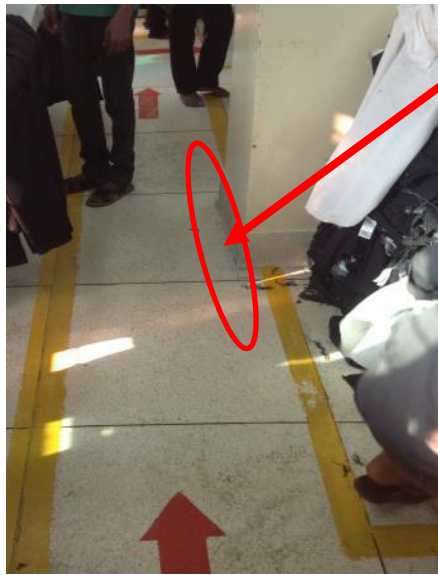
**Crack in floor tiles due to deflection of slab edge**

| Item No. | Observation | Recommended Action Plan | Recommended Timeline |
|---|---|---|---|
| 19 | Large deflections have occurred at slab edges.<br>External brickwork is possibly now carrying vertical load for which it would not have been originally designed | Detail Engineering Assessment to look at deflections and Cantilevers | <b>Immediate - Now</b> |
| 20 | Large deflections have occurred at slab edges.<br>External brickwork is possibly now carrying vertical load for which it would not have been originally designed | Factory Engineer to review design of slab edge cantilevers taking in to account large deflections at edge of slab.<br>Engineer to determine if perimeter walls are now providing support to slab edge and if they are found to do so then the Engineer is to provide a clear statement on what constraints this places on any future alterations to the facades. | <b>6-weeks</b> |

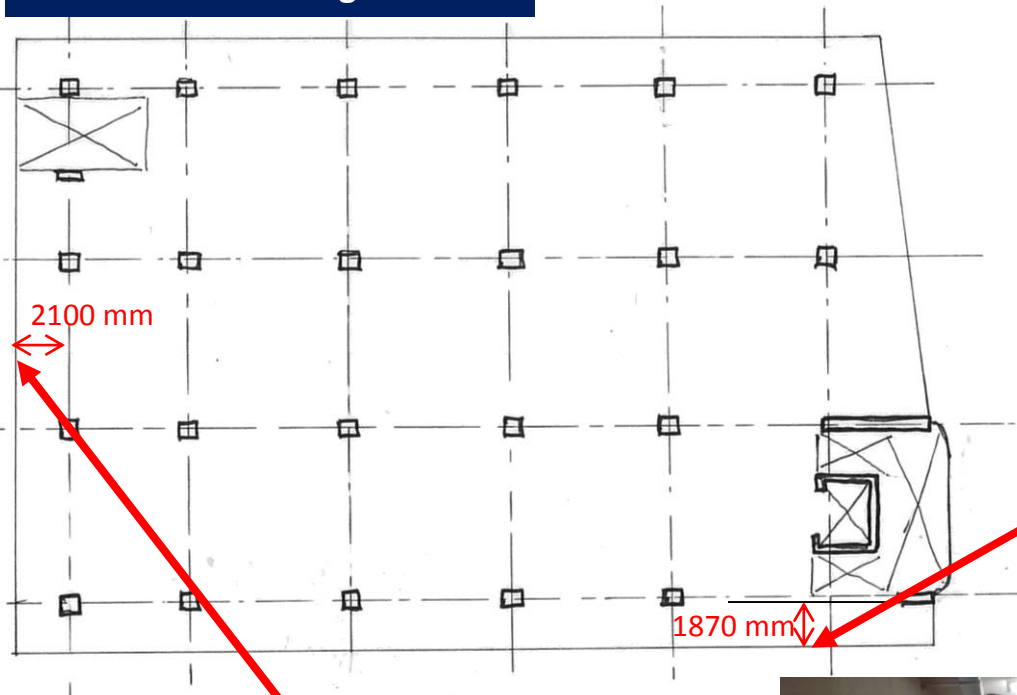
**35mm deflection at tip of cantilever (edge of slab at wall is 35mm lower than slab at column position)**

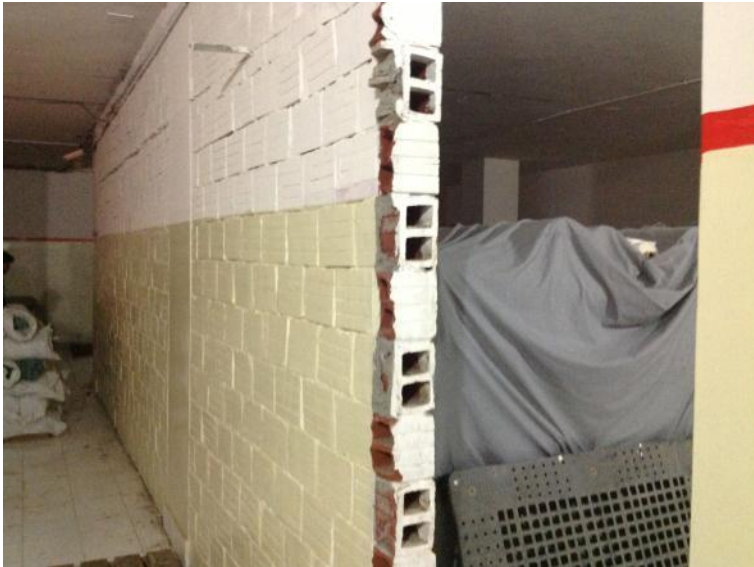
**Slender wall without end restraint. Vulnerable to horizontal impact when moving material or machinery.**
