Leaf Grade Casualwear Ltd.

Kewa (Madrasha Road), Sreepur, Gazipur

14th June 2017

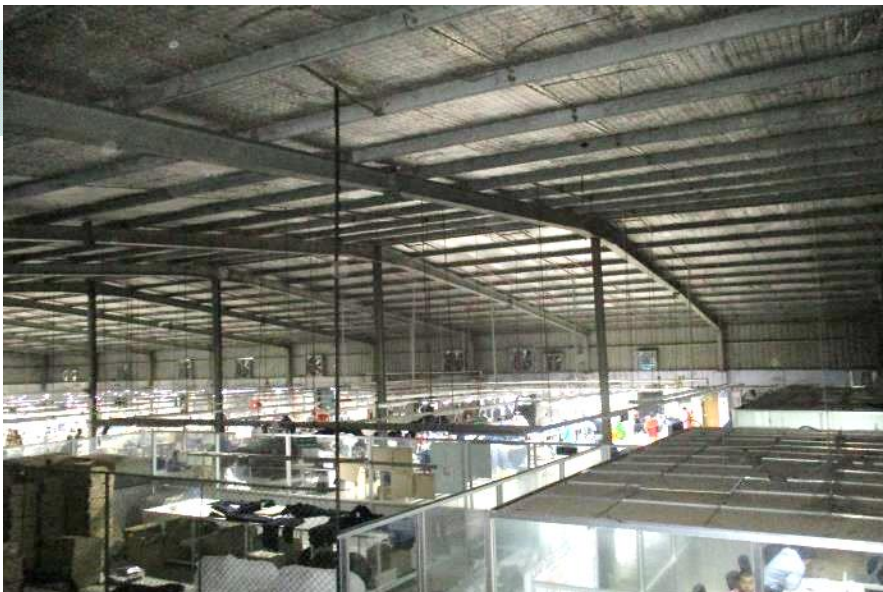
No roof bracing

Specific lateral load resisting system (bracing and compression strut) wasn't observed. Factory is required to engage an engineer for assessment the lateral stability of the shed.

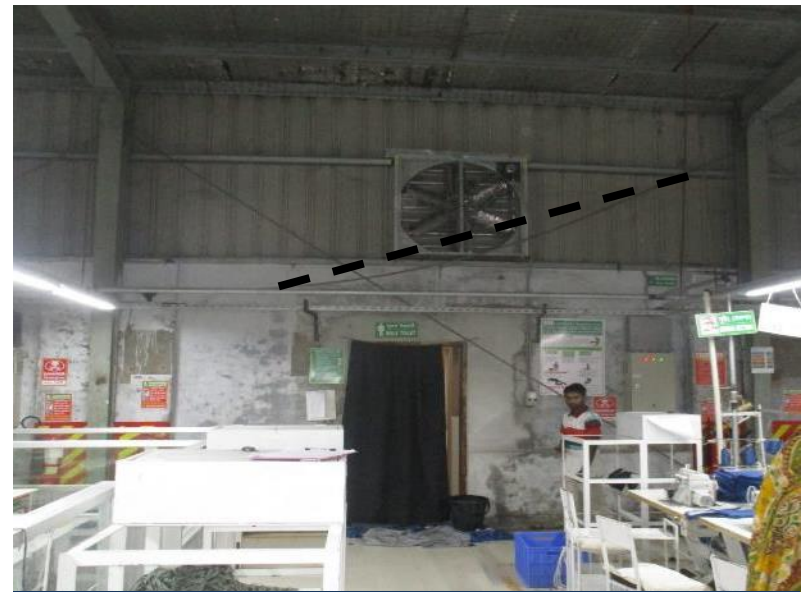
Discontinued Vertical bracing.

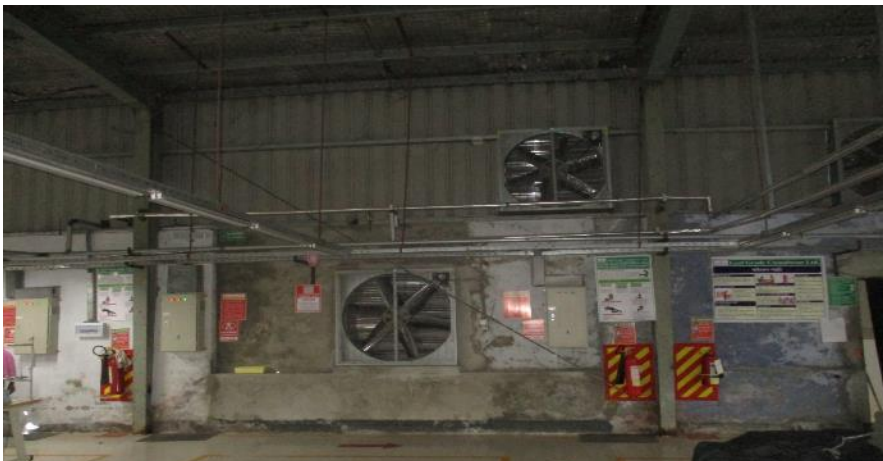
Only continued vertical bracing

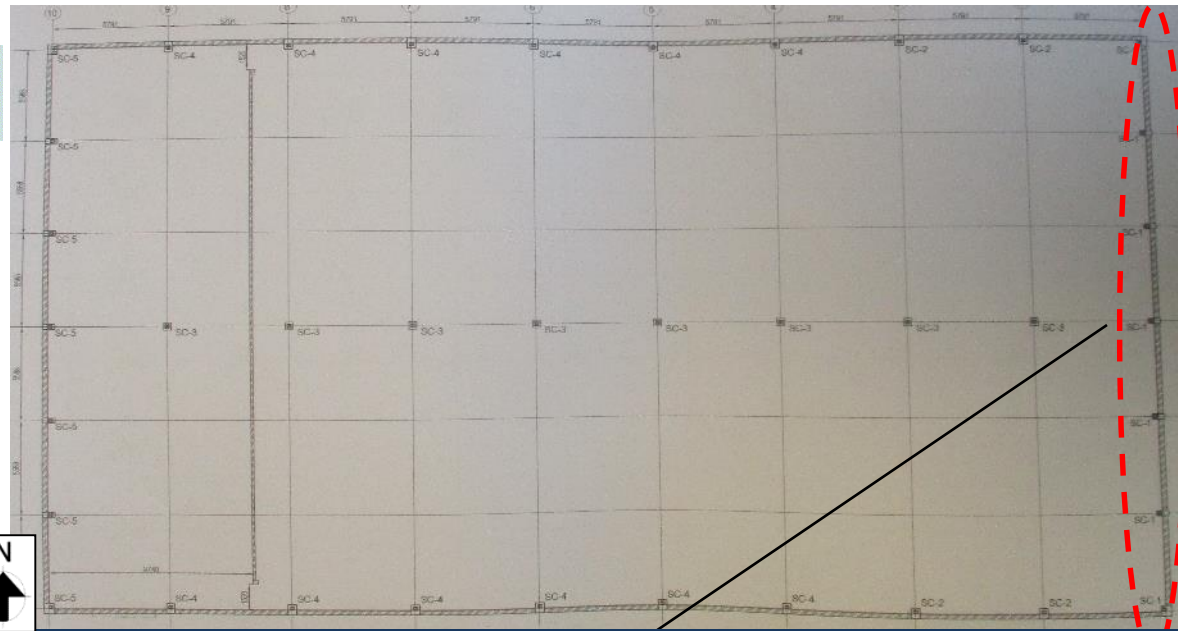
On grid 1-1, bolt was missing on several column rafter joint. In addition, no welding was observed on the joint. Factory is required to engage an engineer to check the joint adequacy and take remedial measures.

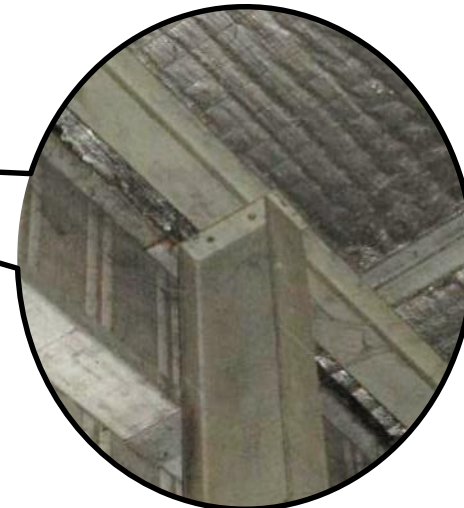
End wall framing at grid 1-1

No bolt was observed Column and rafter joint

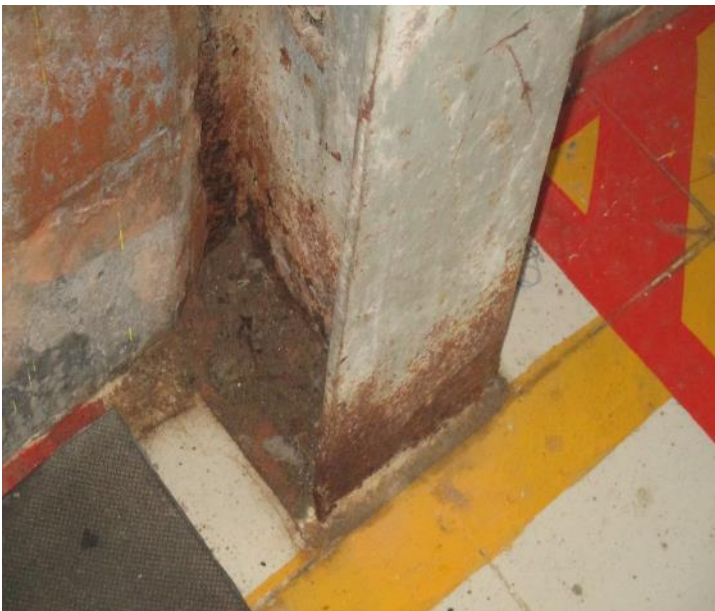
Corrosion on column in front of north west toilet area

Corrosion may cause damage on structural members. Factory is required to repair the corrosion and provide the anti-corrosion paint.

7	(Production Shed) Corrosion observed on structural steel members	Carry out remedial works resulting from engineering assessment where required.	6-months

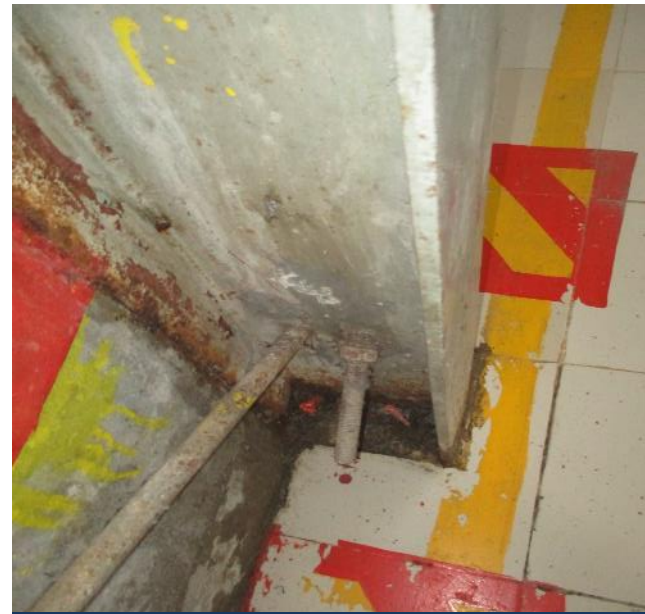
Corrosion on column in front of north east toilet area

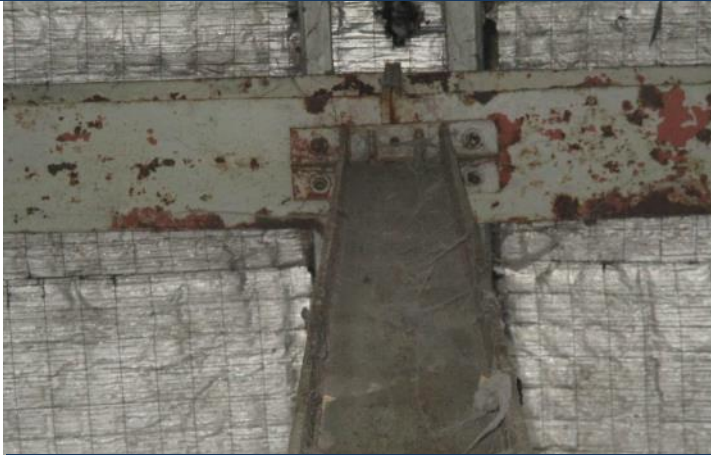
Corrosion on column rafter joint.

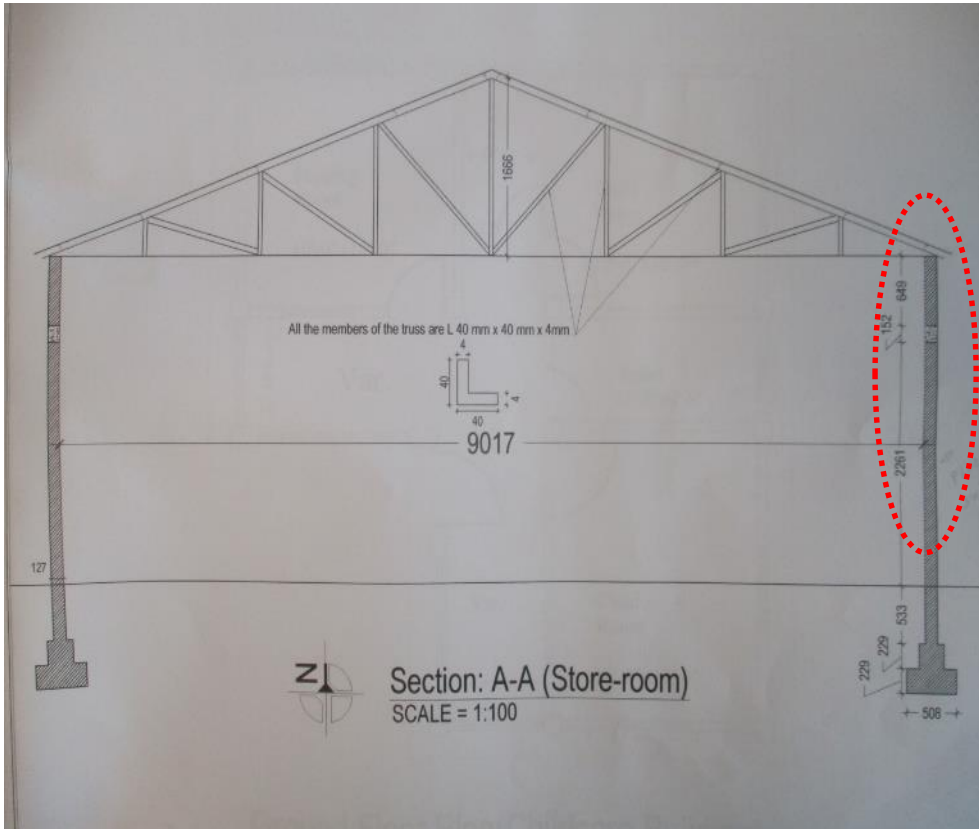
Typical frame section in provided drawing shows truss was supported on brick wall

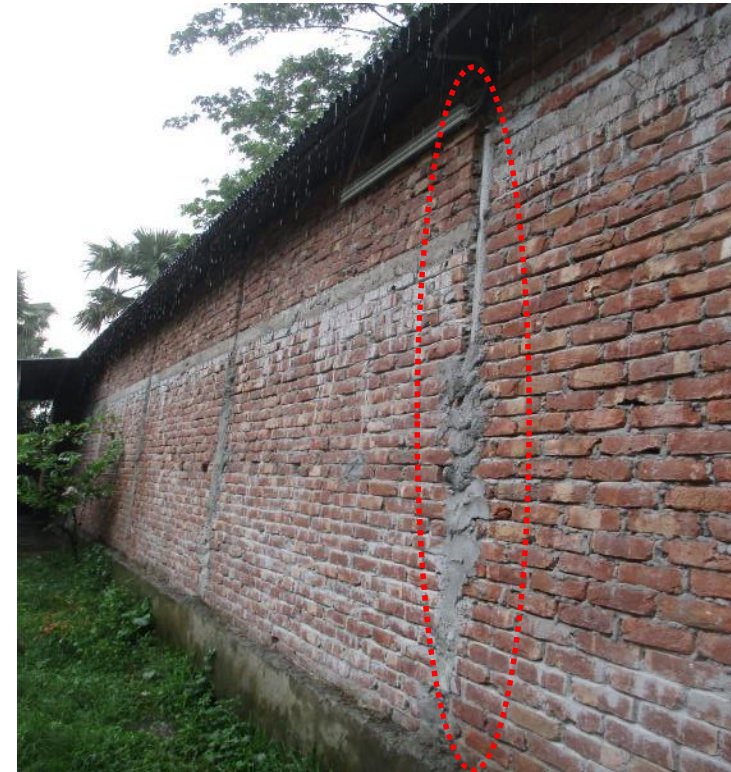
Steel pipe support was found on east side in-place of brick wall.

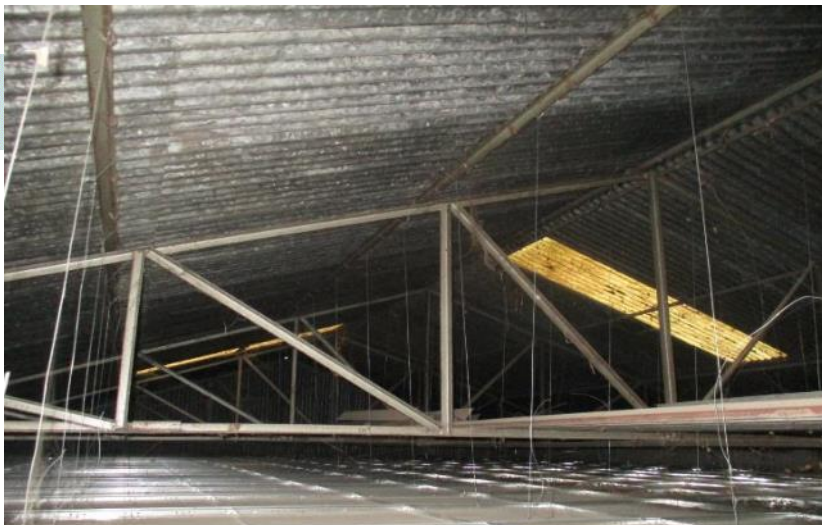
Roof bracing was missing

No proper lateral resisting system was observed. Factory is required to engage an engineer for assessment the lateral stability of the shed.

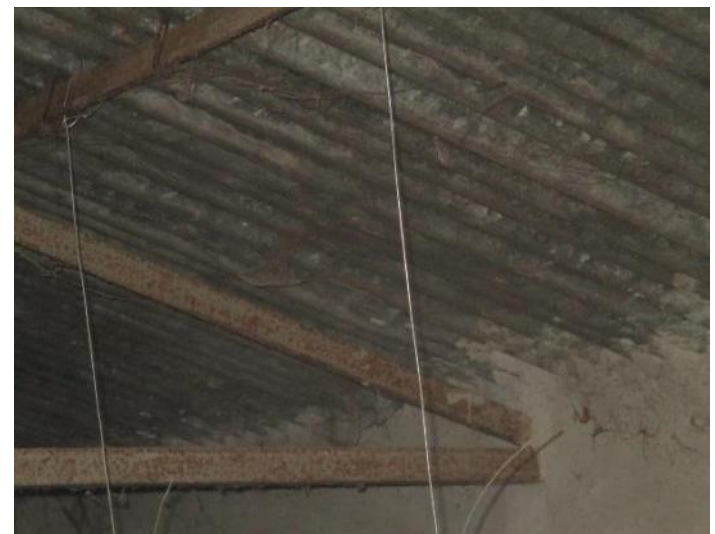
Truss has been found supported with brick wall on south side. It appears to be a non engineered connection.

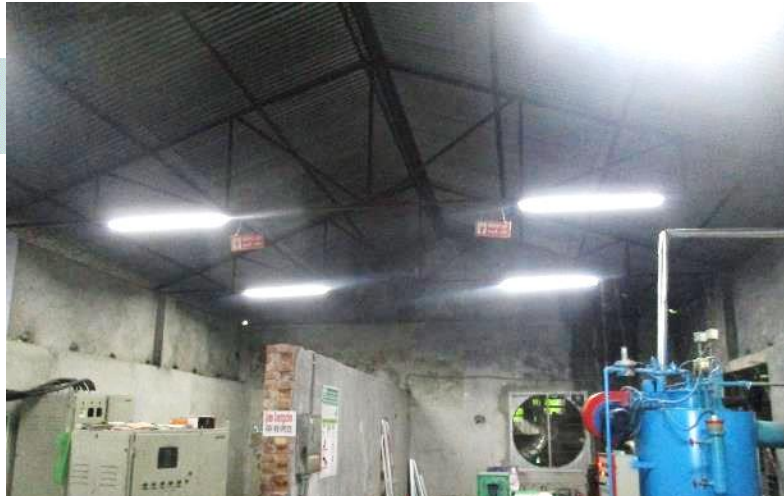
Roof truss system with out any bracing and supported by brick wall.

The support condition of those steel sheds were vulnerable and non engineered due to poor detailing of joints at supports end.

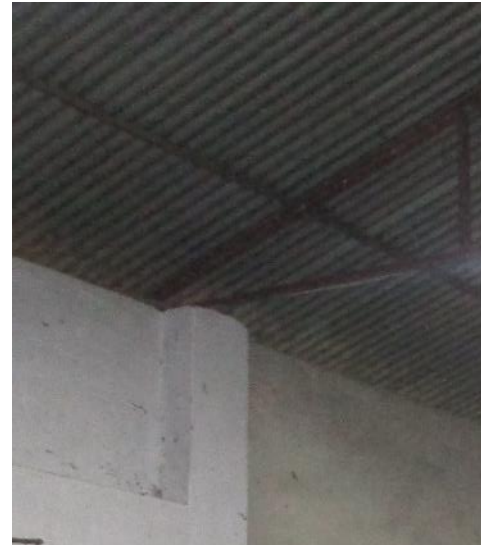
Roof truss supported by brick wall

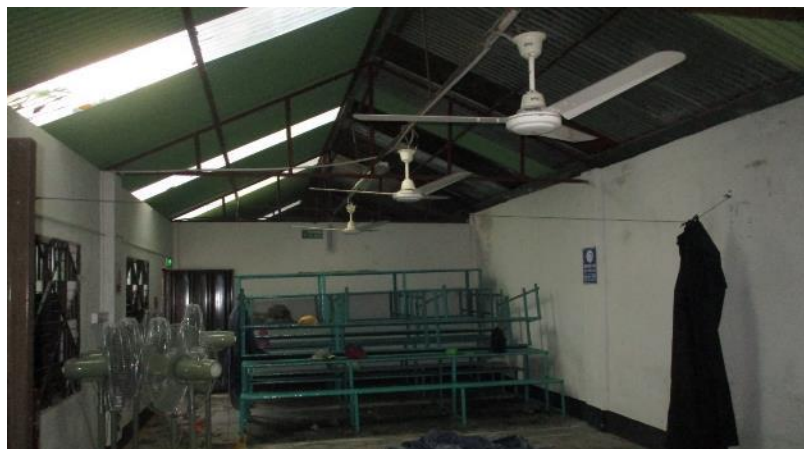
The support condition of the truss was appeared to be non-engineered and inadequate

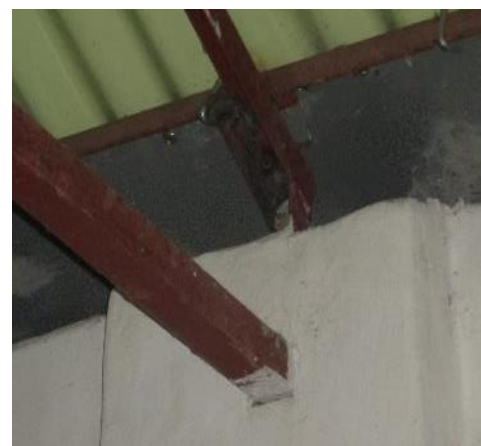
Truss supported on brick wall.

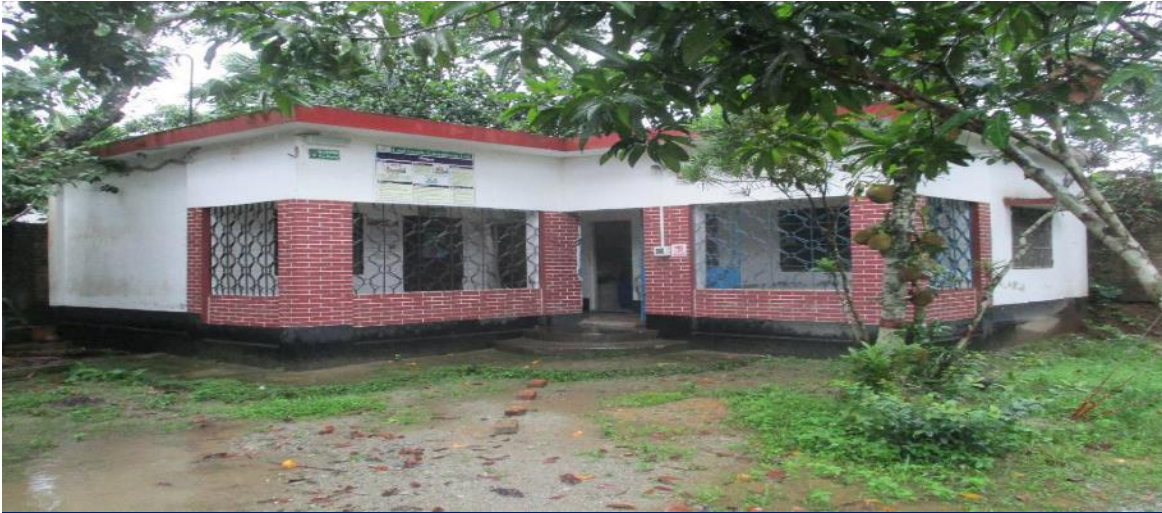
Extent of Childcare building

No detail about the support condition was present in provided drawing. Factory is required to engage an engineer for produce a detail as-build drawing

13	(Childcare Building) Lack of information in as-built drawing	Building engineer to survey the whole building and produce as-built documentation reflecting the as constructed condition.	6-weeks
