Z & Z Intimates Ltd

Plot # 1-3, Road # 02, CEPZ, Chittagong, Bangladesh
(22.289779, 91.777223)
07th January, 2018

Observations

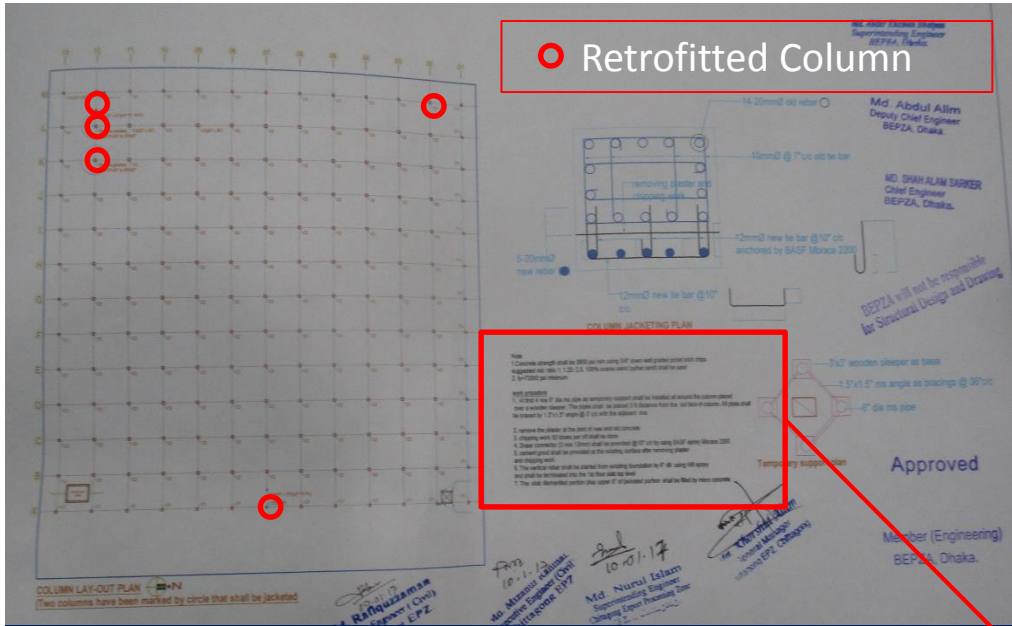
Retrofitting column Layout

Columns were retrofitted considering concrete strength of $f'c$ =26.2 Mpa. However no test report was available. Building engineer is required to ensure the concrete strength of retrofitted column and check with code compliance.

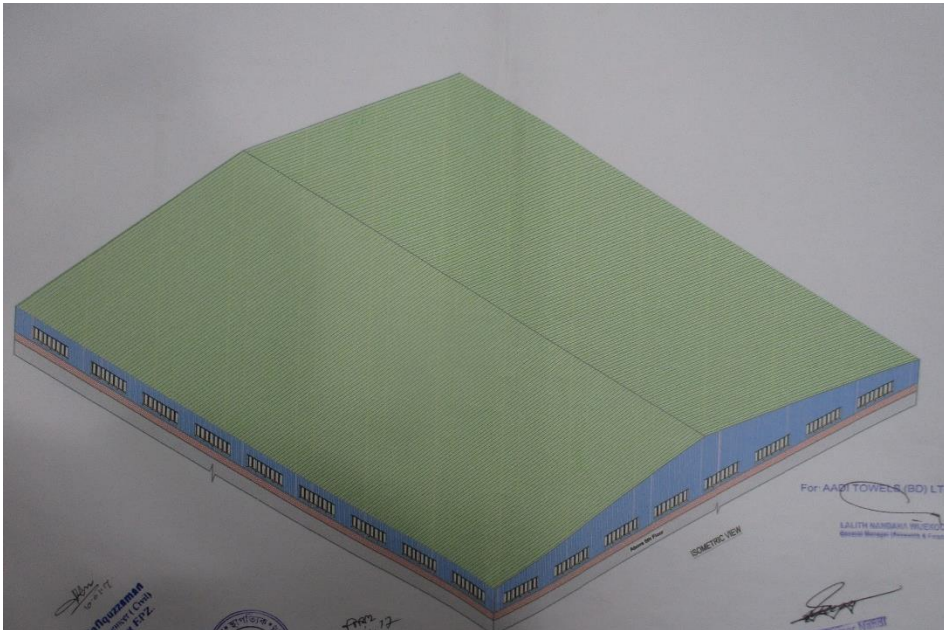
Proposed roof top shed

Insufficient detailing for proposed roof top shed. No obvious lateral load resisting system appeared in proposed drawing. Building engineer is required to check the lateral stability system by further reviewing Detail Engineering Assessment with ACCORD.

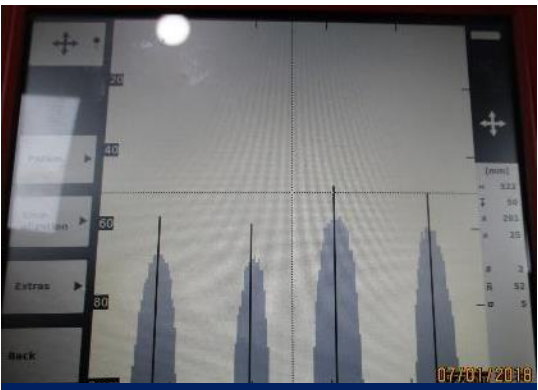
4 nos. rebar was found on long side

Rebar in C-1 type column was found by ferro scanning 10nos. instead of 12nos. on 4th floor.

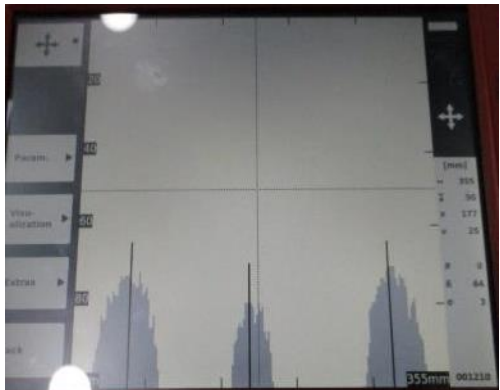
3 nos. rebar was found on short side

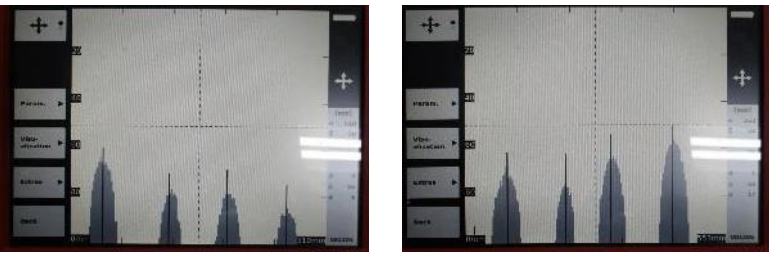
12 nos rebar was found on 4th floor

Rebar in C-2 type column was found 12nos by Ferro scanning. On 4th floor and 14 nos. On 3rd floor whereas 16 nos. rebar was shown in column schedule for 3rd and 4th floor.

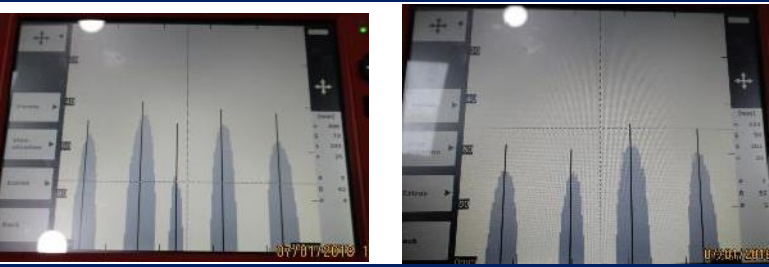
14 nos rebar was found on 3rd floor

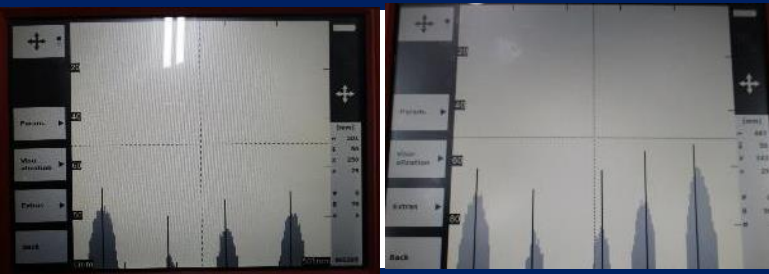
14nos. rebar was found on 3rd floor

The rebar was checked by ferro scanning and found non-identical with column schedule on ground, 1st, 3rd and 4th floor.

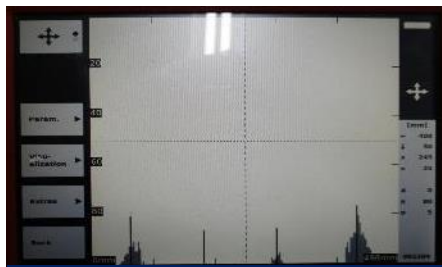
12nos.rebar was found on 4th floor

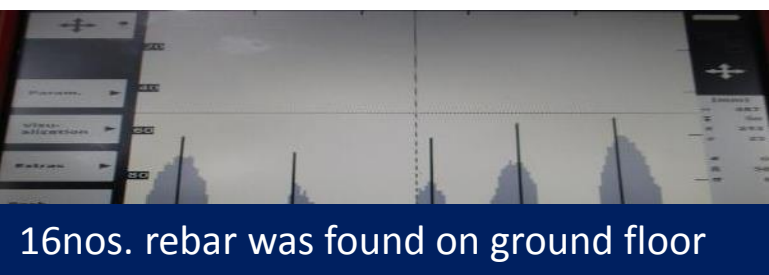
16nos. rebar was found on ground floor

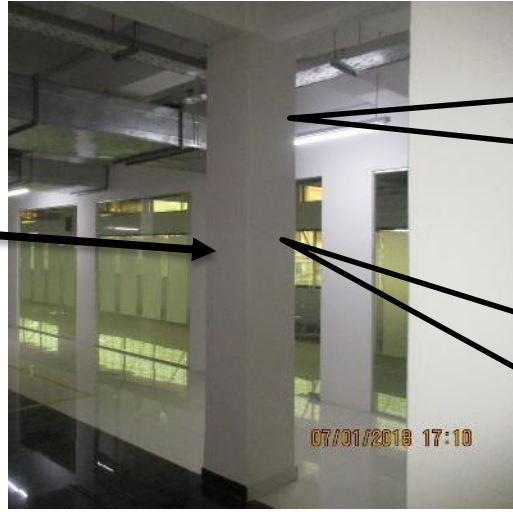
The dimension was measured 400mm x 500mm with plaster for the marked column

The dimension was measured 400mm x 500mm with render on 3rd and 4th floor but the dimension was mention 500mm x 500mm in column schedule.

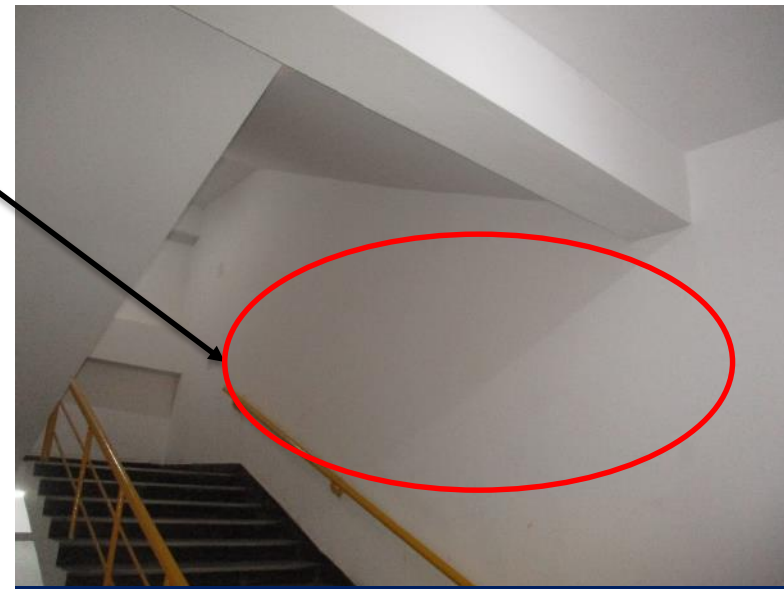
The marked beam was not found on north-west side stair case

The marked beams on south-west and north-west side stair was not found but the beams were shown in drawing. Factory is required to revise the mentioned mismatch and produce the accurate as-build drawing.

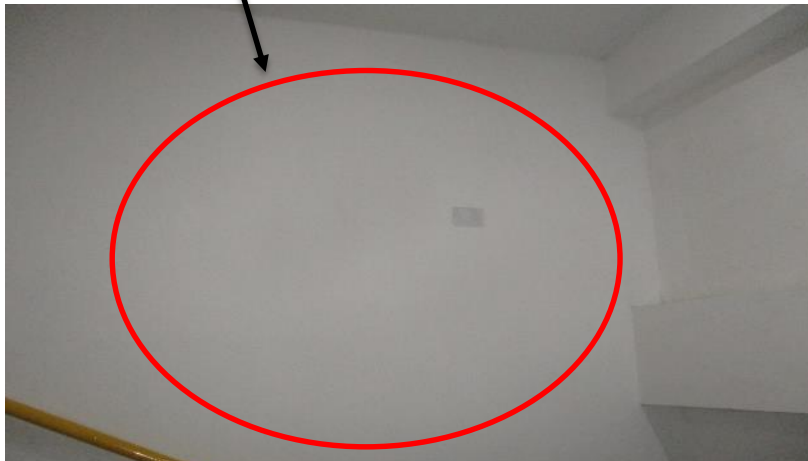
The marked beam was not found on south-west side stair case

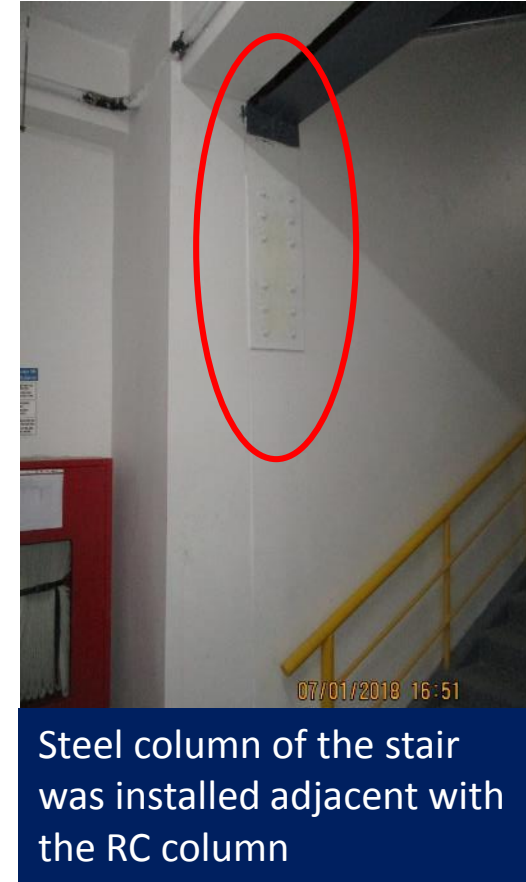
Steel column of the stair was installed adjacent with the RC column

North-East steel stair drawings was not available. Also, the steel columns of the stair are adjacent with the reinforced columns of the building.

6	Lack of Information in Provided Drawing	Make any structural alteration as advised by Engineer.	6-months
7	Columns susceptible to impact loading	Construct and maintain protection to critical column and continue to assess likelihood of vehicle impact to critical elements.	6-weeks
8	Existence of significant gaps at steel connection	Identify all the locations and carryout suitable repair works where necessary .	6-weeks

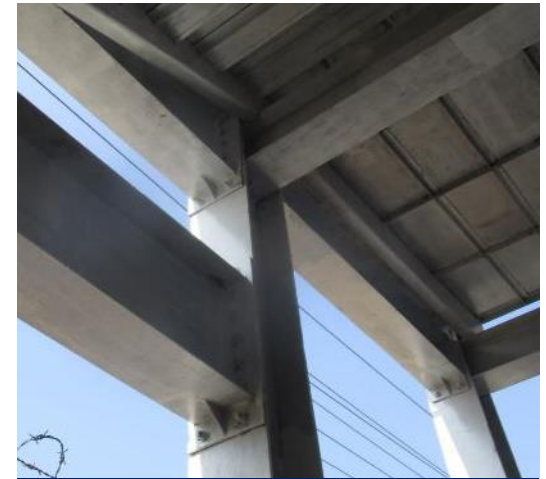
Bolted connection between column and beams.

Connection detail of the beam – column joint and steel beam layout was not include in the provided drawing. Also, the steel columns of the stair were rest the pile cap of the reinforced column. Factory engineer is required to update the drawing and assess the foundation of the stair cases.

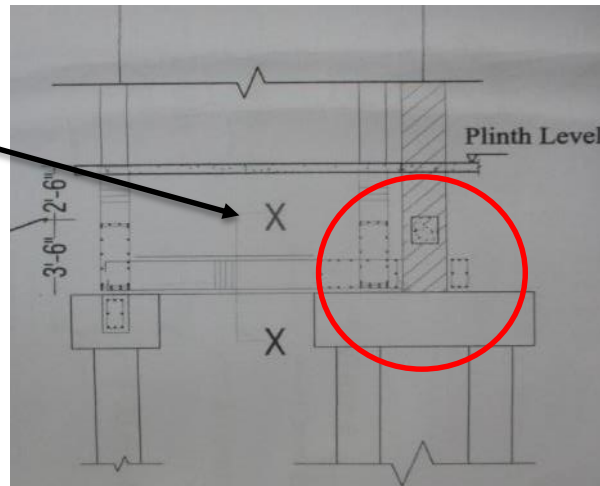
Steel columns on the east side were sheared the pile cap of the factory building's column

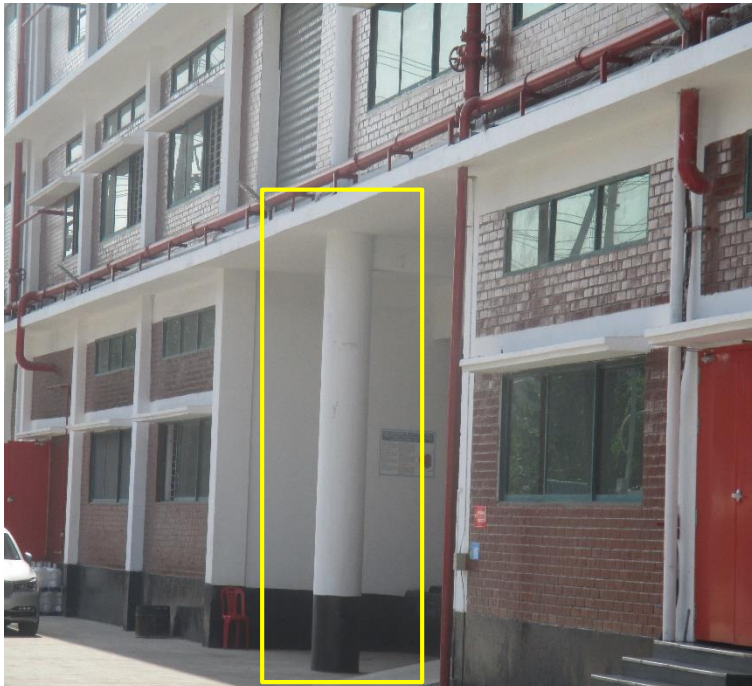
Columns at loading bay are susceptible to impact loading from vehicles.

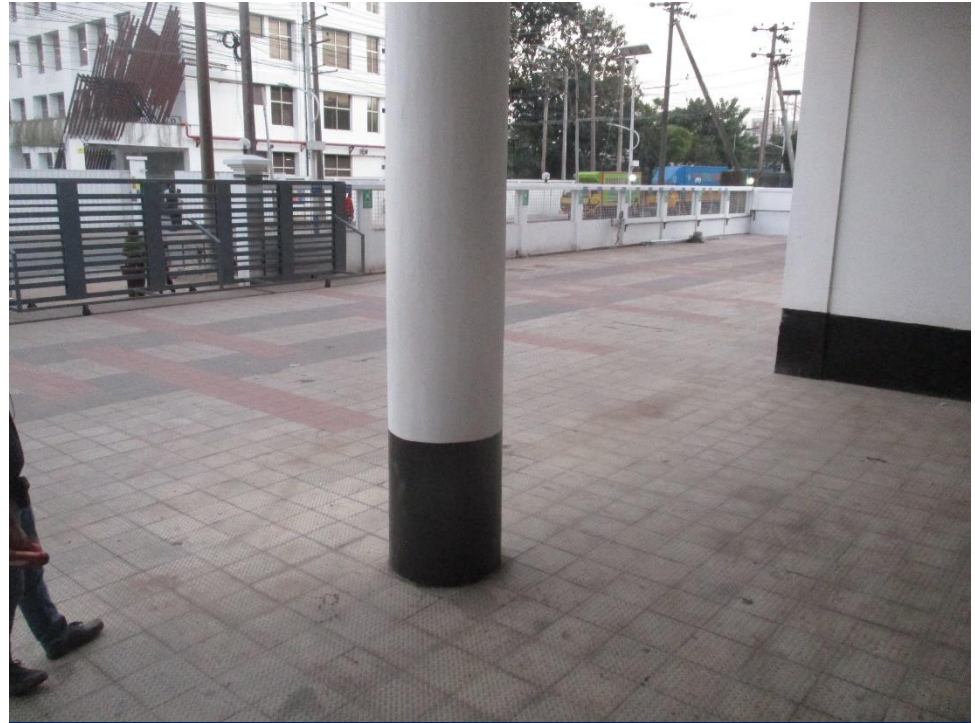
Ground floor column in loading-unloading bay.

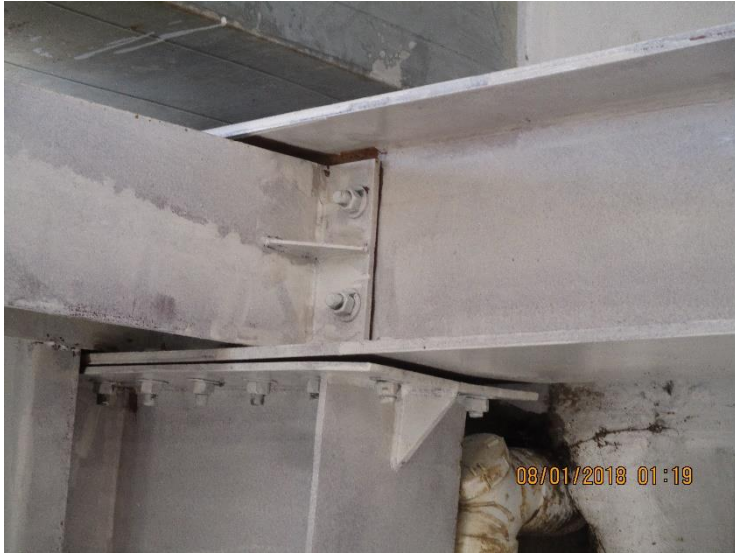
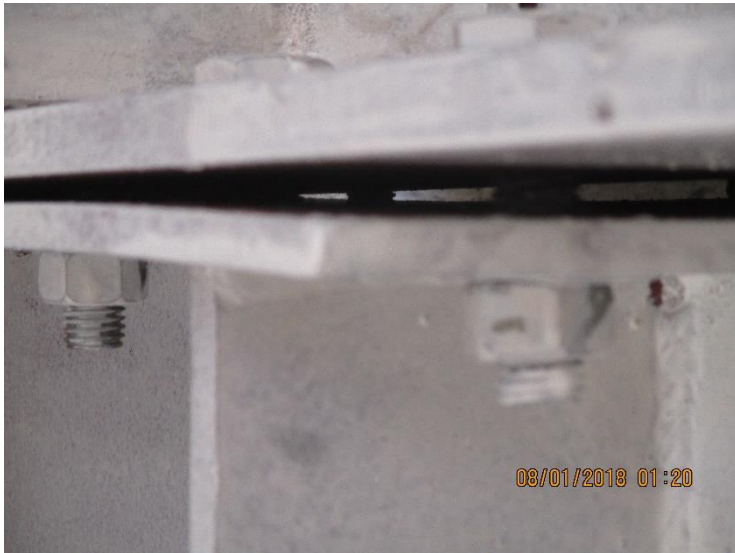
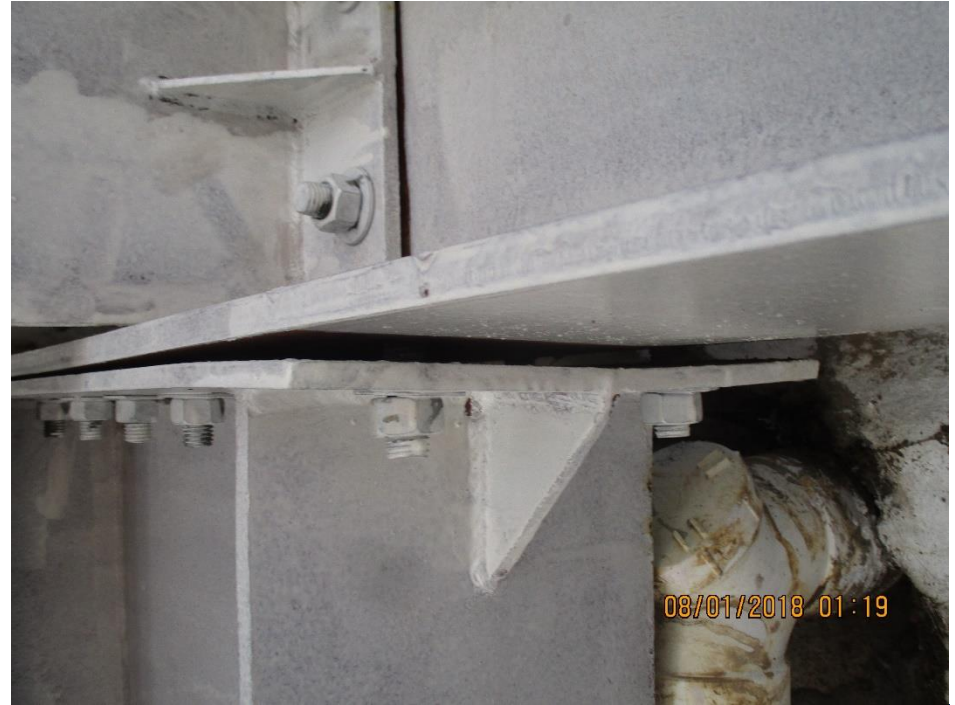
Significant Gaps

Significant gaps were observed in column rafter joint at several location. Building engineer is required to carry out suitable remedial works.
