# Meek Sweater & Fashions Ltd.

Plot No: 1693, Bashon Sarak; Gazipur  
(23.973789N, 90.374398E)  
13<sup>th</sup> May 2018

# Observations

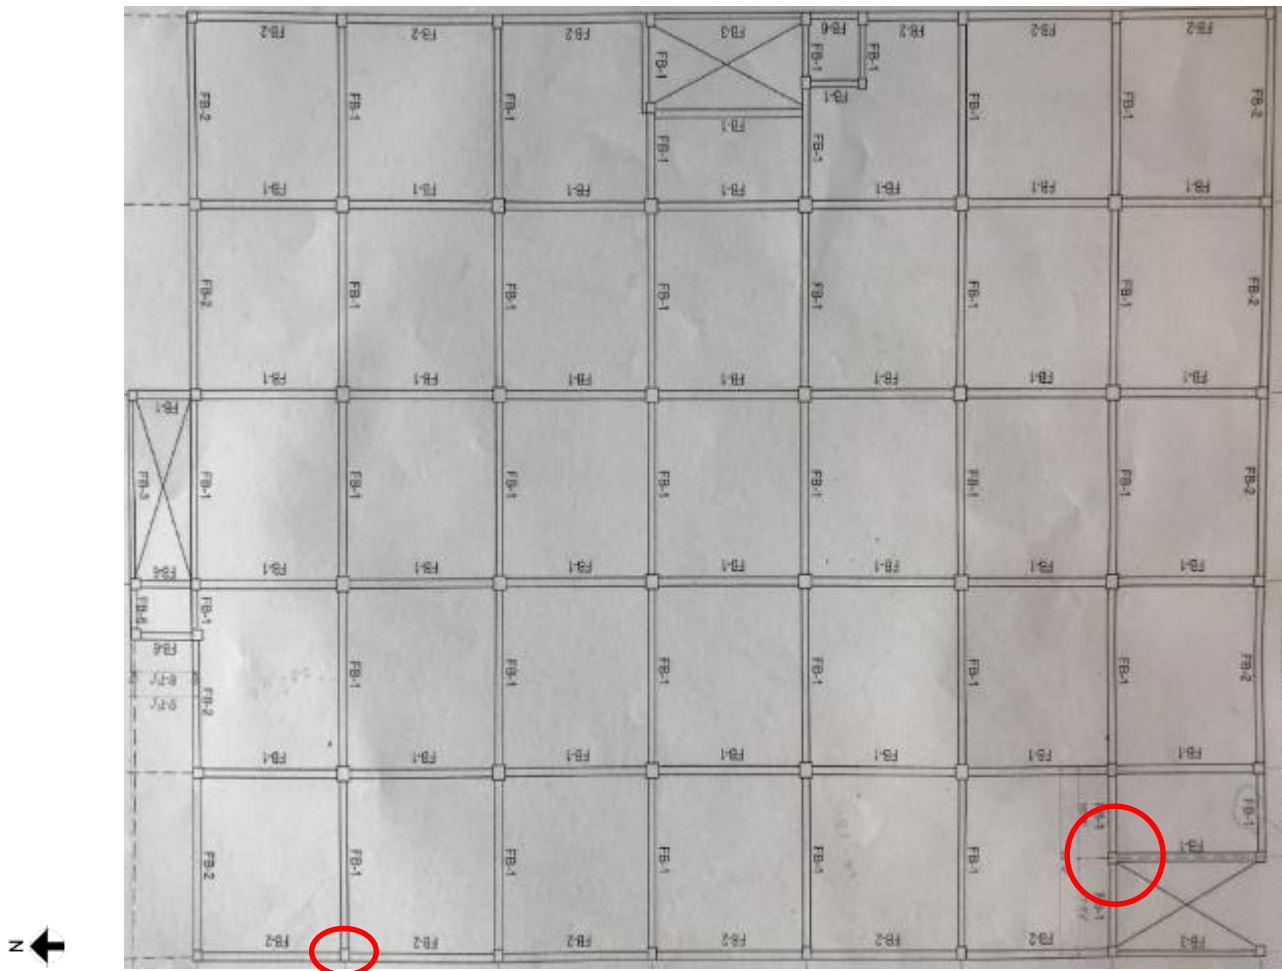
**Observation: Production building**

**Columns and foundations appeared to be stressed above normal design limits**

Cursory calculation indicates that highlighted columns appear to be stressed above normal design limits due to over head water tank and brick wall & floor built-up of toilet area. Factory engineer needs to check column stress as a part of Detail Engineering Assessment(DEA) . Factory should take necessary action according to report.

| Item No. | Observation | Recommended Action Plan | Recommended Timeline |
|---|---|---|---|
| 1 | Production building<br>Columns and foundations<br>appeared to be stressed<br>above normal design limits | Factory Engineer to review design, loads and columns stresses in all columns and foundation. | 6-weeks |
| 4 | Production building<br>Columns and foundations<br>appeared to be stressed<br>above normal design limits | Detail Engineering Assessment to be completed. | 6-weeks |

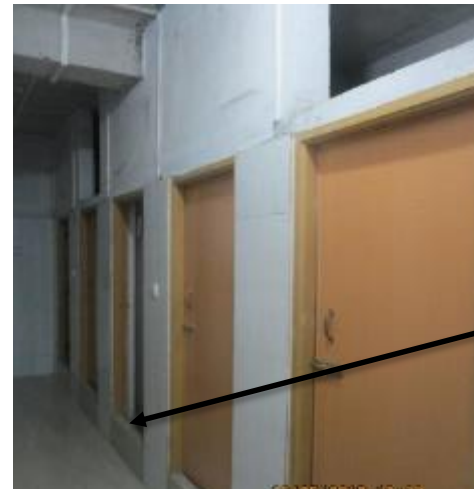
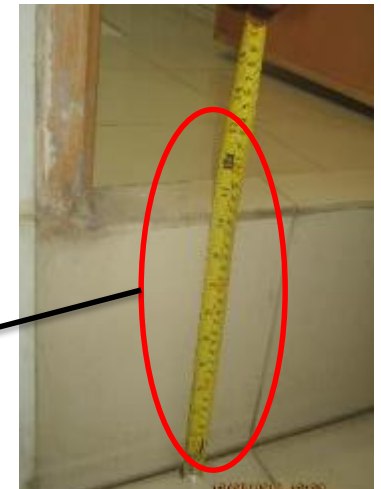
200mm built-up and 125mm thick outer brick wall on toilet area

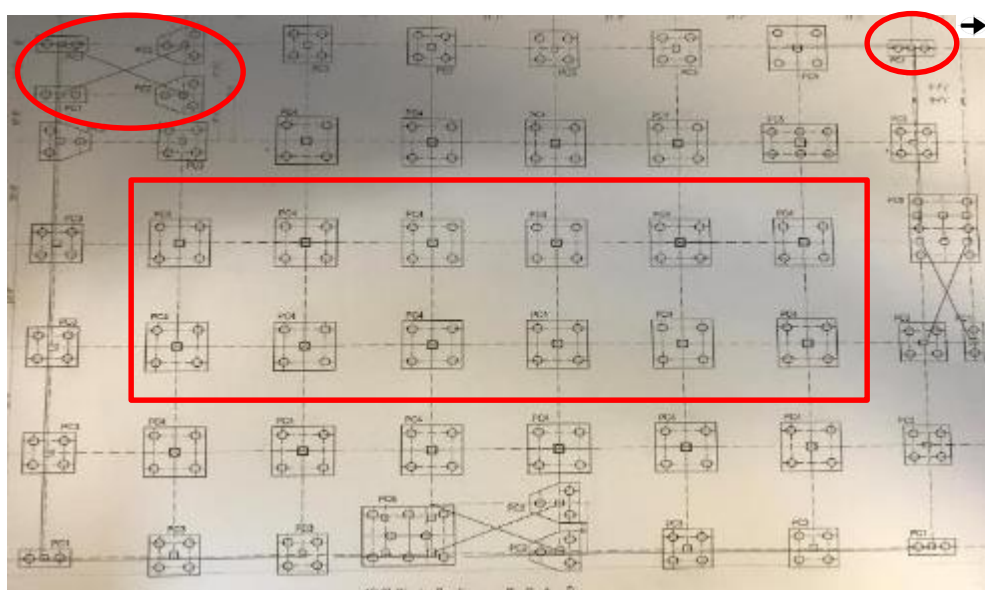
Foundation layout plan

Cursory calculation considering the pile capacity based on soil test report indicates that pile appears to be stressed above normal design limits at marked zone. Factor of safety (FoS) is less than the minimum requirement of BNBC. Factory engineer is required to review the adequacy of pile considering actual bearing capacity of soil and comply with BNBC.

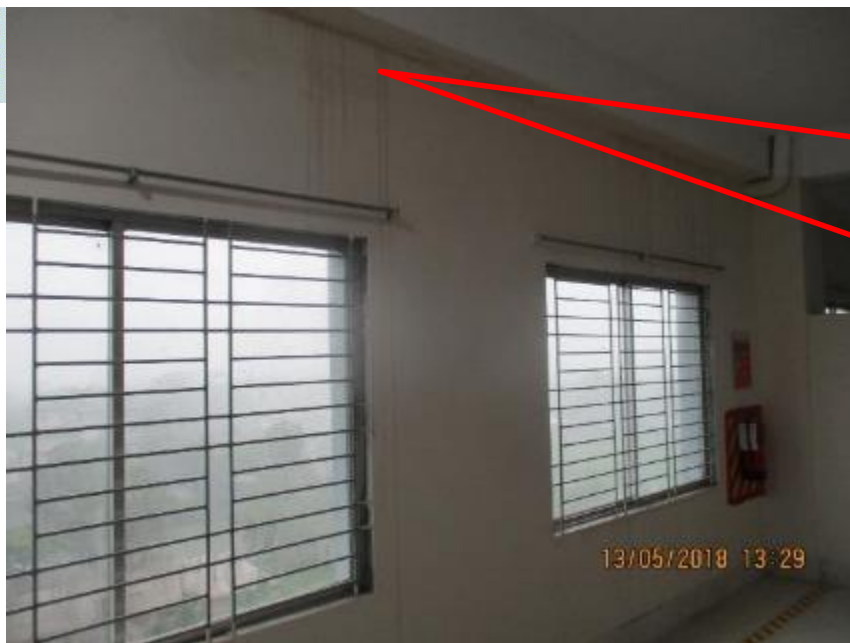
Water ingress was found on 5<sup>th</sup> floor at joint of beam and wall on south side.

| Item No. | Observation | Recommended Action Plan | Recommended Timeline |
|---|---|---|---|
| 7 | Production building<br>Water ingress on beam to<br>wall joint | Factory engineer is required to provide proper remedial method for preventing water ingress. | 6-weeks |

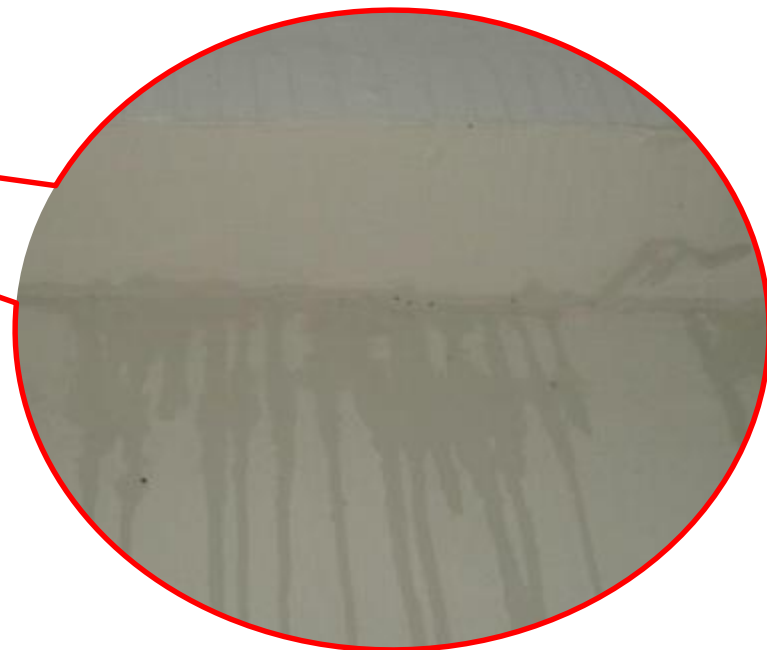
Water ingress was found in several locations along with the beam to wall joint on south side. Factory engineer is required to take proper remediation for preventing further water ingress.

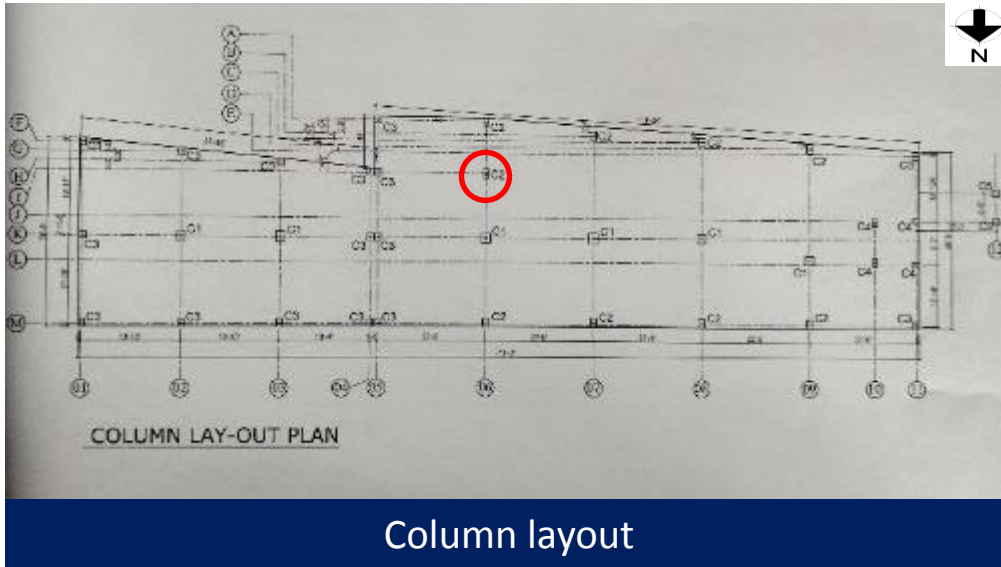
Column layout

**Columns appeared to be stressed above  
normal design limits**

Cursory calculation indicates that highlighted columns appear to be stressed above normal design limits due to loads of water tanks and brick walls of toilet areas. Factory engineer need to check column stress as a part of Detail Engineering Assessment (DEA) and factory should be take necessary action according to report.

| Item No. | Observation | Recommended Action Plan | Recommended Timeline |
|---|---|---|---|
| 8 | Ware House Building<br>Columns appeared to be stressed above normal design limits | Factory Engineer to review design, loads and columns stresses in all columns. | 6-weeks |
| 11 | Ware House Building<br>Columns appeared to be stressed above normal design limits | Detail Engineering Assessment to be completed. | 6-weeks |

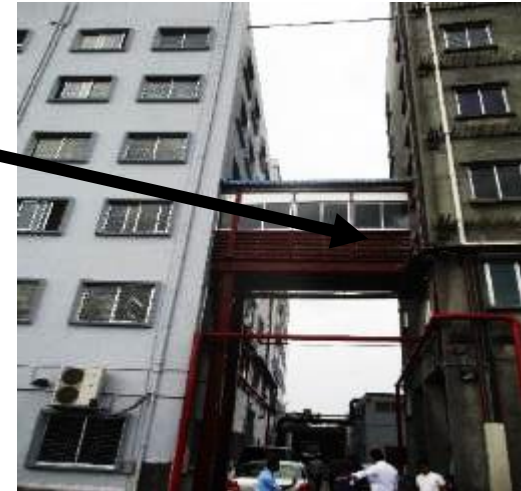
Link Bridge

Two adjacent buildings (production building & ware house building) are connected by a link bridge. Link bridge rests on floor beam, which may not be adequate to carry the load from the link bridge. Factory Engineer is required to carry out adequacy check of the beam as a part of DEA report.

| Item No. | Observation | Recommended Action Plan | Recommended Timeline |
|---|---|---|---|
| 14 | Ware House Building<br>Beam Adequacy check of ware house building for link bridge | Factory Engineer is required to carry out adequacy check of link bridge supported beam as a part of DEA. | 6-weeks |
| 15 | Ware House Building<br>Beam Adequacy check of ware house building for link bridge | Carry out remedial works arise from design review(if requires). | 6-months |

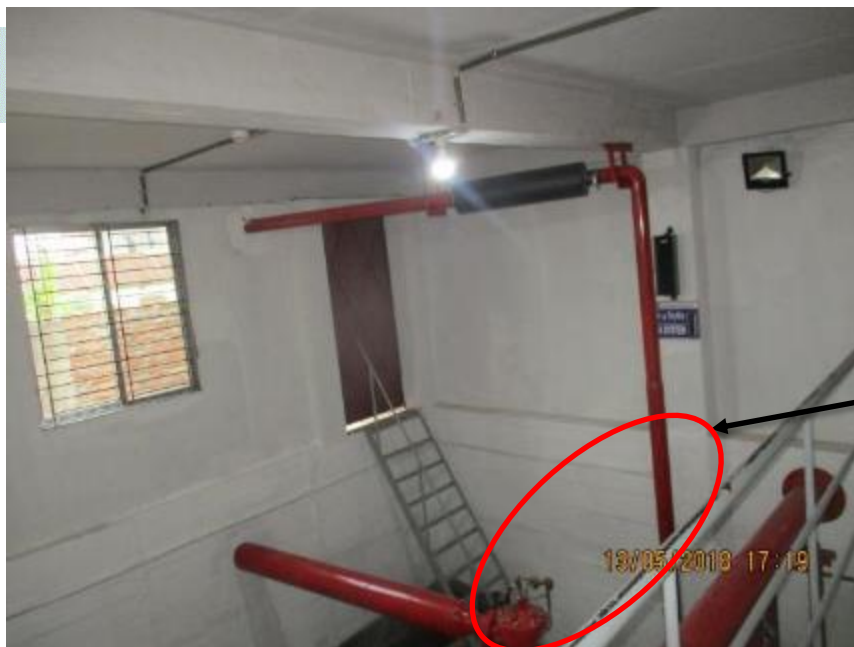
The marked grade beam was not found on site

Factory is required to revise as-built drawings as per actual condition

| Item No. | Observation | Recommended Action Plan | Recommended Timeline |
|---|---|---|---|
| 16 | Utility building (Fire hydrant pump room)<br>Discrepancy between as-built drawings and on site condition | Factory engineer to survey the building and produce as-built documentation reflecting the as constructed condition. | 6-weeks |

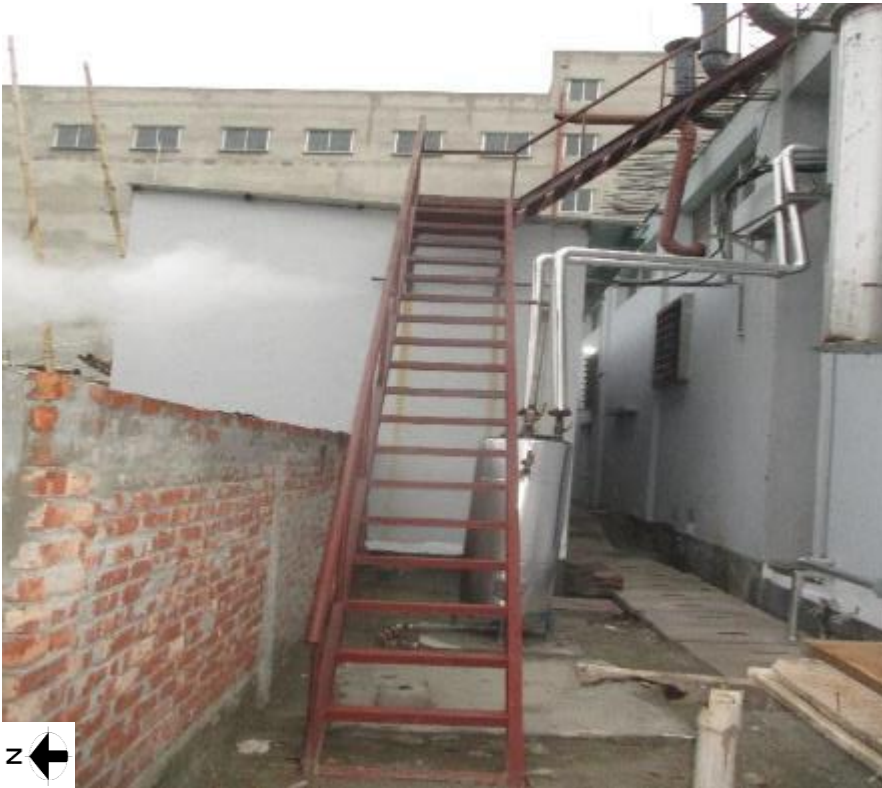
Steel stair beside generator room and canteen shed

During inspection, non-engineered steel stair observed between generator room and canteen shed. Factory engineer is required to check the stair to carry superimposed loads.

| Item No. | Observation | Recommended Action Plan | Recommended Timeline |
|---|---|---|---|
| 18 | (Steel Stair beside Canteen Shed and Generator Room)<br>Non-engineered steel stair beside generator room and canteen shed | Factory Engineer to review the stability of the steel stair to carry superimposed loads. | 6-weeks |
| 19 | (Steel Stair beside Canteen Shed and Generator Room)<br>Non-engineered steel stair beside generator room and canteen shed | Carry out remedial works as per assessment. | 6-months |

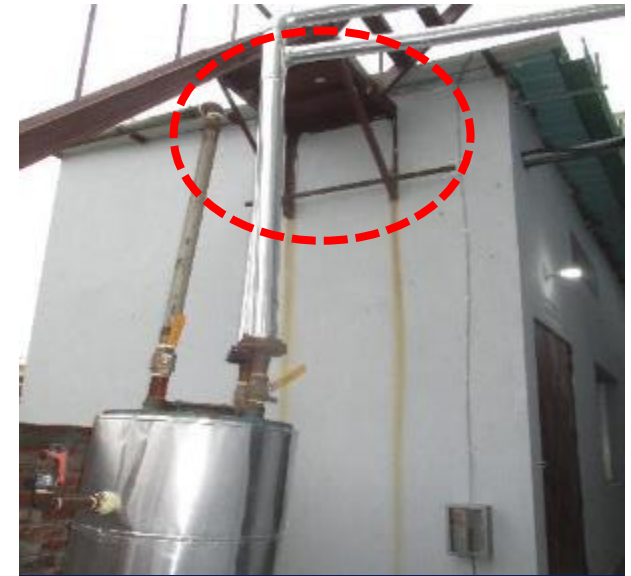
Bolted connection observed with brick wall to support the stair.

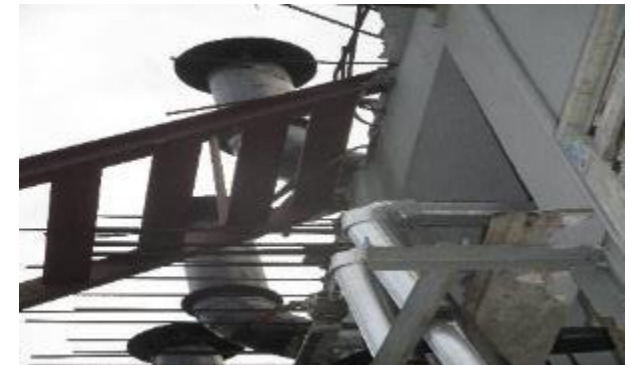
Stair end resting on generator room slab

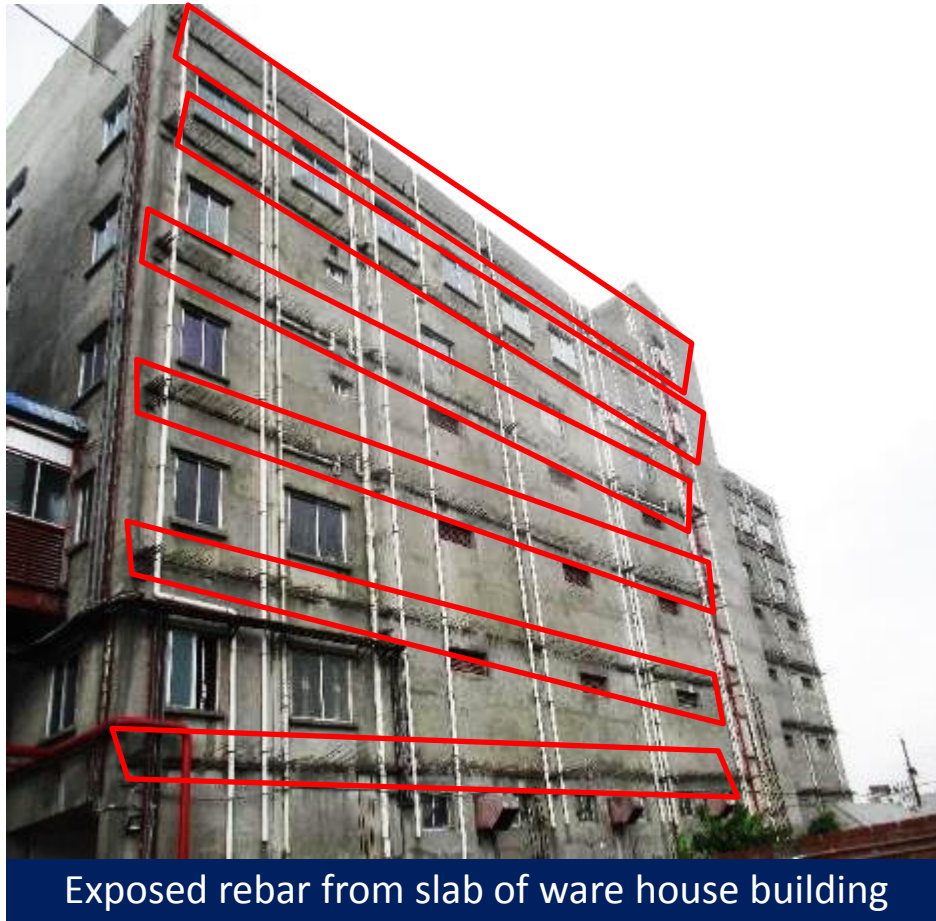
Exposed rebar from slab of ware house building

During inspection, exposed rebar was observed from slab of ware house building and generator room. Factory is required to provide anti corrosive paint on the exposed rebar to avoid corrosion.

| Item No. | Observation | Recommended Action Plan | Recommended Timeline |
|---|---|---|---|
| 20 | (Ware House Building and Generator Room)<br>Exposed rebar from slab prone to corrosion | Factory is required to provide anti corrosive paint on the exposed rebar to avoid corrosion. | 6-weeks |

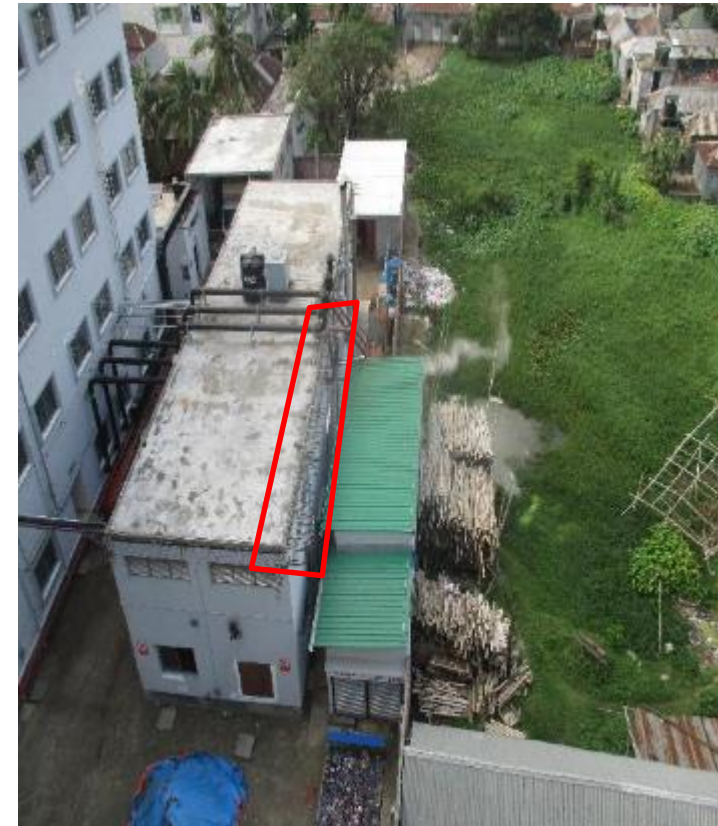
Exposed rebar from slab of generator room
