FIRE SAFETY INSPECTION REPORT

APPAREL GALLERY LTD.

**144,147,148 NARASHINGPUR, ASHULIA, SAVAR,
DHAKA**

ACCORD
on Fire and Building Safety in Bangladesh

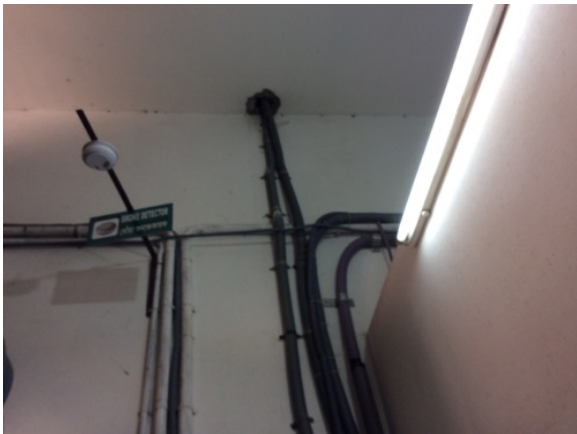
F-1	Fire Rated Construction	Unsealed penetrations and openings are located in the fire-rated floor/ceiling assemblies.	Seal all penetrations and openings in floor/ceiling assemblies to maintain the fire separation.	Within 3 months
-----	-------------------------	--	---	-----------------

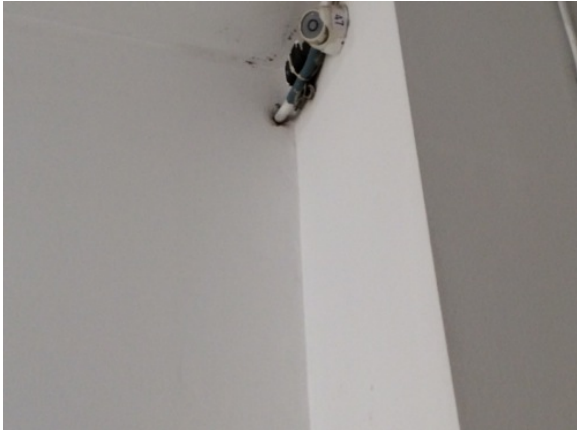
F-2	Fire Rated Construction	Unsealed penetrations and openings are located in exit stair enclosures.	Seal all penetrations and openings in exit stair enclosure walls to maintain the fire separation.	Within 3 months
-----	-------------------------	--	---	-----------------

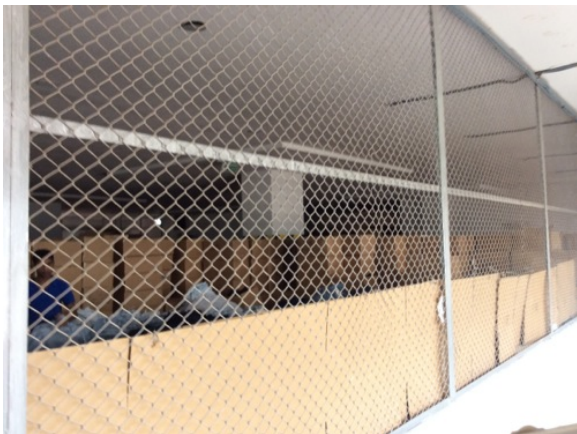
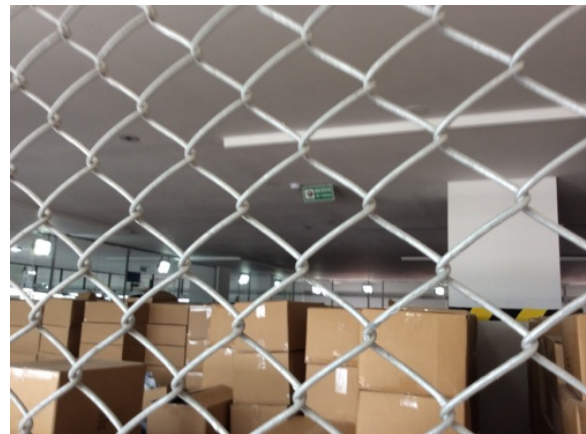
F-3	Fire Rated Construction	Packing storage on the 7th floor is not separated from the production floor by fire rated construction.	Provide dedicated storage rooms separated by minimum 1-hr fire-rated construction.	Within 3 months
-----	-------------------------	---	--	-----------------

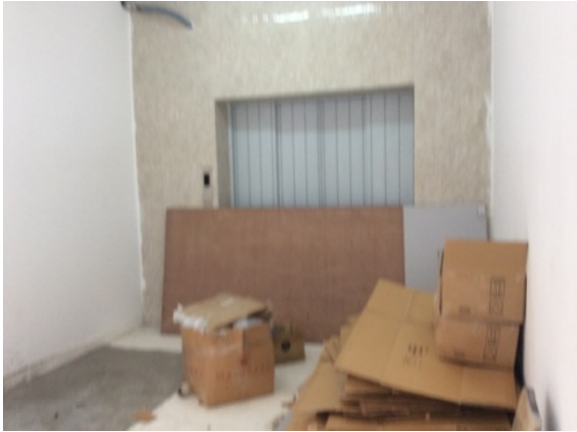
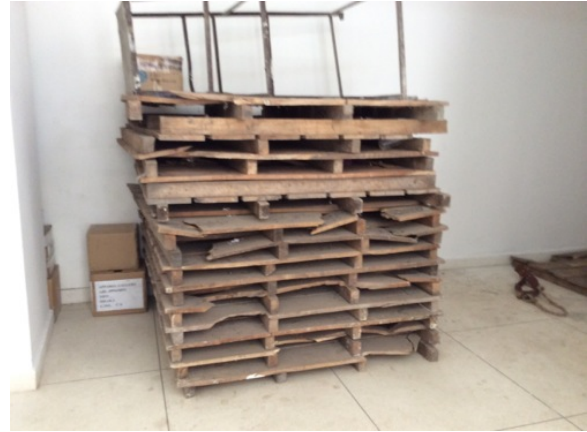
F-4	Egress	Storage was located in the East stairwell. Combustible materials for the elevator installation were located on several landings.	Remove all storage from exit stairs and egress paths.	Immediate
-----	--------	--	---	-----------

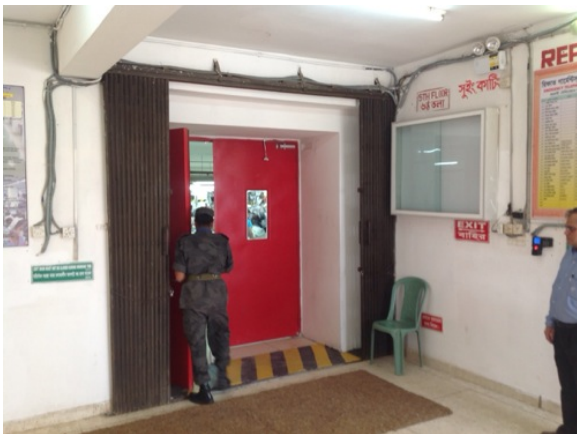
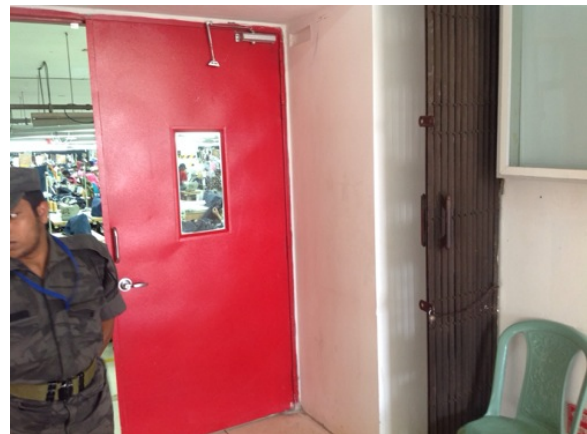
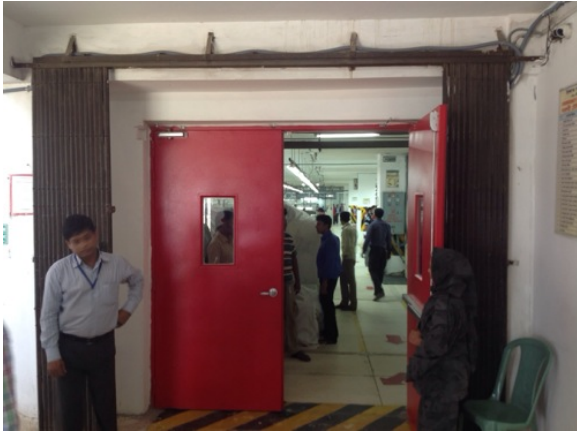
F-5	Egress	Sliding or coiling gates with locking features are provided at building exits, exit stairs, and exit discharge.	Remove locking features from all egress doors / gates. If locks are required for security reasons, utilize special door locking features complying with NFPA 101.	Immediate
-----	--------	---	--	-----------

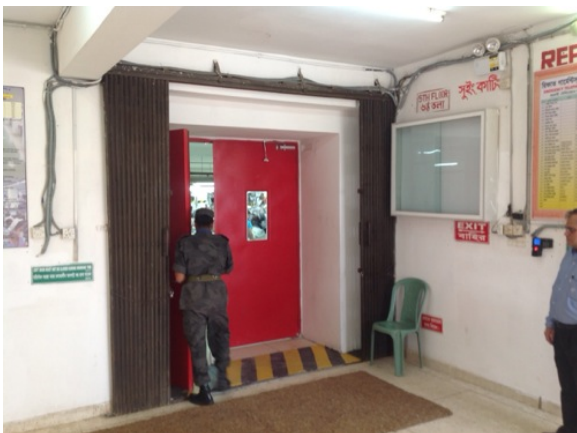
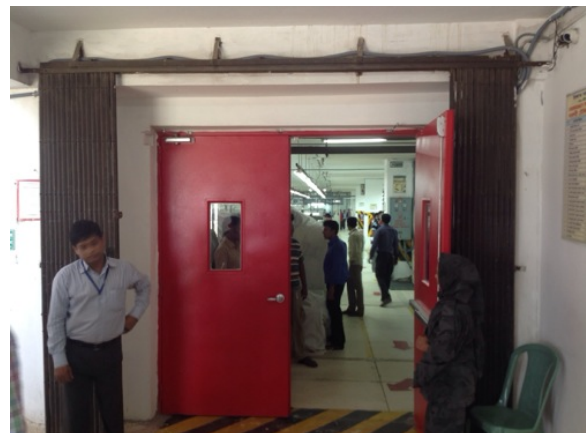
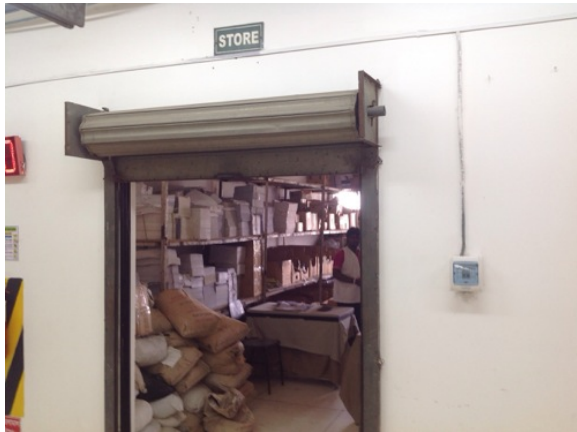
F-6 Egress

Collapsible gates / sliding doors are provided at building exits, exit stairs, along egress routes, exit discharges throughout the factory.

Replace all gates / sliding doors along the means of egress with side-hinged, swinging egress doors.

If locks are required for security reasons, utilize special door locking features complying with NFPA 101.

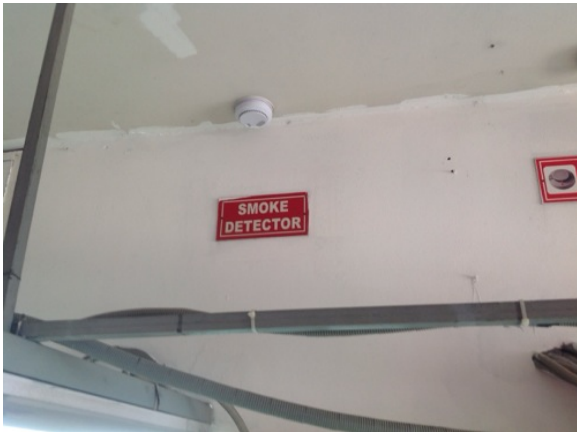
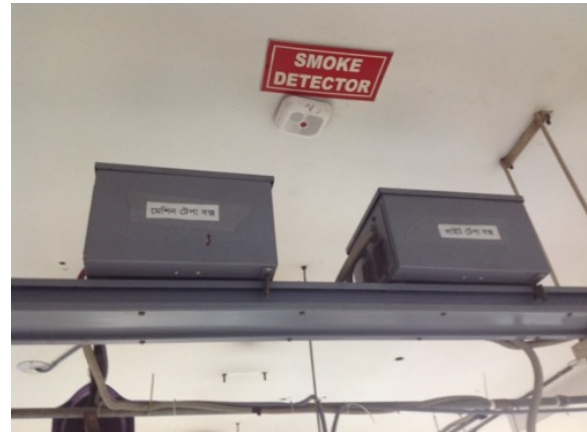
F-7	Fire Protection	The high-rise building has an occupied floor greater than 23m (75 ft) and is not provided with automatic sprinkler protection. The large occupant loads, heavy fuel loading, and anticipated extended egress times warrant sprinkler protection.	Provide automatic sprinkler protection throughout the building in accordance with NFPA 13.	Design within 6 months, install within 12 months
F-8	Fire Protection	Inspection, testing, and maintenance records for the fire alarm system were not in accordance with NFPA 72.	Inspect, test and maintain the fire alarm system, and keep written records on-site, in accordance with NFPA 72.	Within 3 months
F-9	Fire Protection	The building is equipped with single-station smoke alarms. Smoke alarm activation sounds only a local alarm and does not provide automatic fire alarm notification of occupants.	Remove single-station smoke alarms. Provide automatic smoke detection throughout the building in accordance with NFPA 72.	Within 6 months

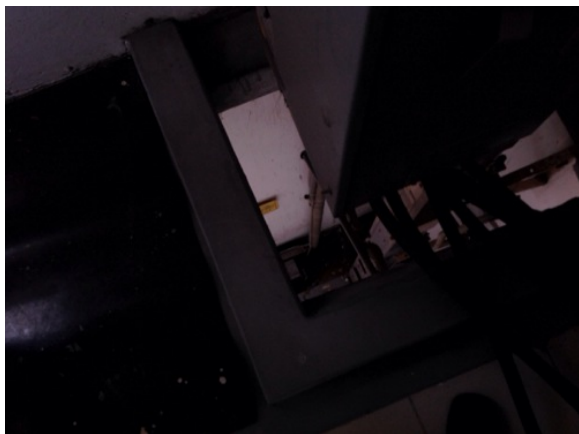
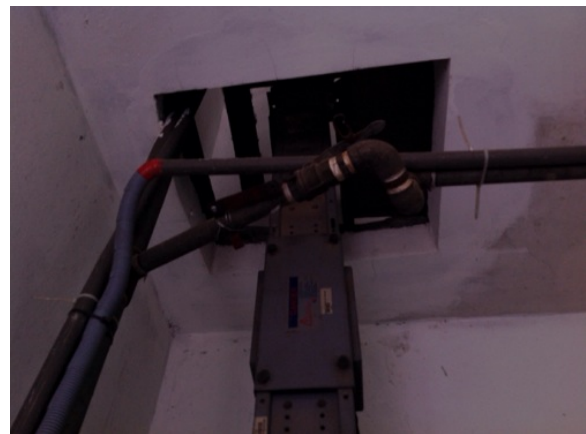
No.	Category	Finding	Recommendation	Remediation Timeframe
F-1	Fire Rated Construction	Unsealed penetrations and openings are located in the fire-rated floor/ceiling assemblies. Main power line for each floor pass though unsealed and unprotected.	Provide a minimum 2-hr fire-rated shaft to separate the utility risers from each floor level. Seal all penetrations and openings in floor/ceiling assemblies to maintain the fire separation.	Within 3 months

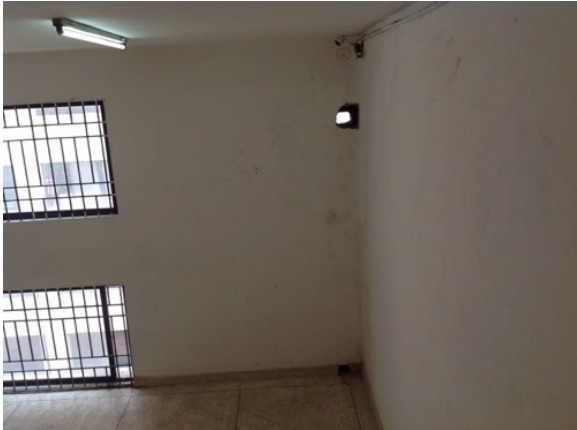
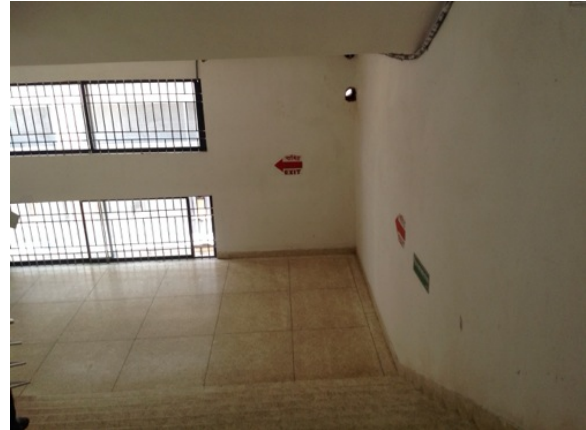
F-2	Fire Rated Construction	Unsealed penetrations and openings are located in exit stair enclosures.	Seal all penetrations and openings in exit stair enclosure walls to maintain the fire separation.	Within 3 months
F-3	Fire Rated Construction	Unsealed penetrations and openings are located in exit stair enclosures.	Seal all penetrations and openings in exit stair enclosure walls to maintain the fire separation.	Within 3 months

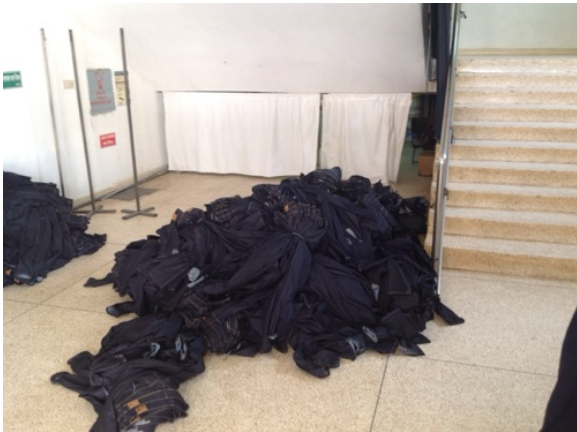
F-4	Fire Rated Construction	Service elevator shaft connects all floors of the building. Fire-rated, smoke-proof doors did not appear to be provided.	Provide a minimum 2-hr fire-rated enclosure to separate the elevator shaft from factory floors. Protect all openings with 1.5-hr fire-rated, smoke-proof doors.	Within 3 months
F-5	Egress	Storage was located in the exit stairwells ground floor wash room loading area. exit.	Remove all storage from exit stairs and egress paths.	Immediate

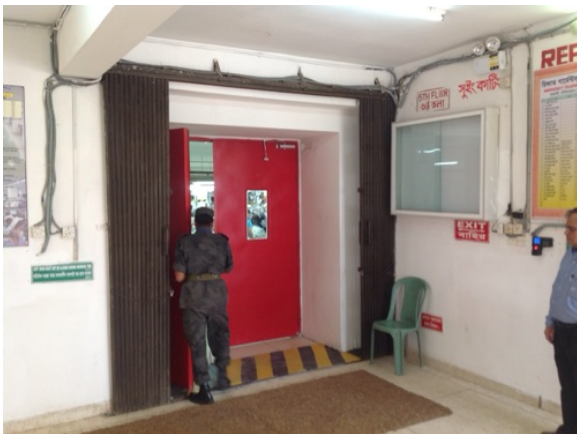
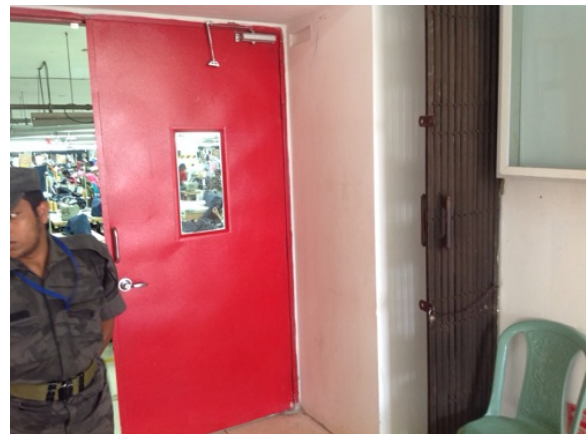
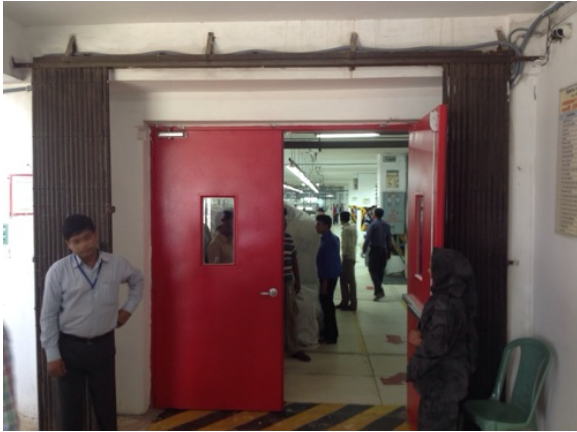
F-6 Egress

Egress doors / gates with locking features are provided at building exits, exit stairs, along egress routes, exit discharge.

Remove locking features from all egress doors / gates.

If locks are required for security reasons, utilize special door locking features complying with NFPA 101.

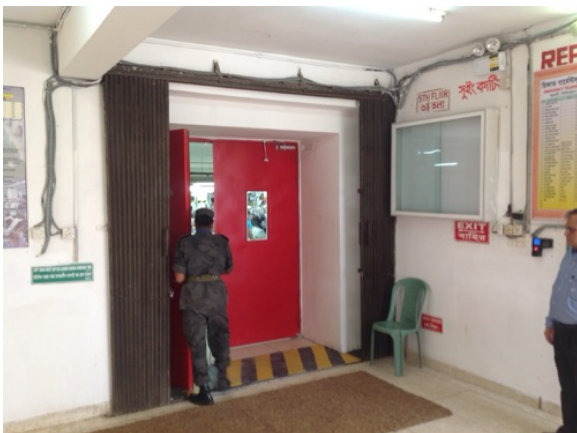
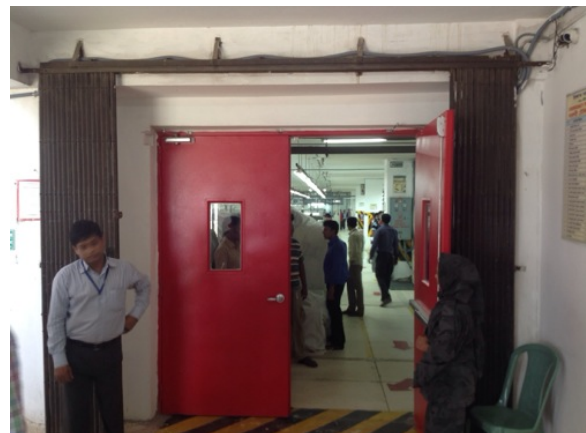
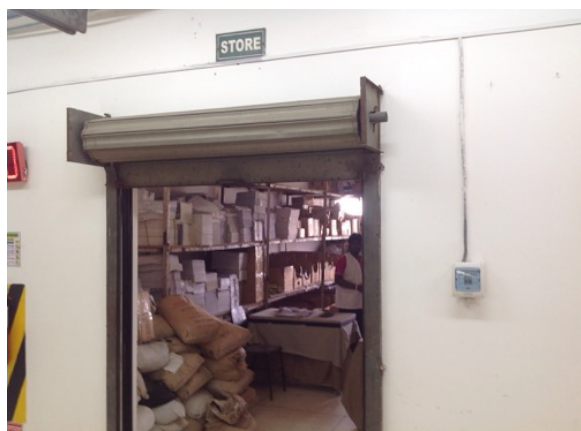
F-7 Egress

Collapsible gates / sliding doors are provided at building exits, exit stairs, along egress routes, exit discharges throughout the factory.

Replace all gates / sliding doors along the means of egress with side-hinged, swinging egress doors.

If locks are required for security reasons, utilize special door locking features complying with NFPA 101.

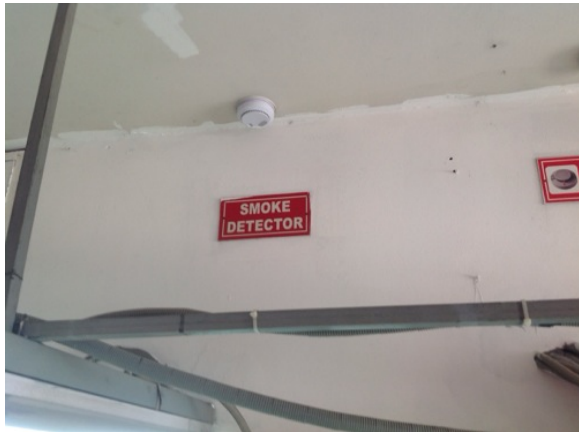
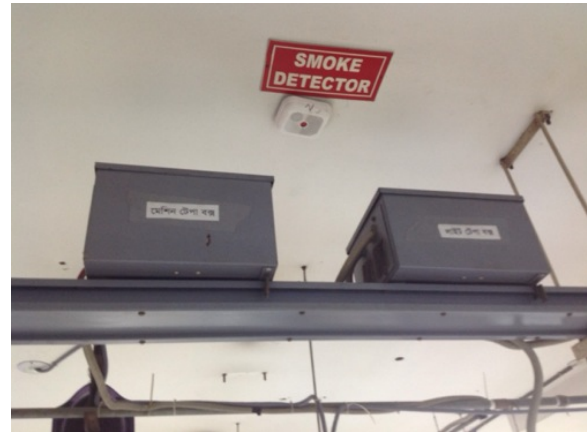
F-8	Fire Protection	Inspection, testing, and maintenance records for the fire alarm system were not in accordance with NFPA 72.	Inspect, test and maintain the fire alarm system, and keep written records on-site, in accordance with NFPA 72.	Design within 4 months, install within 9 months
F-9	Fire Protection	The building is equipped with single-station smoke alarms. Smoke alarm activation sounds only a local alarm and does not provide automatic fire alarm notification of occupants.	Remove single-station smoke alarms. Provide automatic smoke detection throughout the building in accordance with NFPA 72.	Within 6 months
