# Aspire Garments Limited

491, Dhalla Bazar, Singair, Manikgonj

24<sup>th</sup> December 2017

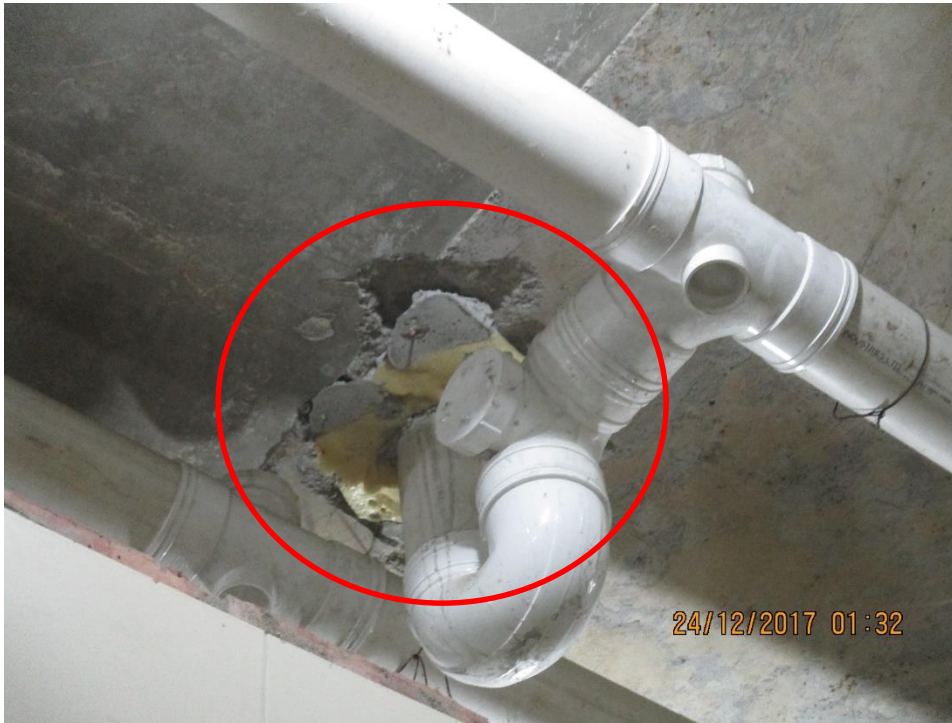
Concreting repair work

Concrete repair work around ducting facility in toilet area appeared loosen. Falling hazard may occurred direct to personal. Building engineer is required to repair the loose material works to prevent falling hazard.

| Item No. | Observation | Recommended Action Plan | Recommended Timeline |
|---|---|---|---|
| 1 | Loose concrete repair work around plumbing area | Building engineer is required to investigate the locations and carry out sustainable repair works. | Immediate - Now |

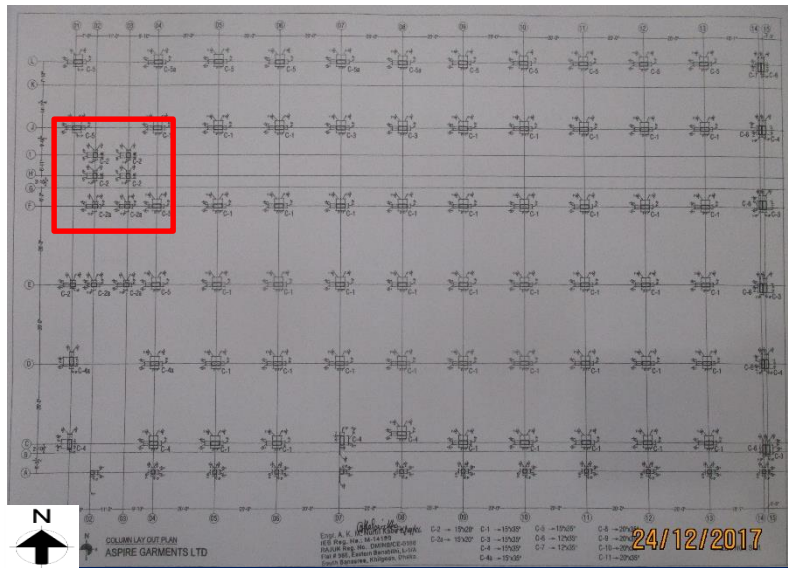
Column layout plan

Shear walls in lift core may have designed for lateral load resisting system. In As built drawing shear wall details was not included. No evidence of shear walls was observed on visual inspection. Building engineer is required to check the shear walls are actually being built or not. If not verify the design report considering only moment resisting frame against lateral loading.

| Item No. | Observation | Recommended Action Plan | Recommended Timeline |
|---|---|---|---|
| 2 | Design report to be verified by Accord | Design report is required to be reviewed by Accord. Considering all the lateral loads and design live load. | 6-weeks |

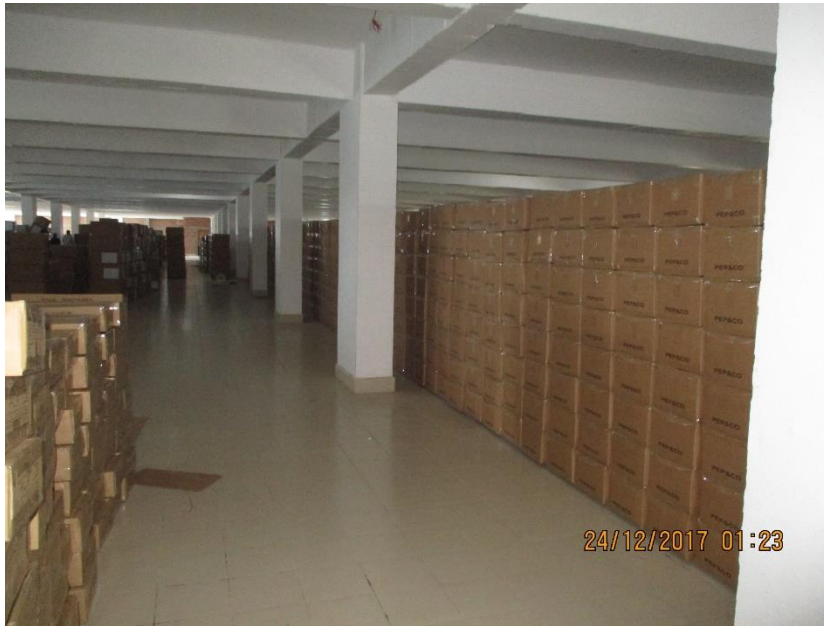
Uncontrolled live loading

No load management programs were visible. Factory is required to implement load management program as per its floor loading capacity and Follow the load plans for all floors of the buildings and make sure that the workers understand the loading requirements.

| Item No. | Observation | Recommended Action Plan | Recommended Timeline |
|---|---|---|---|
| 5 | Implement floor loading management program | Produce and actively manage a loading plan for all floor plates within the factory giving consideration to floor capacity and column capacity. | 6-weeks |

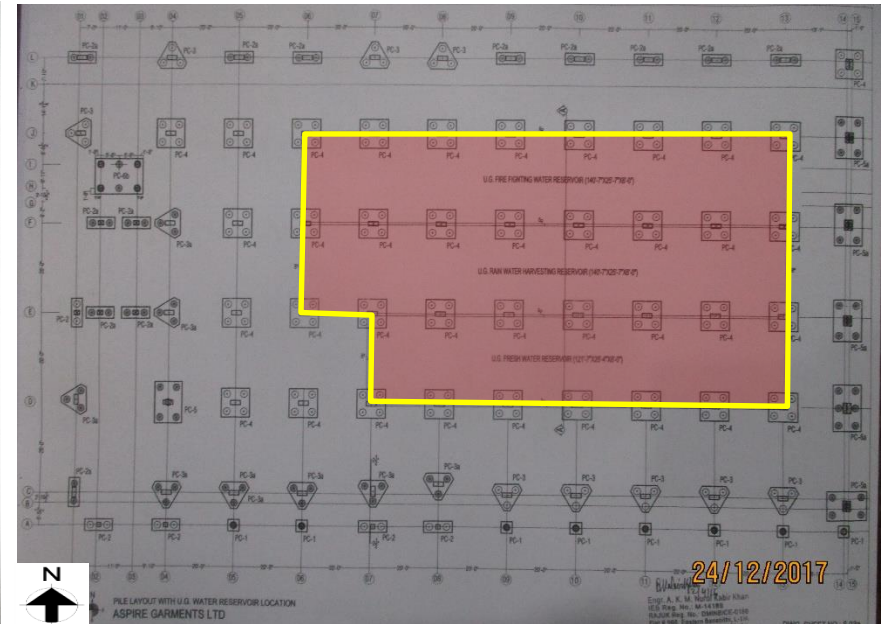
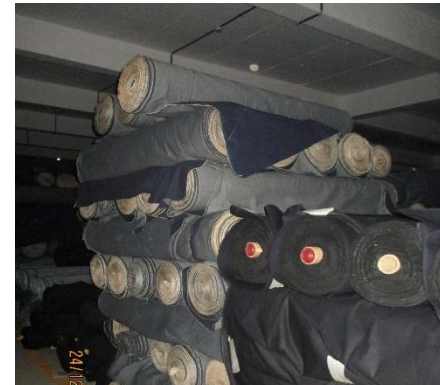
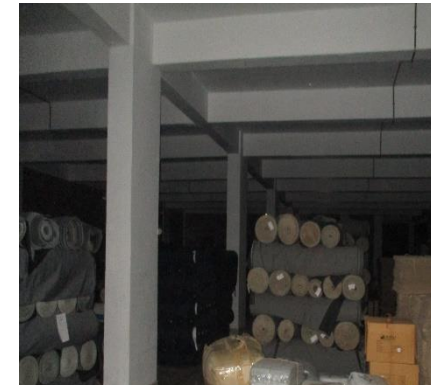
Under Ground water reservoir plan

Uncontrolled live loading on suspended ground slab (Top Slab of U.G.W.R) is required to reduce.

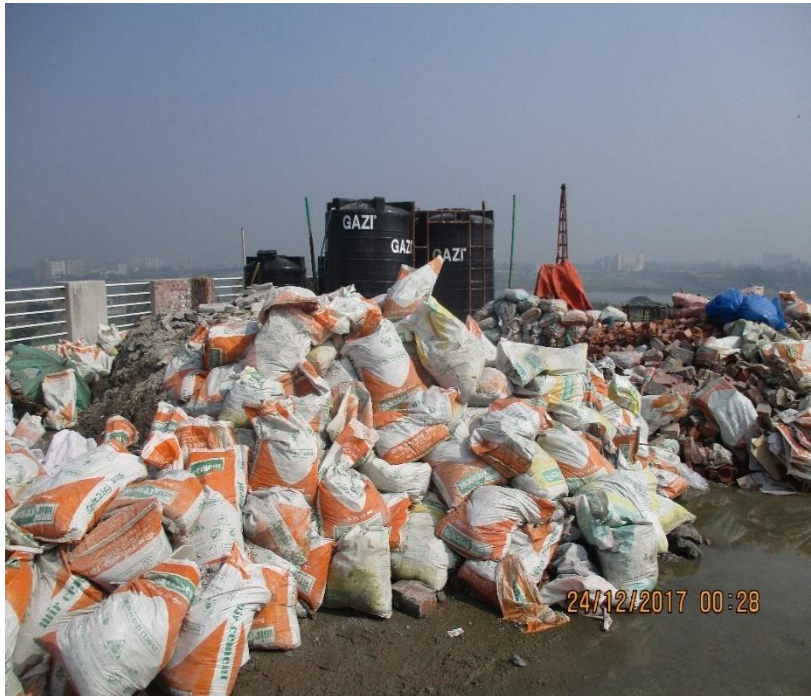
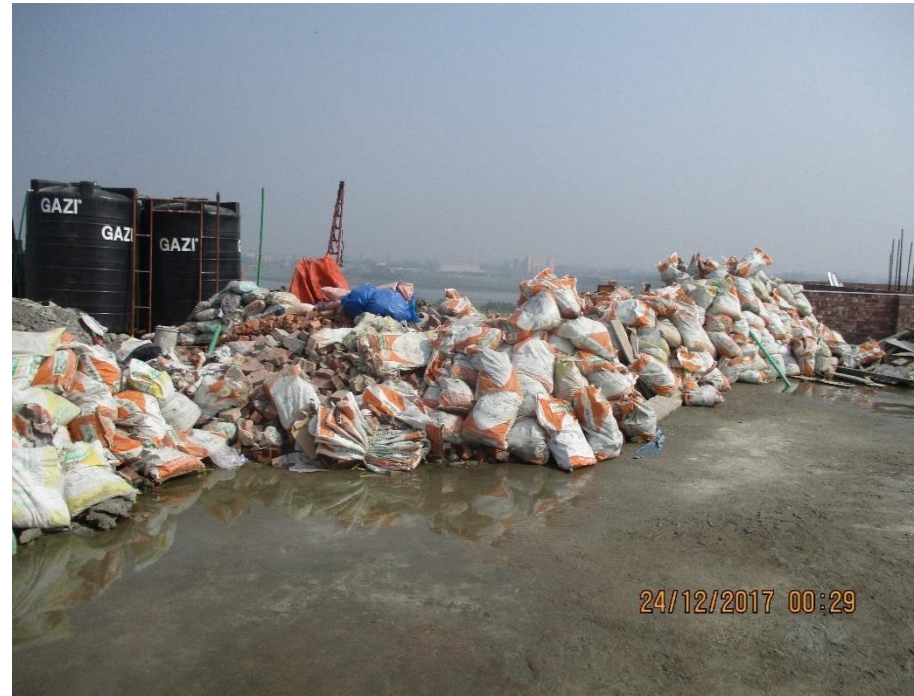
Construction derbies were piled upon roof top

Uncontrolled construction debris piled upon on roof top. Building engineer is required to check whether the piled derbies exceeds the design load capacity or remove the debris.

| Item No. | Observation | Recommended Action Plan | Recommended Timeline |
|---|---|---|---|
| 7 | Construction debris at roof top | Remove the construction debris from the roof top. | 6-weeks |

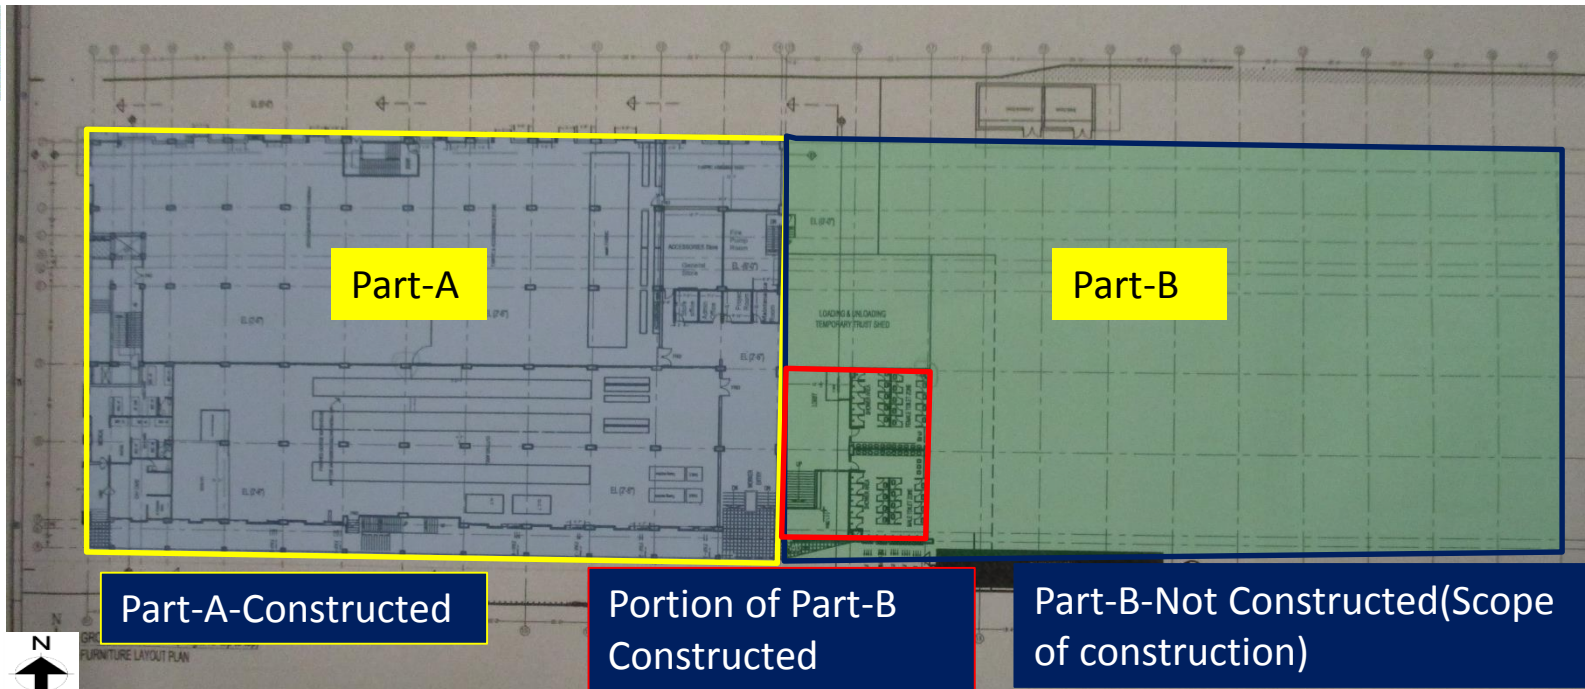
Exposed rebar indication of further construction

A scope of Horizontal extension to be carried out in future. For any kind of extension building engineer is required to evaluate structural member adequacy following BNBC provision.

| Item No. | Observation | Recommended Action Plan | Recommended Timeline |
|---|---|---|---|
| 8 | Future extension to be carried out | For any kind of extension building engineer is required to carry out Detail Engineering Assessment(DEA) considering BNBC provision. | 6-months |

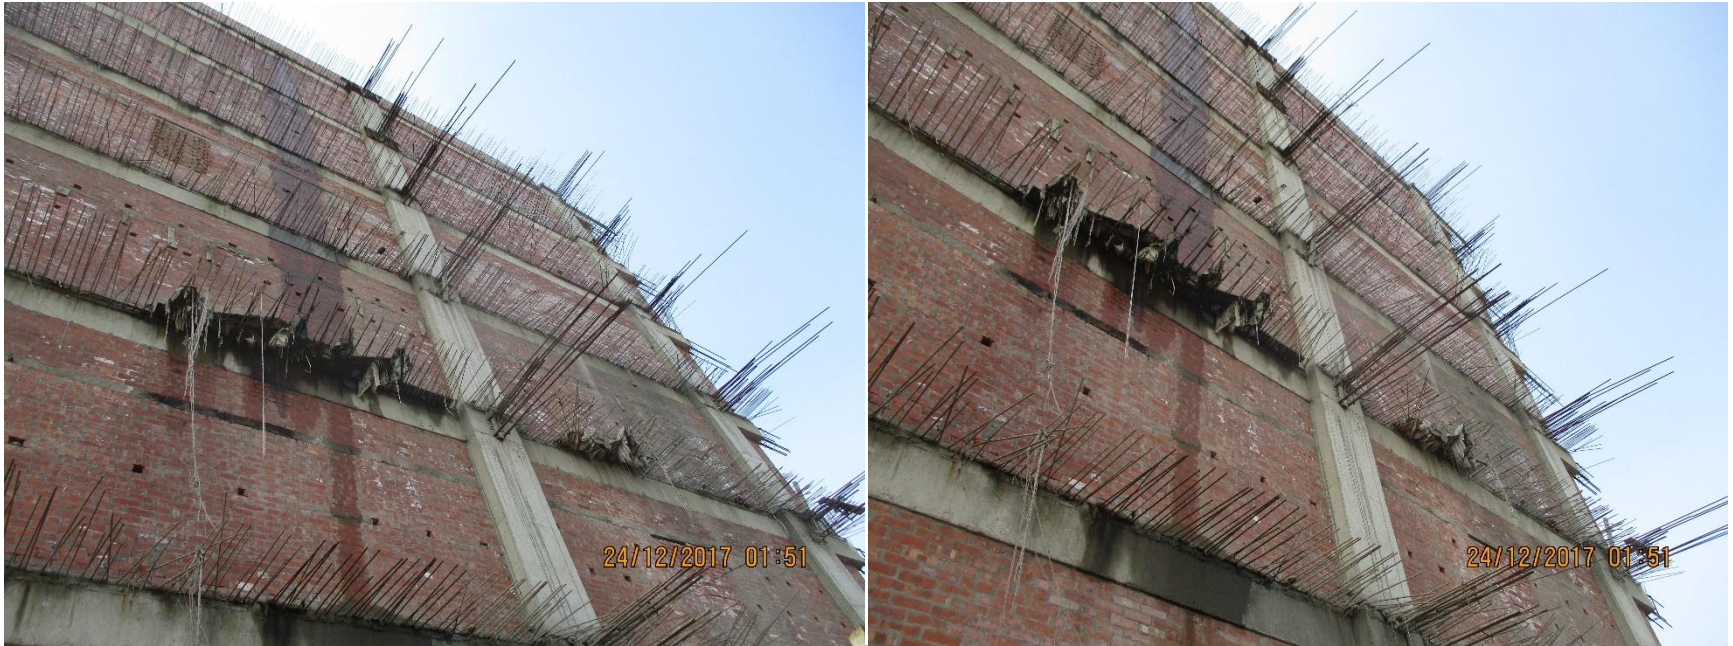
Rebar exposed to weather

Part-B of the building will be constructed in future. Rebar kept exposed without any corrosion protection.

| Item No. | Observation | Recommended Action Plan | Recommended Timeline |
|---|---|---|---|
| 9 | Exposed rebar to weather | For both durability and serviceability, rust proof paint or any appropriate method is recommended. | 6-weeks |

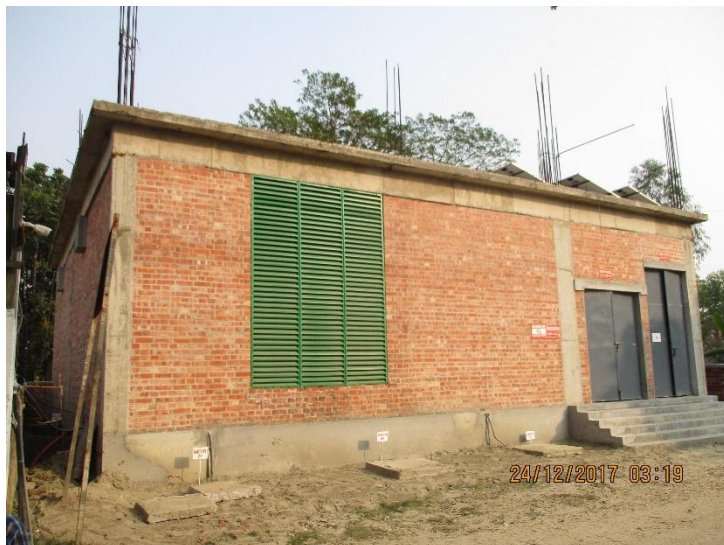
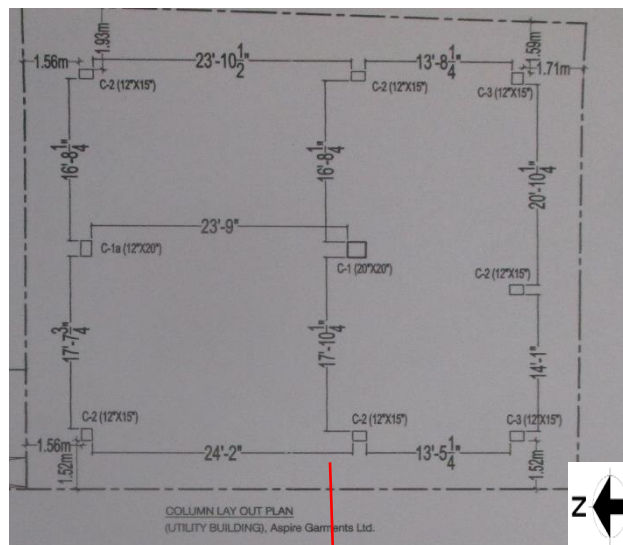
As built drawings of utility building was not reflecting with site condition

Column & Beam Layout was not matched with provided drawing.

| Item No. | Observation | Recommended Action Plan | Recommended Timeline |
|---|---|---|---|
| 10 | Produce as built drawings for the utility and ancillary sheds | Prepare as built drawings for the utility building and ancillary sheds. | 6-weeks |

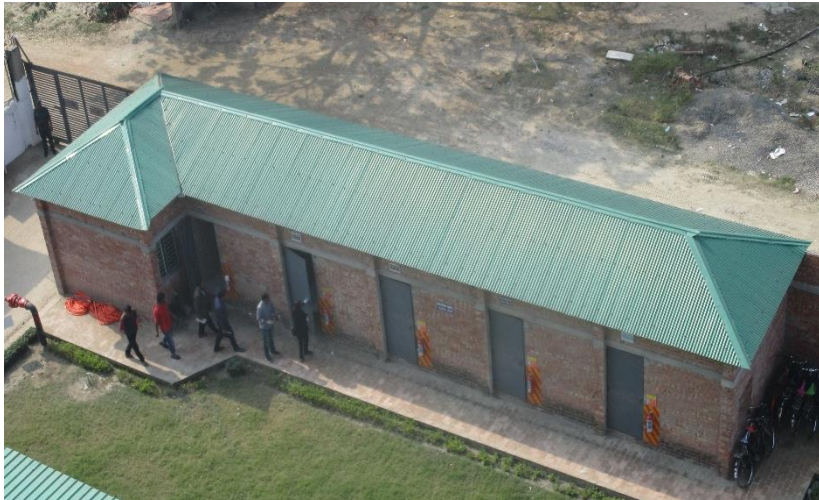
Wastage go-down & security room

No as built documents were available for ancillary structures.

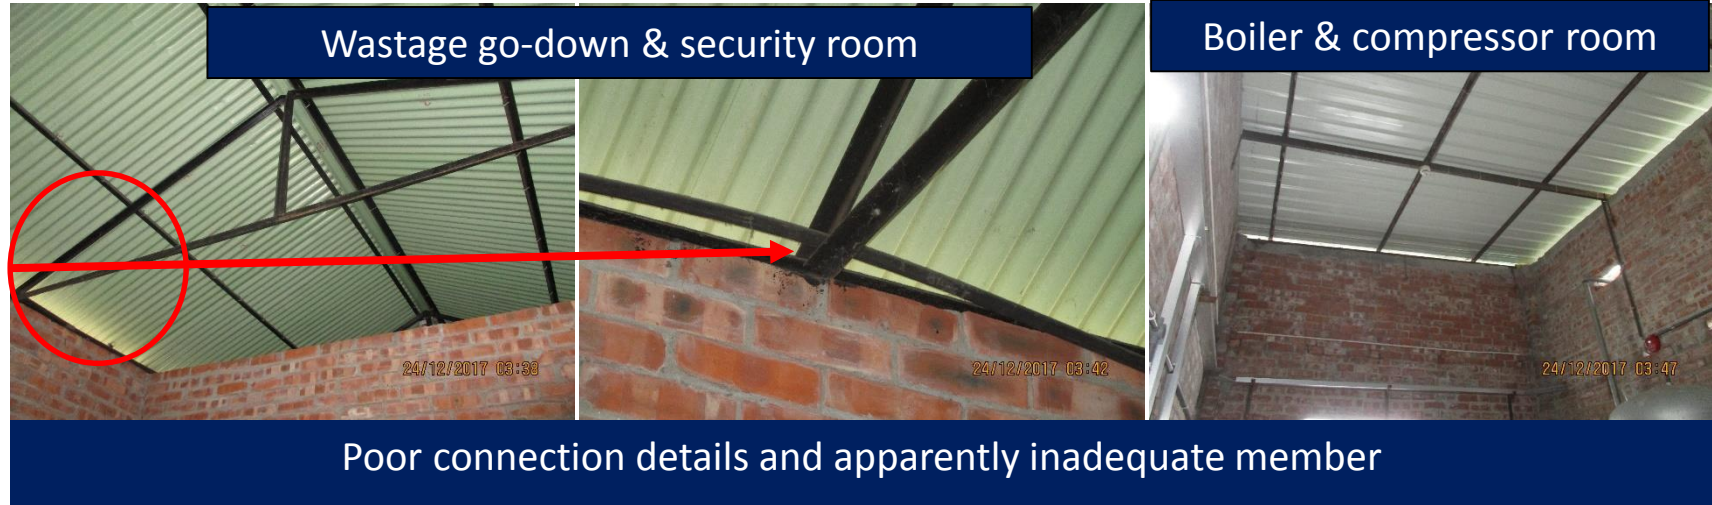
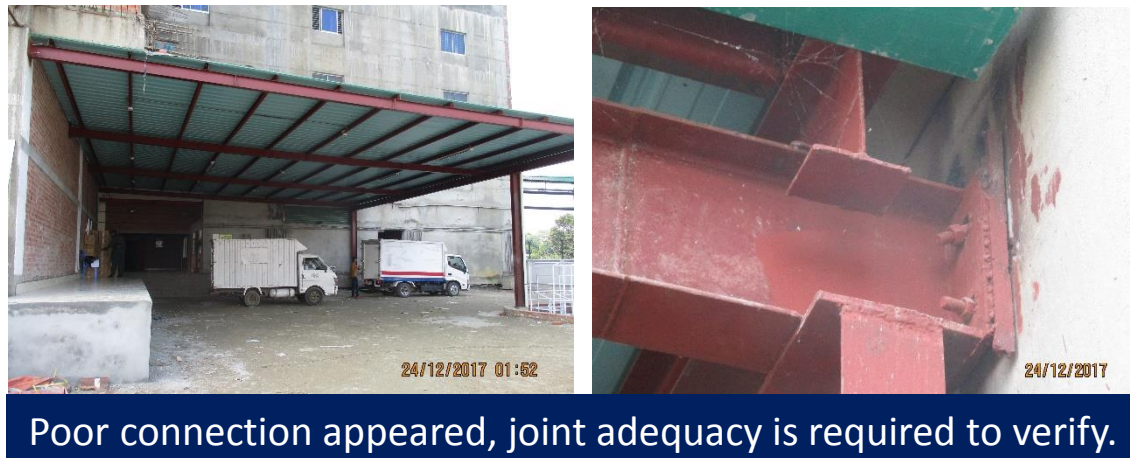
# Check the lateral stability of the ancillary sheds

| Item No. | Observation | Recommended Action Plan | Recommended Timeline |
|---|---|---|---|
| 11 | Check the lateral stability of the ancillary sheds | Building engineer is required to check the lateral stability of the ancillary sheds. | 6-weeks |
| 12 | Check the lateral stability of the ancillary sheds | Carryout remedial works where necessary. | 6-months |
