# Emon Fashion Ltd.

42, Mariali, Joydebpur, Gazipur-1700, Bangladesh  
(24.0096N, 90.4019E)

7<sup>th</sup> June 2018

# Observations

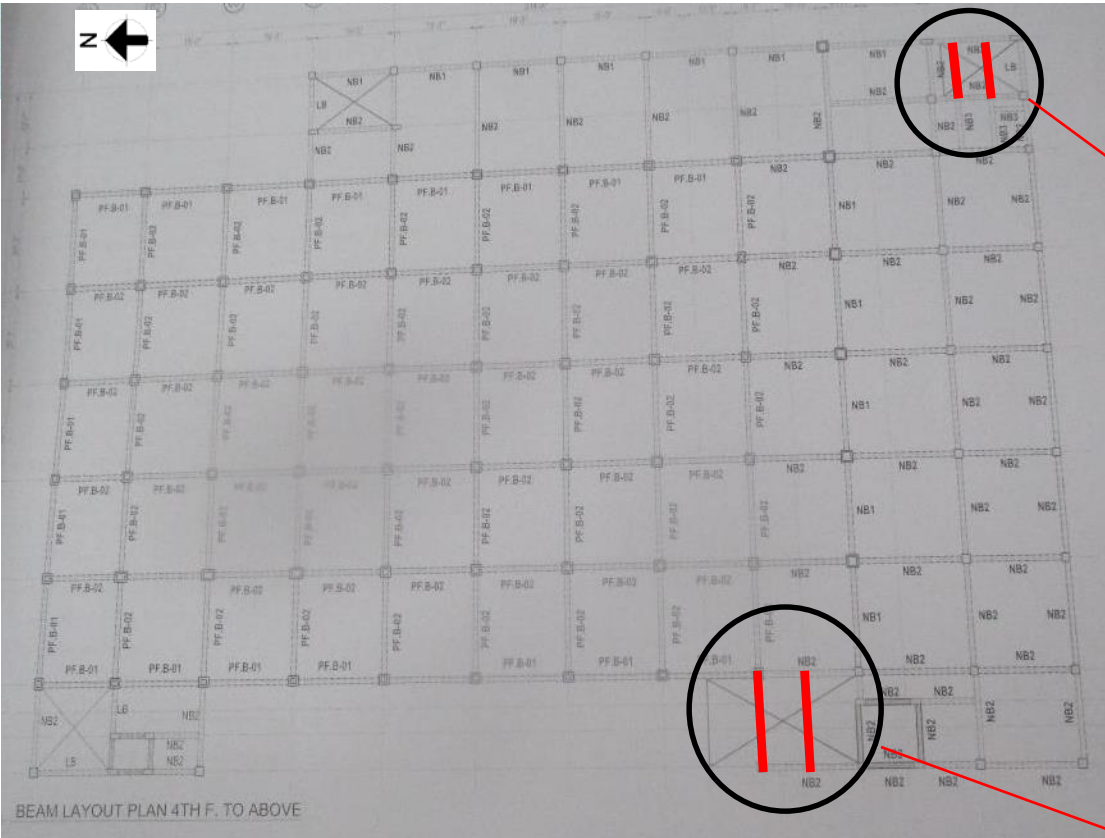
Provided beam Layout for above roof level

Red marked beams (350mm d/sX300mmW) were not shown in provided beam layout for above roof level. Factory engineer is required to update the beam layout

| Item No. | Observation | Recommended Action Plan | Recommended Timeline |
|---|---|---|---|
| 1 | (RMG Building)<br>Discrepancies between provided drawing and on site condition | Factory Engineer is required to prepare As –Built drawings reflecting the actual condition. | 6-weeks |

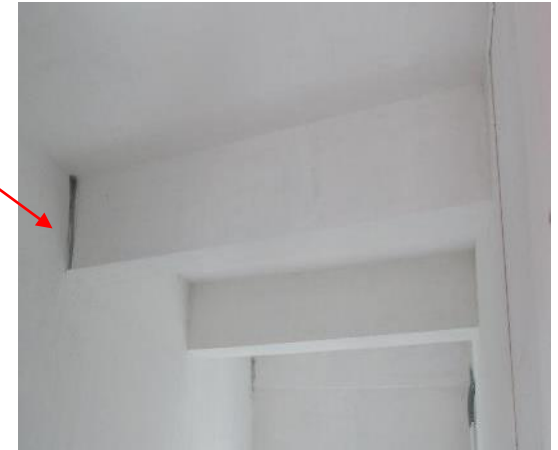
Undocumented beam

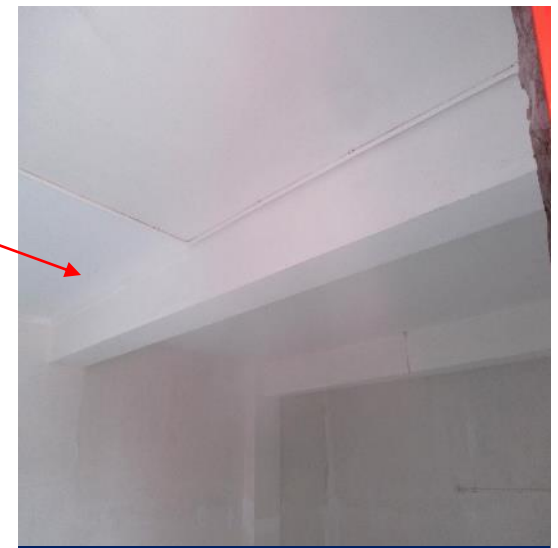
Undocumented beam

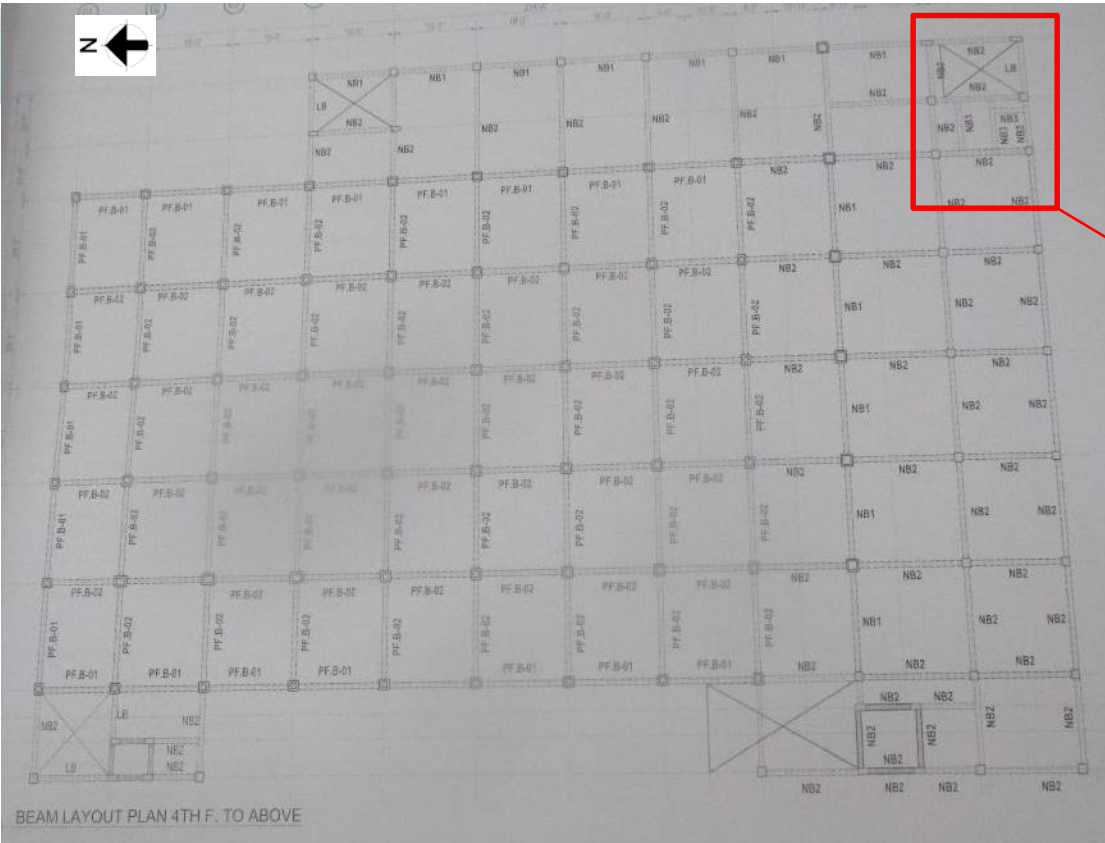
Provided beam Layout for 4<sup>th</sup> to above roof level

Marked beams were shown in beam layout for 1<sup>st</sup>, 2<sup>nd</sup>, 4<sup>th</sup>, 5<sup>th</sup> floor and top slab but those beam were observed only at 2<sup>nd</sup> and 3<sup>rd</sup> floor. Factory engineer is required to update the beam layout.

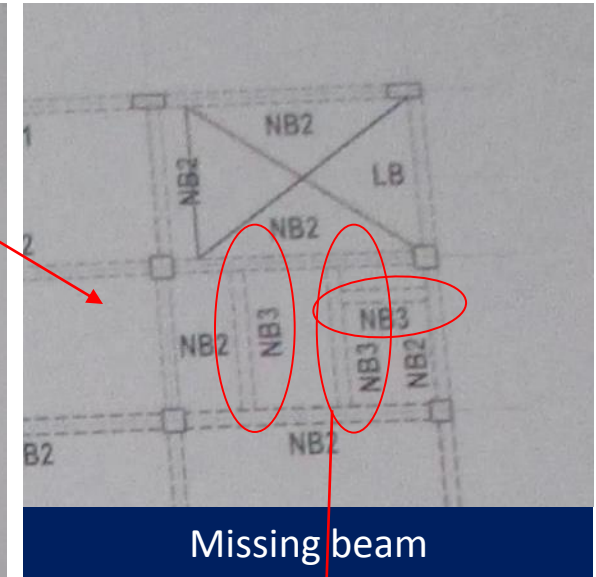
Missing beam

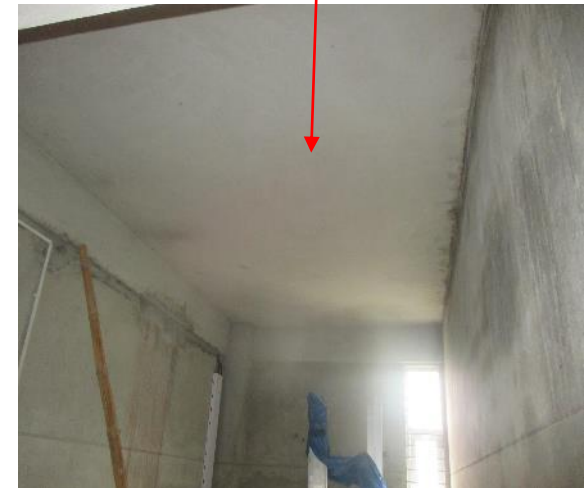
Missing beam

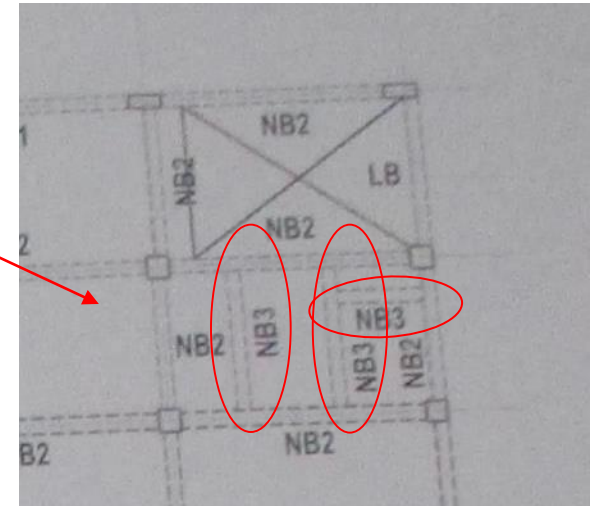
Missing beam

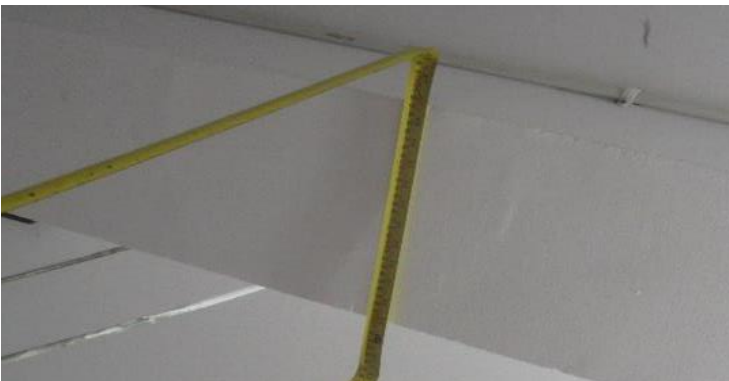
Width of NB was measured as 250 mm

Width of NB-3 was shown as 300 mm in provided drawing but in as-built condition width was observed as 250 mm. Factory engineer is required to update the beam layout.

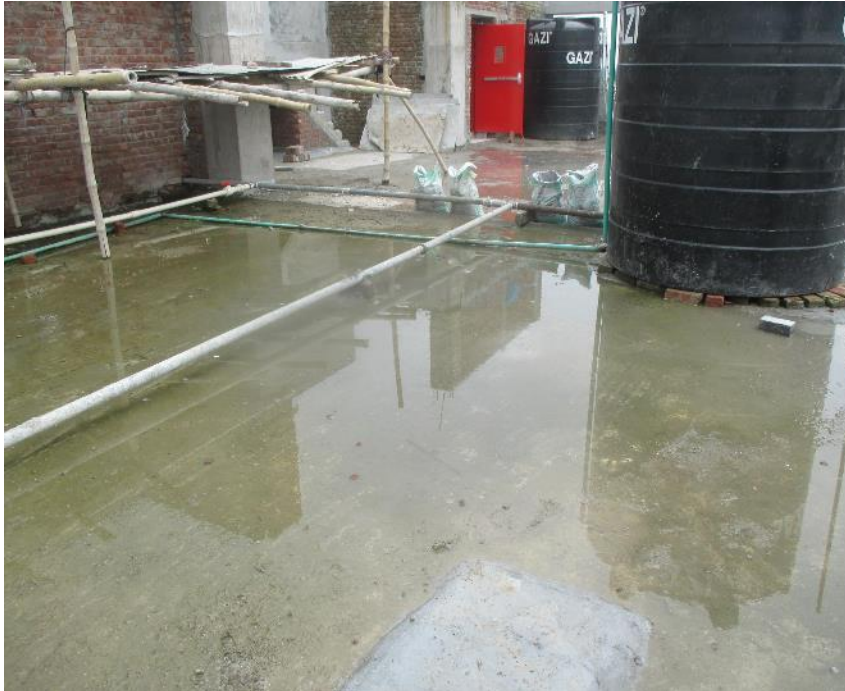
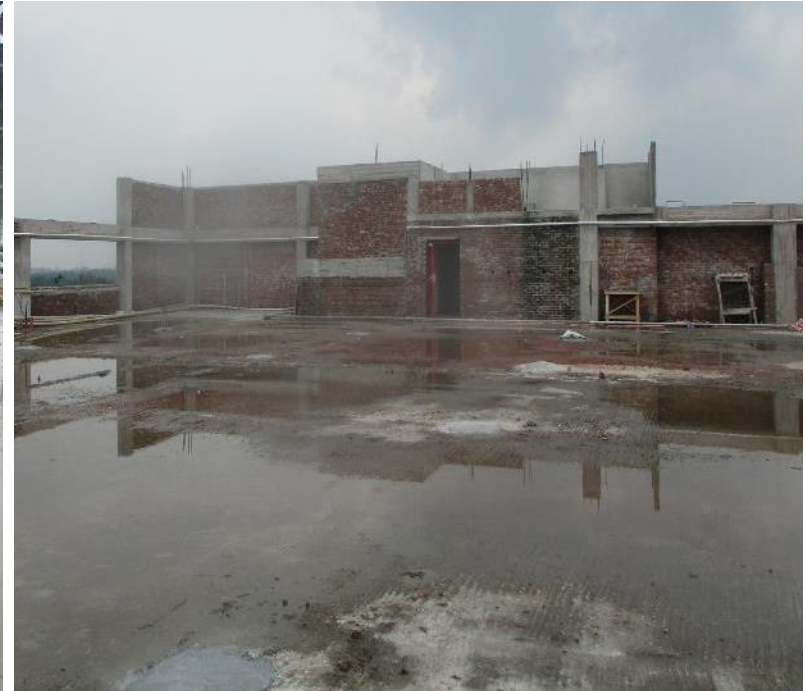
Water ponding on roof slab.

Water ponding was observed on roof slab. Factory is required to provide proper drainage system and water proofing on roof slab.

| Item No. | Observation | Recommended Action Plan | Recommended Timeline |
|---|---|---|---|
| 2 | (RMG Building)<br>Water ponding/clogging on roof slab | Factory is required to provide proper drainage system and water proofing on roof slab. | 6-weeks |

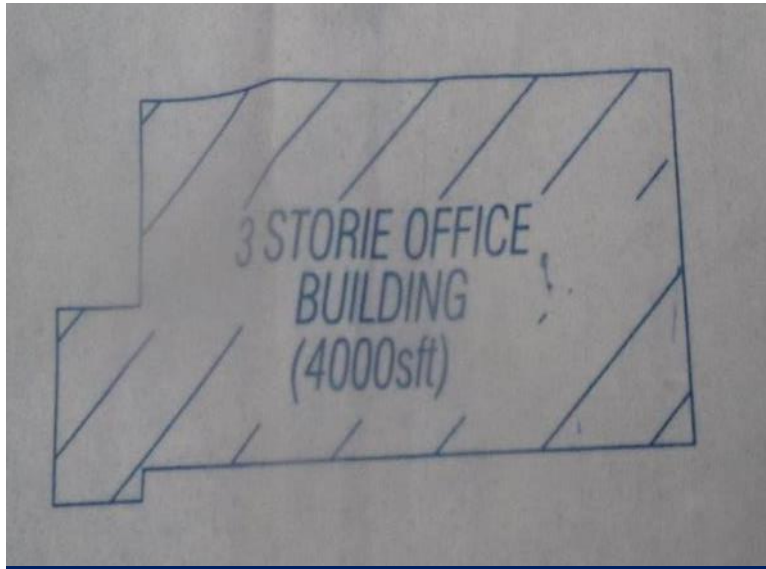
Office building was approved for 3 storied

Office building was approved for 3 storied but in actual site condition, this building was found as 4 storied. Also, no as-built drawing was available for the building. There is no proper stability system in the building. Factory engineer is required to produce accurate as-built drawing and carry out Detailed Engineering Assessment (DEA) for the building.

| Item No. | Observation | Recommended Action Plan | Recommended Timeline |
|---|---|---|---|
| 5 | (Office Building)<br>Lack of documentation and lateral stability for Office building | The Detailed Engineering Assessment to be completed. | 6-weeks |

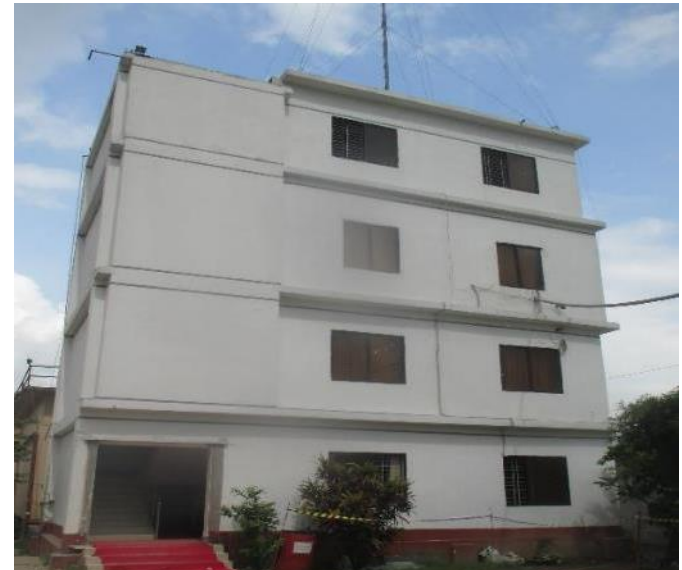
Office building was found as 4 storied

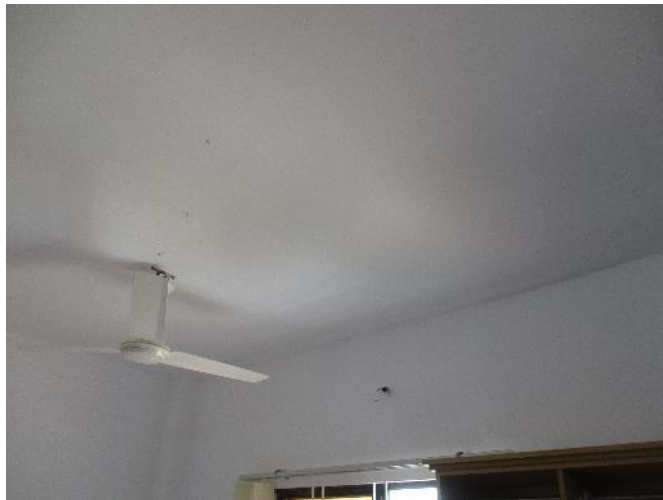
Flat Plate

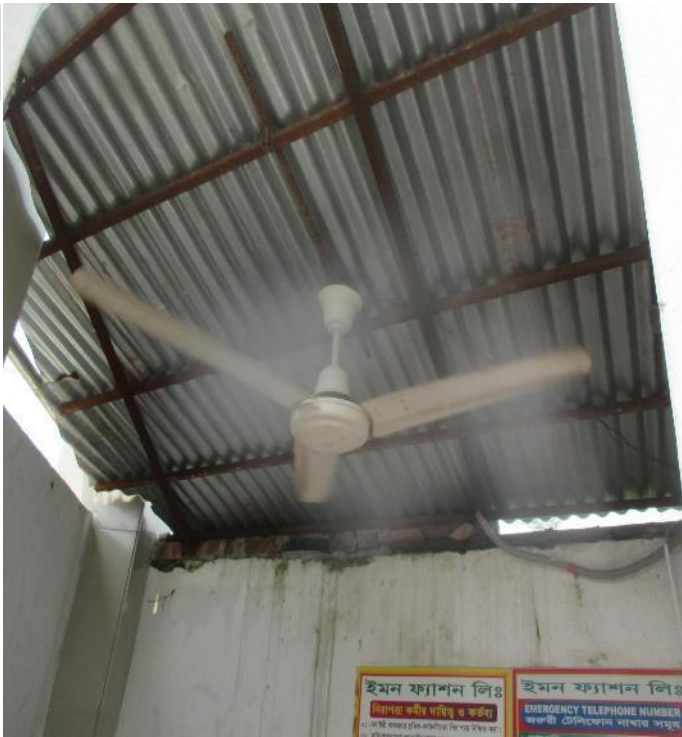
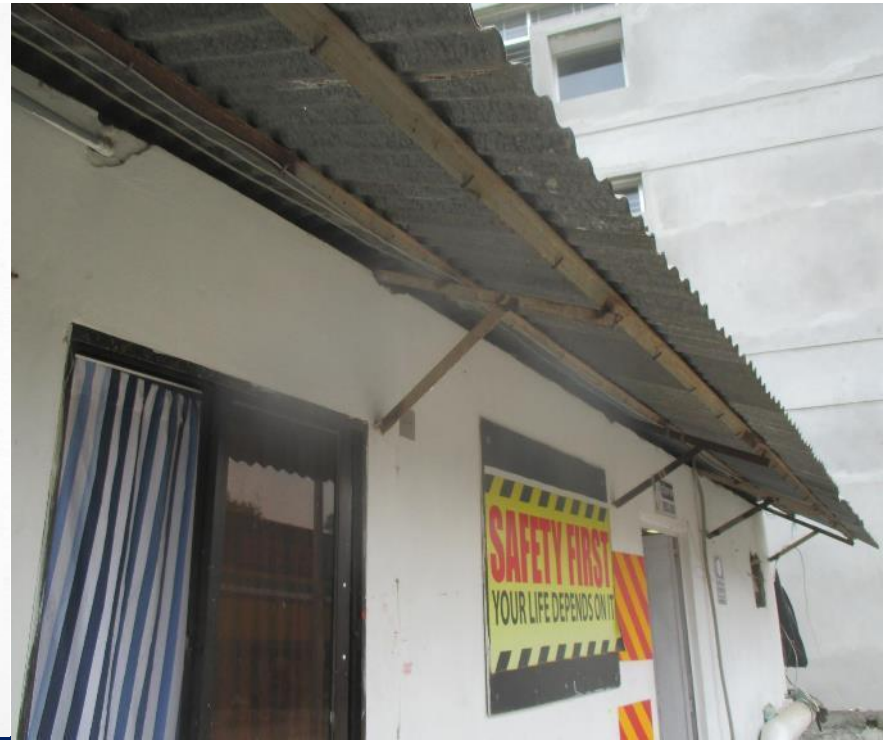
Steel shed appeared to be non-engineered

Connection between steel members and brick walls were appeared to be inadequate . Factory is required to replace the shed.

| Item No. | Observation | Recommended Action Plan | Recommended Timeline |
|---|---|---|---|
| 9 | (Utility-1, Shed-1 )<br>Non engineer shed to be replaced (Utility-1, Shed-1) | Demolish the non engineered shed. | 6-weeks |
| 10 | (Utility-1, Shed-1 )<br>Non engineer shed to be replaced (Utility-1, Shed-1) | Replace the non engineered structure by an engineered structure. | 6-months |

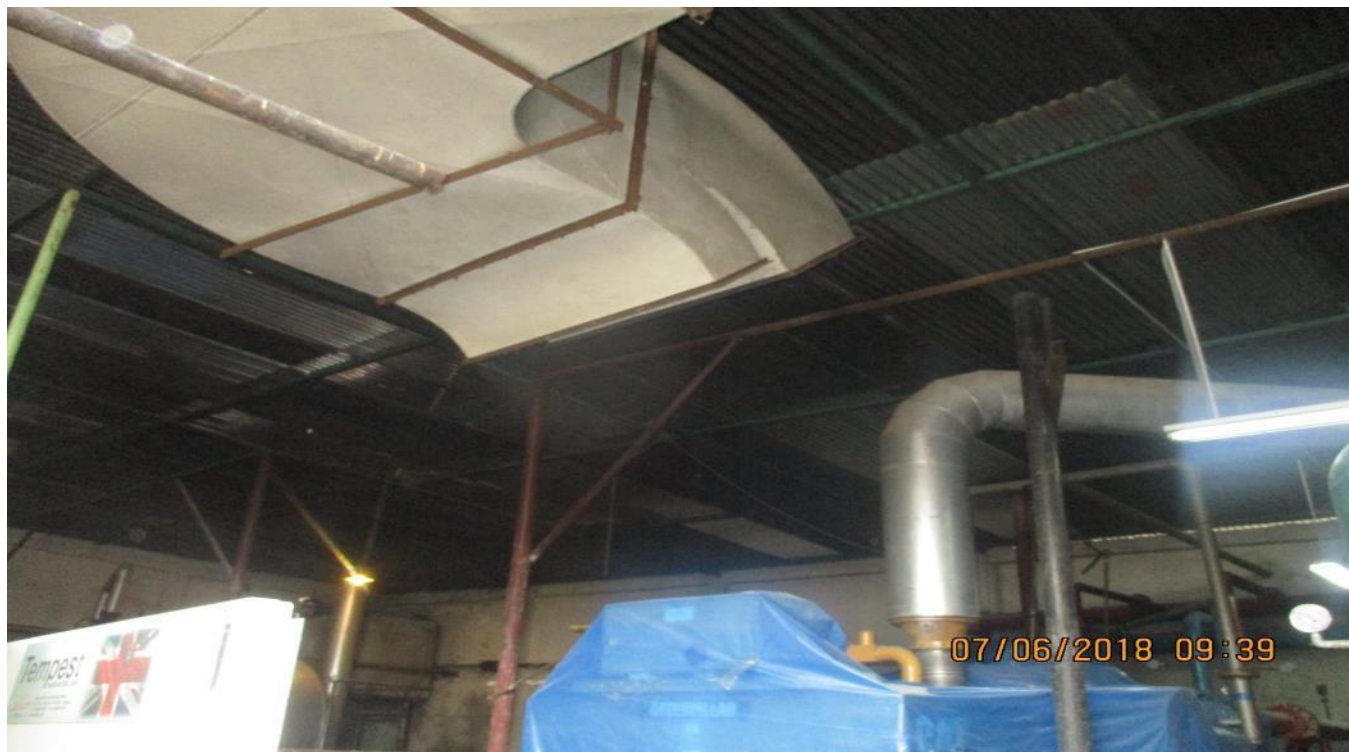
Steel shed appeared to be non-engineered

Load path along the lateral direction is not apparent. Factory engineer is required to replace the shed.
