Logos Apparels Ltd.-Unit-2

Telerchala, Mouchak, Kaliakoir, Gazipur

01st July 2018

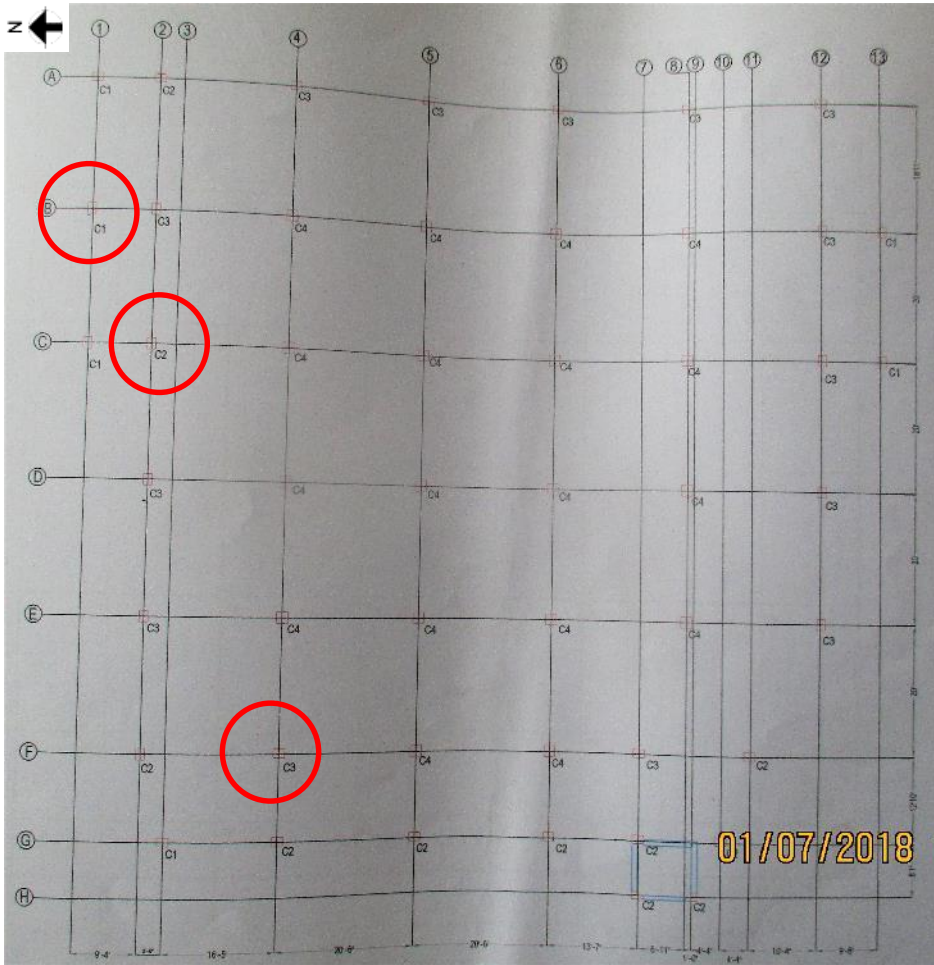
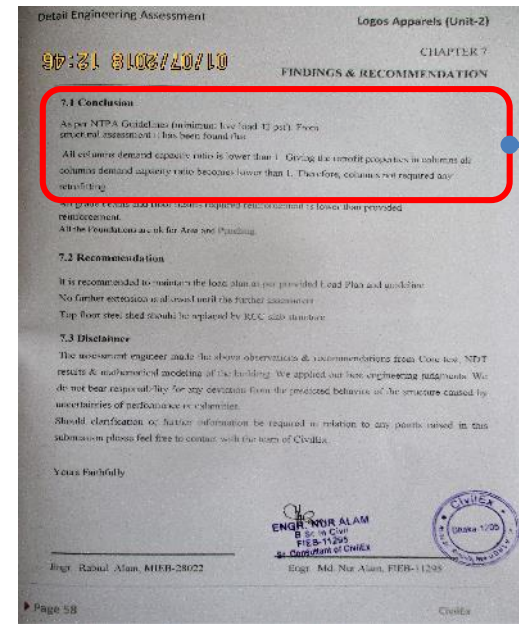
As per NTPA Guidelines (minimum live load 42 psf): From structural assessment it has been found that

All columns demand capacity ratio is lower than 1, Giving the retrofit properties in columns all columns demand capacity ratio becomes lower than 1. Therefore, columns not required any retrofiting.

Cursory calculation (considering 63 psf live load and core test report provided by the factory) indicates that highlighted columns appear to be stressed above normal design limits due to overhead water tank and brick wall & build-up of toilet area. Whereas all columns were declared as safe for carrying 42 psf live load in the conclusion of the provided DEA report. Factory is required to revise the DEA report according to BNBC provision and submit to ACCORD for further review.

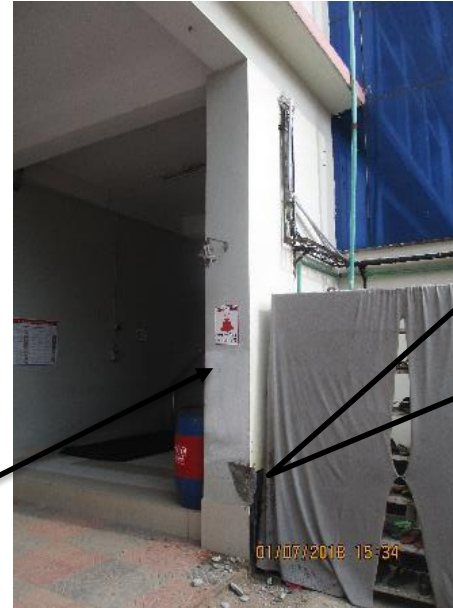
Mixture of stone & brick aggregate was found in the marked column

Combination of stone aggregate & brick aggregate was found in the above marked column. Factory is require to verify the concrete strength of the marked column and incorporate it in the DEA report.

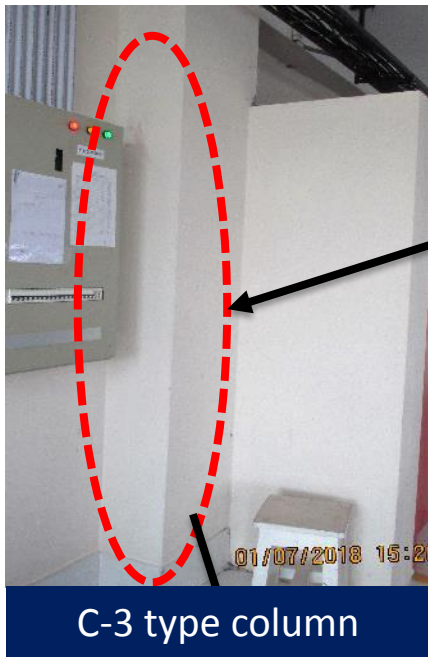
C-3 type column

12 nos. rebar found by ferro scanning in C-3 type columns instead of 16 nos.

Number of rebars in C-3 & C-4 type columns were found less than that of shown in column schedule of as-built structural drawing.

Factory is required to update the as-built drawing which reflect the actual condition.

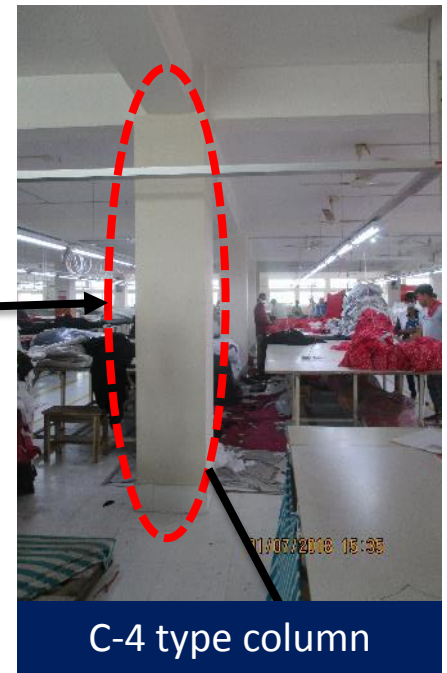
C-4 type column

16 nos. rebar found by ferro scanning in C-4 type columns instead of 20 nos.

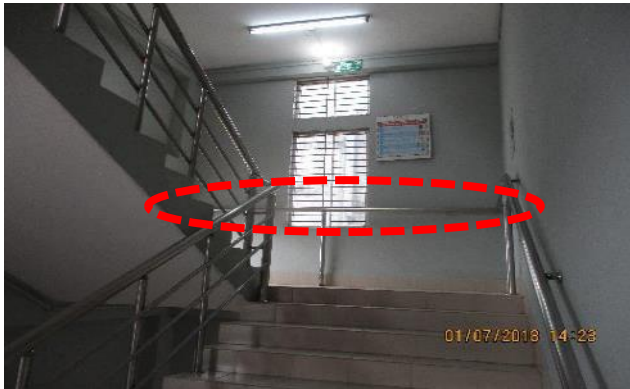
No floor beam was found at stair case on marked location.

Three beams were not found at the marked location on each floor. Whereas, floor beams were shown in provided as-built drawing.

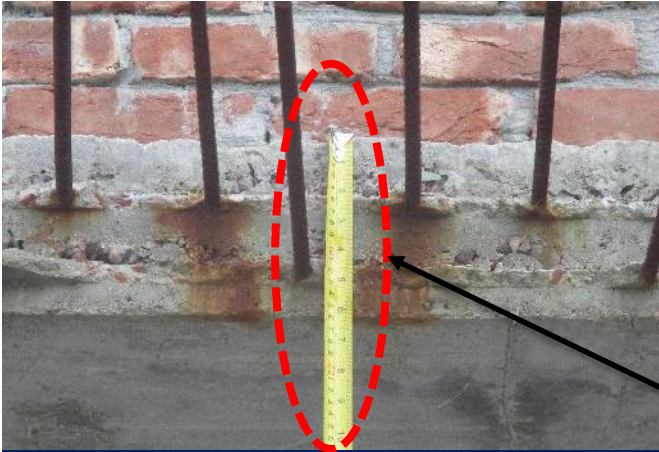
Slab thickness was found 6 inches on site

In provided drawing, slab thickness was shown as 5 inches. Whereas, slab thickness was found 6 inches on site.

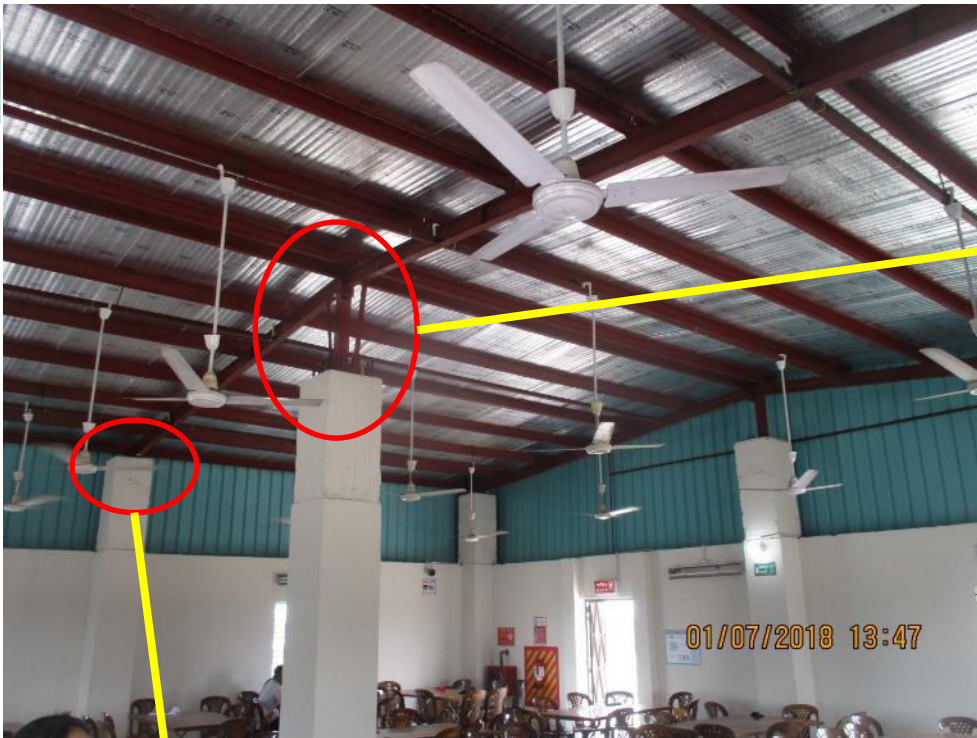
Internal portal frame without any bracing system

During inspection, no roof bracing or compression strut between rafter was observed to provide lateral stability of roof shed on long direction. Factory is required to check lateral stability of roof shed against lateral loads.

7	Production building Lack of Lateral Stability of roof top canteen shed	Carry out remedial action as per engineering assessment where required.	6-months

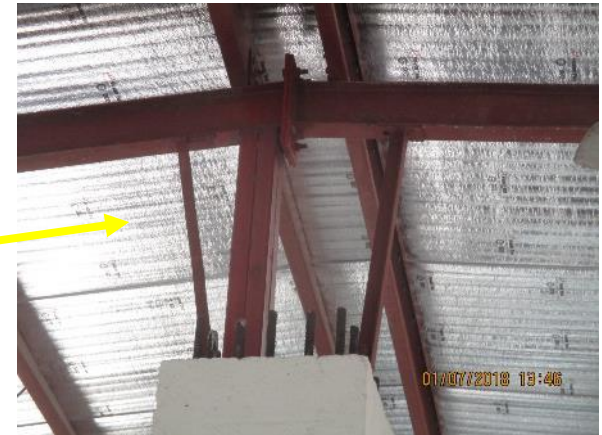
Bolted connection between Steel short column and RC column

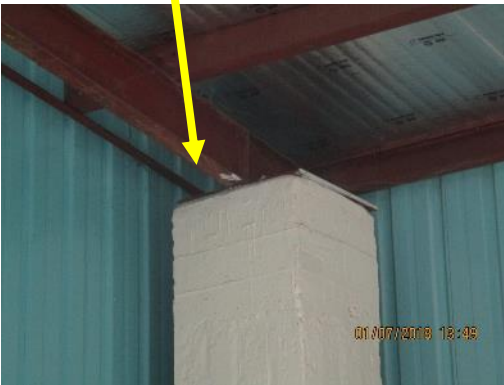
Bolted connection between rafter and RC column

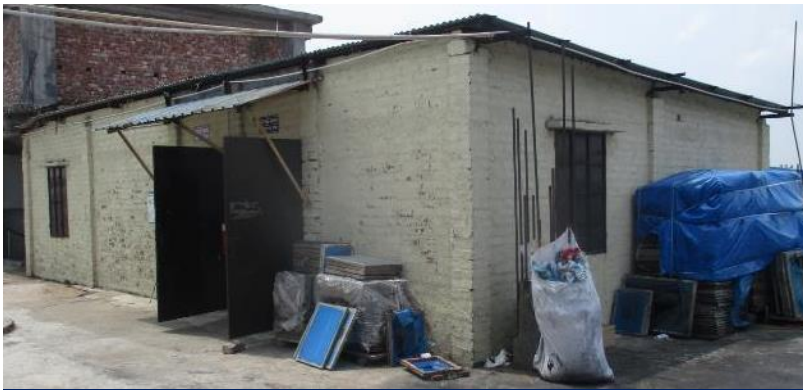
Roof top Chemical shed

The support condition of the steel shed was very weak and non-engineered due to poor detailing of connection of members. Factory is required to replace the shed with an engineered shed

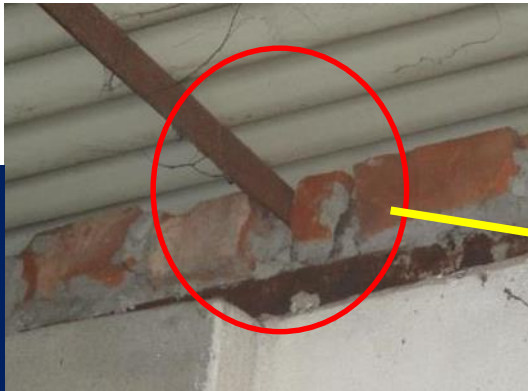
Angles are resting on peripheral brick wall

Support system of 'C' channel

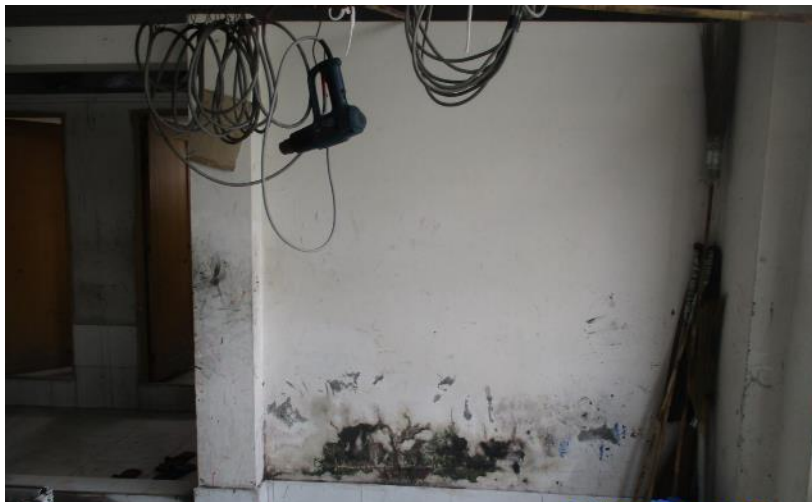
Extensive dampness was observed on masonry walls of toilet area on different floors

Dampness on masonry walls of toilet areas on different floors and top slab were found in several locations. Factory engineer is required to take proper remediation of dampness.

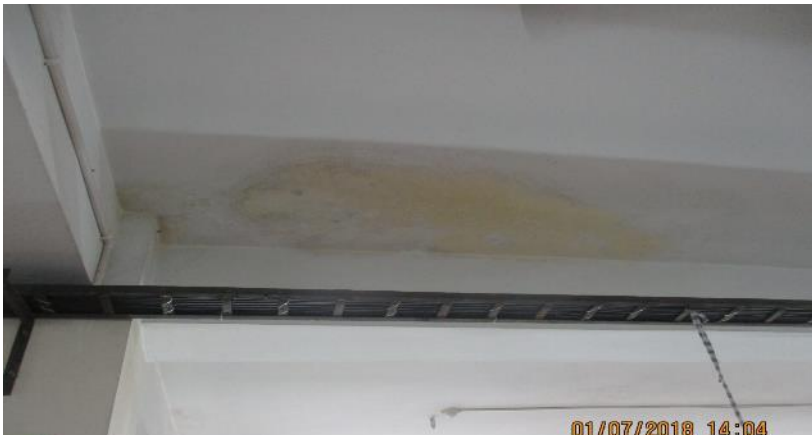
Dampness was observed on roof slab of top floor

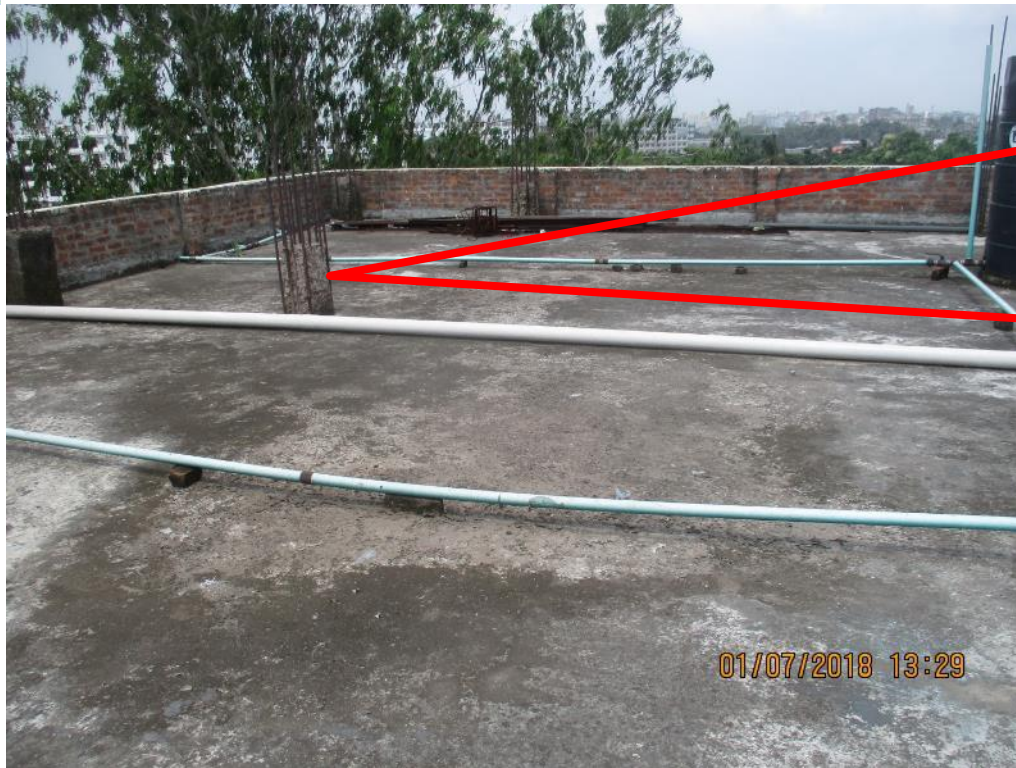
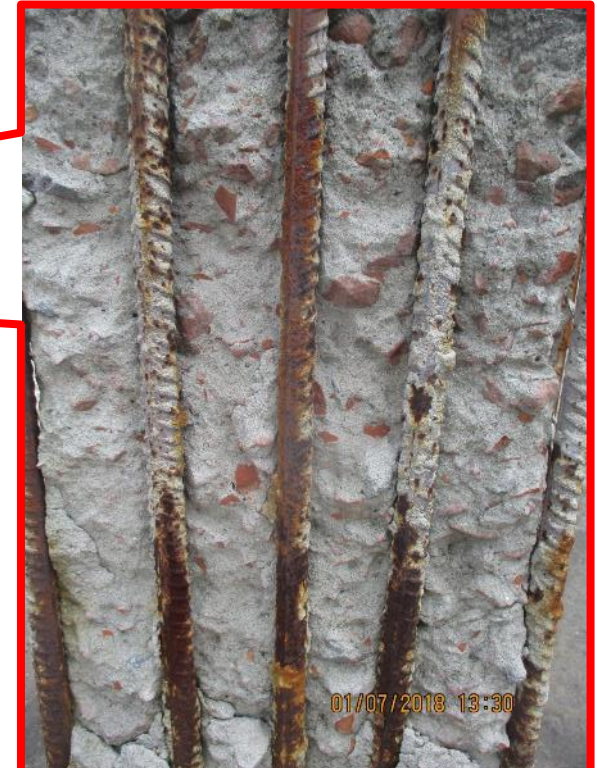
Corrosion was observed on all exposed reinforcement on roof top

Corrosion was observed on all exposed reinforcement on roof top. Factory is required to take proper remedial measures for preventing the corrosion.

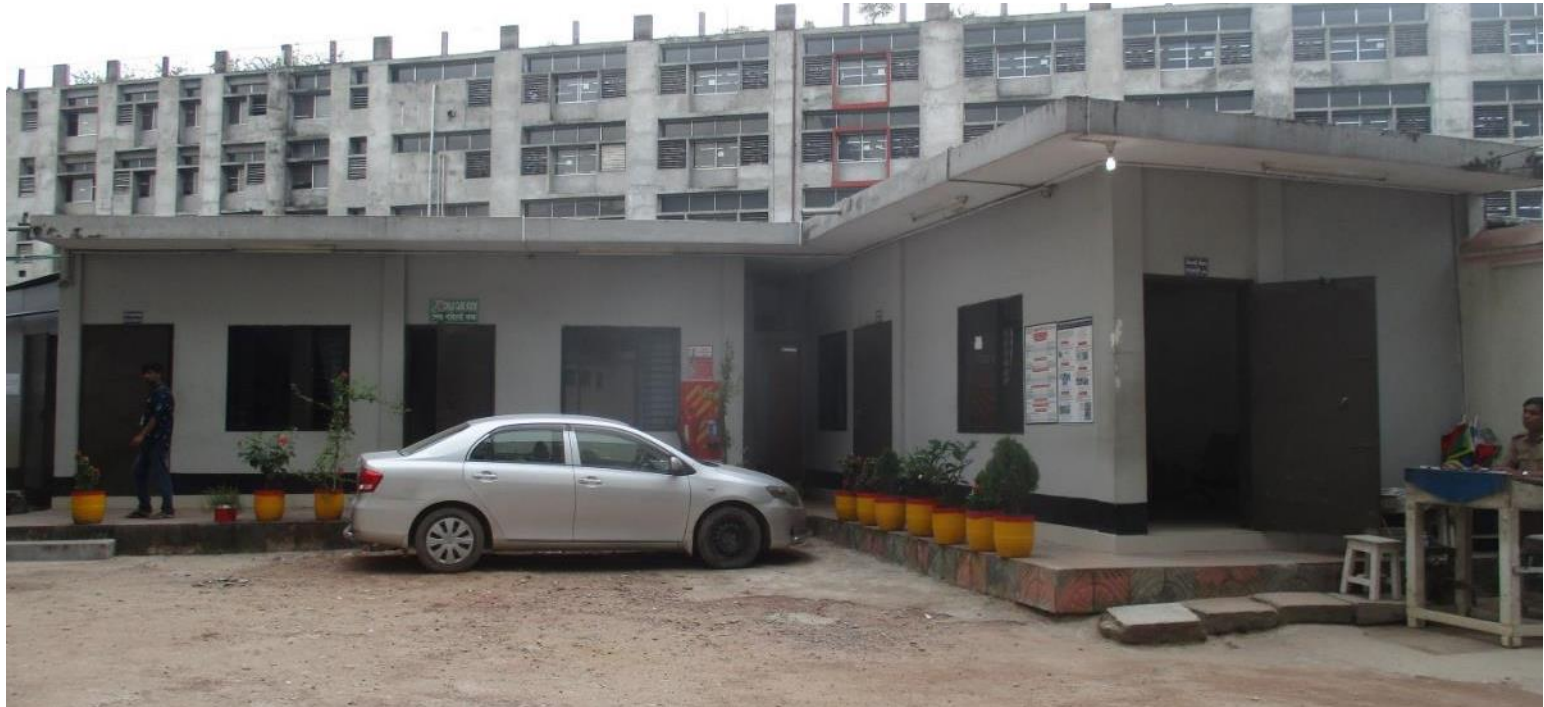
No As-Built drawings were available on site for the Office & Childcare building .
Factory engineer is required to produce as-built drawings reflecting on-site condition.

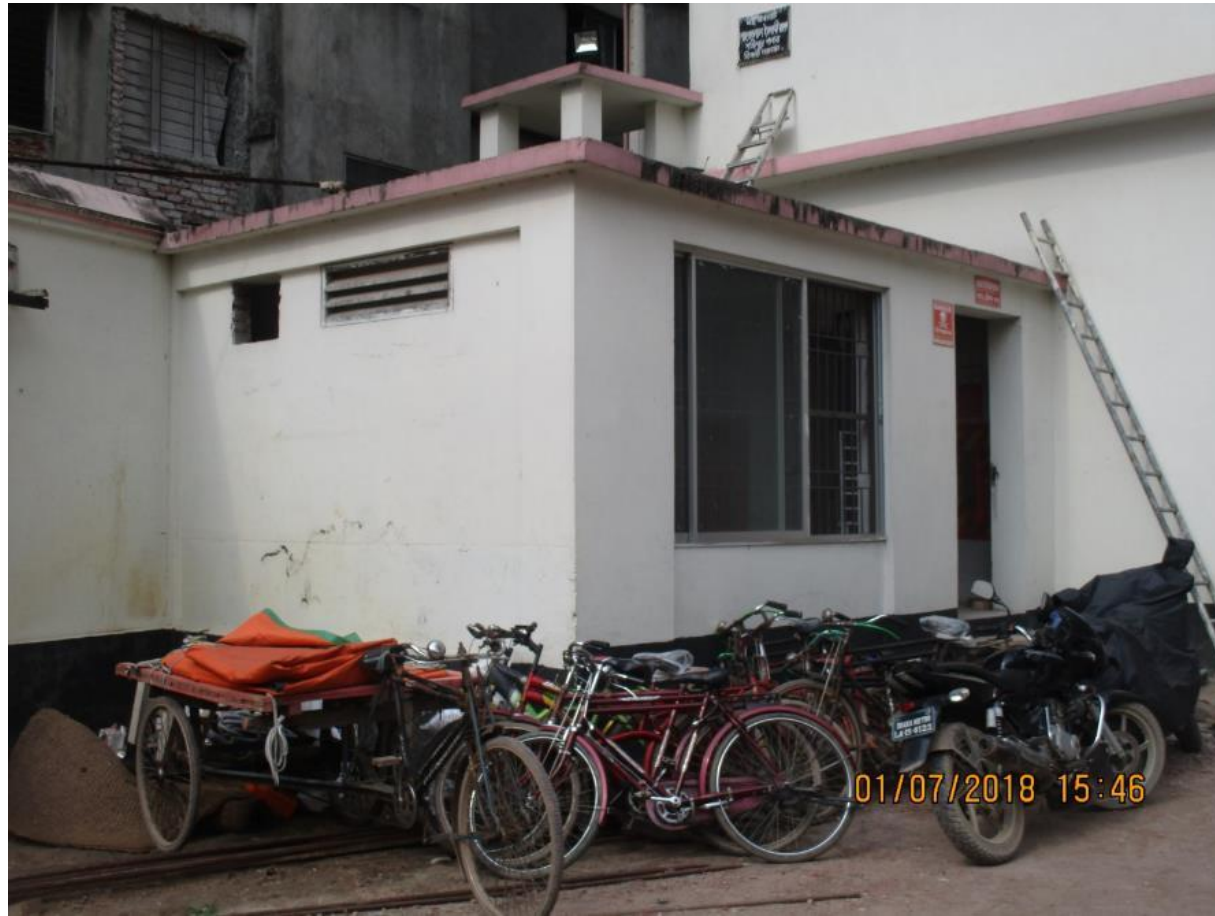
No As-Built drawings were available on site for the Sub-station room. Factory engineer is required to produce as-built drawings reflecting on-site condition.

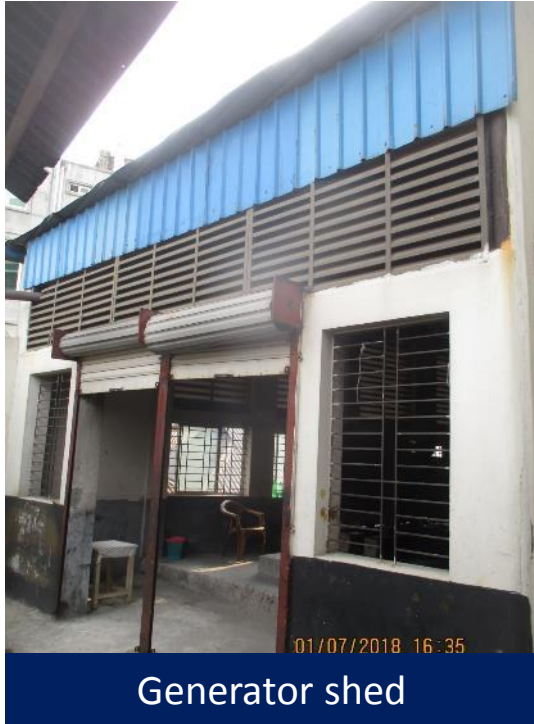
Generator shed

The support condition of the steel roof was very weak and non-engineered due to poor detailing of connection of members. Factory is required to replace the shed with an engineered shed.

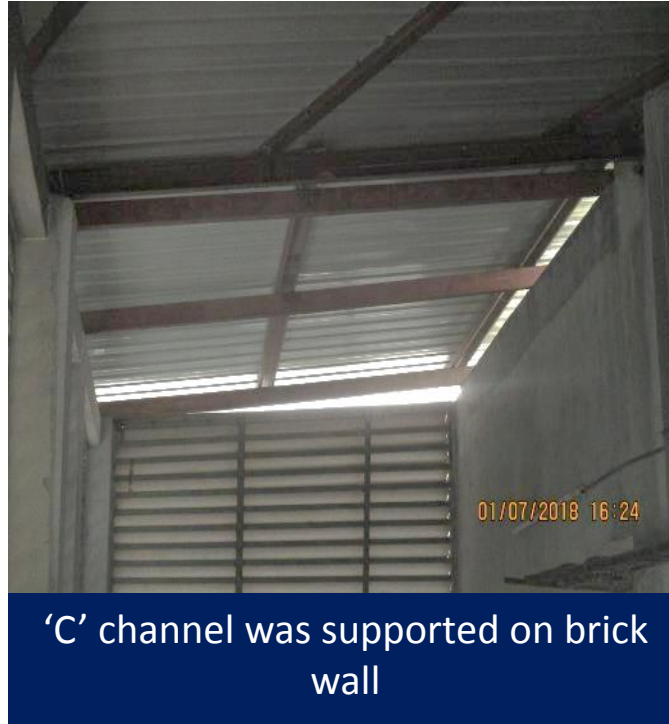
'C' channel was supported on brick wall

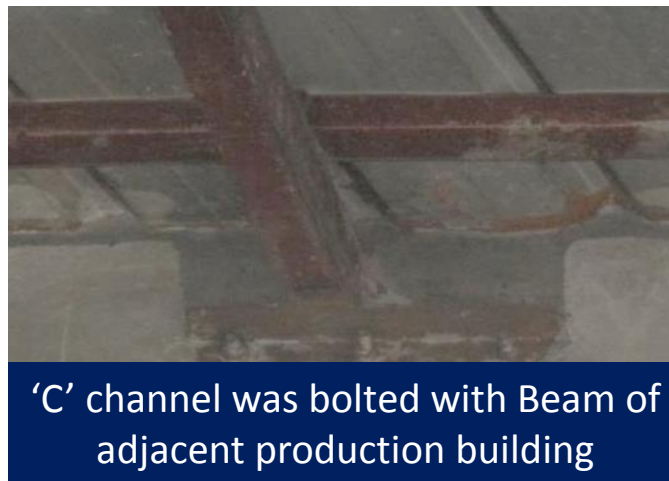
'C' channel was bolted with Beam of adjacent production building
