# **FIRE SAFETY INSPECTION REPORT**

**OCEAN SWEATER LTD.**

**ACCORD ID: 12117**

February 13, 2015

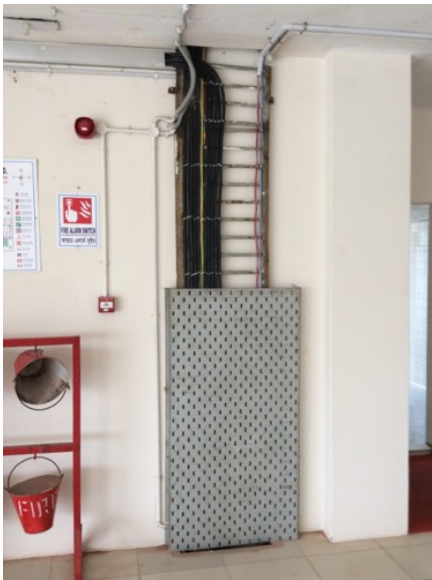
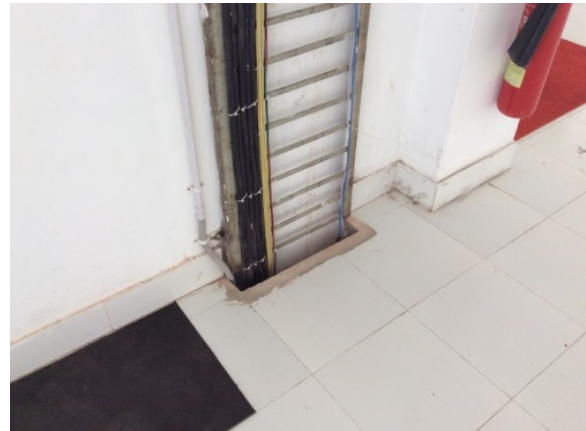
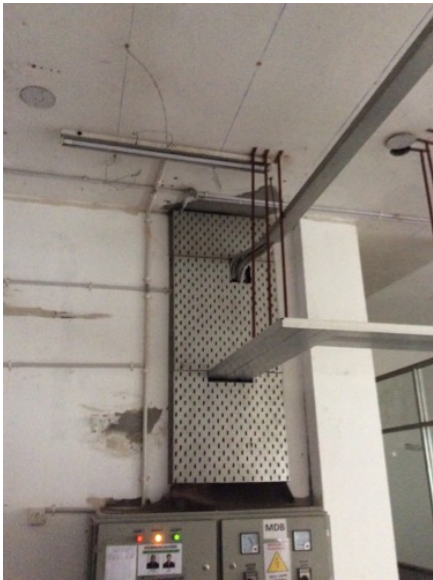
F-1	Fire Rated Construction	An unsealed electrical shaft was located in the fire-rated floor/ceiling assemblies.	Provide a minimum 2-hr fire-rated shaft to separate the utility risers from each floor level and seal all penetrations in floor/ceiling assemblies to maintain the fire separation.	Within 3 months
-----	-------------------------	--	---	-----------------

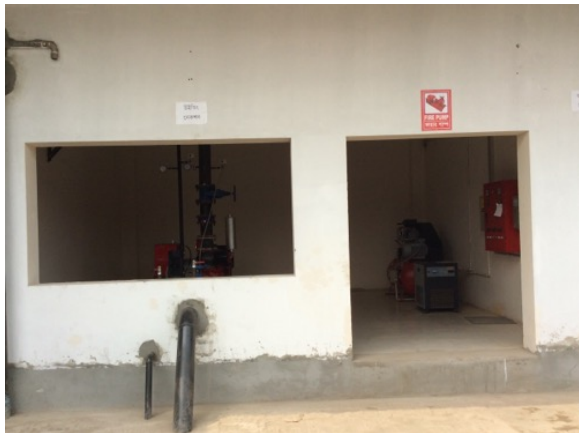
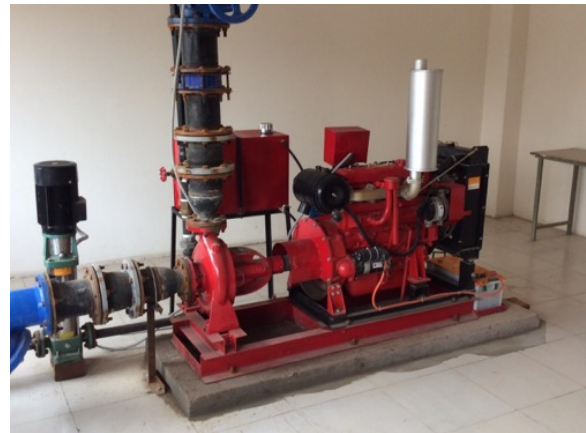
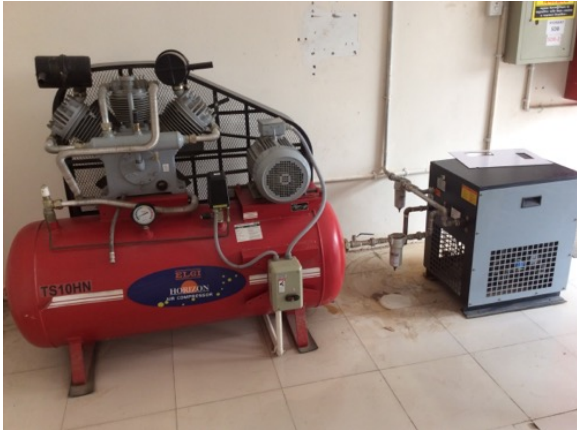
F-2	Fire Rated Construction	The diesel fire pump/electric air compressor room adjacent to the southeast exit stair discharge is not provided with adequate fire rated separation.	Provide fire pump/air compressor room with 2 hr. rated fire separation when not sprinklered and 1 hr. rated fire separation when provided with automatic sprinklers, in accordance with NFPA 20.	Within 3 months
-----	-------------------------	---	--	-----------------

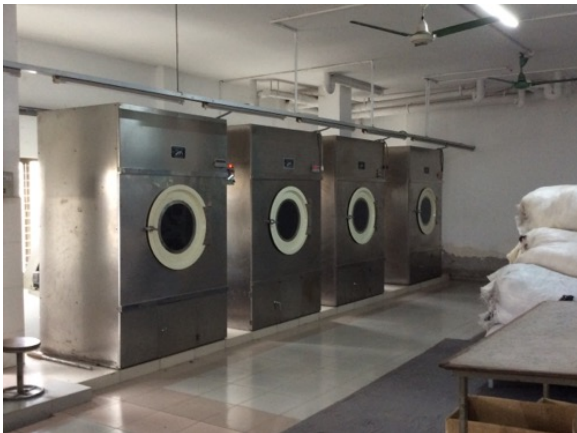
F-3	Fire Rated Construction	The gas industrial dryers on the ground floor are not separated by fire-rated construction and open to the factory floor.	Separate the industrial dryer area by a minimum 2-hr fire-rated construction. Seal and/or protect all openings to maintain the required fire separations. Provide proper ventilation and consult with a qualified engineer.	Within 3 months
-----	-------------------------	---	---	-----------------

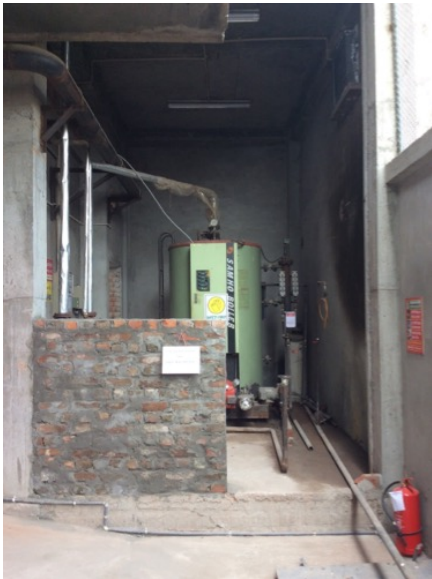
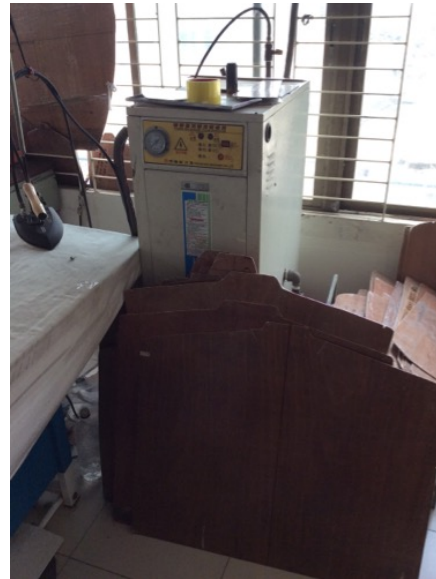
F-4	Fire Rated Construction	The gas boiler room adjacent to the northwest exit stair discharge and the electric boiler on the first floor were not separated by fire-rated construction. The gas boiler had unprotected openings and the electric boiler was open to the factory floor.	Separate the boilers by a minimum 1-hr fire-rated construction for non-high rise, and 2-hr fire rated construction for high rise. Seal and/or protect all openings to maintain the required fire separations. When located to the exterior of a building, 3m (10 ft.) separation is required. Provide proper ventilation and consult a qualified engineer.	Within 3 months
-----	-------------------------	---	--	-----------------

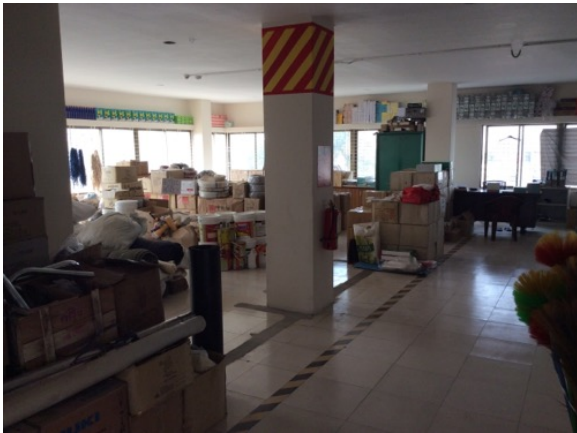
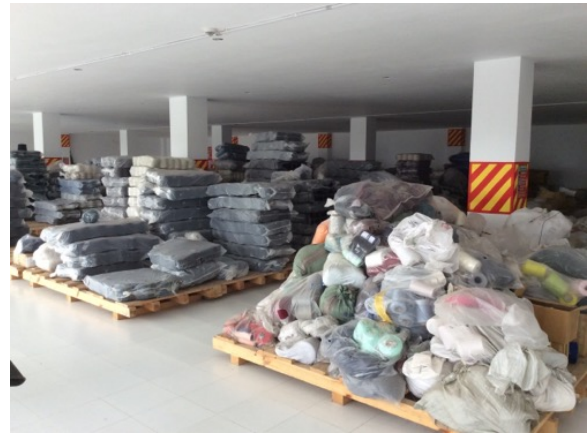
F-5	Fire Rated Construction	Rooms used for combustible storage are not separated by fire-rated construction. Specifically, the second floor accessory store and the third floor yarn store.	Provide dedicated storage rooms separated by minimum 1-hr fire-rated construction.  Where separate storage rooms are not feasible, provide defined storage areas and limit the storage arrangement as follows: - Maximum height of 2.45m (8ft.) and maximum area of 23m <sup>2</sup> (250 ft <sup>2</sup> ) - If sprinkler protected: maximum height of 3.66m (12ft.) and maximum area of 93m <sup>2</sup> (305ft <sup>2</sup> )  Separate areas of unenclosed combustible storage by a minimum clear distance of 3m (10ft.).	Within 3 months
-----	-------------------------	---	---	-----------------

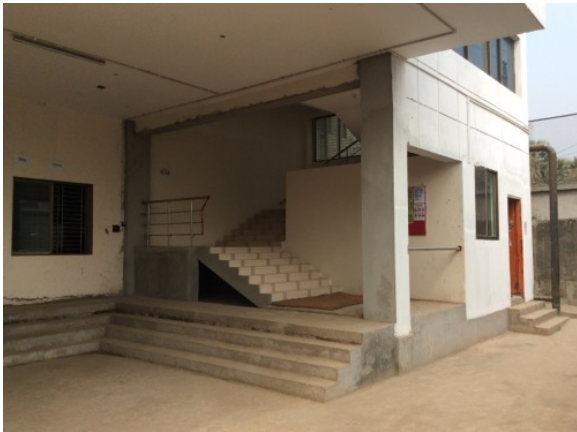
F-6	Fire Rated Construction	The exit stairs are not separated from work areas and other spaces on each floor by fire-rated construction.	<p>Provide minimum 1-hr rated doors for buildings with 3 or fewer stories and 1.5-hr fire rated doors for buildings that are 4 or more stories. Seal all unprotected openings to separate the exit stairs from work areas and other building spaces on all floor levels. Ensure that the fire doors are self-closing and positive latching and that they are provided with fire exit (panic) hardware where serving production floors.</p> <p>If fire doors are required to be held open for functional reasons, provide automatic-closing devices tied to the fire alarm system.</p> <p>Once fire doors are installed, every door in a stair enclosure serving more than 5 stories shall be provided with re-entry unless it meets ACCORD standard 6.8.3.1.</p>	Within 3 months
F-7	Fire Rated Construction	The northeast exit stair enclosure is not separated from other spaces on the ground floor by fire-rated construction.	The exit stair enclosure shall be provided with a minimum 1-hr fire resistance rating for buildings with 3 or fewer stories and a minimum of 2-hr fire resistance rating for buildings 4 or more stories.	Within 3 months

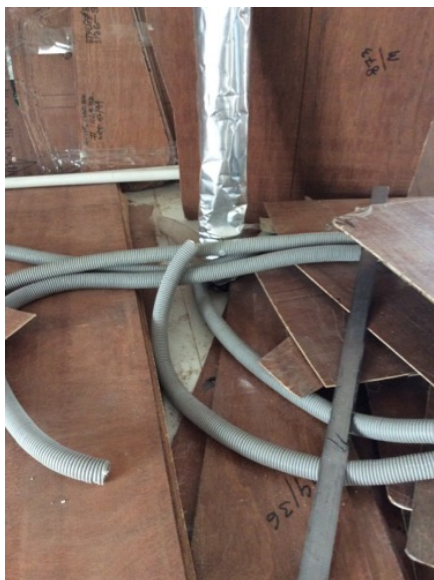
F-8	Fire Rated Construction	A possible unsealed boiler pipe penetration was located in the fire-rated floor/ceiling assembly on the first floor.	Seal all penetrations and openings in floor/ceiling assemblies to maintain the fire separation.	Within 3 months
-----	-------------------------	--	---	-----------------

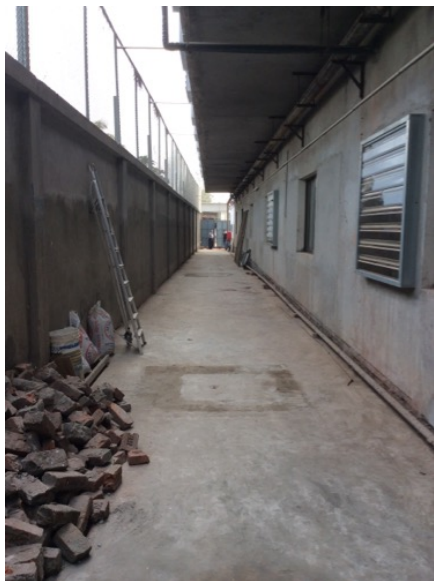
F-9	Fire Rated Construction	The exit discharge path serving the northwest exit stair discharge, is less than 3 m (10 ft.) wide and is not separated from the building interior.	Seal all penetrations and openings to the interior of the building along the discharge path, up to a height of 10 ft., to provide a minimum 1-hr fire separation.	Within 6 months
-----	-------------------------	---	---	-----------------

Alternatively, provide a second remote discharge path to the public way by clearing the path along the west and south sides of the building. Ensure that a minimum egress path width of 36 in. is maintained and that the path is even and clear. The gas boiler room adjacent to the northwest exit stair discharge will need to be relocated as the second egress path is not permitted to pass through a utility room.

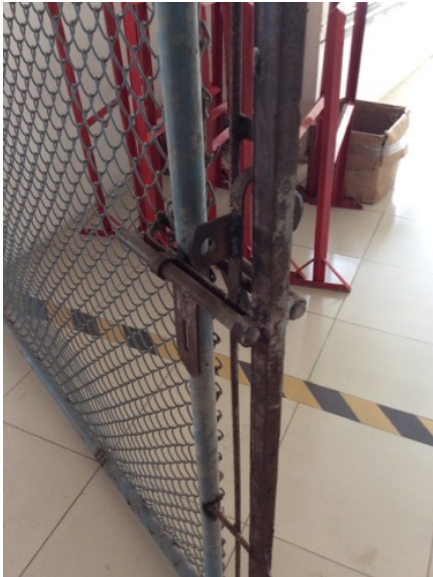
F-10	Egress	Building did not have occupant load signs at the required locations. The building did have some emergency evacuation plans, however not at all required locations.	Provide occupant load signs and emergency evacuation plans at all required locations.	Immediately
F-11	Egress	Egress doors with locking features are provided along egress routes. All doors were open and unlocked during the inspection.	Remove locking features from all egress doors.  If locks are required for security reasons, utilize special door locking features complying with NFPA 101 and ACCORD standard 6.8.2.	Immediately

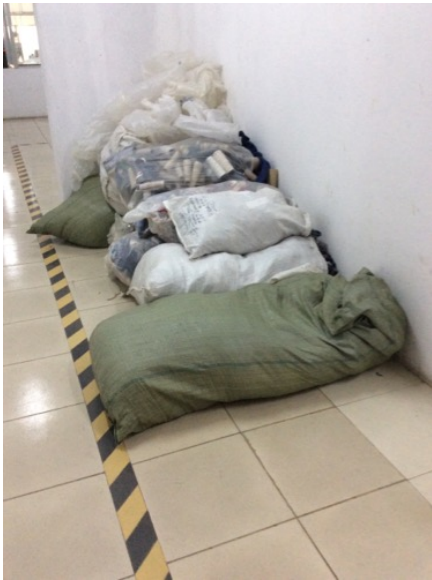
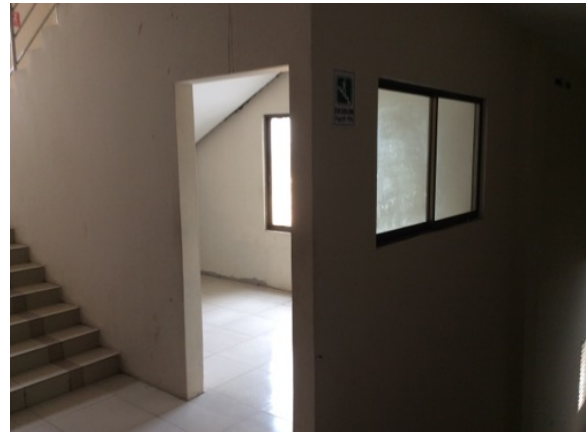
F-12	Egress	Storage was located in the northwest exit stair on the ground floor and there was also a small storage room located on the first floor.	Remove all storage from exit stairs and egress paths.	Immediately
------	--------	---	---	-------------

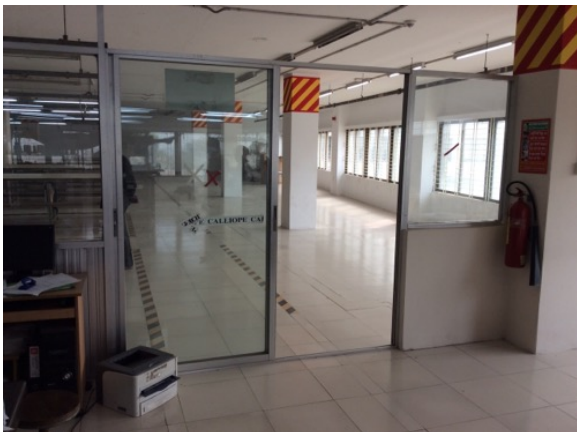
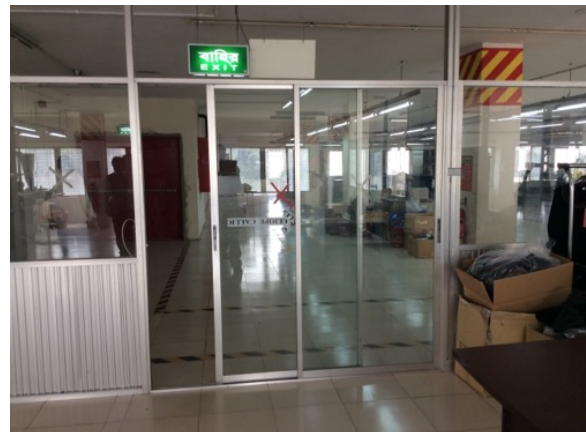
F-13 Egress

Sliding doors are provided along egress routes.

Replace all sliding doors along the means of egress with side-hinged, swinging egress doors in accordance with ACCORD standard 6.8.1.

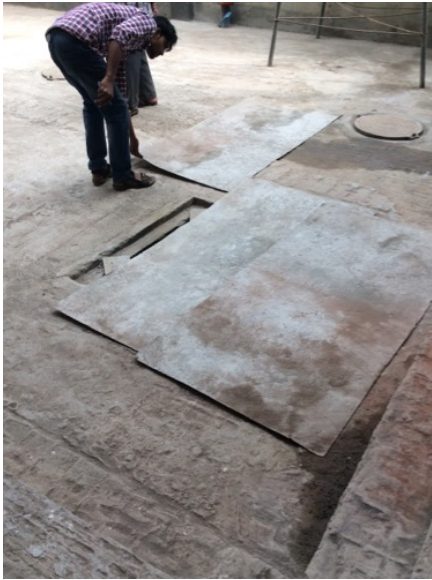
F-14	Egress	After discharge from the southeast exit stair there was a hole in the ground that was covered up with metal sheeting.	Cover the hole with a concrete slab to prevent the metal sheeting from being accidentally moved in an emergency situation, and causing a hazard to evacuating occupants.	Within 1 month
------	--------	---	--	----------------

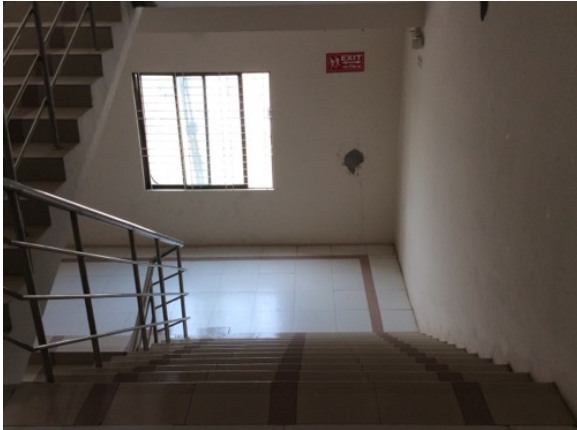
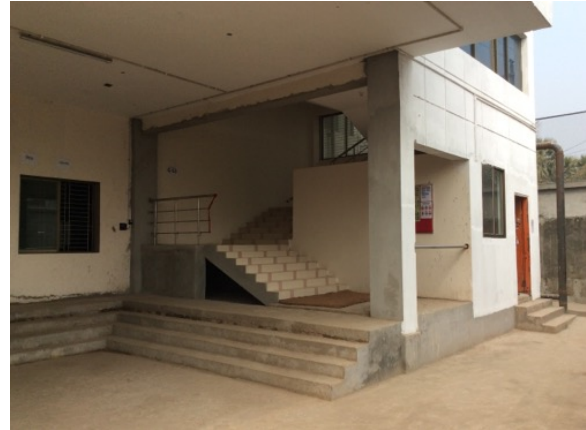
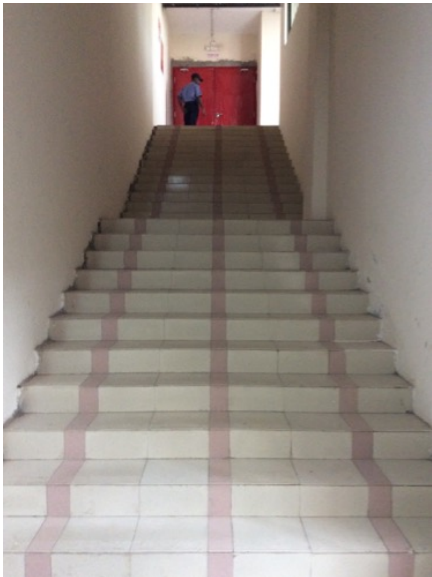
F-15	Egress	Handrails are not provided on both sides of all exit stairs.	Provide handrails on both sides of the exit stair. New handrails shall have a minimum height of 865 mm (34 in.) and a maximum height of 965 mm (38 in.) as measured from the leading edge of the tread. Intermediate handrails shall be provided when the stair width exceeds 2.2 m (87 in.)	Within 3 months
------	--------	--	--	-----------------

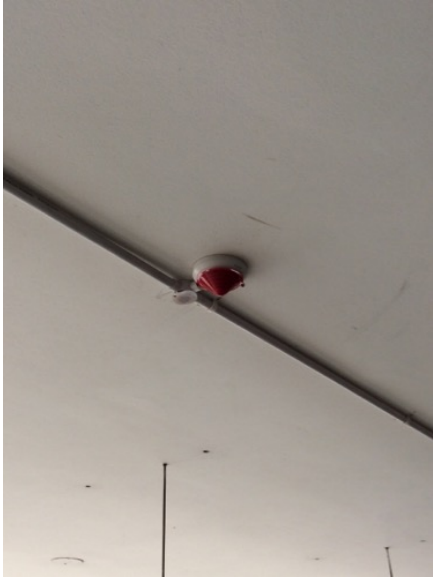
F-16	Fire Protection	Some of the interconnected smoke detectors throughout the building still had covers on them from when the system was installed.	Remove covers from all interconnected smoke detectors so that the detection system will function properly.	Immediately
------	-----------------	---	--	-------------

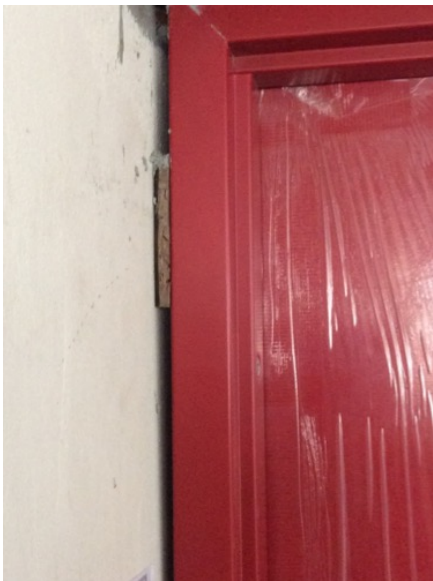
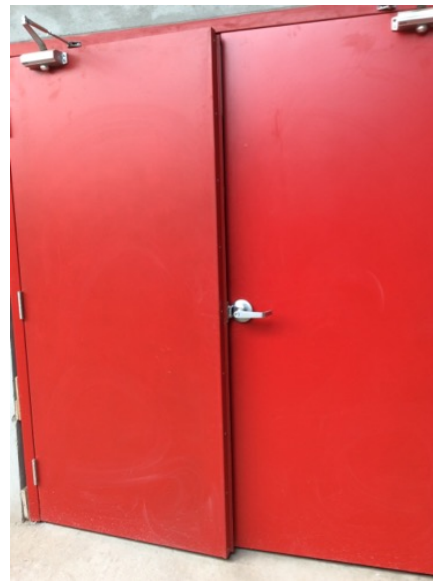
F-17	Fire Protection	Some of the installed fire doors were not properly sealed or positive latching.	Ensure that all fire doors are properly sealed. Modify the door closing hydraulics to ensure that the doors are positive latching to prevent the flow of combustion byproducts between compartments or into the exit stair enclosures.	Within 1 month
------	-----------------	---	--	----------------

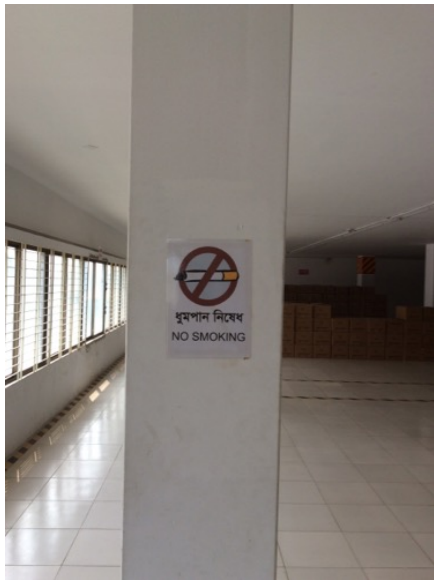
F-18	Fire Protection	Some no smoking signs are present in the factory, however they are not provided at the required locations.	Smoking is prohibited in any garment factory building or separate storage building. Signs shall be posted in Bengali and English at all building entrances. If the factory creates a designated smoking area outside the building, information of these areas will be posted on the signs.	Within 1 months
------	-----------------	--	--	-----------------

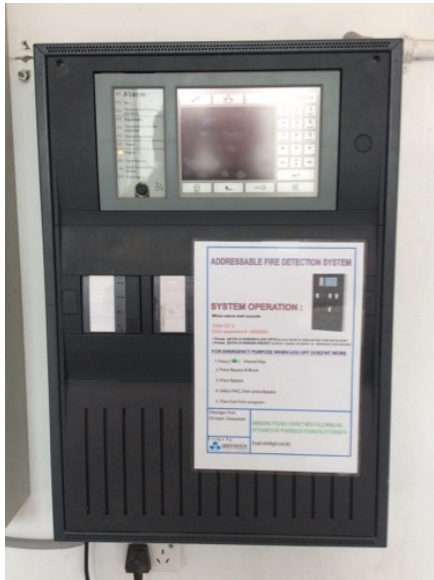
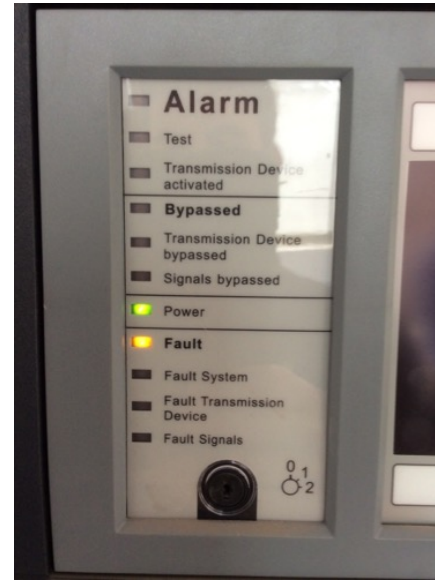
F-19	Fire Protection	The addressable fire alarm panel showed a "Fault" at the time of the inspection.	Ensure that the fire alarm system is installed in accordance with NFPA 72 and that all components are fully operational.	Within 3 months
------	-----------------	--	--	-----------------

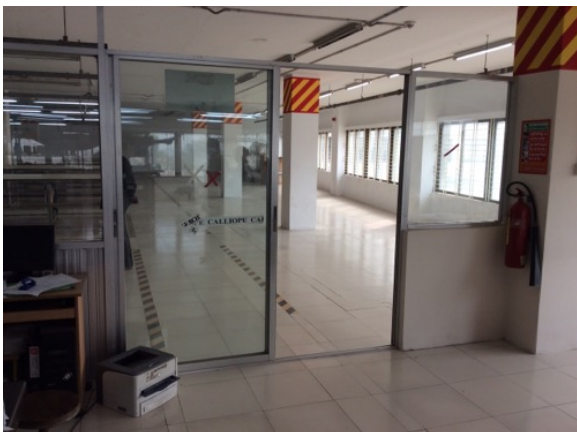
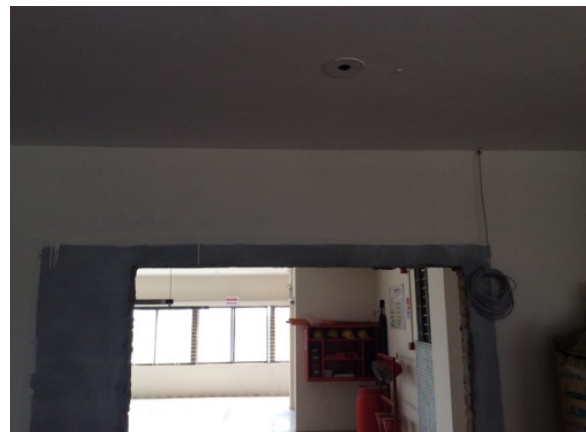
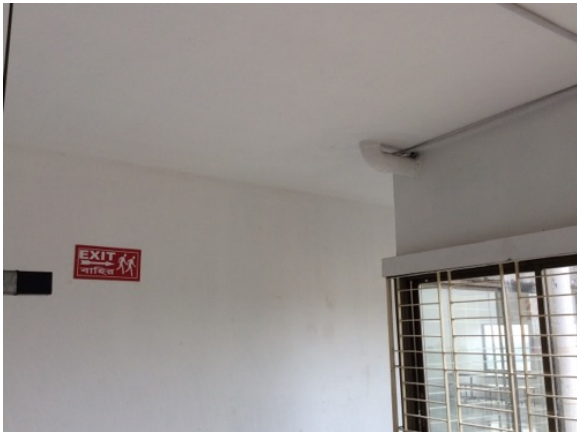
F-24	Fire Protection	Visible notification was not provided for the building in accordance with NFPA 72.	Provide visible notification for the building in accordance with NFPA 72.	Within 3 months
F-25	Fire Protection	Fire pump did not meet ACCORD standard 5.5.1 and 5.5.1.1.	Update current fire pump or provide a new fire pump that meets ACCORD standard 5.5.	Within 6 months
F-26	Fire Protection	The building is equipped with interconnected smoke detectors, however the detection system does not cover all areas of the building.	Provide automatic smoke detection throughout the building, tied into the fire alarm system, in accordance with NFPA 72.	Within 9 months
F-27	Egress Lighting	Exit signage was not provided from the third floor linking section, from the second floor accessory store and from the first floor sample section.	Provide exit signs above all building exits to the exterior, all doors to the exit stairs and along all paths of travel where a change of direction is not obvious.	Within 1 month

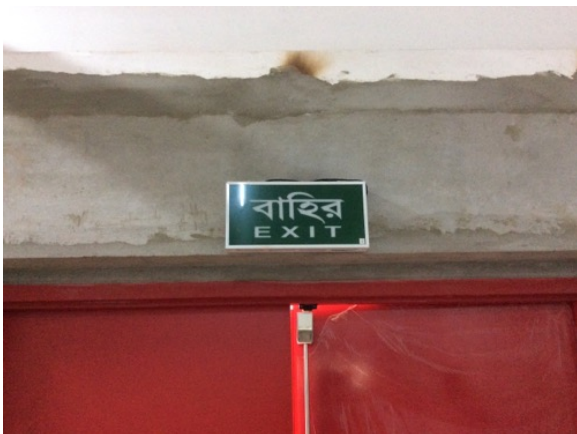
F-28 Egress Lighting

An exit sign at the building exit from the northwest exit stair on the ground floor was not illuminated (burned out, broken, etc.).

Regularly inspect all exit signage and replace/install lights as needed to illuminate signs. The source of illumination shall provide not less than 50 lux at the illuminated surface with a contrast of not less than 0.5. Approved self luminous signs which provide evenly illuminated letters having a minimum luminance of 0.2 cd/m<sup>2</sup> may also be used.
