# Tusuka Apparels Ltd/Jeans & Polo Ltd

BSCIC Industrial Area, Tongi, Gazipur, Dhaka  
(23° 53' 35.26"N, +90° 24' 56.68"E)

3 February 2014

# Building Observations

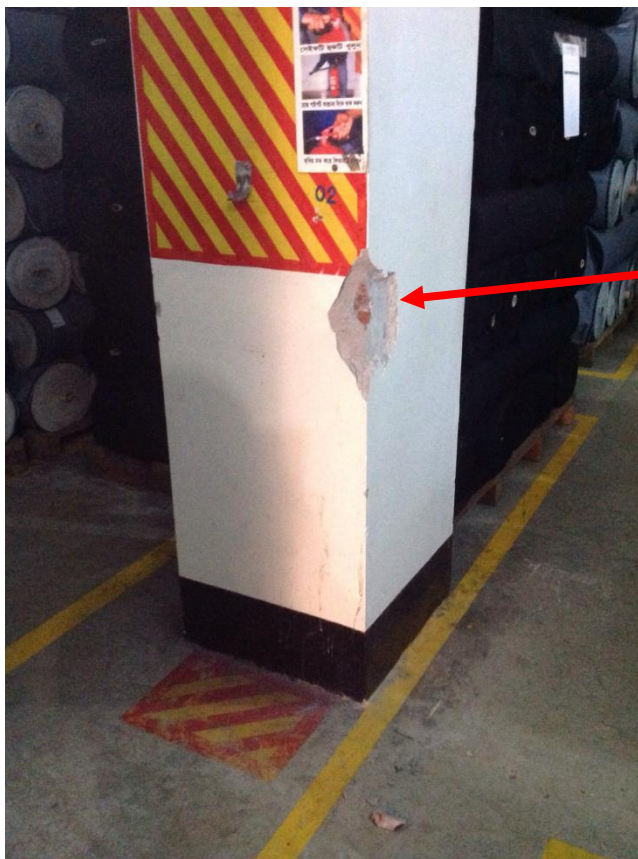
**Columns appear to be stressed in excess of  
normal design limits**

Cursory calculations indicate that column size appears to be smaller than required by code for the applied dead and live load, assuming typical concrete strength

Brick aggregate seen when plaster removed.

**ITEM 1:** Columns appear to be stressed in excess of normal design limits – Building Engineer to verify concrete stresses, in-situ concrete strength and reinforcement provided

Building Engineer to perform detailed calculations and concrete tests to prove column size and (if required) :

- Reduce loads by preparation of allowable floor loading plans
- Carry out strengthening works

| Item No. | Observation | Recommended Action Plan | Recommended Timeline |
|---|---|---|---|
| 1 | Columns appear to be stressed in excess of normal design limits – Building Engineer to verify concrete stresses, in-situ concrete strength and reinforcement provided | Factory Engineer to review design, loads and columns stresses in area identified above. | 6-weeks |
| 2 | Columns appear to be stressed in excess of normal design limits – Building Engineer to verify concrete stresses, in-situ concrete strength and reinforcement provided | Verify insitu concrete strength either by cores or existing cylinder strength data for 6 columns. | 6-weeks |
| 3 | Columns appear to be stressed in excess of normal design limits – Building Engineer to verify concrete stresses, in-situ concrete strength and reinforcement provided | Verify that reinforcement content in columns at 4 locations at ground floor is per the design drawings. | 6-weeks |
| 4 | Columns appear to be stressed in excess of normal design limits – Building Engineer to verify concrete stresses, in-situ concrete strength and reinforcement provided | Produce and actively manage Allowable Floor Loading plans for all floor plates within the factory giving consideration to floor capacity and column capacity. | 6-months |

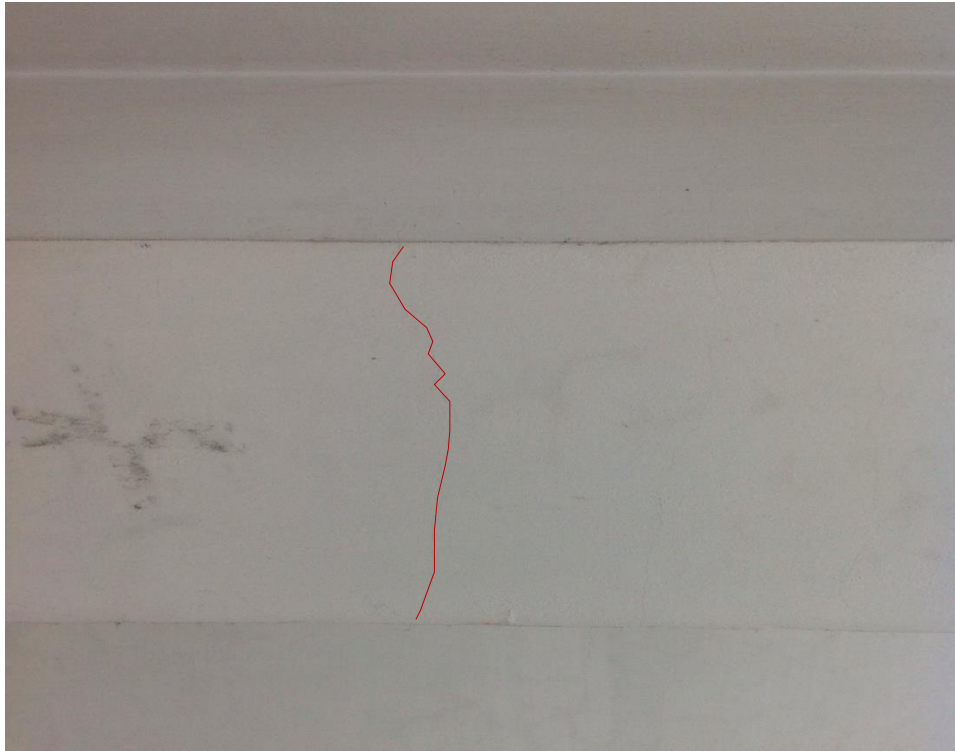
**Cracking to concrete beams on the underside  
of 2<sup>nd</sup>, 4<sup>th</sup> and 5<sup>th</sup> floors**

**Hairline crack in finishes to underside of beams close to the midspan is quite typical. This example is on the underside of the 2<sup>nd</sup> Floor. Similar examples seen on the underside of the 2<sup>nd</sup>, 4<sup>th</sup> & 5<sup>th</sup> Floor.**

**ITEM 2:** Cracking to concrete beams and slab on the underside of 2<sup>nd</sup>, 4<sup>th</sup> and 5<sup>th</sup> floors

| Item No. | Observation | Recommended Action Plan | Recommended Timeline |
|---|---|---|---|
| 5 | Cracking to concrete beams and slab on the underside of 2nd, 4th and 5th floors | Sections of plaster finish to beams/slab to be removed to investigate if cracks penetrate the building structure. | 6-weeks |
| 6 | Cracking to concrete beams and slab on the underside of 2nd, 4th and 5th floors | Building Engineer to carry out design check on beams/slab to confirm that these cracks are non-structural. | 6-months |
| 7 | Cracking to concrete beams and slab on the underside of 2nd, 4th and 5th floors | Building Engineer to issue details of repair works to be completed | 6-months |

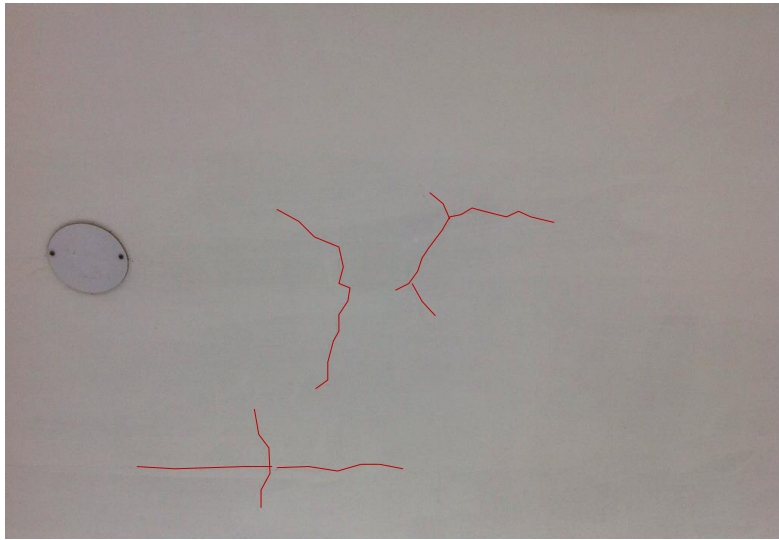
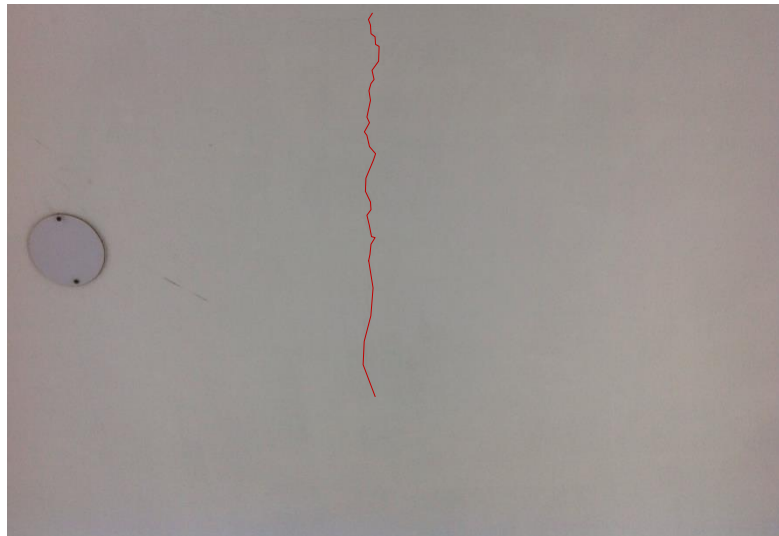
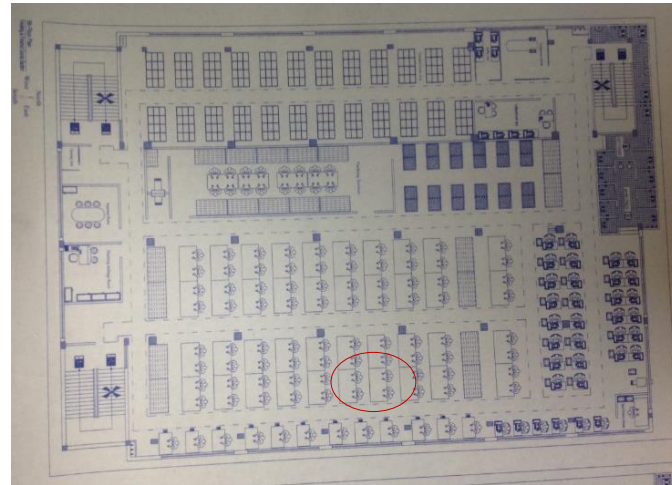
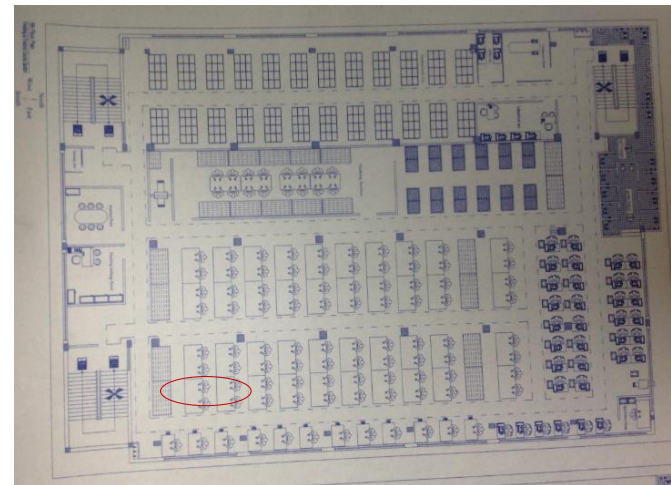
**Cracking to concrete slab on the underside of  
the 5<sup>th</sup> floor**

**Cracking to concrete beams and slab**

**Underside of 5<sup>th</sup> floor slab (Seen from 4<sup>th</sup> floor)  
Building Engineer to assess.**

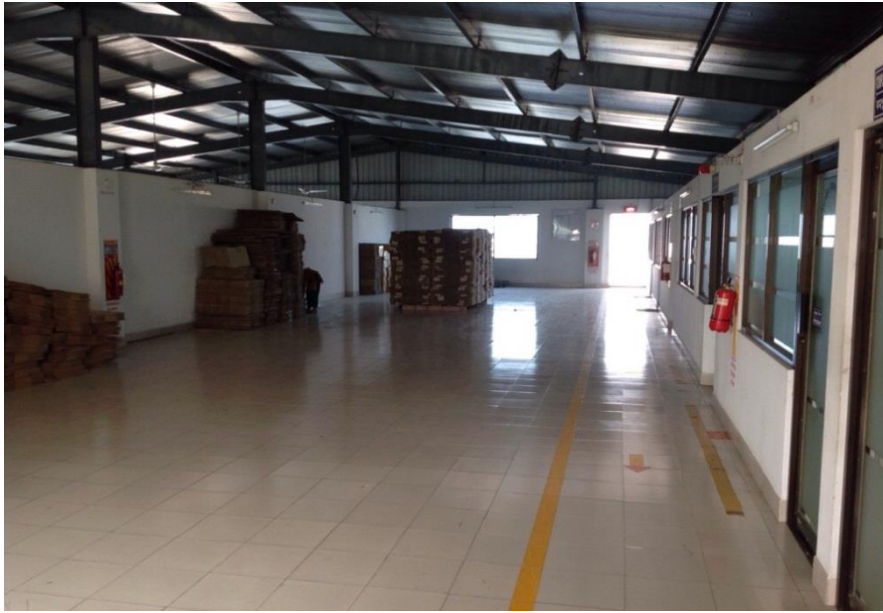
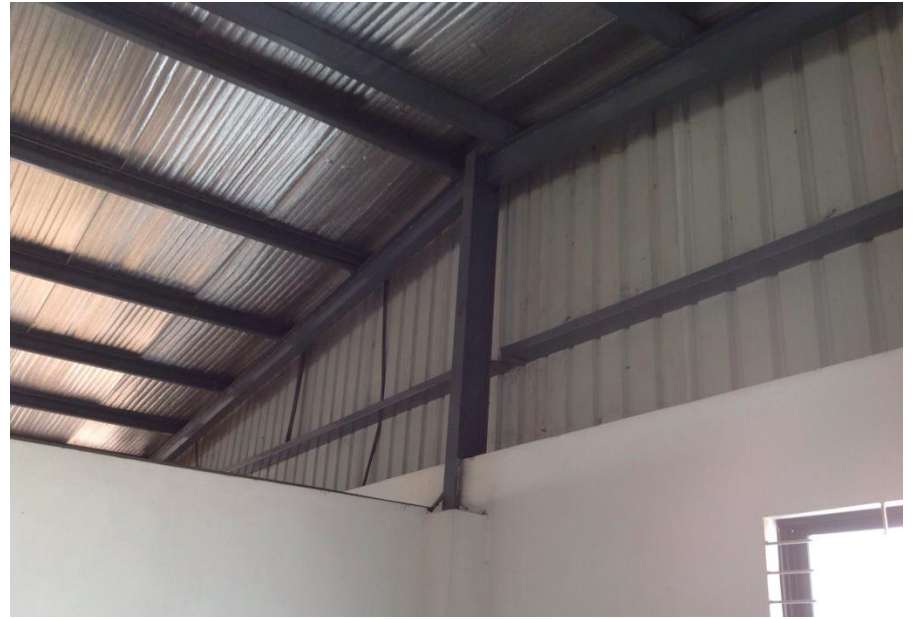
**Steel roof to Dining/Storage Area**

**Lightweight steel roof does not appear to  
have adequate bracing to resist high wind  
loading**

**No obvious stability system or bracing provided orthogonal to roof portals.  
Reliance on diaphragm action through purlins and metal deck?  
Requirement for bracing system to be assessed by Building Engineer.**

**ITEM 3:** Lightweight steel roof does not appear to have adequate bracing to resist high wind loading

| Item No. | Observation | Recommended Action Plan | Recommended Timeline |
|---|---|---|---|
| 8 | Check required to confirm that lightweight steel roof has adequate bracing to resist high wind loading | Steel roof should be designed by the Building Engineer and, if required, upgraded to support code vertical and wind loads or the area should be vacated and removed – specifically the requirement for lateral bracing to be reviewed. | 6-weeks |

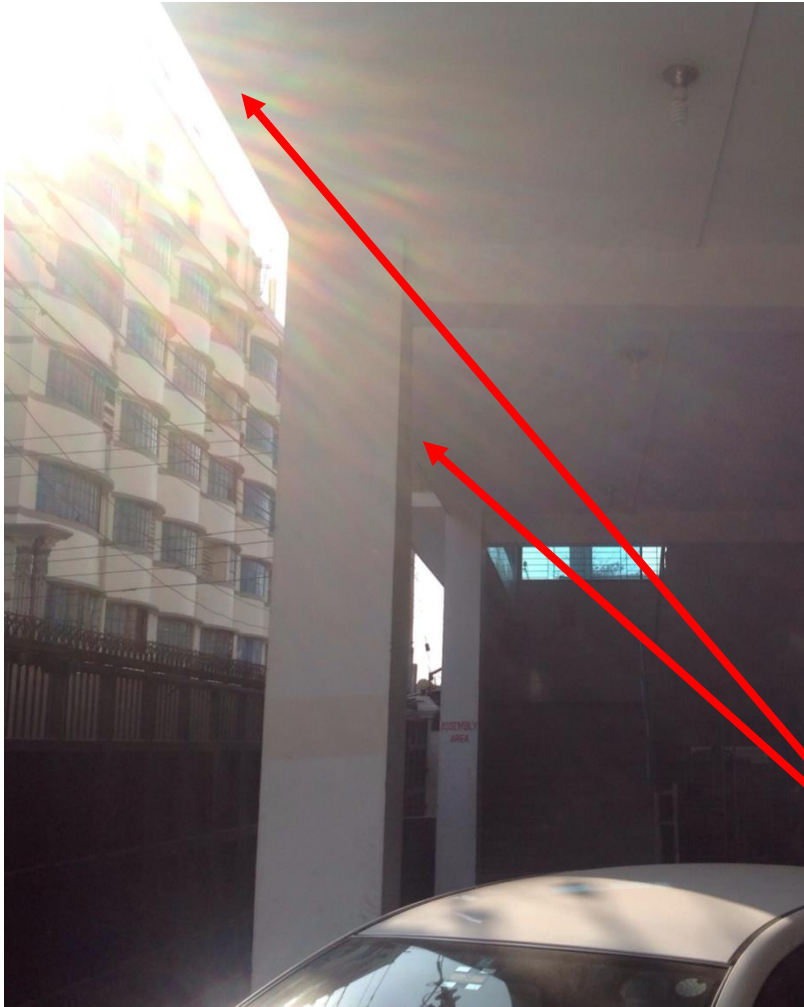
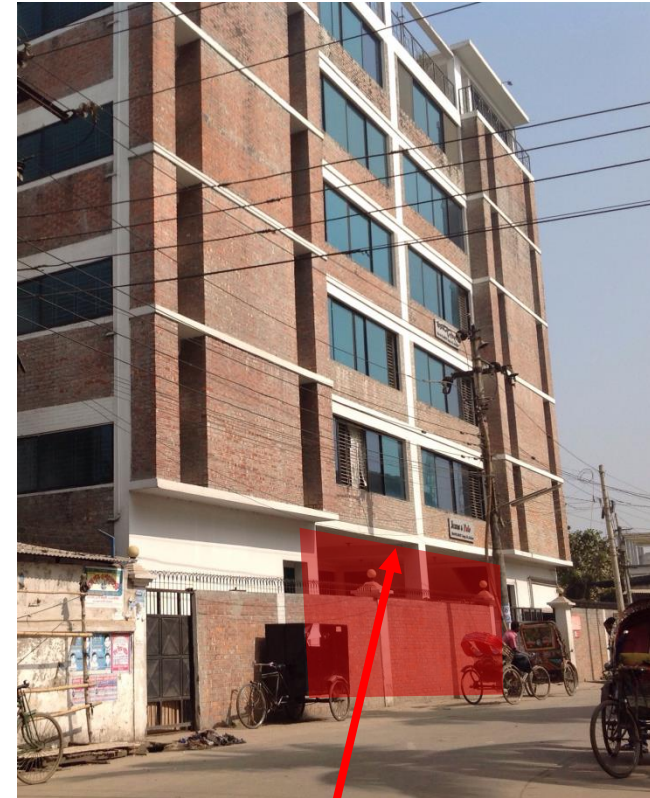
**Perimeter beam on soffit of 1<sup>st</sup> floor at south elevation may be missing**

**Large opening.  
Downstand beams provided elsewhere  
but not provided here.  
Building Engineer to assess.**

**ITEM 4:** Perimeter beam on soffit of 1<sup>st</sup> floor at south elevation may be missing

| Item No. | Observation | Recommended Action Plan | Recommended Timeline |
|---|---|---|---|
| 9 | Perimeter beam on soffit of 1st floor at south elevation may be missing | Building Engineer to survey locations of perimeter beams to south elevation and carry out a design check on the 1st floor slab to check if remedial works are required. | 6-weeks |
