# Asrotex Ltd

Batjuri, Natun Bazar, Sreepur,  
Gazipur, Bangladesh

23 October 2013

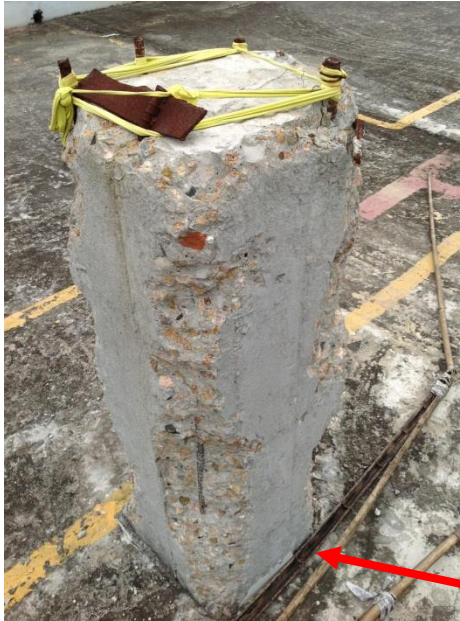
# Check required on column loads and design

Column details according to drawing No. S-05

Column with brick aggregate on roof

| Item No. | Observation | Recommended Action Plan | Recommended Timeline |
|---|---|---|---|
| 2 | Check on column loads and design required | Factory Engineer to review design, loads and columns stresses in area identified above. | Immediate - Now |
| 3 | Check on column loads and design required | Verify insitu concrete stresses either by cores or existing cylinder strength data for all columns | Immediate - Now |

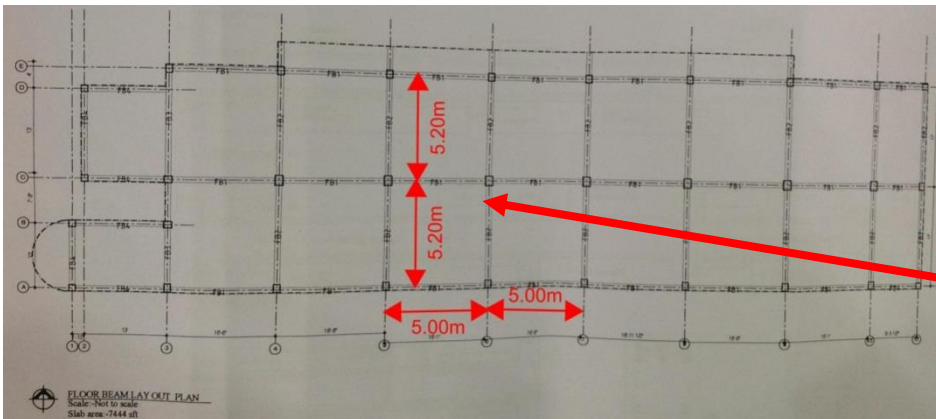
Spans between columns

Check required on column load and design

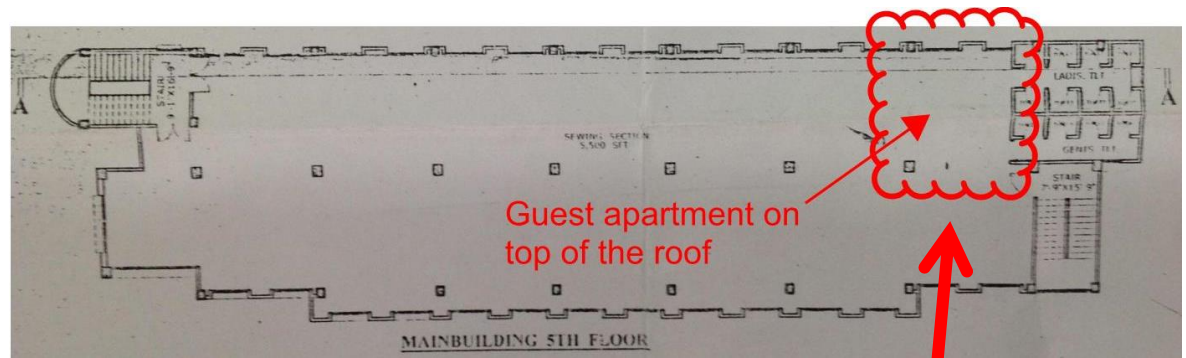
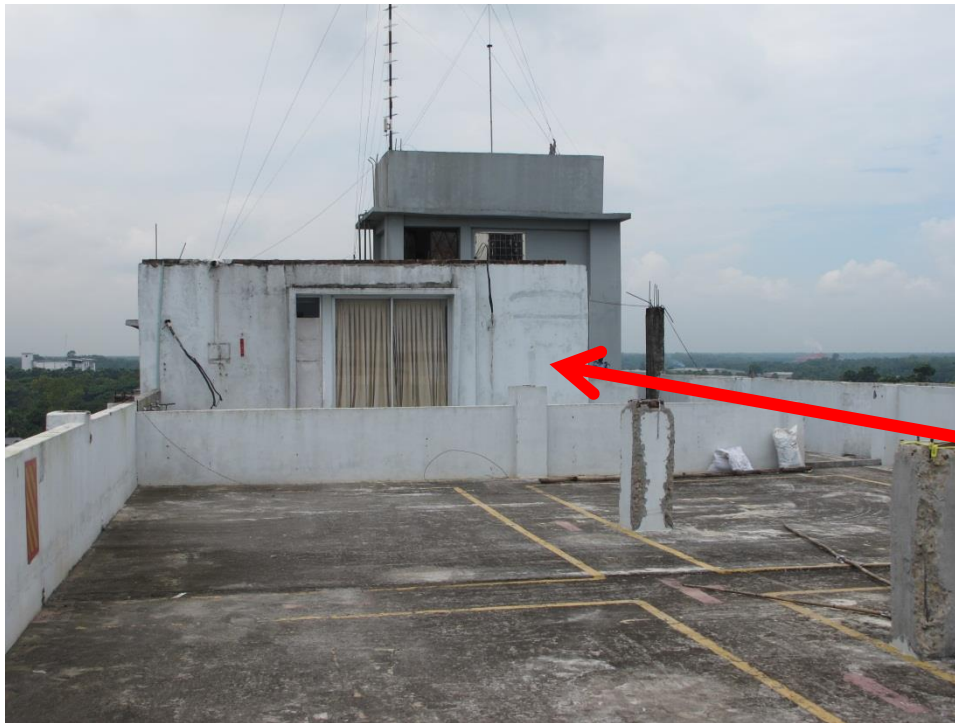
**Addition of guest apartment on roof that does not appear on the drawings**

Roof slab to be checked for taking the loading of the walls of the apartment

| Item No. | Observation | Recommended Action Plan | Recommended Timeline |
|---|---|---|---|
| 9 | Addition of guest apartment on roof | Get engineer to check if the loading from walls of additional guest apartment can be safely carried by roof slab | 6-months |

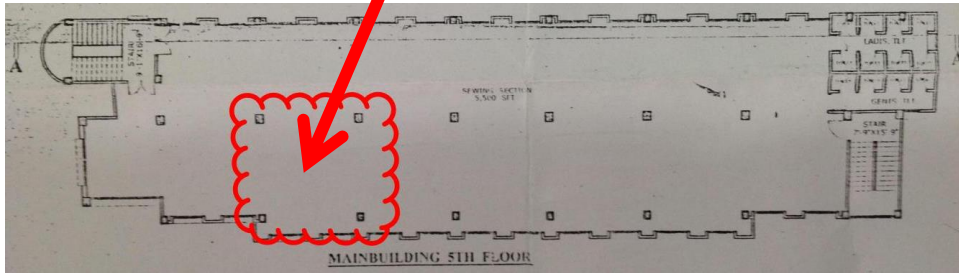
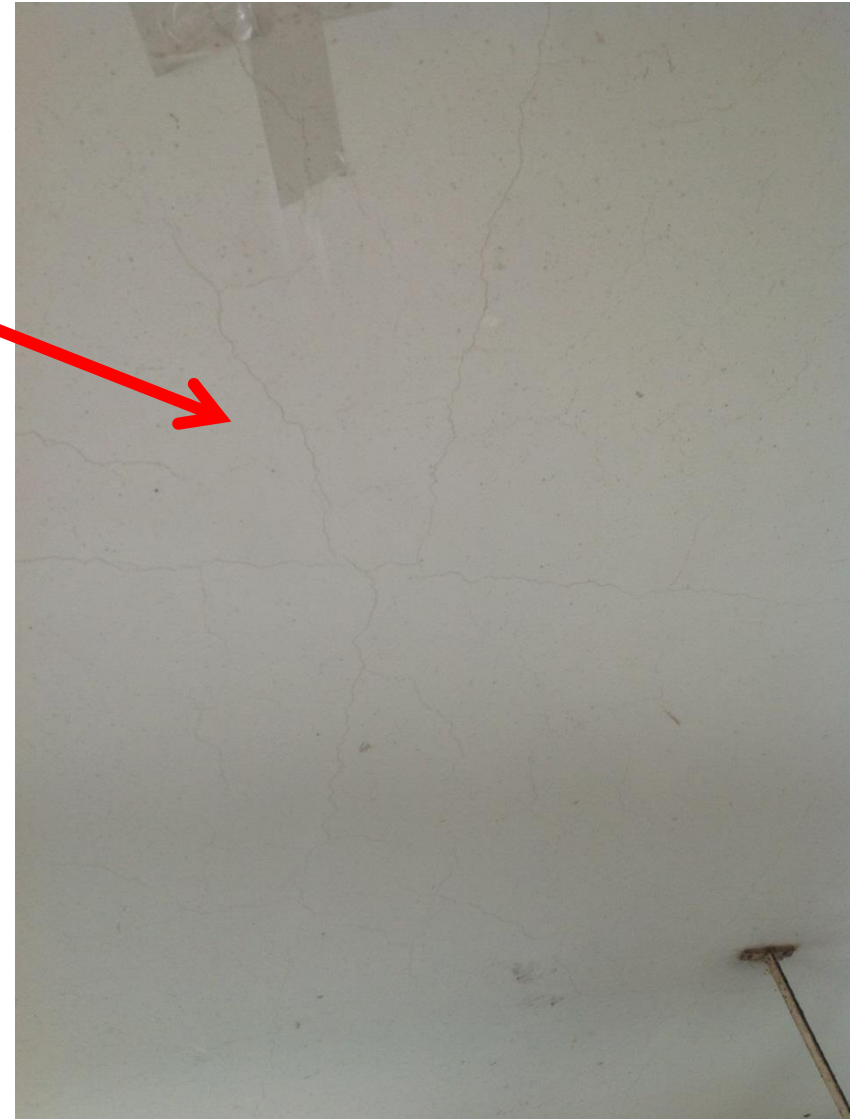
**Minor cracking underside roof slab (ceiling of 5th Floor space)**

**Roof slab to be checked for maximum allowable loading and cracking investigated**

| Item No. | Observation | Recommended Action Plan | Recommended Timeline |
|---|---|---|---|
| 10 | Minor cracking underside roof slab (ceiling of 5th Floor space) | Get engineer to check the roof slab for maximum allowable loading | 6-months |

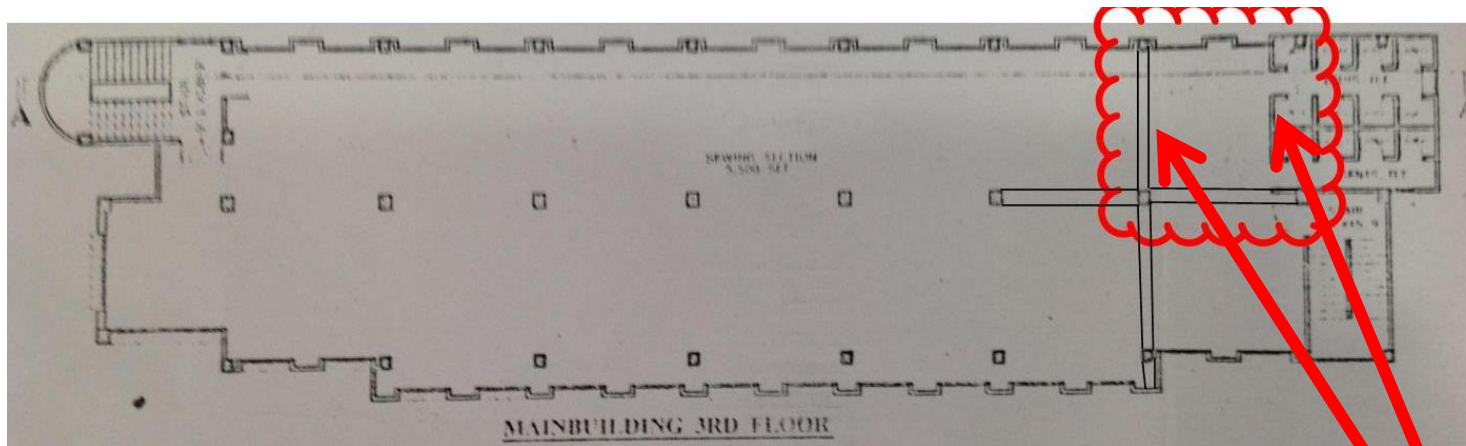
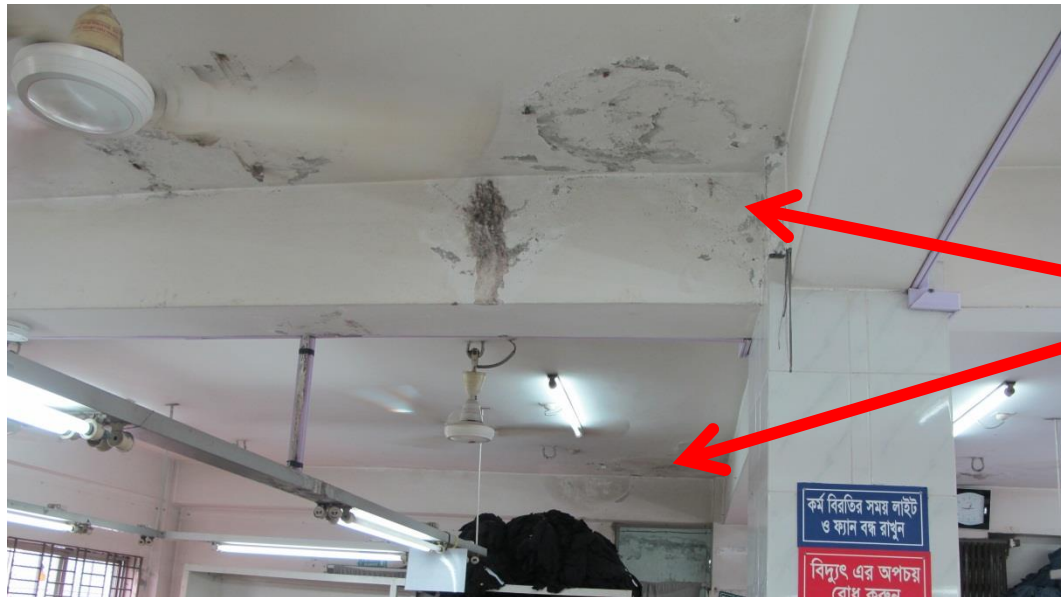
**Degradation of the beam on the last bay on the W side at 2nd and 3rd Floors**

Reason for degradation to be investigated and concrete cover to be checked

| Item No. | Observation | Recommended Action Plan | Recommended Timeline |
|---|---|---|---|
| 11 | Degradation of beam (2nd and 3rd Floor) | Remedy reasons for degradation in beams of 2nd and 3rd floor and check concrete cover of beams affected | 6-months |

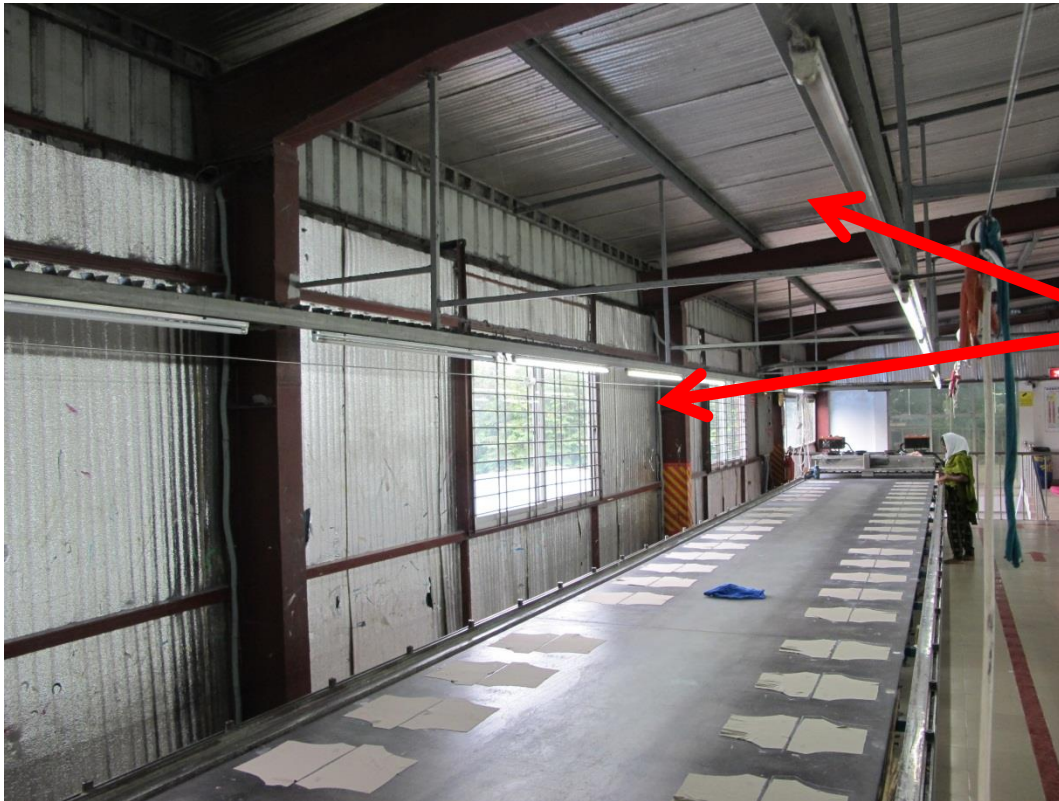
**Lack of lateral bracing to the steel  
roofs of the Sheds**

**Stability Checks required  
by building engineer for  
Steel Structure in the 1<sup>st</sup>  
Floor of Sheds 3 and 4**

| Item No. | Observation | Recommended Action Plan | Recommended Timeline |
|---|---|---|---|
| 12 | Lack of lateral bracing to the steel roofs of the Shed buildings 3 and 4 | Get engineer to check stability of steel structure in first floors of sheds 3 and 4 | 6-months |
