# Bela Fashions Ltd.

6 Shing Bari Road Boro Dewra Tongi, Gazipur-1700.

15<sup>th</sup> July 2018

# Observations

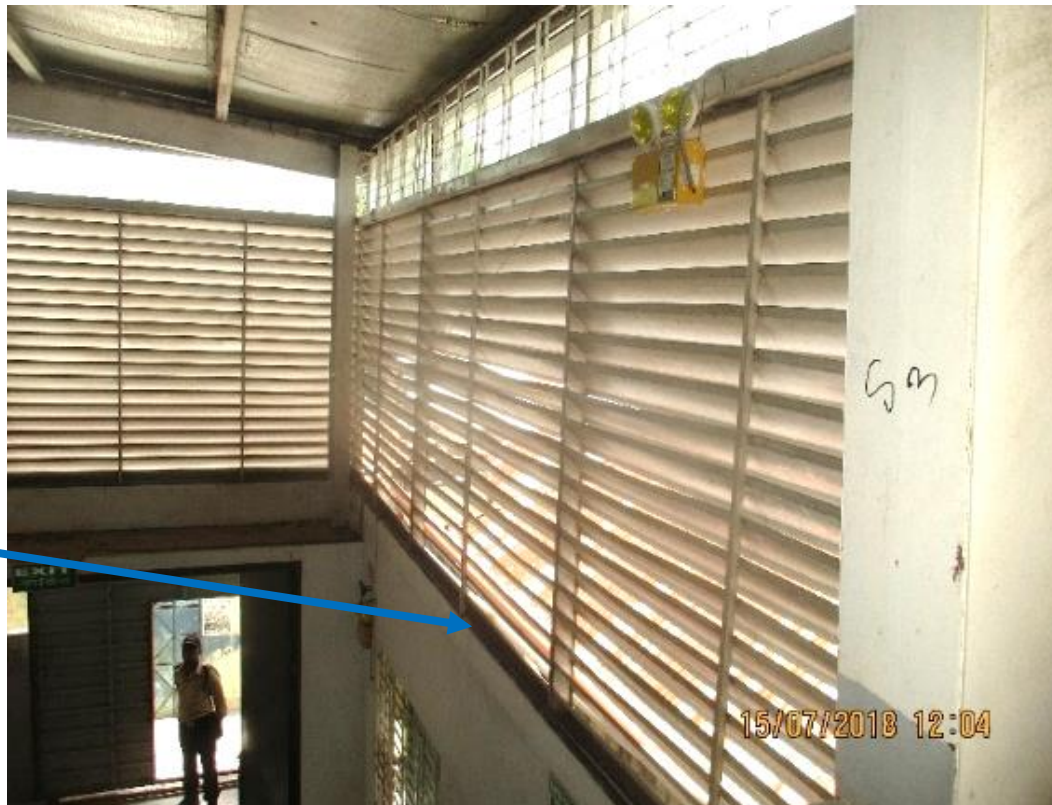
End beam missing at East stair

At end bay (near stair) no steel beam has been provided. But in provided design report that beam has been considered . Load transferring medium of end frame and first internal frame is not clear.

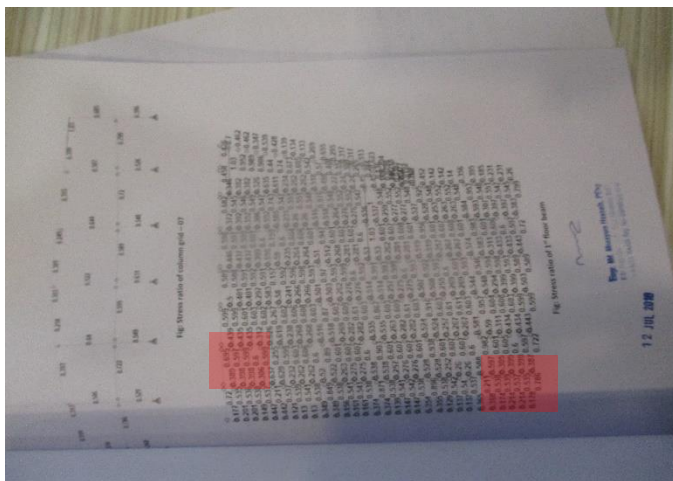
Stress ratio in 1<sup>st</sup> floor beam

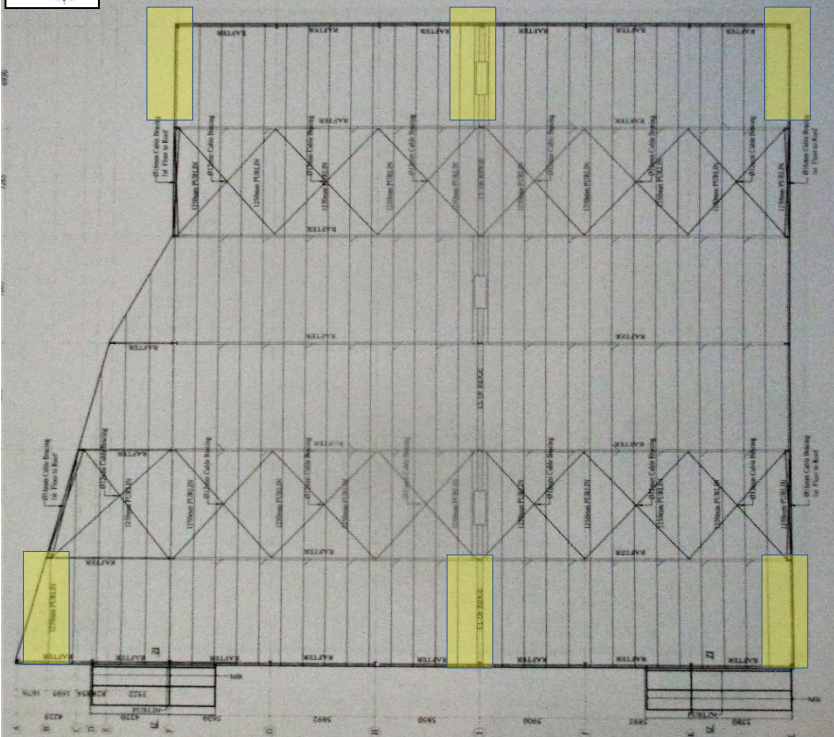
Bracing Layout

No compression strut or bracings were found between the end frame and first internal frame to transfer the lateral loads towards that direction.

| Item No. | Observation | Recommended Action Plan | Recommended Timeline |
|---|---|---|---|
| 1 | Lateral stability | Factory engineer need to check stability system of the structure against lateral loading. | 6-weeks |

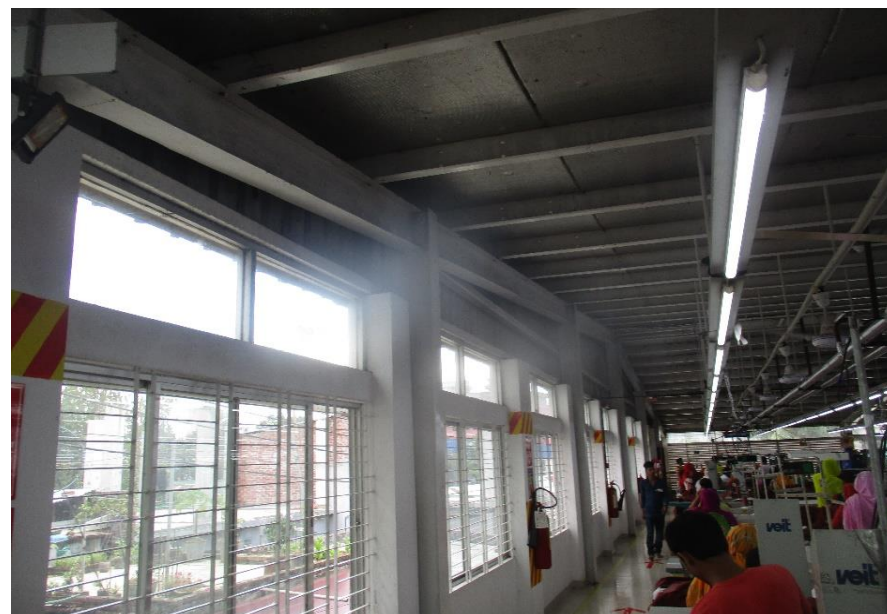
No compression stud

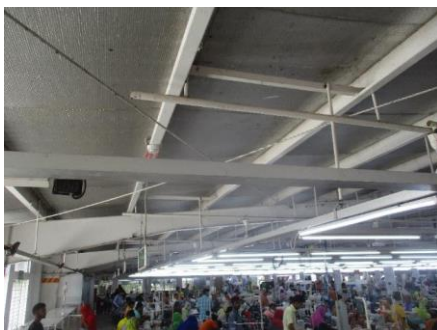
Also, loose vertical & horizontal bracings were found. Factory engineer is required check the stability of the structure against lateral loading.

Loose roof bracing

| Item No. | Observation | Recommended Action Plan | Recommended Timeline |
|---|---|---|---|
| 2 | Lateral stability | Tighten loose bracings where required. | 6-weeks |

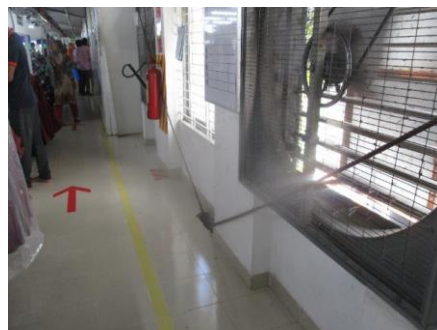
Loose vertical bracing

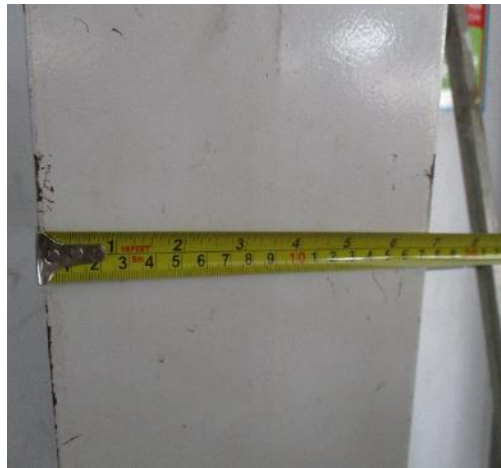
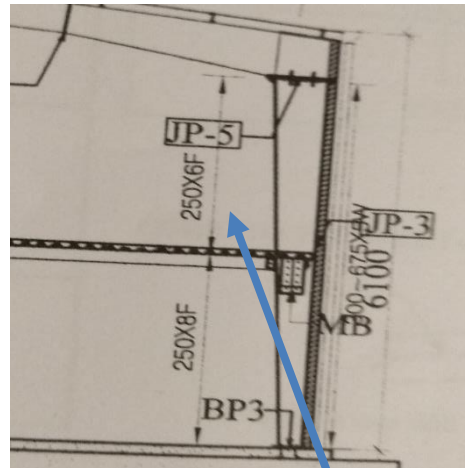
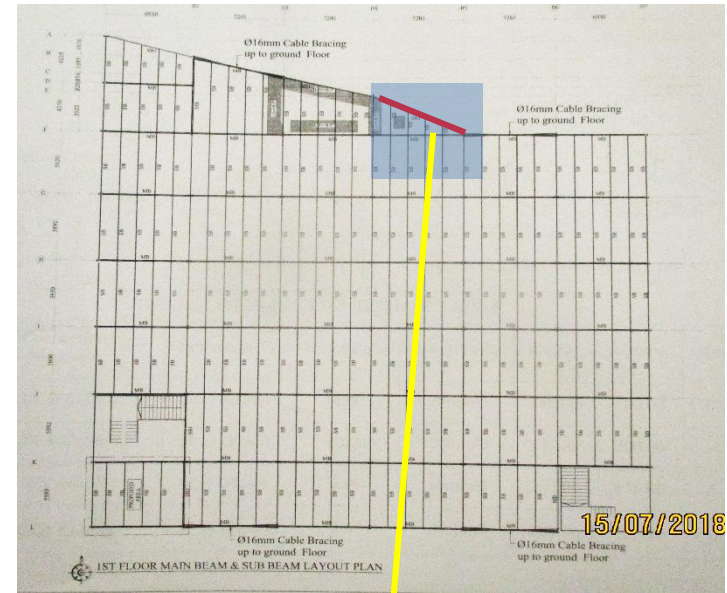
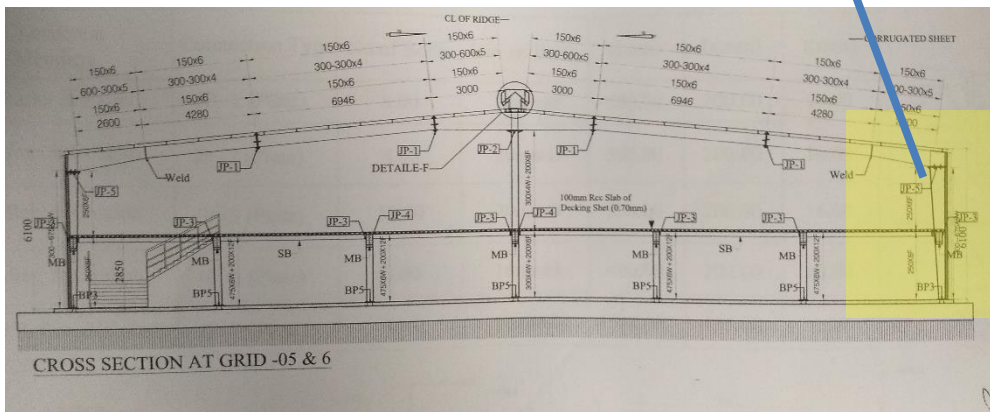
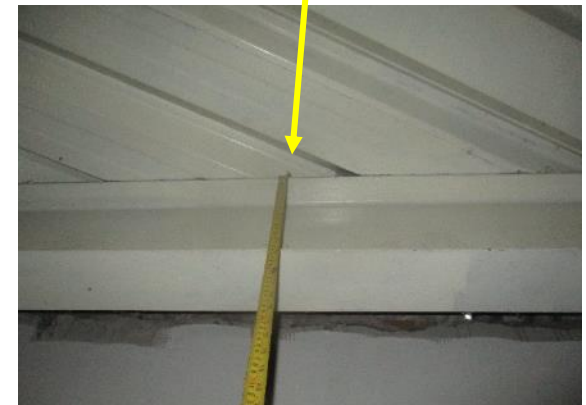
Sub-beam layout does not fully match with as-built condition. At North SB type beam was found instead of SB-1. Mismatch is shown in red on drawings.

Width of flange does not match with as-built condition for periphery column at 1<sup>st</sup> floor. 175mm width was found instead of 250 mm.

SB instead of SB-1

| Item No. | Observation | Recommended Action Plan | Recommended Timeline |
|---|---|---|---|
| 4 | Discrepancies in as-built drawings | Building Engineer to survey as-built structure and prepare accurate as-built survey information for the building. | 6-weeks |

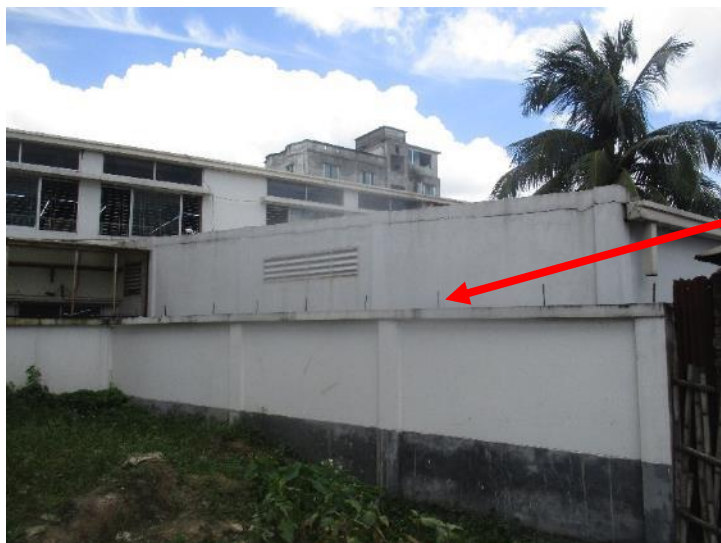
Single storied extension used as finishing

Undocumented extension observed at South side of production building.

| Item No. | Observation | Recommended Action Plan | Recommended Timeline |
|---|---|---|---|
| 5 | Discrepancies in as-built drawings | Prepare as-built documentation and check lateral stability for undocumented portion. | 6-weeks |

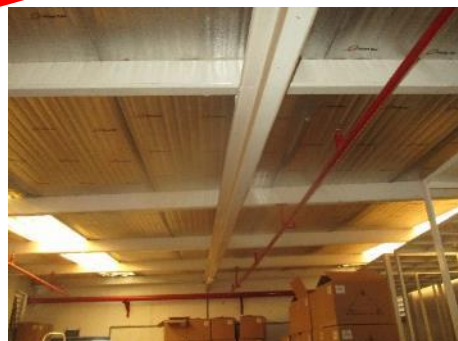
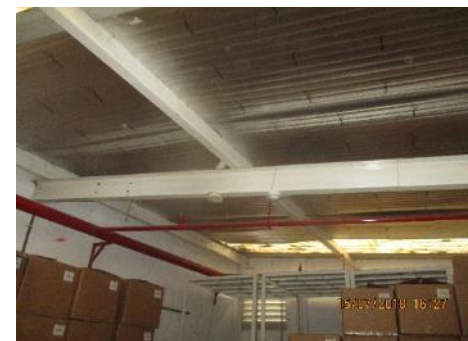
Inside of single storied extension

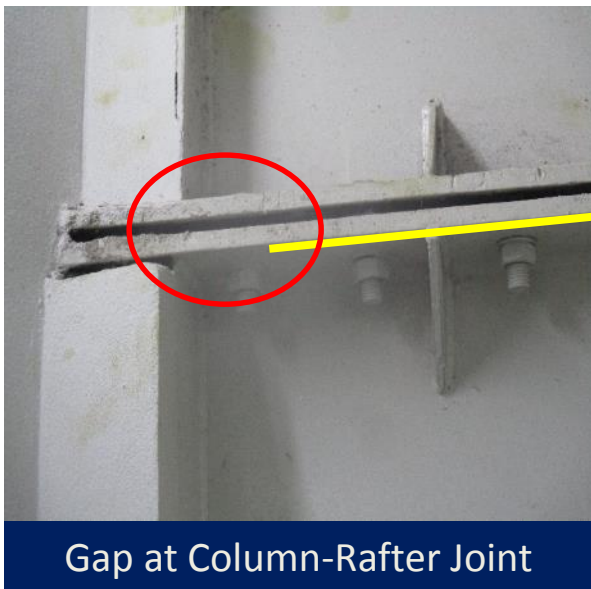
Gap at Column-Rafter Joint

Significant gaps and undersized bolts were observed in column rafter joint at several locations. Building engineer is required to carry out suitable remedial works.

| Item No. | Observation | Recommended Action Plan | Recommended Timeline |
|---|---|---|---|
| 6 | Significant gaps and loose bolts at several connections | Identify all the location and carryout suitable repair works where necessary. | 6-weeks |

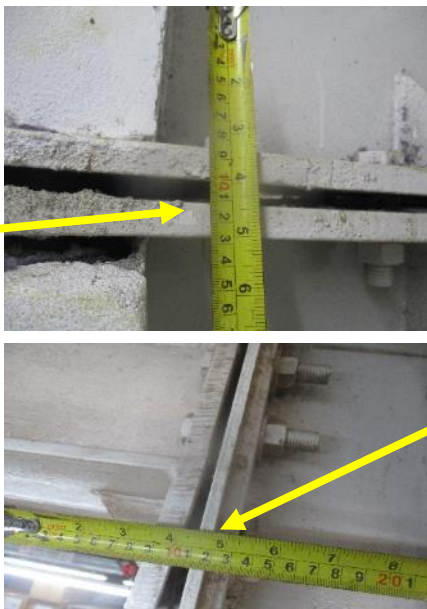
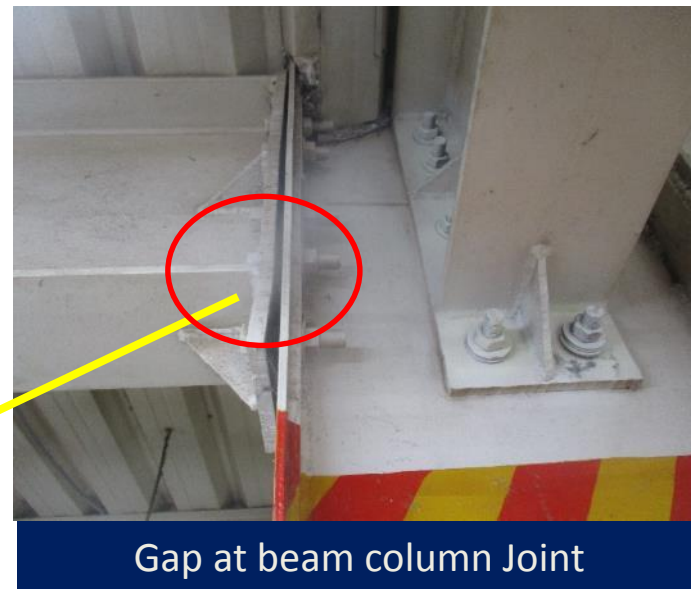
Gap at beam column Joint

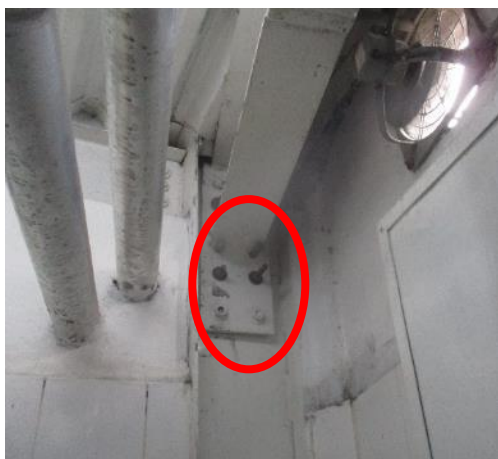
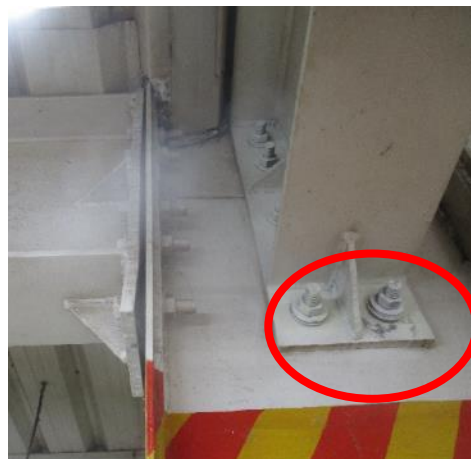
Improper bolt connection

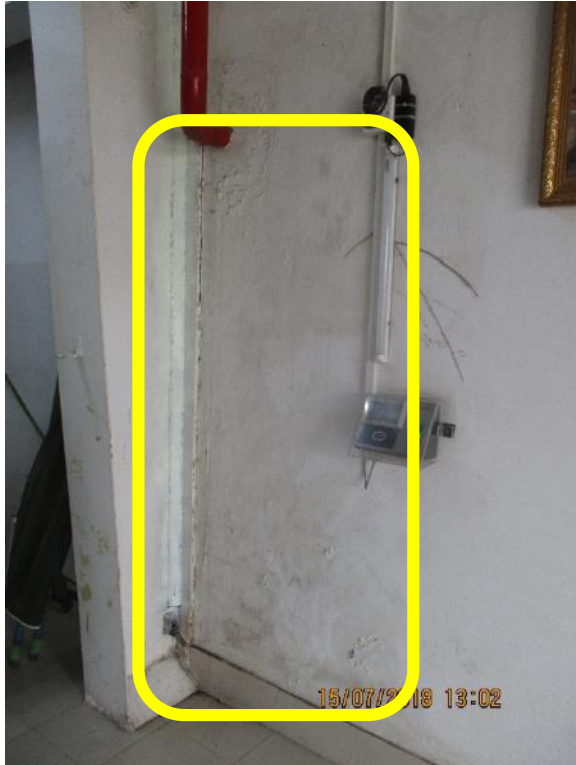
Steel columns at periphery is prone to be corroded due to observed water leakages.

Dampness on periphery wall

| Item No. | Observation | Recommended Action Plan | Recommended Timeline |
|---|---|---|---|
| 7 | Corrosion and dampness | Factory engineer is required check the cause of dampness and suggest suitable repair method. | 6-weeks |

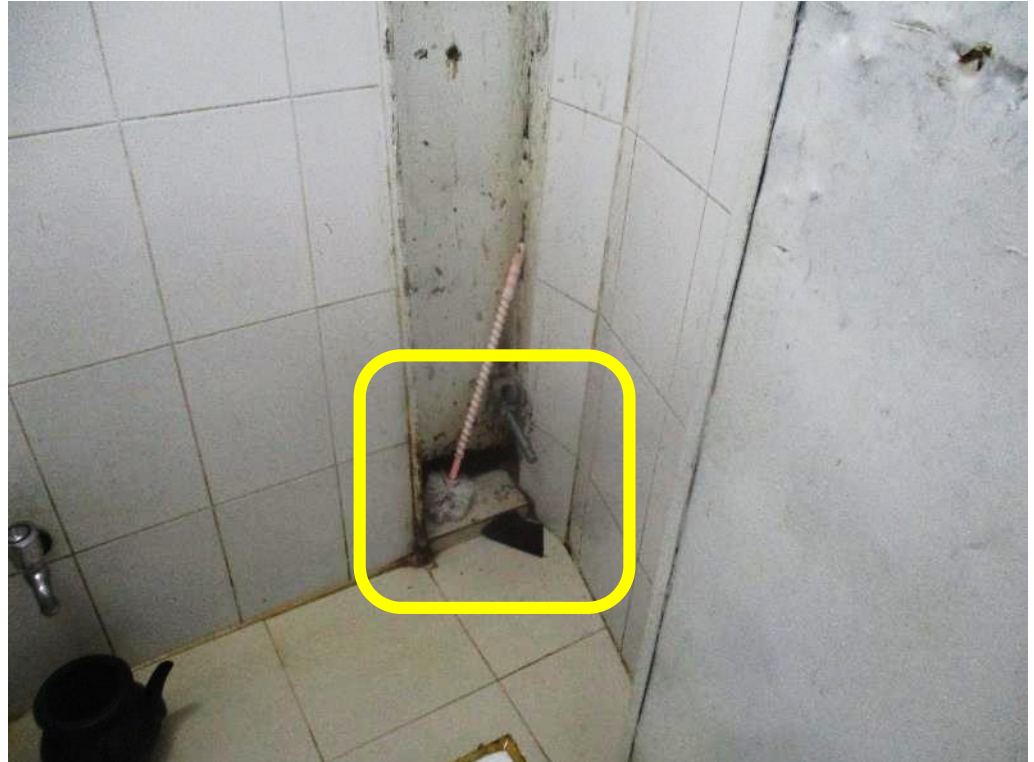
Also, corrosion found at column inside Ground floor toilet zone. Factory engineer to identify the cause of dampness & suggest appropriate remedial action. Also, apply suitable method to protect the steel members from corrosion.

Corrosion at column base inside toilet zone

| Item No. | Observation | Recommended Action Plan | Recommended Timeline |
|---|---|---|---|
| 8 | Corrosion and dampness | Apply suitable method to protect the steel members from corrosion. | 6-weeks |

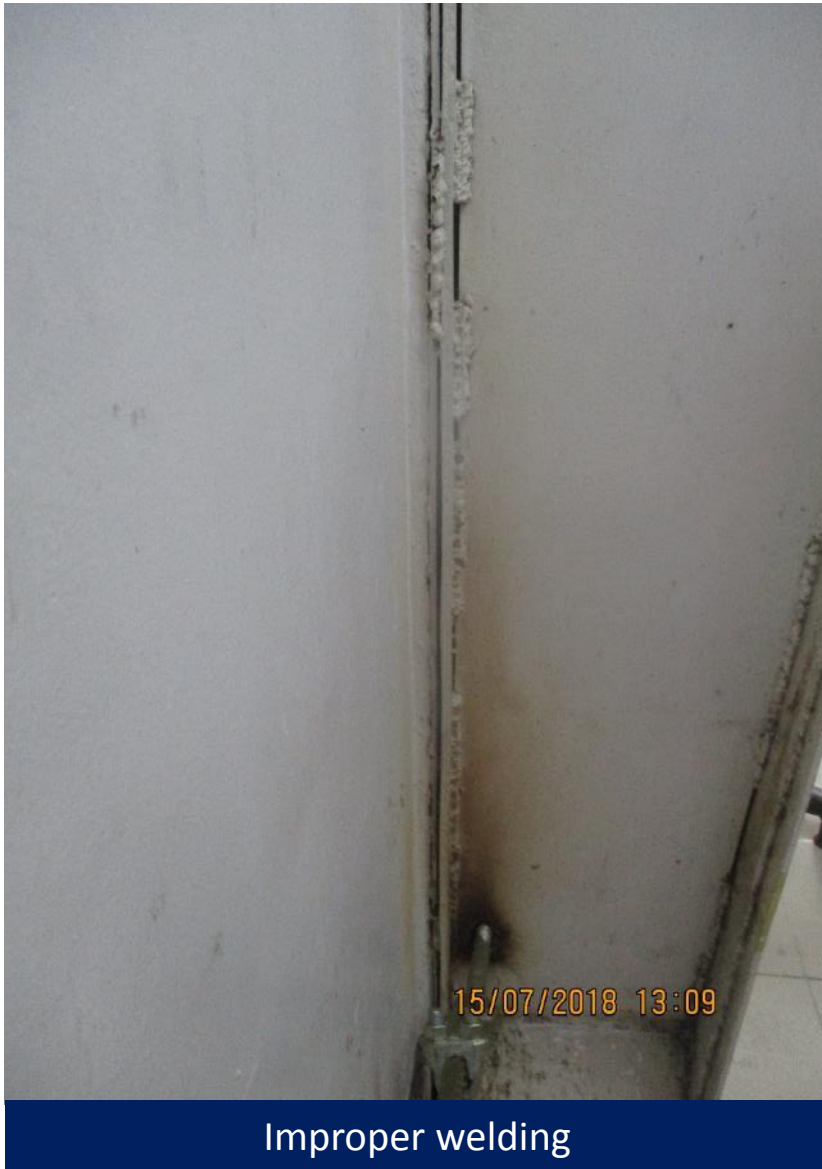
Improper welding

Tack welding was found in several columns. Flange and web are poorly welded.

| Item No. | Observation | Recommended Action Plan | Recommended Timeline |
|---|---|---|---|
| 9 | Poor construction Poor construction works in retrofitted columns | Building Engineer is required to confirm adequate welding joints where necessary. | 6-weeks |

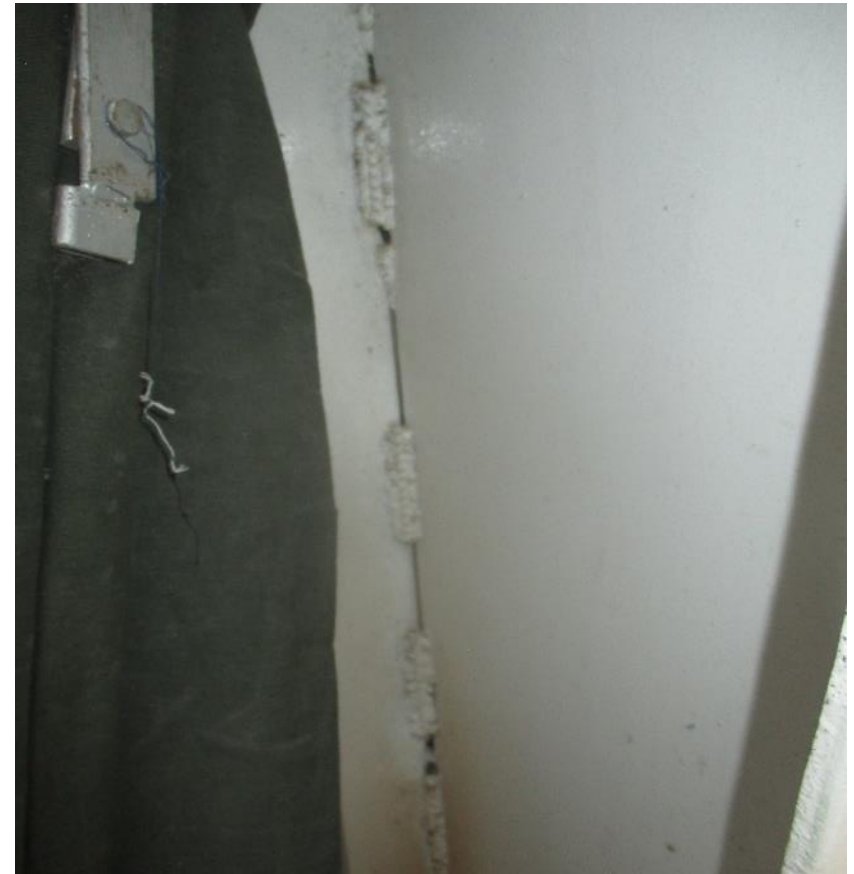
Improper welding

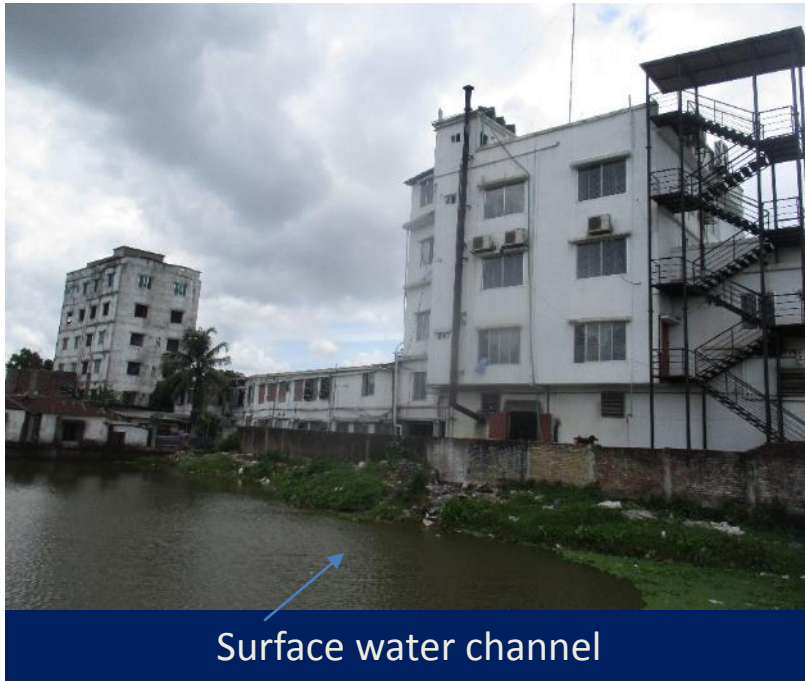
Lake is very close to structure. Building engineer to monitor building for signs of water ingress and appropriate action to be taken if ingress occurs.

Surface water channel

| Item No. | Observation | Recommended Action Plan | Recommended Timeline |
|---|---|---|---|
| 10 | Proximity of Lake/Surface water channel | Building Engineer to monitor the structure for signs of water ingress and take preventative action if necessary. | 6-months |

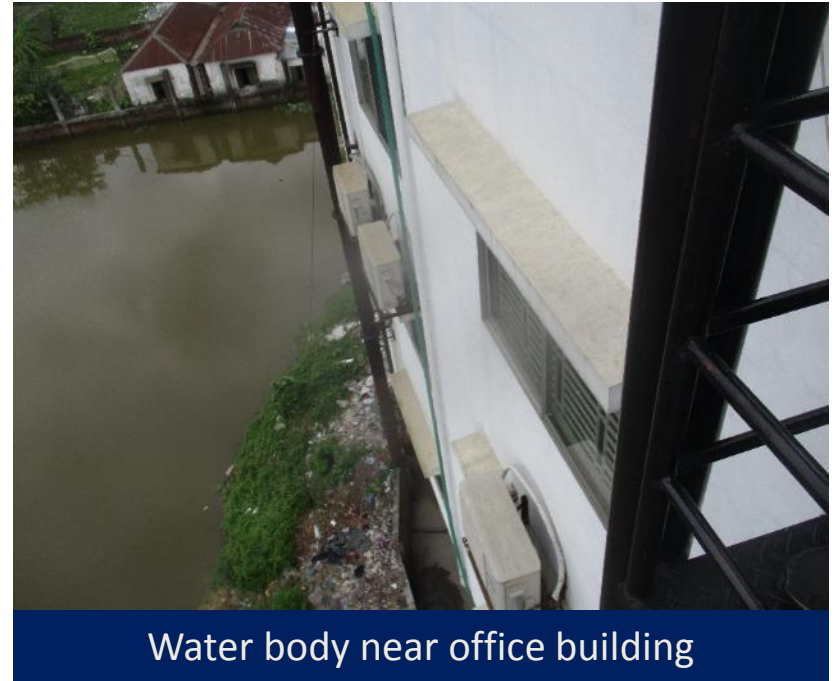
Water body near office building

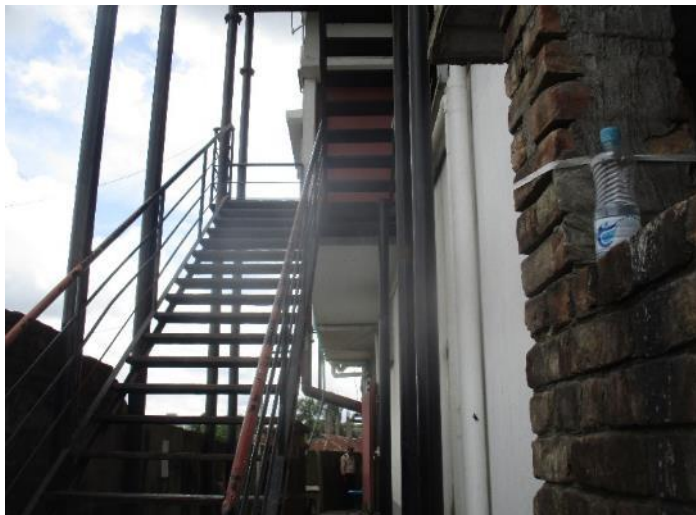
No lateral stability for steel stair

| Item No. | Observation | Recommended Action Plan | Recommended Timeline |
|---|---|---|---|
| 12 | Apparently non-engineered external steel stair | Engage Building Engineer to check load bearing capacity of external escape stair and to ensure adequate stability and connections are provided. | 6-weeks |

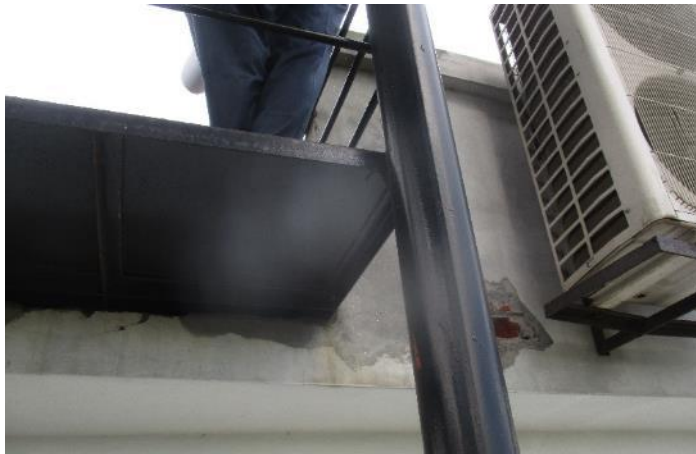
Stair landing Poorly connected with office building

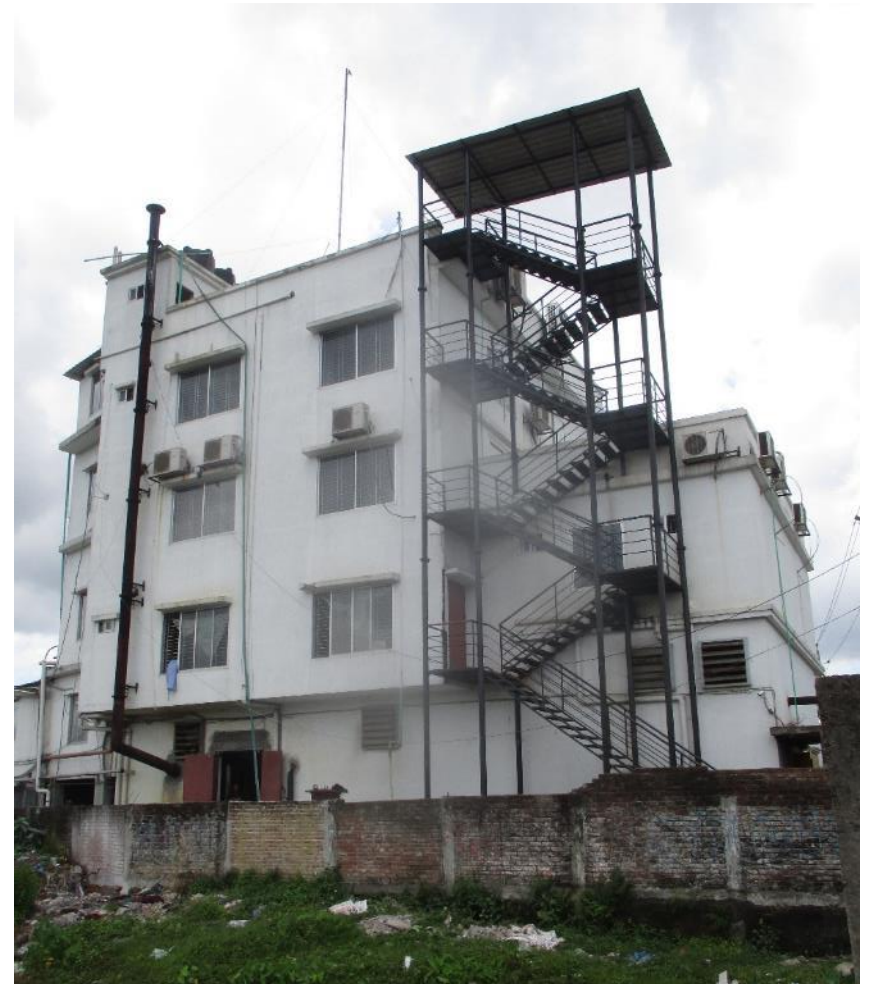
External steel stair at south. No drawing was available during inspection.

| Item No. | Observation | Recommended Action Plan | Recommended Timeline |
|---|---|---|---|
| 11 | Apparently non-engineered external steel stair | Prepare required documentation. | 6-weeks |
