# ELECTRICAL SAFETY INSPECTION REPORT

DEKKO KNITWEARS LTD

Plot # I/5, I/7, I/9, I/11 and I/13, Road # 6, Section-7, Mirpur, Dhaka

**Inspected on :** May 16, 2017

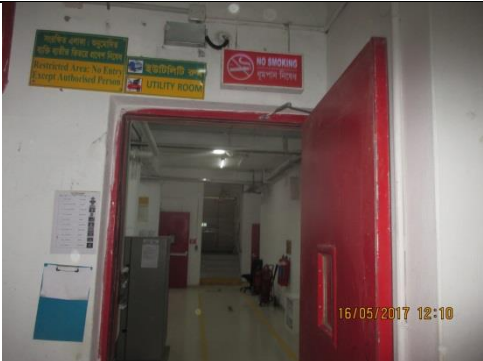
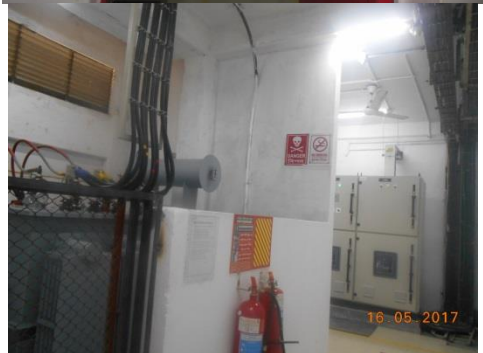
| <b>FINDING:</b> | <p>High voltage equipments are placed near the entrance aisle without any separation. This is the only entrance of both the substation room and LT panel room. Again, on the entrance of the substation room, generators, compressors and other utilities are installed without separation.</p> | |

| <b>RECOMMENDATION:</b> | <p>A separate exit is required as the separation of transformer room will make an obstacle of cross ventilation in transformer room.</p> | |

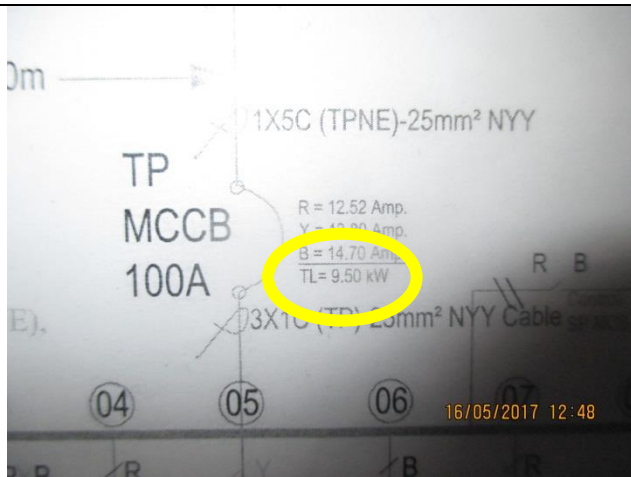
| FINDING NO: | E - 2 | |

| FINDING: | MCCBs are not adjusted per load demand. | |

| RECOMMENDATION: | All the MCCBs must be adjusted per rated load current; if adjustment is not possible, replacement will be the only way. | |

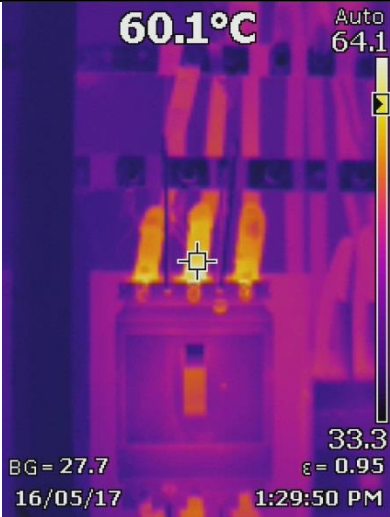
| <b>FINDING NO:</b> | <b>E - 3</b> | |

| <b>FINDING:</b> | Hot spots were observed at several points. | |

| <b>RECOMMENDATION:</b> | Hot spots must be eliminated from entire electrical system and shall be always carried forward. | |

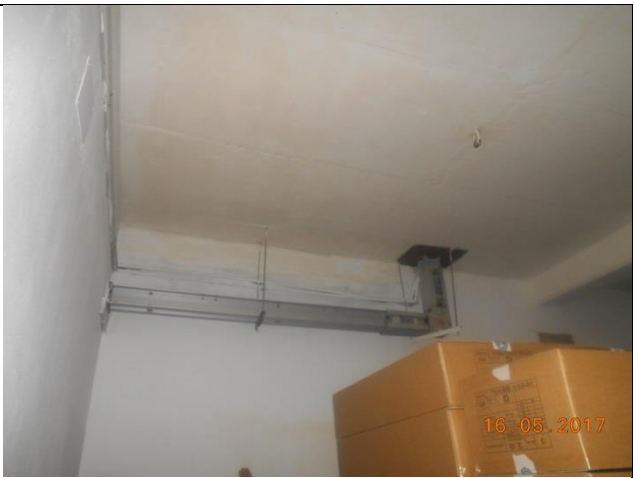
| <b>FINDING NO:</b> | <b>E - 4</b> | |

| <b>FINDING:</b> | Main BBT passed through store room and without any separation. | |

| <b>RECOMMENDATION:</b> | BBT in store room has to be properly separated/ concealed with fire rated materials. | |
