# **FIRE SAFETY INSPECTION REPORT**

**MARK SWEATER LTD.**

**ACCORD ID: 11808**

February 20, 2015

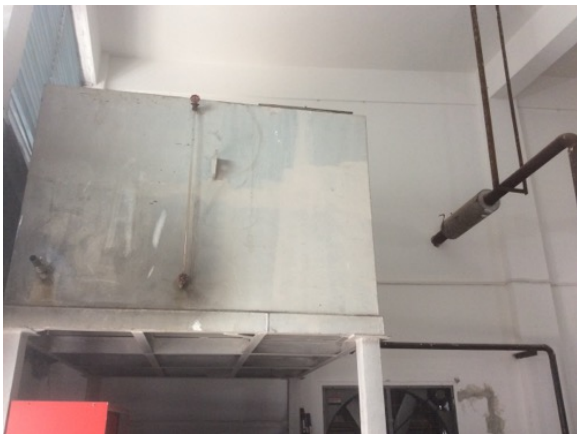
No.	Category	Finding	Recommendation	Remediation Timeframe
F-1	Fire Rated Construction	Diesel fuel storage was located inside the generator room.	Remove all diesel fuel storage from the generator room and relocate to the exterior such that the diesel fuel storage is at least 10 ft. from required egress paths. If located along egress paths or in a utility building, provide the diesel fuel storage with 2-hr fire rated construction. There shall be no diesel fuel storage in a factory production building.	Immediately

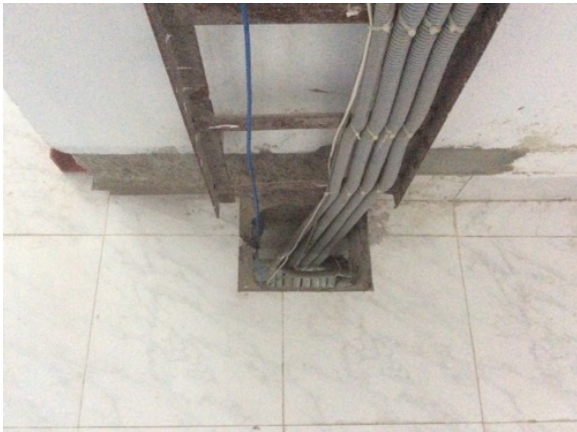
F-2	Fire Rated Construction	Unsealed electrical shafts are located in all the fire-rated floor and ceiling assemblies except the ground floor.	Provide a minimum 2-hr fire-rated shaft to separate the utility risers from each floor level and seal all penetrations in floor and ceiling assemblies to maintain the fire separation.	Within 3 months
-----	-------------------------	--	---	-----------------

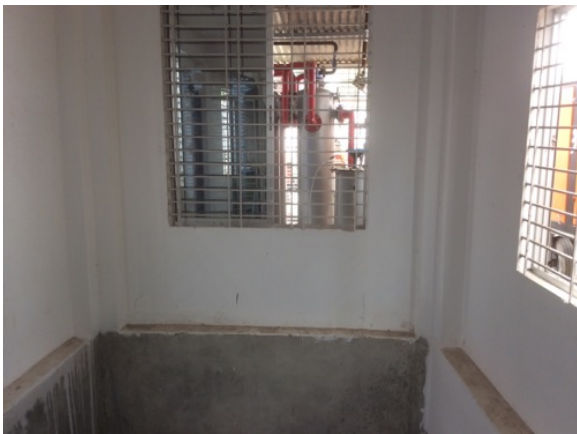
F-3	Fire Rated Construction	The fire pump room is not provided with adequate fire rated separation in the utility building.	Provide fire pump room with 2 hr. rated fire separation when not sprinklered and 1 hr. rated fire separation when provided with automatic sprinklers, in accordance with NFPA 20.	Within 3 months
-----	-------------------------	---	---	-----------------

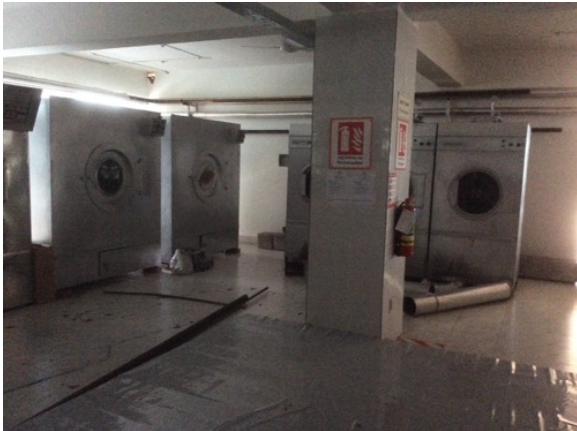
F-4	Fire Rated Construction	The industrial dryers are not separated by fire-rated construction on the fourth floor.	Separate the industrial dryer room by a minimum 2-hr fire-rated construction. Seal and protect all openings to maintain the required fire separations. Provide proper ventilation and consult with a qualified engineer.	Within 3 months
-----	-------------------------	---	--	-----------------

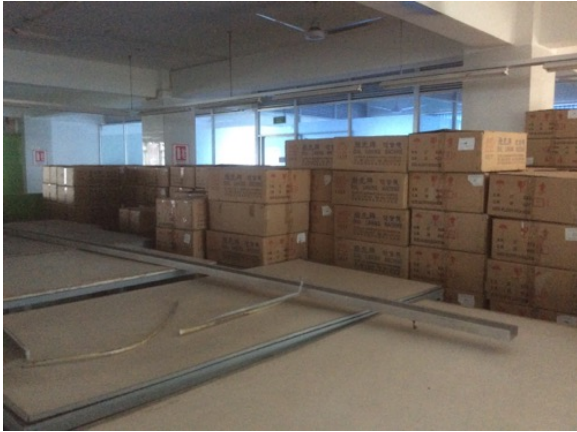
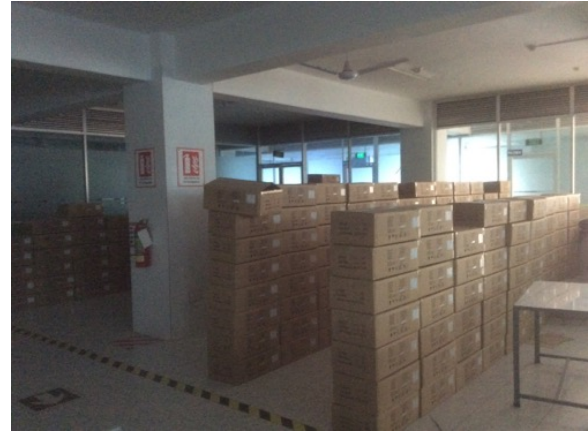
F-5	Fire Rated Construction	Areas used for combustible storage open to the factory are not separated by fire-rated construction on second and fourth floors.	<p>Provide defined storage areas and limit the storage arrangement as follows:</p> <ul style="list-style-type: none"> <li>- Maximum height of 2.45m (8ft.) and maximum area of 23m<sup>2</sup> (250 ft<sup>2</sup>)</li> <li>- If sprinkler protected: maximum height of 3.66m (12ft.) and maximum area of 93m<sup>2</sup> (305ft<sup>2</sup>).</li> </ul> <p>Separate areas of unenclosed combustible storage by a minimum clear distance of 3m (10ft.).</p>	Within 3 months
-----	-------------------------	--	---	-----------------

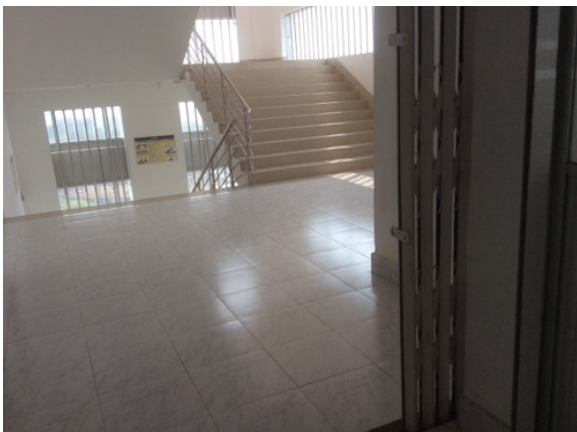
F-6	Fire Rated Construction	Exit stairs are not separated from work areas and other spaces on each floor by fire-rated construction.	<p>Provide minimum 1-hr rated doors for buildings with 3 or fewer stories and 1.5-hr fire rated doors for buildings that are 4 or more stories. Seal all unprotected openings to separate the exit stairs from work areas and other building spaces on all floor levels. Ensure that the fire doors are self-closing and positive latching and that they are provided with fire exit (panic) hardware where serving production floors.</p> <p>If fire doors are required to be held open for functional reasons, provide automatic-closing devices tied to the fire alarm system.</p> <p>Once fire doors are installed, every door in a stair enclosure serving more than 5 stories shall be provided with re-entry unless it meets ACCORD standard 6.8.3.1.</p>	Within 3 months
-----	-------------------------	--	--	-----------------

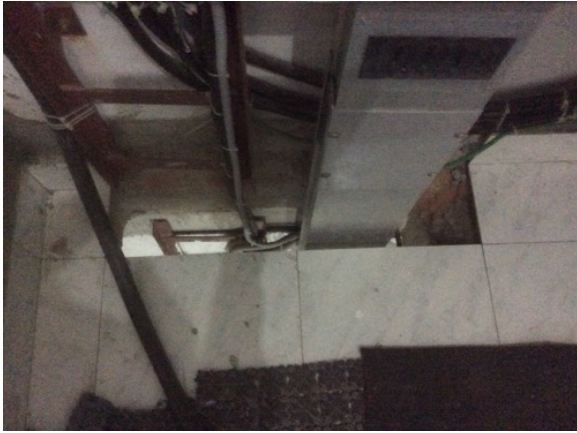
F-7	Fire Rated Construction	Unsealed penetrations and openings are located in all the fire-rated floor and ceiling assemblies except the ground floor.	Seal all penetrations and openings in floor and ceiling assemblies to maintain the fire separation.	Within 3 months
-----	-------------------------	--	---	-----------------

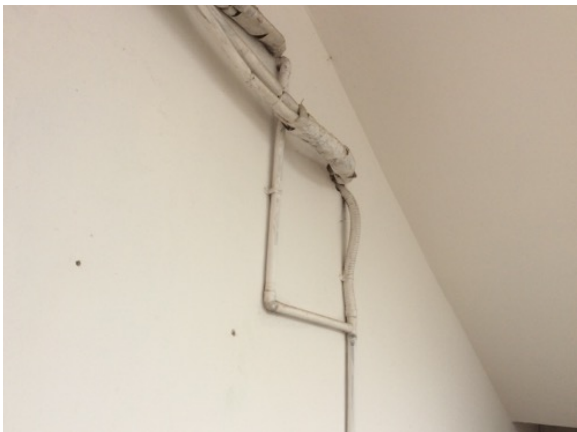
F-8	Fire Rated Construction	Unsealed penetrations and openings are located in the north west exit stair enclosure on the ground floor.	Seal all penetrations and openings in exit stair enclosure walls to maintain the fire separation.	Within 3 months
-----	-------------------------	--	---	-----------------

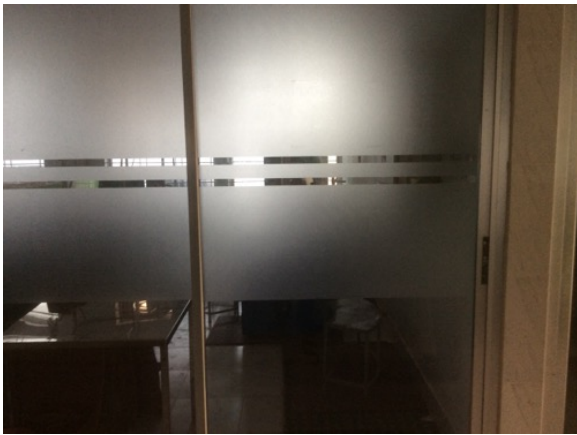
F-9	Fire Rated Construction	The boiler and compressor rooms are not separated by fire-rated construction due to openings and non-rated doors on second floor and utility building.	Separate the boiler and compressor room by a minimum 1-hr fire-rated construction for non-high rise, and 2-hr fire rated construction for high rise. Seal and protect all openings to maintain the required fire separations. When located to the exterior of a building, 3m (10 ft.) separation is required. Provide proper ventilation and consult a qualified engineer.	Within 3 months
-----	-------------------------	--	--	-----------------

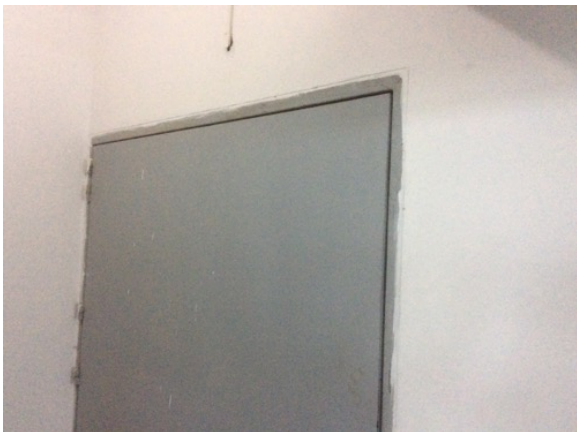
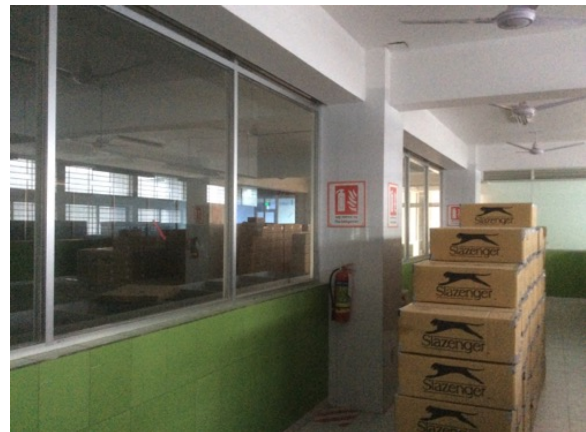
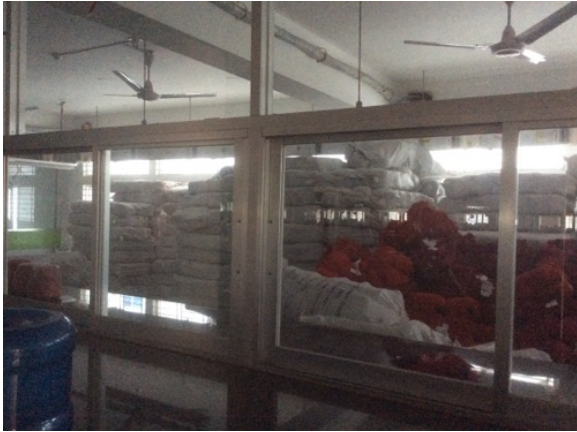
F-10	Fire Rated Construction	Rooms used for combustible storage are not separated by fire-rated construction on ground, first, second, fourth and seventh floors.	<p>Provide dedicated storage rooms separated by minimum 1-hr fire-rated construction.</p> <p>Where separate storage rooms are not feasible, provide defined storage areas and limit the storage arrangement as follows:</p> <ul style="list-style-type: none"> <li>- Maximum height of 2.45m (8ft.) and maximum area of 23m<sup>2</sup> (250 ft<sup>2</sup>)</li> <li>- If sprinkler protected: maximum height of 3.66m (12ft.) and maximum area of 93m<sup>2</sup> (305ft<sup>2</sup>)</li> </ul> <p>Separate areas of unenclosed combustible storage by a minimum clear distance of 3m (10ft.).</p>	Within 3 months
------	-------------------------	--	---	-----------------

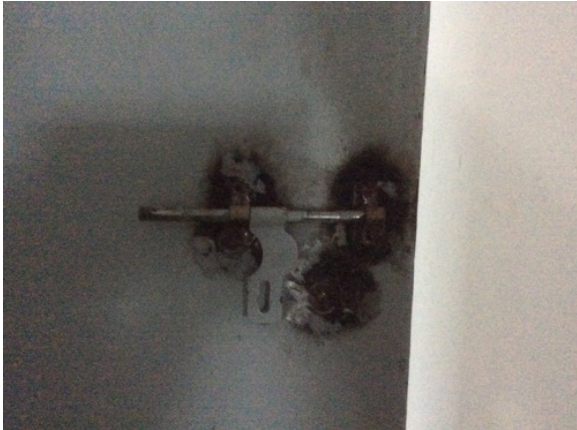
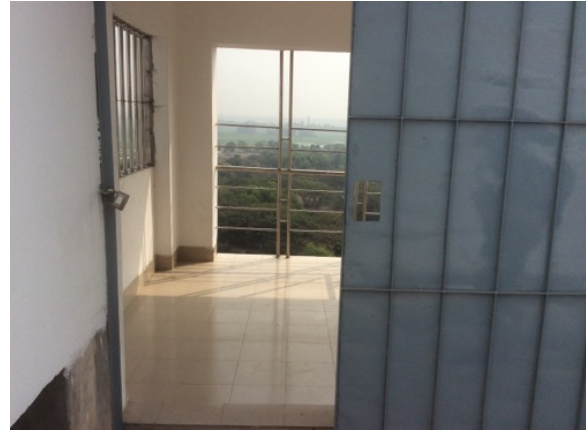
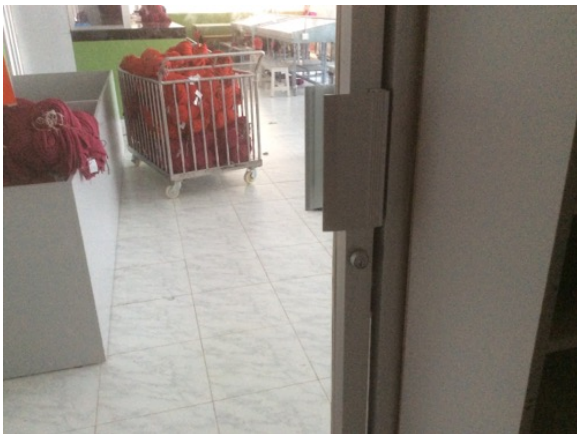
F-11	Egress	Building did not have stair designation signs and occupant load signs at floor entrances.	Provide stair designation signs, occupant load signs and emergency evacuation plans at required locations.	Immediately
F-12	Egress	Egress doors and gates with locking features are provided at building exits, exit stairs and along egress routes. All gates and doors were not open and unlocked during the inspection.	Remove locking features from all egress doors and gates.  If locks are required for security reasons, utilize special door locking features complying with NFPA 101 and ACCORD standard 6.8.2.	Immediately

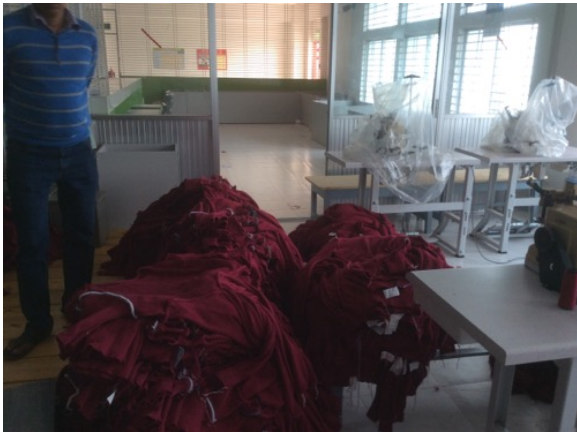
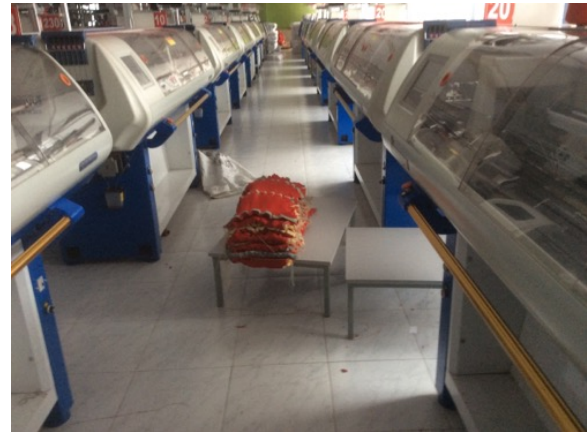
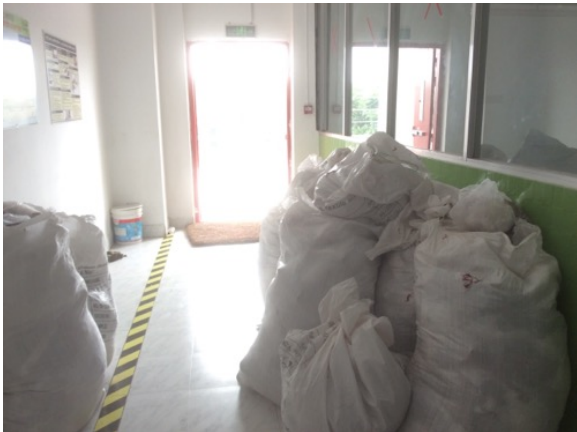
F-13	Egress	Storage and obstructions were located in the egress paths on first, fifth and sixth floors.	Keep egress paths and stairs immediately clear of storage and obstructions.
------	--------	---	---

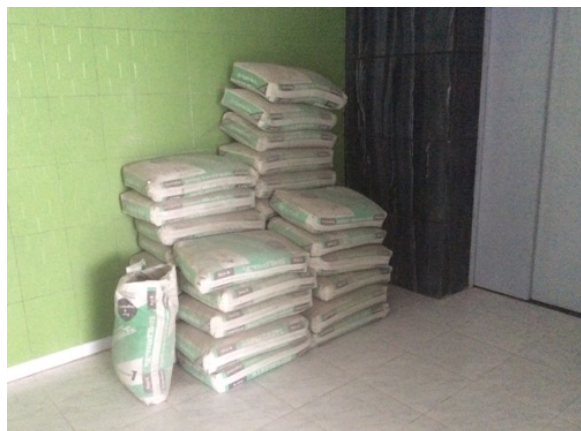
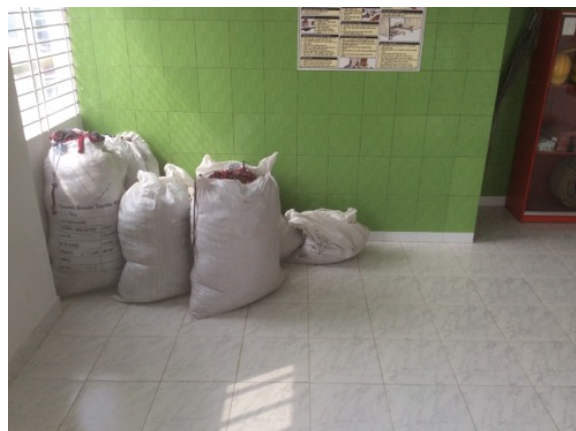
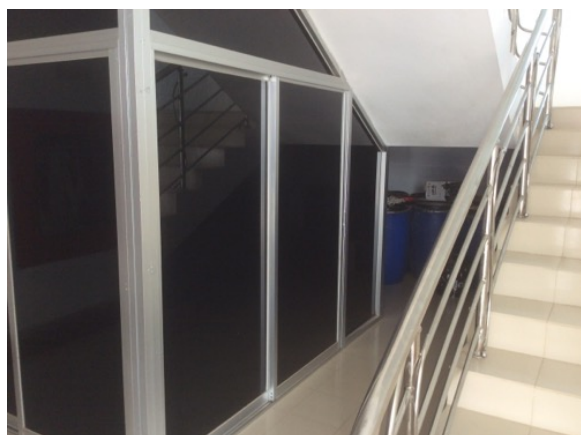
F-14 Egress

Storage was located in the south east exit stair on the sixth, fifth and ground floors and in south west and north west exit stairs on the ground floors.

Remove all storage from exit stairs and egress paths. Immediately

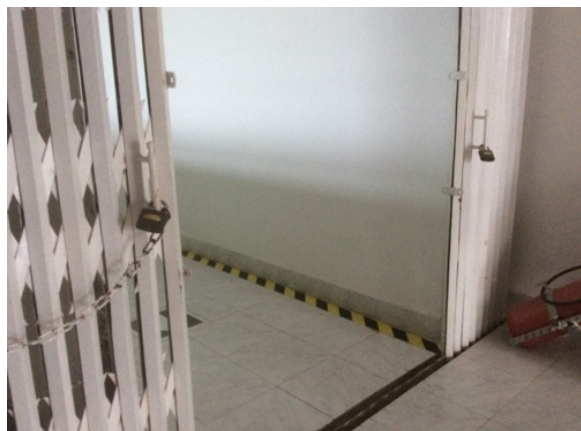
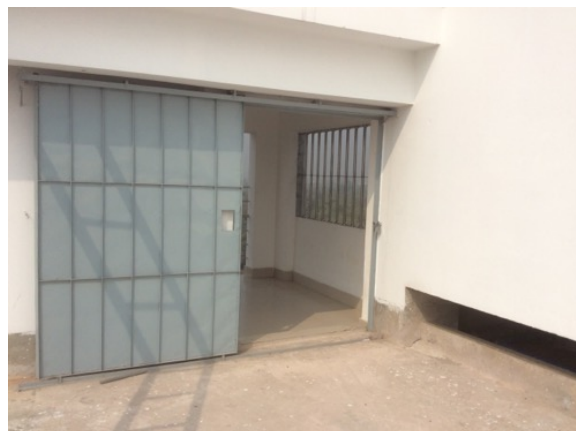
F-15	Egress	Collapsible gates and sliding doors are provided at building exits, exit stairs and along egress routes.	Replace all gates and sliding doors along the means of egress with side-hinged, swinging egress doors in accordance with ACCORD standard 6.8.1.	Within 1 month
------	--------	--	---	----------------

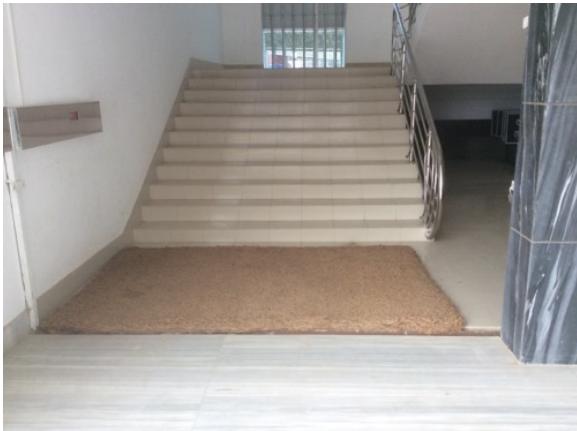
F-19	Egress	Handrails are not provided on both sides of all the exit stairs.	Provide handrails on both sides of the exit stair. New handrails shall have a minimum height of 865 mm (34 in.) and a maximum height of 965 mm (38 in.) as measured from the leading edge of the tread. Intermediate handrails shall be provided when the stair width exceeds 2.2 m (87 in.)	Within 3 months
------	--------	--	--	-----------------

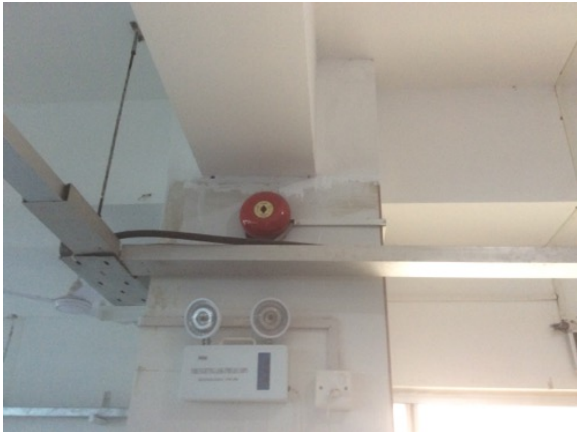
F-27	Fire Protection	Visible and audible notification was not provided for the building in accordance with NFPA 72.	Provide visible and audible notification for the building in accordance with NFPA 72.	Within 3 months
------	-----------------	--	---	-----------------

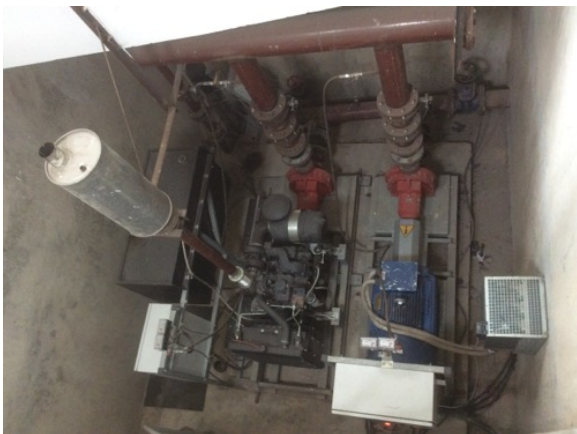
F-28	Fire Protection	Fire pump did not meet ACCORD standard 5.5.1 and 5.5.1.1.	Update current fire pump or provide a new fire pump that meets ACCORD standard 5.5.	Within 6 months
------	-----------------	---	---	-----------------

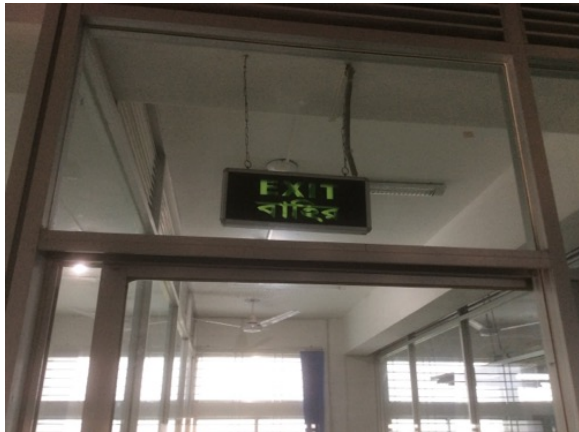
F-29	Egress Lighting	Exit signs were placed in areas that were not exits almost on all the floors.	Remove exit signs from noted areas to avoid confusion from actual exits.	Immediately
------	-----------------	---	--	-------------

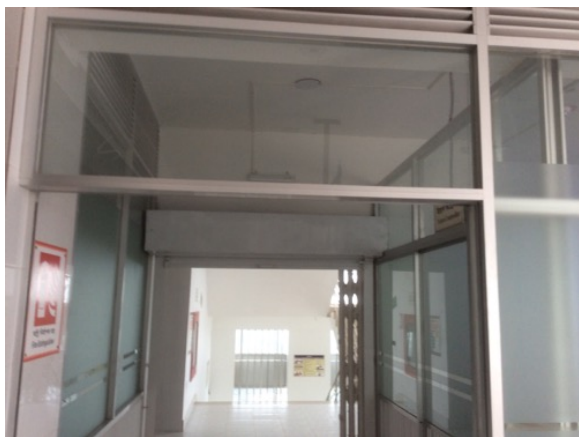
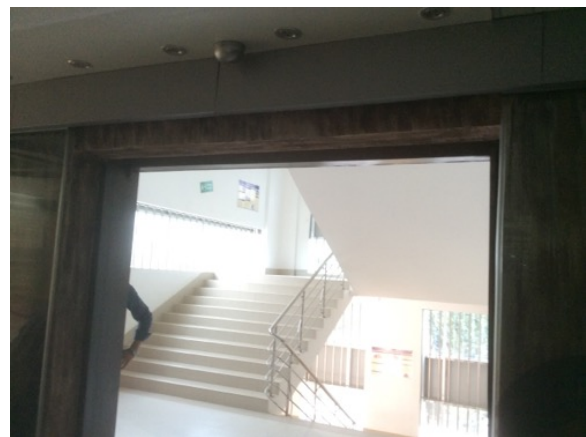
F-30	Egress Lighting	Exit signage was not provided at south east exit stair entrance on the sixth floor and south west exit stair on the second floor.	Provide exit signs above all building exits to the exterior, all doors to the exit stairs and along all paths of travel where a change of direction is not obvious.	Within 1 month
------	-----------------	---	---	----------------

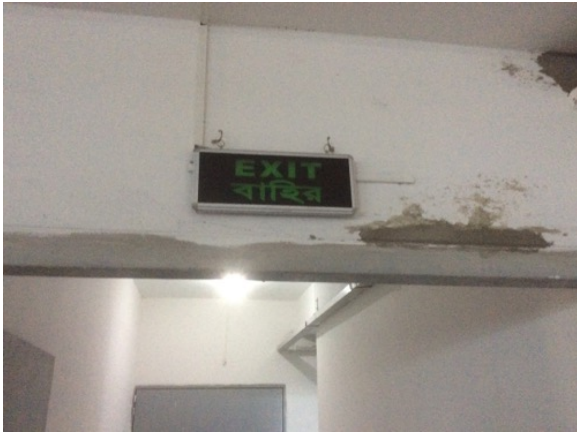
F-31	Egress Lighting	Exit signage not illuminated on third, fourth, fifth and seventh floors.	Regularly inspect all exit signage and replace and install lights as needed to illuminate signs. The source of illumination shall provide not less than 50 lux at the illuminated surface with a contrast of not less than 0.5. Approved self luminous signs which provide evenly illuminated letters having a minimum luminance of 0.2 cd/m <sup>2</sup> may also be used.	Within 1 month
------	-----------------	--	---	----------------

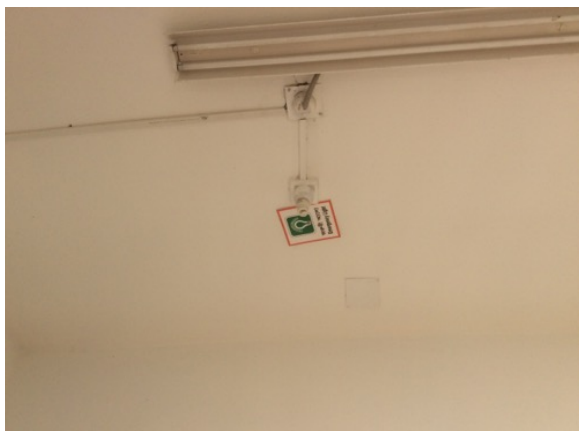
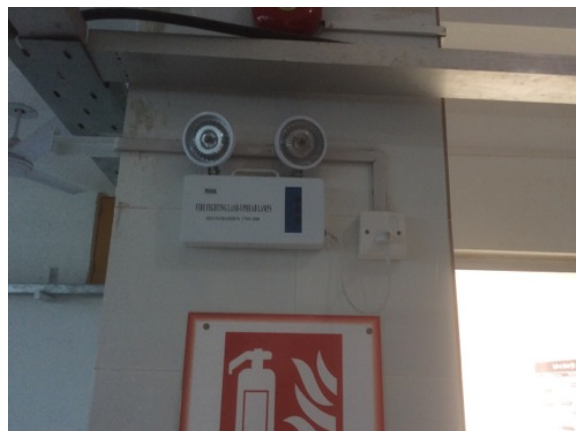
F-32	Egress Lighting	Emergency lighting did not function in test mode on the seventh floor. Emergency lights are burnt out on the north east exit stair and ground floor.	Regularly test the emergency lighting system on each floor and replace or repair lights as needed.	Within 1 month
------	-----------------	--	--	----------------

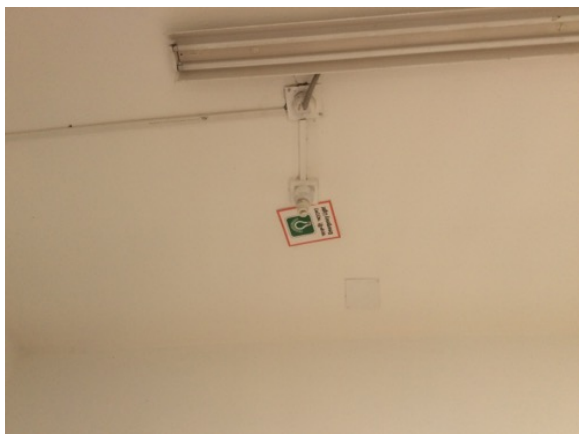
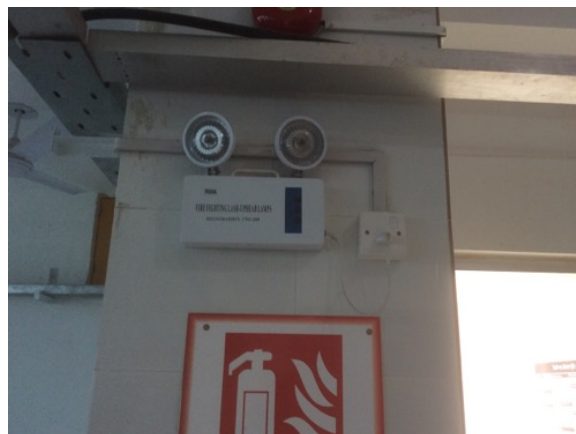
F-33	Egress Lighting	Manual on-off switches are provided for emergency lighting and exit signage units on the body of the units and on the IPS Battery units.	Remove manual on/off switches from emergency lighting and IPS units to prevent them from being switched off.	Within 1 month
------	-----------------	--	--	----------------
