# Dress & Dismatic Co., Ltd. (10466)

15.MARCH.2014

ACCORD  
on Fire and Building Safety in Bangladesh

## Site Observations

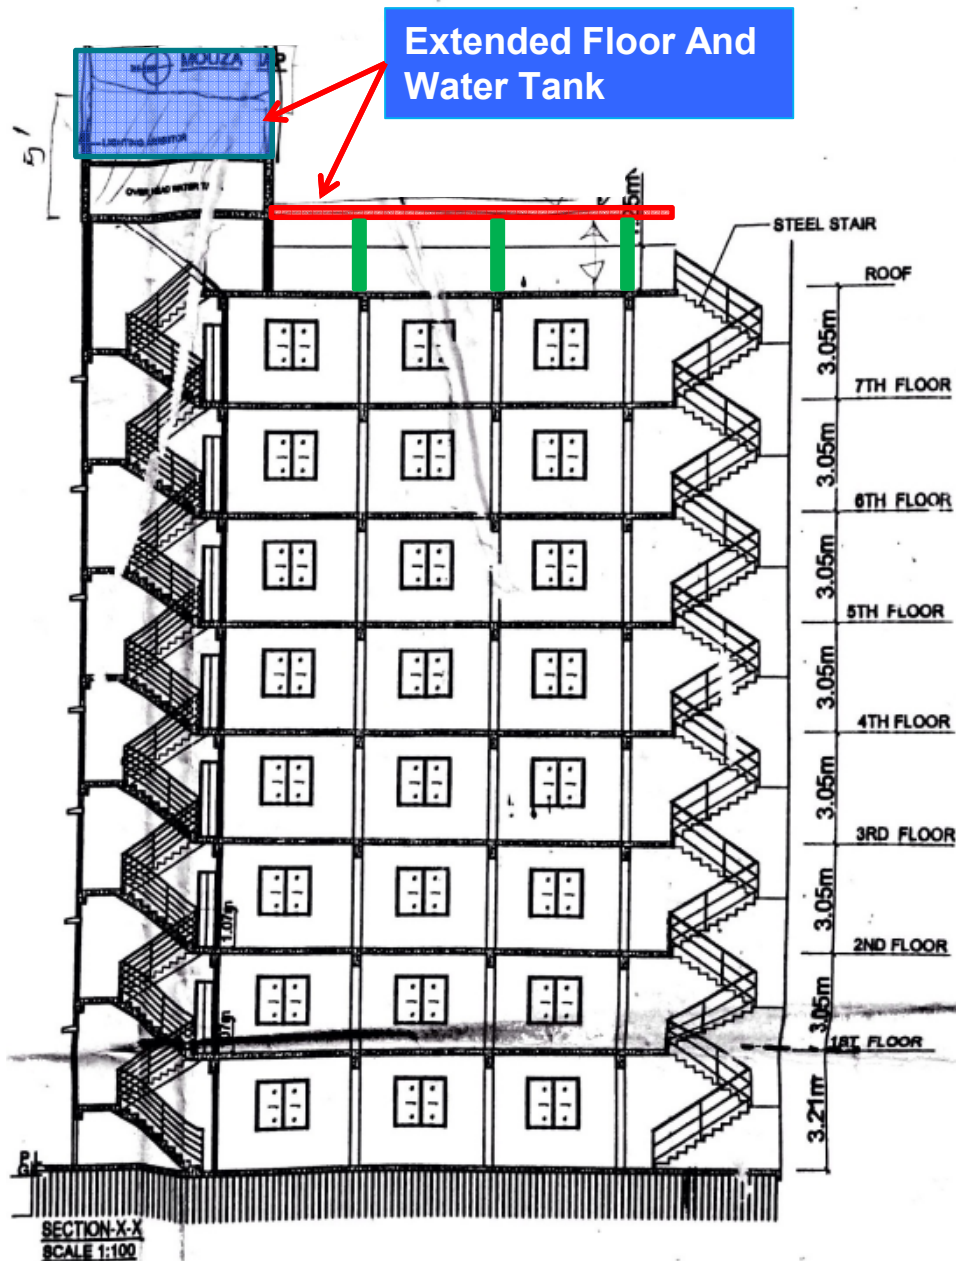
Extended concrete floor and water tank on the roof does not match submission drawing, a capacity check is required.

Extended concrete floor and water tank on the roof does not match submission drawing, foundation capacity check is required.

- Engineering assessment of factory to be carried out and in particular foundation capacity aspects to be investigated in detail.

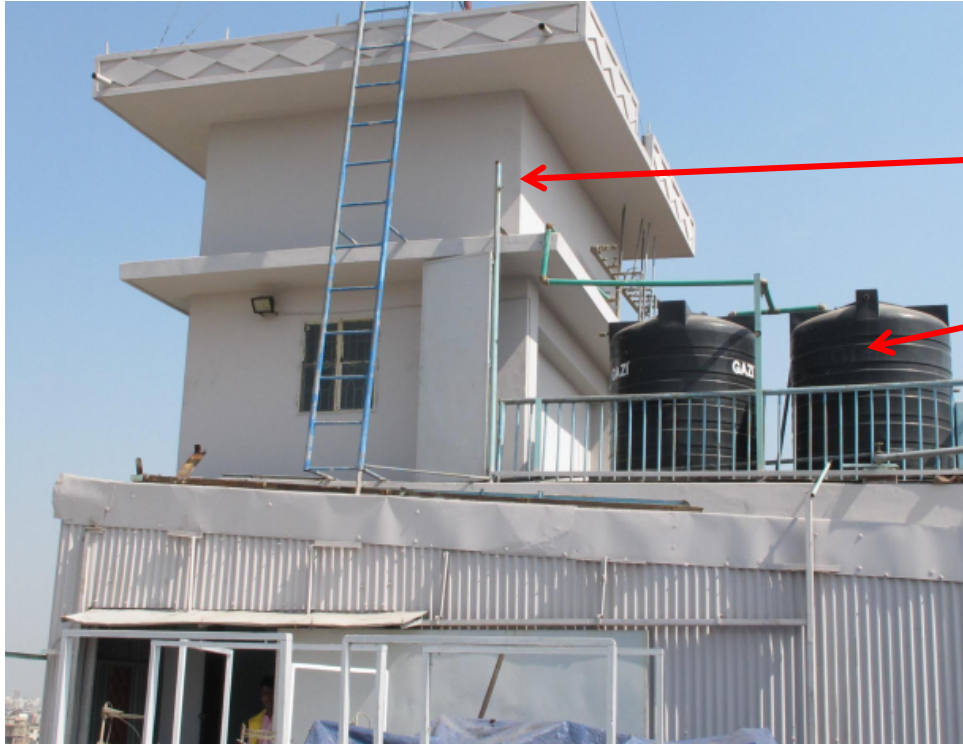
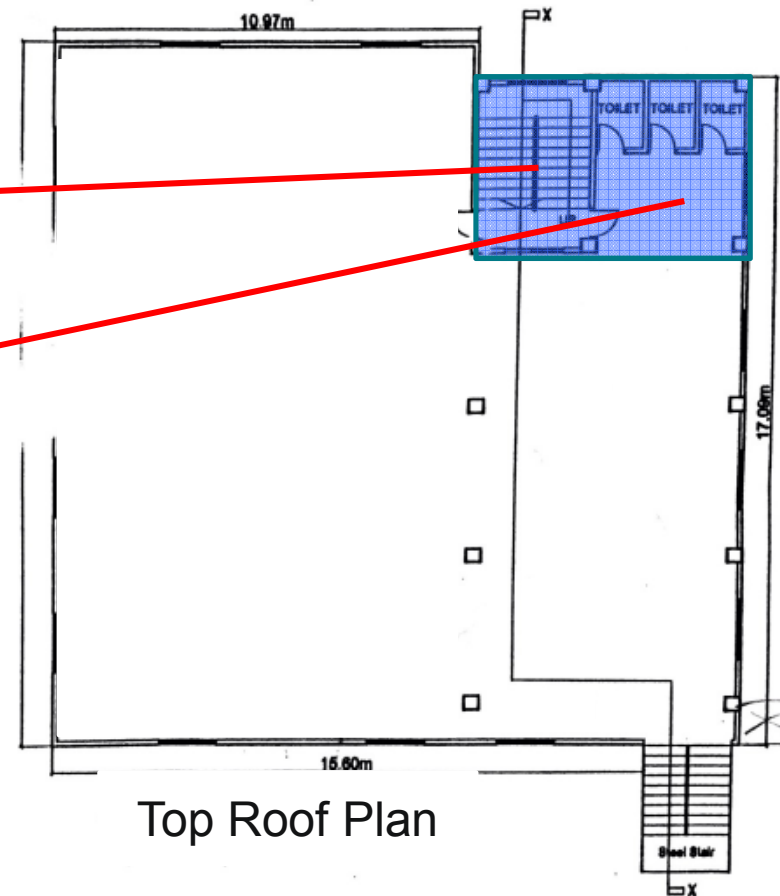
Top Roof Plan

Water tank on top roof does not match with structure drawing, foundation capacity check is required.

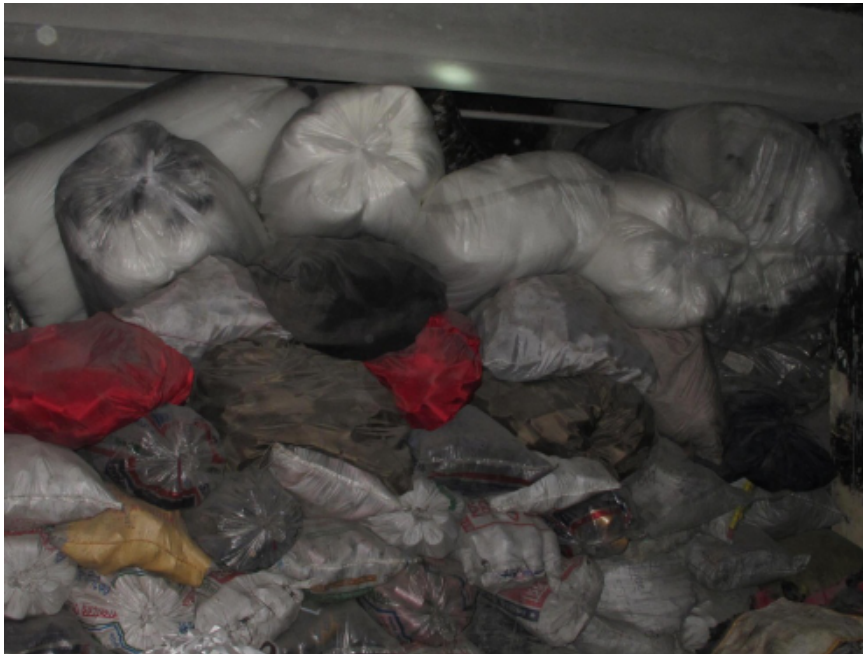
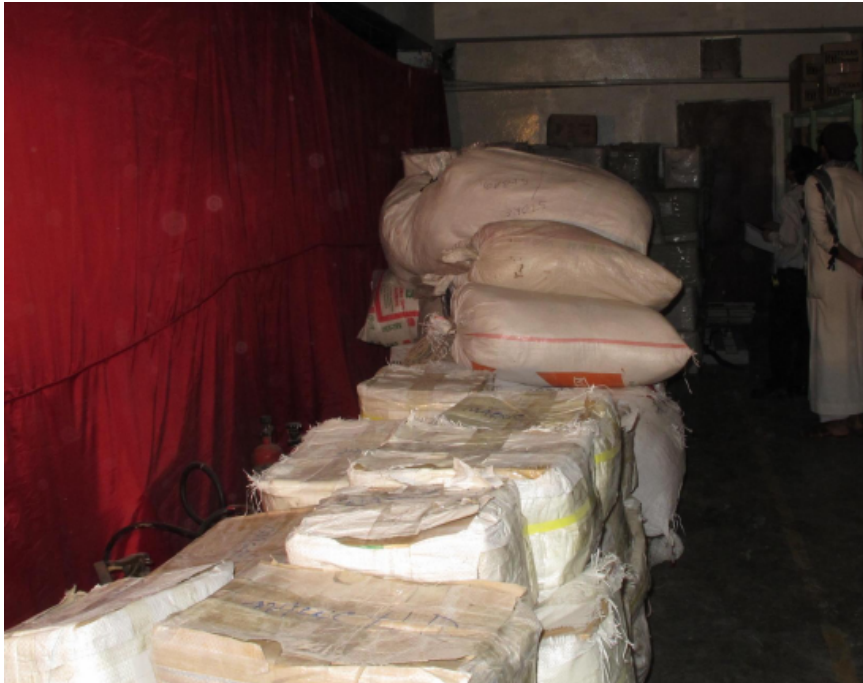
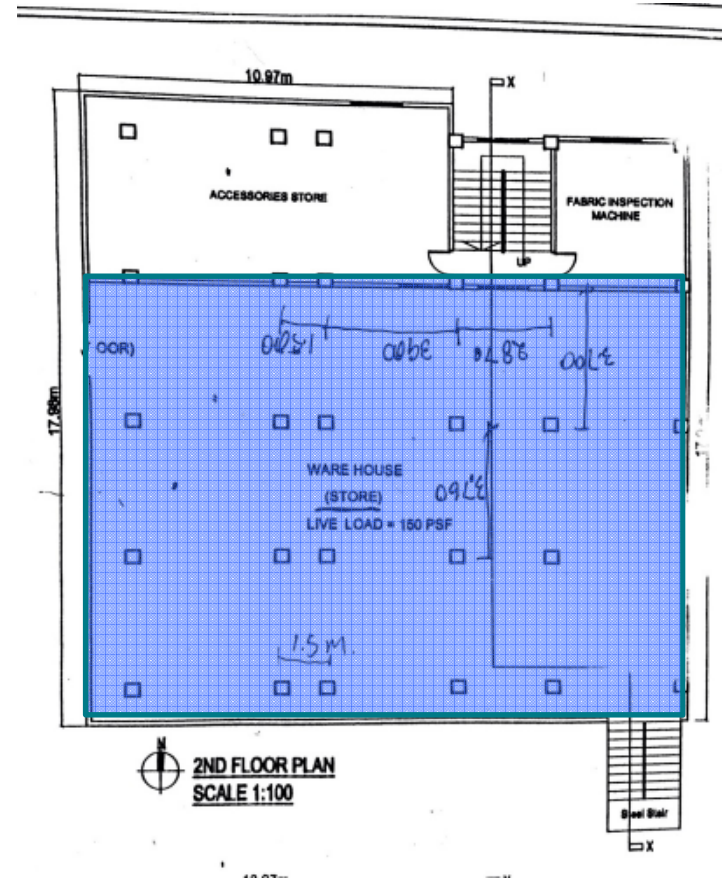
Uncontrolled heavy storage on 2<sup>nd</sup> floor. Immediately removal is required.

Slab capacity check is required

- Immediately reduce stacking height of fabric rolls to ensure total load does not exceed 3.0kPa

- Adopt some sort of signage/staff guidance to ensure that the maximum weight of storage is not exceeded .

- Maintain standards of quality control to ensure that storage procedures are correctly followed so that overloading problems do not arise in the future.

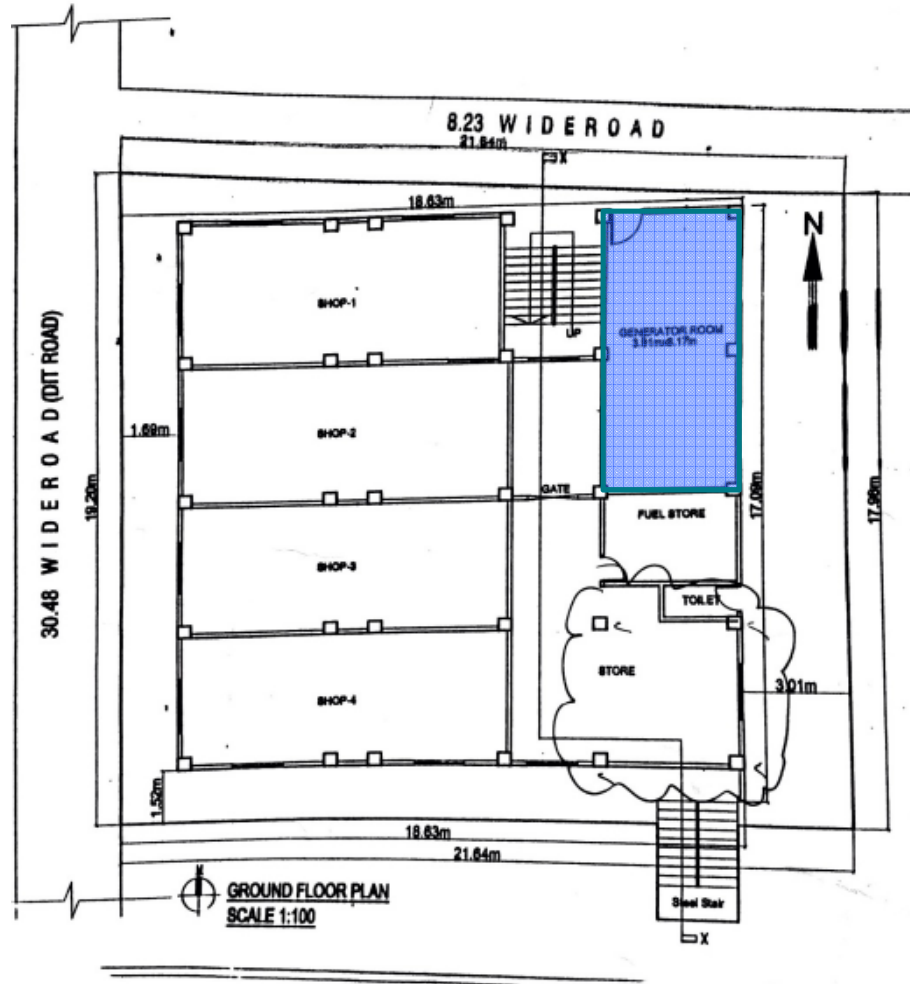
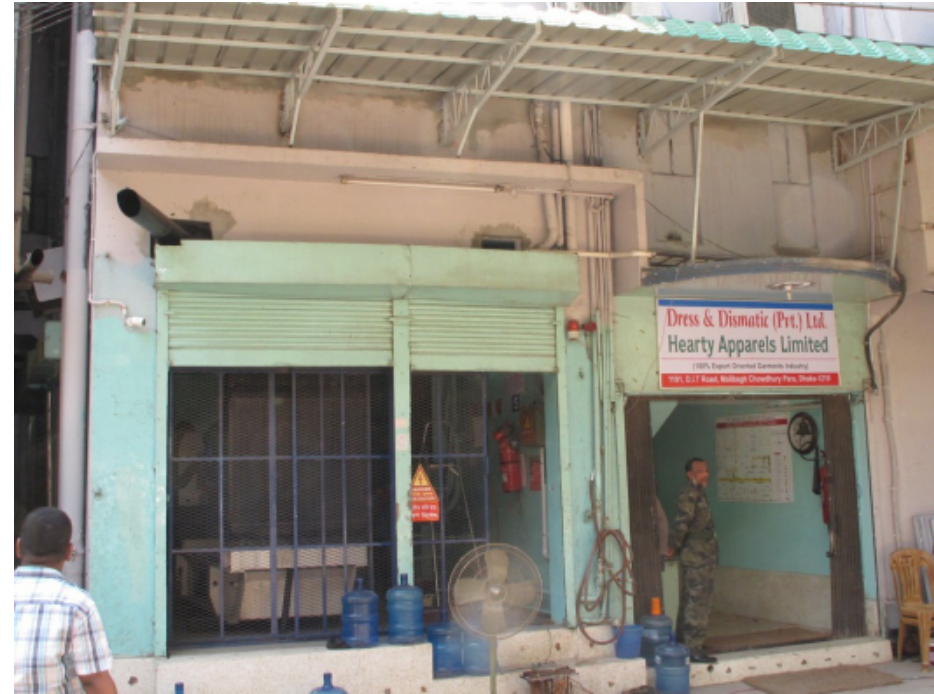
The original slab is designed for residential purpose, hence, a capacity check is required.

- Factory Engineer to review slab design and/or strengthening.

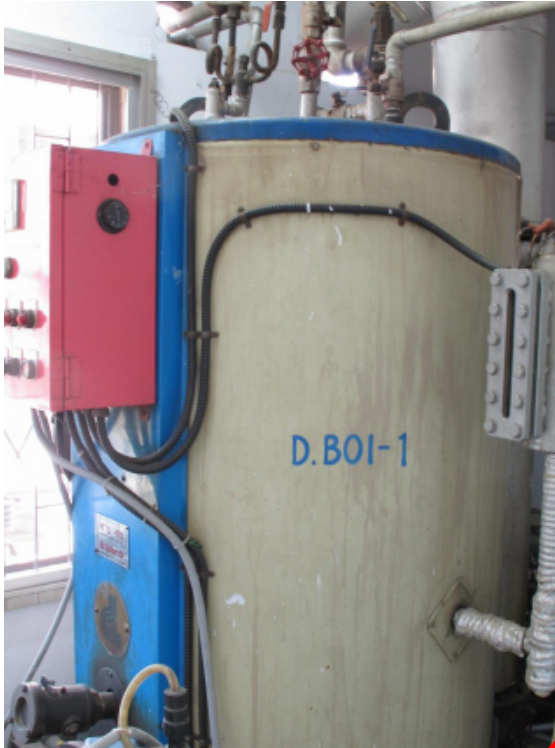
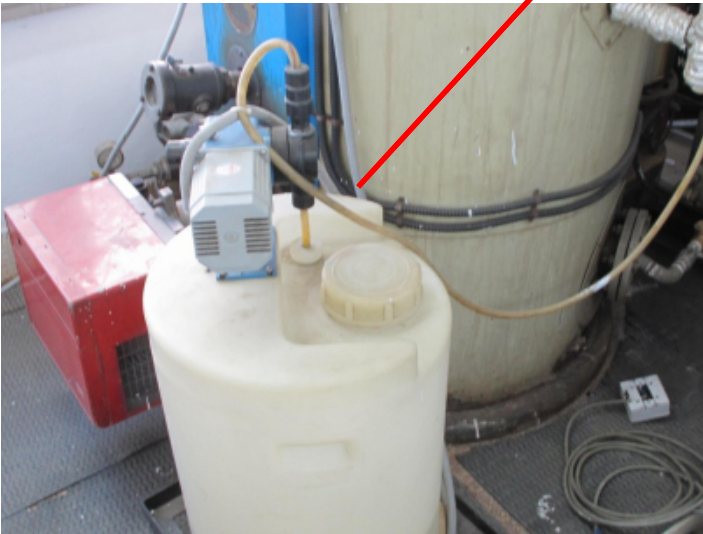
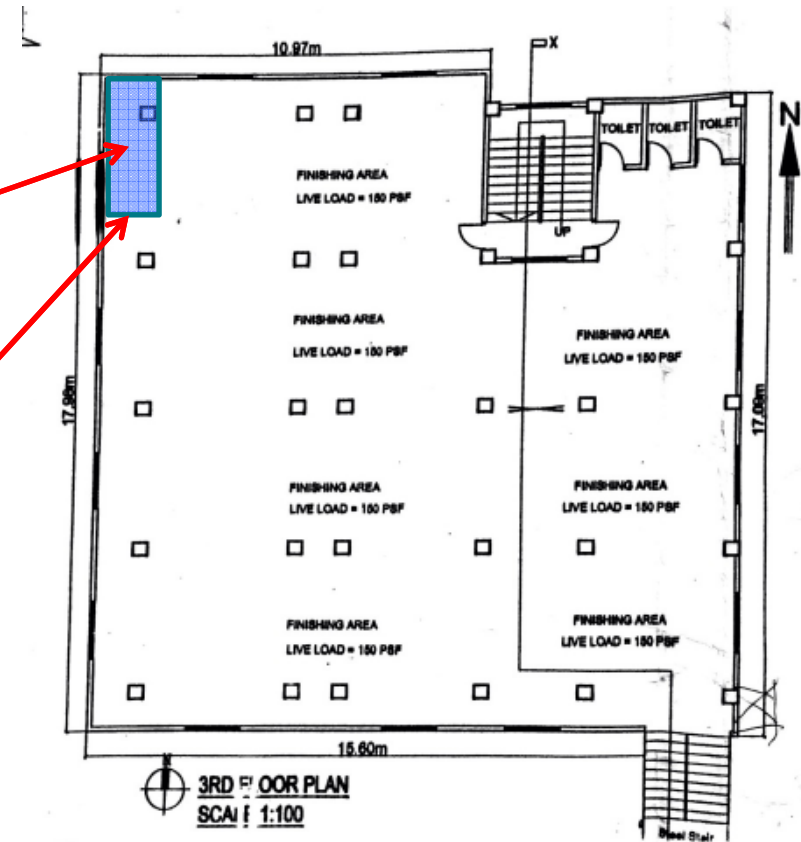
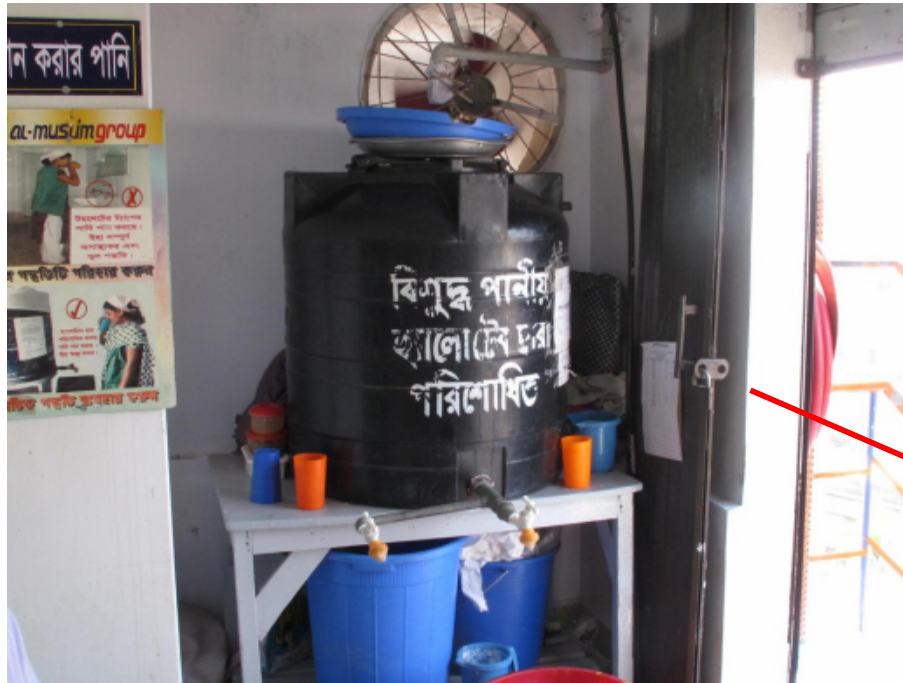
The original slab is designed for residential purposes, hence, a capacity check is required.

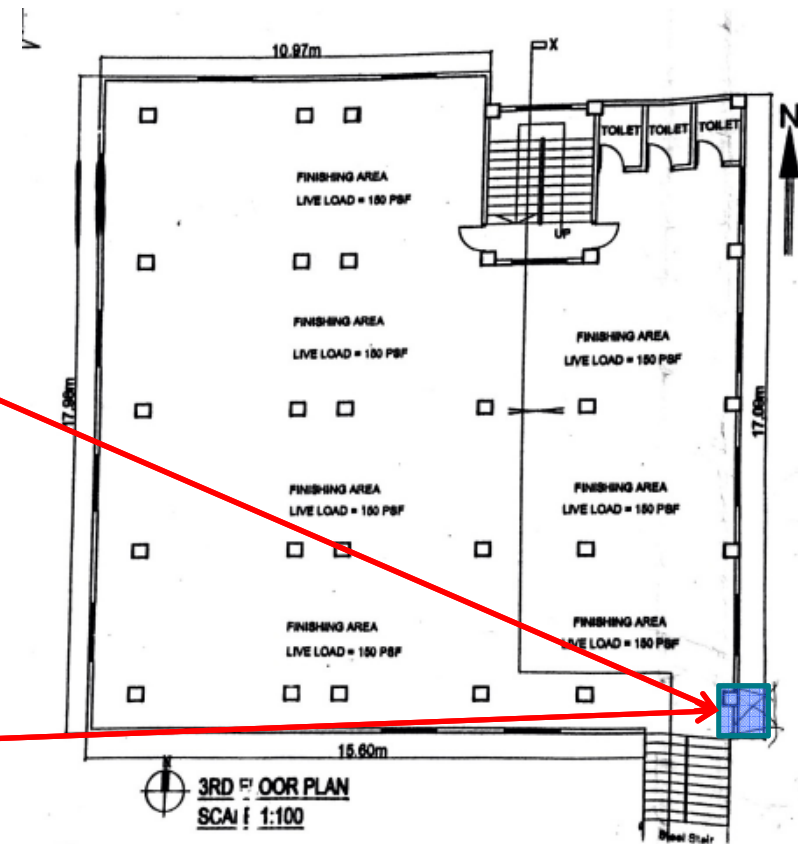
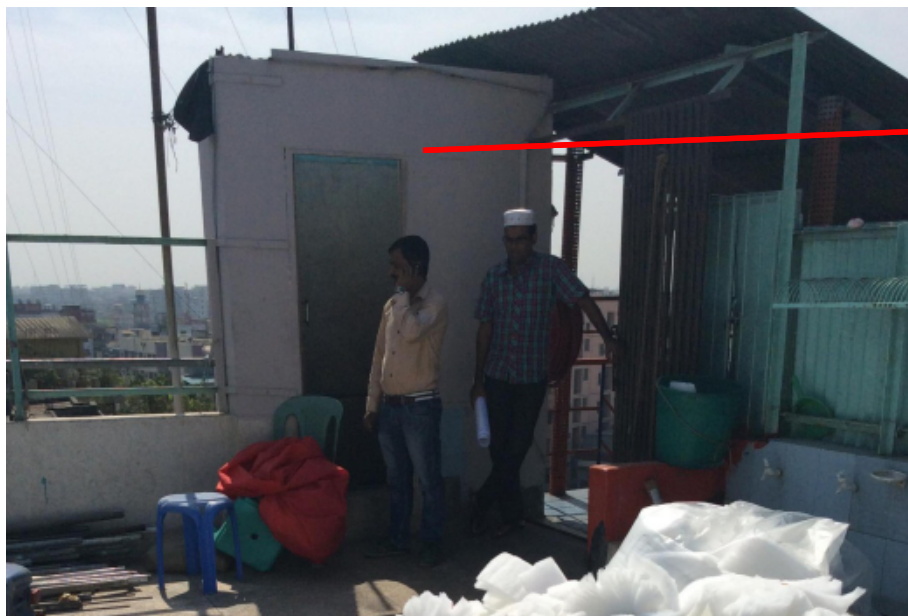
Extension cantilever slab on 2<sup>nd</sup> to roof floors does not match with structural drawings. Slab capacity checks are required.

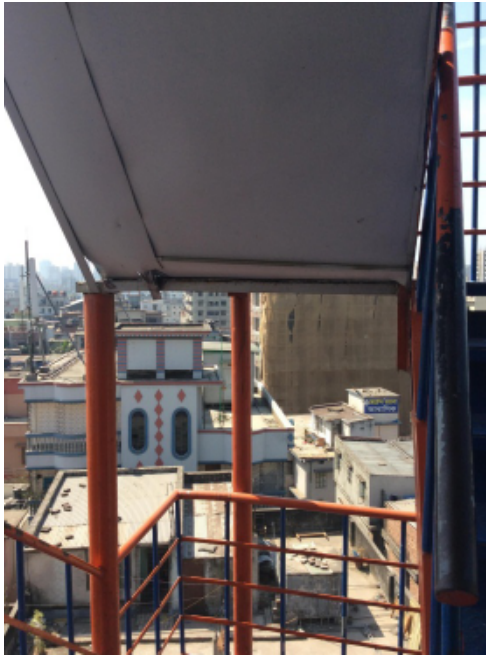
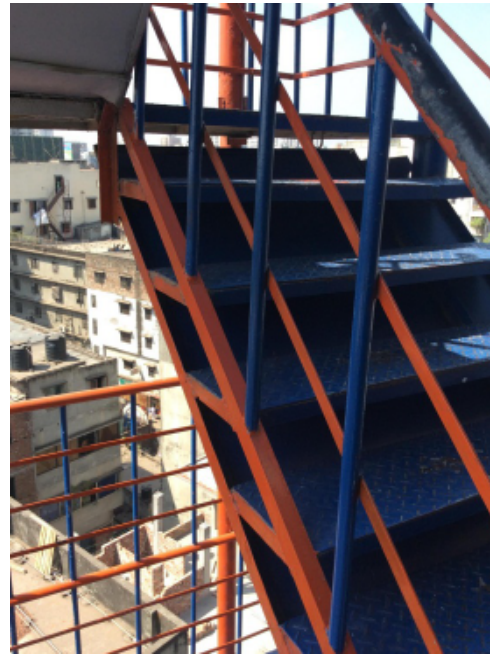
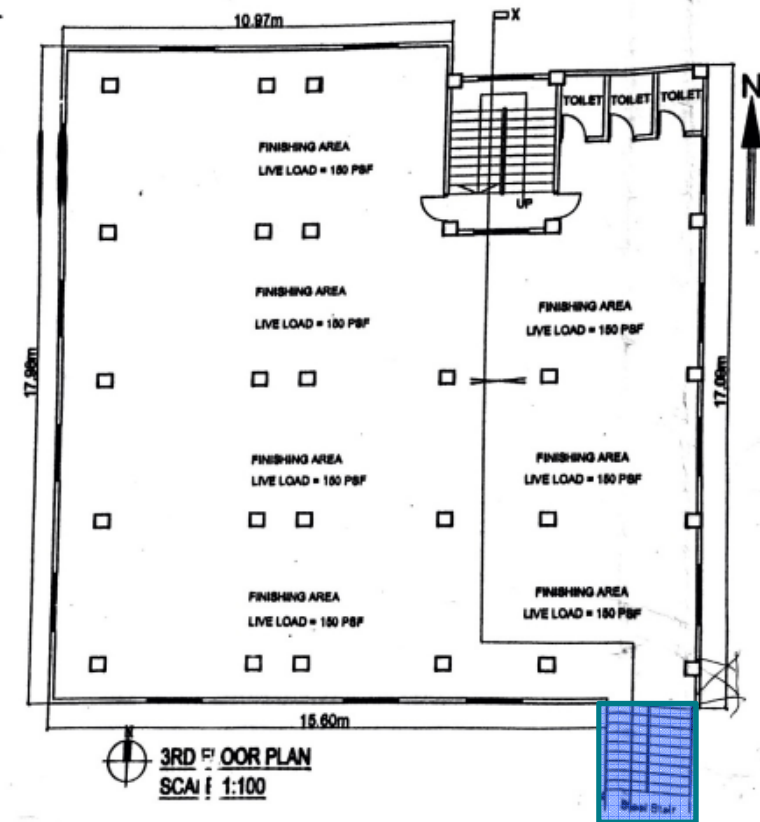
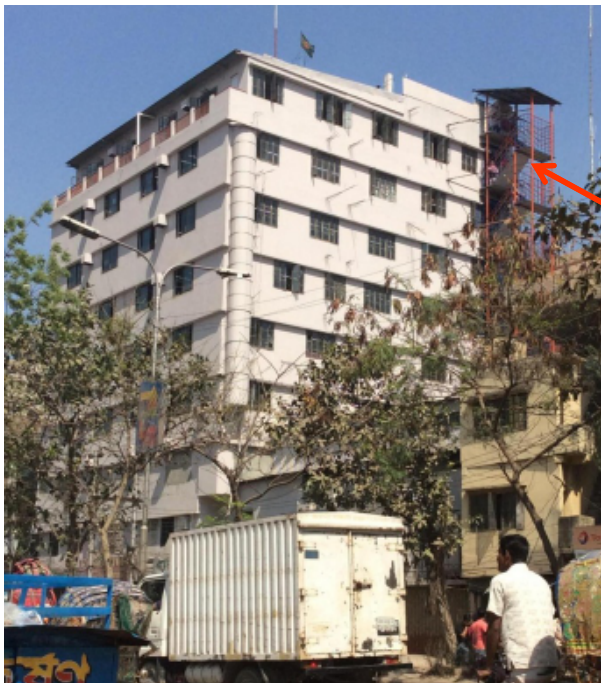
Capacity check for steel escape stair, especially at support connections.

- Detail engineering assessment to be carried out in particular the steel column capacities and the connection capacities.

- Continue to implement loading plan. Detailed Engineering Assessment is to be completed.

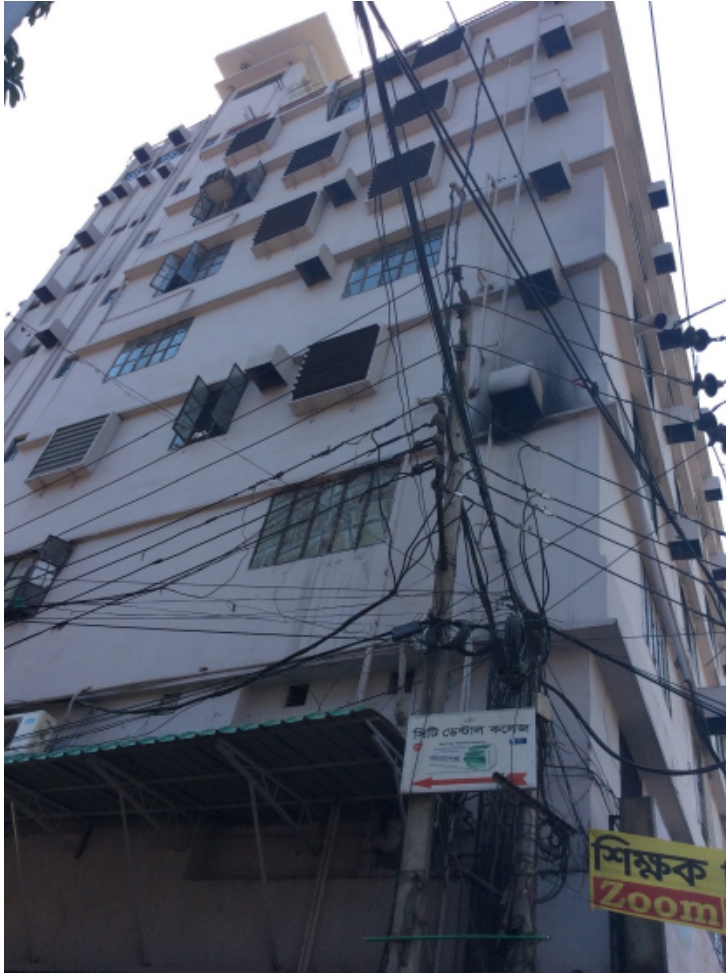
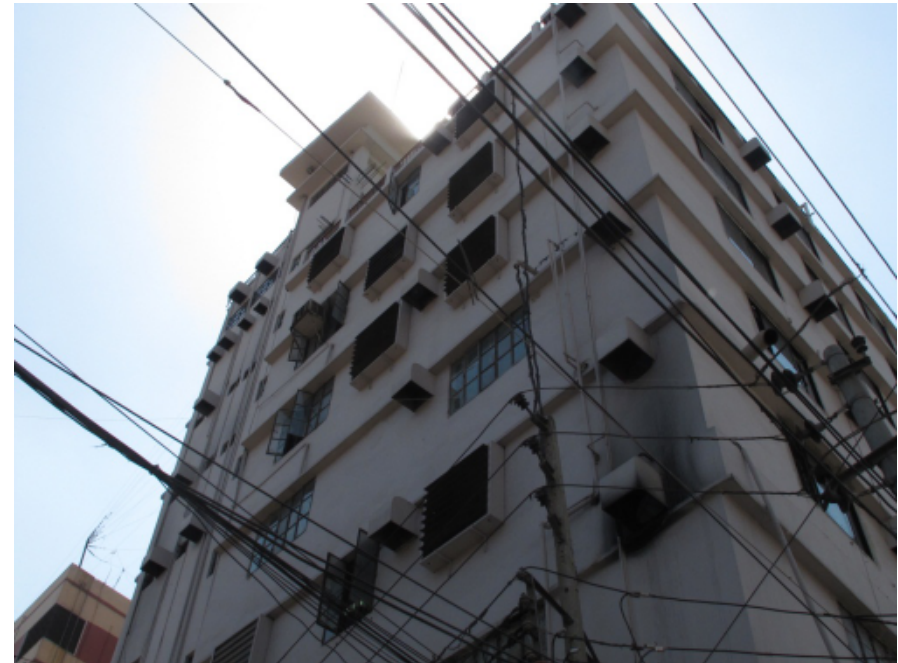
Concerns on the stability system for lateral loading and seismic loading. Façade brickwork with little capacity; lack of moment capacity in connection between columns and beams.

Further detail engineering assessment is required whether such system can resist the lateral load from wind & earthquake

- Detail engineering assessment to be carried out in particular stability and foundation aspects to be investigated in detail.

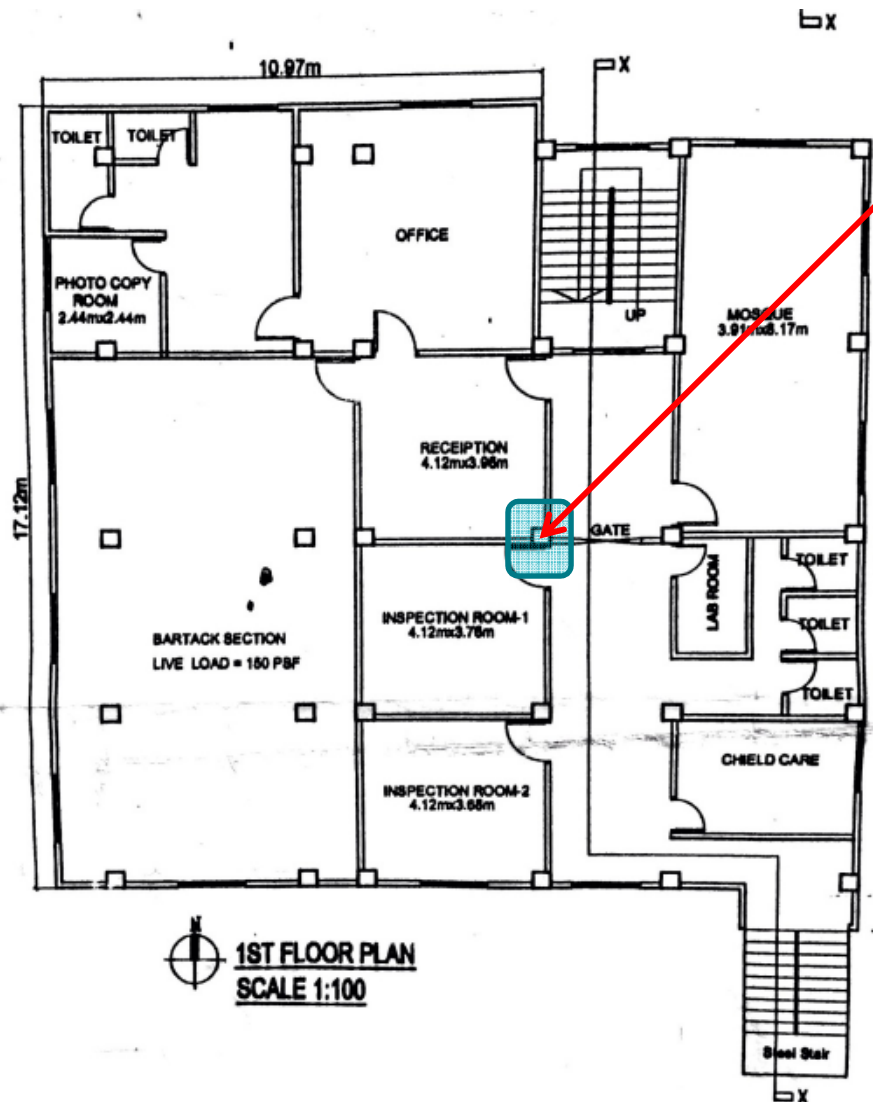
Internal Column Stress

From the column stress check at the key column as shown, it is found that the apparent working stress is within the range of FOS of 1.25 to 1.50 which is an AMBER rating.
