A-One Polar Ltd. (New Buildings)

Vulta, Rupgonj

28th May and 3rd June 2018

Observations

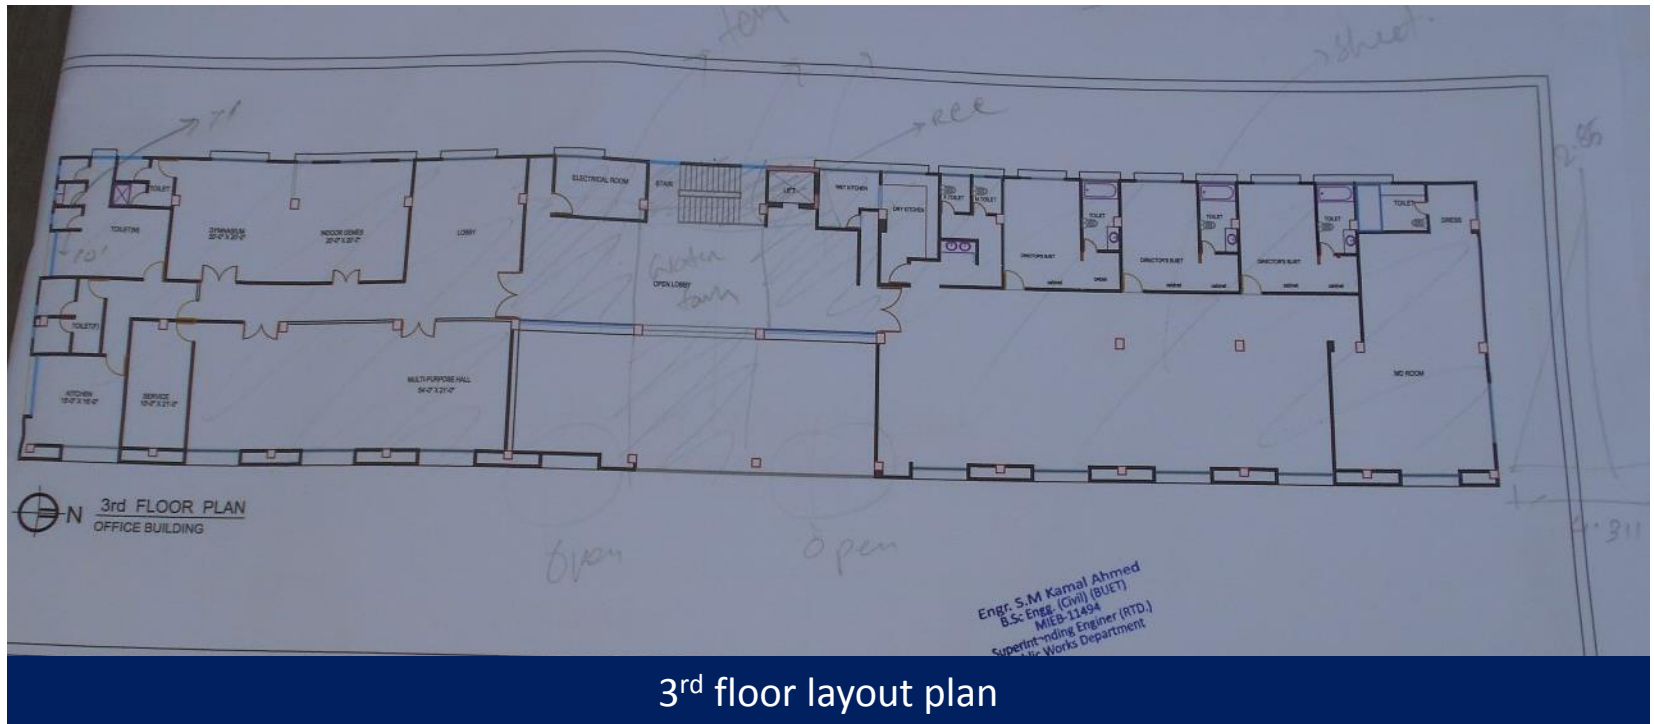
Incomplete as-built documents

As-built drawing was found up to 2nd floor. No drawing was observed for roof truss. Column schedule of 3rd floor was found missing in the given As-built drawing.

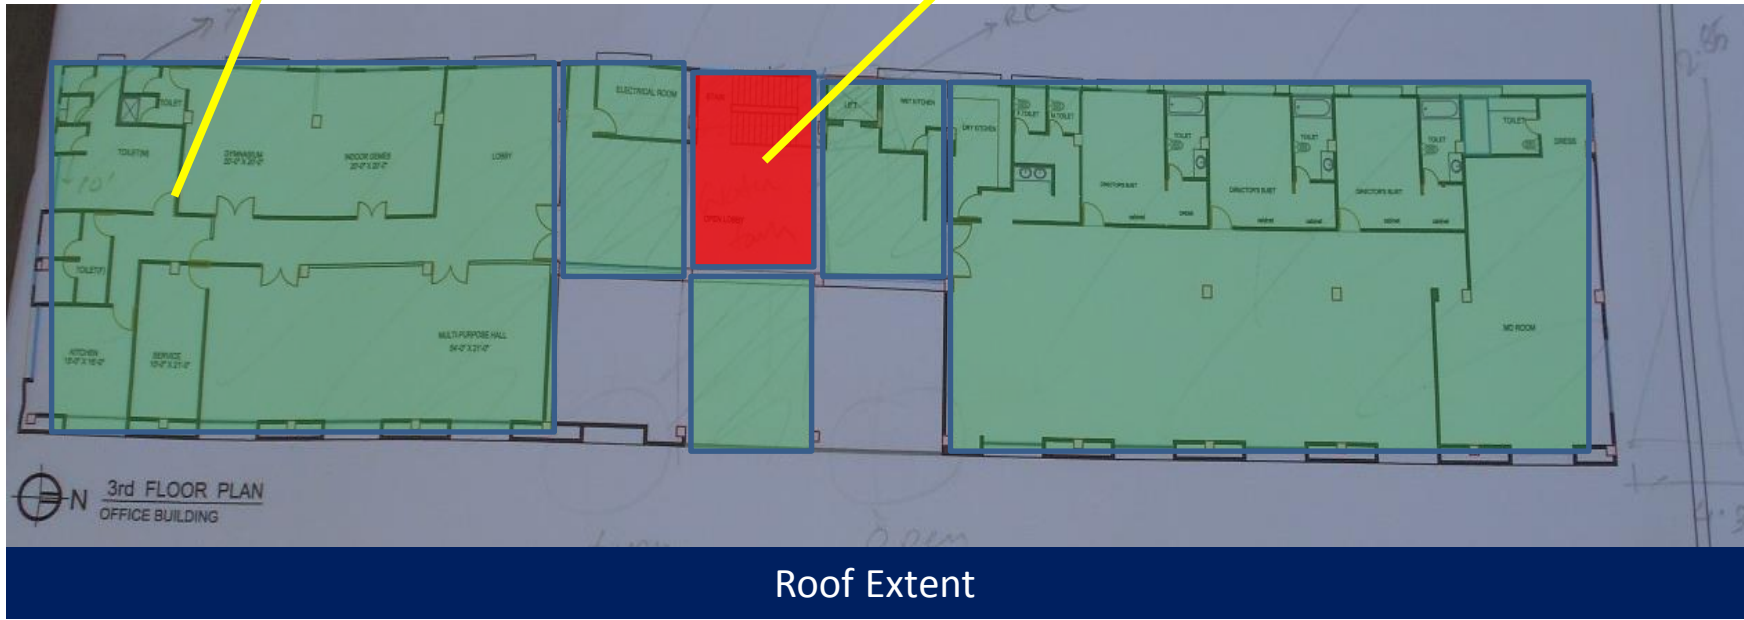
Location and details drawing of water tank was not found in the As-built drawing. As-built drawing of roof truss was missing.

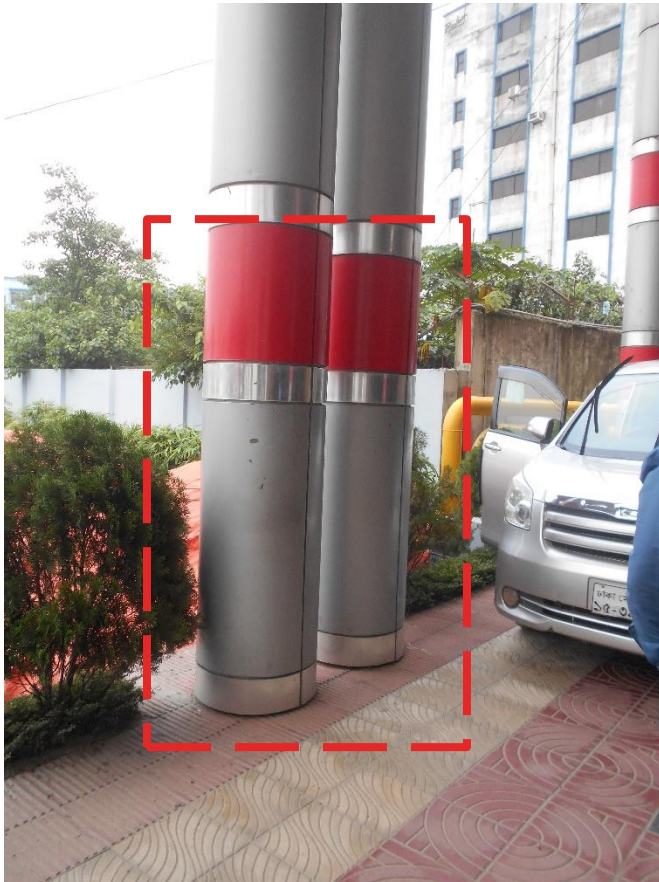
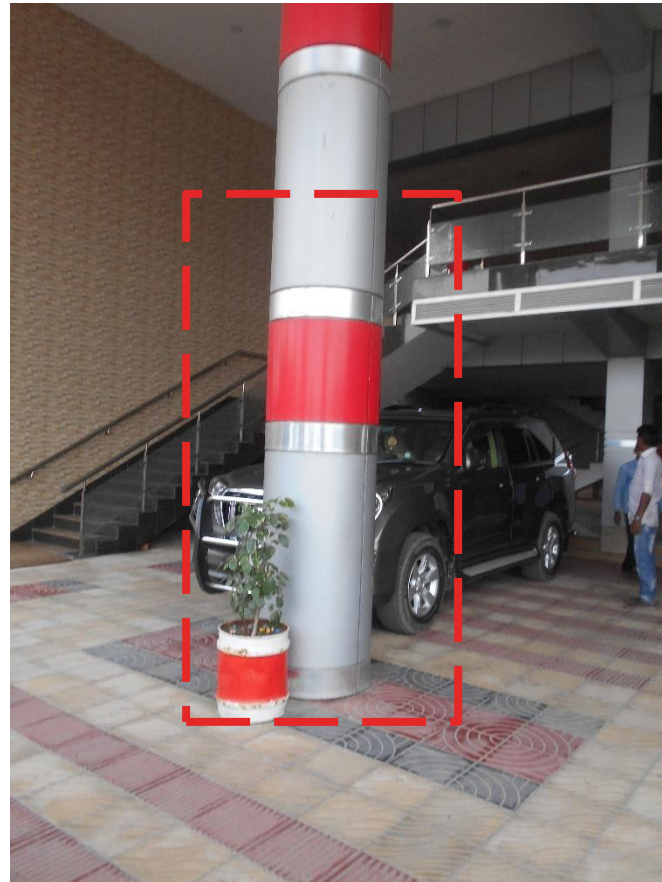
Probable vehicle impact for ground floor columns

Columns of ground floor are prone to vehicular impact. Factory is required to protect the columns from vehicular impact.

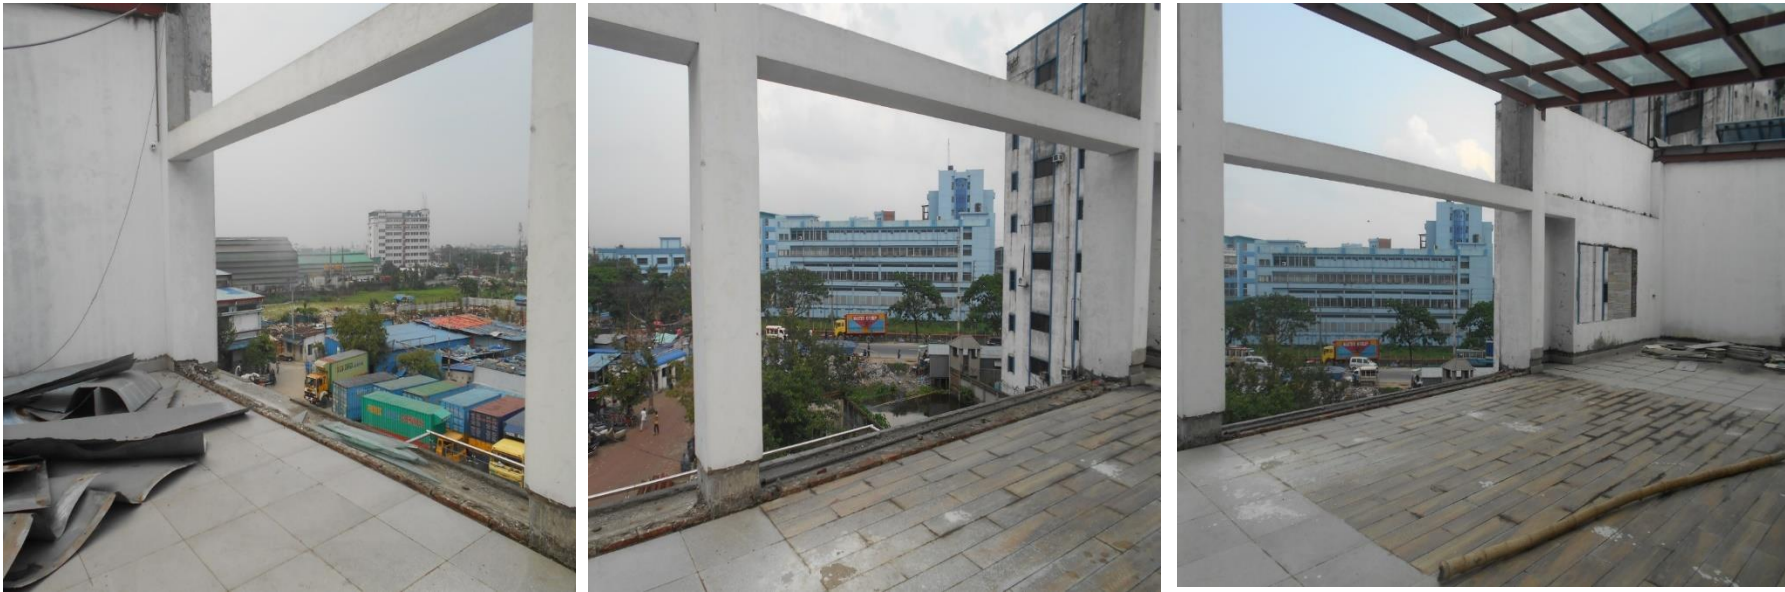
Falling hazard in 3rd floor

No safety guard or parapet was observed at the opening at roof top. This area is prone to falling hazard.

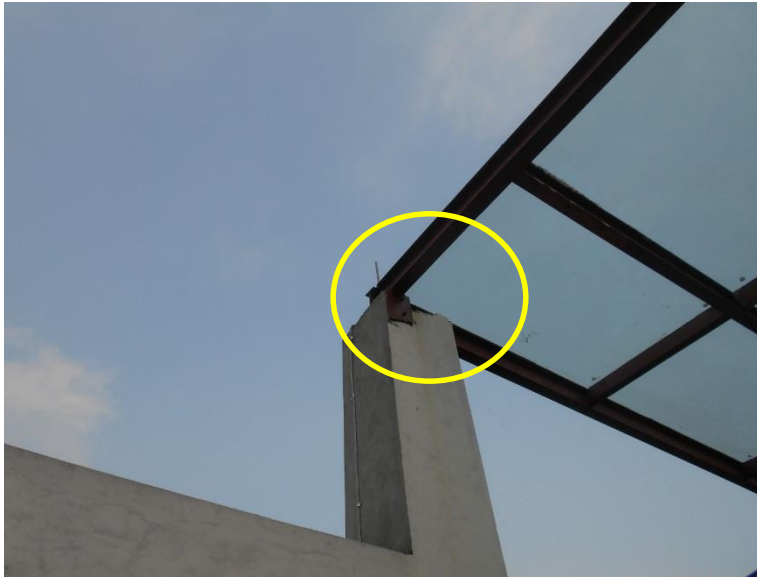
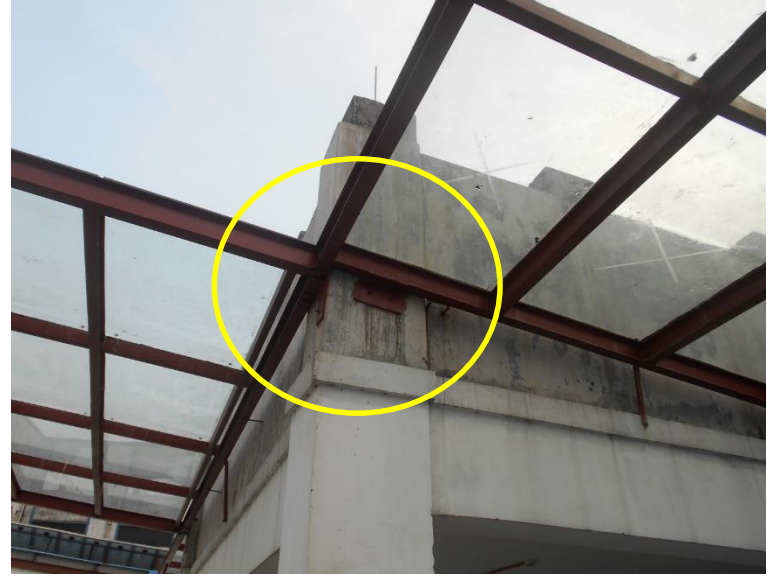
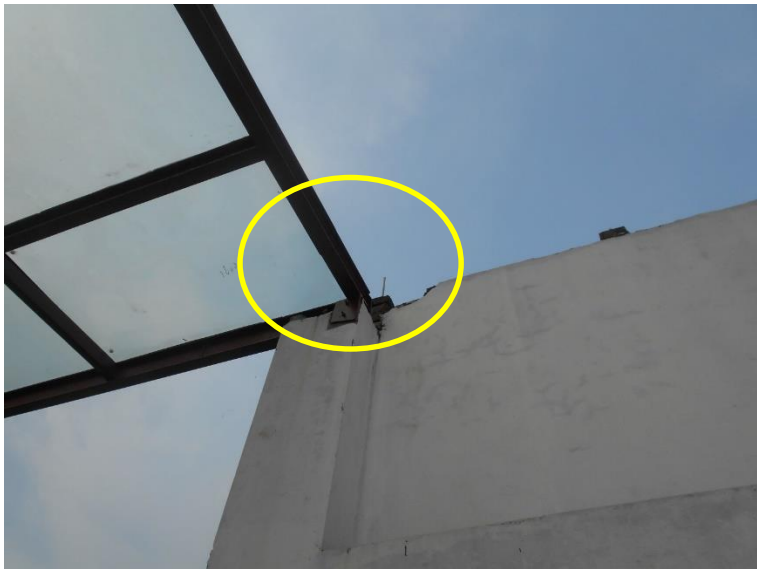
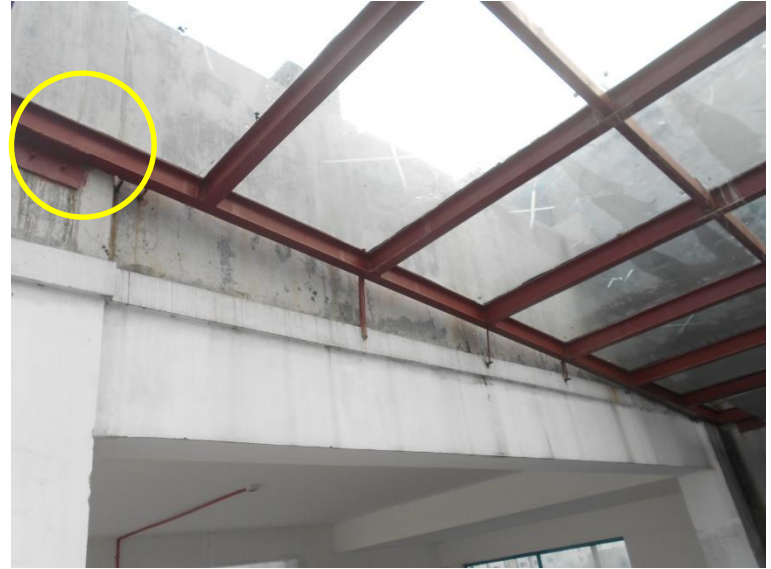
Non-engineering connection roof shed

Apparently non-engineered connection was observed in the truss at roof

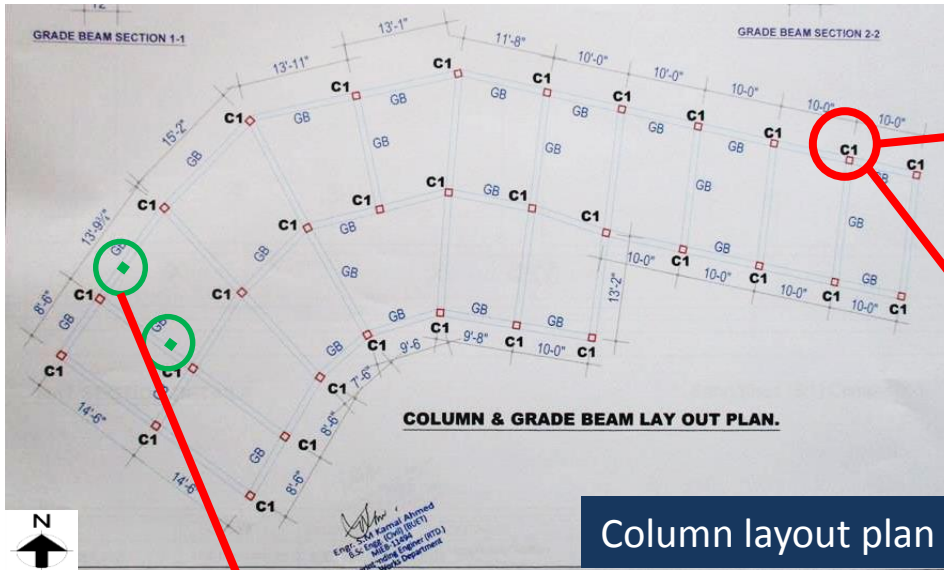
Column layout plan

8 nos. rebars are shown in column schedule where 6 rebars were found onsite. Also, the column layout of the provided drawings did not match with on site arrangement. Additional columns were found during inspection which has been marked as green.

6 Rebars in stair column

Additional column

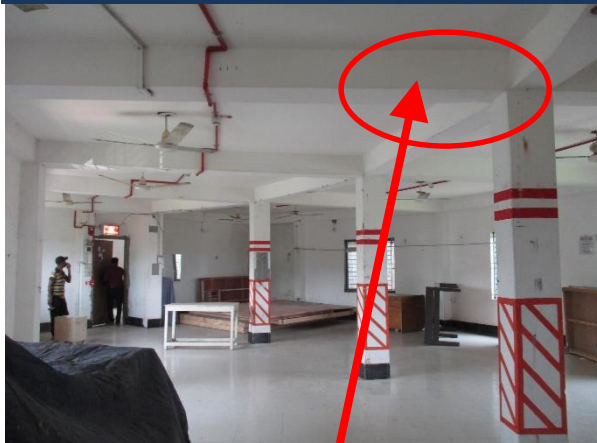
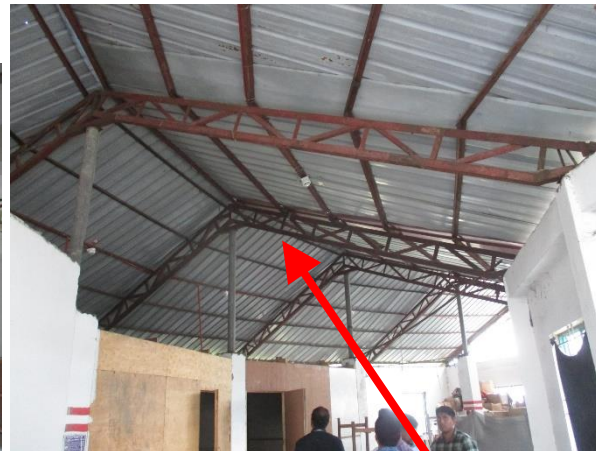
Beam missing in 1st & 2nd floor

Floor beams were missing on marked location of 1st & 2nd floor. Undocumented roof truss was found on 3rd floor . Water tanks were observed on 2nd floor roof (4x1000 litre). Also, Cantilever beams were found in south direction of the building but not shown in as built drawing .

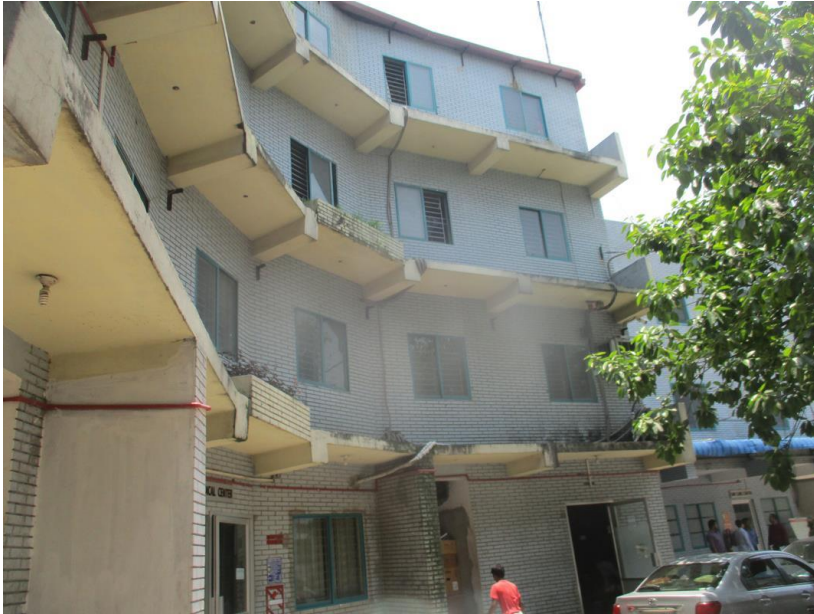
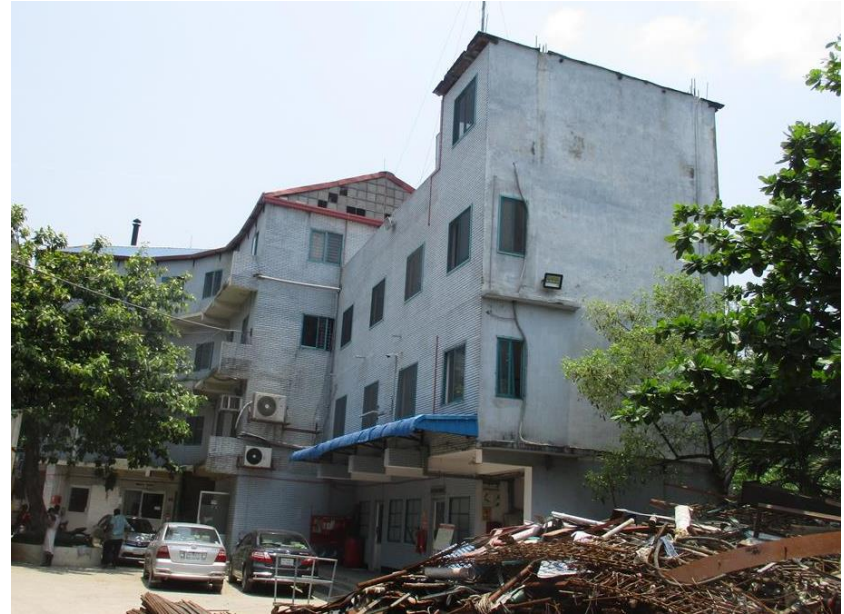
The shape of the building is irregular. A portion of the building is consist of the single bay and another portion is two bays. However, there is no shear wall or other form of lateral load resisting systems in the building. Factory engineer to check the stability of the building against lateral forces following BNBC provisions.

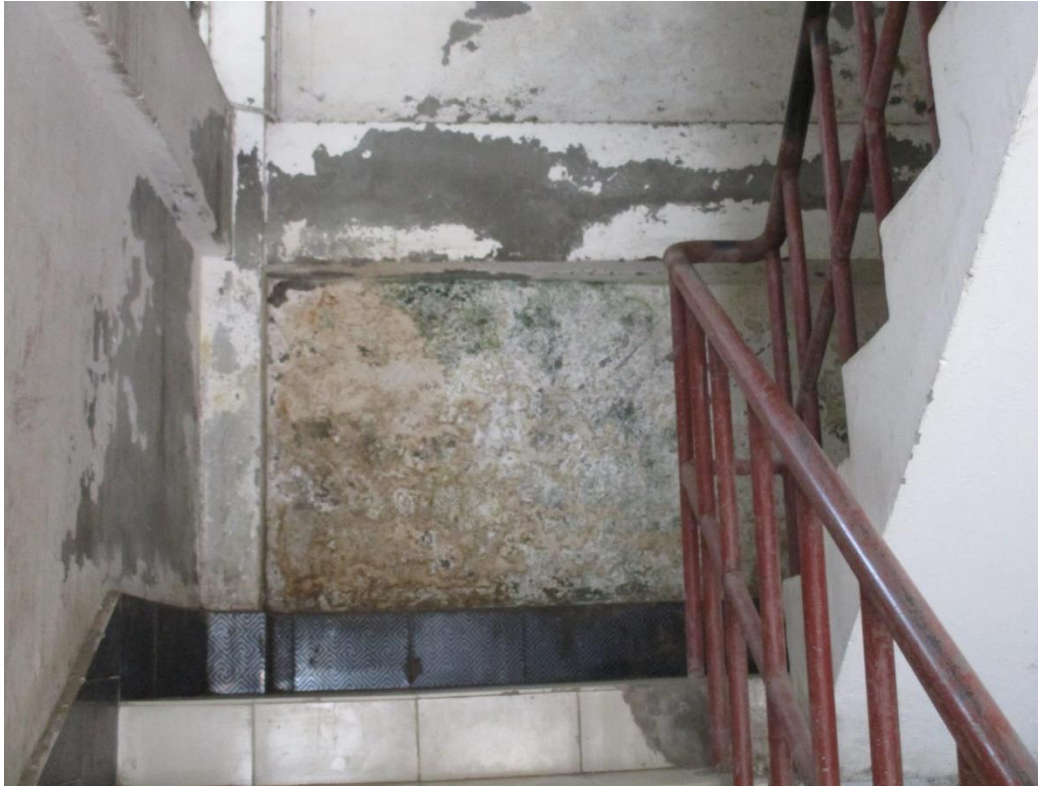
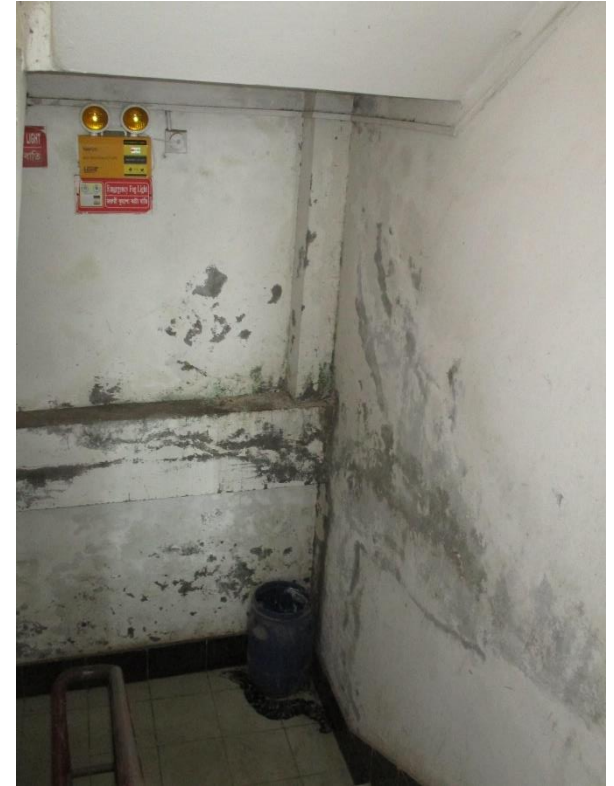
Dampness due to water intrusions was observed in various locations.

8	Lateral stability (Inspection Building)	Carryout any remedial works arise from Engineering Assessment.	6-months
9	Dampness on brick façade (Inspection Building)	For both durability and serviceability, repair works or any appropriate method is recommended.	6-weeks

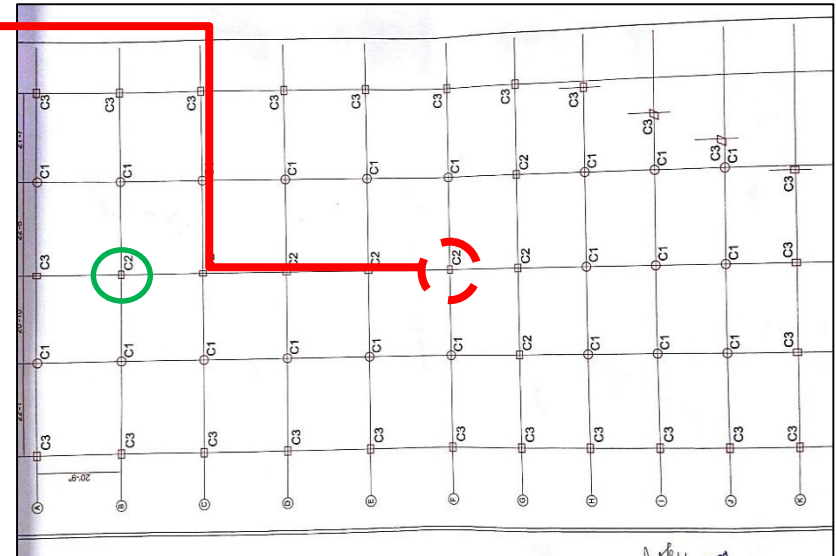
Column Layout plan.

C2 Column was measured 500mm instead of 550mm

The dimension of all C1 and C2 type columns were found smaller than column schedule. Diameter of C1 column was measured 600mm instead of 650mm and C2 column dimension was found 600mm instead 550mm. Moreover, on B-3 grid (marked as green on layout) the orientation of C2 column didn't match with column layout plan.

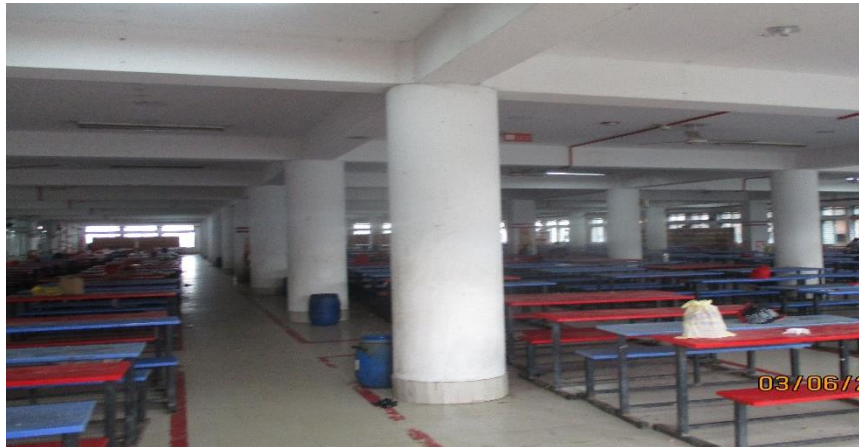
Diameter of C1 Column was measured 600mm instead of Diameter 650mm.

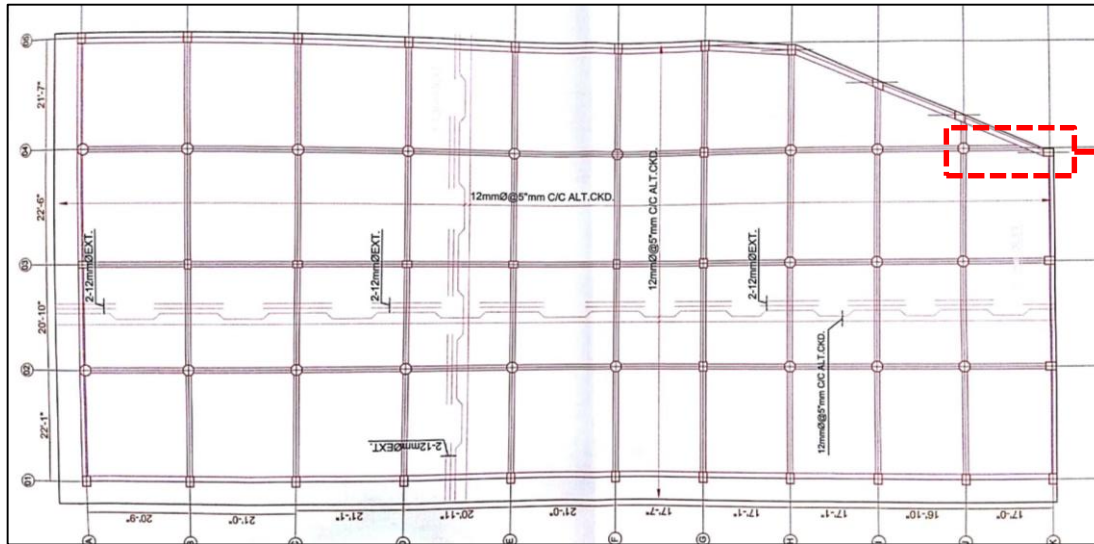
Floor beam layout Plan

Beam layout on site didn't match with as-built drawing. In 1st and 2nd floor beam wasn't found on the marked portion.

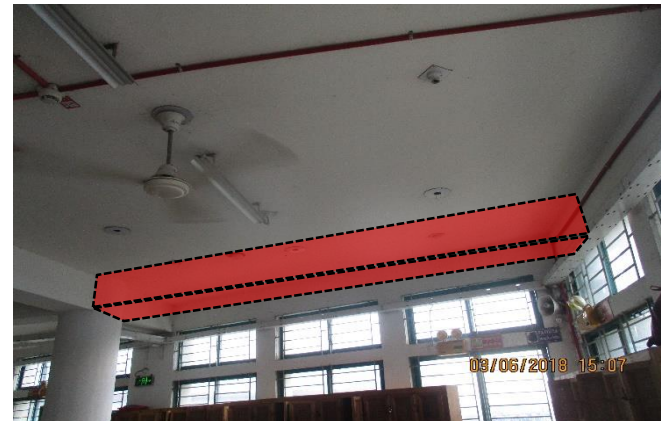
Location of the missing beam

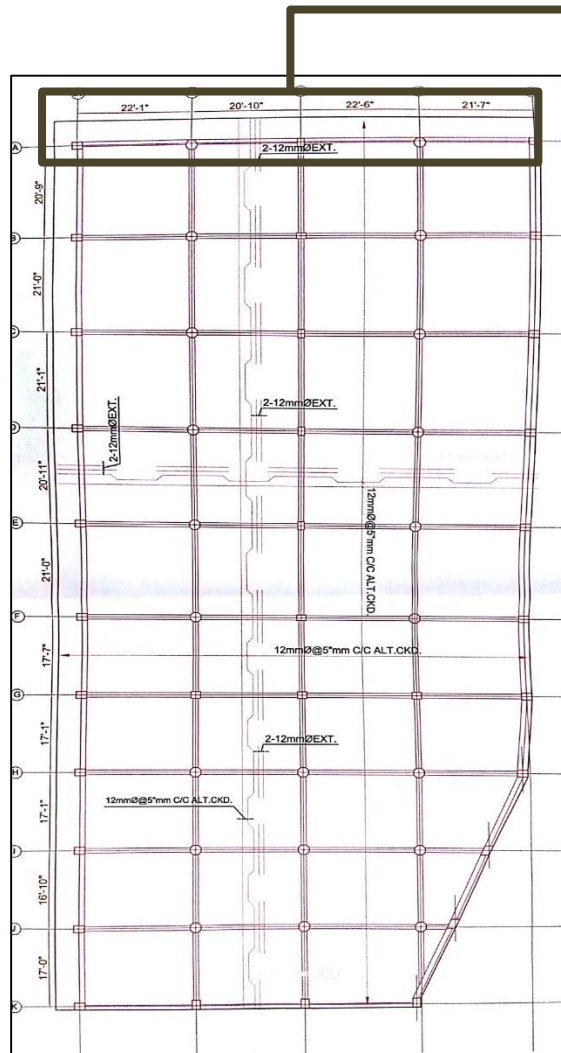
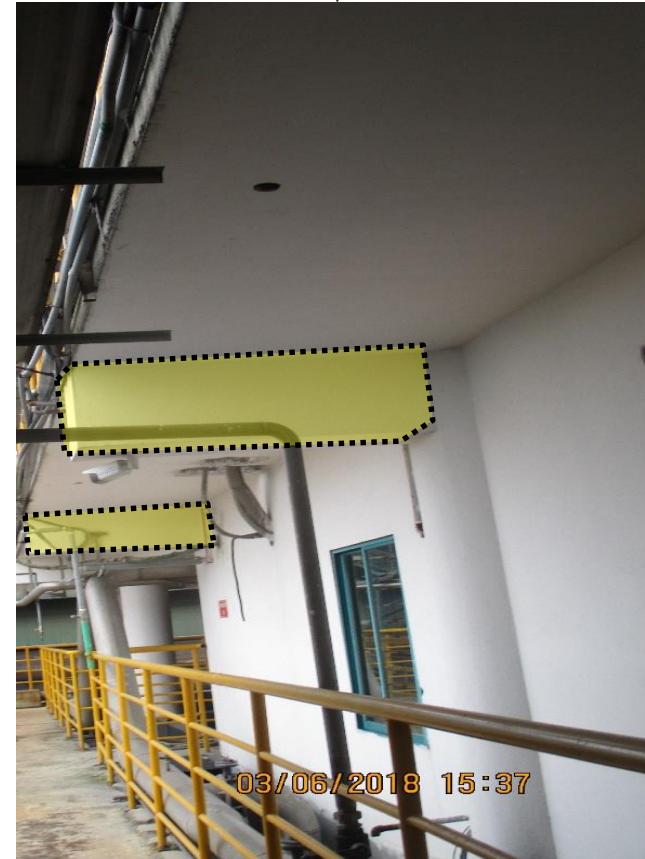
On north face, cantilever beams are present which aren't shown in as-built drawings.

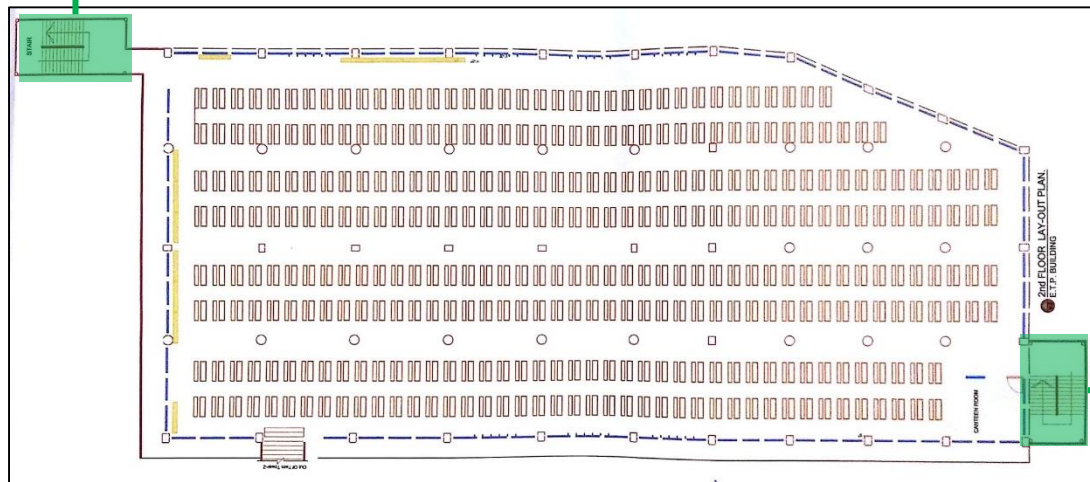
Floor layout plan

Emergency Steel stair on north face.

No document was found of emergency steel stair on north side and south side. Factory Engineer is required to prepare as-built drawing (structural and architectural) and carry out stability check against the lateral loads.

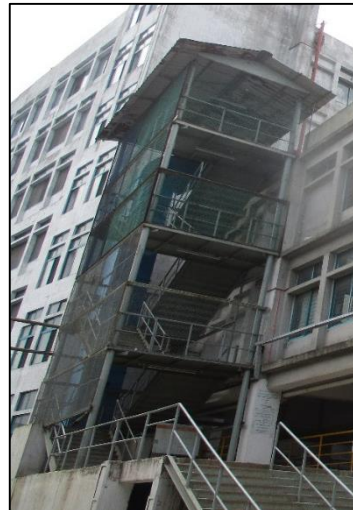
Emergency Steel stair on south face.

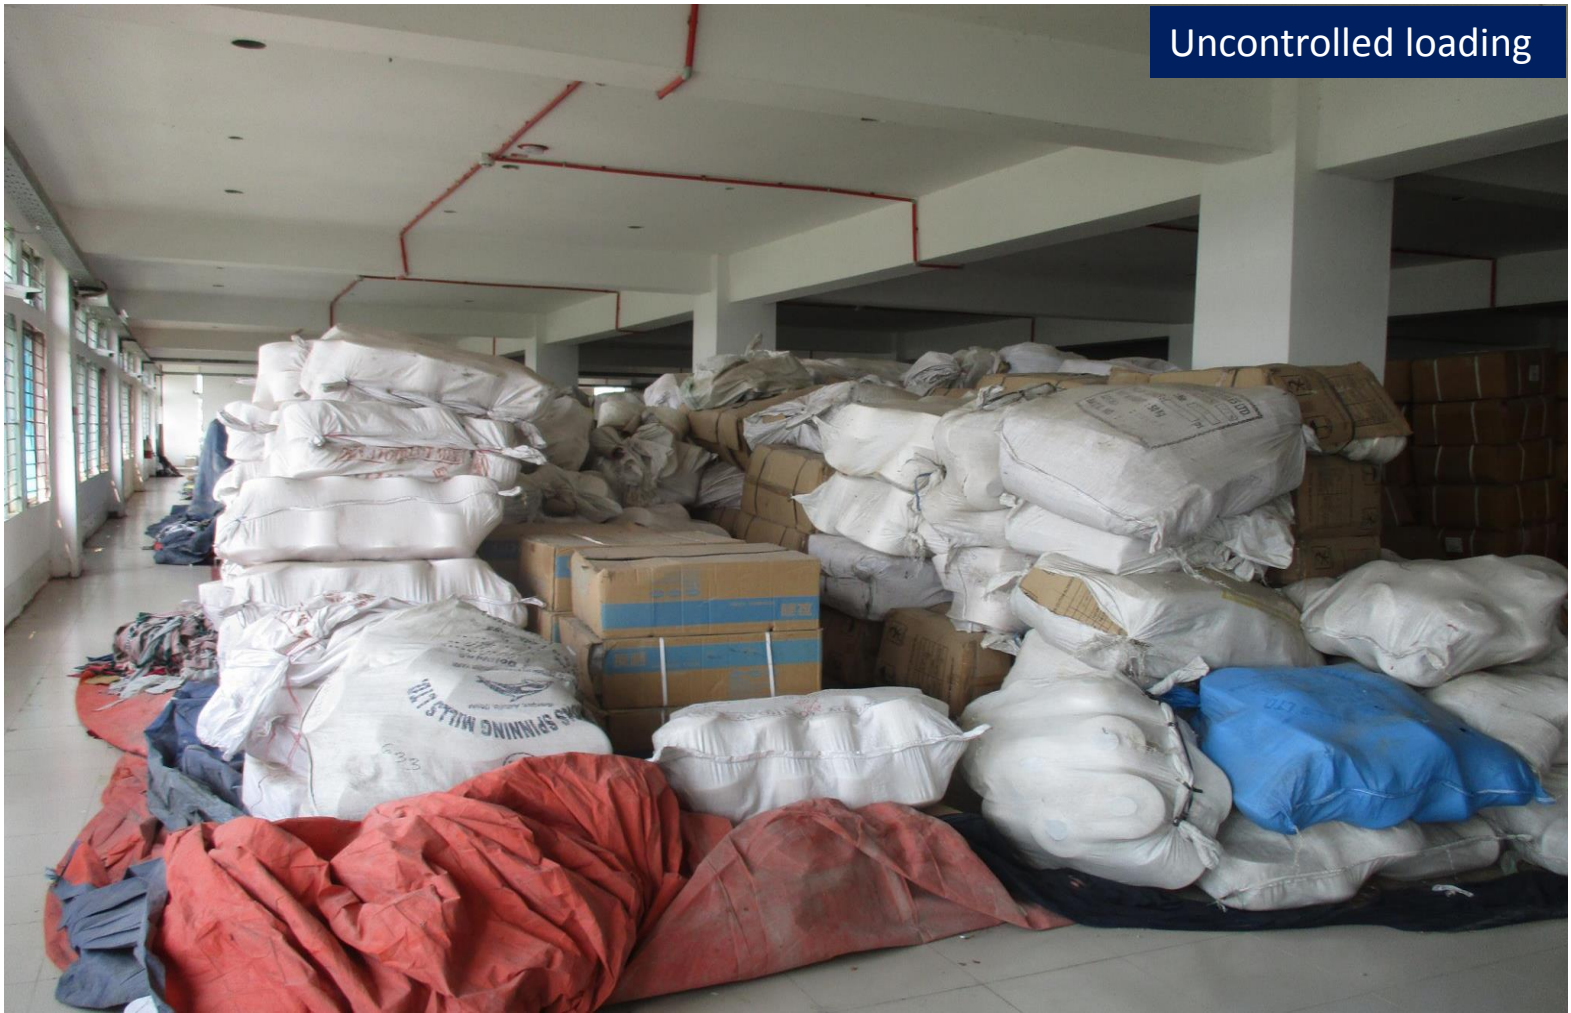
Uncontrolled loading

No load management program (i.e load restriction height marking, posting load plan, signage) was implemented. Factory engineer is required to implement floor load management.

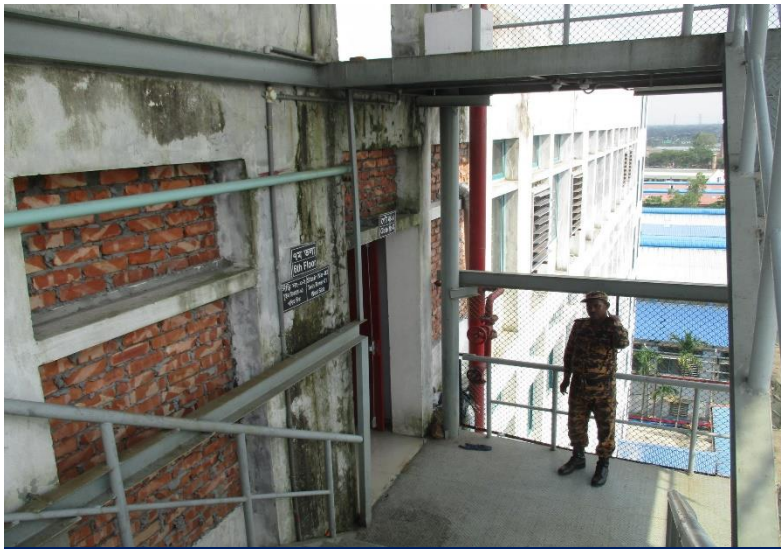
Steel stair adjacent to Twin Tower-1

Some steel stair, roof frame and connecting bridges were found adjacent to the Twin Tower buildings having no structural details.

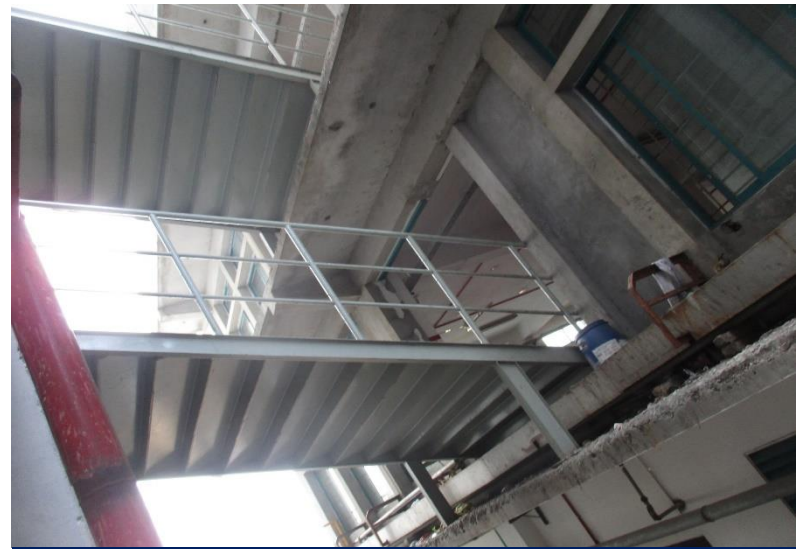
Steel stair in between Twin Tower-2 to ETP

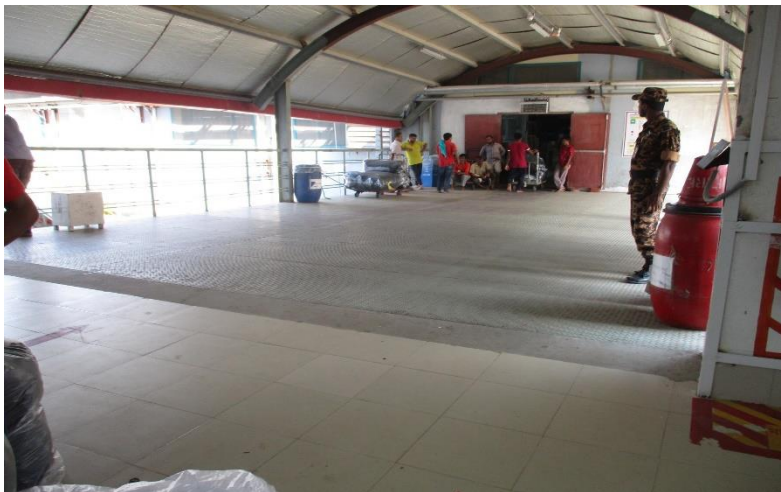
Steel connecting bridge from Twin Tower

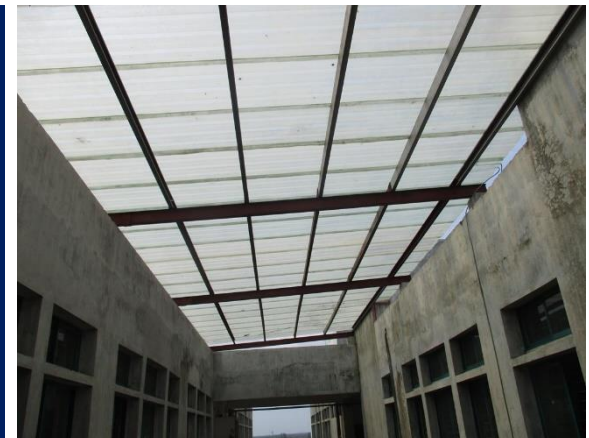
Steel Roof frame of Twin Tower-1 & 2

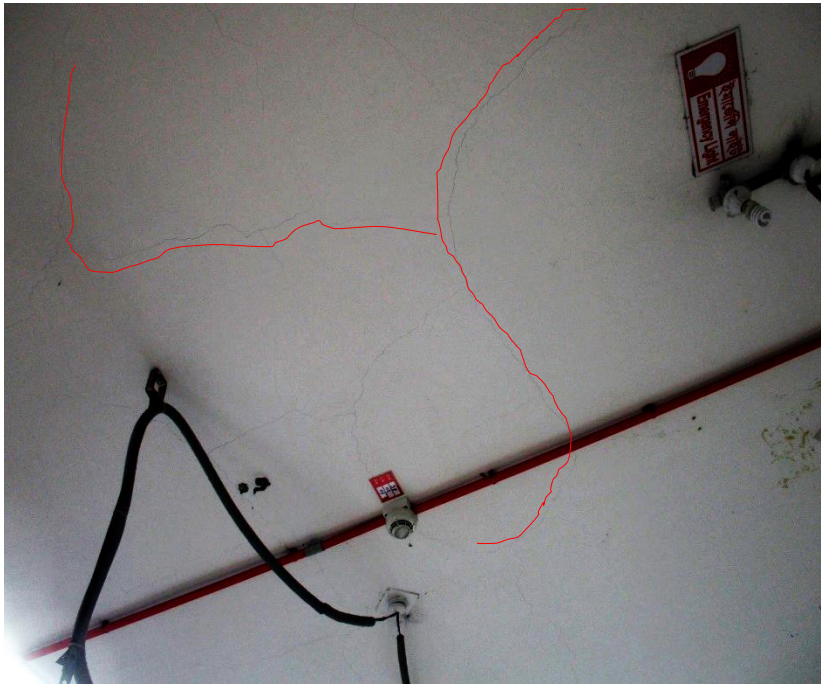
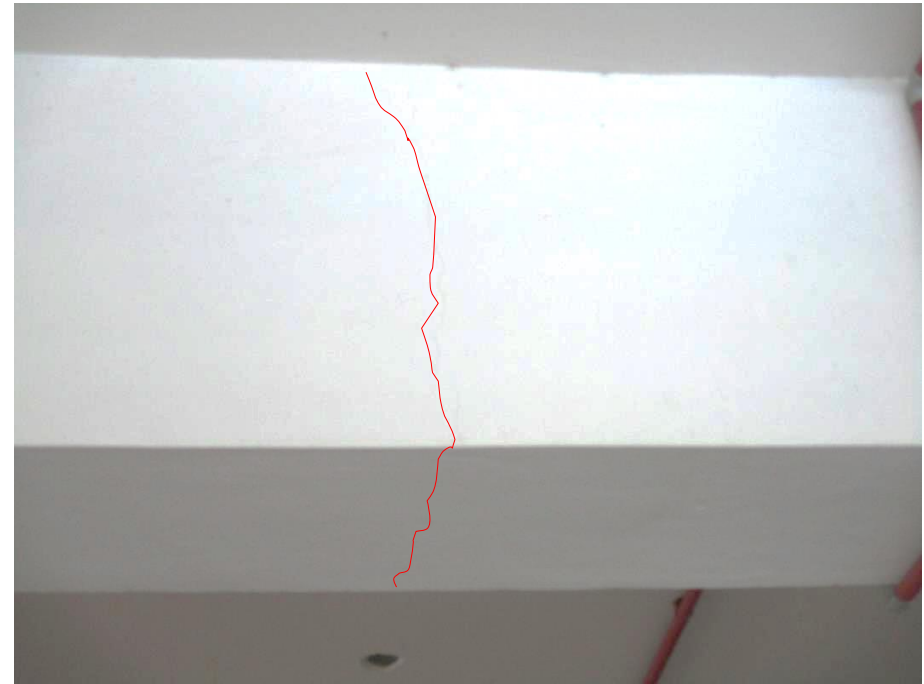
Hairline crack was found soffit of 5th floor slab and 6th floor beam

16	Hairline crack on floor beam & slab (Twin Tower-1 & 2 Building)	Building Engineer to investigate the crack and prepare an investigation report with proper remedial measure.	6-weeks
17	Hairline crack on floor beam & slab (Twin Tower-1 & 2 Building)	Implement the remedial actions as per investigation report	6-months

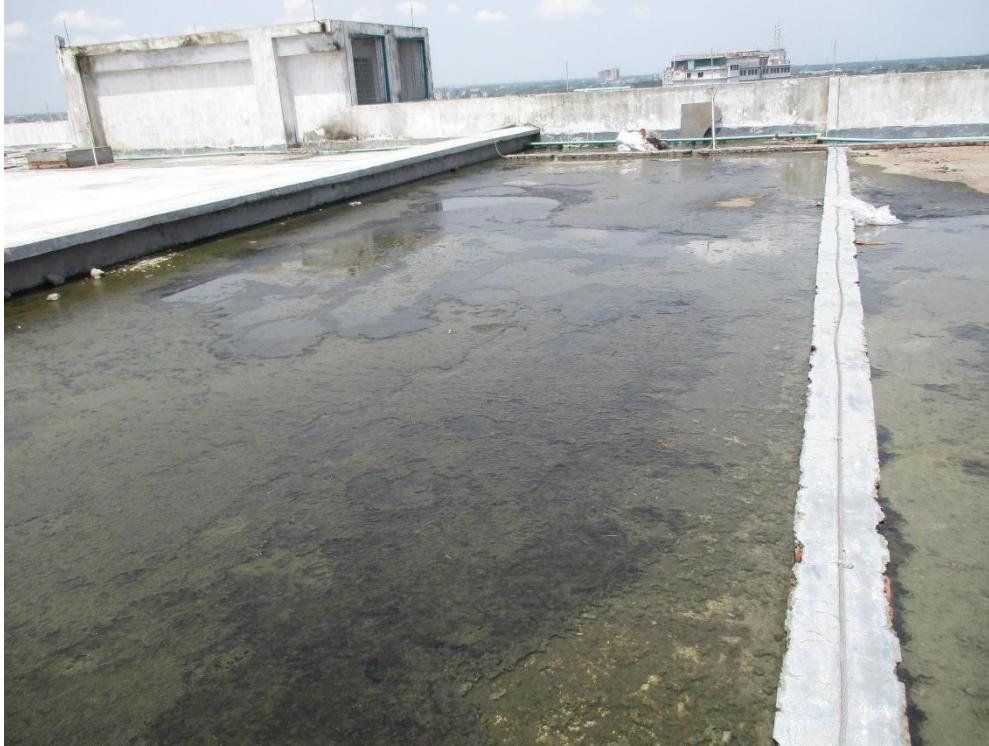
Water ponding was found in the roof. Also, poor water proofing layer was observed on roof slab. Building engineer to develop proper drainage system and provide proper water proofing layer on roof.

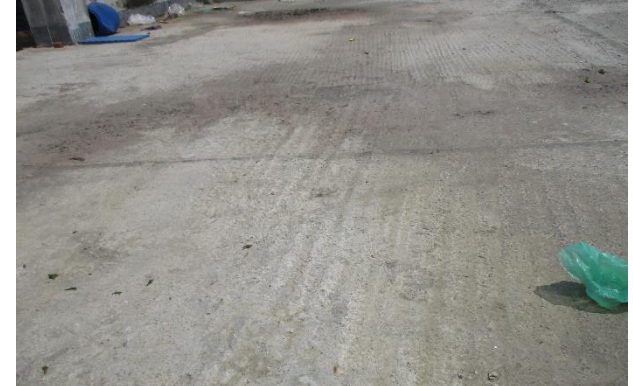
No water proofing layer

Poor water proofing layer

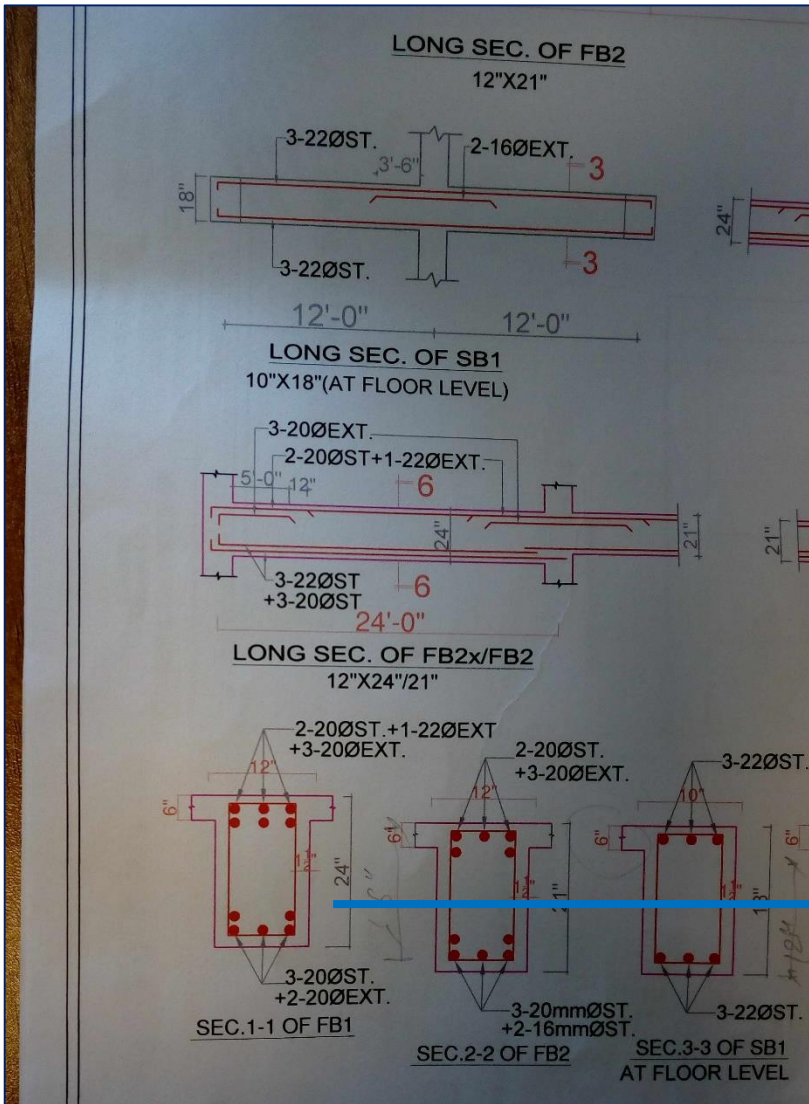
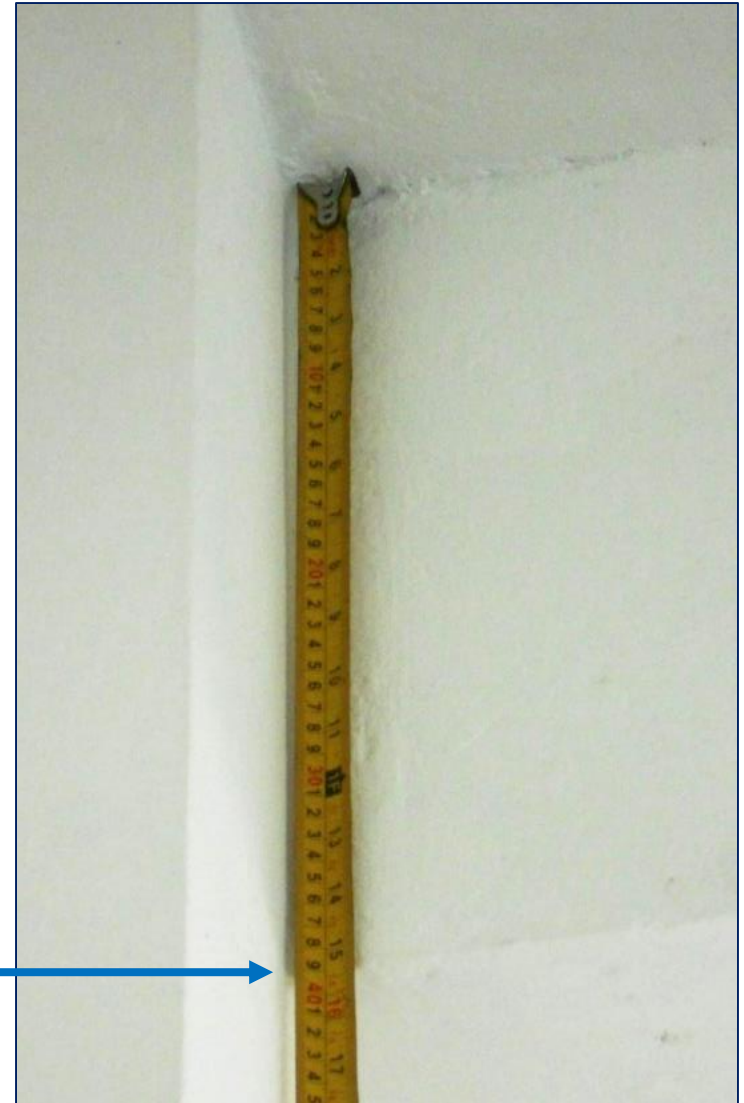
FB-1 d/s was found 375mm instead of 450 mm in the roof top.

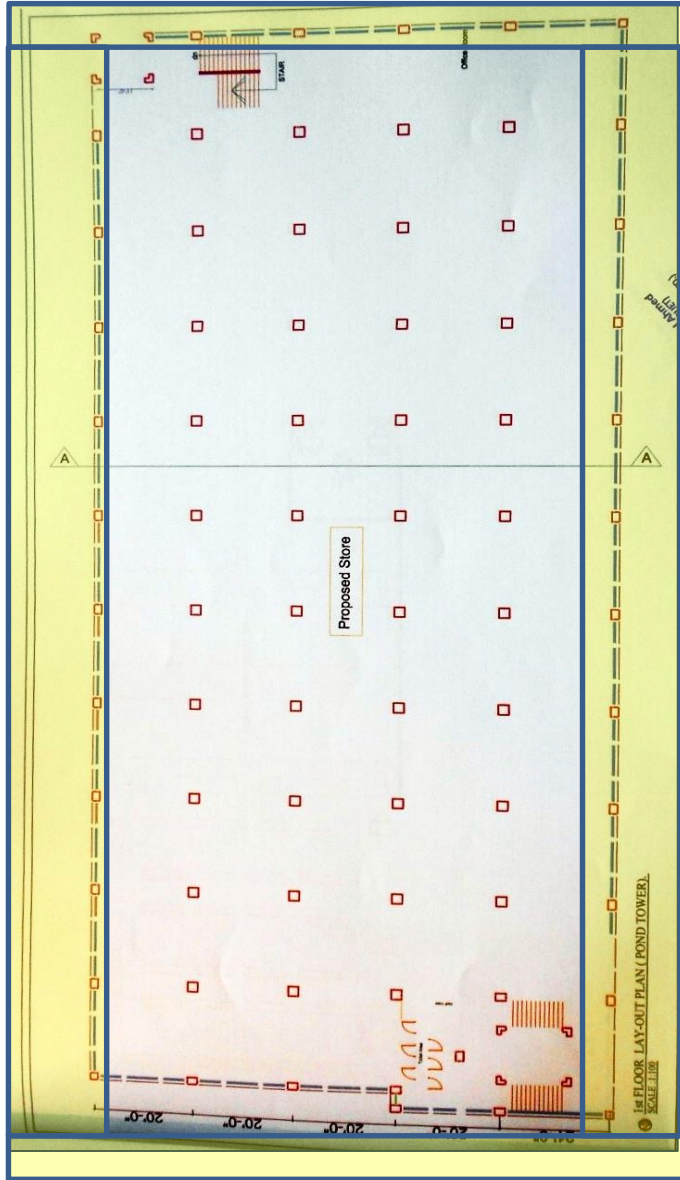
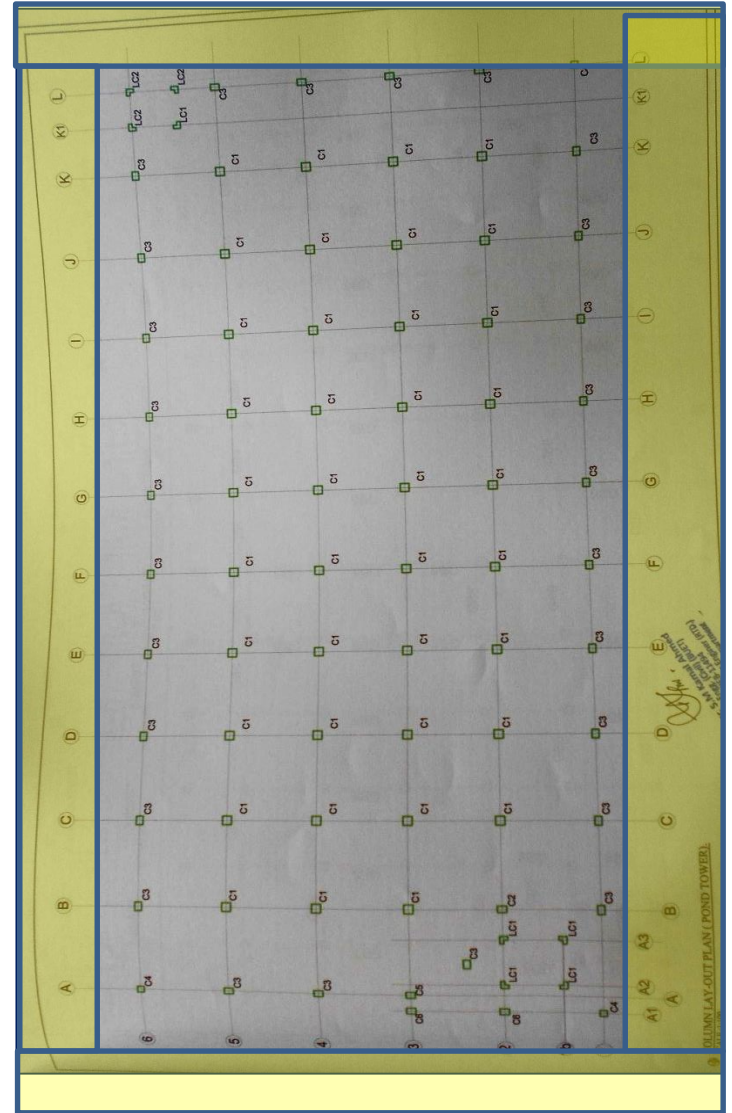
Grid dimension missing in Architectural and structural drawing. Floor layout (PW, Build Up) need to update on architectural drawings.
