A-One Polar Ltd. (New Buildings)

Vulta, Rupgonj

28th May and 3rd June 2018

Observations

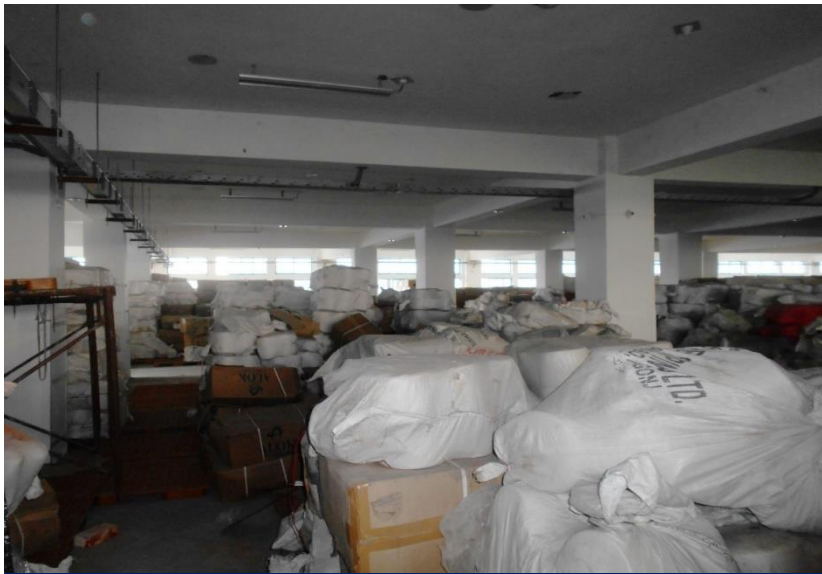
Loading in 3rd floor

No load management program was found. Load was found around 83 psf. Load restriction height marking is required and load management plan is required to be followed.

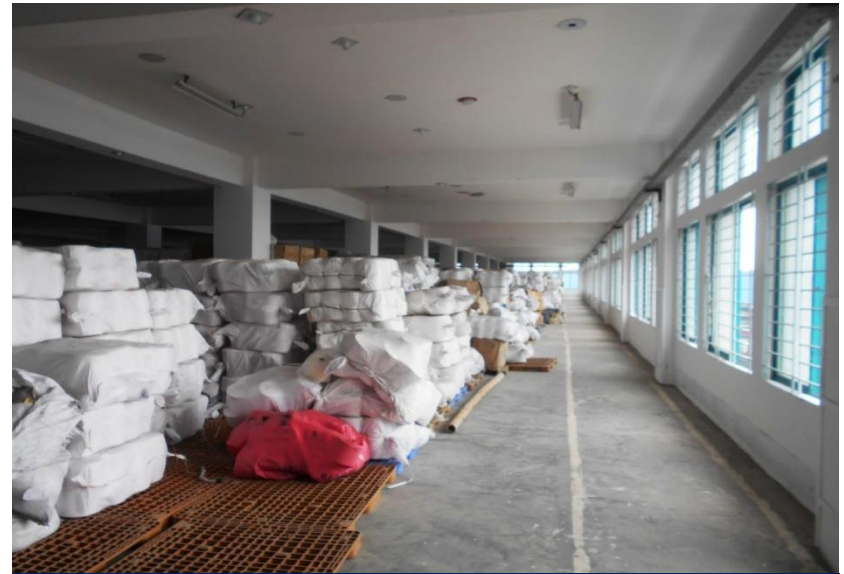
Loading in 2nd floor

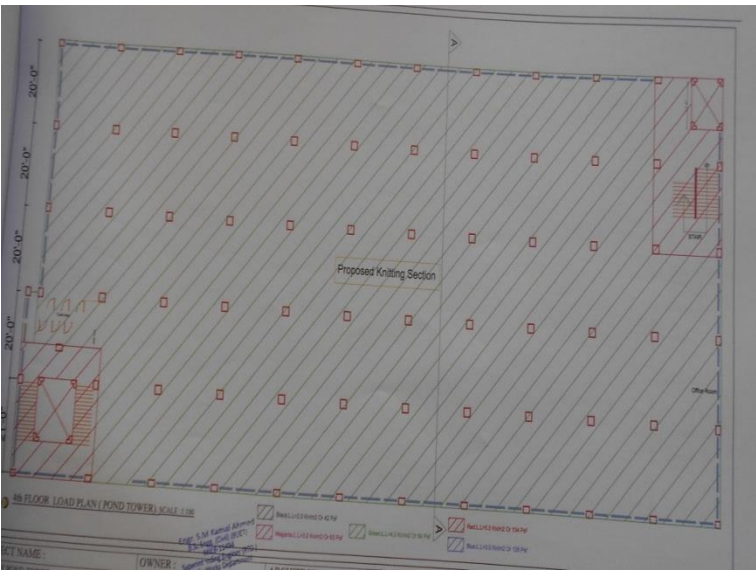
Existing load plan (4 kPa)

Design concrete strength was considered 3500 psi (24.13 MPa). Equivalent concrete strength was found 3190 psi (22 MPa). Live load considered 4 kPa for all floors. Factory is required to check the design report considering live load above 3 kPa with the value obtained from core test report. Otherwise maintain live load below 3 kPa.

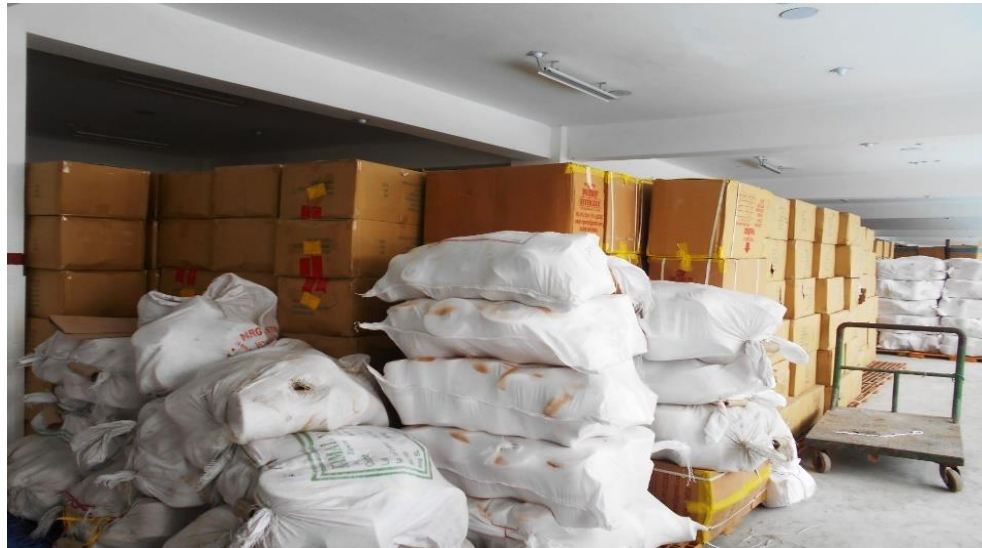
Loading condition

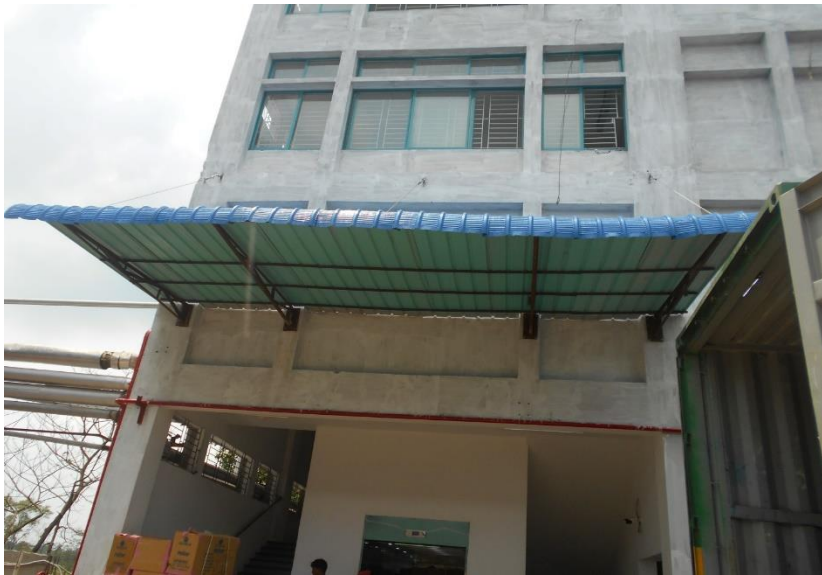
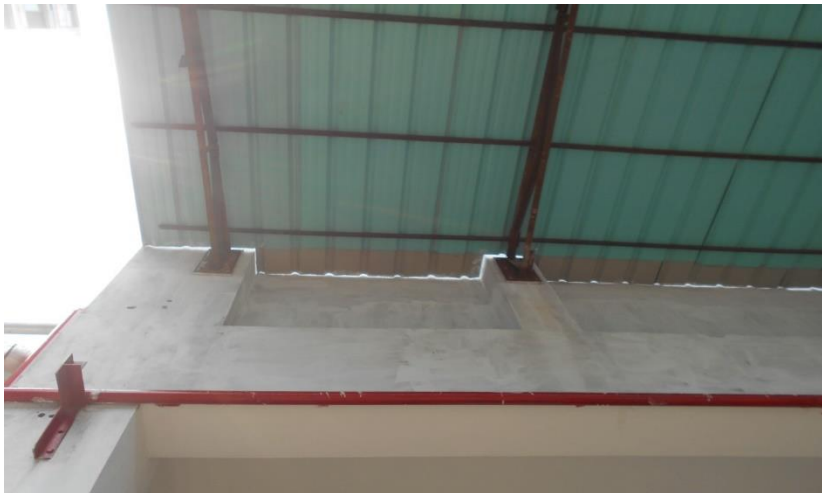
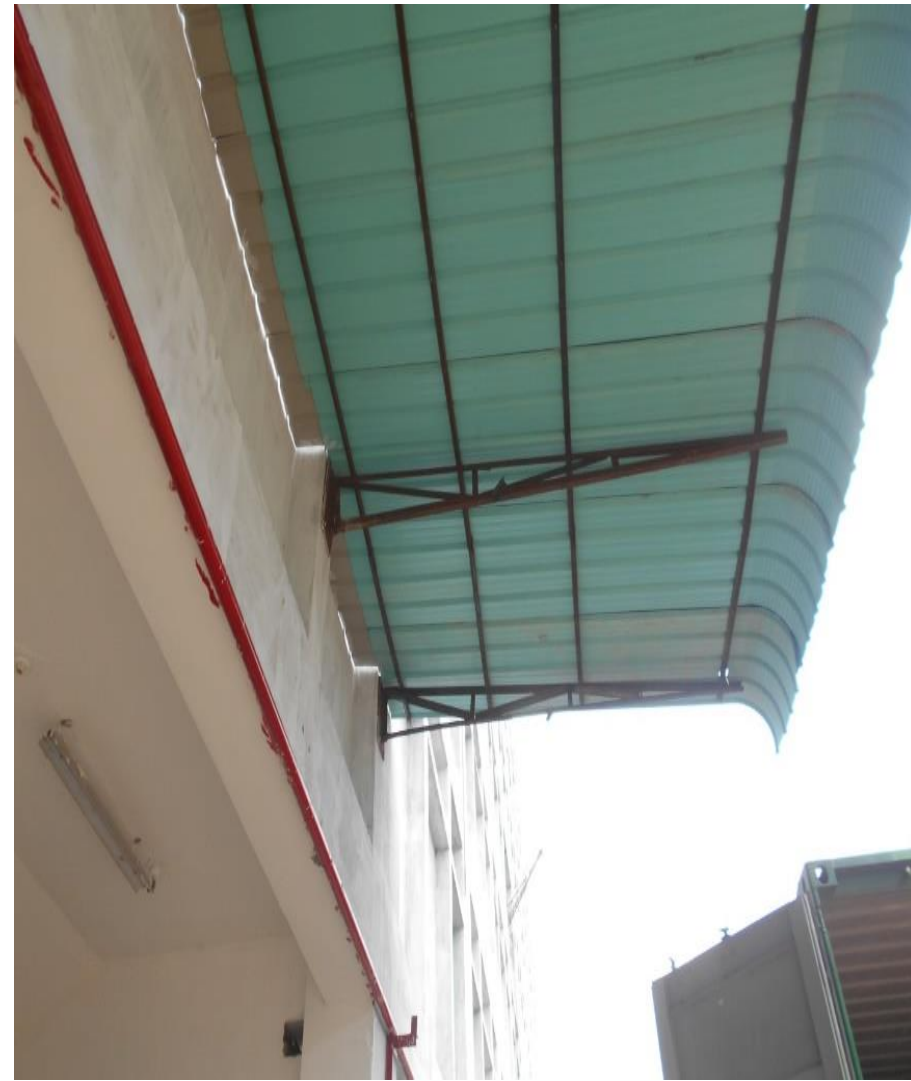
Non-engineered connection was observed in the canopy. The details of connection or Canopy is not included in the as-built drawing.

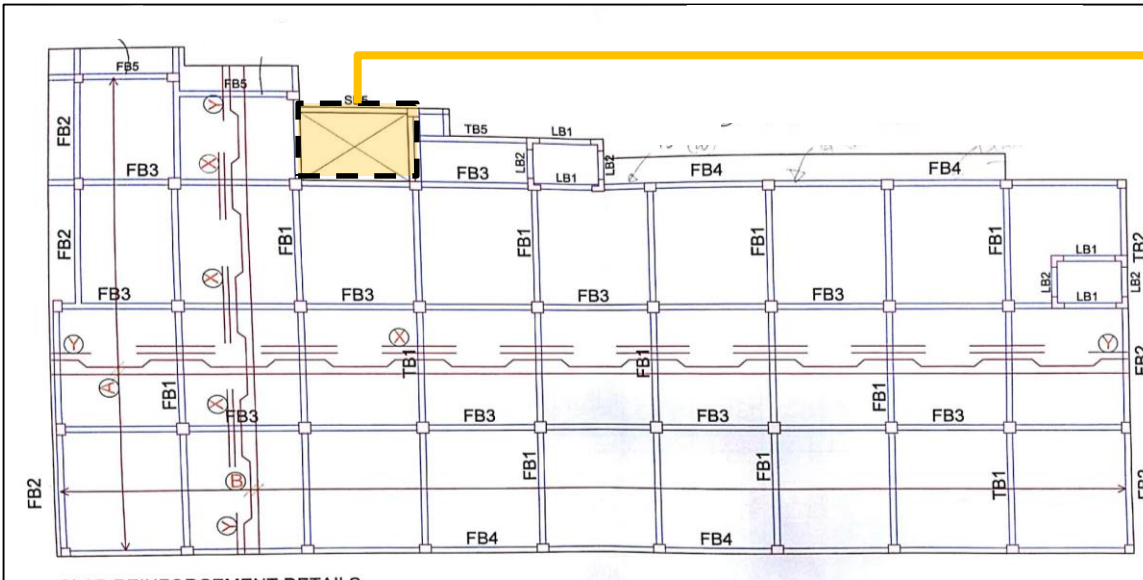
Beam layout on site didn't match with as-built drawing. In 6th floor staircase, the landing beam SB3 wasn't found on site. But the beam was shown in as-built drawings.

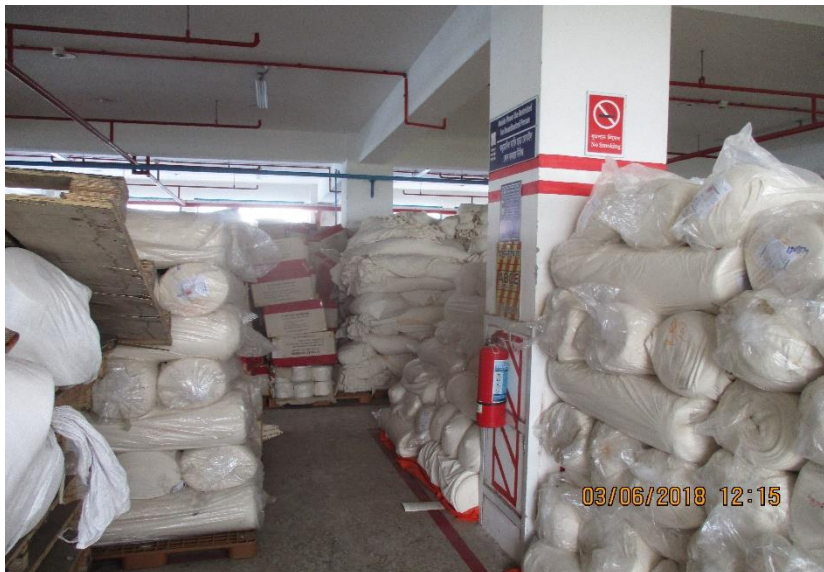
Loading in 5th floor

No load management program was found. Load was more than 63 psf. Load restriction height marking is required and load management plan is required to be followed.

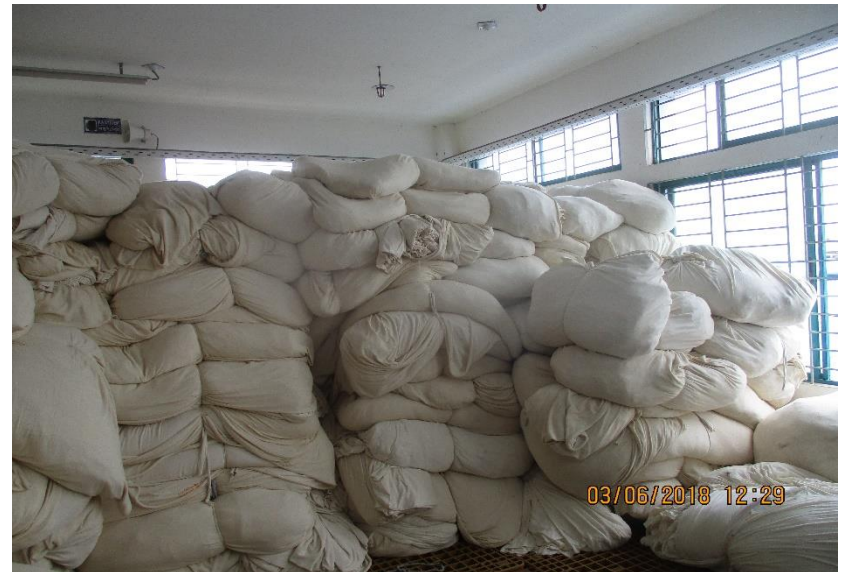
Loading in 2nd floor

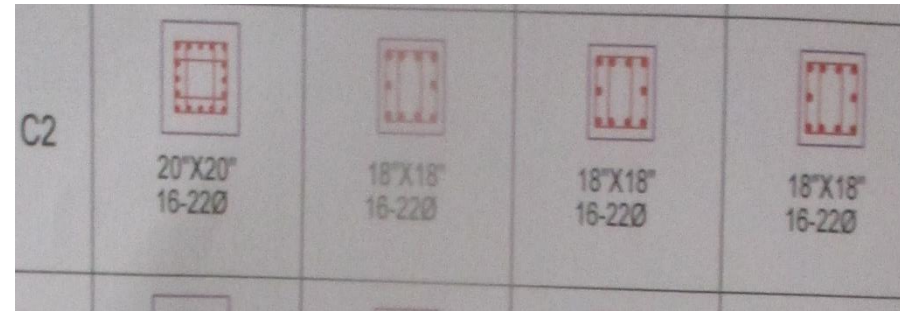
During inspection, 12 rebars were found by ferro scan (4 rebars each side) in central C2 columns where provided drawings shows 16 rebars.

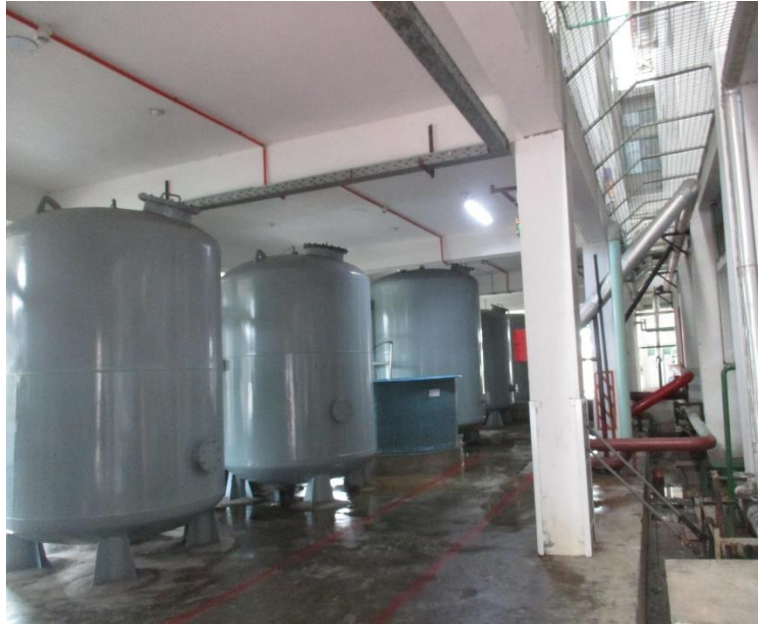
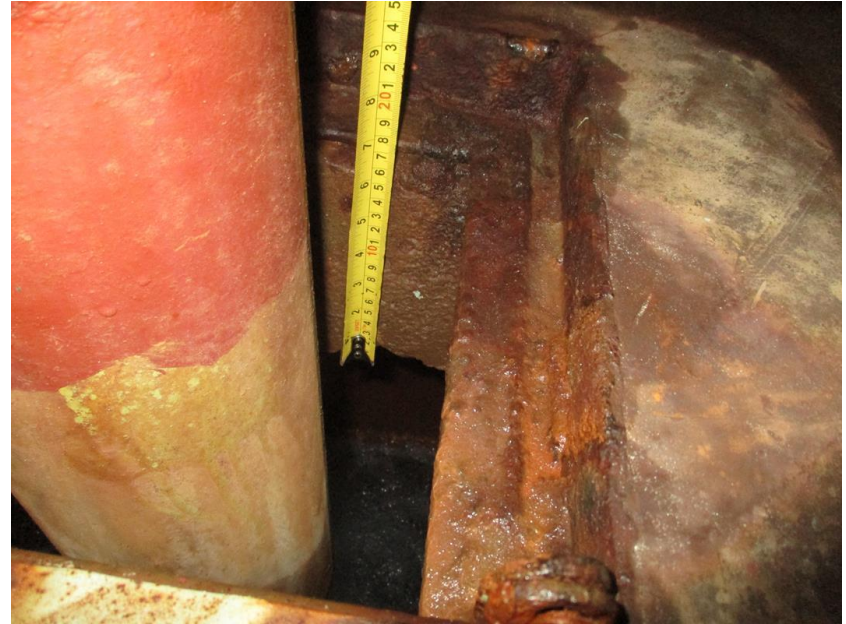
Large vessel were found resting on ground floor slab/top slab of U.G.W.R. So, factory engineer is required to check the adequacy of slab due to the heavy loading.

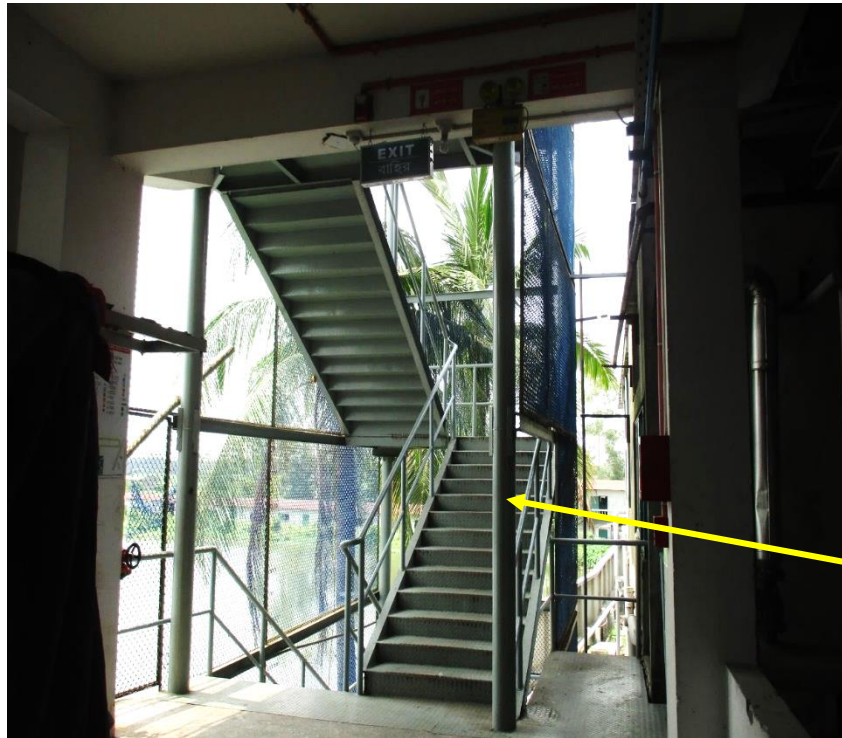
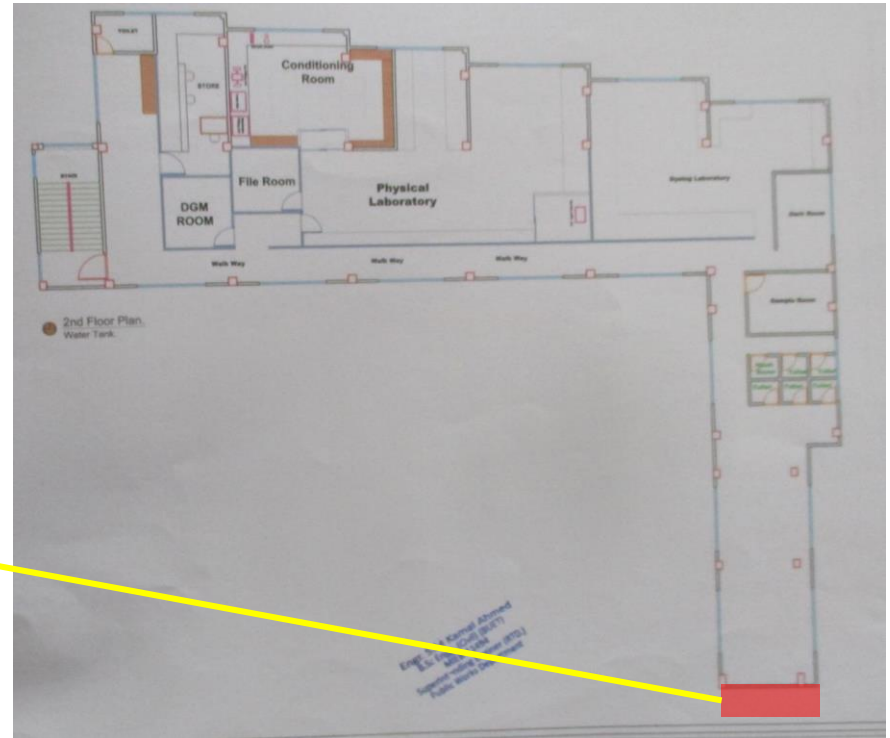
No structural details were available for steel stair.

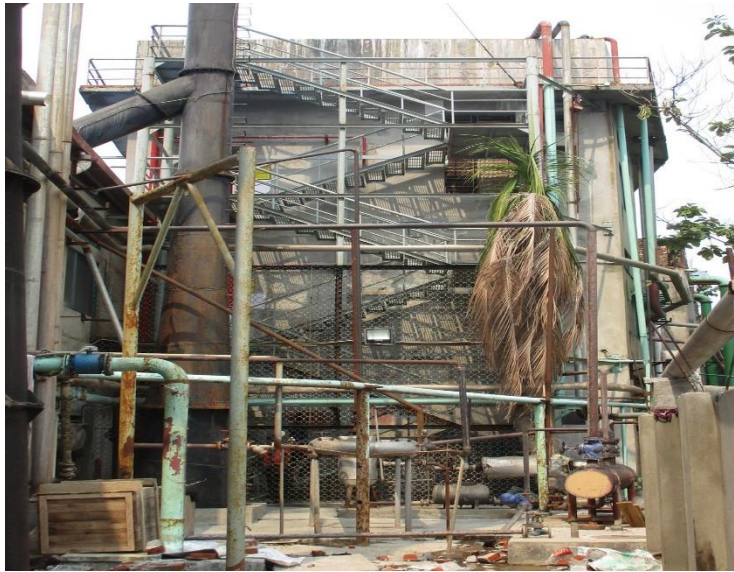
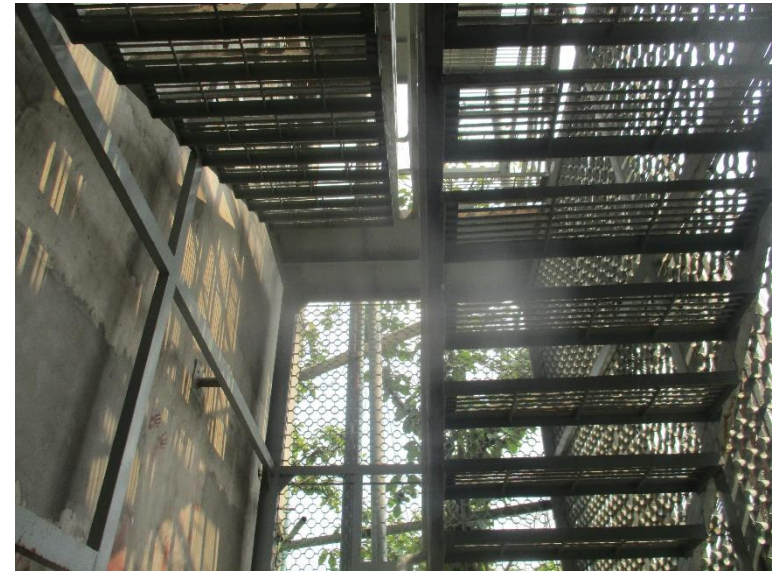
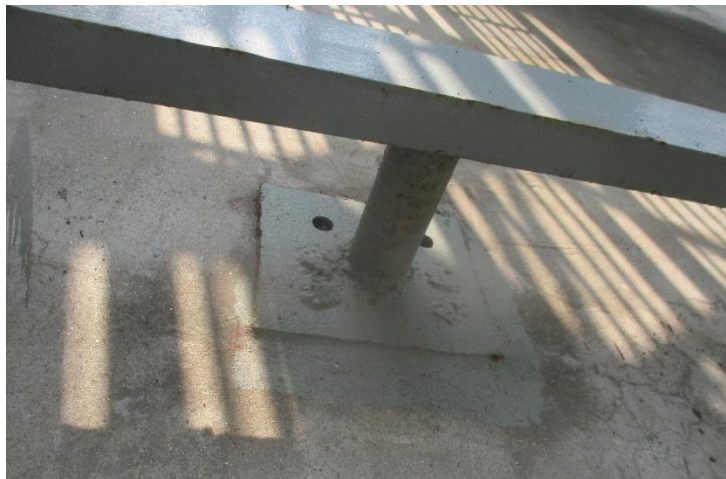
Poor connection

During inspection an apparently non engineered stair was found structurally connected to O.H.W.T building and also some bolt missing was observed. Factory Engineer is required to prepare as-built drawing(structural and architectural) and carry out stability check against the lateral loads.

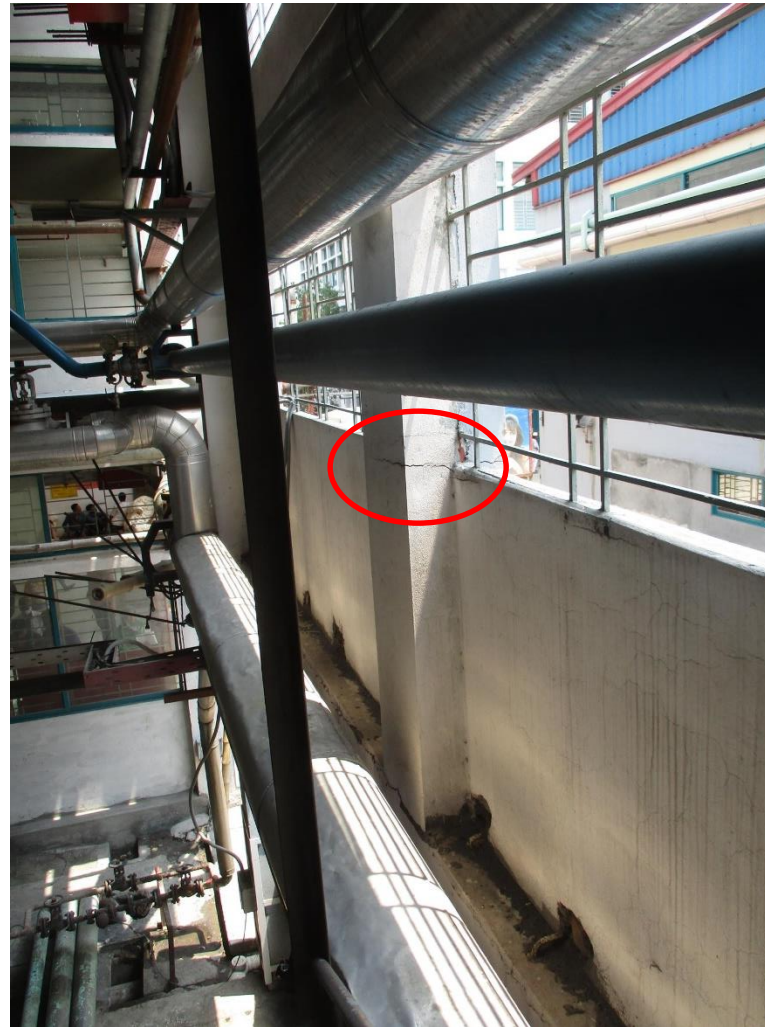
Crack was observed in brick pier. Factory engineer is required to investigate reason of crack and suggest proper remedial method.

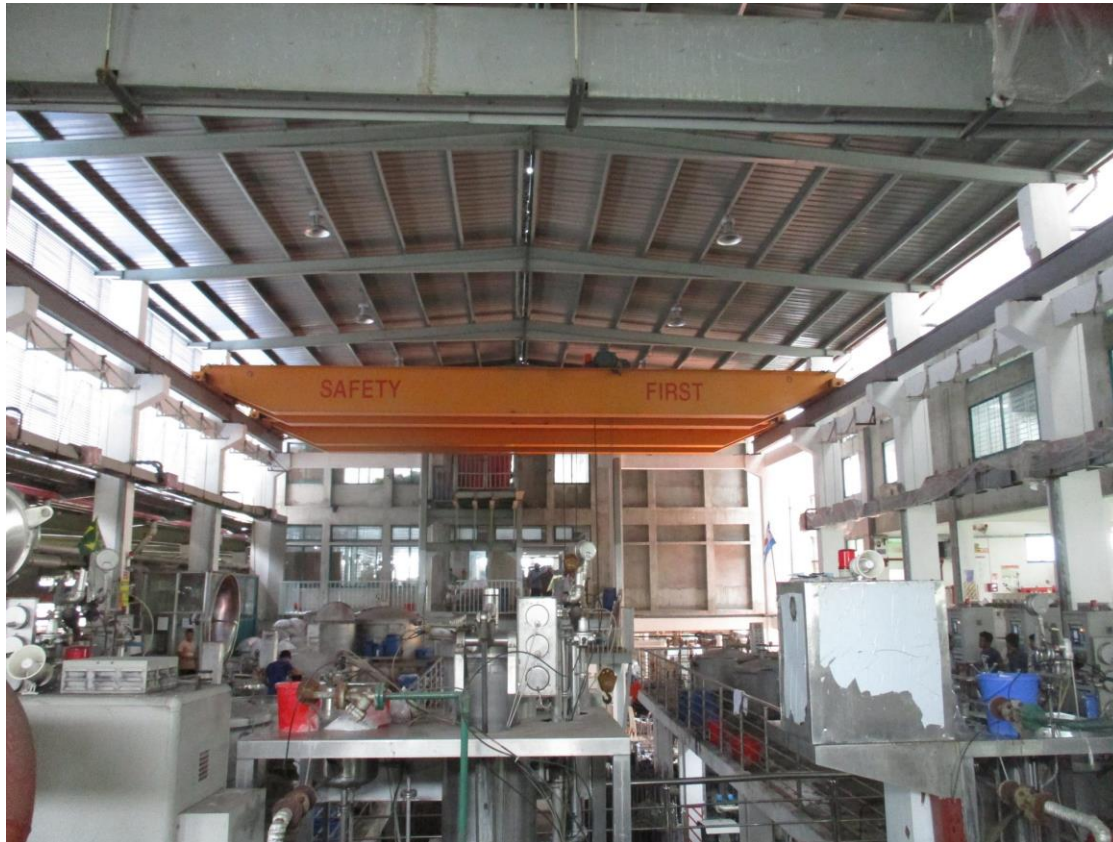
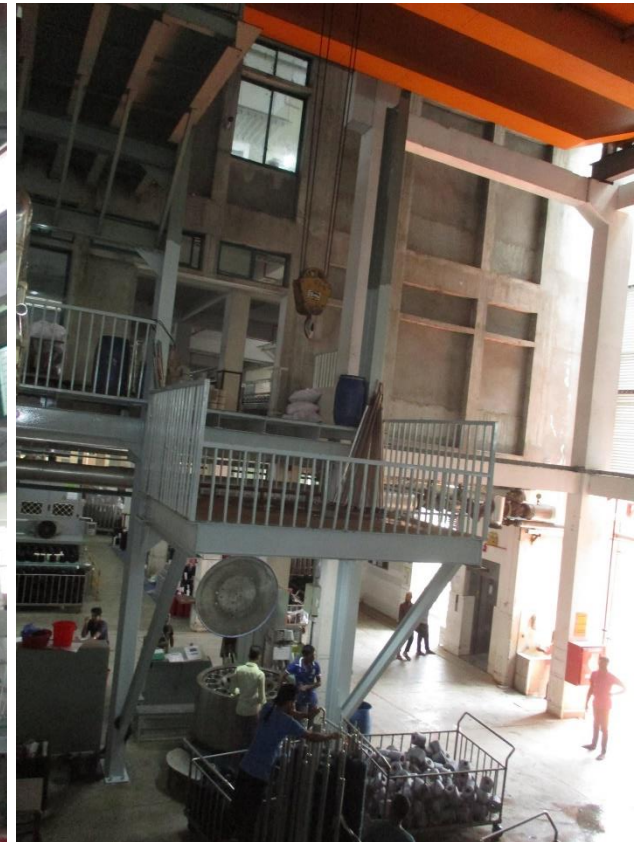
No obvious lateral stability system was observed. Factory engineer is required to carry out stability check against the lateral loads.

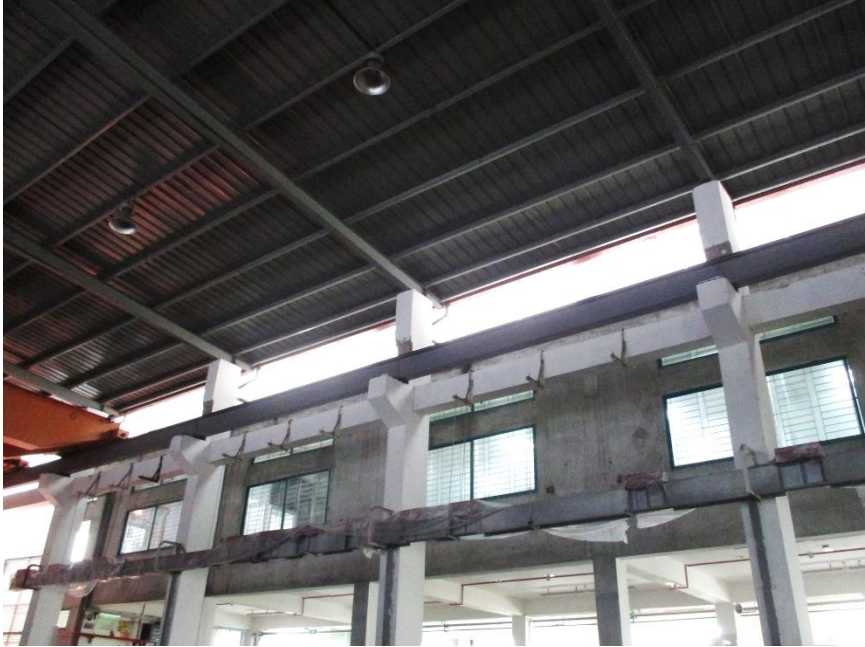
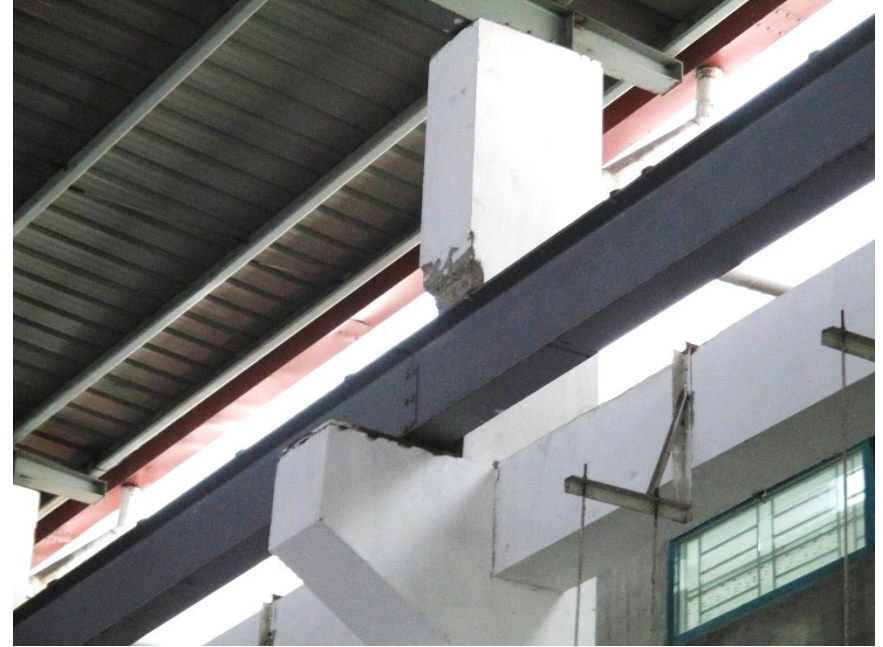
Column damaged due to installation of crane beam. The clear cover of column is reduced significantly. The capacity of the columns and corbel to be checked for the upcoming load from crane beams.

39	Damaged column surface (Yarn Dyeing Shed)	Building Engineer to investigate the extend scratch and prepare an investigation report with proper remedial measure.	6-weeks
40	Damaged column surface (Yarn Dyeing Shed)	Building Engineer to check the capacity of the columns for crane loads as well as lateral loads	6-weeks
41	Damaged column surface (Yarn Dyeing Shed)	Carryout any remedial works arise from Engineering Assessment.	6-months
