# Union Knitting and Dyeing Ltd

42&44 Boro Rangamatia Zirabo Savar, Dhaka

01<sup>st</sup> October 2018

# Observations

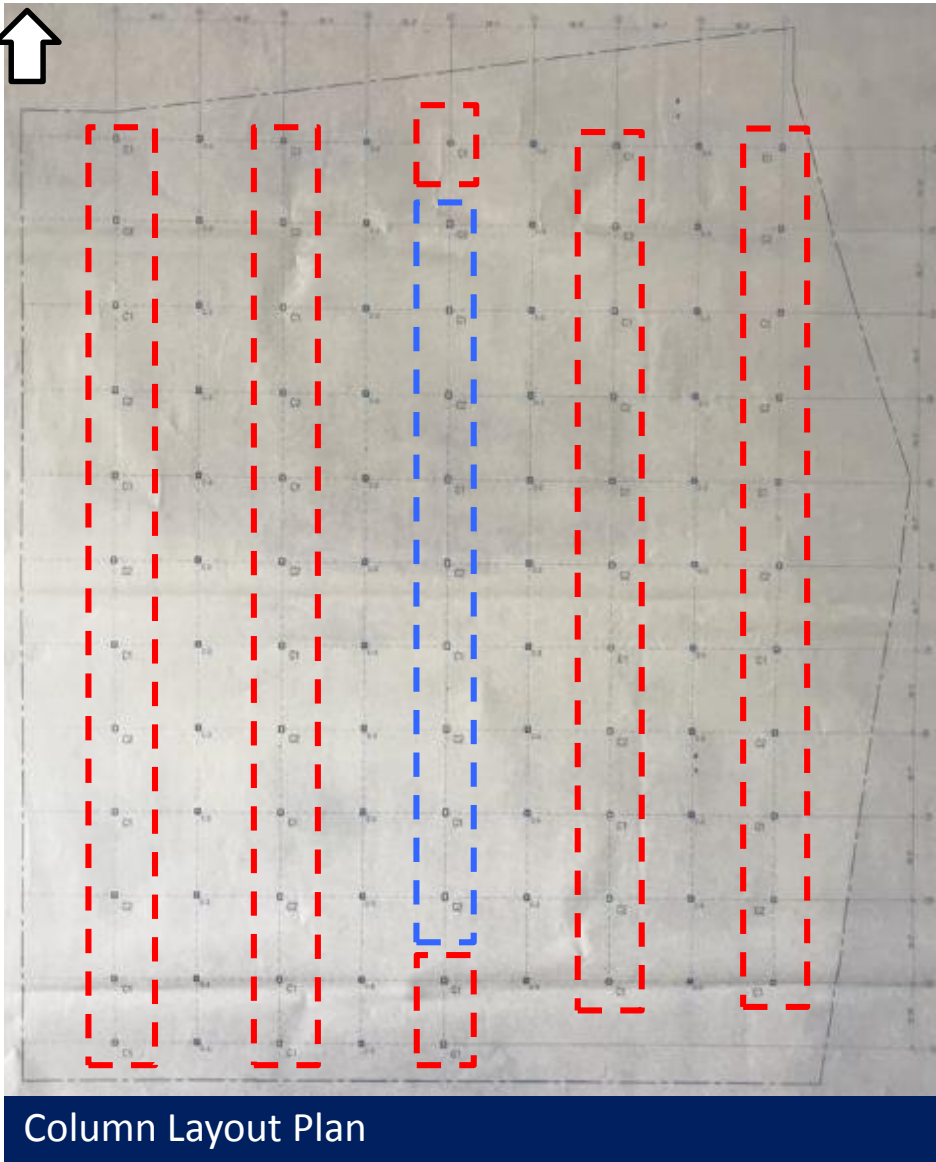
Column layout of onsite condition did not match with provided drawing. In the blue marked location and red marked location, 10inch x 15inch column, and 10inch x 12inch was found respectively. Whereas in the provided column layout, C1 and C2 type column was shown as the alternate arrangement in the North-South direction.

| Item No. | Observation | Recommended Action Plan | Recommended Timeline |
|---|---|---|---|
| 1 | (Production shed)<br>Discrepancy between as-built drawings and on site condition | Factory engineer to survey the whole building and produce as-built documentation which reflects the as constructed condition. | 6-weeks |

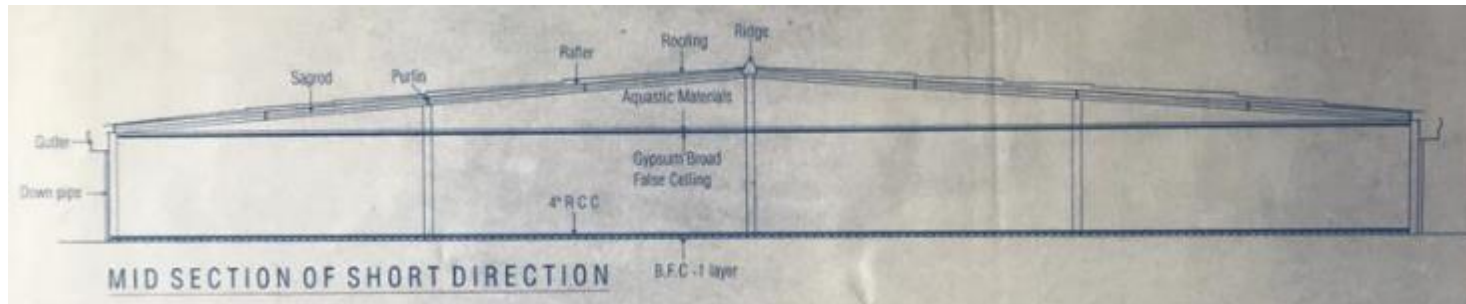
Typical frame (From Drawing)

In the provided structural drawing rafter was mentioned as roof framing system whereas truss frame was found on site. Factory is required to produce as –built drawing which reflect the onsite condition.

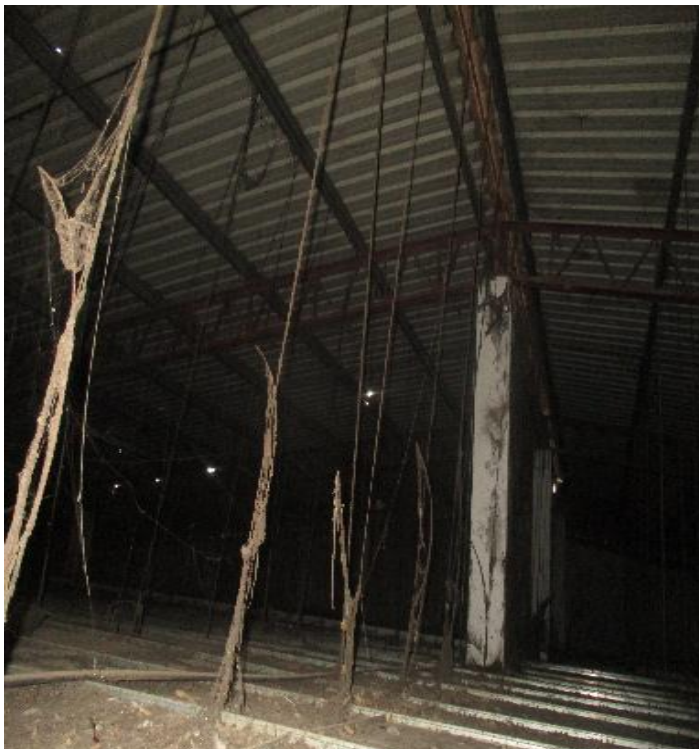
No bracing system was observed between truss frames

The connections of the truss & RC column are apparently non-engineered. Also, no bracing system was observed. The stability system is required to be checked against lateral and vertical loads.

| Item No. | Observation | Recommended Action Plan | Recommended Timeline |
|---|---|---|---|
| 2 | (Production shed)<br>Lateral stability is required to check | Factory is required to check stability against lateral and vertical loads. | 6-weeks |
| 3 | (Production shed)<br>Lateral stability is required to check | Carry out remedial action as per engineering assessment where required. | 6-months |

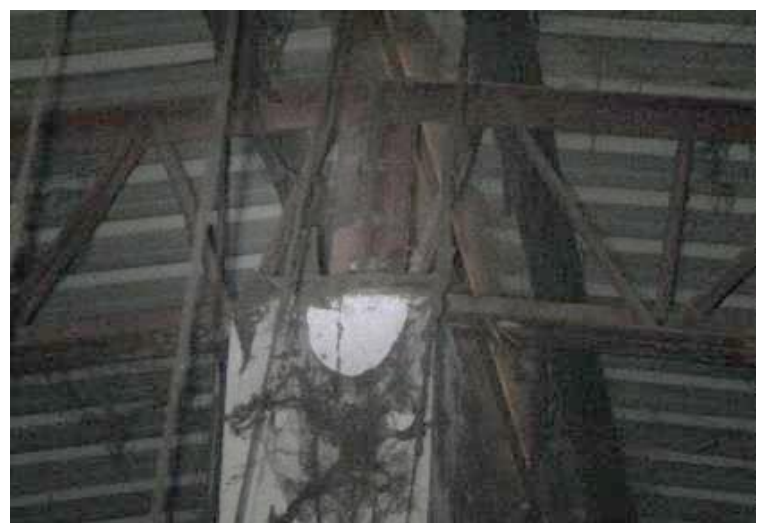
No connection detail was found in drawing. All members were connected by welding joint.

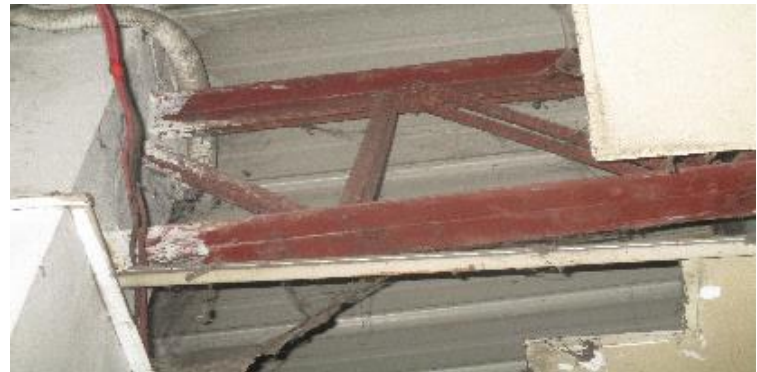
Welded connection between edge columns & truss

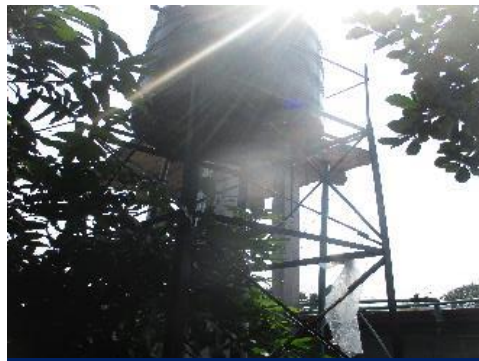
2000 litre water tank on steel frame over men toilet roof top

Concerns on the roof slab and steel frame supporting 2000 Liter water tanks. A capacity check of these slabs and all related elements need to be carried out. In addition, improve the drainage system for preventing the water clogging on slab.

| Item No. | Observation | Recommended Action Plan | Recommended Timeline |
|---|---|---|---|
| 4 | (Production shed)<br>Capacity check of roof slab and steel frame supporting water tanks is required | Factory engineer to review design, loads and related elements including roof slabs in area identified above to confirm capacity of the tanks. | 6-weeks |
| 6 | (Production shed)<br>Capacity check of roof slab and steel frame supporting water tanks is required | Carry out remedial action as per engineering assessment where required. | 6-months |

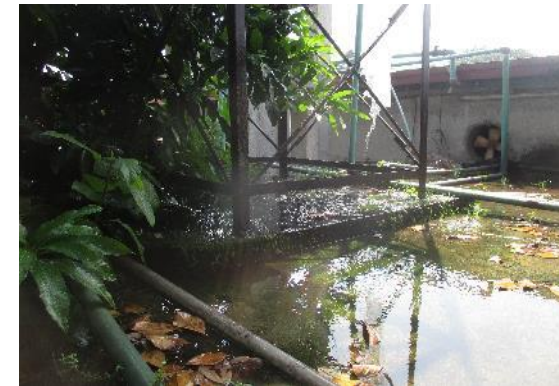
Water clogging observed over roof top of men's toilet

| Item No. | Observation | Recommended Action Plan | Recommended Timeline |
|---|---|---|---|
| 5 | (Production shed)<br>Capacity check of roof slab and steel frame supporting water tanks is required | Factory is required to improve the drainage system for preventing the water clogging on slab. | 6-weeks |

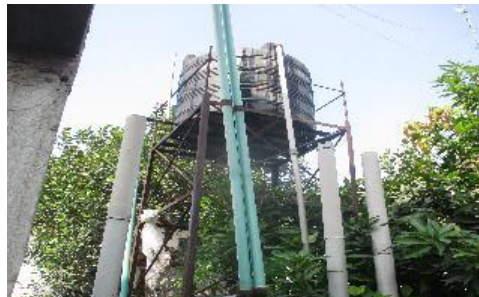
2000 litre water tank on steel frame over women toilet roof top

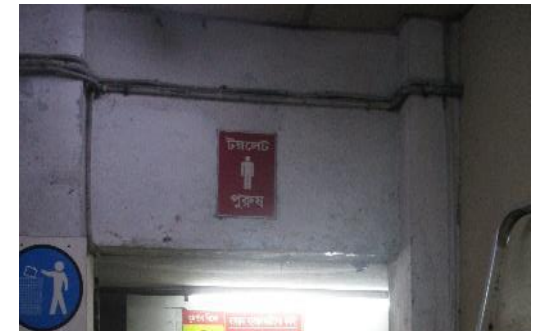
Deflection of roof slab of men's toilet

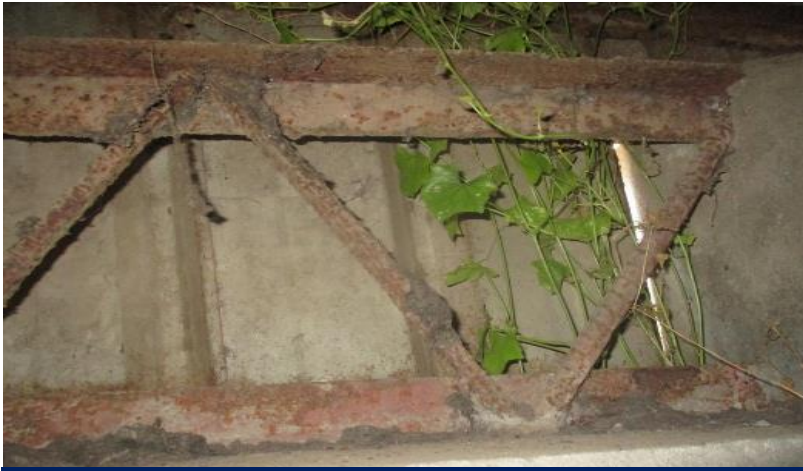
Extensive corrosion observed in truss member

Extensive corrosion was observed on various location in structural members as well as gutter and canopy. Factory is required to identify all the corroded locations and take proper remedial measures according to the engineer's recommendation.

| Item No. | Observation | Recommended Action Plan | Recommended Timeline |
|---|---|---|---|
| 7 | (Production shed)<br>Corrosion observed at steel sections | Factory is required to identify all the corroded members and take proper remedial measures according to the engineer's recommendation. | 6-weeks |

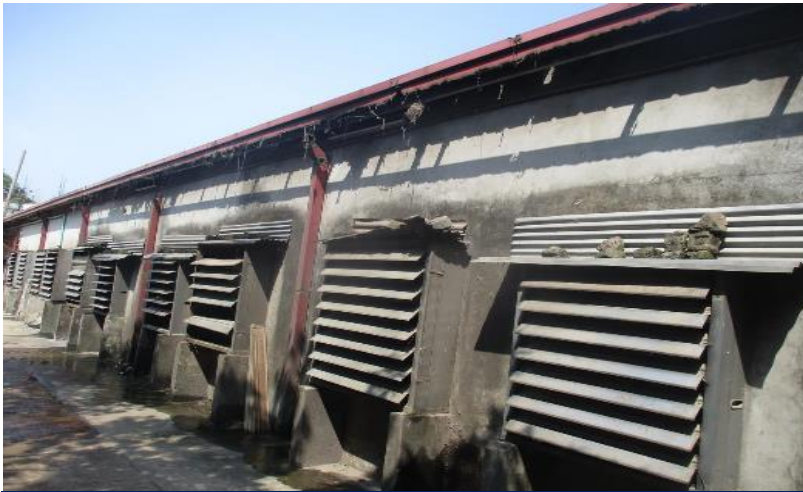
Extensive corrosion observed in gutter

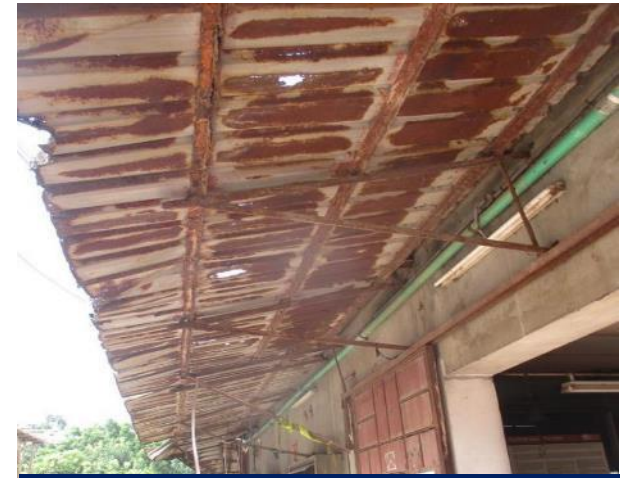
Extreme Corrosion observed in canopy

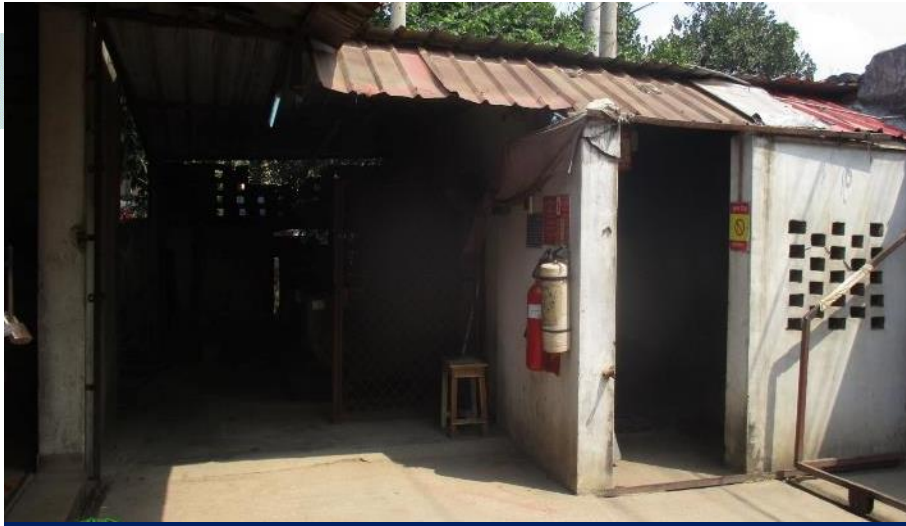
Generator shed

The support condition of those steel sheds were vulnerable and non engineered due to poor detailing of connection between members.

| Item No. | Observation | Recommended Action Plan | Recommended Timeline |
|---|---|---|---|
| 8 | (Generator shed & Boiler shed)<br>Apparently non-engineered light weight roof shed | Factory engineer to check the capacity of the lightweight steel roofs under lateral and vertical loading. | 6-weeks |
| 9 | (Generator shed & Boiler shed)<br>Apparently non-engineered light weight roof shed | Carry out remedial action as per engineering assessment where required. | 6-months |

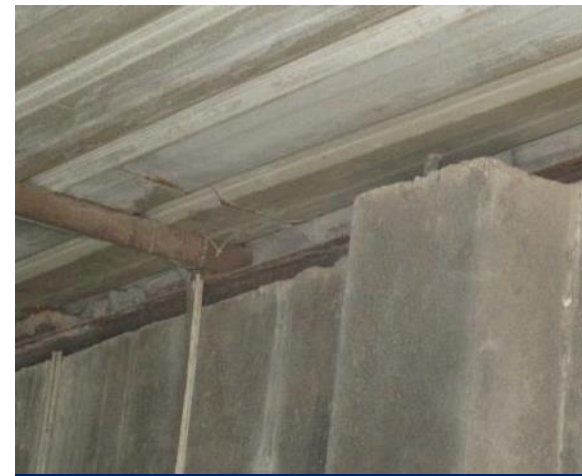
Steel angle was supported on brick wall

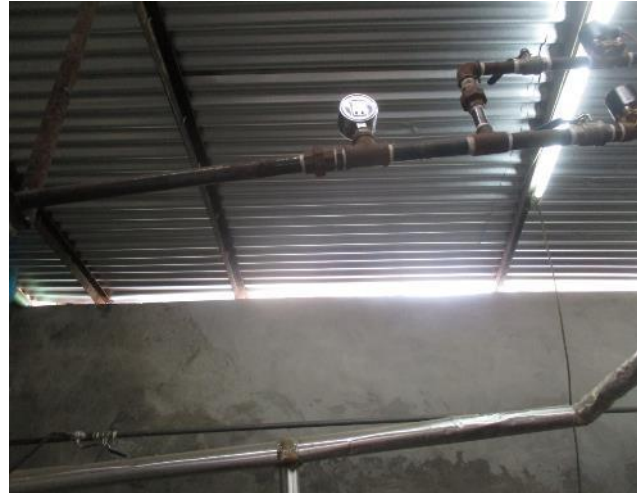
Steel angle was supported on brick wall
