FIRE SAFETY INSPECTION REPORT

GOLDEN REFIT GARMENT LTD.

**589 CHIRIR CHALA, BAGHAR BAZAR, BHABANIPUR,
GAZIPUR**

April 23, 2014

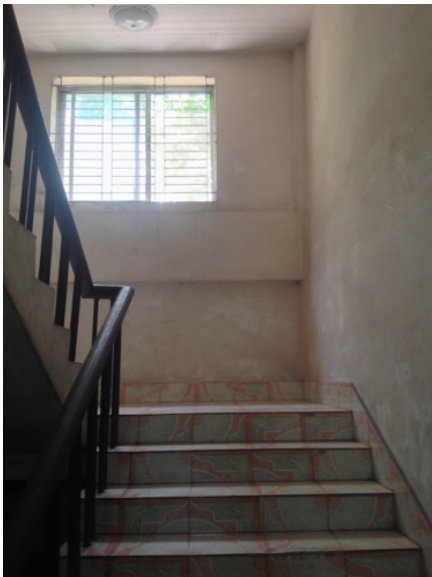
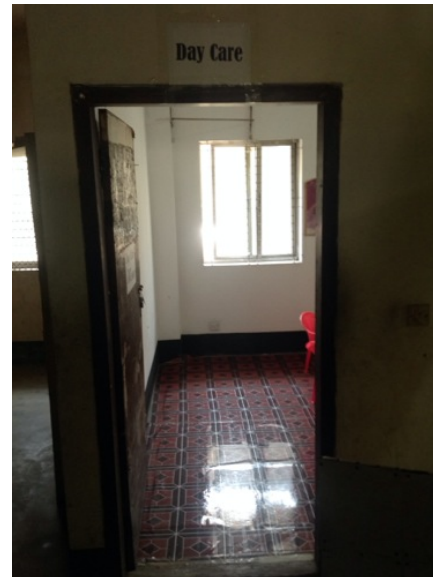
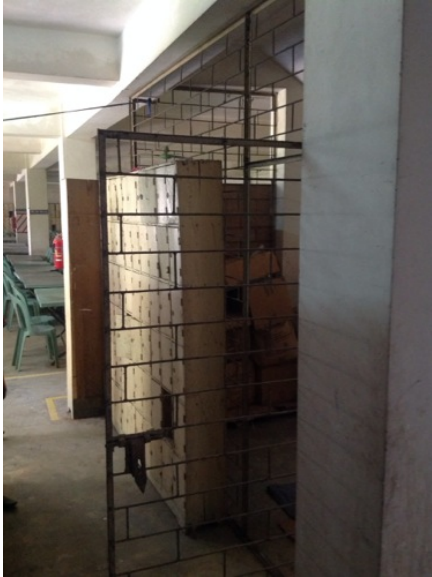
No.	Category	Finding	Recommendation	Remediation Timeframe
F-1	Fire Rated Construction	The exit stairs are not separated from work areas, other spaces on each floor by fire-rated construction.	<p>Provide minimum 1.5-hr fire rated doors and seal all unprotected openings to separate the exit stairs from work areas and other building spaces on all floor levels. Ensure that the fire doors are self-closing and positive latching and that they are provided with fire exit (panic) hardware where serving production floors.</p> <p>If fire doors are required to be held open for functional reasons, provide automatic-closing devices tied to the fire alarm system.</p>	Within 3 months

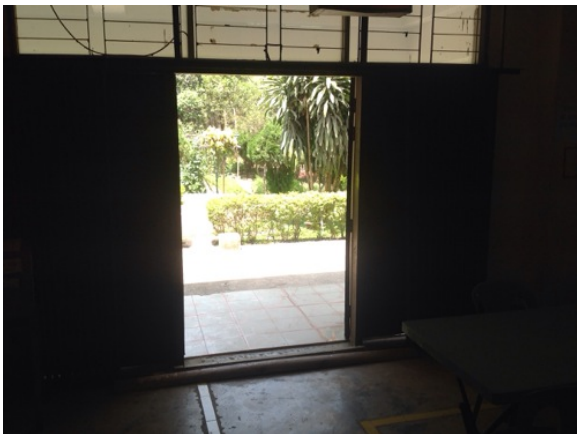
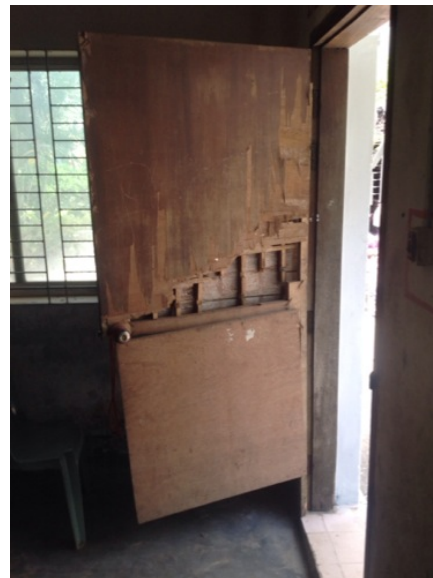
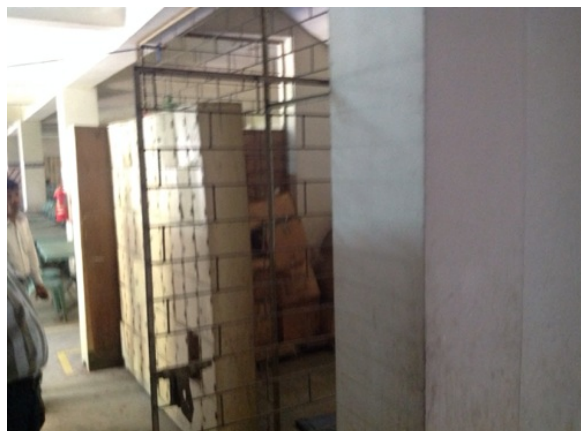
F-2	Egress	Egress doors / gates with locking features are provided at building exits, exit stairs, along egress routes, exit discharge.	Remove locking features from all egress doors / gates. If locks are required for security reasons, utilize special door locking features complying with NFPA 101.	Immediate
-----	--------	--	--	-----------

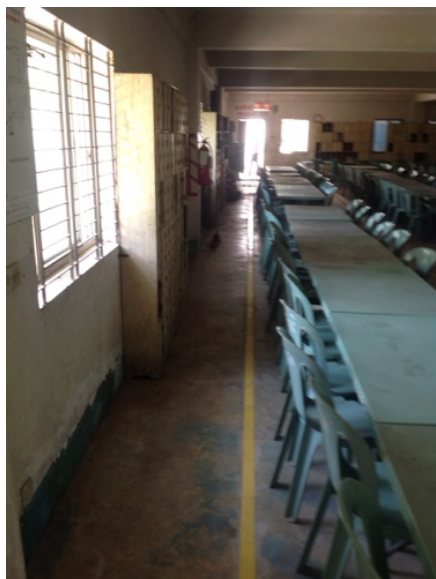
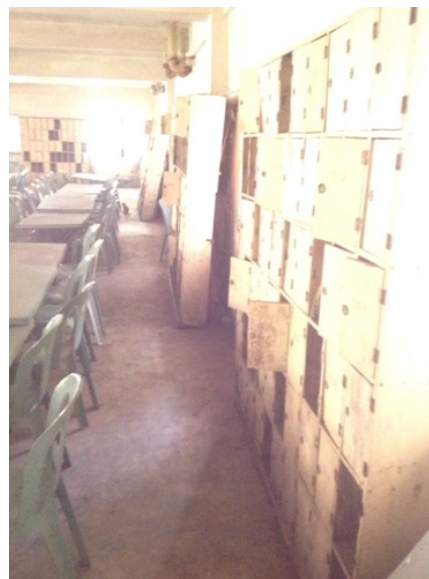
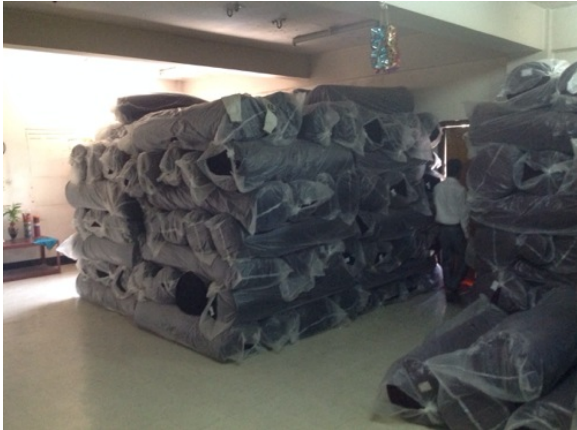
F-3 Egress

Storage was located in the egress throughout the facility.

Keep egress paths and clear of storage at all times.

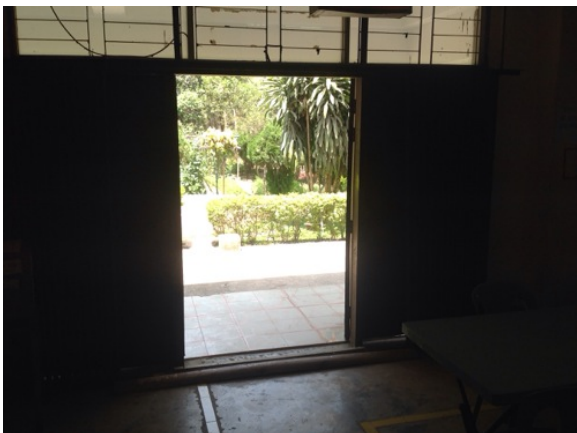
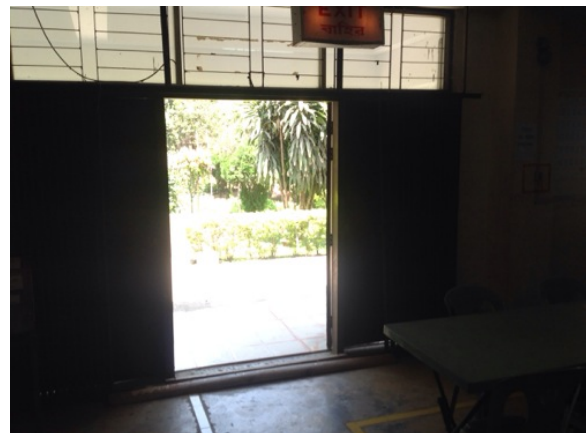
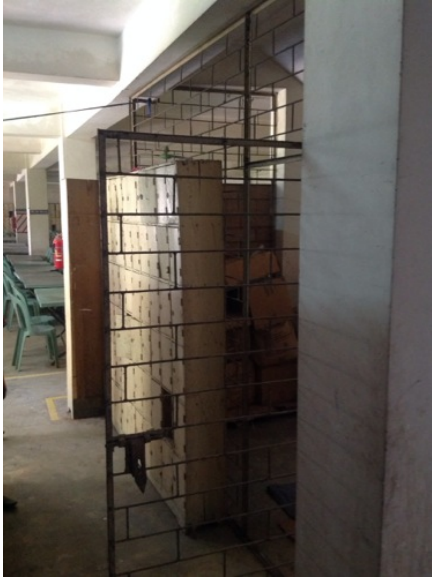
F-4 Egress

Collapsible gates / sliding doors are provided at building exits, exit stairs, along egress routes, exit discharges throughout the factory.

Replace all gates / sliding doors along the means of egress with side-hinged, swinging egress doors.

If locks are required for security reasons, utilize special door locking features complying with NFPA 101.

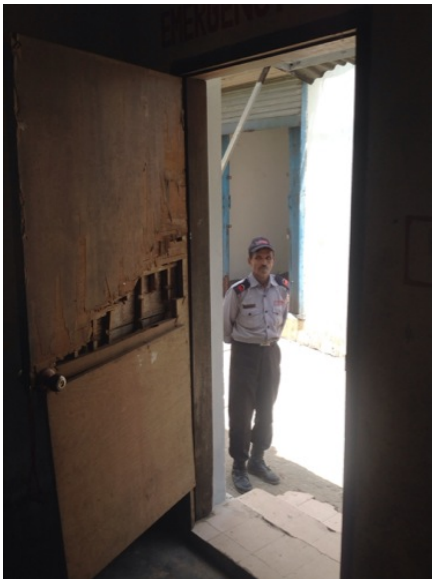
F-5	Egress	Egress door serving 50 or more occupants does not swing in the direction of egress travel ground floor second exit.	Modify the egress door to swing in the direction of egress travel.	Within 3 months
-----	--------	---	--	-----------------

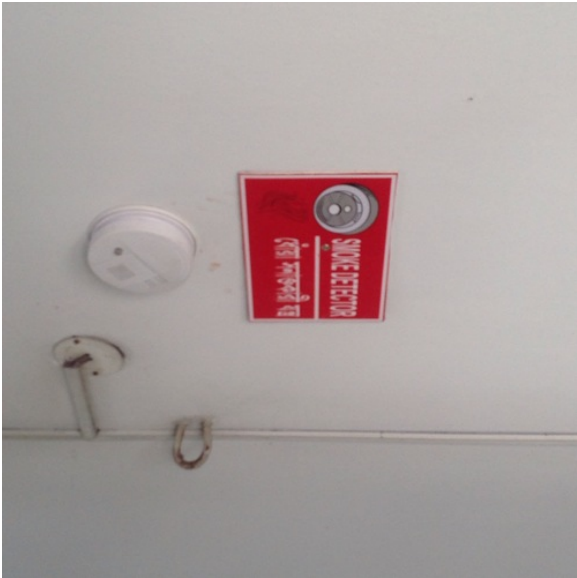
F-7	Fire Protection	The building is equipped with single-station smoke alarms. Smoke alarm activation sounds only a local alarm and does not provide automatic fire alarm notification of occupants. Ground floor only.	Replace the single-station smoke alarms. Provide automatic smoke detection throughout the building in accordance with NFPA 72.	Within 6 months

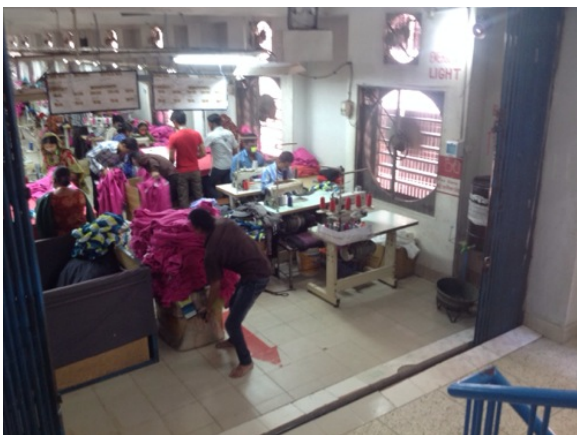
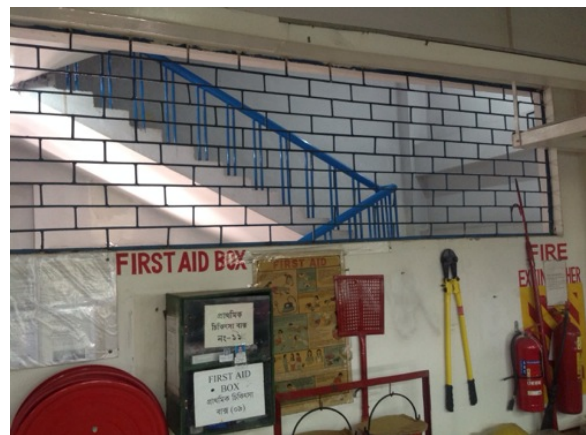
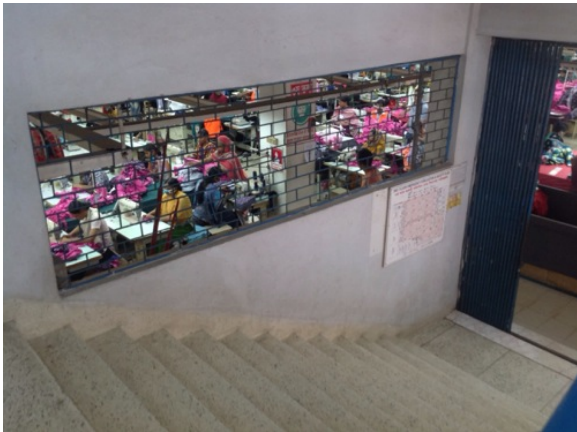
No.	Category	Finding	Recommendation	Remediation Timeframe
F-1	Fire Rated Construction	The exit stairs are not separated from work areas, other spaces on each floor by fire-rated construction.	<p>Provide minimum 1.5-hr fire rated doors and seal all unprotected openings to separate the exit stairs from work areas and other building spaces on all floor levels. Ensure that the fire doors are self-closing and positive latching and that they are provided with fire exit (panic) hardware where serving production floors.</p> <p>If fire doors are required to be held open for functional reasons, provide automatic-closing devices tied to the fire alarm system.</p>	Within 3 months

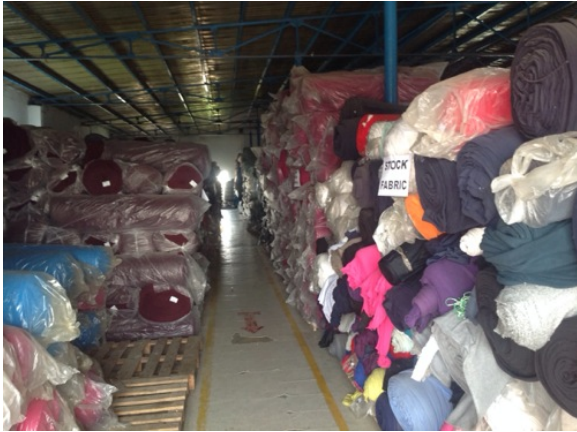
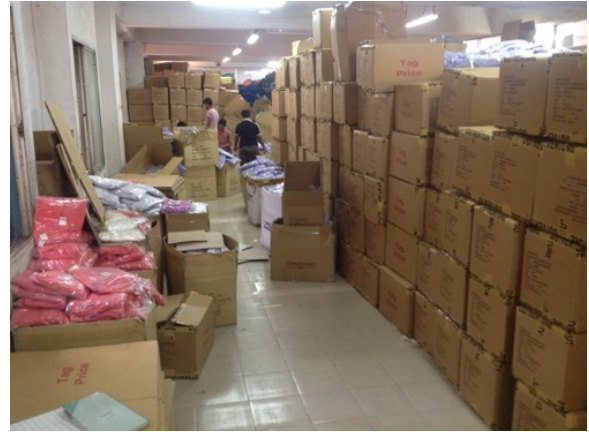
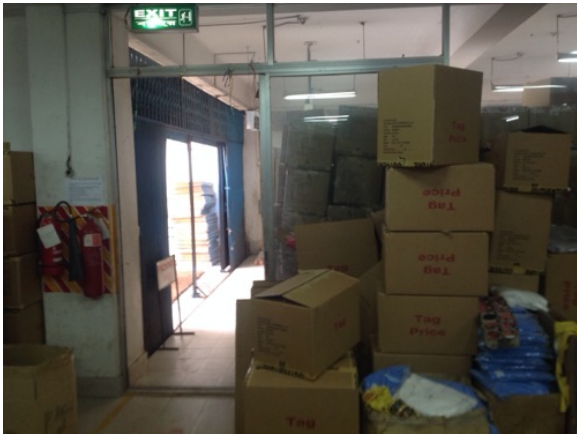
F-2	Fire Rated Construction	Areas used for storage are not separated by fire-rated construction on ground floor or fourth floor.	<p>Provide dedicated storage rooms separated by minimum 1-hr fire-rated construction.</p> <p>Where separate storage rooms are not feasible, provide defined storage areas and limit the storage arrangement as follows:</p> <ul style="list-style-type: none">- Maximum height of 2.4m and maximum area of 23m²- If sprinkler protected: maximum height of 3.66m and maximum area of 93m² <p>Separate areas of unenclosed combustible storage by a minimum clear distance of 3m.</p>	Within 3 months
-----	-------------------------	--	---	-----------------

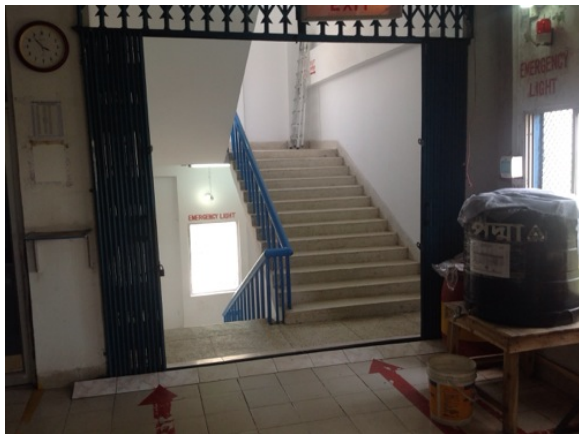
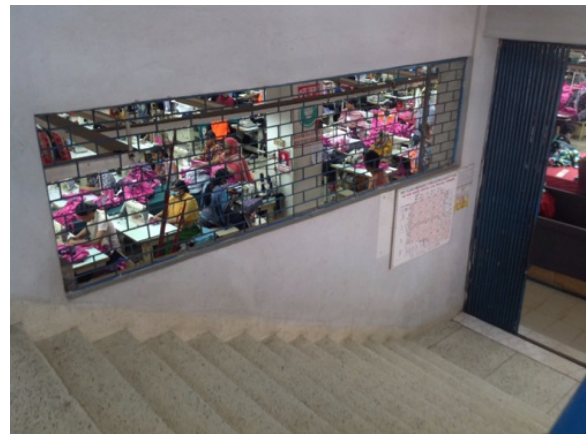
F-3	Fire Rated Construction	The exit stairs are not separated from work areas, other spaces on each floor by fire-rated construction.	Provide minimum 1.5-hr fire rated doors and seal all unprotected openings to separate the exit stairs from work areas and other building spaces on all floor levels. Ensure that the fire doors are self-closing and positive latching and that they are provided with fire exit (panic) hardware where serving production floors. If fire doors are required to be held open for functional reasons, provide automatic-closing devices tied to the fire alarm system.	Within 3 months
-----	-------------------------	---	---	-----------------

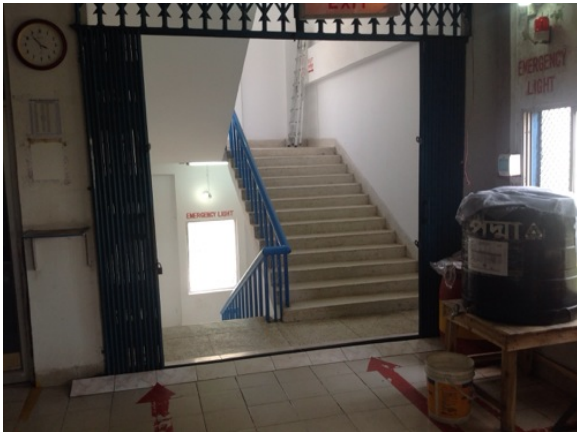
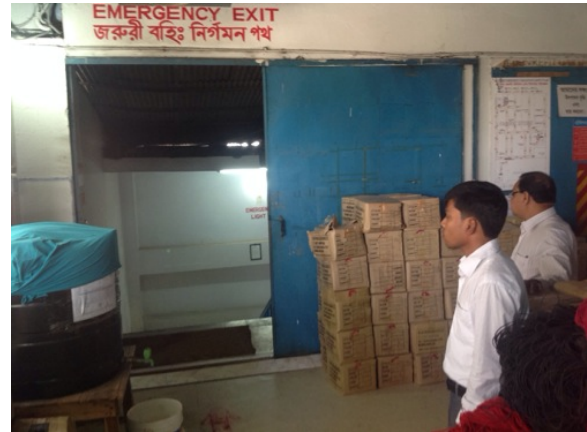
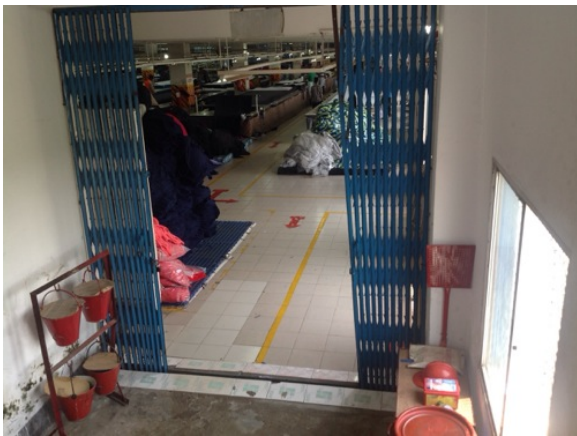
F-4	Egress	Egress doors / gates with locking features are provided at building exits, exit stairs, along egress routes, exit discharge.	Remove locking features from all egress doors / gates. If locks are required for security reasons, utilize special door locking features complying with NFPA 101.	Immediate
-----	--------	--	--	-----------

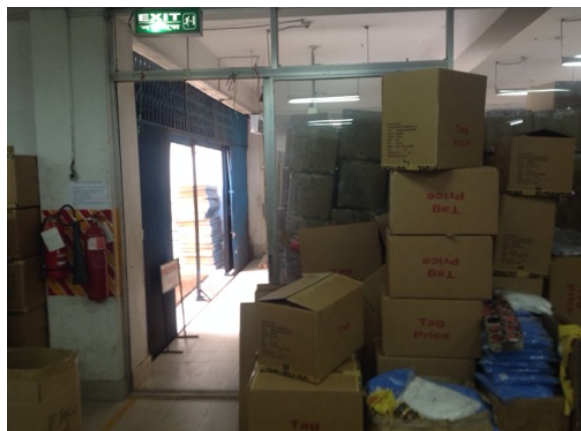
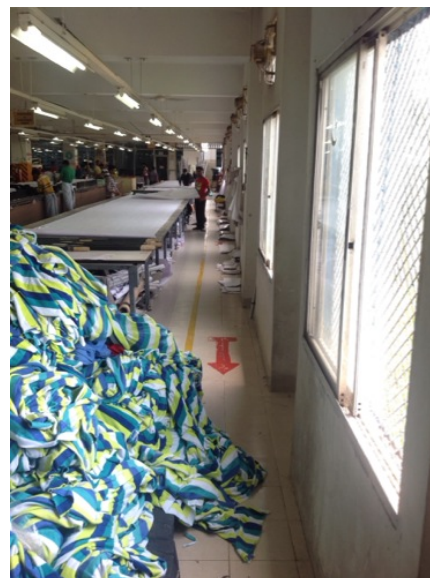
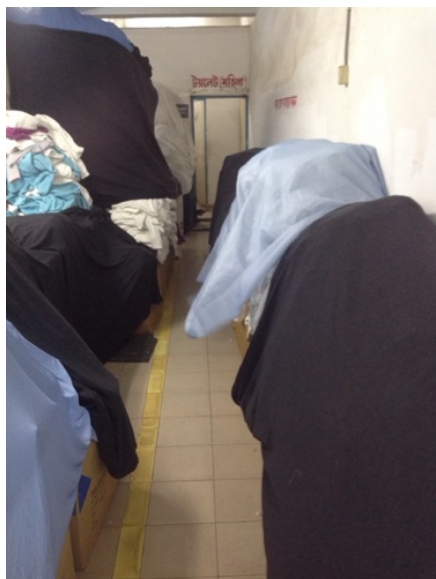
F-5	Egress	Storage was located in the egress path south wall fourth floor and ground floor packing area.	Keep egress paths and stairs clear of storage.	Immediate
-----	--------	---	--	-----------

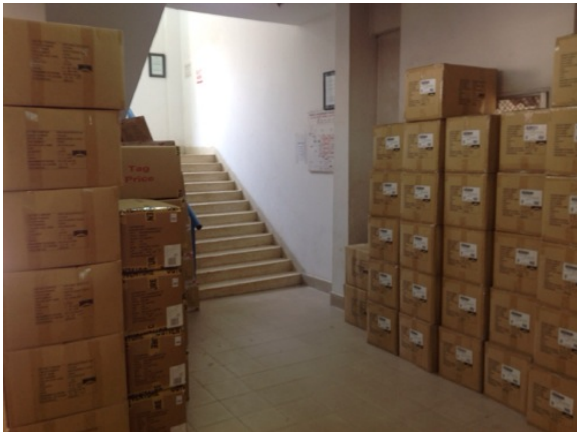
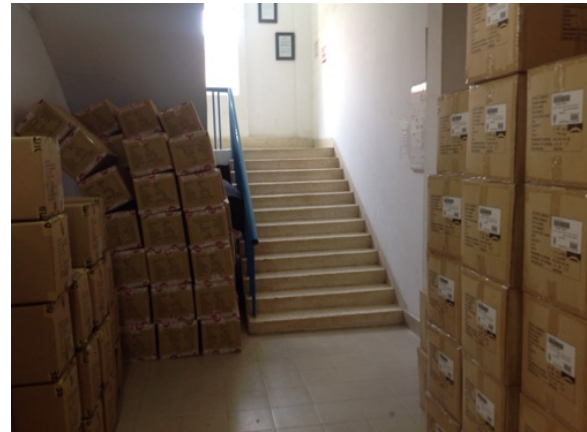
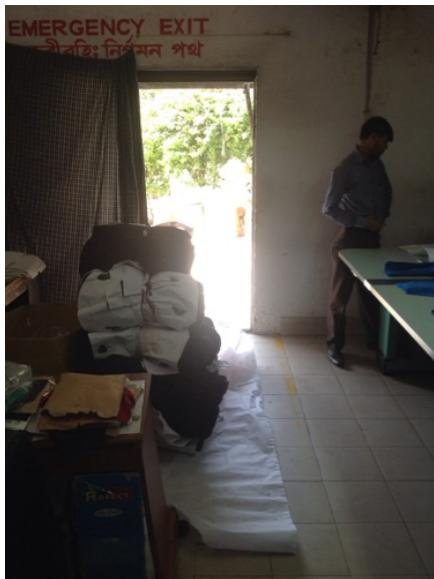
F-6	Egress	Storage was located in the exit stair throughout the facility.	Remove all storage from exit stairs and egress paths.	Immediate
-----	--------	--	---	-----------

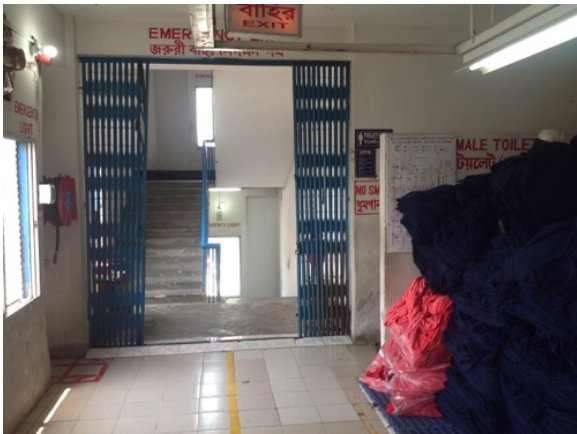
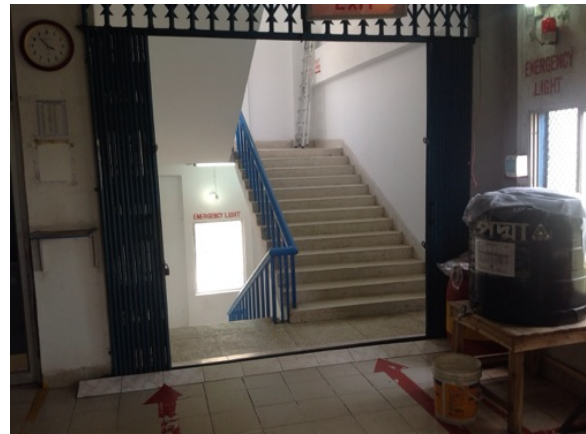
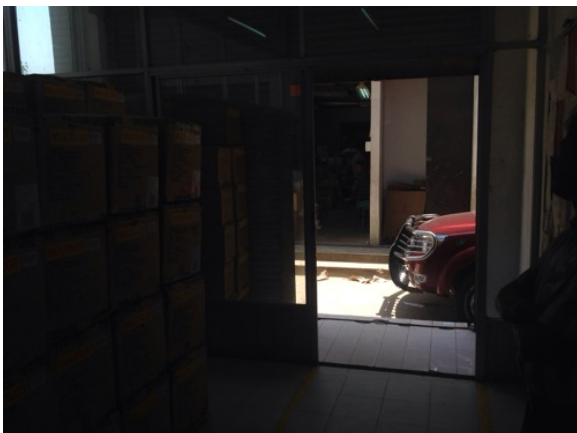
F-8	Egress	Collapsible gates / sliding doors are provided at building exits, exit stairs, along egress routes, exit discharges throughout the factory.	Replace all gates / sliding doors along the means of egress with side-hinged, swinging egress doors.	Within 1 month
			If locks are required for security reasons, utilize special door locking features complying with NFPA 101.

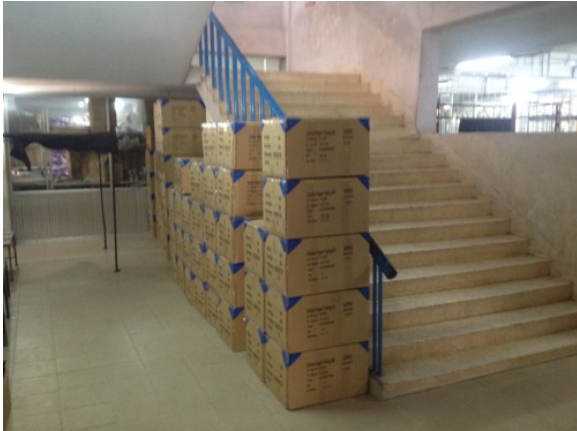
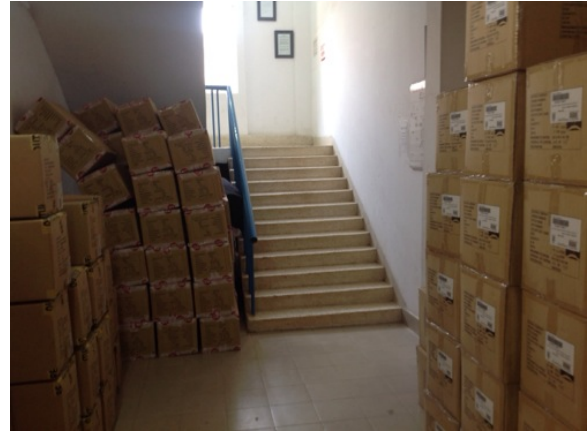
F-9	Egress	Exit stairs discharge inside the building ground floor from the south exit.	Provide 2-hr fire-rated exit passageway leading directly outside (vestibules to separate any storage areas).	Within 6 months
-----	--------	---	--	-----------------

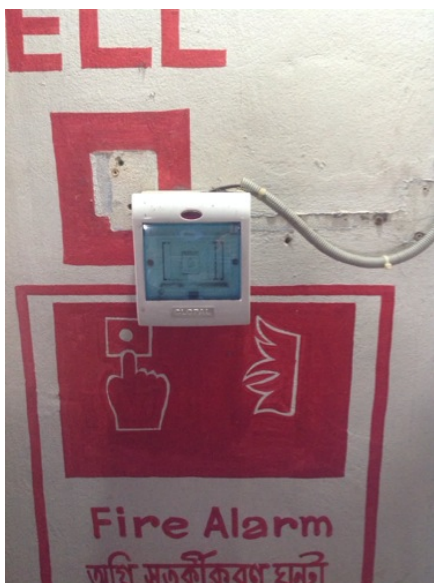
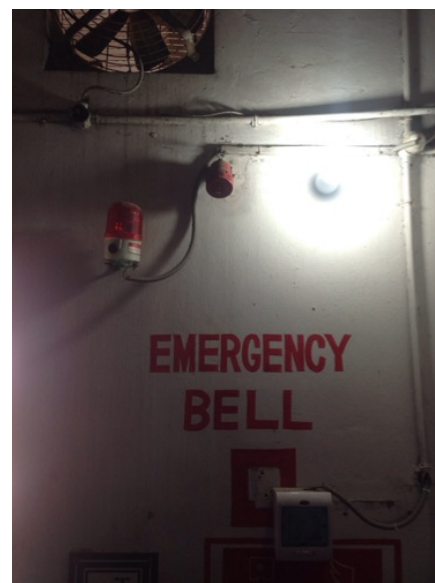
F-10	Fire Protection	The fire alarm system is antiquated, not a listed system, and does not provide alarm and notification features consistent with acceptable standards.	Replace the fire alarm system with a new, listed addressable fire alarm system in accordance with NFPA 72.	Design within 4 months, install within 9 months
------	-----------------	--	--	---

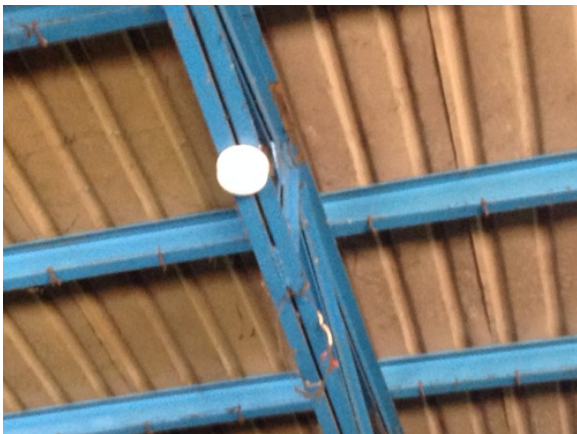
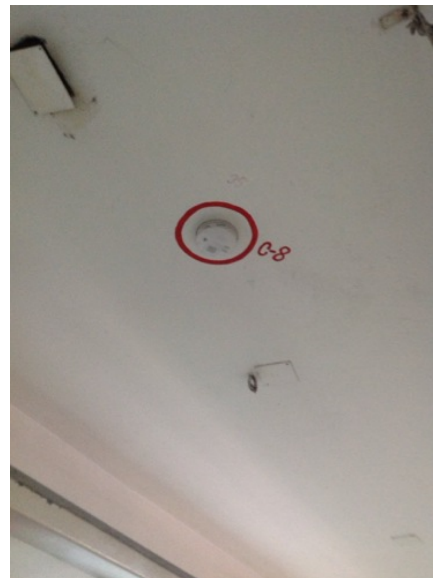
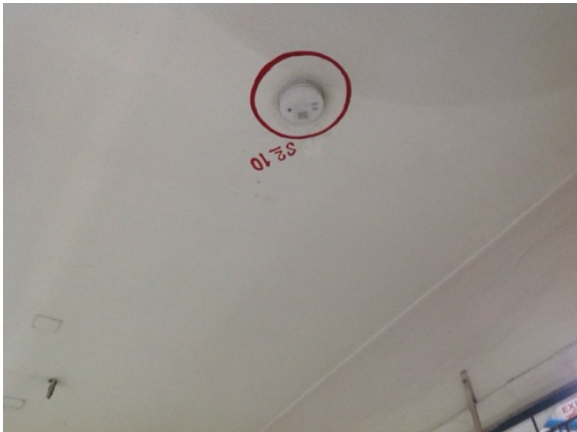
F-11	Fire Protection	Inspection, testing, and maintenance for the fire alarm system was not in accordance with NFPA 72.	Inspect, test and maintain the fire alarm system, and keep written records on-site, in accordance with NFPA 72.	Within 3 months
F-12	Fire Protection	The building is equipped with single-station smoke alarms. Smoke alarm activation sounds only a local alarm and does not provide automatic fire alarm notification of occupants.	Replace the single-station smoke alarms and provide automatic smoke detection throughout the building in accordance with NFPA 72.	Within 6 months

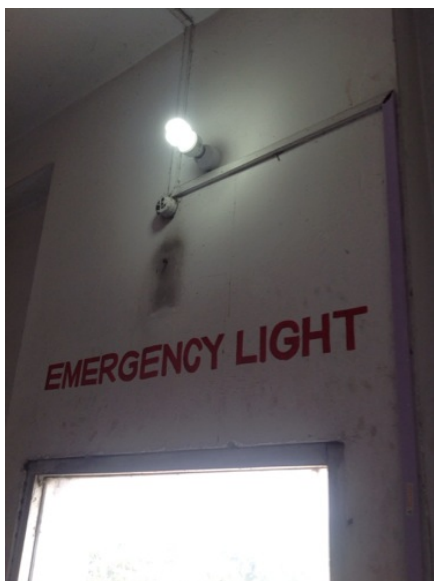
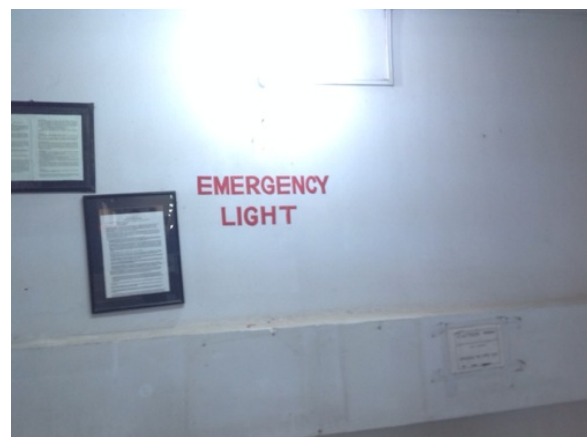
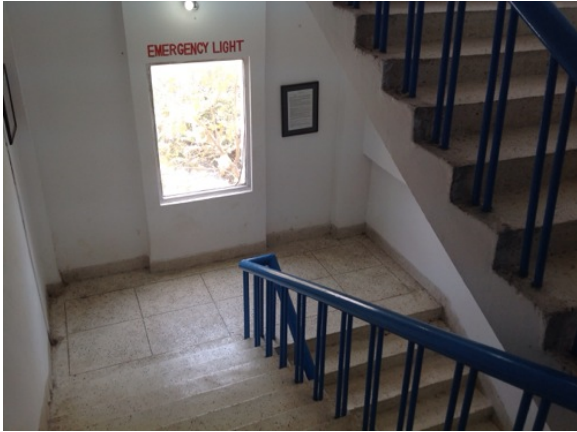
F-13 Egress Lighting

Based on the number and location of emergency lights observed, adequate illumination levels are not anticipated along egress routes on ground or first floor.

Test the emergency lighting system on each floor and provide additional emergency fixtures to provide adequate illumination along the means of egress. Provide a minimum illumination of 10 lux at the floor level within exit stairs and exit discharge paths and minimum 2.5 lux along exit access aisles.
