# Four H Apparels Ltd. (New Building)

295, Jalalabad, Hathazari Road, Chittagong

27<sup>th</sup> September 2018

# Observation

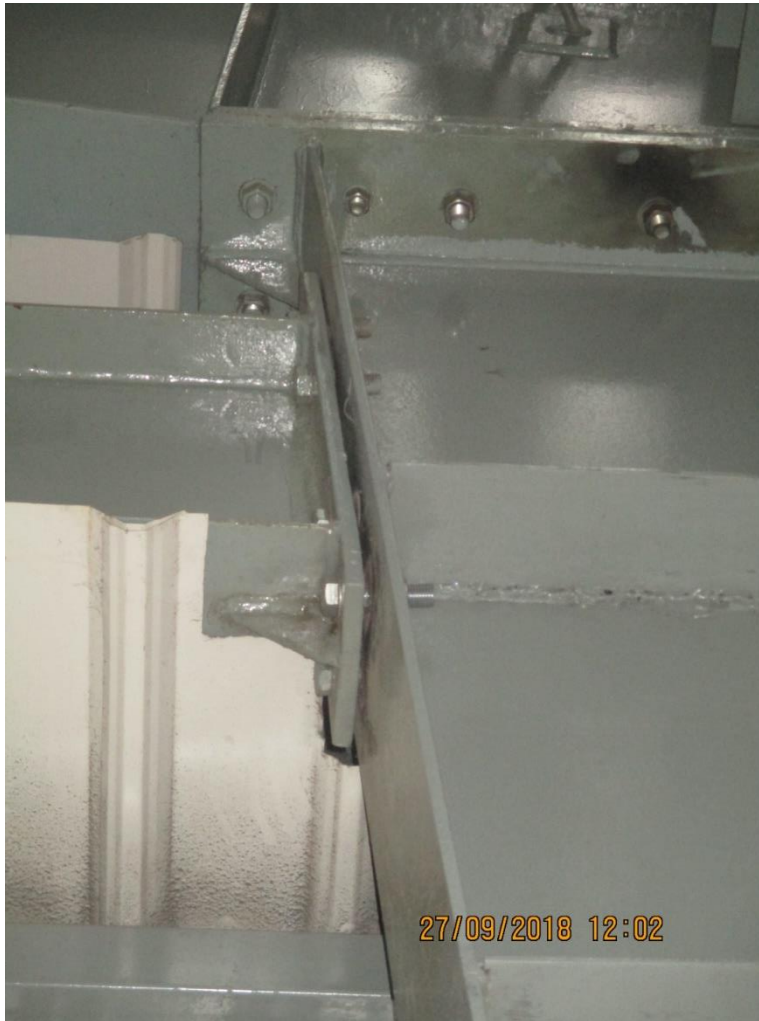
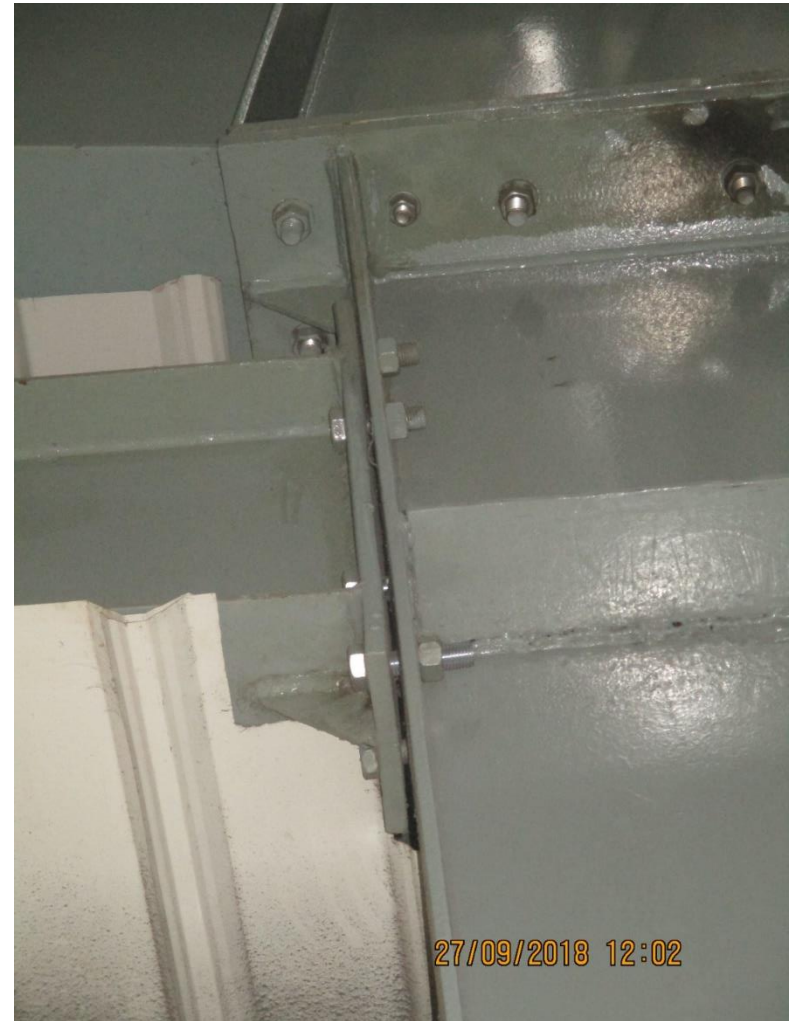
## Significant gaps in connection

Significant gaps were observed in column-rafter joint. Building engineer is required to carry out suitable remedial works.

Item No.	Observation	Recommended Action Plan	Recommended Timeline
1	Significant gaps in connection (Cutting Shed)	Building engineer is required to carryout suitable repair works.	6-weeks
2	Uncontrolled Loading on Utility Building-1	Maintain Loading below 3 kPa.	6-weeks
3	Uncontrolled Loading on Utility Building-1	Building engineer is required to produce and actively manage allowable floor load plan.	6-weeks
4	Uncontrolled Loading on Utility Building-1	Continue to implement load plan.	6-months
5	No as-built drawings available for Utility Building 1 & 2.	Building engineer is required to survey the structure and produce accurate as-built drawings.	6-weeks

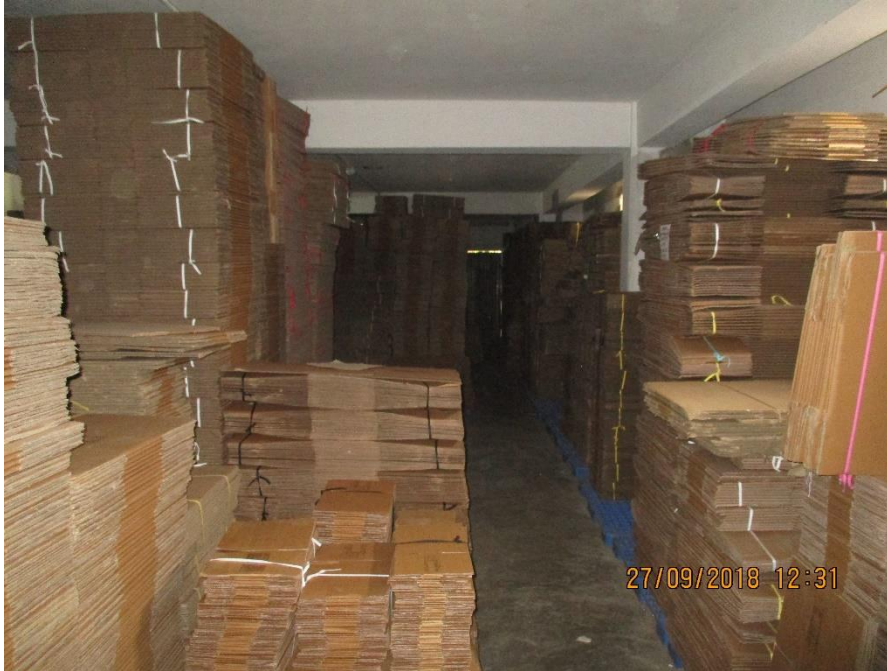
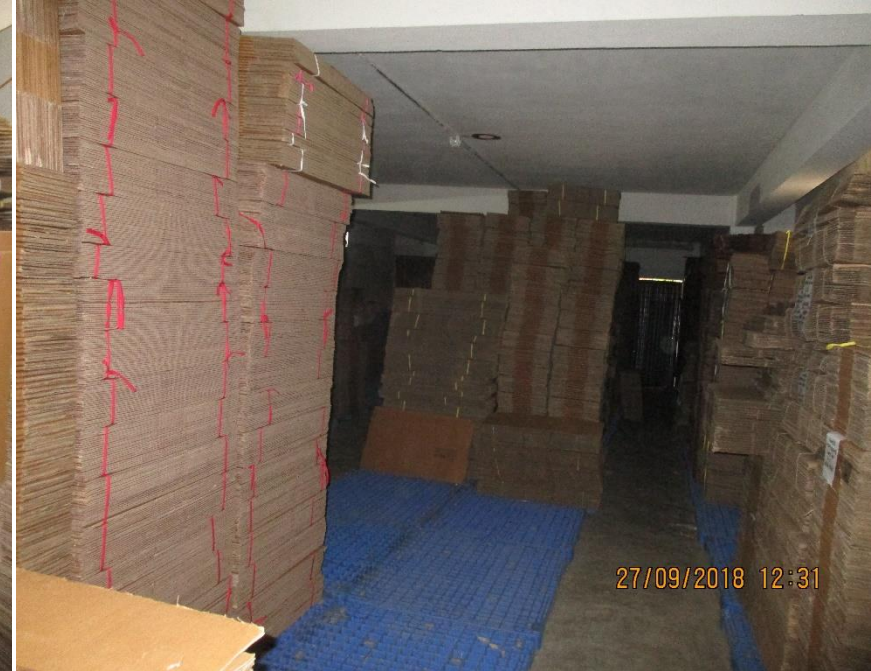
# Uncontrolled Loading on Utility Building-1

Uncontrolled loading was observed on 1<sup>st</sup> floor of utility building-1. Building engineer is required to produce the allowable load plan and implement the load management program.

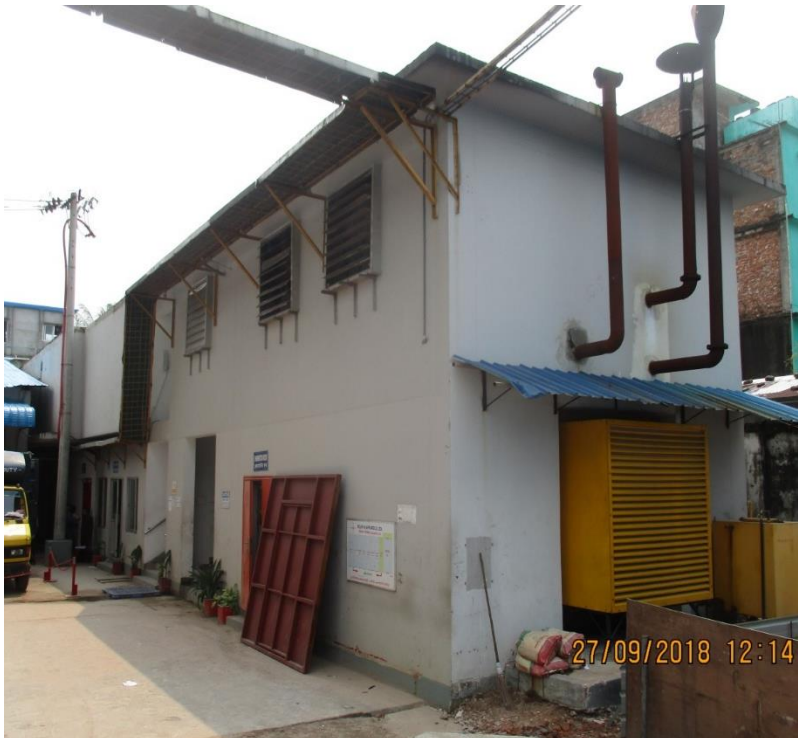
Utility Building-1

No indicative as-built drawings were available for Utility Buildings. Building Engineer is required to produce accurate as-built drawings.
