# Mega Denim Ltd.

88/1, B.K Bari, Taltoli, Mirjapur, Gazipur sadar, Gazipur  
(24.120966, 90.378342)

23<sup>rd</sup> September 2018

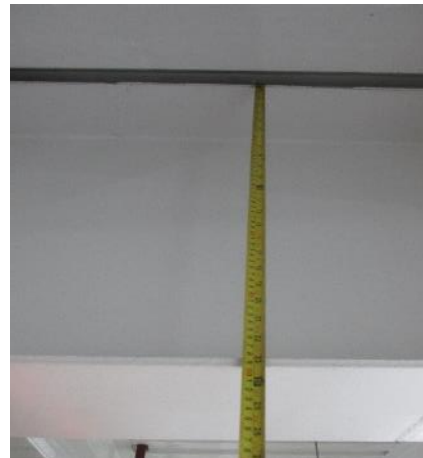
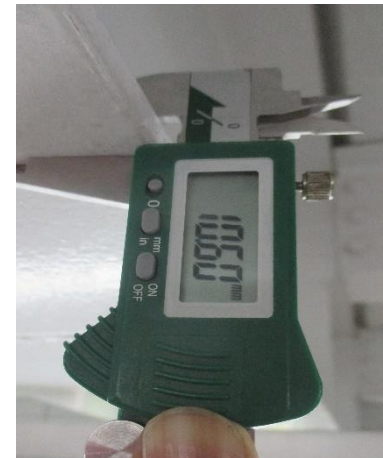
Flange thickness of column & main beam did not match with the provided drawings. Building engineer is required to produce an “as constructed” drawings to reflect the actual site dimensions with complete structural information.

10 mm thickness of flange instead of 12 mm

| Item No. | Observation | Recommended Action Plan | Recommended Timeline |
|---|---|---|---|
| 1 | Discrepancies between drawings and on site condition | Engage an Engineer to produce an “as constructed” drawings which reflect the actual site dimensions with complete structural information. | 6-weeks |

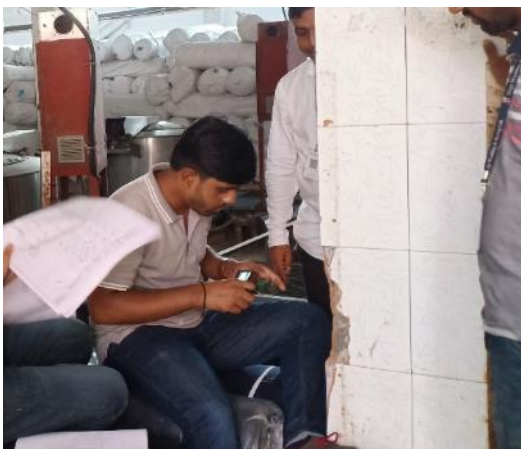
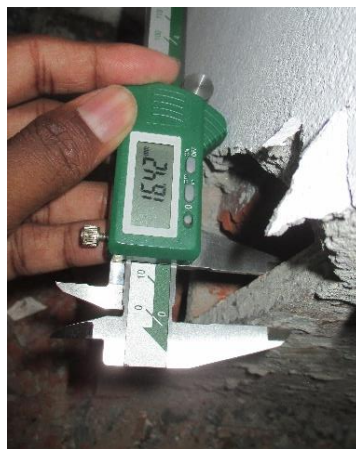
Column thickness 16 mm instead of 20 mm

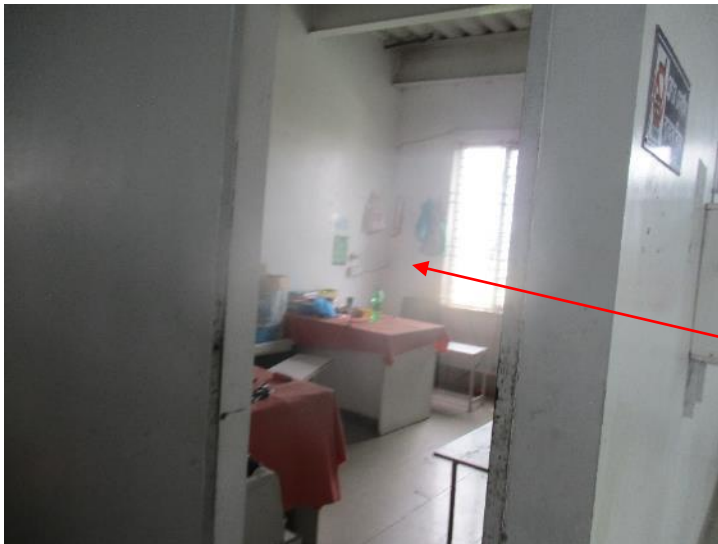
Vertical Bracing missing

Bracings were not installed as per bracing layout. Bracing was missing at several location on 2<sup>nd</sup>, 3<sup>rd</sup> and Ground floor.

| Item No. | Observation | Recommended Action Plan | Recommended Timeline |
|---|---|---|---|
| 2 | Bracings are not installed as per bracing layout | Install missing bracing as per bracing layout. | 6-weeks |

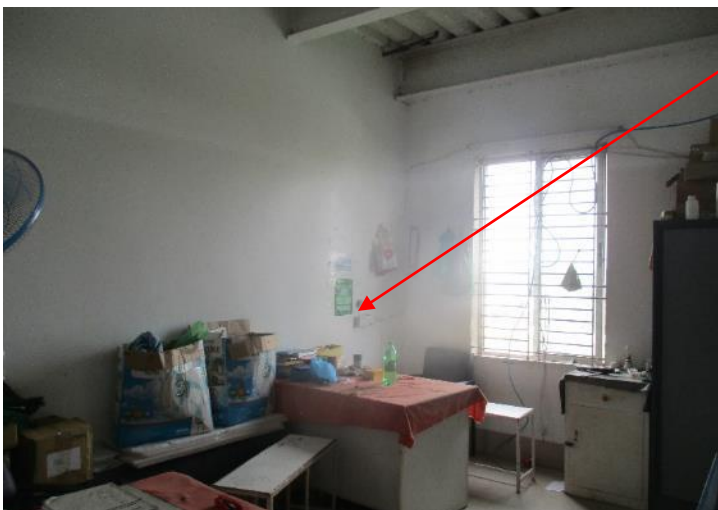
Vertical Bracing missing

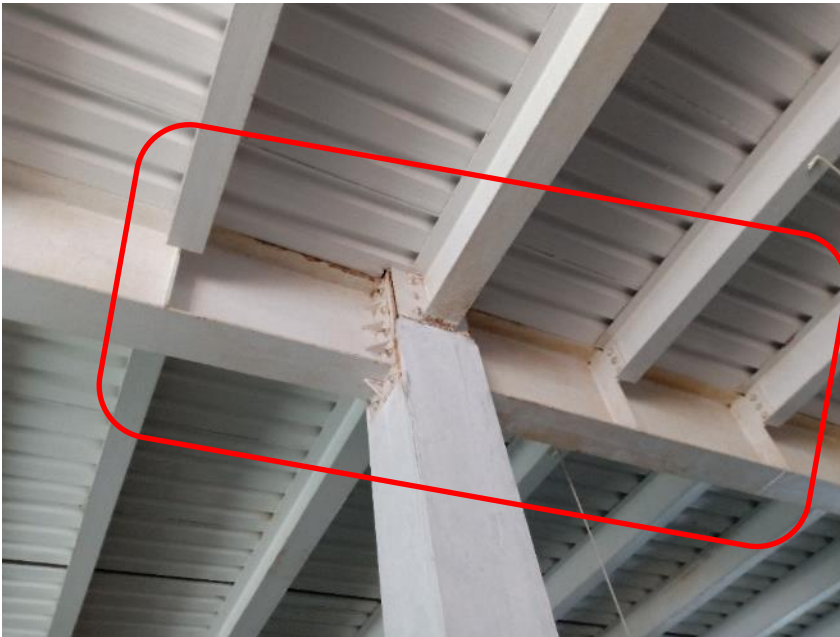
Corrosion found in beam column connection at GF. Corrosion also found in bracing connection at toilet zone.

Corrosion at beam-column joint

| Item No. | Observation | Recommended Action Plan | Recommended Timeline |
|---|---|---|---|
| 3 | Corrosion in Steel member | Apply suitable method to protect the steel members from corrosion. | 6-weeks |

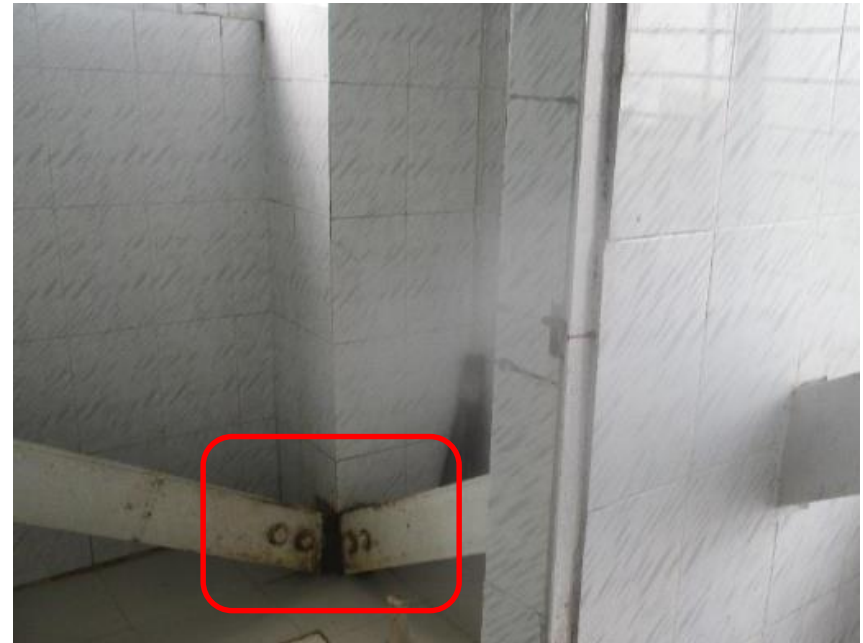
Corrosion at bracing connection

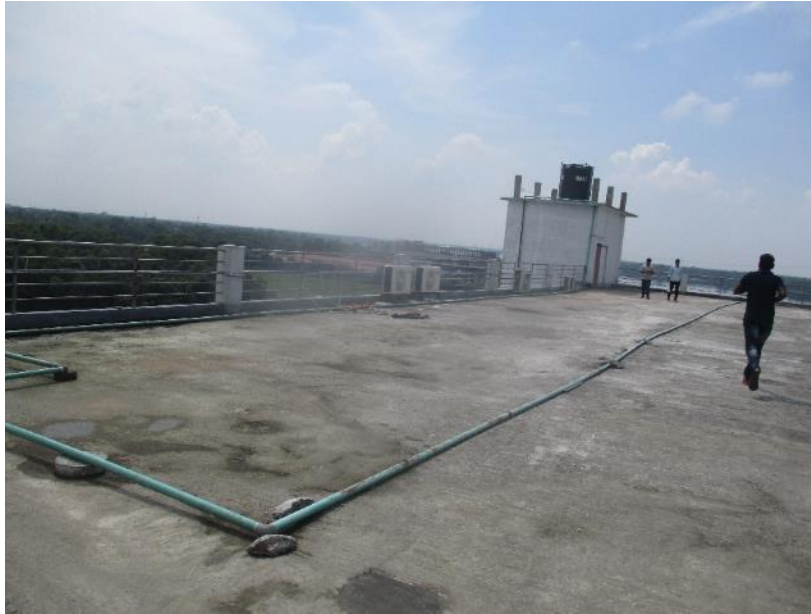
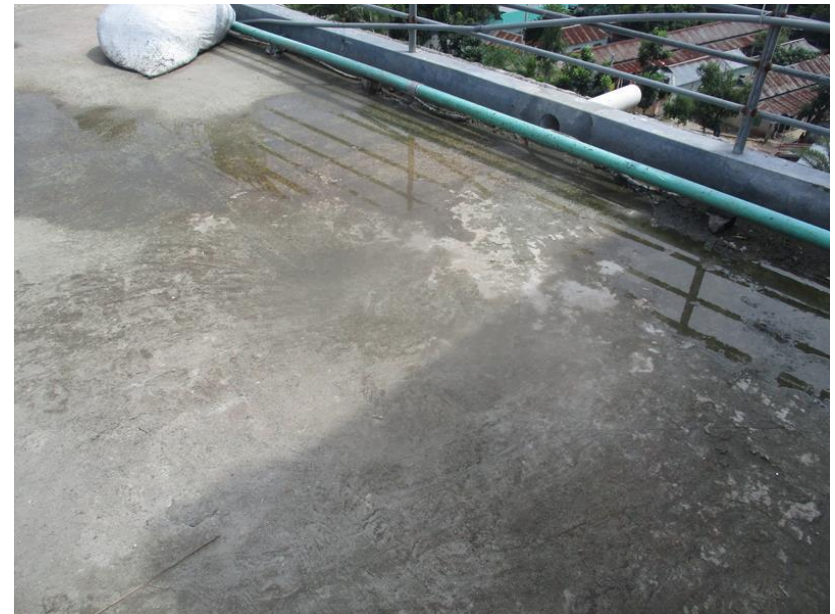
No waterproofing membrane was visible on these roofs. Proper drainage system and water proofing membrane need to apply on roof to resist water ingress into the slab.

| Item No. | Observation | Recommended Action Plan | Recommended Timeline |
|---|---|---|---|
| 4 | Lack of waterproofing system on roof | Waterproofing on the roof slab is to be applied. Moreover the roof slab drainage system should be investigated and improved. | 6-months |
