MUAZUDDIN KNIT FASHION LTD (10862)

Plot# B-31, East Chandura, Kaliakoir, Gazipur
(+24.0201N, 90.1619E)
15 Marsh 2014

ACCORD
on Fire and Building Safety in Bangladesh

Site Observations

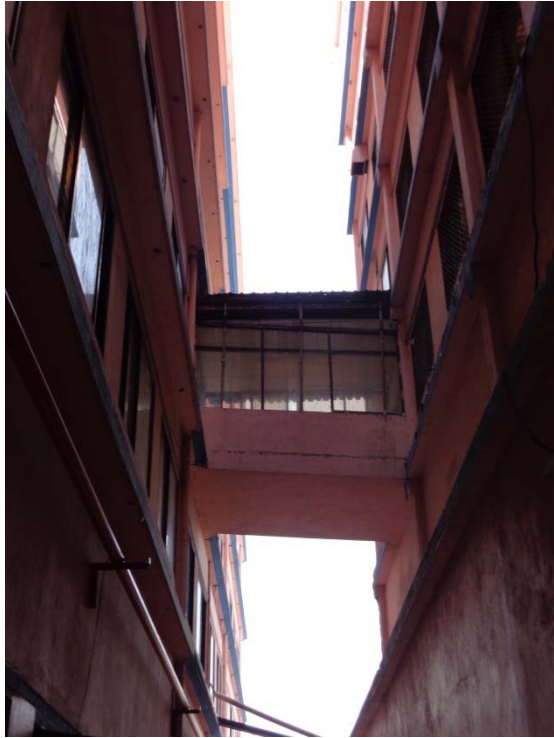
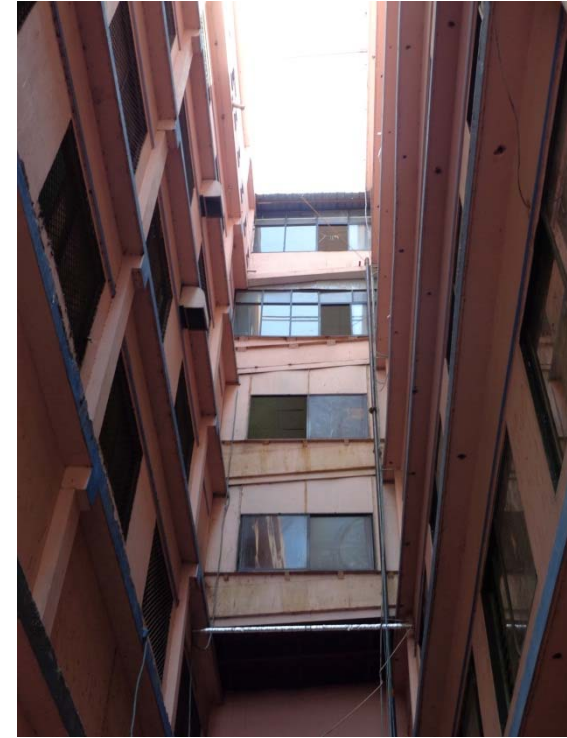
Connecting bridges

Presence of connecting bridges

Connecting bridges, supported on beams.
Building Engineer to check that beam and columns have been designed to accommodate loads.

Check on structure from localized high loading from connecting bridges

- The factory engineer is to verify the capacity of beams and columns.

- Carry out any remedial measures that the factory engineer considers necessary to ensure the long term stability of both the tower and the building itself.

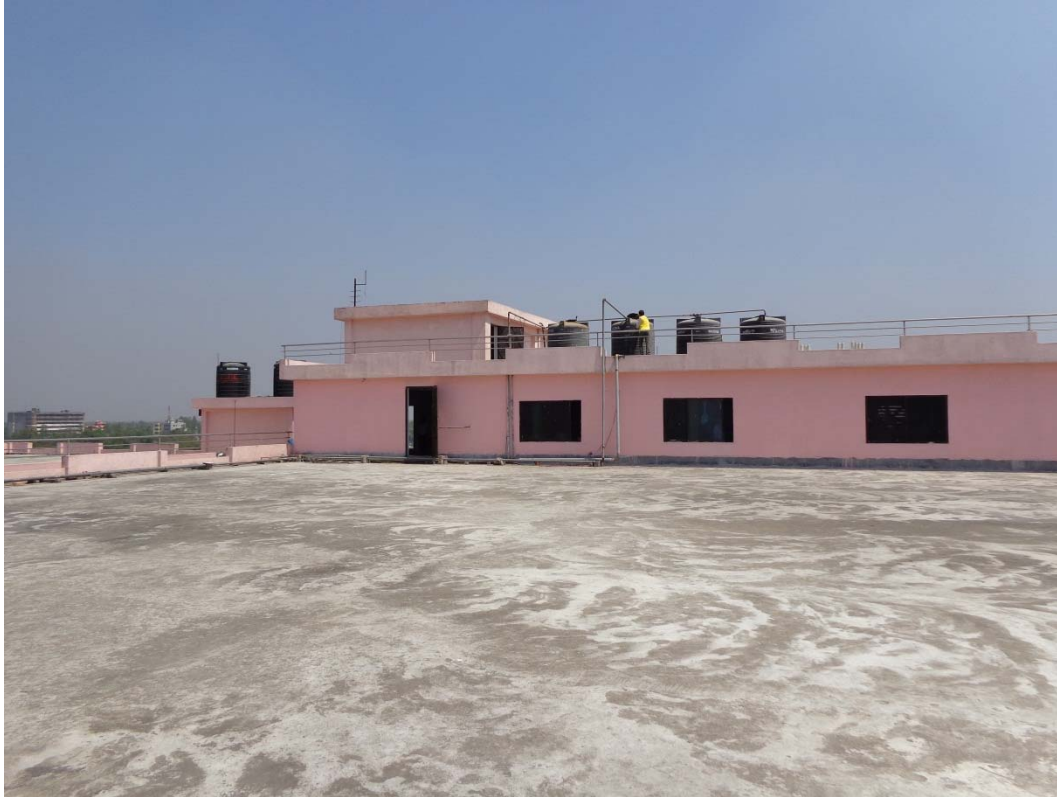
Lack of water proofing membrane on roof

No waterproofing membrane was visible on the roof of the building. This means that any cracks in the surface finishes on the roof will allow water to seep into the concrete slab beneath the finishes, and cause long-term soaking of the slab.

Roof appears not to have any waterproofing system applied.

- Consider adding a waterproofing membrane on roof.
