# **FIRE SAFETY INSPECTION REPORT**

**MANTA APPARELS LIMITED.**

**DIAKHALI, YEARPUR, JAMGORA, SAVAR, DHAKA.**

March 30, 2014

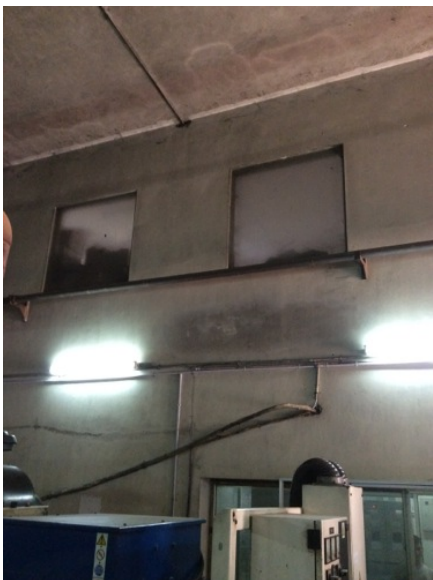
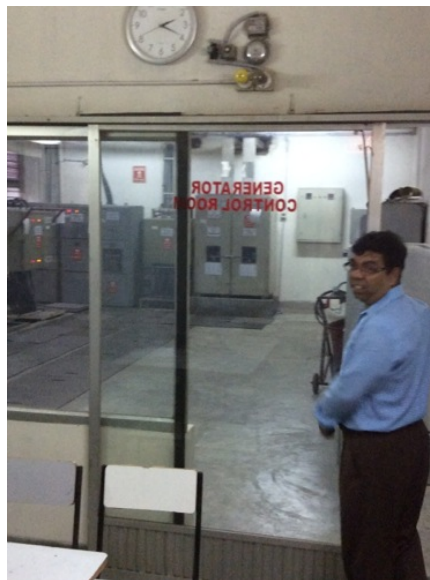
| No. | Category | Finding | Recommendation | Remediation Timeframe |
|---|---|---|---|---|
| F-1 | Fire Rated Construction | The generator and transformer room is not separated by fire-rated construction due to openings and penetrations. | Separate the generator and transformer room by a minimum 2-hr fire-rated construction. Seal all openings to maintain the required fire separations. | Within 3 months |

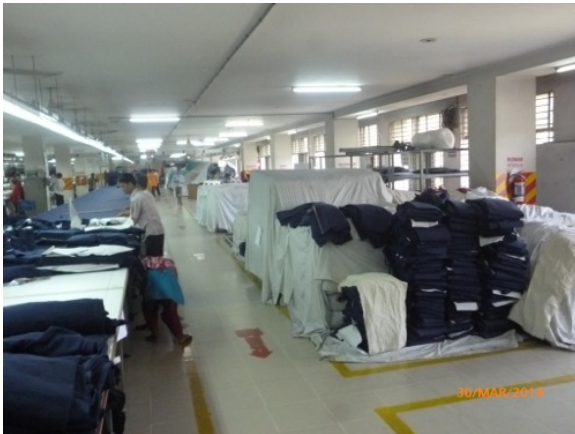
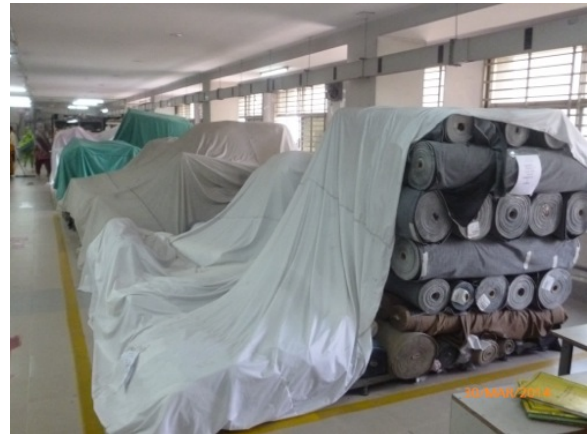
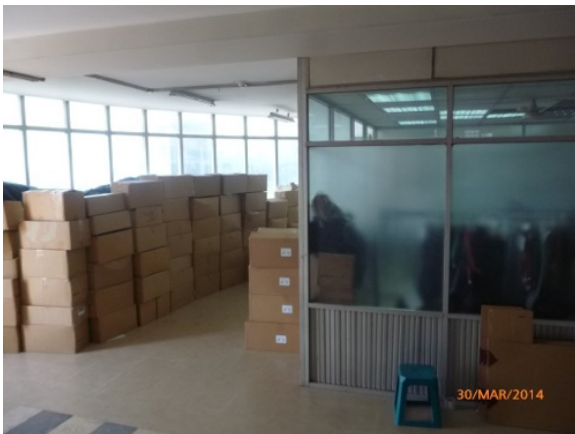
| No. | Category | Finding | Recommendation | Remediation Timeframe |
|---|---|---|---|---|
| F-2 | Fire Rated Construction | Areas used for combustible storage are not separated by fire-rated construction.<br><br>Location:<br>Ground floor-General storage, Fabric storage.<br>3rd floor-production area and stairwell. | Provide dedicated storage rooms separated by minimum 1-hr fire-rated construction. Storage maximum height of 2.4m and maximum area of 23m2 | Within 3 months |

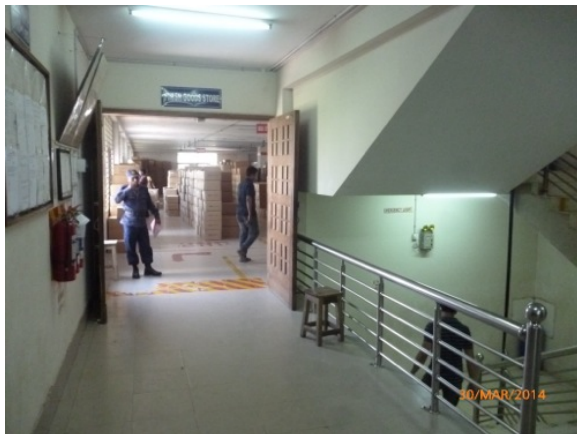
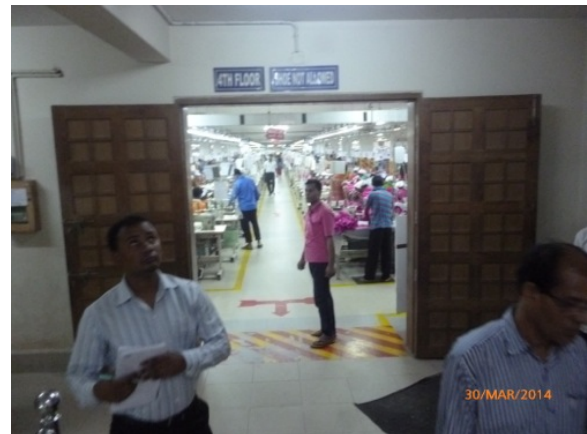
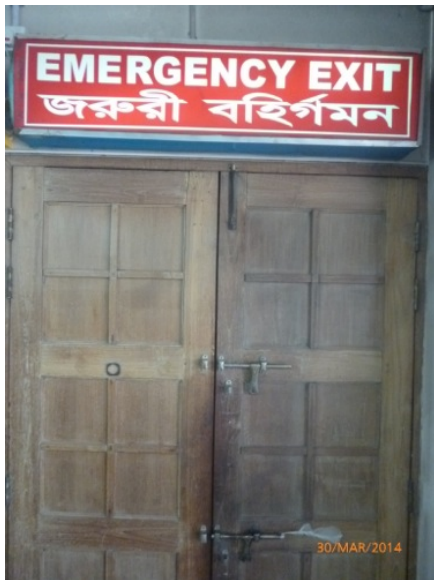
| F-3 | Fire Rated Construction | The exit stairs are not separated from work areas on each floor by fire-rated construction. | Provide minimum 1.5-hr fire rated doors and seal all unprotected openings to separate the exit stairs from work areas and other building spaces on all floor levels. Ensure that the fire doors are self-closing and positive latching and that they are provided with fire exit (panic) hardware where serving production floors. | Within 3 months |

| | | | If fire doors are required to be held open for functional reasons, provide automatic-closing devices tied to the fire alarm system. | |

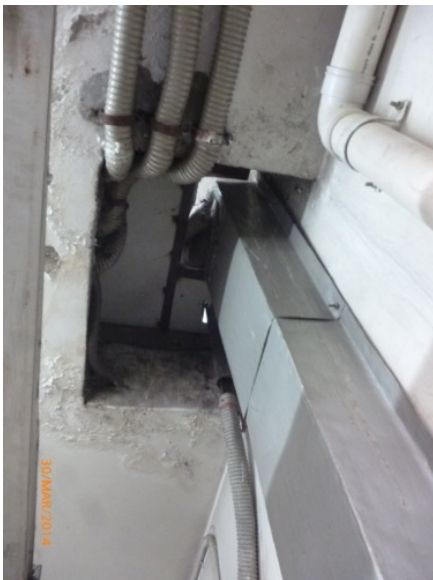
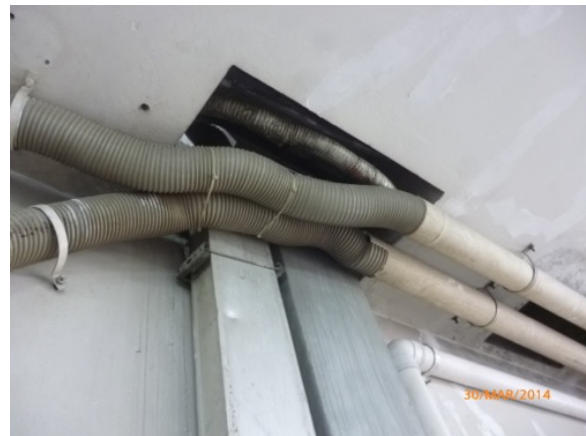
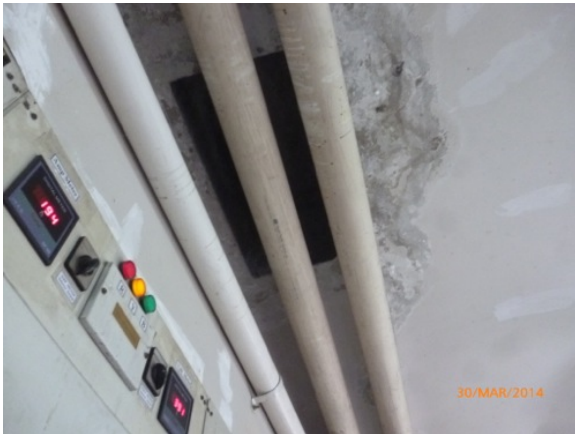
| F-4 | Fire Rated Construction | Unsealed penetrations and openings are located in the fire-rated floor/ceiling assemblies. | Provide a minimum 2-hr fire-rated shaft to separate the utility risers from each floor level. | Within 3 months |

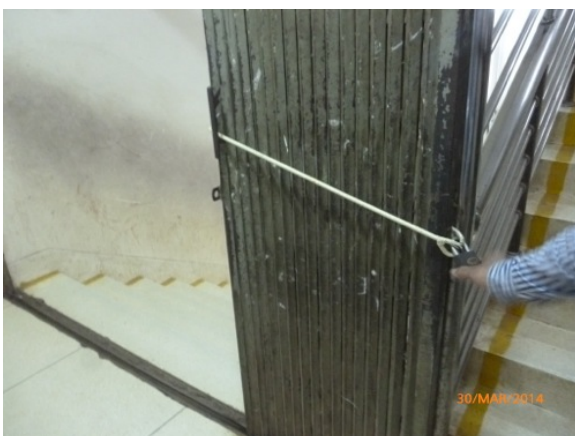
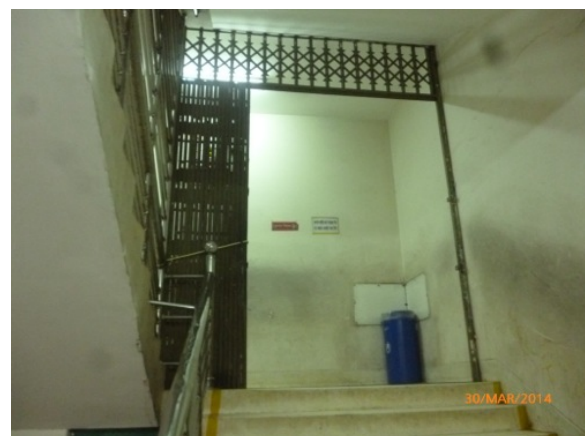
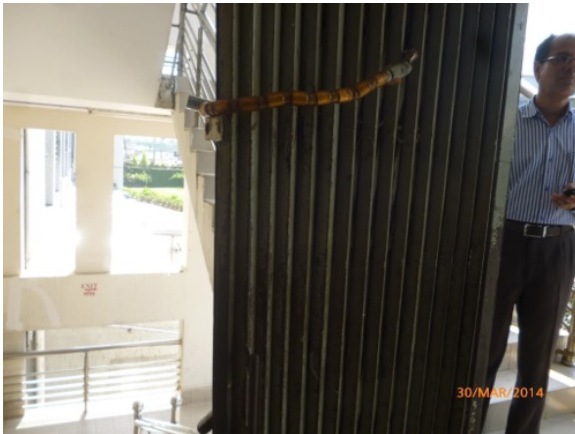
| F-5 | Egress | <p>Egress doors and gates with locking features are provided at building exits, exit stairs and exit discharge.</p> <p>All gates and doors were open and unlocked during the inspection.</p> | <p>Remove locking features from all egress doors / gates.</p> <p>If locks are required for security reasons, utilize special door locking features complying with NFPA 101.</p> | Immediate |

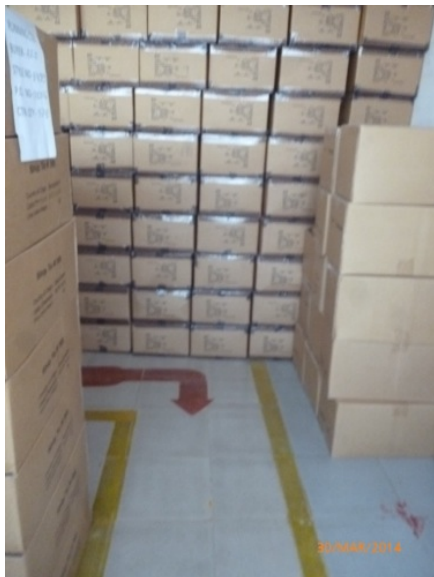
| F-6 | Egress | Storage was located in the exit stair at 5th floor finished goods store. | Remove all storage from exit stairs and egress paths. | Immediate |

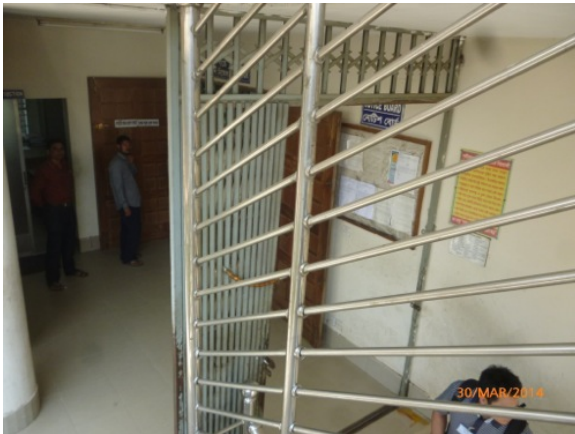
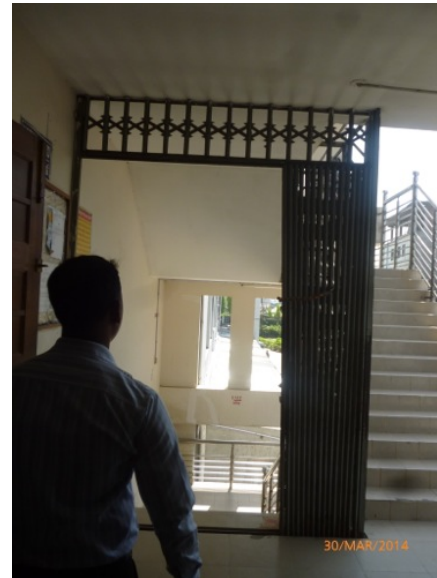
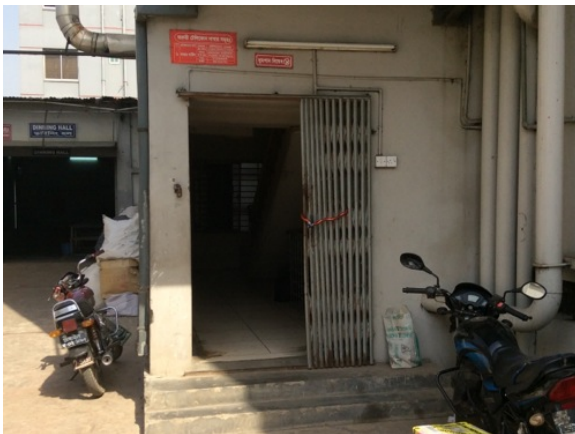
| F-7 | Egress | Collapsible gates and sliding doors are provided at building exits, exit stairs and exit discharge. | Replace all gates and sliding doors along the means of egress with side-hinged, swinging egress doors.<br><br>If locks are required for security reasons, utilize special door locking features complying with NFPA 101. | Within 1 month |

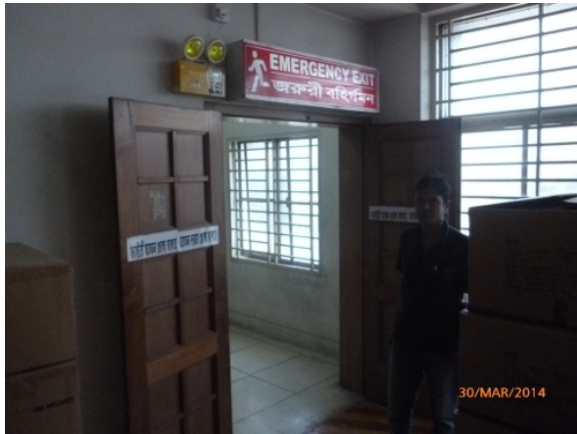
| F-8 | Egress | West exit stairwell doors serving 50 or more occupants does not swing in the direction of egress travel. | Modify the egress door to swing in the direction of egress travel. | Within 3 months |

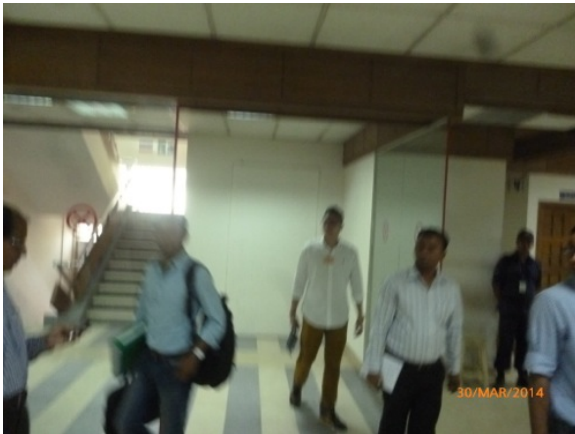
| F-11 | Egress Lighting | Exit sign not provided at 1st floor office | Provide exit signs above all exits to the exterior and all doors to the exit stairs. | Immediate |

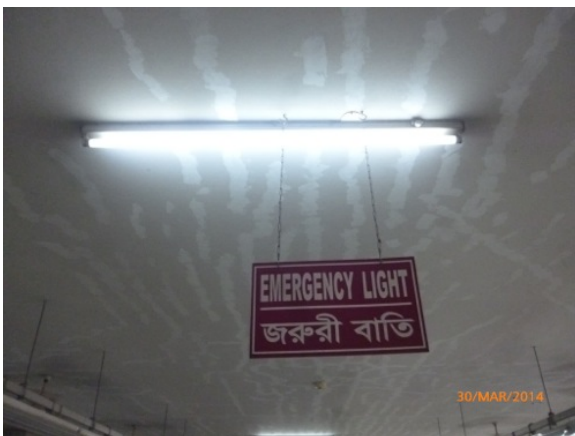
| F-12 | Egress Lighting | Manual on-off switch is provided for emergency lighting and exit signage units. | Remove manual on/off switches from emergency lighting and exit signage units to prevent them from being switched off. | Within 1 month |
