# **FIRE SAFETY INSPECTION REPORT**

**Factory Name: Apex Fashion Wear Limited**

**ACCORD ID: 23353**

**Date: 24 November 2018**

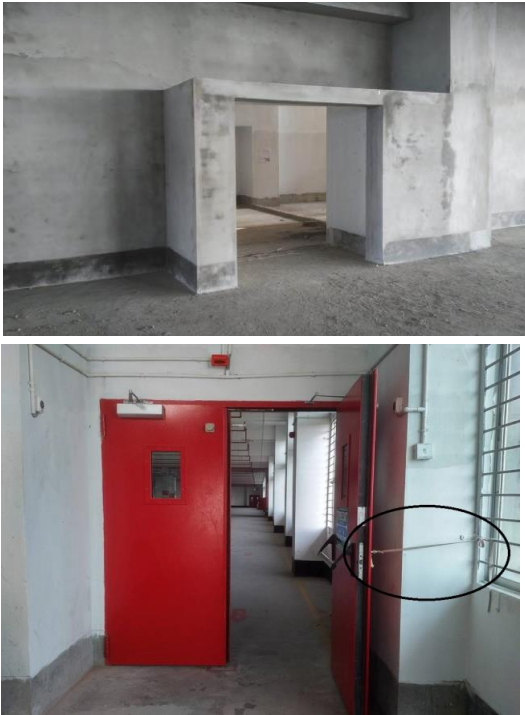
| Sl No. | Category | Findings | Required Action | Remediation Time Frame | Pictorial Evidence |
|---|---|---|---|---|---|
| 1 | Fire rated construction | <p>The exit stairs are not separated from [work areas, other spaces] on each floor by fire-rated construction.</p> <p><b>Location: Building- 7 &amp; 8</b></p> | <p>Stair shall be enclosed with a minimum 2-hr fire-rated construction. Seal all unprotected openings and provide minimum 1.5-hr fire rated doors to separate the exit stairs from work areas and other building spaces on all floor levels. Ensure that the fire doors are self-closing, positive latching and that they are provided with fire exit (panic) hardware where serving production floors.</p> <p>If fire doors are required to be held open for functional reasons, provide automatic-closing devices tied to the fire alarm system.</p> | Within 03 Months | |

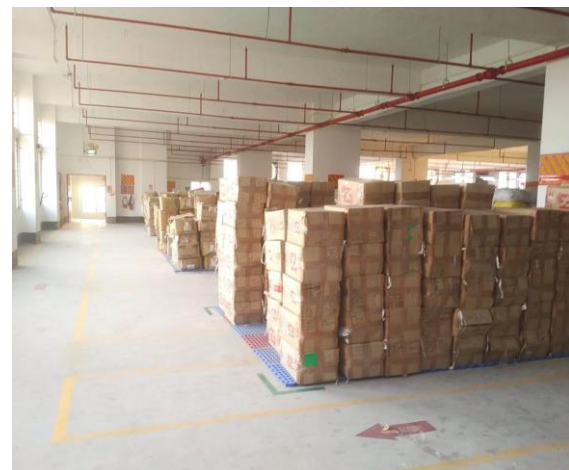
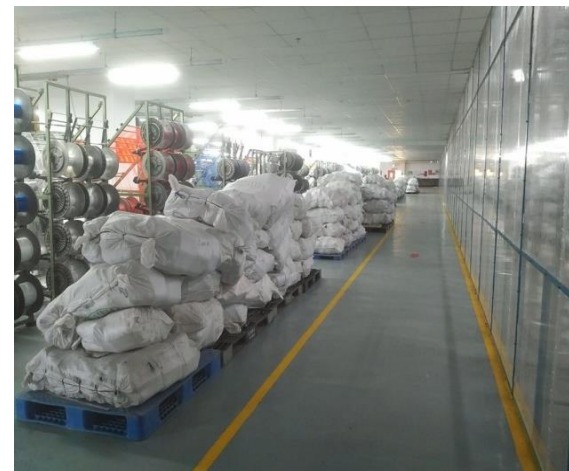
| 2 | Fire rated construction | <p>Areas used for in-process storage of combustible materials are open to the surrounding occupancy</p> <p><b>Location: Building- 7 or others</b></p> | <p>Provide defined storage areas and limit the storage arrangement as follows:-</p> <p>1. General Condition: Maximum height of 2.4m and maximum area of 23m<sup>2</sup>. Separate areas of unenclosed combustible storage by a minimum clear distance of 3m.</p> <p>2. If sprinkler protected: maximum height of 3.66m and maximum area of 93m<sup>2</sup>. Separate areas of unenclosed combustible storage by a minimum clear distance of 3m.</p> <p>or</p> <p>3. Enclose the storage area from the surrounding occupancy with a minimum 1 hour construction.</p> | Within 03 Months | |

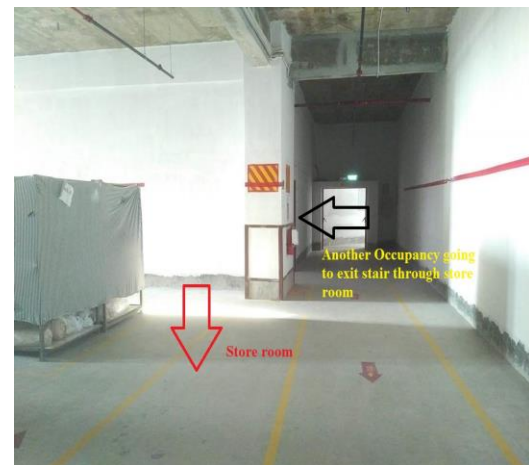
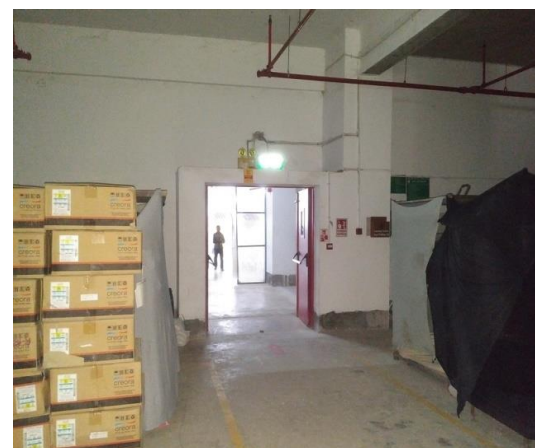
Rooms used for storage of combustible materials are not separated from the surrounding occupancy/areas

Rooms used for storage of combustible materials shall be separated from the surrounding occupancy with a minimum 1 hour construction.

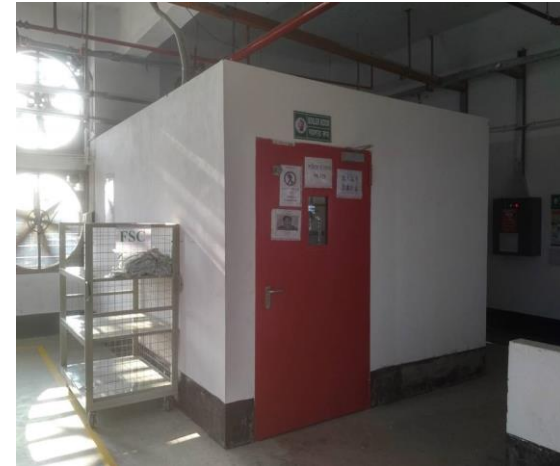
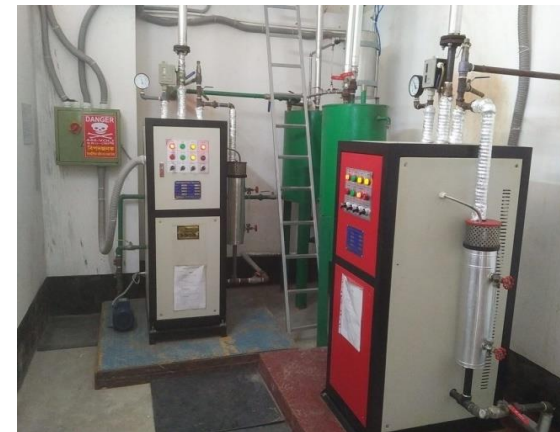
| 4 | Fire rated construction | <p>Rooms containing boilers having a capacity of more than 22.76 liter is not properly separated by fire rated construction with other Occupancies/Areas</p> <p>Location: 2nd floor, Building-7</p> | <p>Boilers or other heat producing equipment shall be separated from other occupancies by a minimum 1-hr (2-hr for high-rise building) fire rated construction (wall, floor, slab etc.). Seal all penetrations and openings (door, window etc.) should be protected by 0.75-hr (45 min) fire rated materials to maintain the fire separation if required. All exhaust systems shall discharge to the exterior of the building in a safe location.</p> | Within 03 Months | |

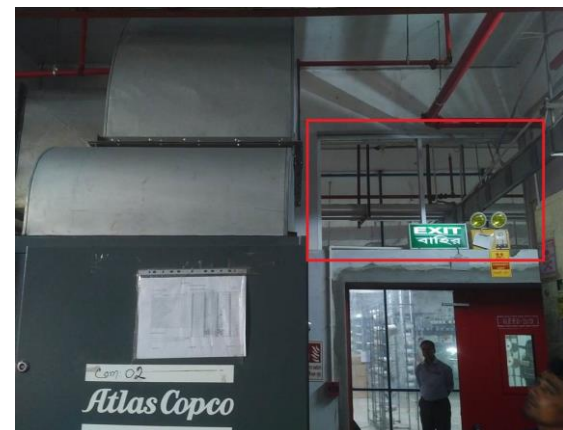
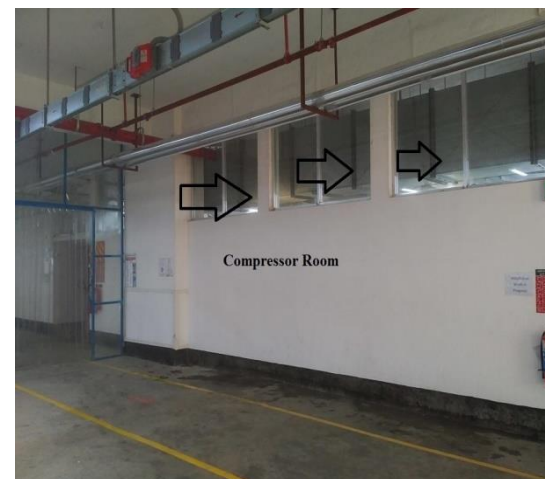
**Location: Ground floor, Building-7**

Compressors located at ground floor are not separated by fire rated constructions from other occupancies.

Compressor room shall be separated from other occupancies by a minimum 2-hr fire rated construction (wall, floor, slab etc.). Seal all penetrations and openings (door, window etc.) should be protected by 1.5-hr fire rated materials to maintain the fire separation if required. All exhaust systems shall discharge to the exterior of the building in a safe location.

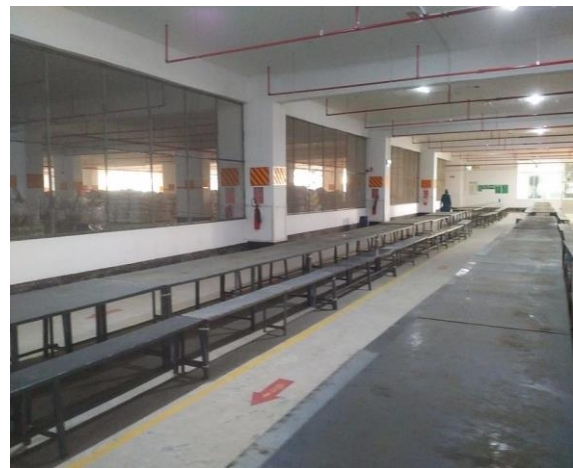
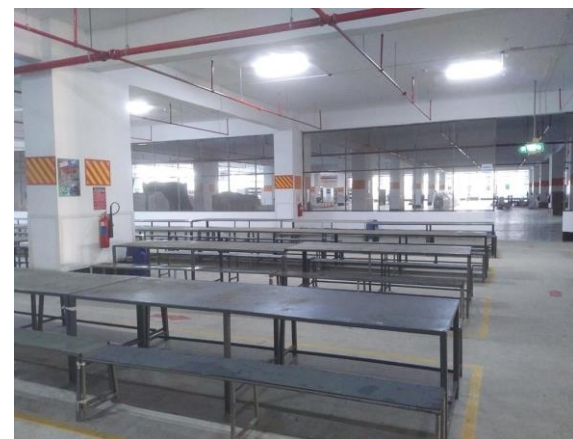
| 6 | Fire rated construction | Dining room having a capacity more than 500 is not separated from others occupancies.<br><br>Location: 1st floor, Building-7 | Separate the dining room from others occupancy by 2 hr. fire rated construction. Seal all penetrations and openings (door, window etc.) should be protected by 1.5-hr fire rated materials to maintain the fire separation if required. Direct access to exit stair shall be ensured. | Within 03 Months | |

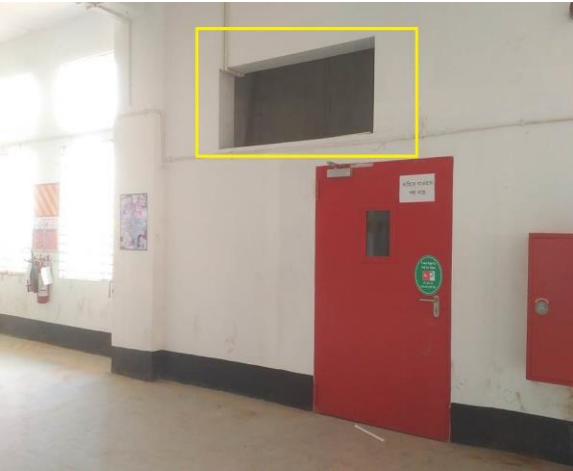
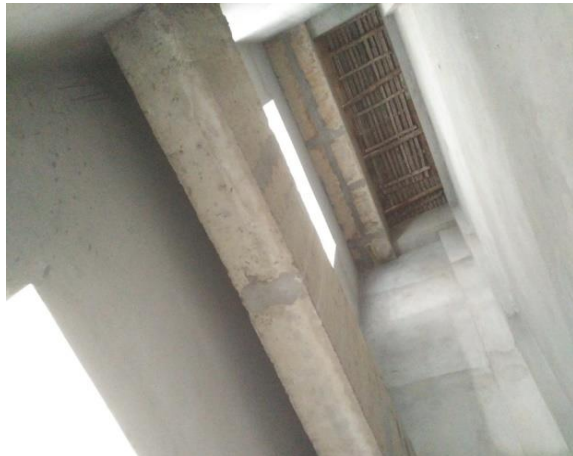
| 7 | Fire rated construction | Penetrations through floor/ceiling assemblies are found unsealed. | Seal all penetrations and openings in floor/ceiling (full thickness of the floor/ceiling) assemblies by fire rated materials to maintain the fire resistance rating. | Within 03 Months | |
| | | Location(s): All floors, South side, Building-7 | Or<br>Provide a minimum 2-hr fire rated shaft to separate the utility risers from each floor if required. | | |

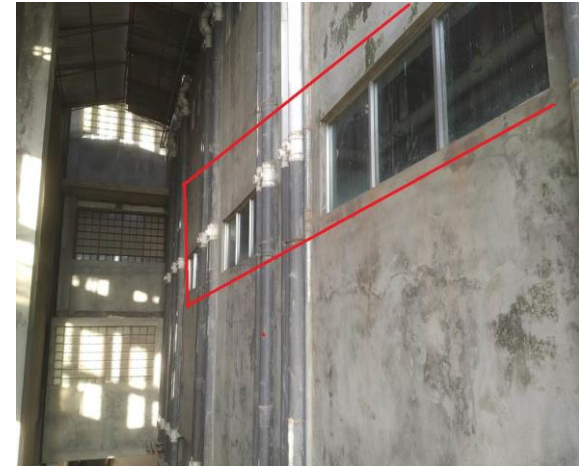
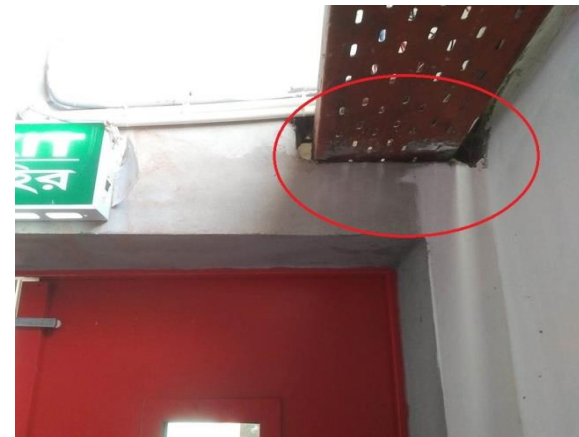
**Location(s): Stair-2, Building-7 & 8**

Unsealed penetrations and openings are located in exit stair enclosures.

Seal all penetrations and openings in the wall of exit enclosure walls (full thickness of the wall) by fire rated materials to maintain the fire resistance rating.

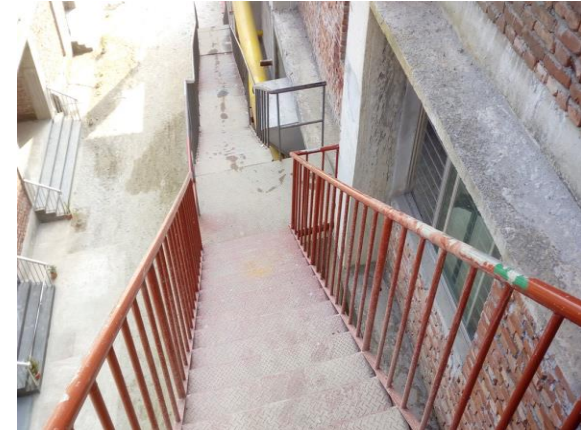
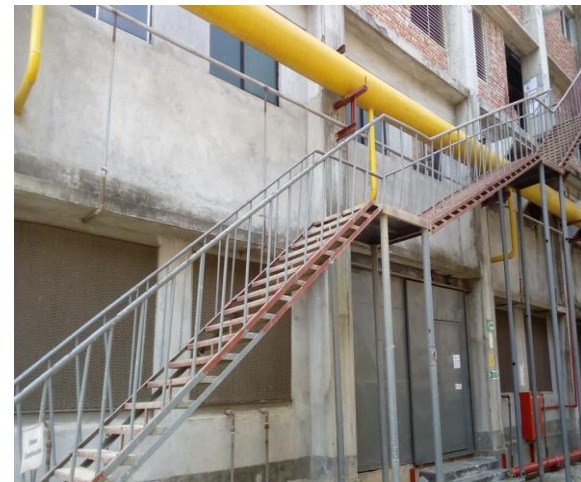
The exterior exit stair is not separated from the building.  
Location: Generator & Chiller Building: B9

Exterior exit stairs shall be separated by minimum 2-hr fire-rated construction and The rating of the exterior wall shall extend 3.05 m (10 ft.) beyond the ends of the stair structure. Provide minimum 1.5-hr fire rated doors to separate the exit stairs from work areas and other building spaces on all floor levels. Ensure that the fire doors are self-closing, positive latching and that they are provided with fire exit (panic) hardware where serving production floors.

If fire doors are required to be held open for functional reasons, provide automatic-closing devices tied to the fire alarm system.

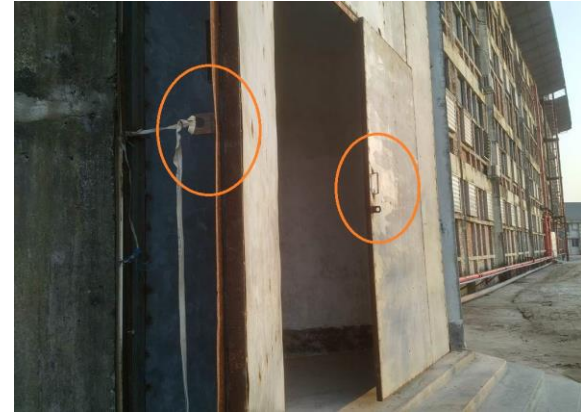
Location: Building-7&8

Doors along means of egress are provided with non compliant locking system.

1. Remove all non compliant locking features from egress doors.
2. If locks are required for security reasons, utilize special door locking features complying with NFPA 101.
3. Doors may be locked where the latch and lock are disengaged with one motion where the occupant load does not exceed 49 persons.
4. Doors may be provided with locking hardware from the ingress side provided that a panic bar is installed on any door with an occupant load exceeding 49 persons.

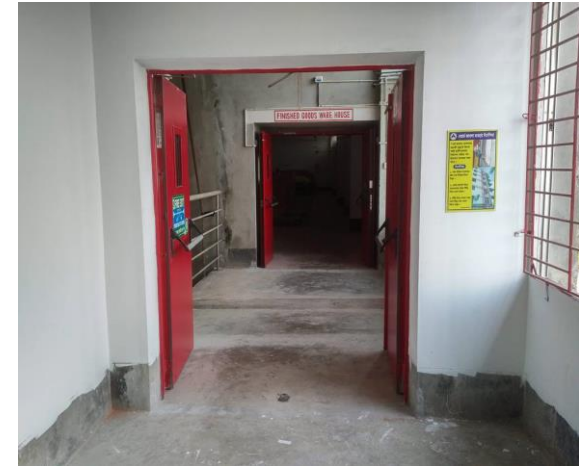
| 11 | Egress | <p>Occupants of store building-8 could find the secondary exit through building-7, but door swing is not to egress travel.</p> <p><b>Location: All floors of building-8</b></p> | <p>Modify the door swing to egress travel</p> | <p>Within 01 Month</p> | |

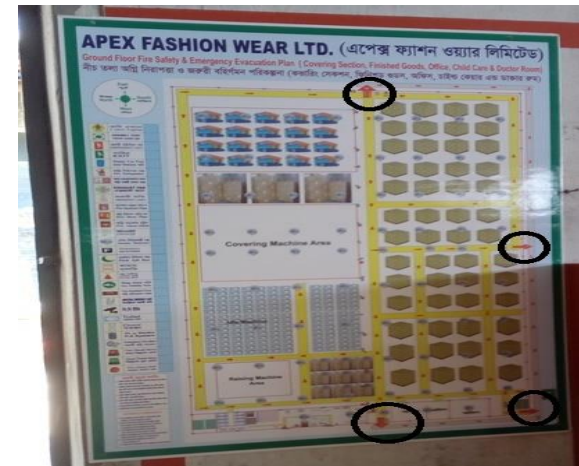
| 12 | Egress | <p>Exits are not remotely located from each other. Due to this reason, travel distance/dead end of aisles/common path of travel is exceeding from the requirements.</p> <p><b>Building: Shed-6 &amp; 15</b></p> | <p>Modify exit arrangement<br/>or<br/>Provide additional exit(s)<br/>or<br/>Reconfigure the egress arrangement to reduce the maximum common path of travel to not more than 23m<br/>or<br/>Provide automatic sprinkler system throughout the building as per NFPA 13</p> | <p>Within 01 Month</p> | |

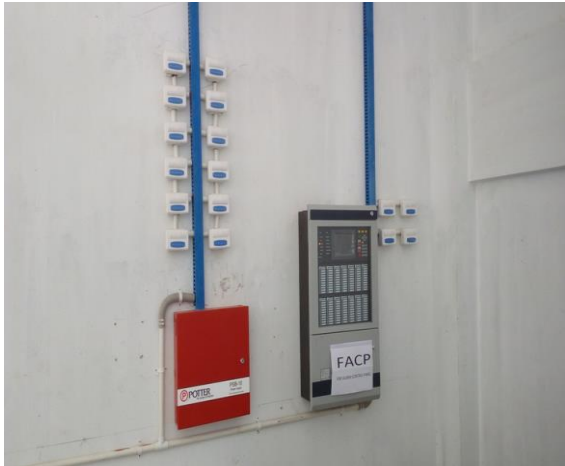
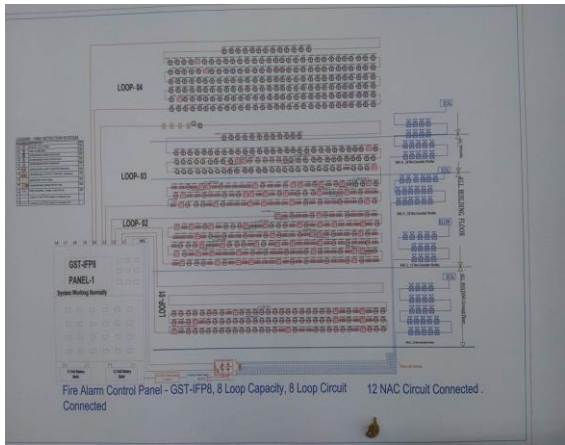
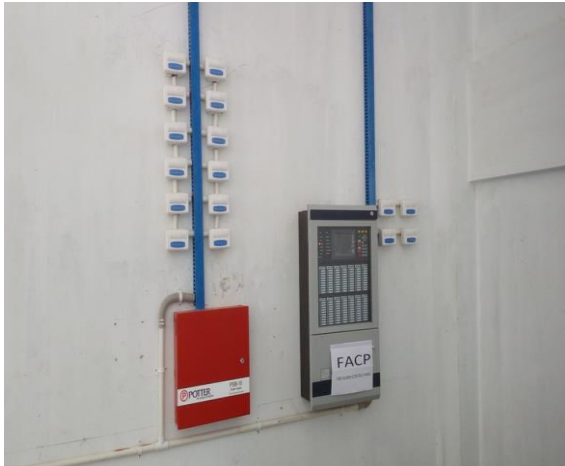
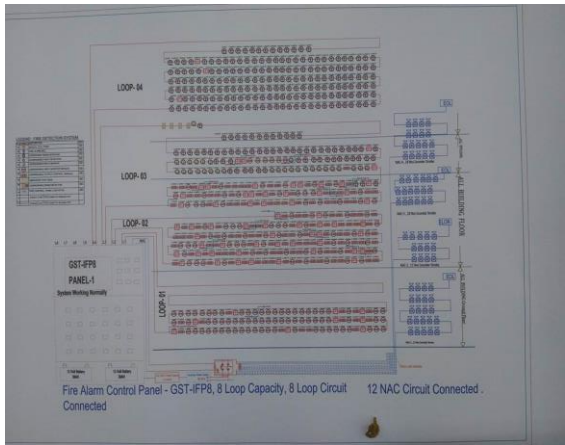
| 13 | Fire Alarm & Detection System | <p>Currently the factory has designed the fire alarm and detection system and started to installation. The design has not been reviewed/approved by any AHJ.</p> <p><b>Location: All buildings &amp; Sheds</b></p> | <p>Submit the addressable fire alarm &amp; detection system drawing to Accord for review. Modify/replace the fire alarm system with a new, listed addressable fire alarm system in accordance with NFPA 72.</p> | <p>Design Submission within 02 Months &amp; Installation within 06 Months</p> | |

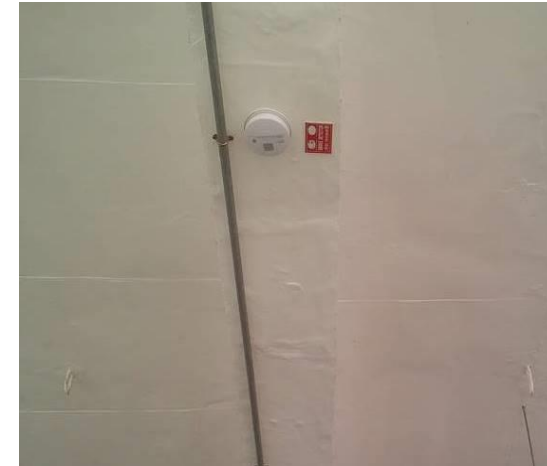
| 14 | Fire Alarm & Detection System | The building is equipped with single-station smoke alarms. Smoke alarm activation sounds only a local alarm and does not provide automatic fire alarm notification of occupants. | Remove single-station smoke alarms. Provide automatic smoke detection throughout the building, tied into the fire alarm system, in accordance with NFPA 72. | Within 06 Months | |

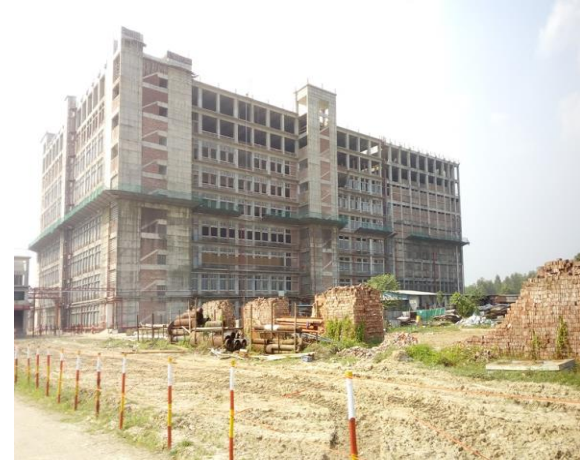
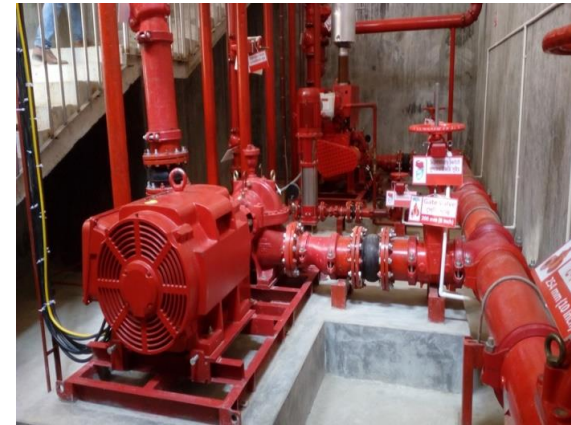
| 16 | Water Based Fire Protection System | <p>The existing high-rise building with an Occupiable floor greater than 23 m (75 ft.) above the finished grade is not protected with an approved automatic sprinkler system. The large occupant loads, heavy fuel loading, and anticipated extended egress times warrant sprinkler protection</p> <p><b>Location: Building 7&amp;8</b></p> | <p>Provide an automatic sprinkler protection throughout the building in accordance with NFPA 13. Pump Installation shall be as per NFPA 20. Required materials shall be listed/3rd party certified.</p> | <p>Design Submission within 02 Months &amp; Installation within 09 Months</p> | |
