# Designtex Knitwear Ltd.

Beraiderchala, Sreepur, Gazipur, 1740, Dhaka

16<sup>th</sup> September 2018

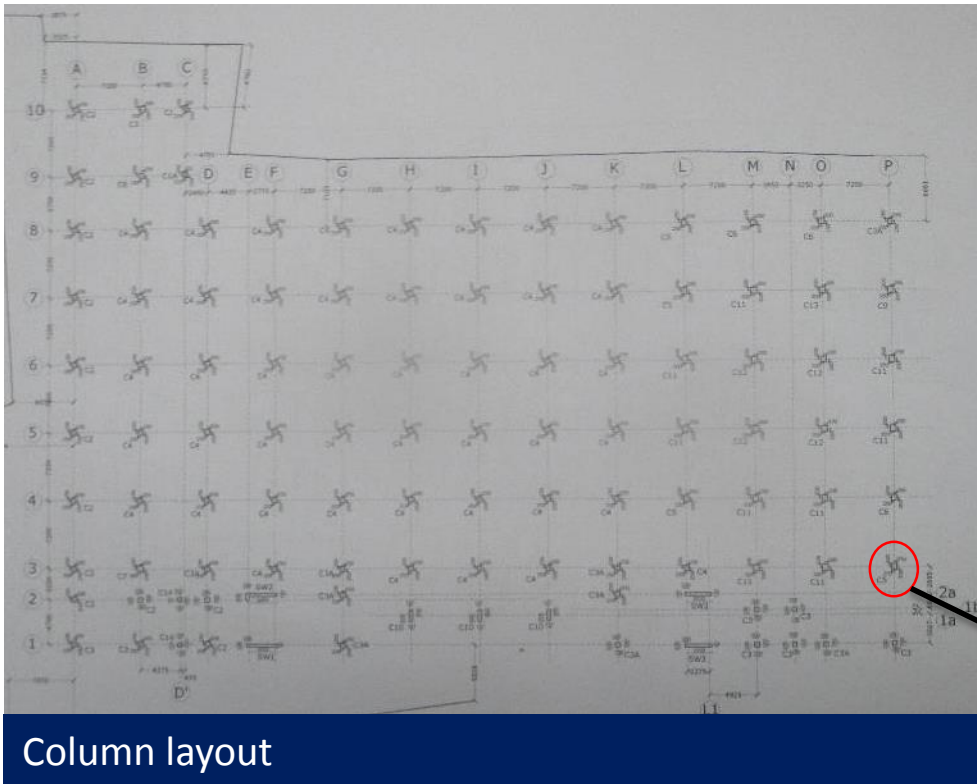
Column layout

The size of the marked column was found 500mm instead of 600mm as shown in the as-built drawing. The dimension of the column is required to be revised in column schedule and layout.

| Item No. | Observation | Recommended Action Plan | Recommended Timeline |
|---|---|---|---|
| 1 | (Main Production Building)<br>Discrepancies between drawings and on-site observation | Factory engineer is required to survey all the structural elements properly and produce correct as built drawings. | 6-weeks |

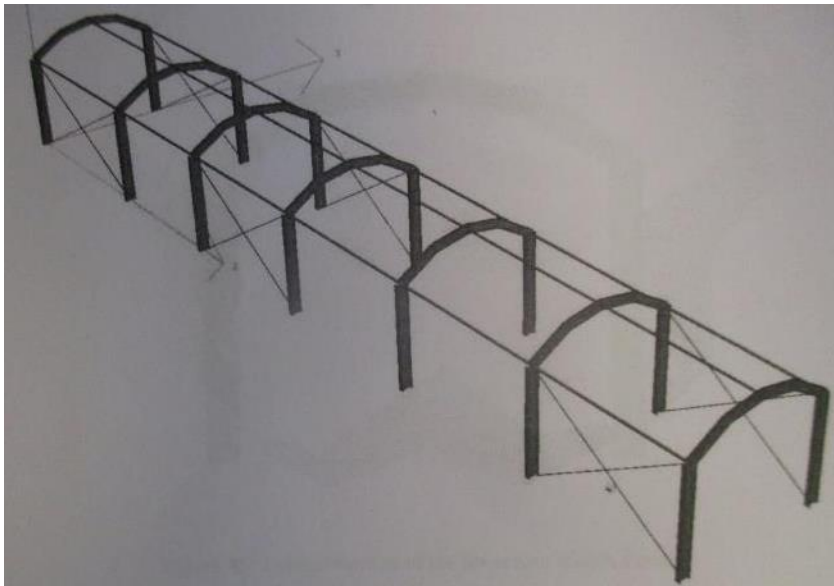
Arrangement of Vertical cable bracings considered in the design report

The on-site location of vertical cable bracing did not match with design report. Moreover, no bracing layout was found in the structural drawing. Factory is required to review the design and submit to ACCORD for reviewing.

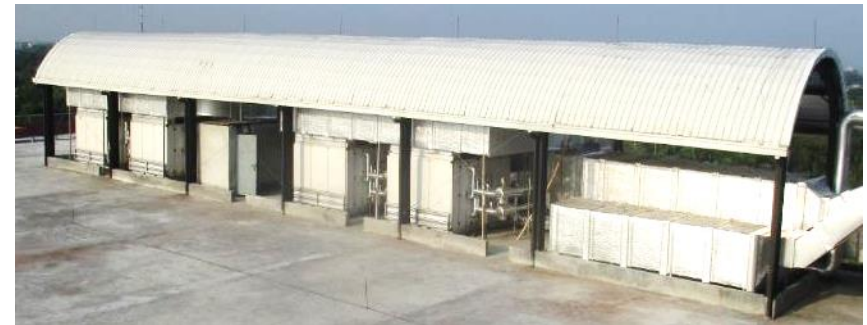
On site location of vertical bracing

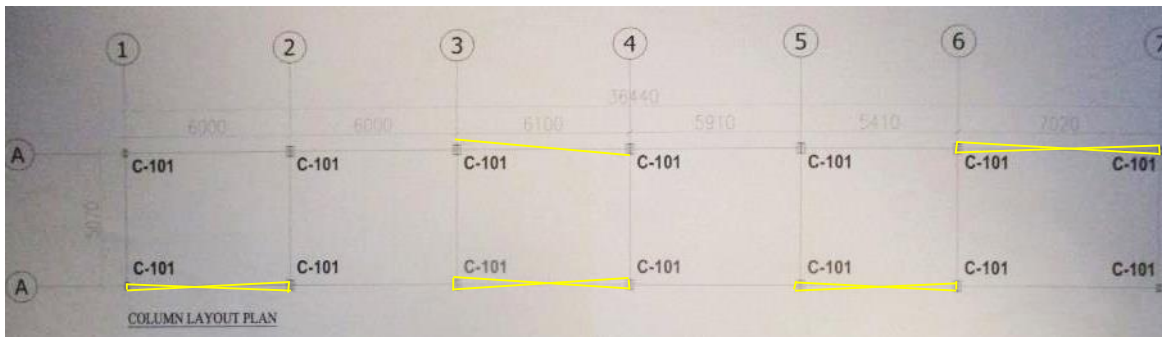
On site location of vertical bracing

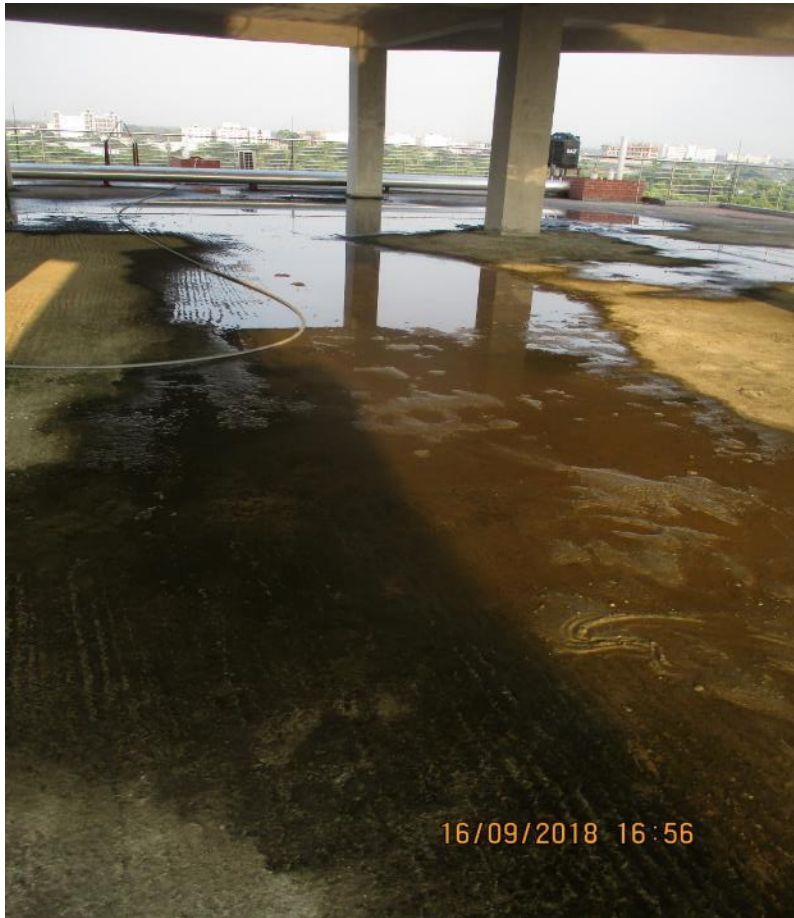
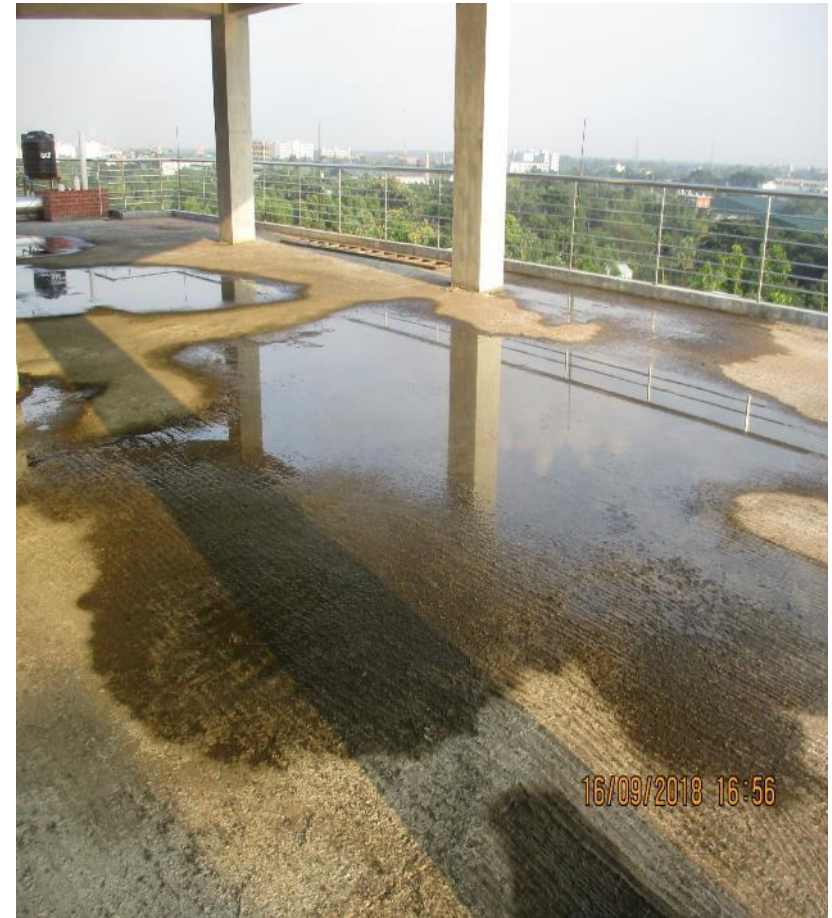
Water ponding was observed on roof. Factory is required to install the proper drainage system.

| Item No. | Observation | Recommended Action Plan | Recommended Timeline |
|---|---|---|---|
| 4 | (Main Production Building)<br>Water ponding on roof | Factory is required to implement proper drainage system and other remedial measures to prevent water ponding. | 6-weeks |

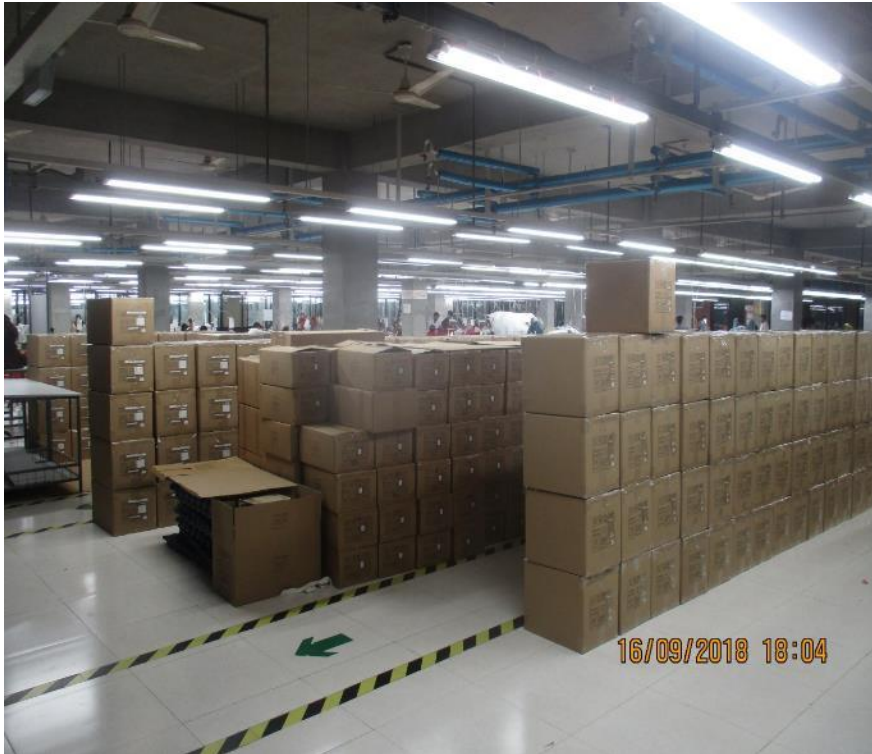
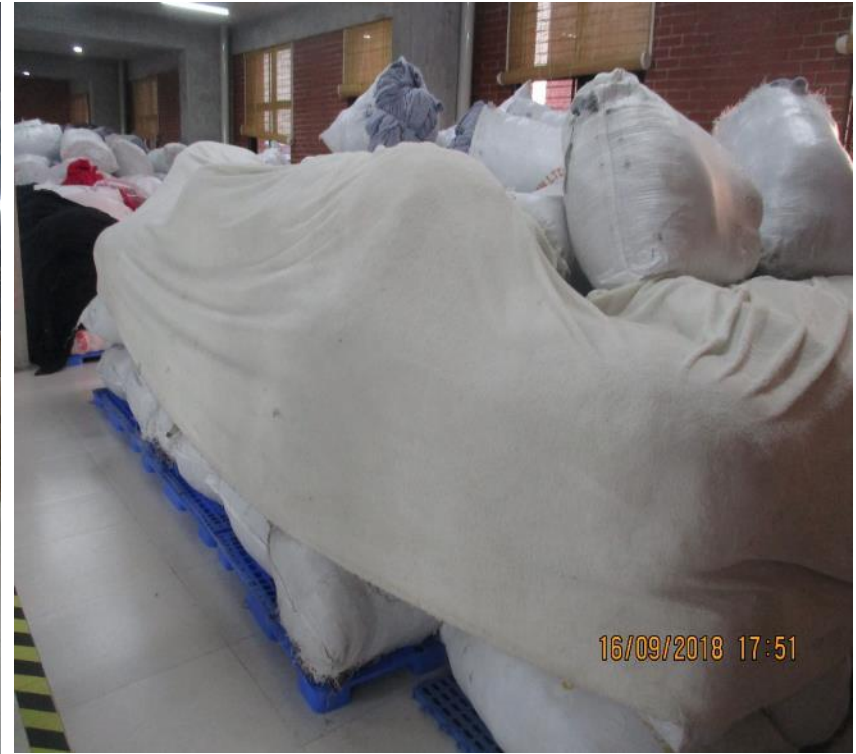
No load management programs were visible except posting load plan. Factory is required to implement load management program as per its floor loading capacity and Follow the load plans for all floors of the buildings and make sure that the workers understand the loading requirements.

| Item No. | Observation | Recommended Action Plan | Recommended Timeline |
|---|---|---|---|
| 5 | (Main Production Building)<br>Implement floor load management program | Factory is required to implement load management program (signage, load restriction height marking) as per its floor load plan. | 6-weeks |
| 6 | (Main Production Building)<br>Implement floor load management program | Continue to implement load plan. | 6-months |

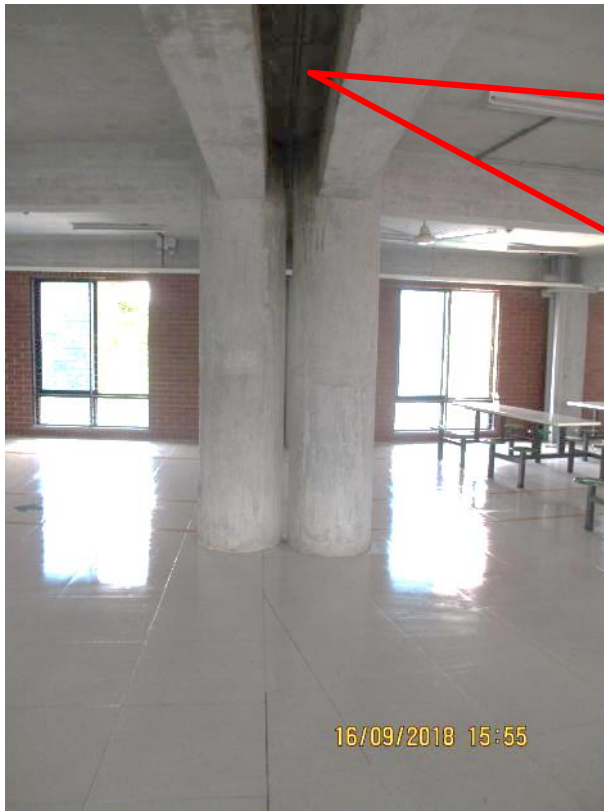
Gap at expansion joint covered with mortar and tiles

The expansion joints are covered with cement mortar with tiles on top. Clear gap is required to be provided throughout the expansion joint and the gap is to be filled with appropriate materials as per engineer's recommendation.

| Item No. | Observation | Recommended Action Plan | Recommended Timeline |
|---|---|---|---|
| 7 | (Facility Building )<br>Expansion joints do not have gap/adequate clearance | Clear gap is required to be provided throughout the expansion joint and the gap is to be filled with appropriate materials as per engineer's recommendation. | 6-weeks |

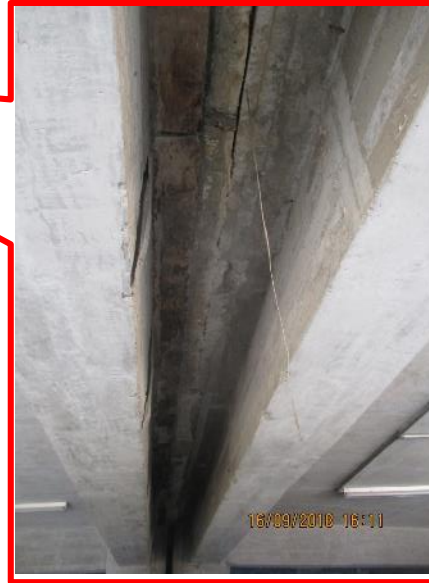
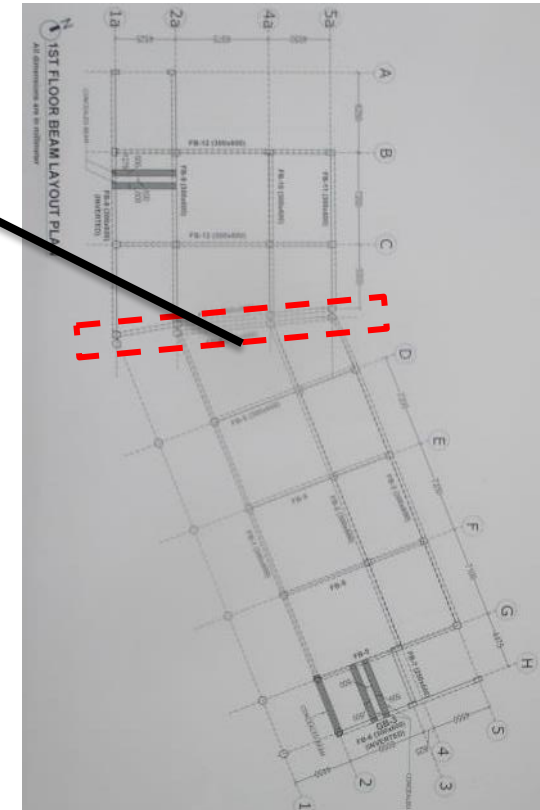
Location of expansion joint in beam layout drawing

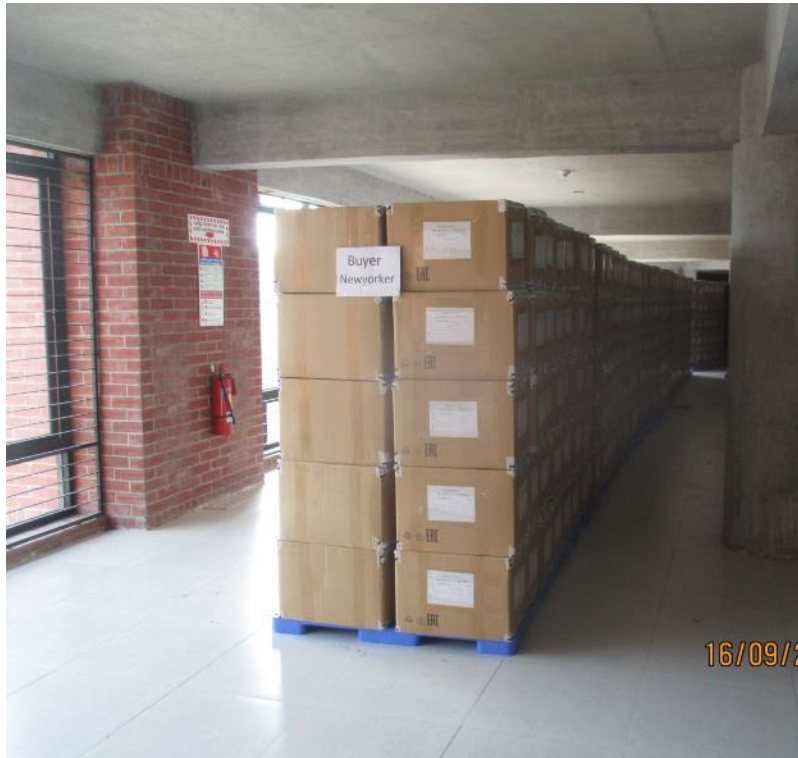
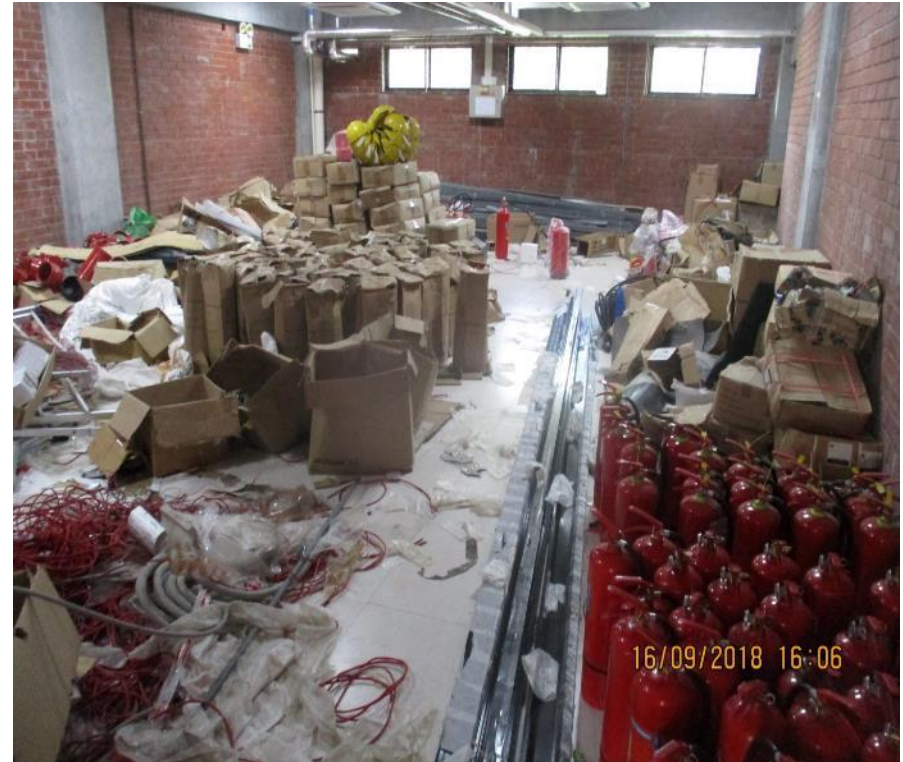
No load management programs were visible except posting load plan. Factory is required to implement load management program as per its floor loading capacity and Follow the load plans for all floors of the buildings and make sure that the workers understand the loading requirements.

| Item No. | Observation | Recommended Action Plan | Recommended Timeline |
|---|---|---|---|
| 8 | (Facility Building )<br>Implement floor load management program | Factory is required to implement load management program (signage, load restriction height marking) as per its floor load plan. | 6-weeks |

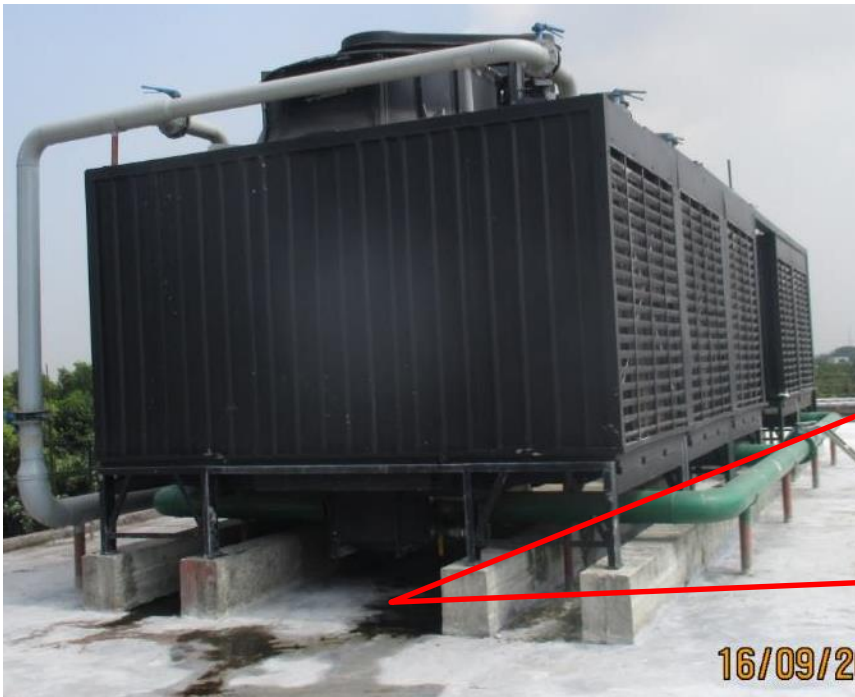
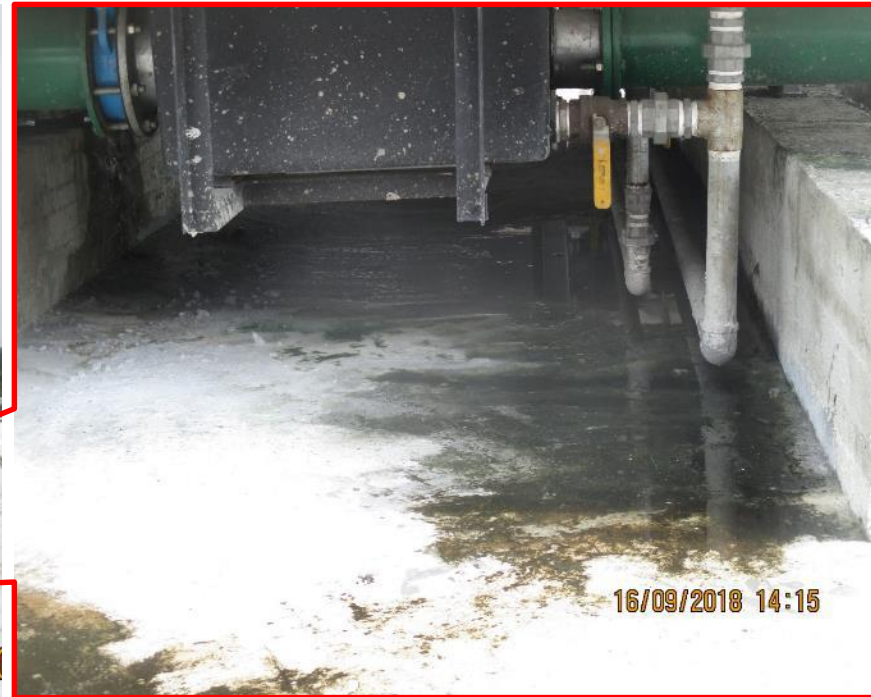
Water ponding was observed under cooling tower on roof. Factory is required to install the proper drainage system.

| Item No. | Observation | Recommended Action Plan | Recommended Timeline |
|---|---|---|---|
| 9 | (Utility Building )<br>Water ponding on roof | Factory is required to provide proper drainage and other remedial measures to prevent water ponding. | 6-weeks |

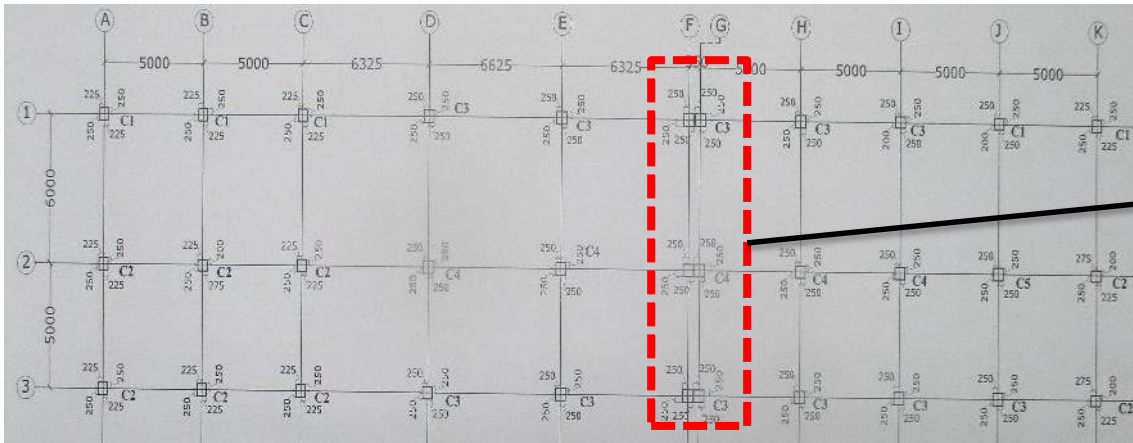
Location of expansion joint in column layout drawing

The expansion joints are covered with cement mortar with tiles on top. Clear gap is required to be provided throughout the expansion joint and the gap is to be filled with appropriate materials as per engineer's recommendation.

| Item No. | Observation | Recommended Action Plan | Recommended Timeline |
|---|---|---|---|
| 10 | (Utility Building )<br>Expansion joints do not have gap/adequate clearance | Clear gap is required to be provided throughout the expansion joint and the gap is to be filled with appropriate materials as per engineer's recommendation. | 6-weeks |

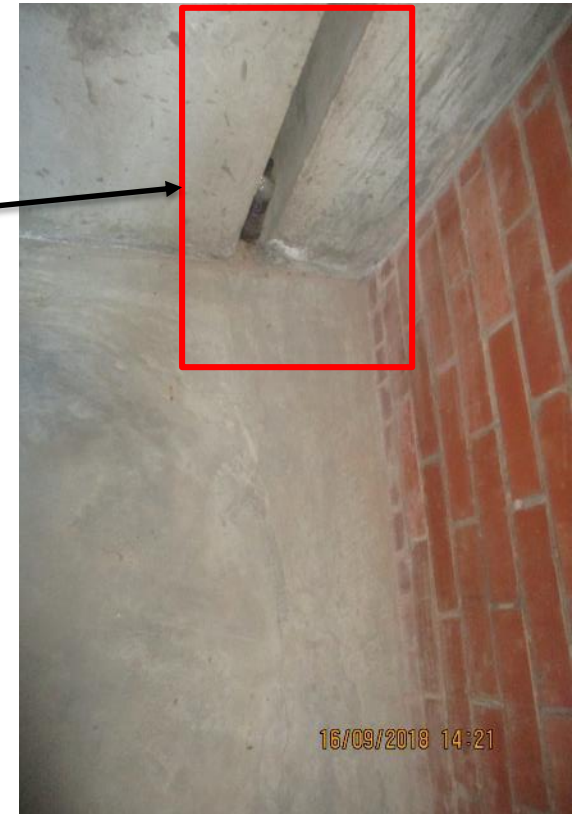
Expansion joint covered with mortar

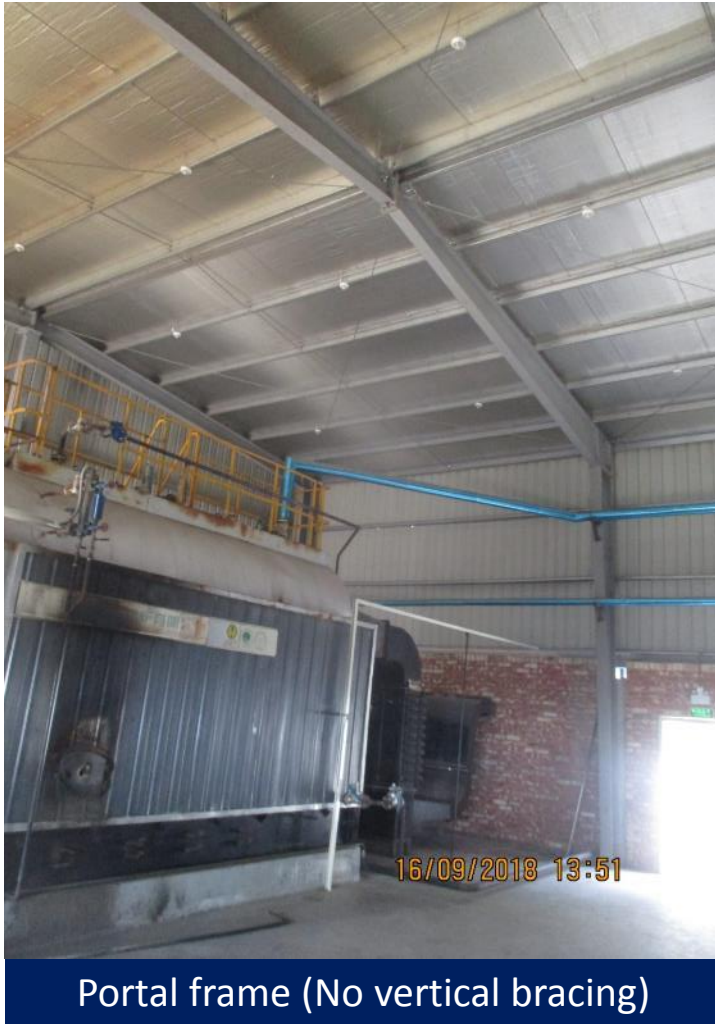
Portal frame (No vertical bracing)

During inspection, no vertical bracing or compression strut was observed. Factory is required to check lateral stability of boiler shed against lateral loads.

| Item No. | Observation | Recommended Action Plan | Recommended Timeline |
|---|---|---|---|
| 12 | (Boiler Shed)<br>Lateral stability is required to be verified | Factory is required to provide lateral stability check against lateral loads. | 6-weeks |
| 13 | (Boiler Shed)<br>Lateral stability is required to be verified | Carry out remedial action as per engineering assessment where required. | 6-months |

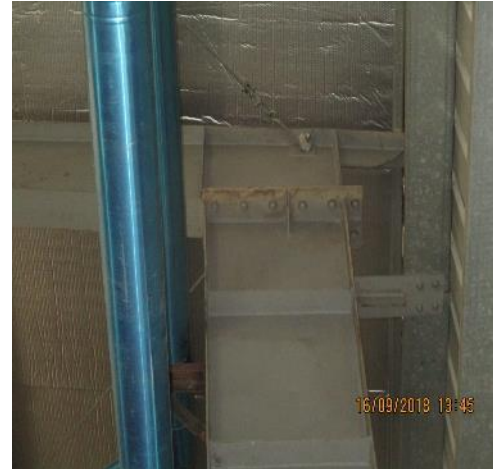
Bolted connection  
between rafter and  
column

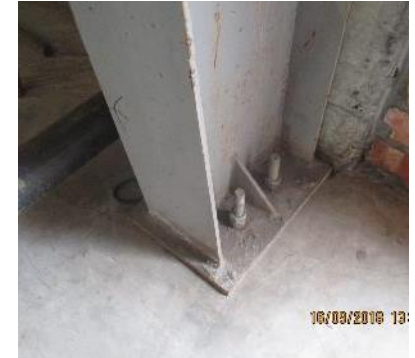
Bolted connection  
between pedestal  
column and steel  
column

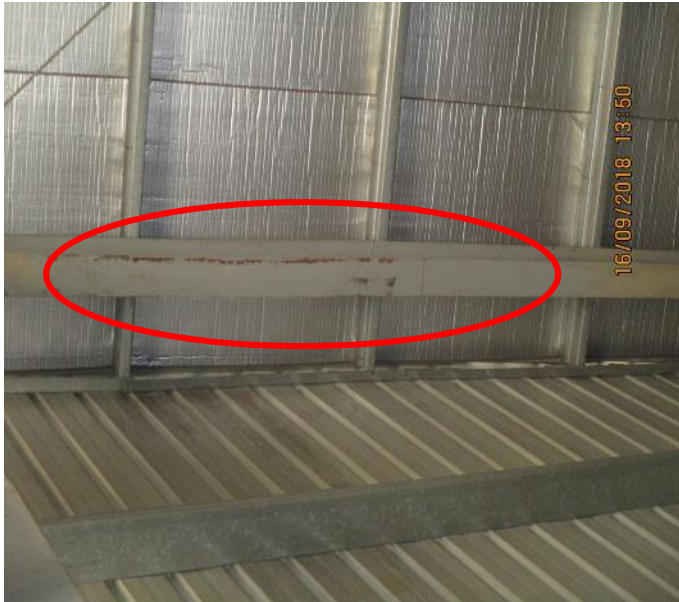
Corrosion was observed at rafter

Corrosion was observed at various location on steel members. Factory is required to identify all the corroded locations and take proper remedial measures.

| Item No. | Observation | Recommended Action Plan | Recommended Timeline |
|---|---|---|---|
| 14 | (Boiler Shed)<br>Corrosion observed at steel sections | Factory engineer to recommend proper remedial measures for protection of steel sections from corrosion. | 6-weeks |

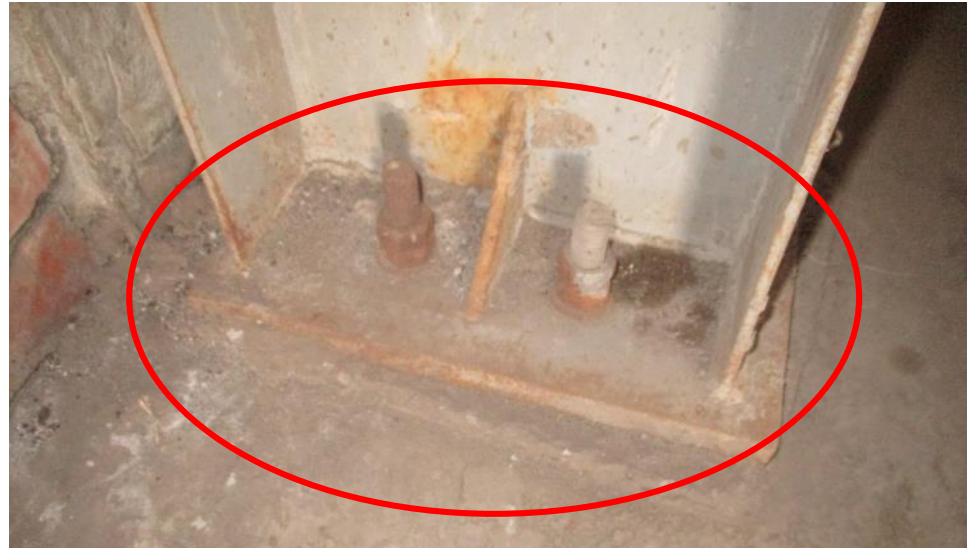
Corrosion was observed at joint of steel column and pedestal column
