# **FIRE SAFETY INSPECTION REPORT**

**MILLENNIUM TEXTILES (SOUTHERN) LTD**  
**BARA RANGAMATIA, ZIRABO, ASHULIA, SAVAR**

**ACCORD**  
on Fire and Building Safety in Bangladesh

April 8, 2014

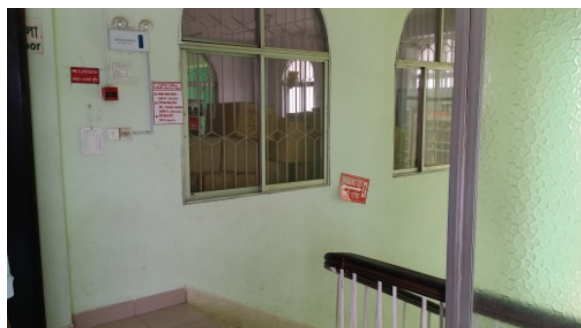
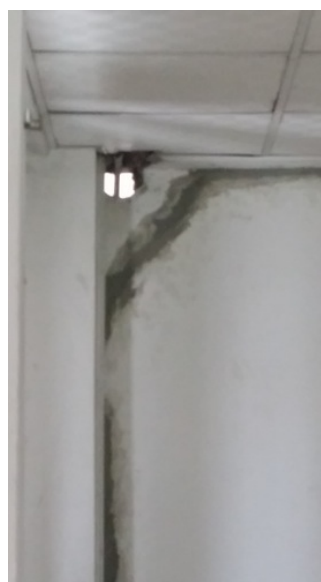
No.	Category	Finding	Recommendation	Remediation Timeframe
F-1	Fire Rated Construction	Unsealed penetrations and openings were present and located in the North and West exit stairwells on most floors.	Seal all penetrations and openings in exit stair enclosure walls to maintain the fire separation.	Within 3 months

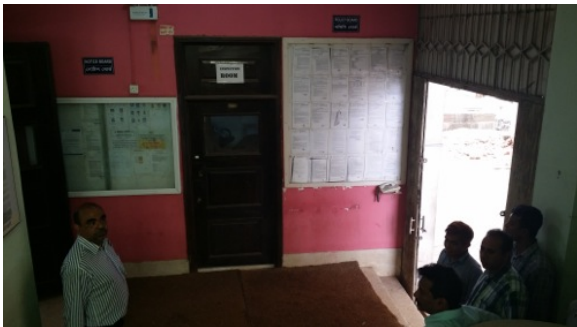
F-2	Fire Rated Construction	The exit stairs are not separated from work areas on each floor by fire-rated construction. Affected stairwells were the North and West.	Provide minimum 1.5-hr fire rated doors and seal all unprotected openings to separate the exit stairs from work areas and other building spaces on all floor levels. Ensure that the fire doors are self-closing and positive latching and that they are provided with fire exit (panic) hardware where serving production floors.  If fire doors are required to be held open for functional reasons, provide automatic-closing devices tied to the fire alarm system.	Within 3 months
-----	-------------------------	--	---	-----------------

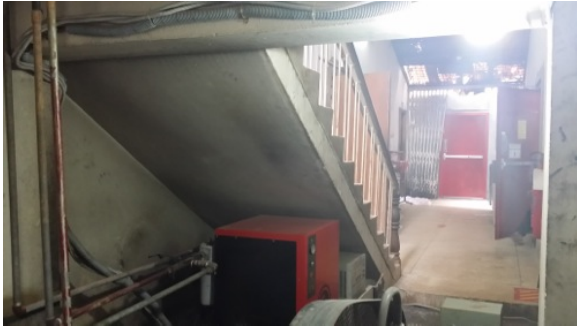
F-3	Egress	Storage located in the west stairwell on ground floor, underneath the stairwell.	Remove all storage from exit stairs and egress paths.	Immediate
-----	--------	--	---	-----------

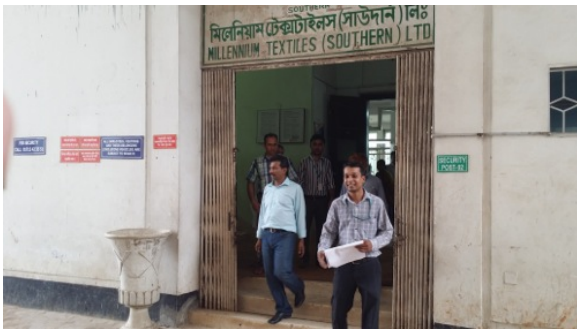
F-4	Egress	Egress doors / gates with locking features are provided at building exits, and some exit stairs, throughout the building.	Remove locking features from all egress doors / gates.  If locks are required for security reasons, utilize special door locking features complying with NFPA 101.	Immediate
-----	--------	---	--	-----------

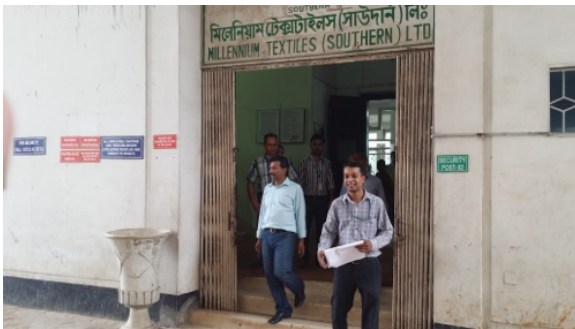
F-5	Egress	Although fire rated doors with panic hardware were installed, some exit doorways on various floors continued to utilize sliding gate type doors.	Replace all gates / sliding doors along the means of egress with side-hinged, swinging egress doors.  If locks are required for security reasons, utilize special door locking features complying with NFPA 101.	Within 1 month
-----	--------	--	--	----------------

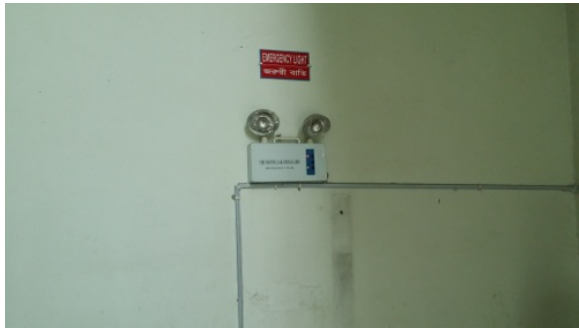
F-6	Fire Protection	Inspection, testing, and maintenance records for the fire alarm system was not in accordance with NFPA 72.	Inspect, test and maintain the fire alarm system, and keep written records on-site, in accordance with NFPA 72.	Within 3 months
F-7	Egress Lighting	Manual on-off switch is provided for emergency lighting units. This was reflected on all floors.	Remove manual on/off switches from [emergency lighting / exit signage] units to prevent them from being switched off.	Within 1 month
