# Anowara Fashions Ltd.

35/A ,Hajigonj Road,Narayanganj.

24<sup>th</sup> September 2018

# Observation

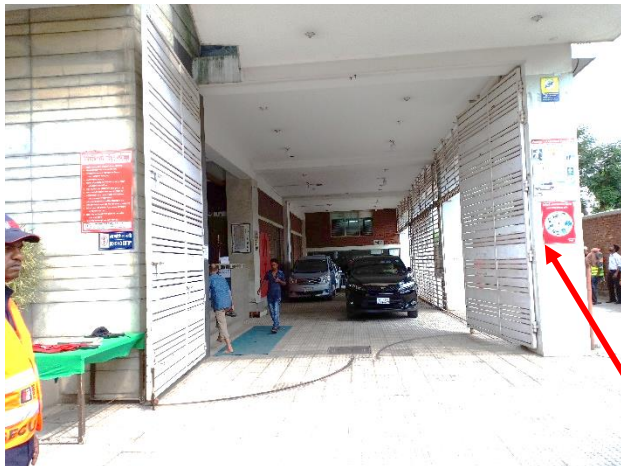
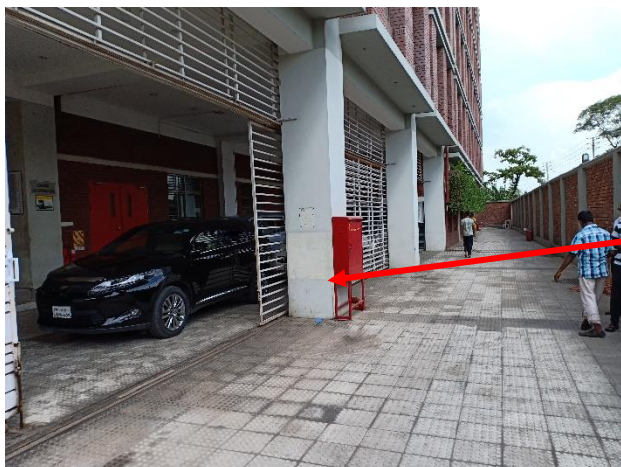
# Columns susceptible to vehicle impact

Impact protection not provided to columns at loading –unloading area. Columns are susceptible to impact loading from vehicles.

1: Columns susceptible to vehicle impact.

| Item No. | Observation | Recommended Action Plan | Recommended Timeline |
|---|---|---|---|
| 1 | Columns susceptible to vehicle impact. (Factory Building) | Install a barrier to prevent vehicle impact in column. | 6-weeks |

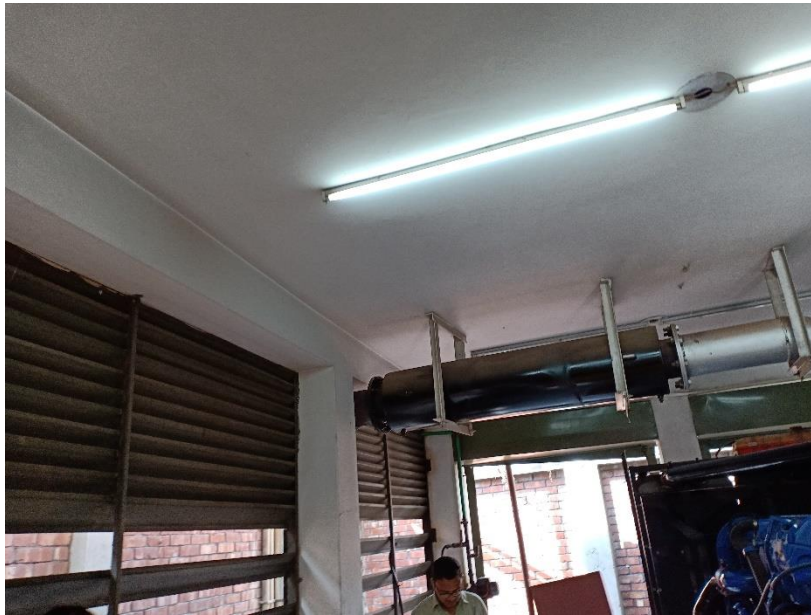
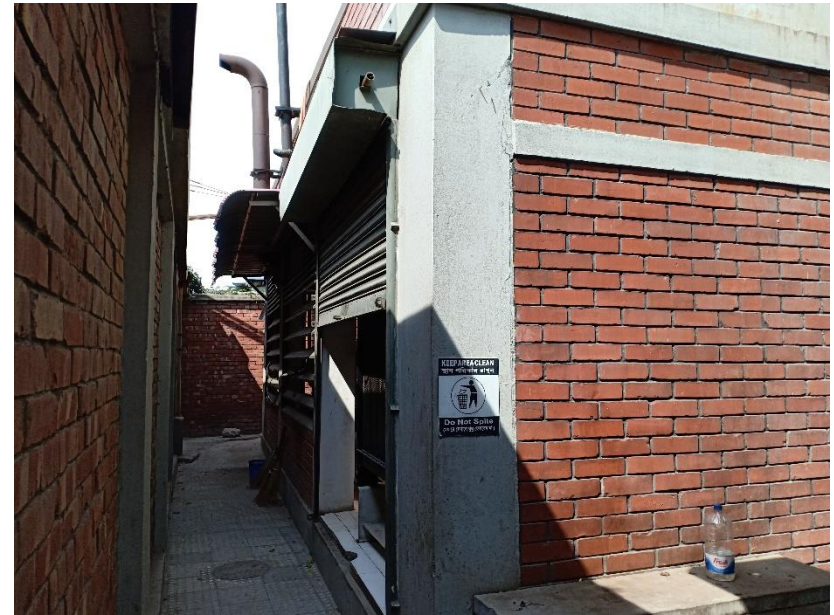
Generator Building

No drawings were available for generator building.

2: Lack of drawing for Generator Building.

| Item No. | Observation | Recommended Action Plan | Recommended Timeline |
|---|---|---|---|
| 2 | Lack of drawing for Generator Building. (Generator Building) | Prepare update as-built documentation Generator Building. | 6-weeks |
